Department of Water Resources

INVESTIGATION OF FAILURE
BALDWIN HILLS RESERVOIR

APRIL 1964

Baldwin Hills Reservoir Failure Consulting Board Report

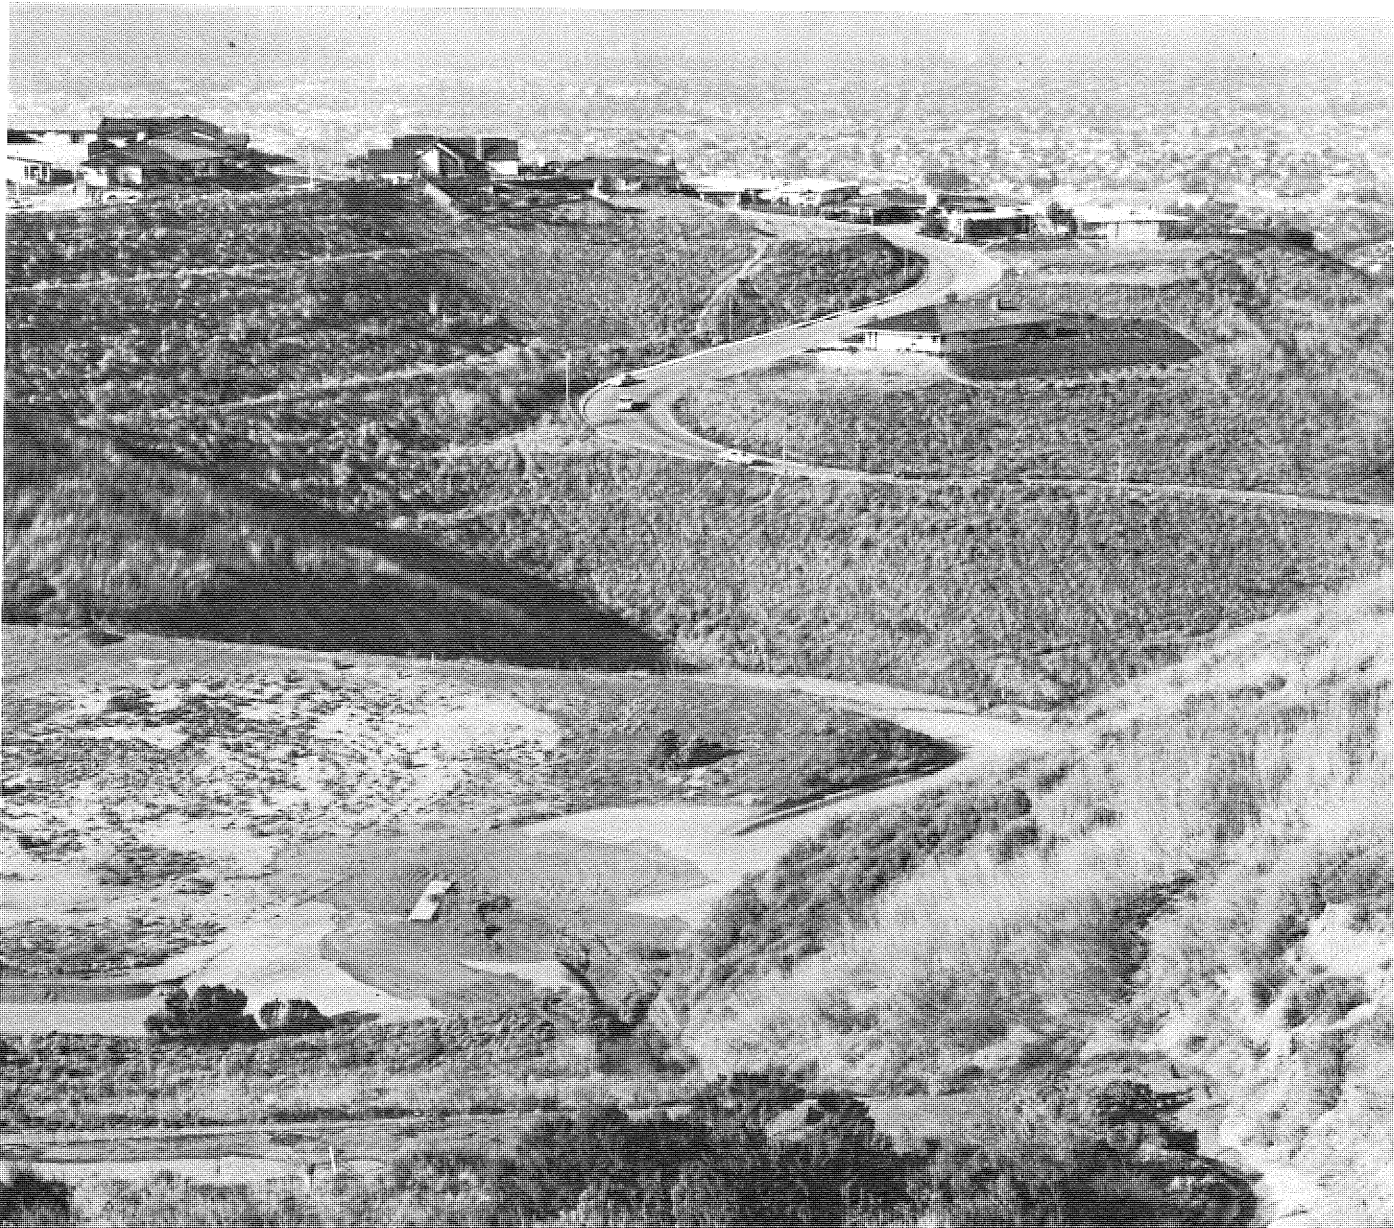
Tate reports that he and Wells were the first to observe the leakage emerging downstream of the dam. He believes that the flow through the structure had just begun because the wet spot was not more than 4 or 5 feet in diameter. He estimates that the water running into the surface drain had not flowed for a distance greater than about 4 or 5 feet. The surface drain was a concrete gutter constructed to carry rainwater to the catch basin. Tate is of the opinion that the leakage was emerging from the abutment and not from the embankment. He estimates that the first time he saw this leakage must have been within 15 minutes of the time that it started. Upon returning from his home, in about a half hour, the flow had increased so that it was running down the surface drain into the catch basin near Manhole A. (Photos 1 through 4)

PHOTO 1. Discharge at east abutment of the main dam at about 2:15 p.m. Note flow entering
catch basin.

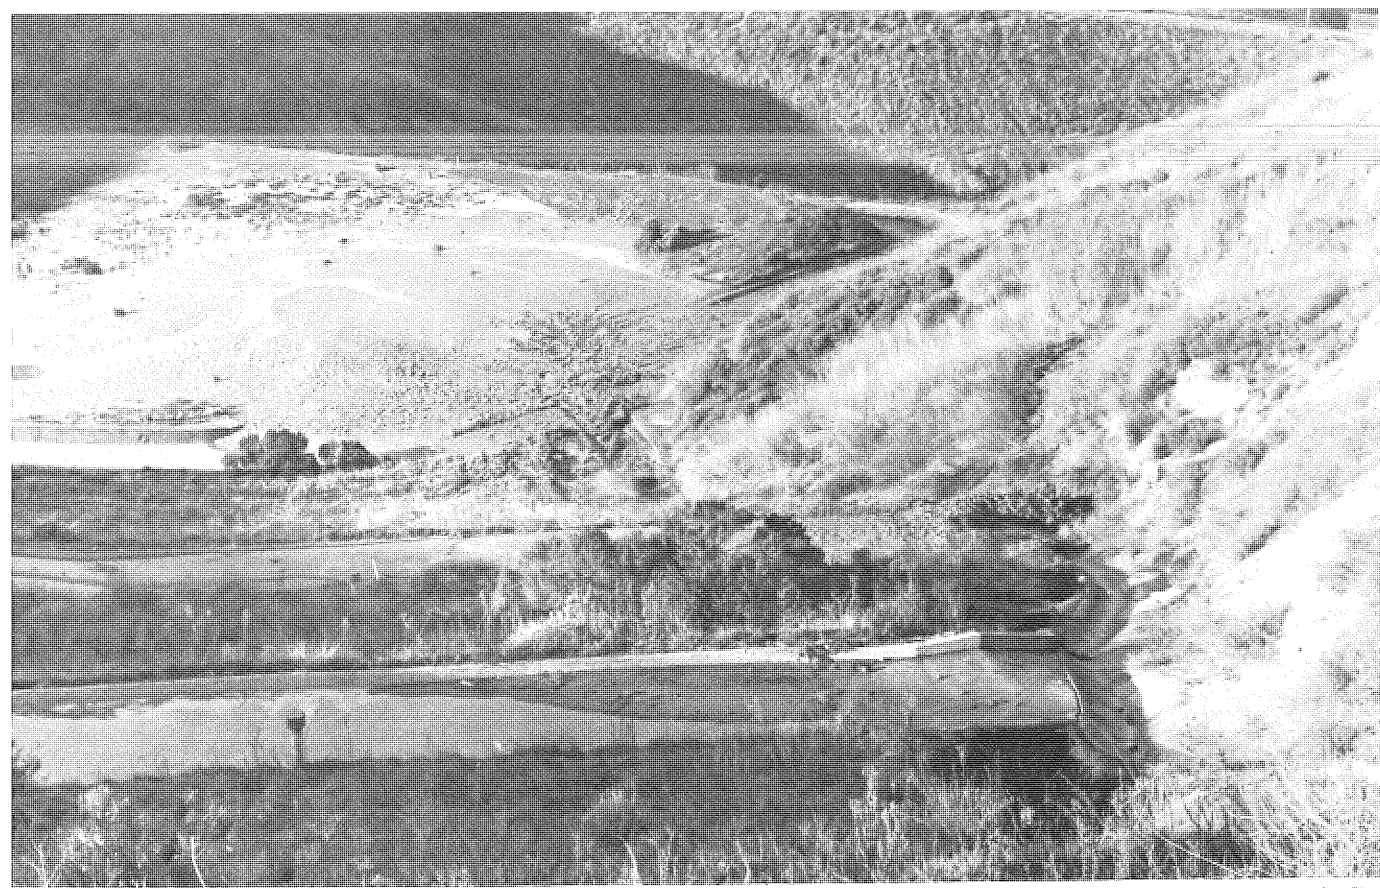
PHOTO 2. Flow spreading on Elevation 340 berm. Estimated time 2:30 p.m. Note submergence of catch basin and cavities developing at gutter.

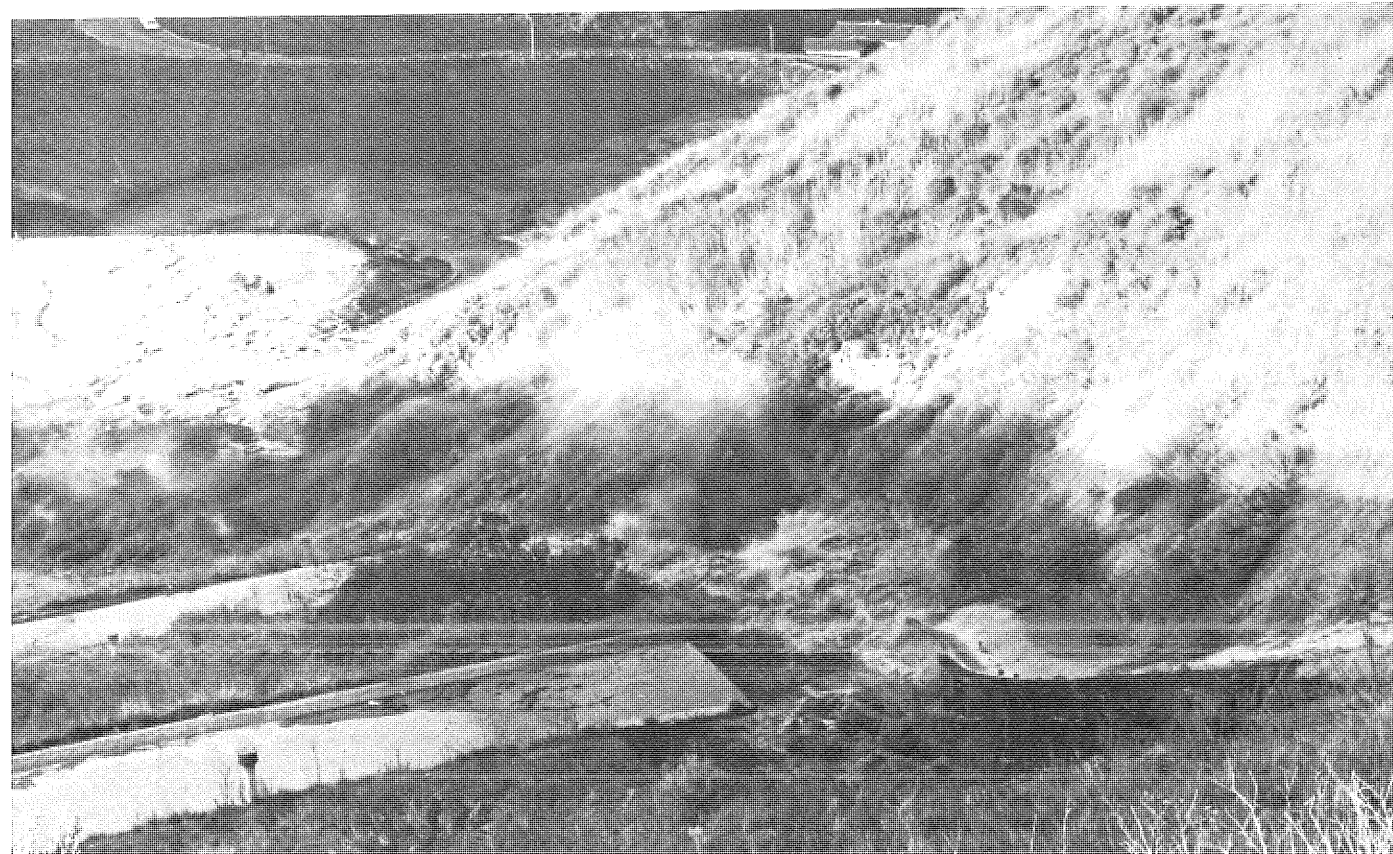
PHOTO 3. Accelerating discharge at about 3:30 p.m. Observe ponding at street embankment.

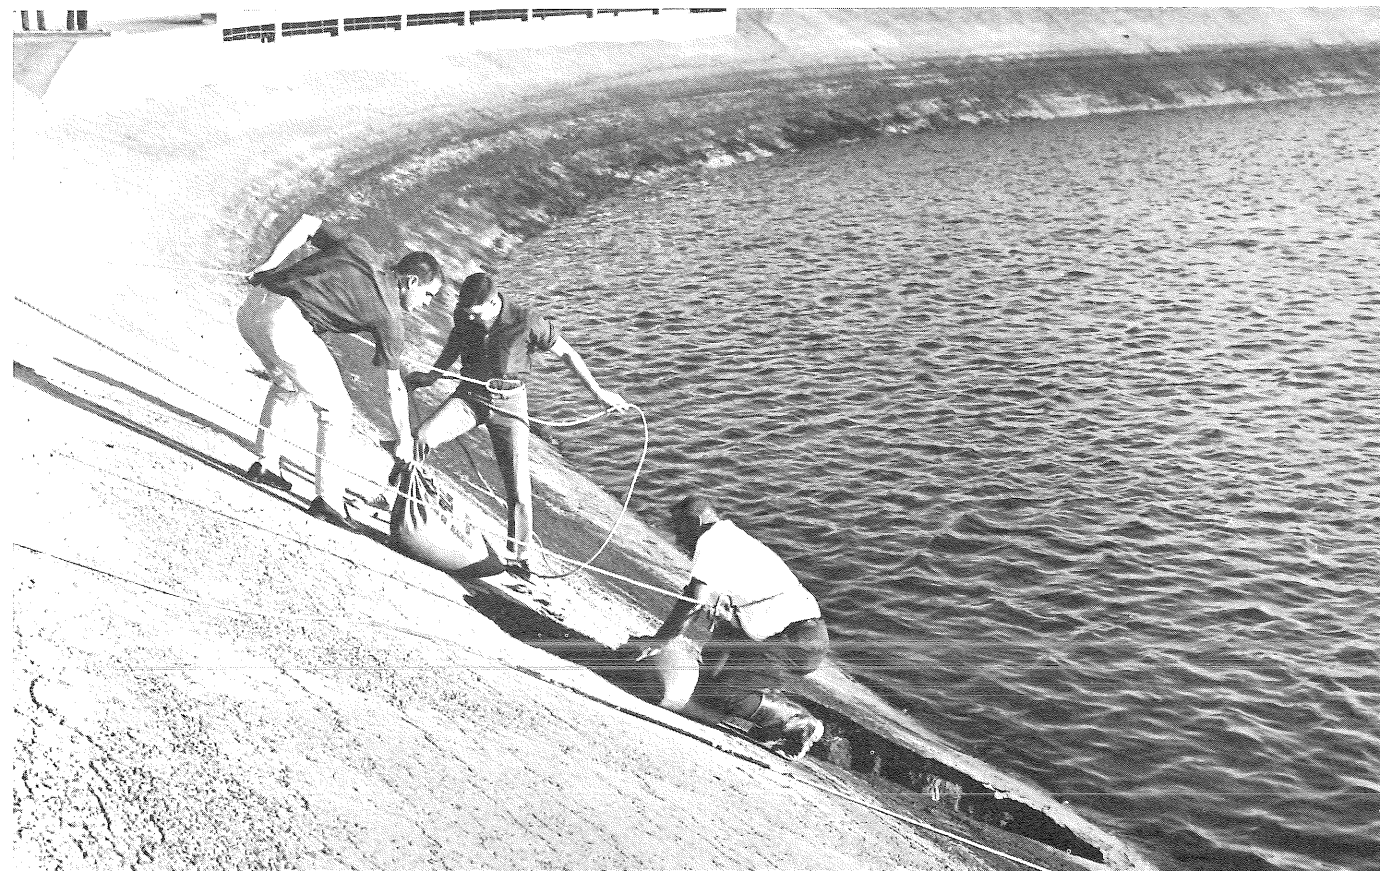
PHOTO 6. Attempt at sandbagging hole in main dam, at about 2:50 p.m.

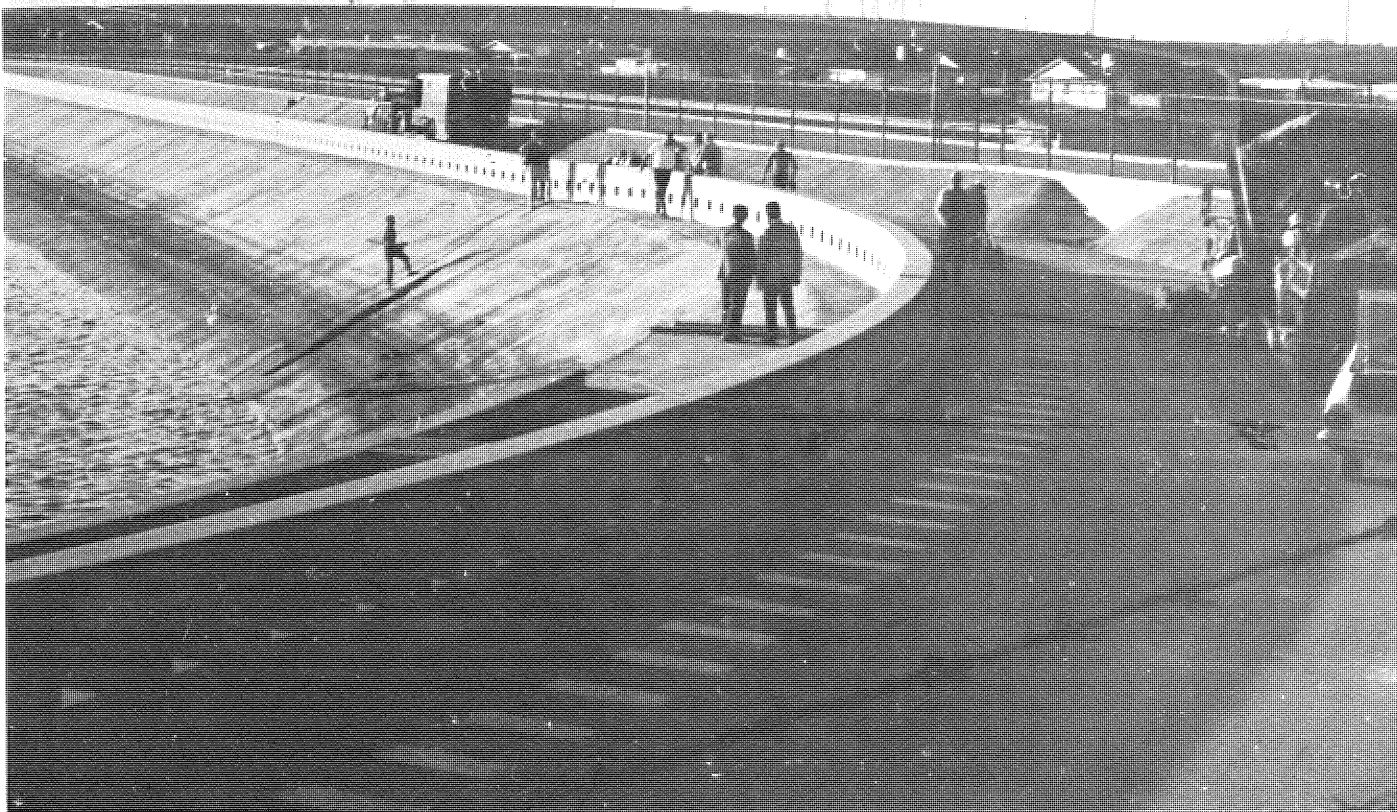
PHOTO 7. Efforts toward plugging hole proved futile. Note lowering of water level in race to empty the reservoir. Estimated time 3:00 p.m.

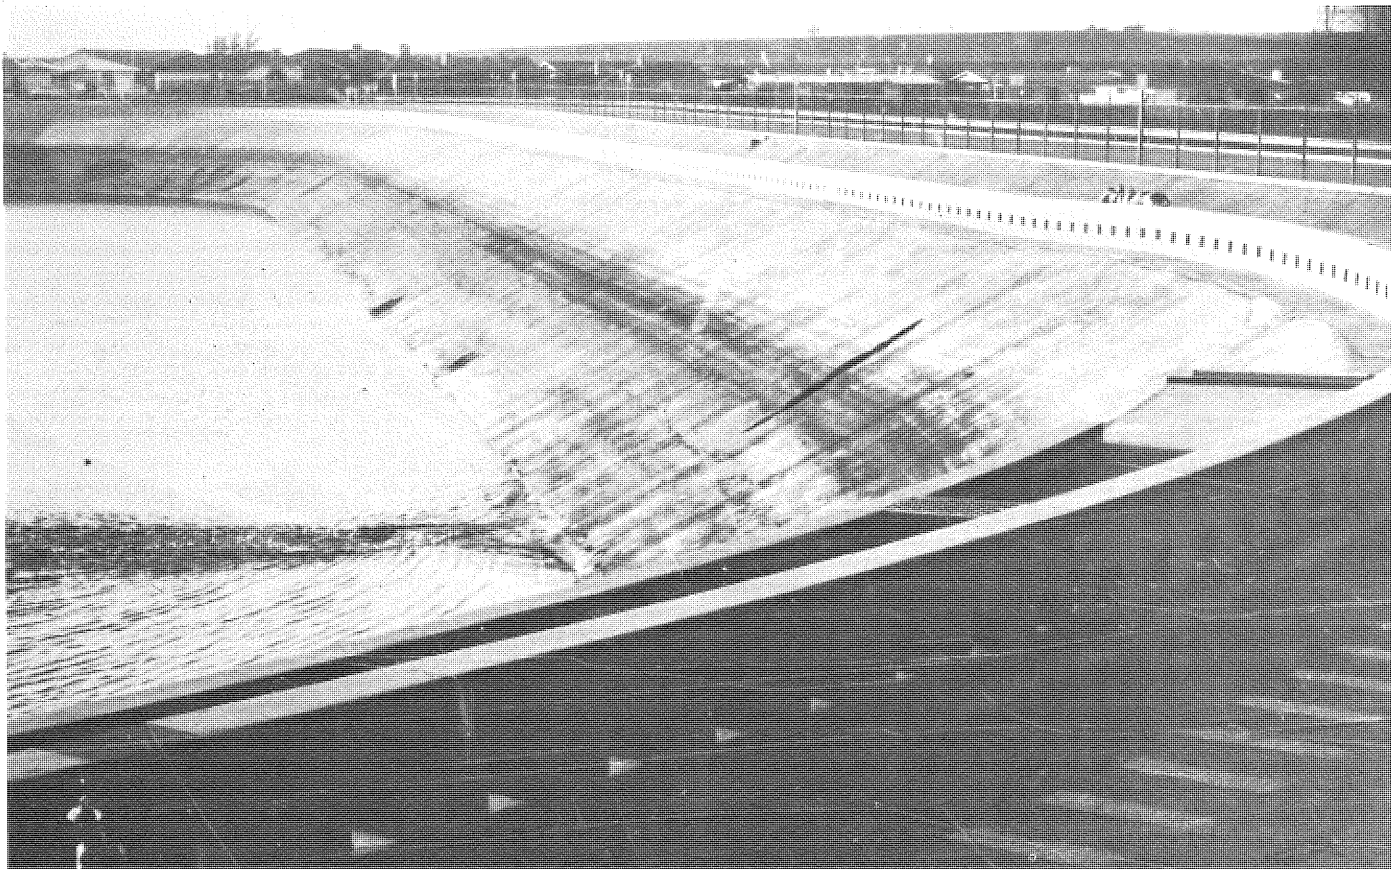
PHOTO 8. Appearance of a vortex on the water surface indicating the start of a major breakthrough, at about 3:20 p.m.

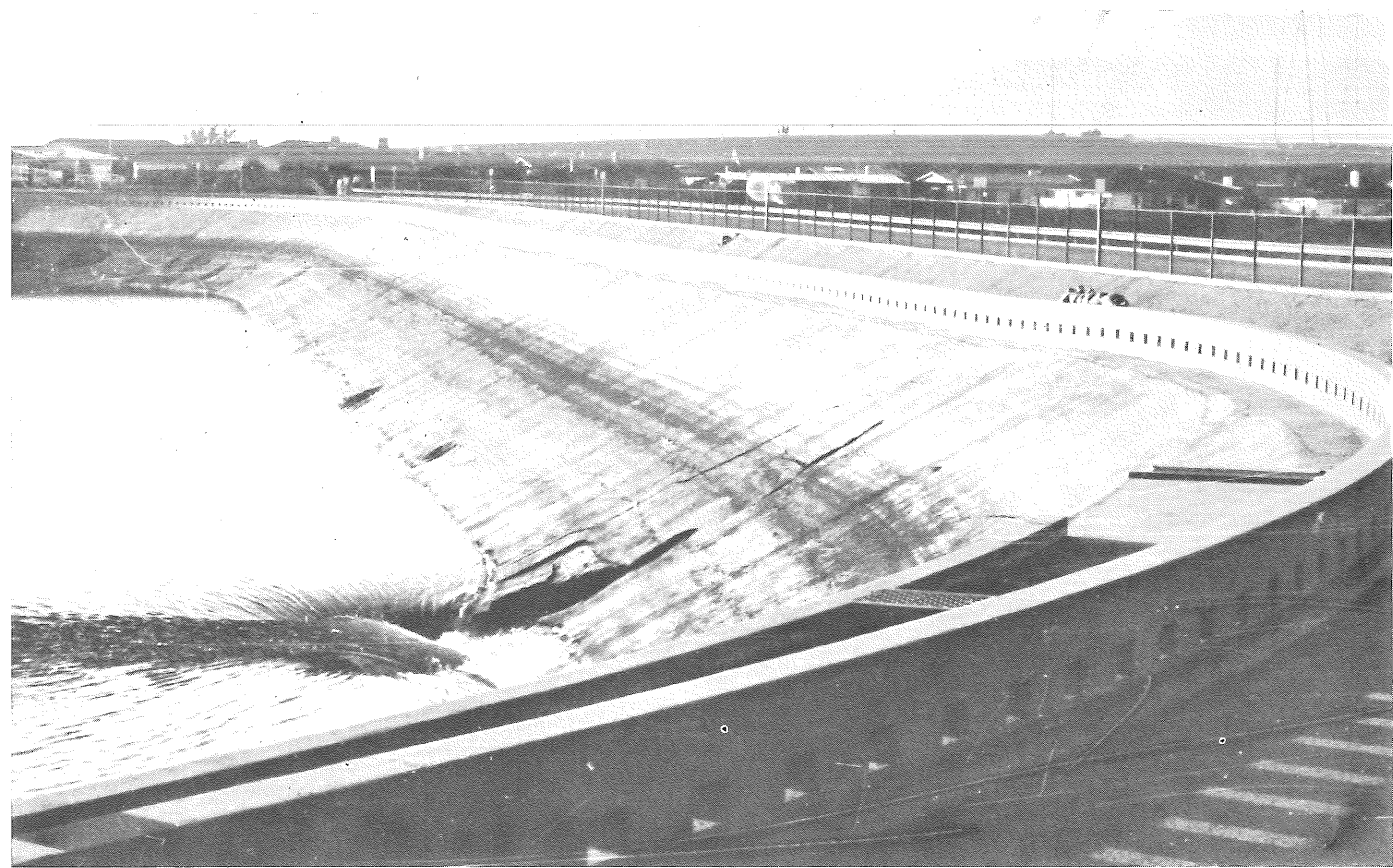
PHOTO 9. Widening of the break at approximately 3:25 p.m.

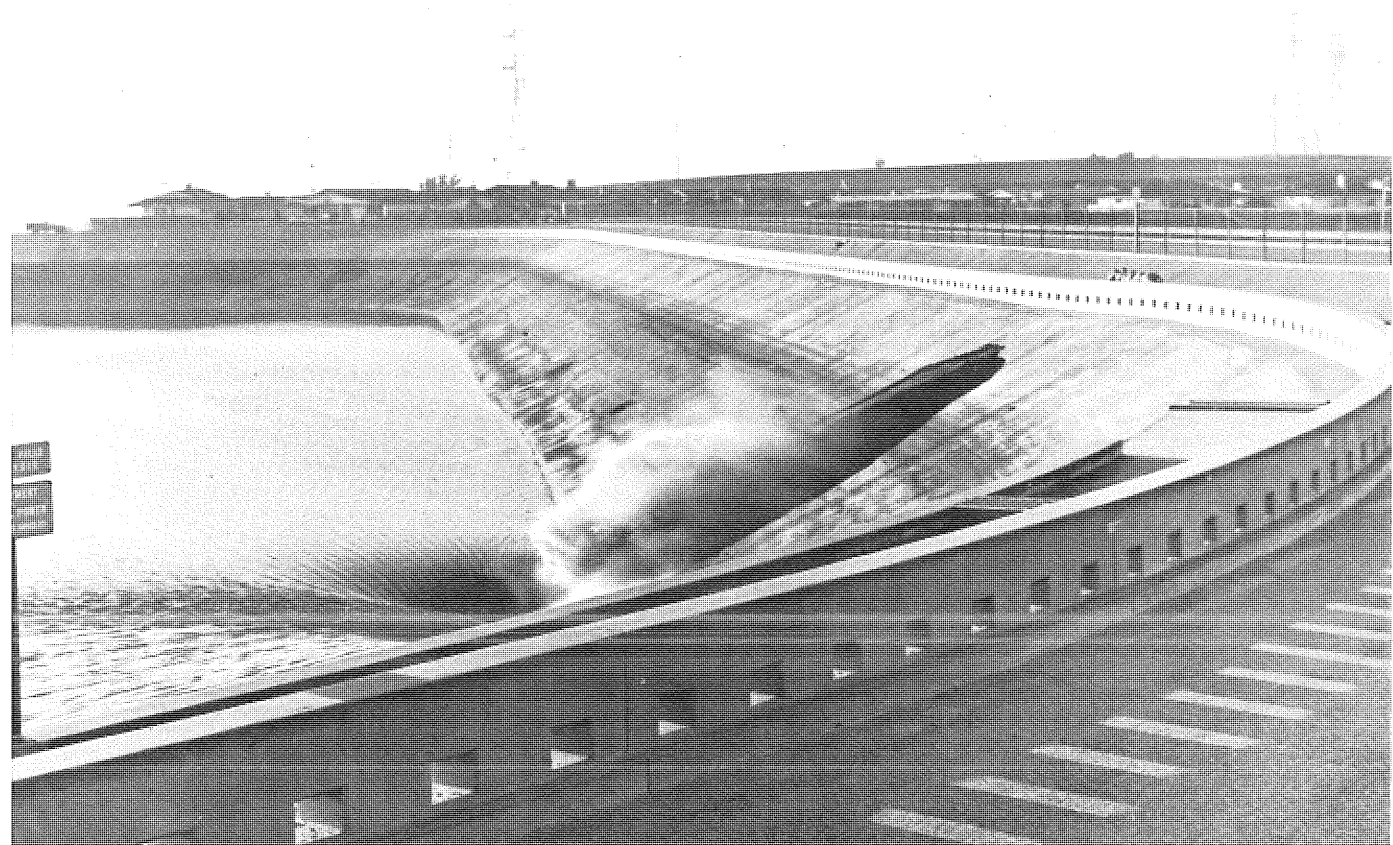
PHOTO 10. The break, at about 3:30 p.m.

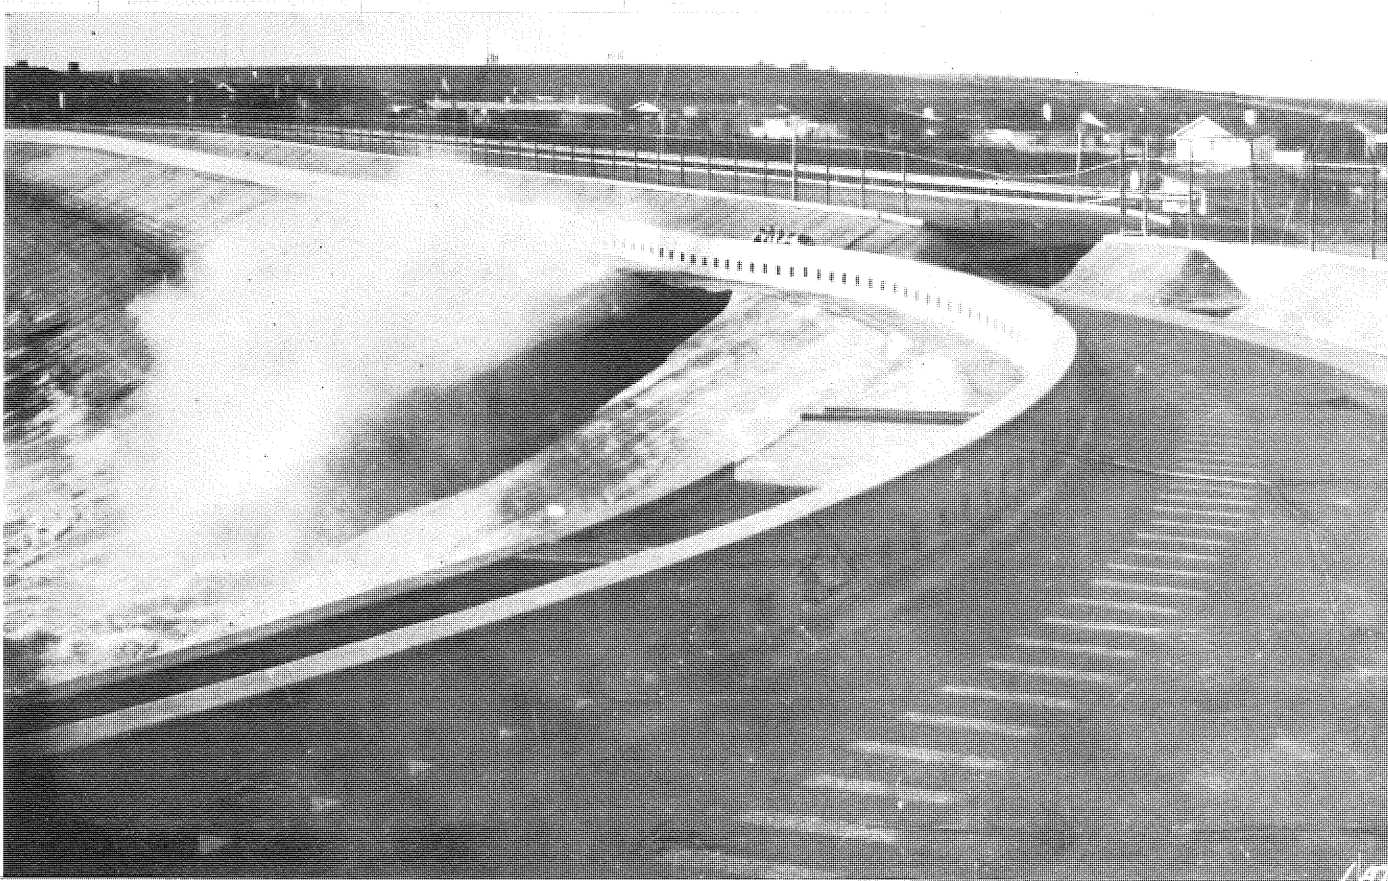
PHOTO 11. Dam crest roadway and parapet wall starting to collapse at about 3:35 p.m.

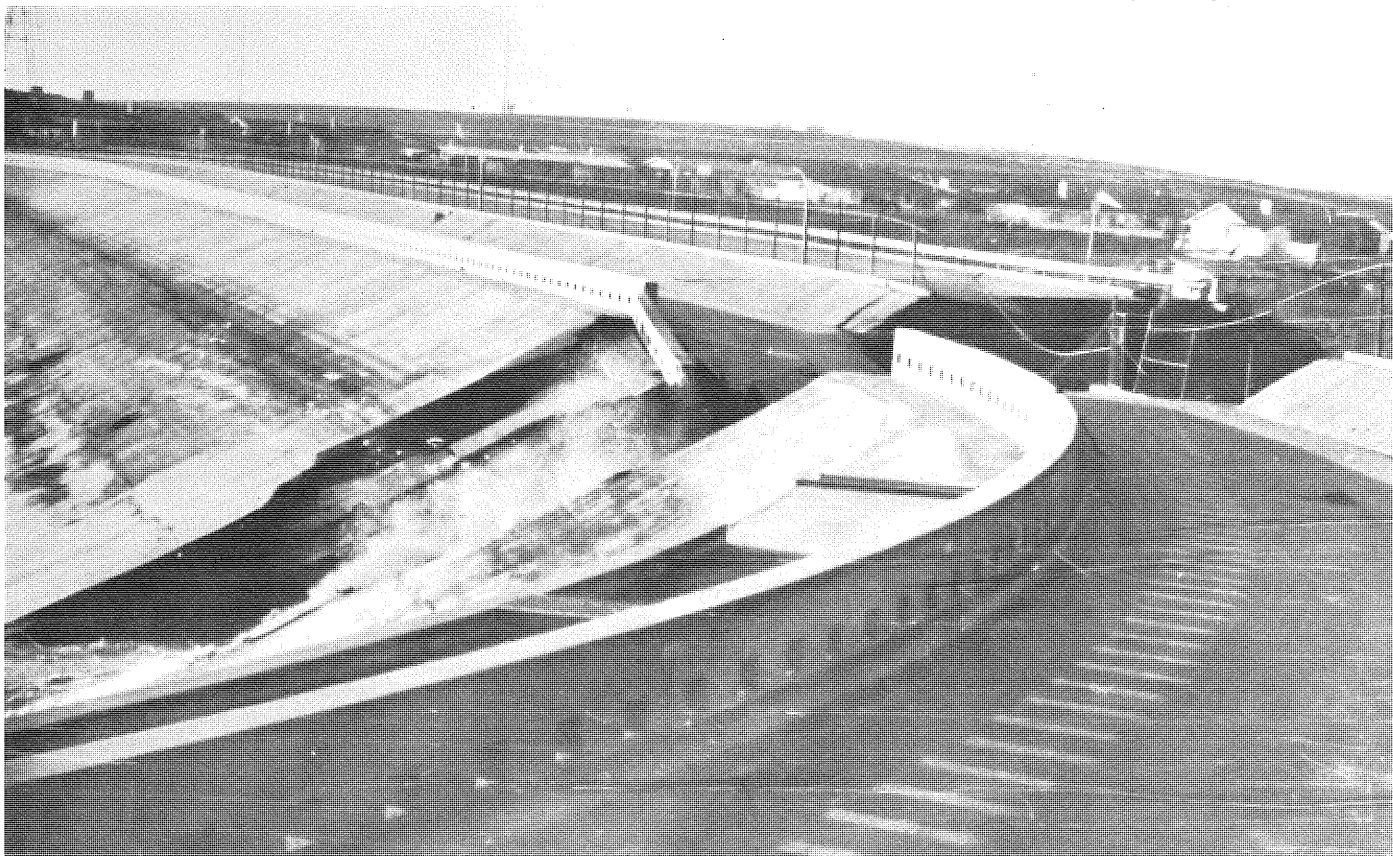
PHOTO 12. Total collapse of the dam crest roadway at 3:38 p.m.

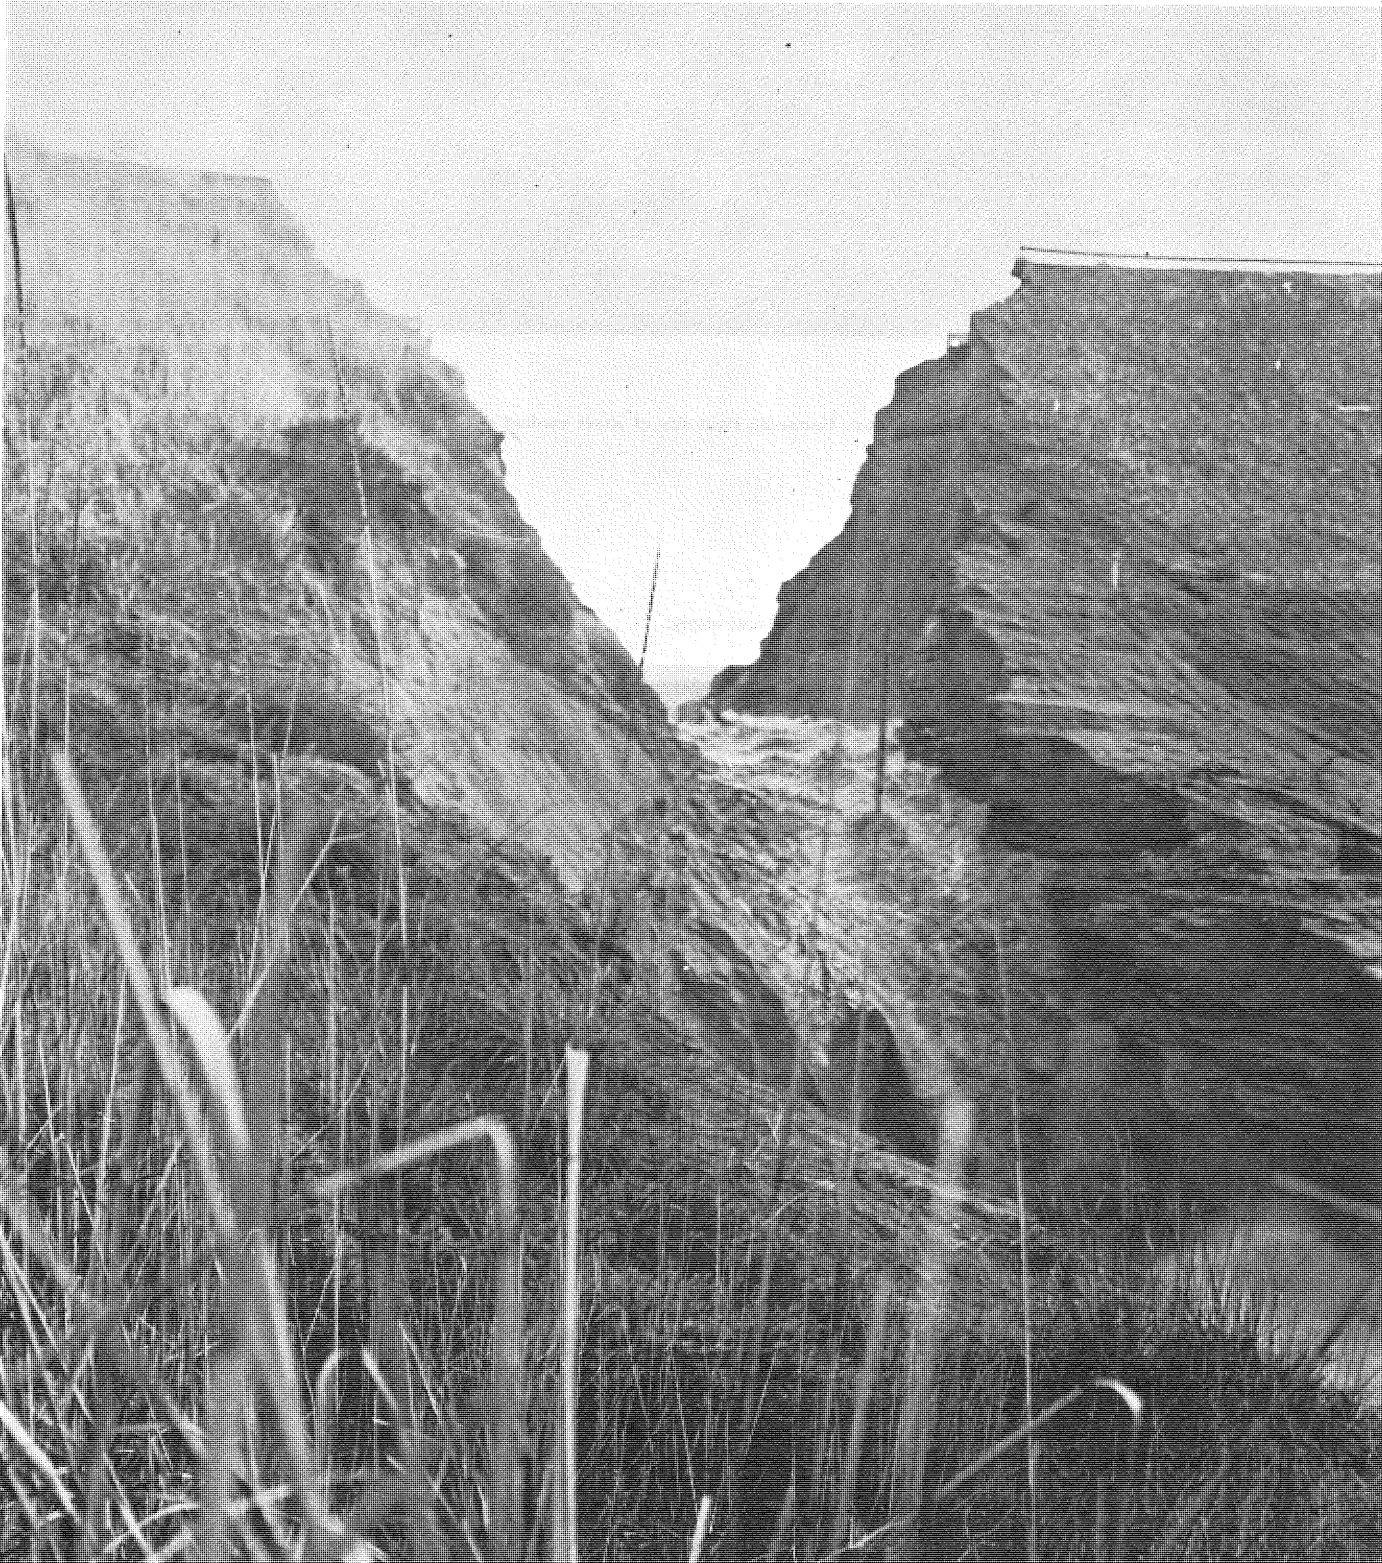
In the final stages of failure muddy water was gushing from a slot extending the full height of the abutment crack. Then, suddenly, there was an eruption of muddy water and fragments of earth near the bottom, forming a large hole into which the upper areas of abutment and embankment collapsed. By 3:38 p.m. the failure was regarded as essentially complete. (Photos 14 through 17)

PHOTO 14. Discharge following dam crest collapse, at approximately 3:40 p.m.

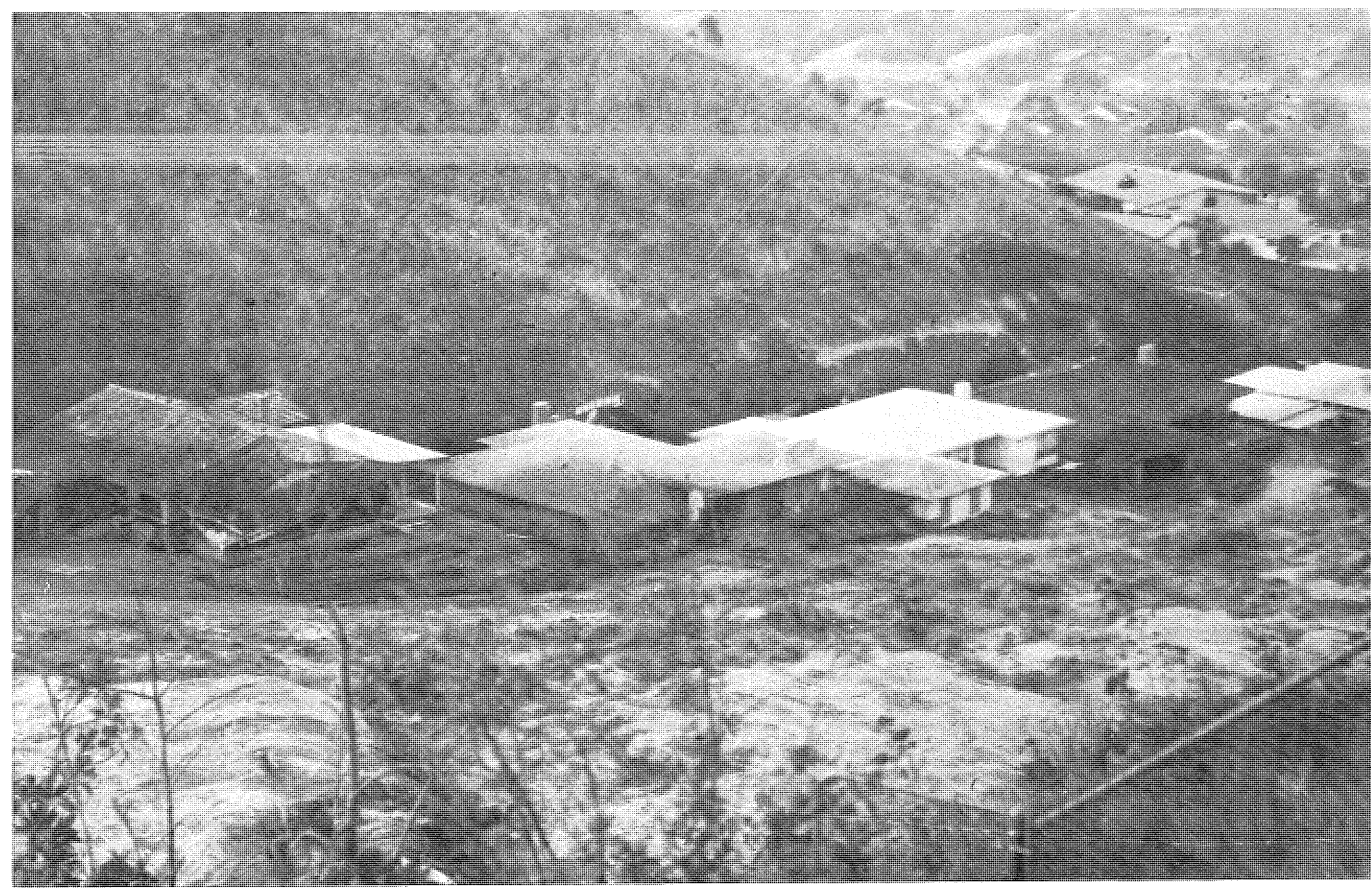
PHOTO 15. Cloverdale Avenue after flood crest. Homes on right side of street washed away.

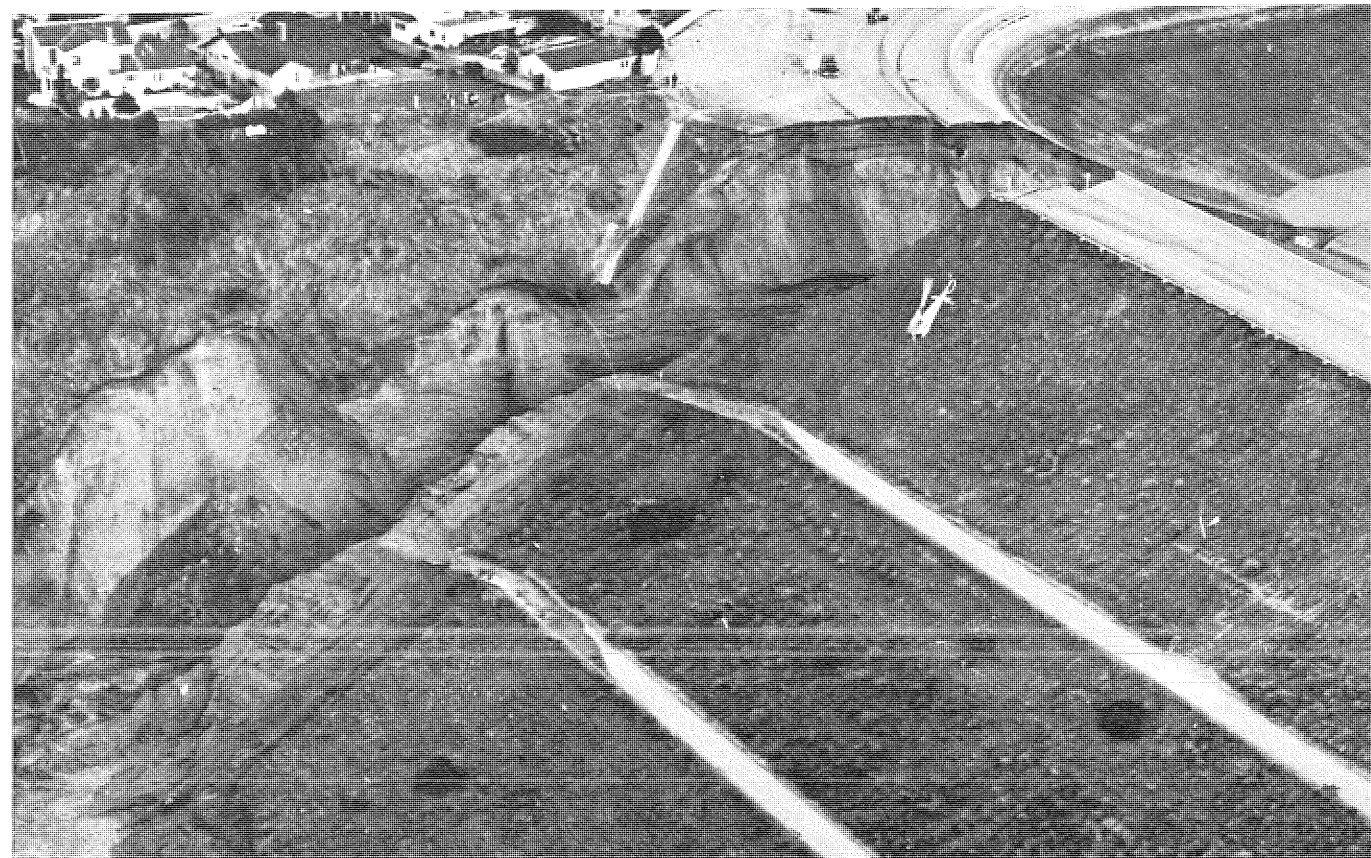
PHOTO 16. Breach with failure complete and reservoir almost empty.

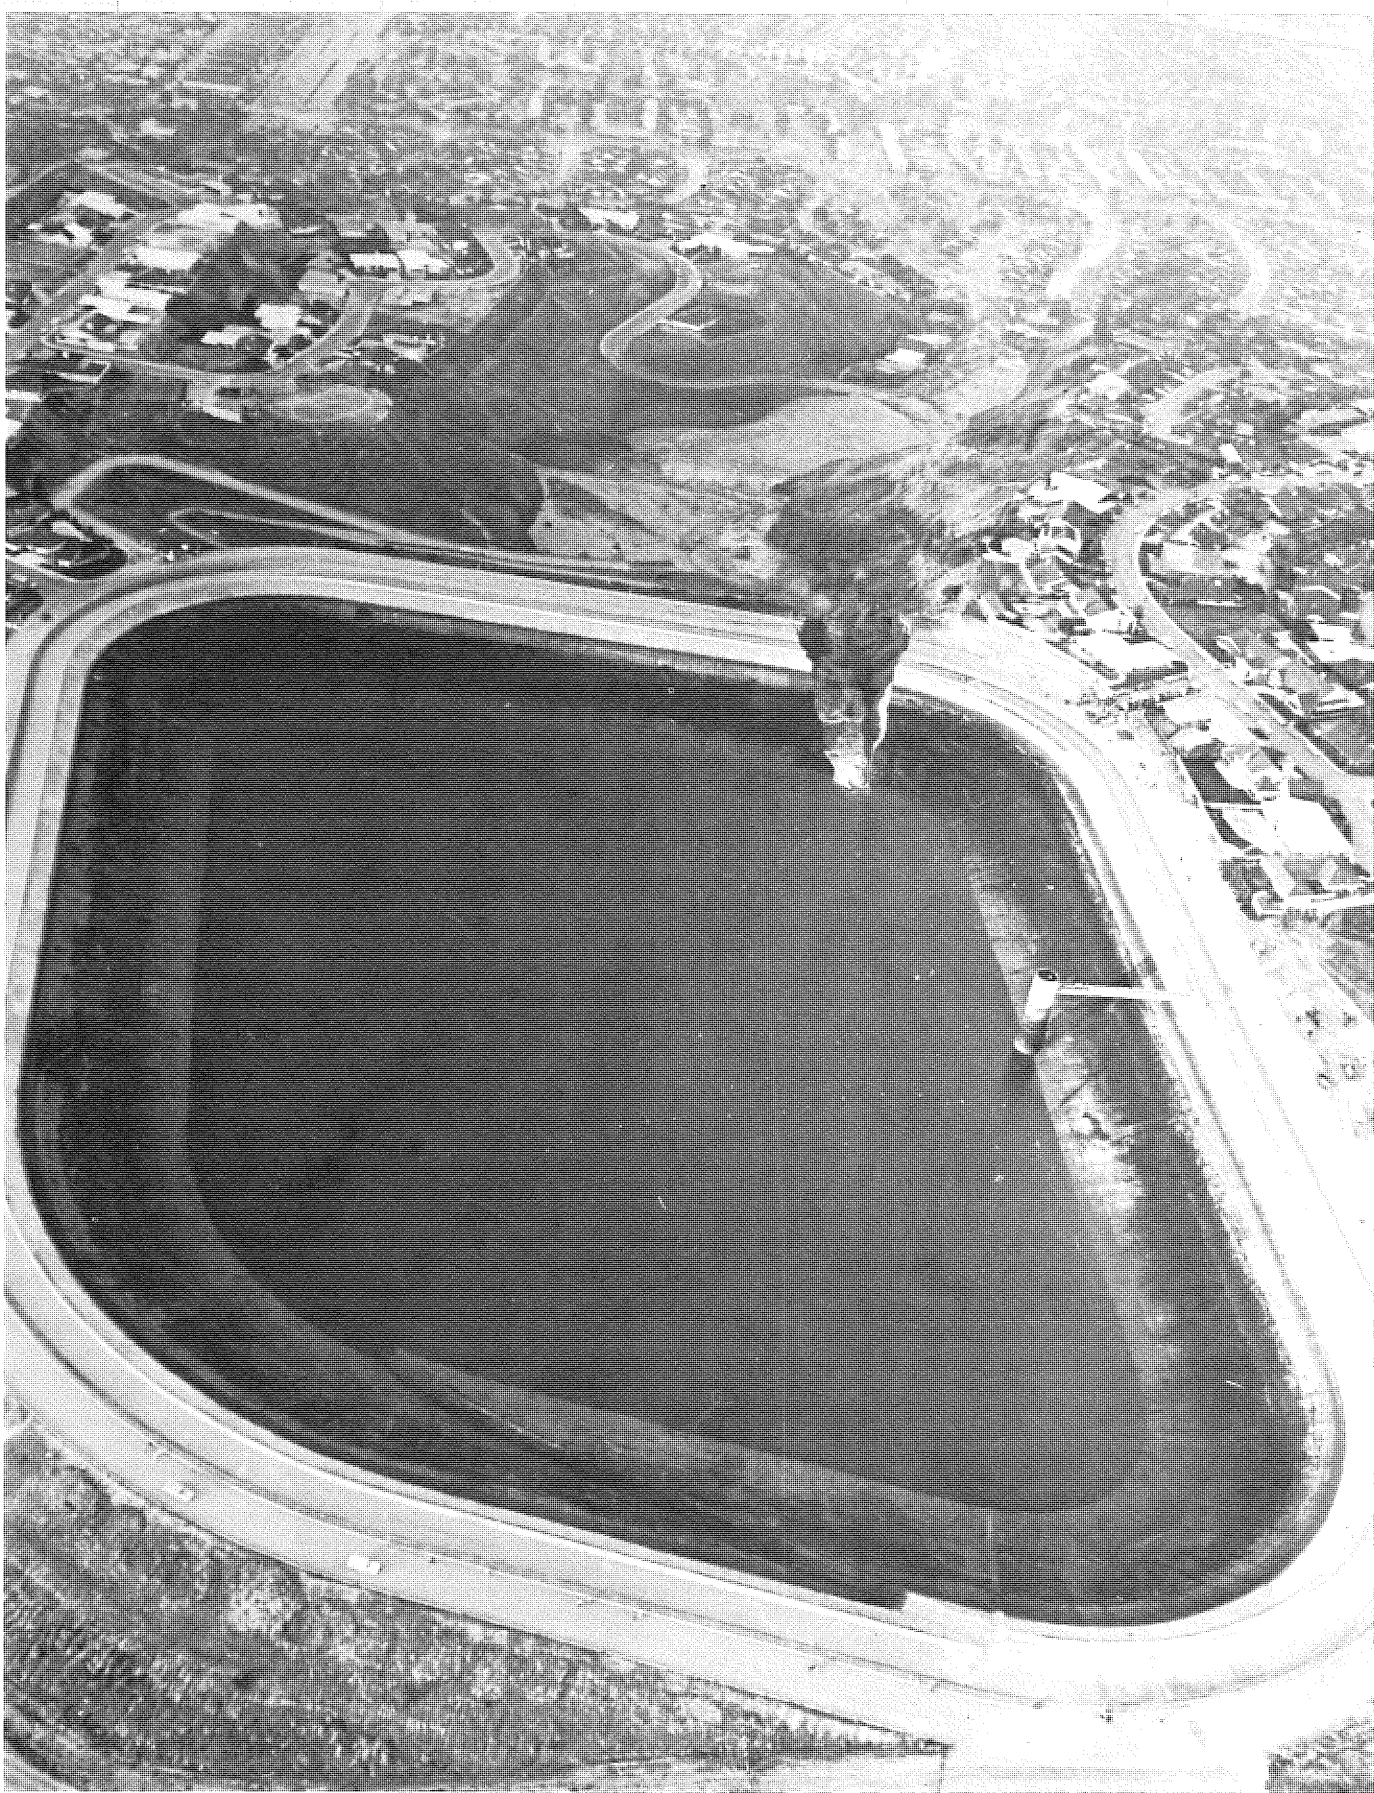
PHOTO 17. Aerial view of the reservoir at about 4:00 p.m.

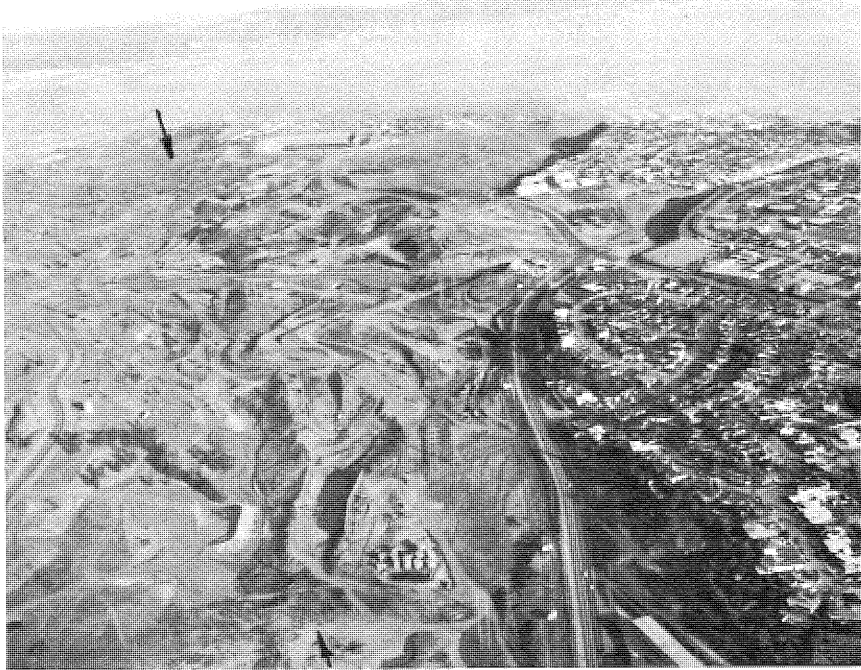
PHOTO 18. View looking north toward reservoir. Note physiographic expression of Inglewood fault indicated by arrows.

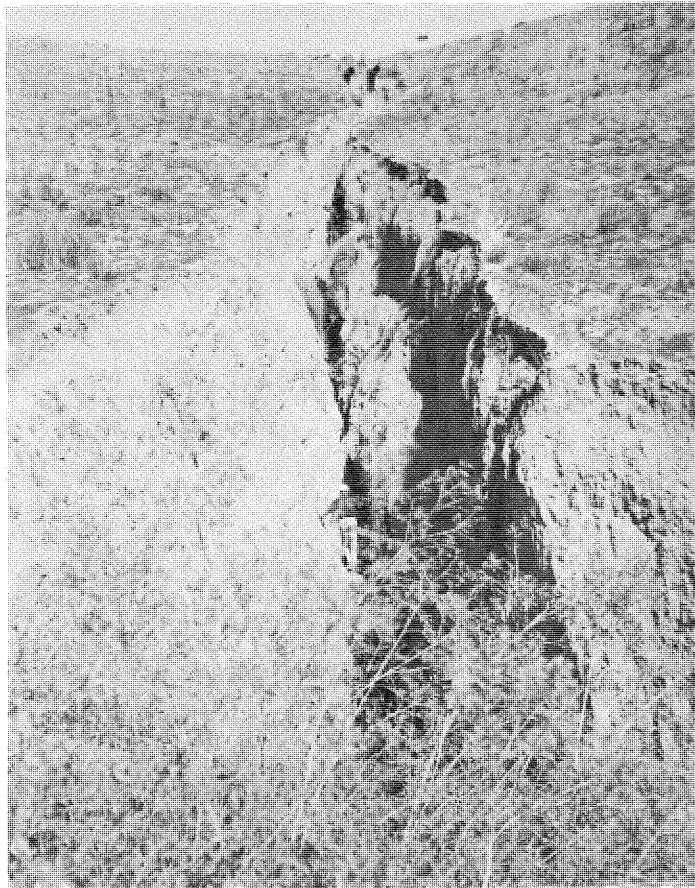
PHOTO 19. Illustration of erodibility of Inglewood formation. Gully is about 40 feet deep.

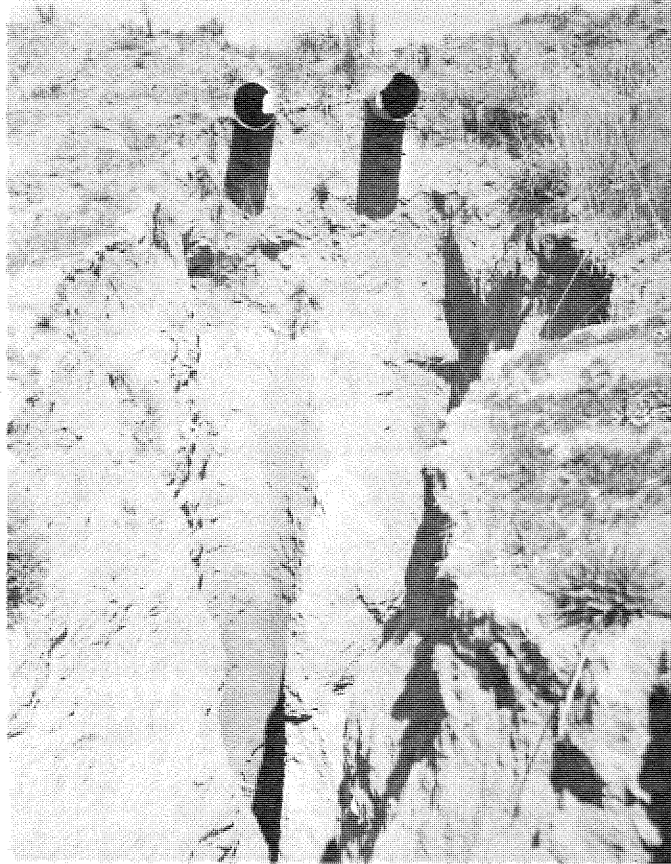
PHOTO 20. Head of the gully shown in Photo 19. Erosion is due to runoff from road above culverts.

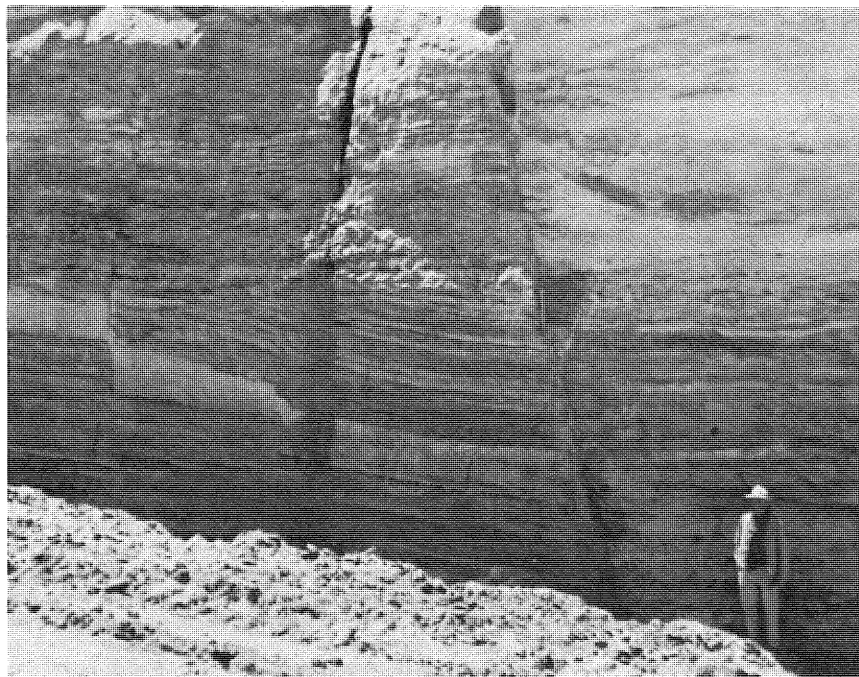
PHOTO 21. South face of an excavation into zone of Fault 1 near gate tower site, April 29, 1948. Total offset across the four faults shown estimated in excess of 30 feet.

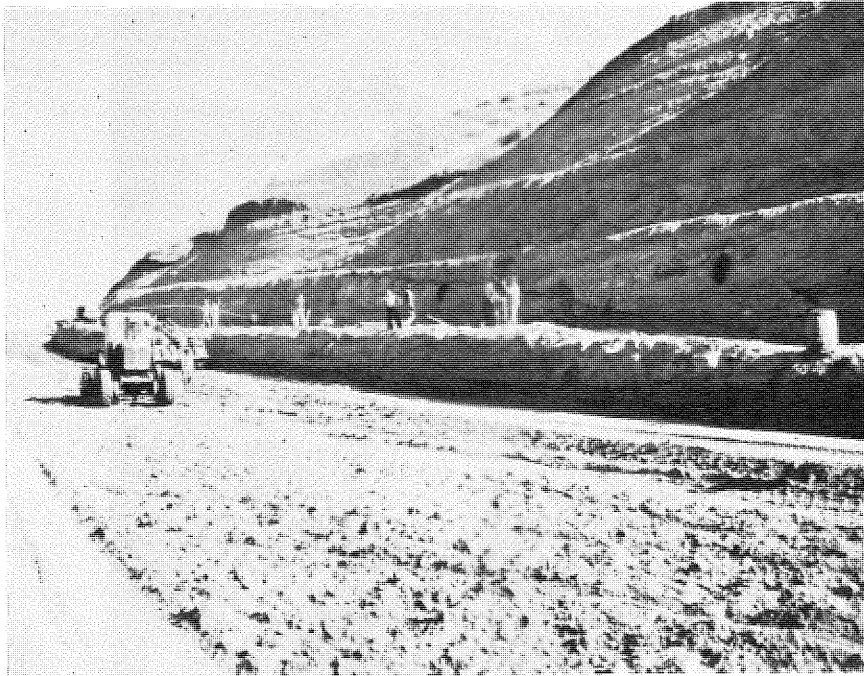
PHOTO 22. Slide area in east abutment looking northeasterly. Men shown are drilling horizontal drain holes into the abutment below the slide. Sloping dark line above men is clay slip-bed.
