Department of Water Resources

INVESTIGATION OF FAILURE
BALDWIN HILLS RESERVOIR

APRIL 1964

Baldwin Hills Reservoir Failure Consulting Board Report

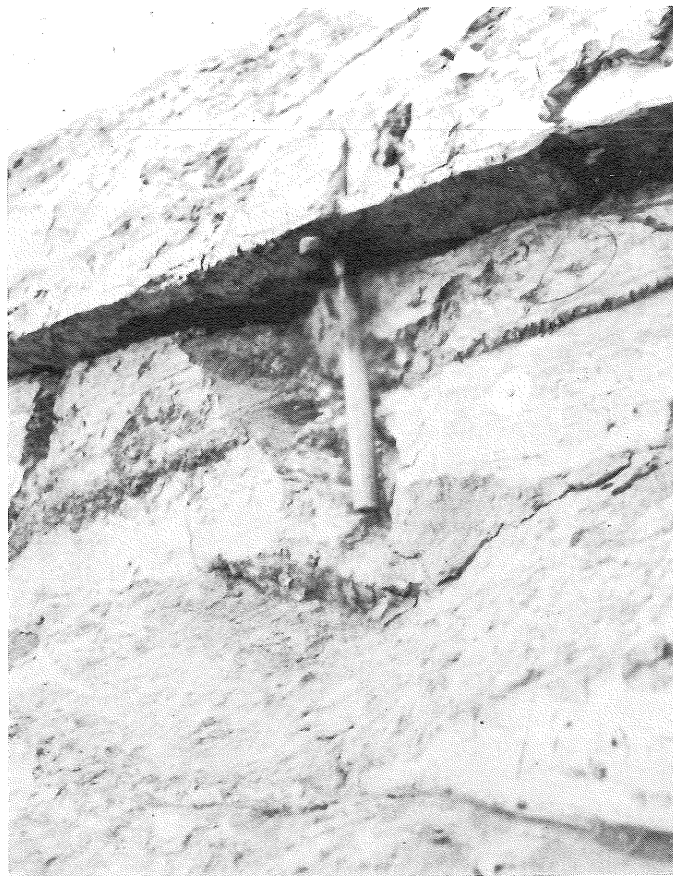
PHOTO 23. Close-up of slip-bed showing the magnitude of movement, which measured a maximum of 0.43 foot.

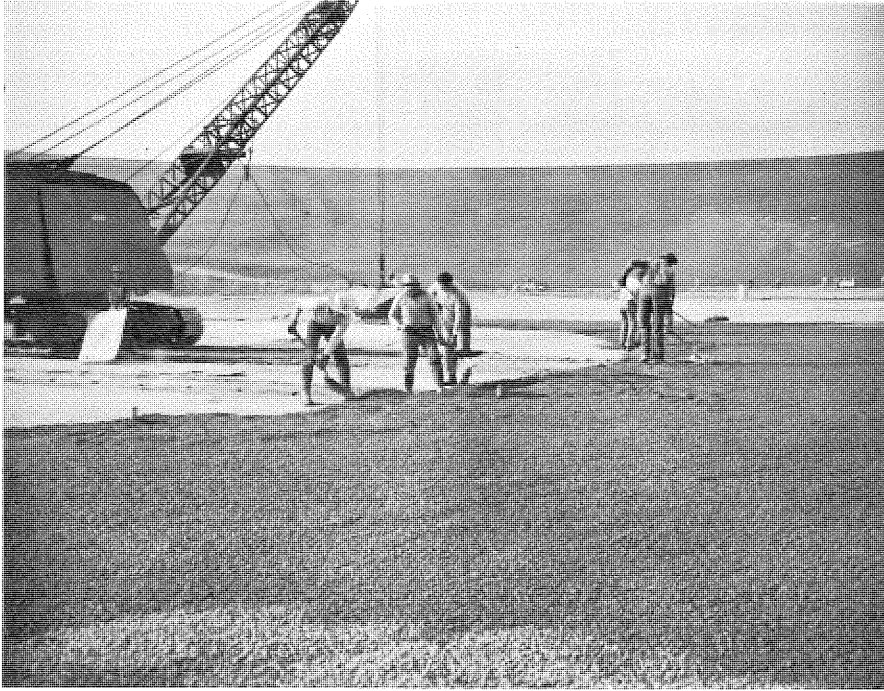
PHOTO 34. Spreading cemented pea gravel. Note grade stakes apparently driven through asphaltic membrane.

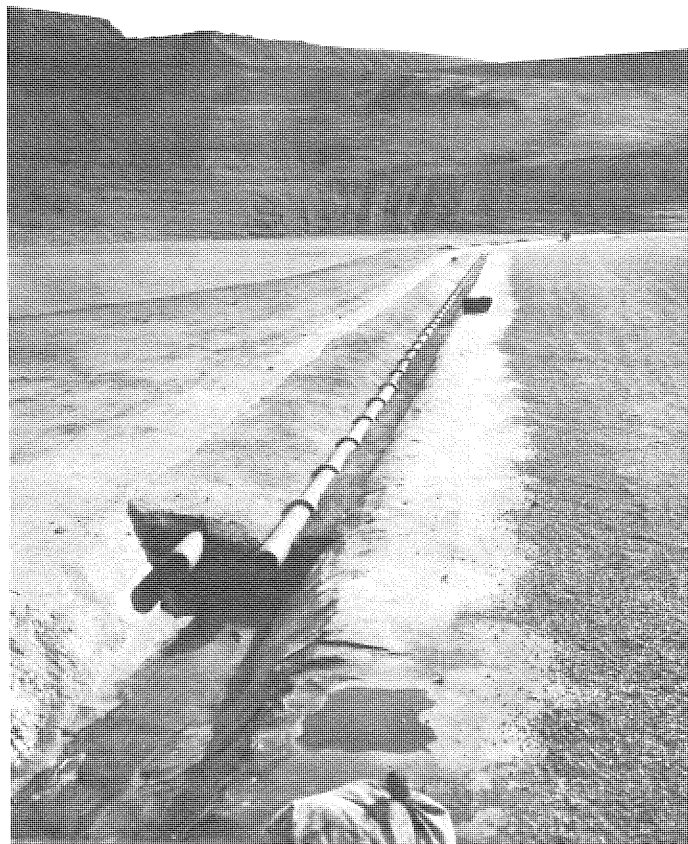
PHOTO 37. Installation of 4-inch tile drains. Note one line completely encased in concrete and other with open joints on top.

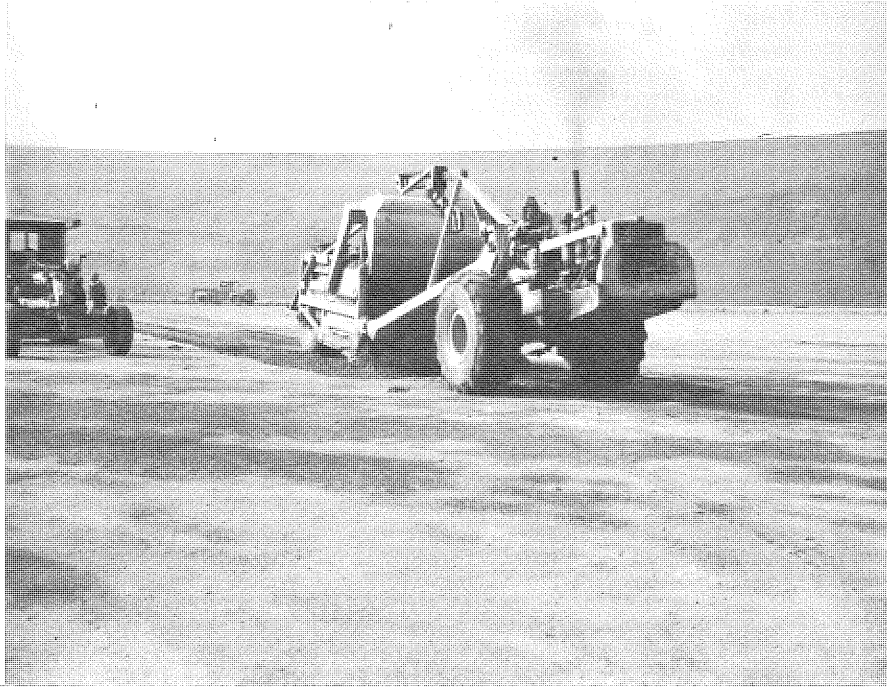
PHOTO 38. Scraper spreading first layer of earth on cemented pea gravel. Note equipment operating directly on surface of pea gravel.

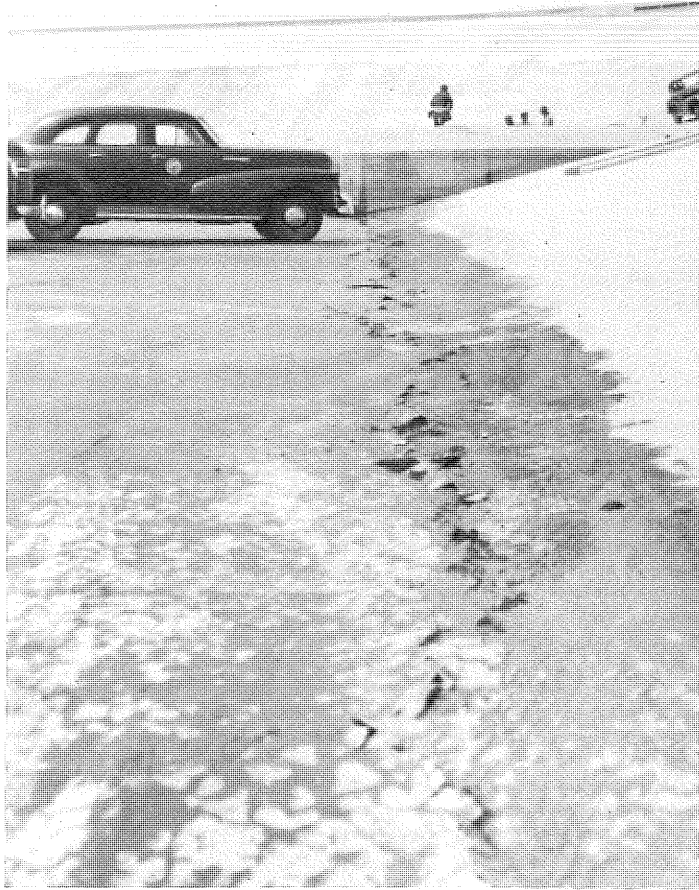
PHOTO 49. Buckling of asphaltic paving, May 11, 1951.

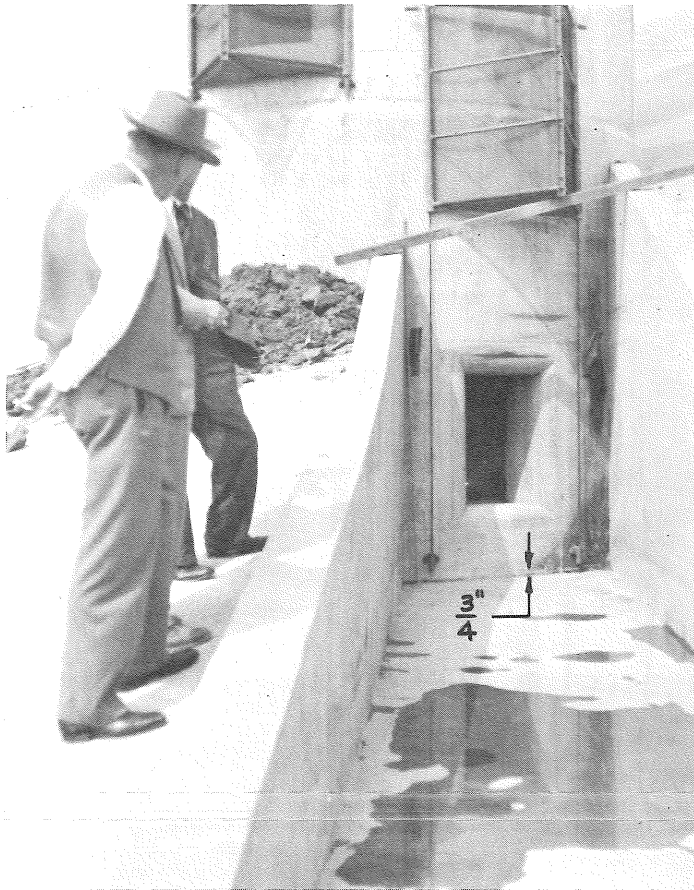
PHOTO 50. Settlement of gate approach channel, May 11, 1951

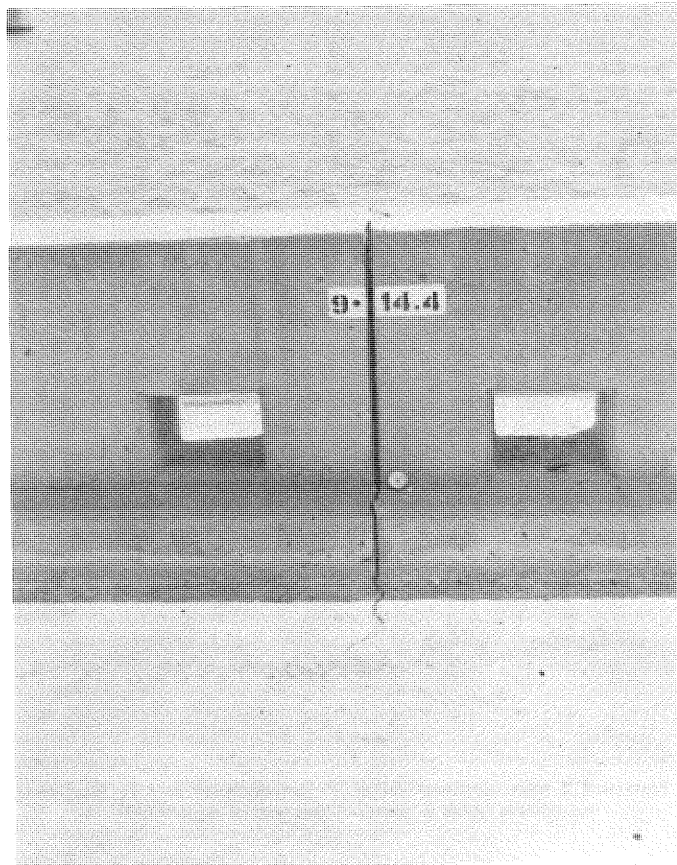
PHOTO 52. Opening in north parapet wall at Station 9+14.4, May 16, 1955.

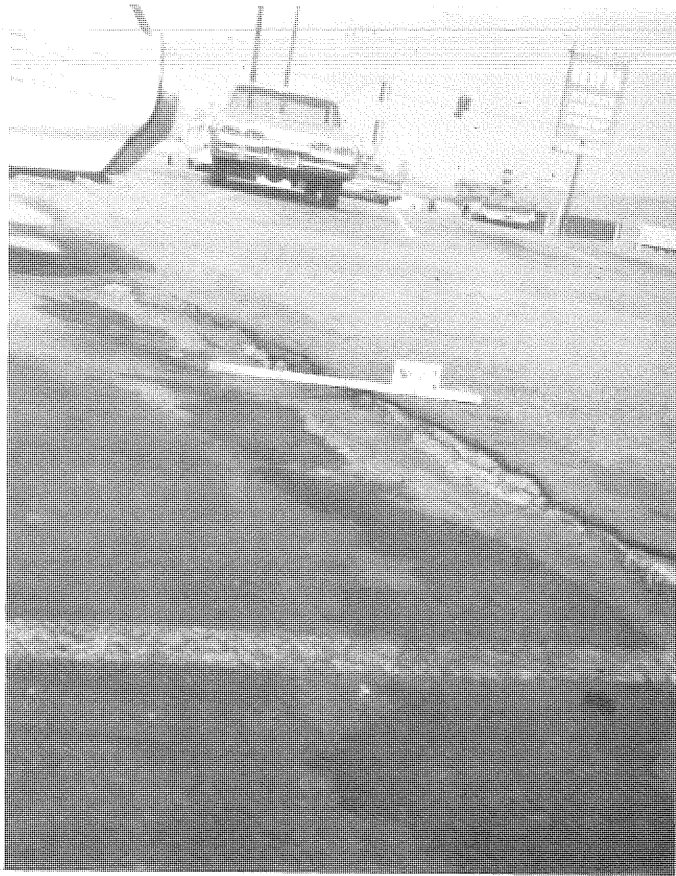
PHOTO 53. Earthcrack 2. Looking north across restaurant parking lot near southwest corner of Stocker Street and La Brea Avenue. Maximum vertical displacement 2 inches. Opening 1 inch.

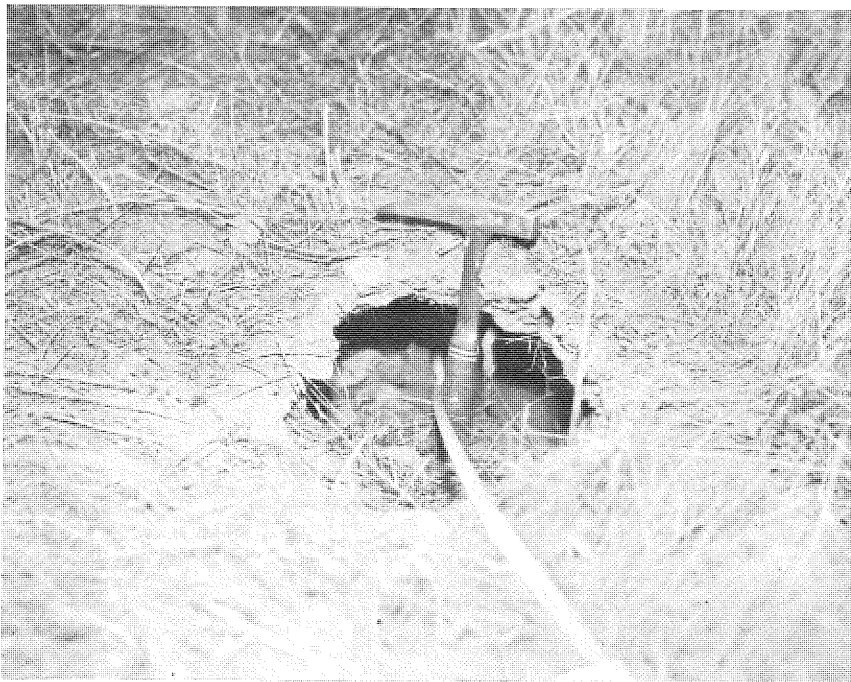
PHOTO 54. Earthcrack 2 near northwest corner of Stocker Street and La Brea Avenue, showing pothole which is typical of this type of earthcrack.

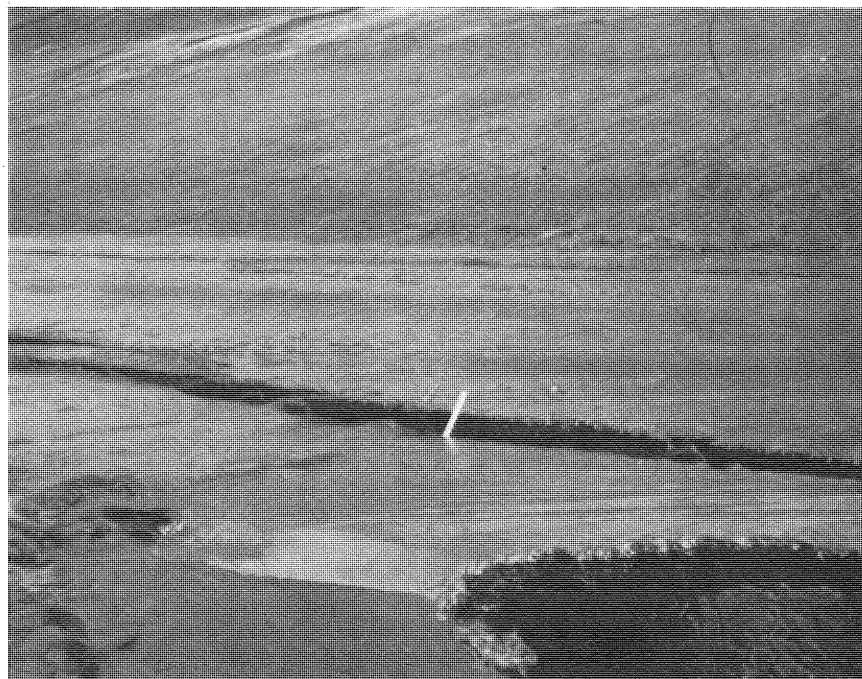
PHOTO 60. Typical displacement and collapse at Fault I, December 15, 1963.

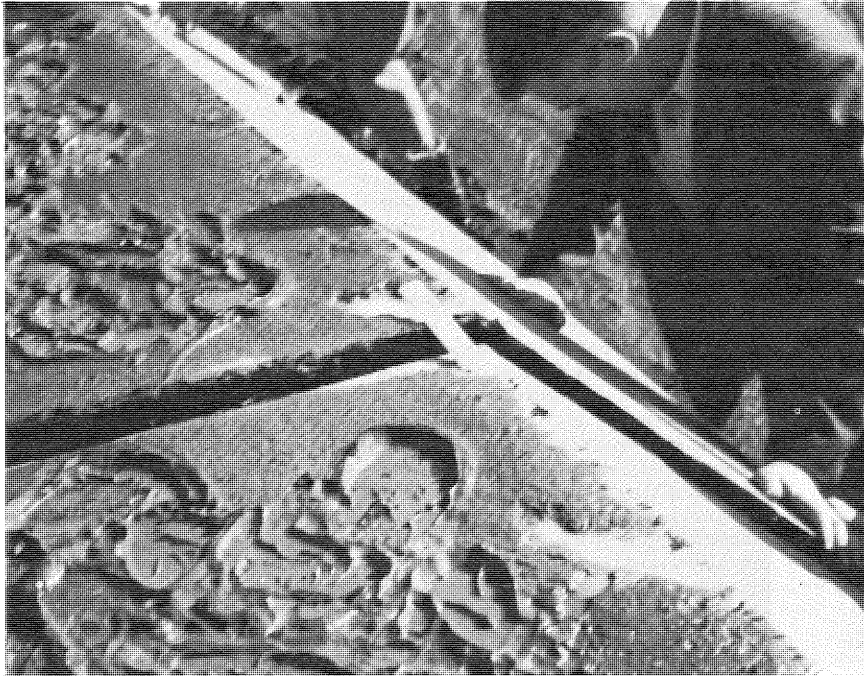
PHOTO 61. Opening of second joint from gate tower in circulator connection conduit, December 15, 1963.

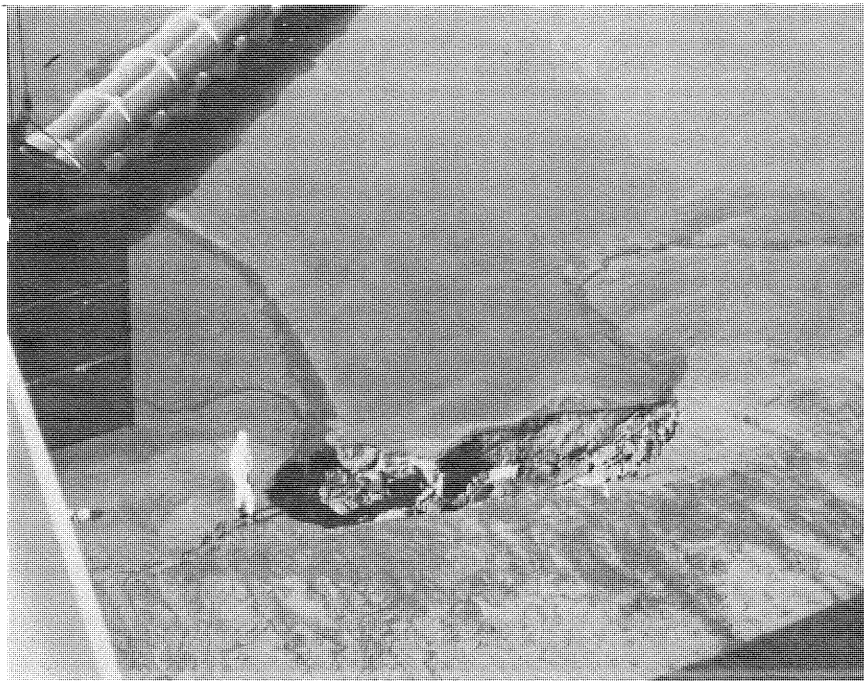
drainage inspection chamber, and at the south end of the reservoir. Others of smaller size were also observed. Flow through the large sink holes undoubtedly caused vortices reported by eyewitnesses to the failure. (Photos 62 through 66)

PHOTO 62. Asphaltic paving and compacted earth lining adjacent to subsurface drainage inspection chamber, December 15, 1963.

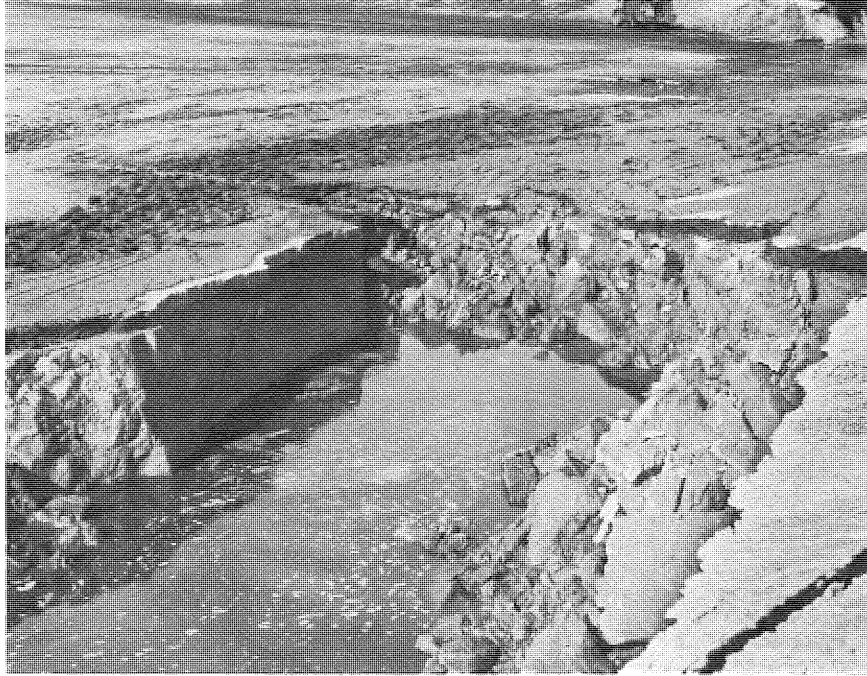
PHOTO 63. Ruptured lining near drainage inspection chamber, December 16, 1963.

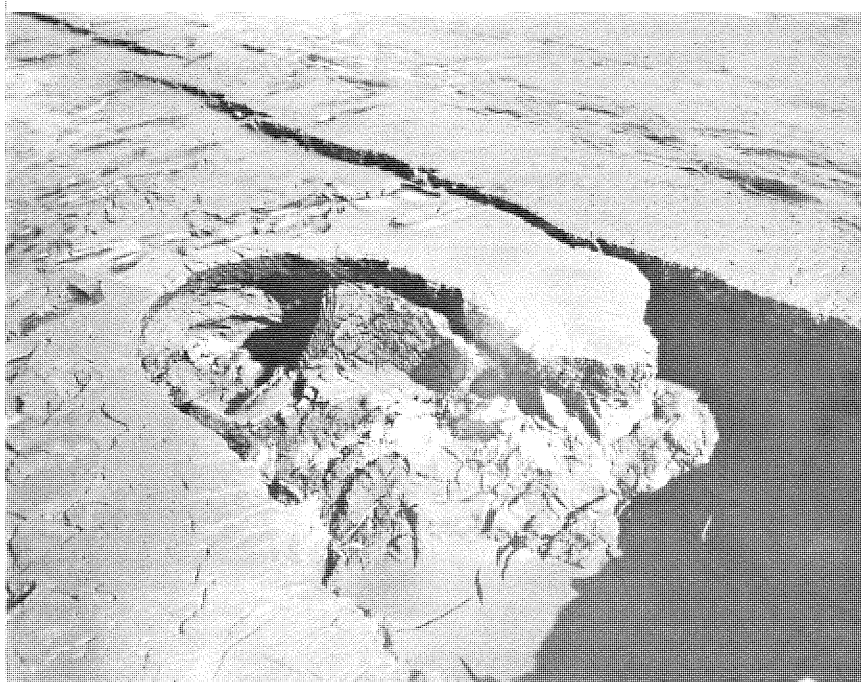
PHOTO 65. Collapse feature west of surface expression of Fault I north of Excavation No. 2.

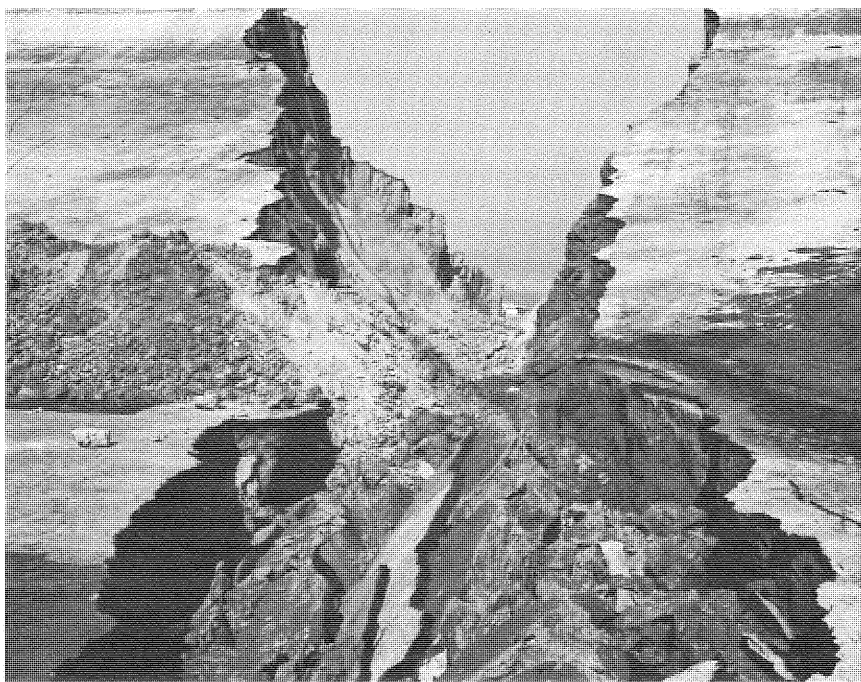
PHOTO 66. Breach seen from inside reservoir, December 22, 1963.

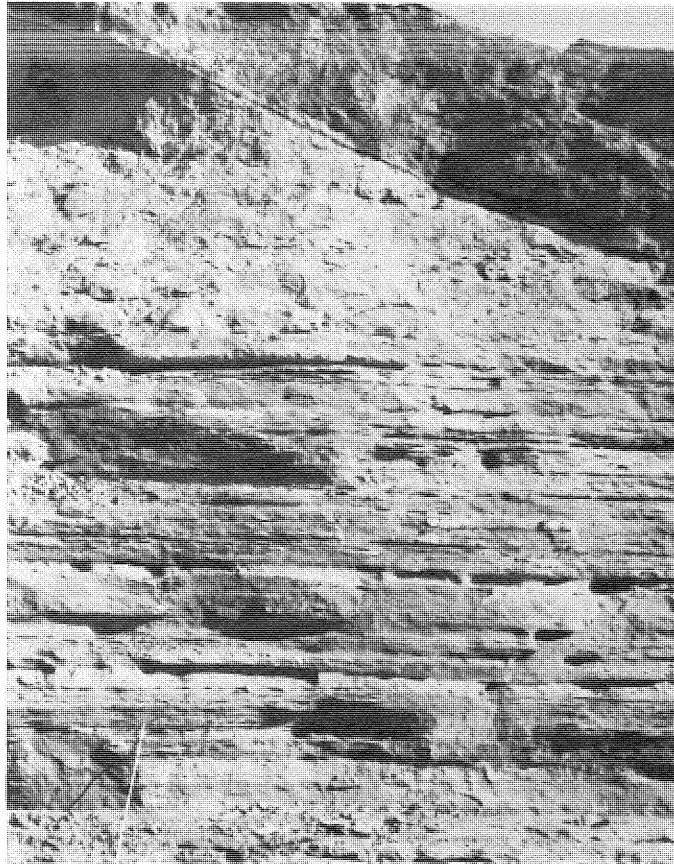
PHOTO 68. Stratification in foundation at east side of breach. Note pea-gravel drain and compacted earth lining above. December 28, 1963.

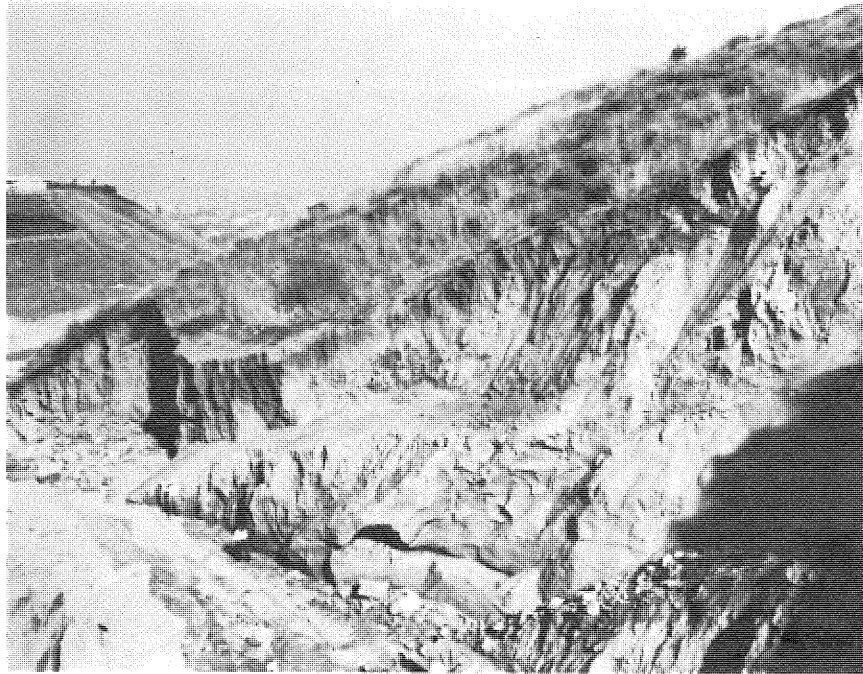
PHOTO 70. Landslide plane exposed in east side of breach, believed to be part of slide encountered during construction of dam.

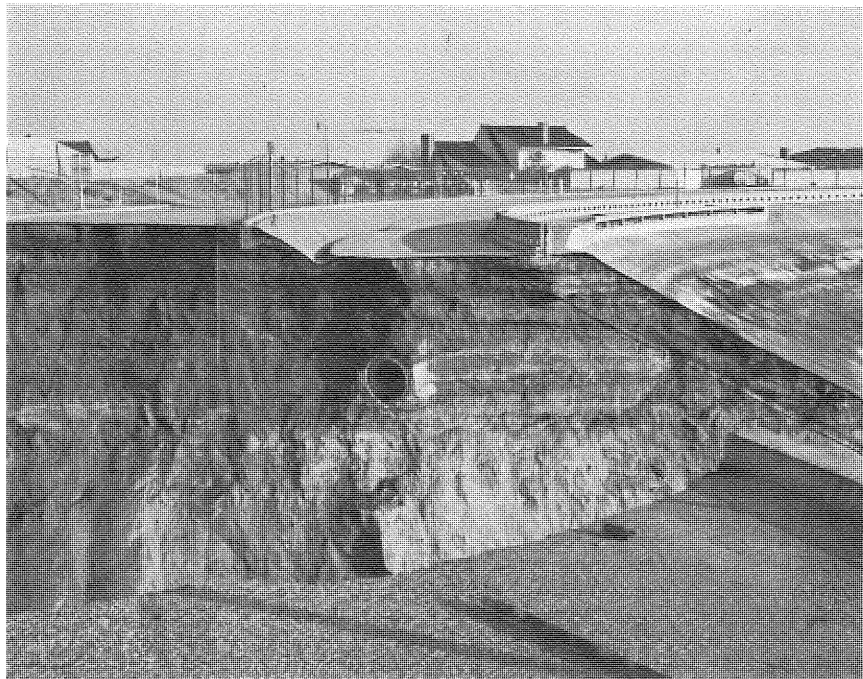
PHOTO 71. East side of breach showing spillway pipe and reservoir lining, December 22, 1963.

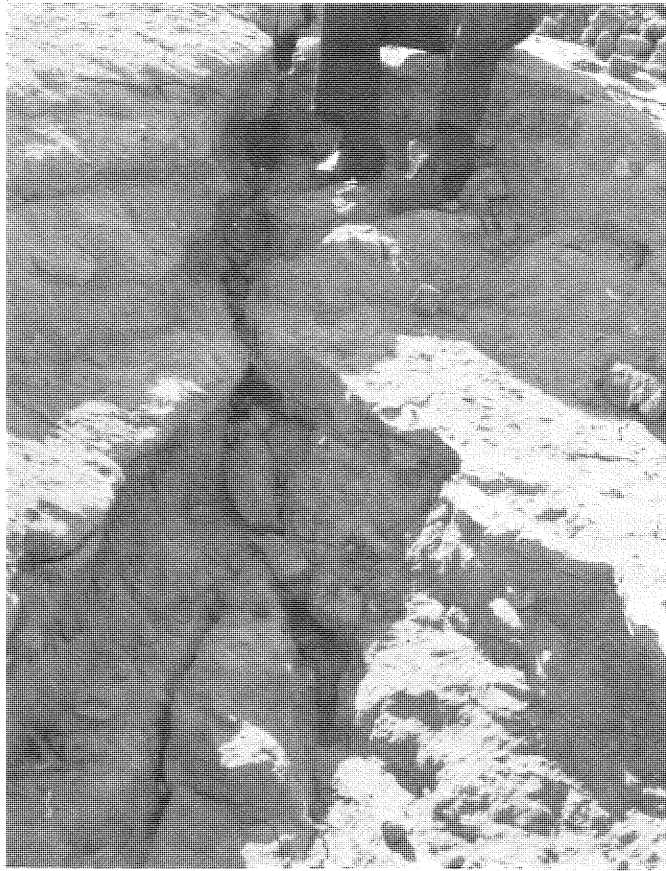
An inspection on January 4, 1964, revealed cracks in the embankment immediately downstream from the 340 berm on the main dam. It appeared that the openings had been increased in size by water erosion. The most pronounced crack was observed at the east side of the embankment at about Elevation 325. There was some vertical displacement across the crack. (Photo 74)

PHOTO 74. Scour and cracking in main dam downstream from 340 berm, January 4, 1964.

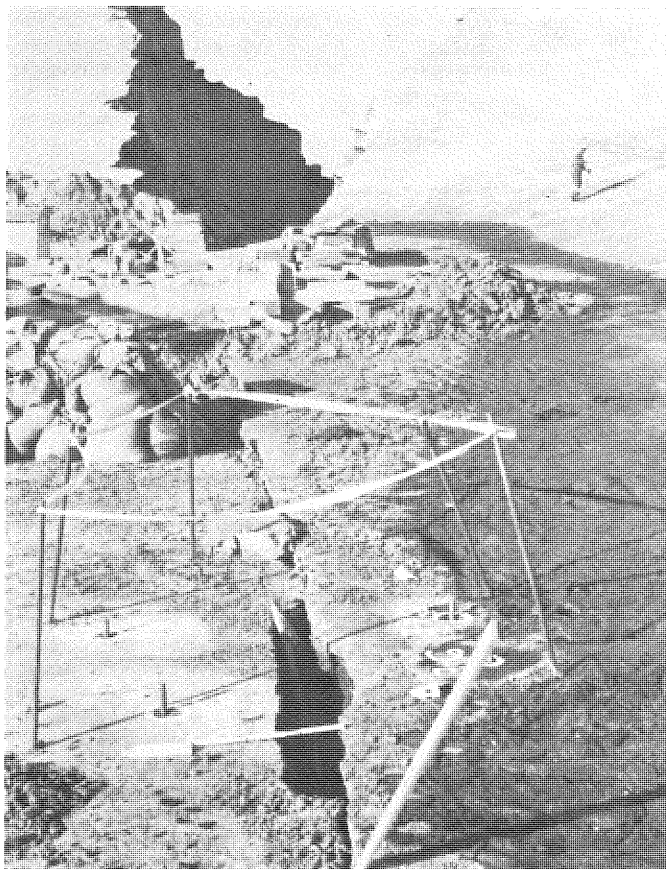
Immediately following the failure, straddler points were established across the break in the asphaltic paving at a number of selected locations. (Photo 75) These were steel pegs placed as reference points. Daily measurements were then taken to detect continuing movement at the faults. The results were inconsequential.

PHOTO 75. Lining separation and straddler points set after failure, December 28, 1963.

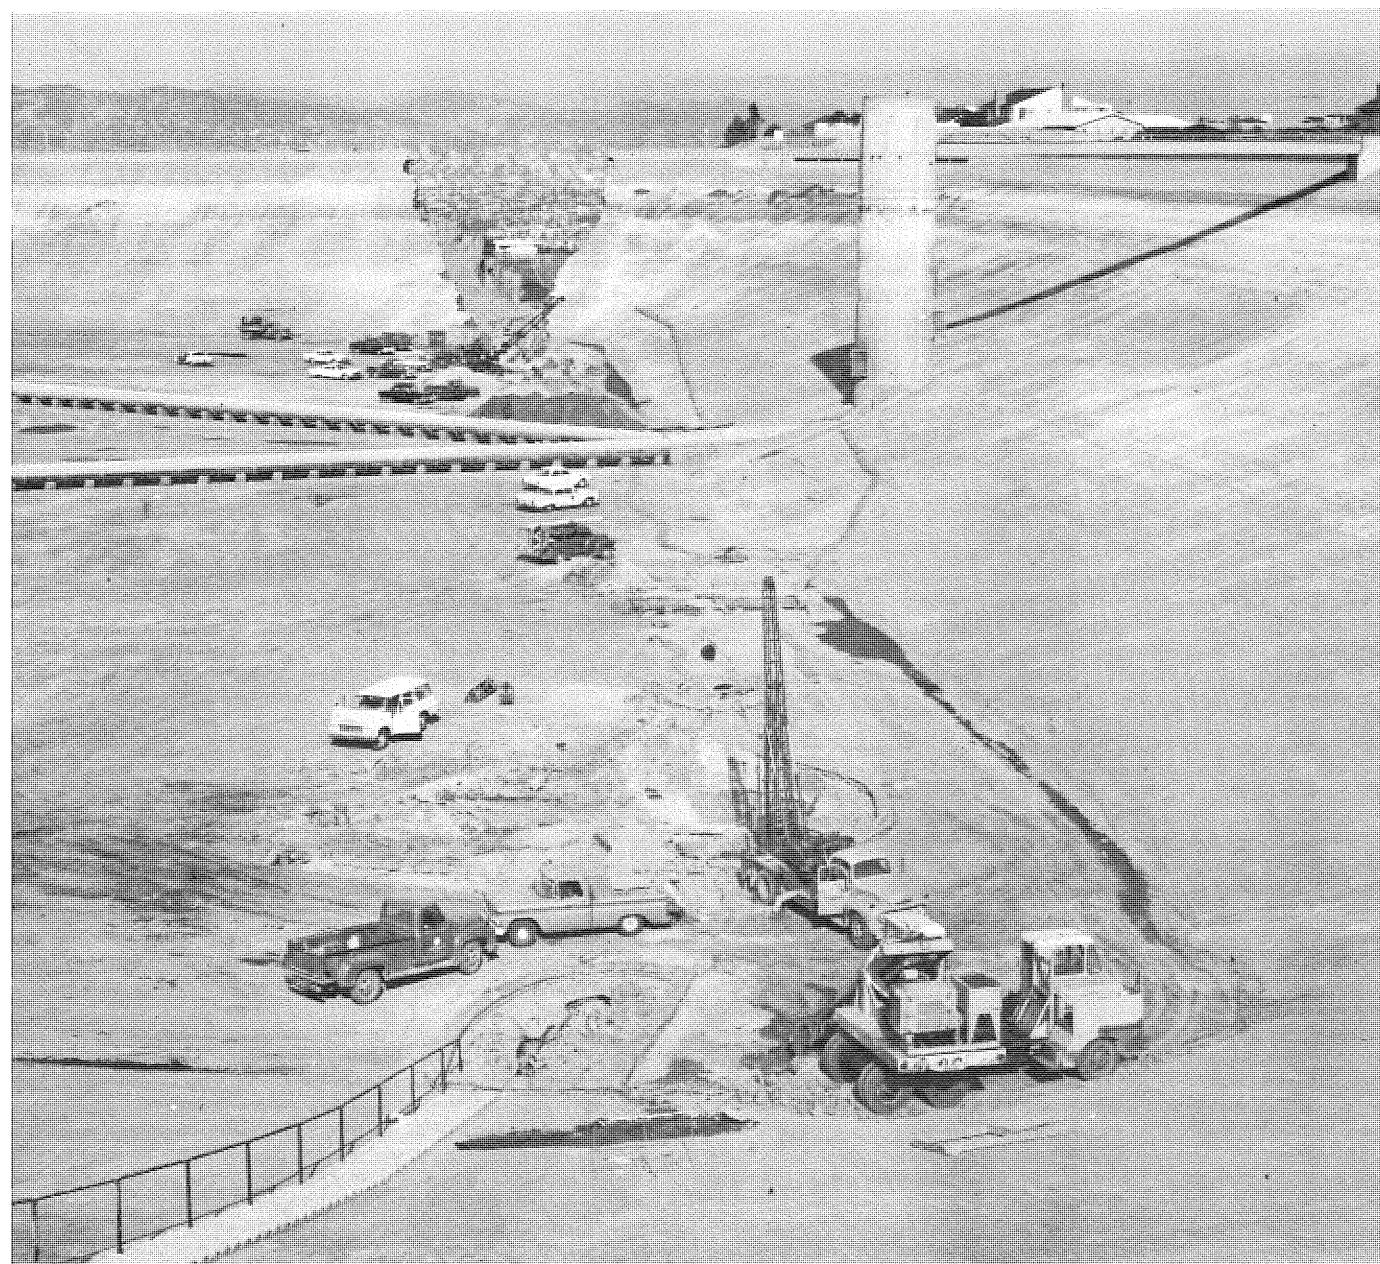
As part of this investigation, a total of 15 excavations were made in and adjacent to the reservoir, and seven exploratory holes were drilled. These were mapped and logged by geologists of the Department of Water Resources task force, and soil sampling was conducted by a team from the department laboratories in Bryte, California. On Plates 22a through 22m are shown the post-failure exploration data. All excavations and borings from which samples and data were obtained for use by the Engineering Board of Inquiry were made by forces of the Department of Water and Power. (Photo 76)

PHOTO 76. Exploratory activity at reservoir, January 6, 1964. Excavation No. 8 in foreground.

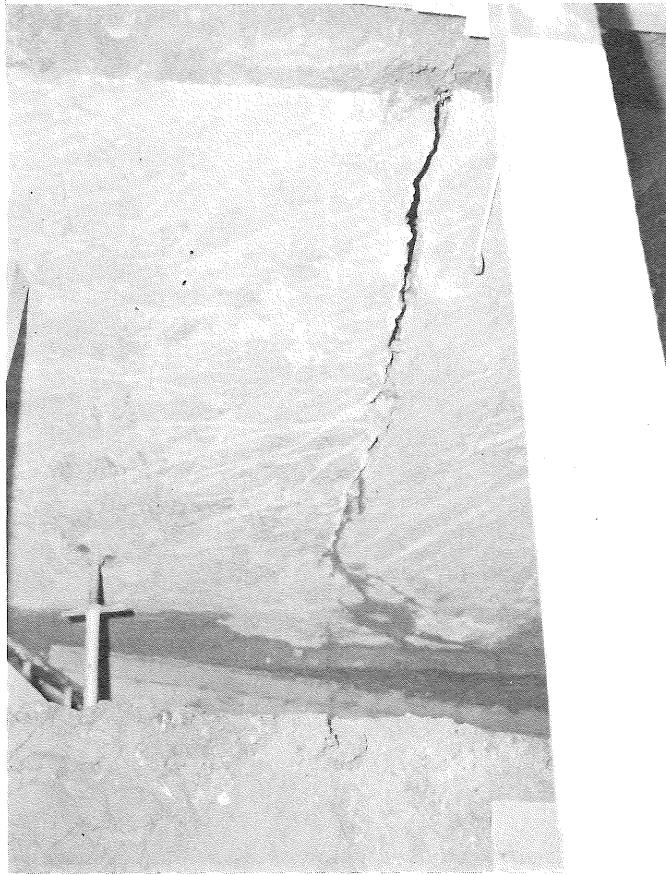
Excavation No. 7 had as its fundamental purpose the uncovering of the drainage inspection chamber and its foundation. Initially an area to the south of the chamber was excavated so that the chamber wall was exposed. However, rain on January 18, 1964, resulted in collapse of most of the excavations before any examination could be made of Excavation No. 7. In the final exploration, Excavation No. 7B was made to replace Excavation No. 7. This was excavated on the north side of the drainage inspection chamber and extended between the two main breaks in the chamber. Photos 77 through 80 show the breaks in the north face of the chamber.

PHOTO 77. Break in north wall of drainage inspection chamber at Station 0+70.3, as exposed in Excavation No. 7B.

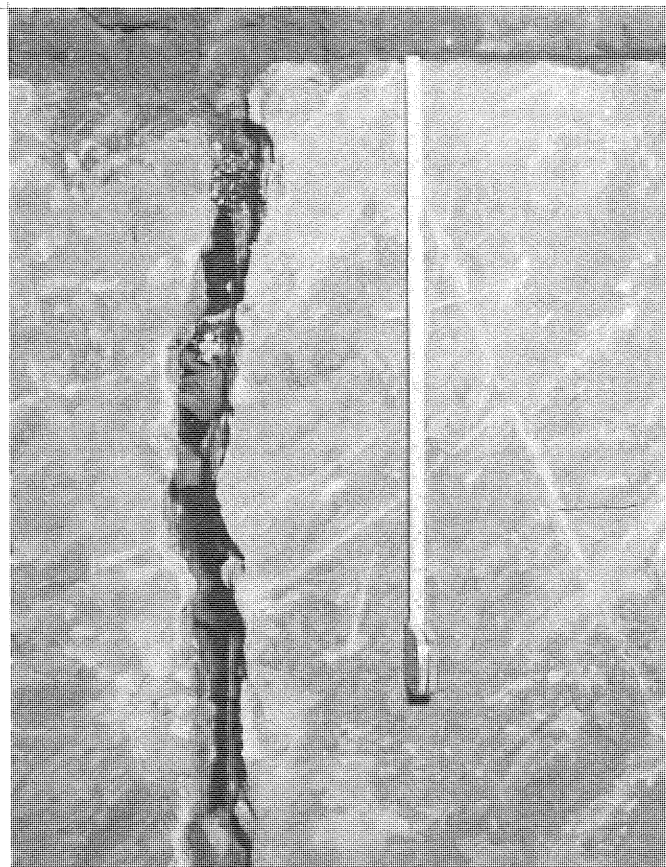
PHOTO 78. Top of break in north wall of drainage inspection chamber at Station 0+70.3, showing exposed reinforcing steel.

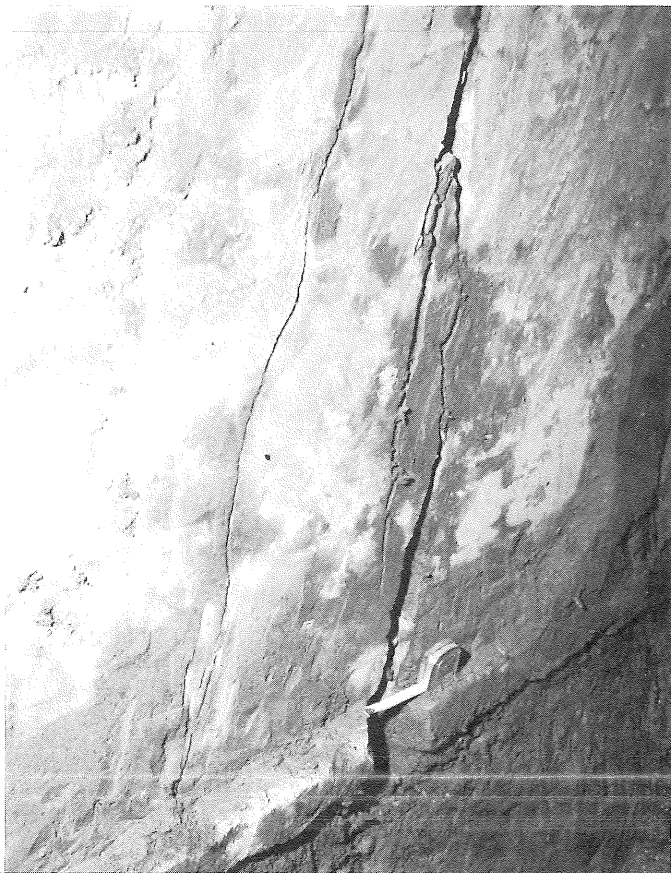
PHOTO 80. Bottom of break in north wall of drainage inspection chamber of Station 0+89.

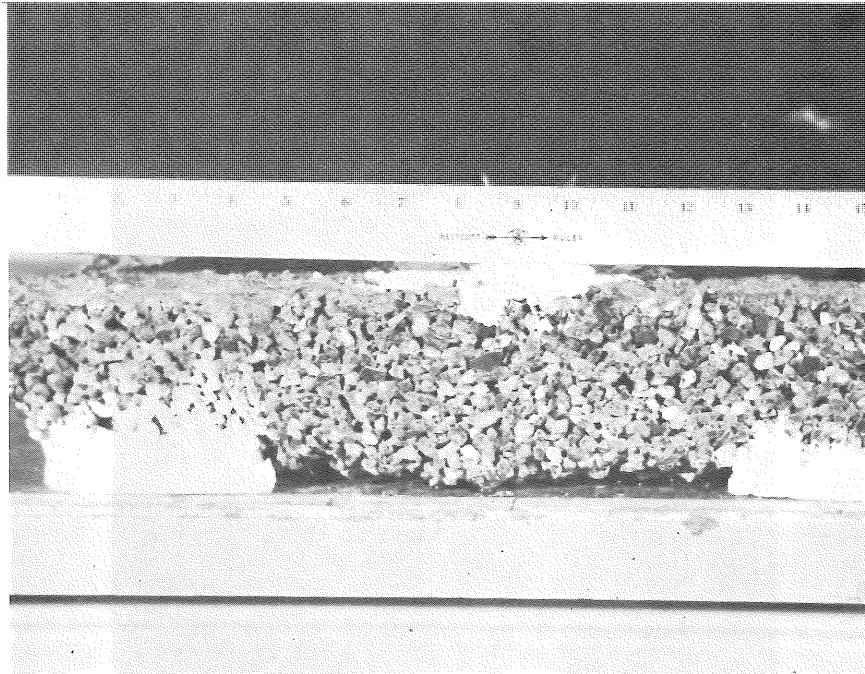
Mathematical analysis indicates the cemented pea-gravel drain represented by the test specimens to have sufficient beam strength to bridge a void of from 6 to 10 inches before rupturing, under a load corresponding to 10 feet of saturated earth lining and 65 feet of reservoir water. (Photos 81 and 82)

PHOTO 81. Pea-gravel drain Flexure Test Specimen B1 after cutting with diamond saw (length to depth ratio approximately 3).

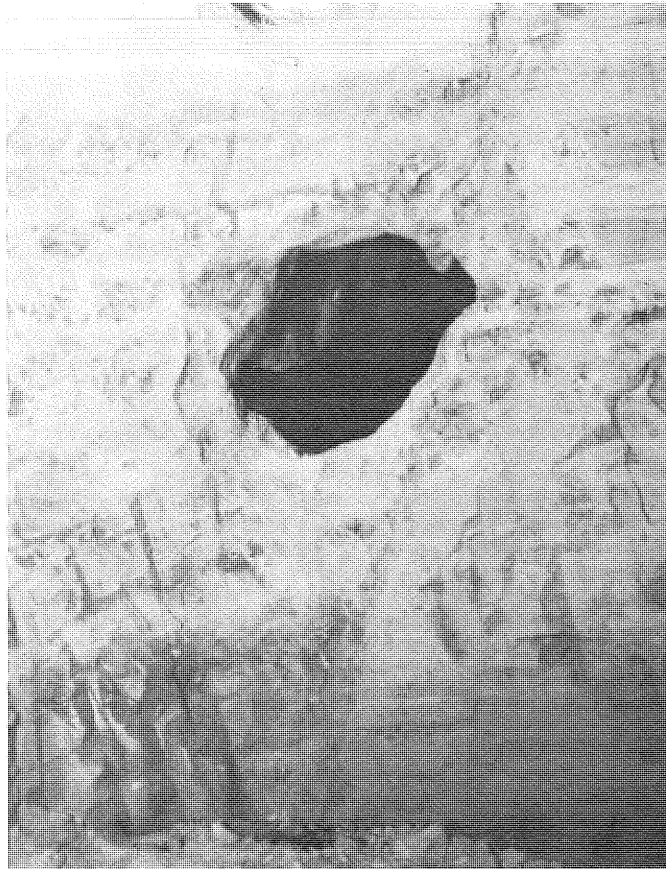
In the north face of Excavation No. 3 a cavity large enough to admit a man was found about 8 feet below the pea-gravel drain. (Photos 83 and 84 and Plate 22f) It extended in a northerly direction along the west side of Fault V. Although the pea-gravel drain at the fault was displaced, it had not collapsed. There was slight calcification on the surfaces of the cavity, suggesting that the cavern had existed for some period of time.

PHOTO 83. Cavity as first exposed near bottom of Excavation No. 3. Hole is about 5 inches in diameter. Fault V forms right edge of cavity.

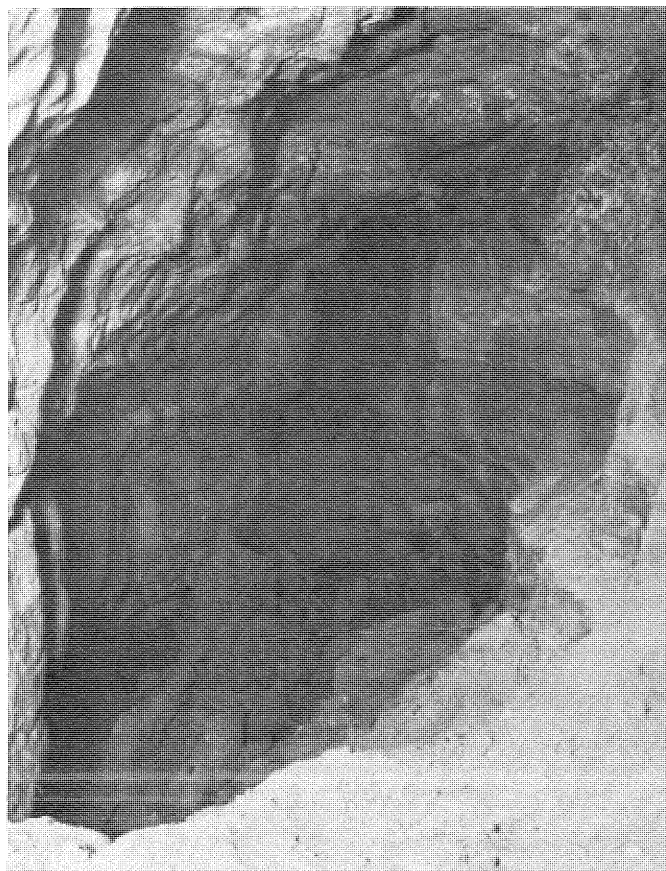
PHOTO 84. Cavity near bottom of Excavation No. 3 after digging farther into wall of trench. Cavity is sufficiently large for man to enter.

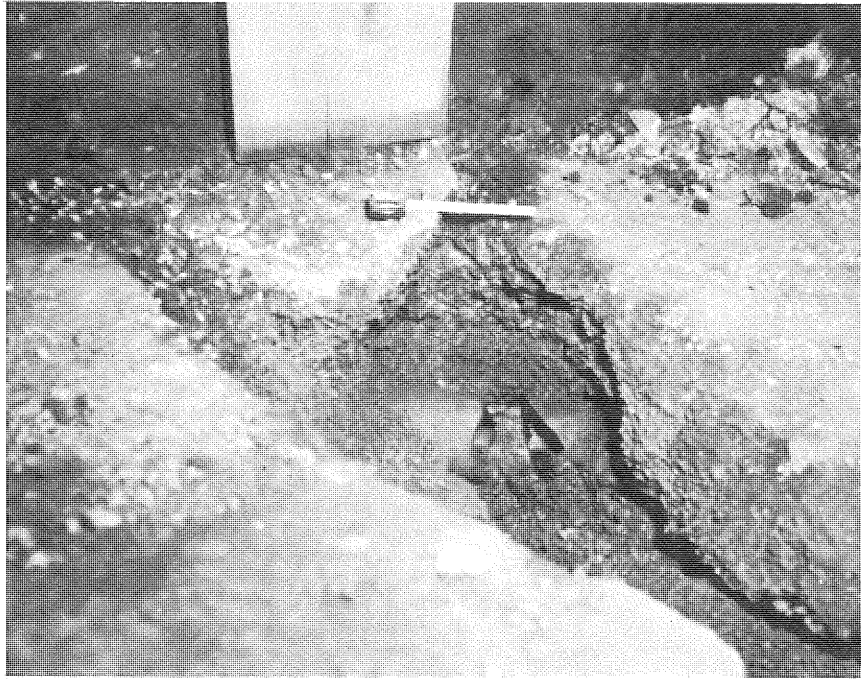
Excavation No. 8 was made specifically to expose the assumed crossing of Fault I by the southeast toe drain. The compacted earth lining was carefully removed from the pea-gravel drain. It was found that the drain and membrane were ruptured at the fault line, with the west side down about $\frac{1}{4}$ inch. The fractured pea-gravel drain was carefully removed. An open cavity was found immediately beneath it, extending between the southeast toe drain and an adjacent sink hole in the reservoir floor. The cavity was approximately 1 foot wide and 6 inches high. The 4-inch clay tile in the southeast toe drain was broken at the fault line. (Photo 85) It was evident that this break had occurred at some time in the past because the broken surface had an incrustation of calcium carbonate. Photos 86 and 87 show a fragment of the 4-inch tile with the calcium deposit.

PHOTOS 85. Broken 4-inch clay tile drain in Excavation No. 8. Faces of break were coated with a calcium carbonate deposit.

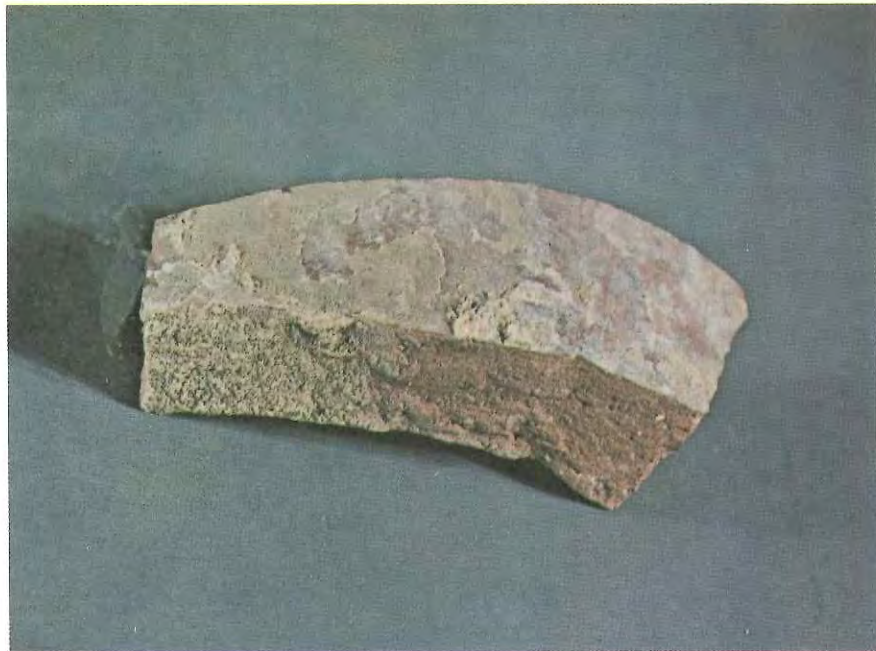
PHOTO 86. Broken clay tile pipe taken from Excavation No. 8, showing calcium carbonate deposit on face of old fracture.

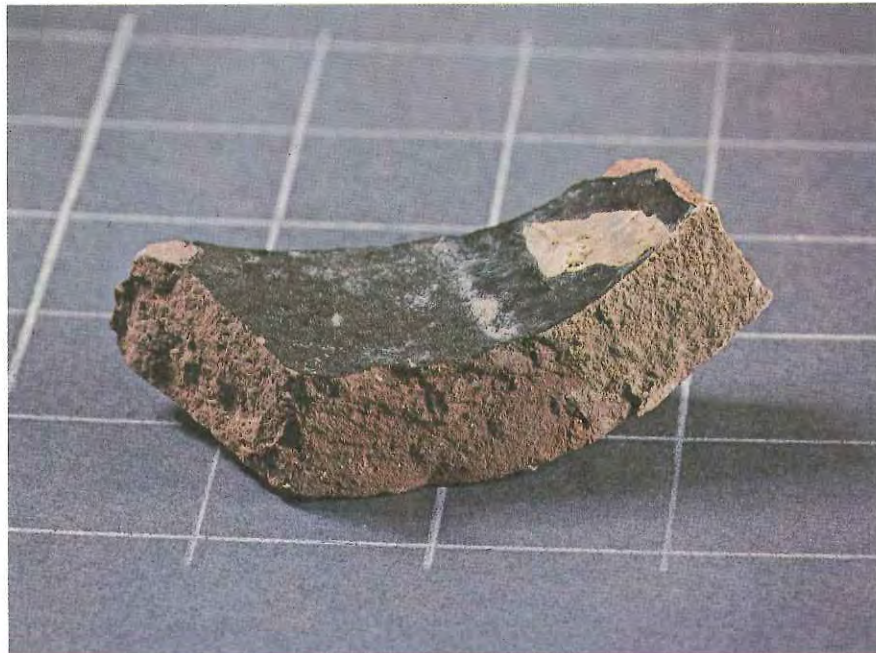
PHOTO 87 Another view of broken clay tile pipe taken from Excavation No. 8.

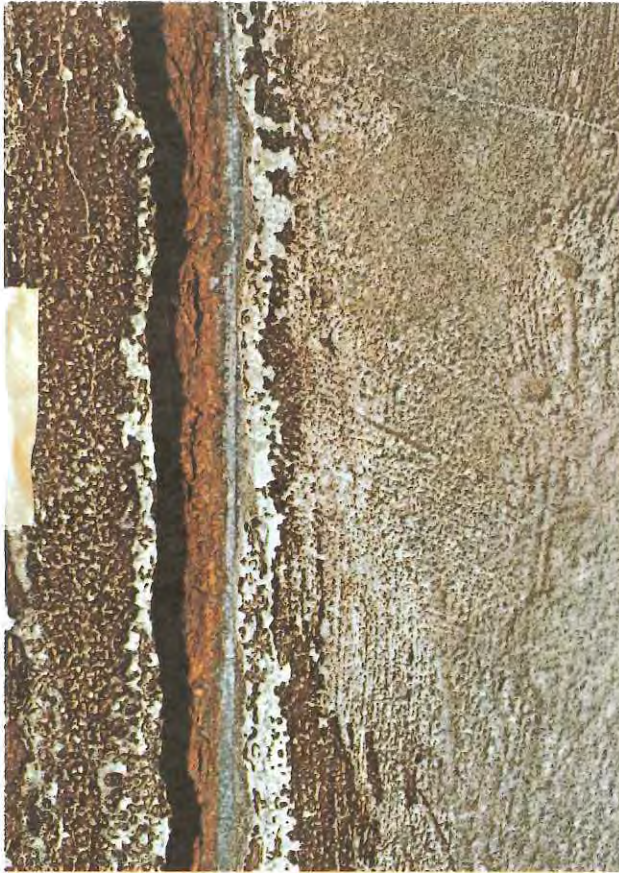
would be difficult if not impossible to determine, however, it serves to substantiate the conclusion that the crack in the lining has existed for a number of years.” (Photos 90 and 91)

PHOTO 90. Interior of circulator connector conduit, showing corrosion of steel bell ring at a joint where the cement mortar lining separated. Blue line is uncorroded steel recently exposed.

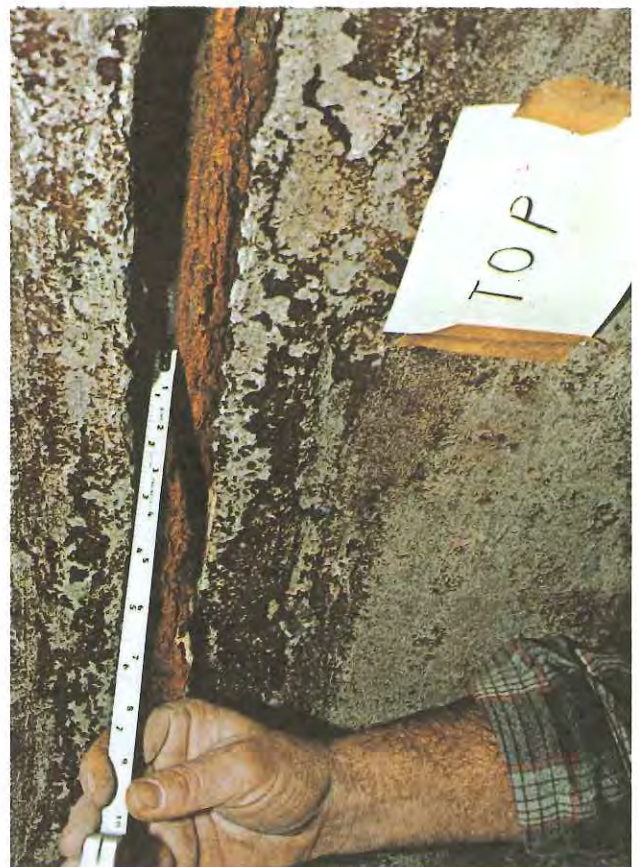
PHOTO 91. Interior of circulator connector conduit showing corrosion layers on steel bell ring at lining separation.
