Department of Water Resources

INVESTIGATION OF FAILURE
BALDWIN HILLS RESERVOIR

APRIL 1964

Baldwin Hills Reservoir Failure Consulting Board Report

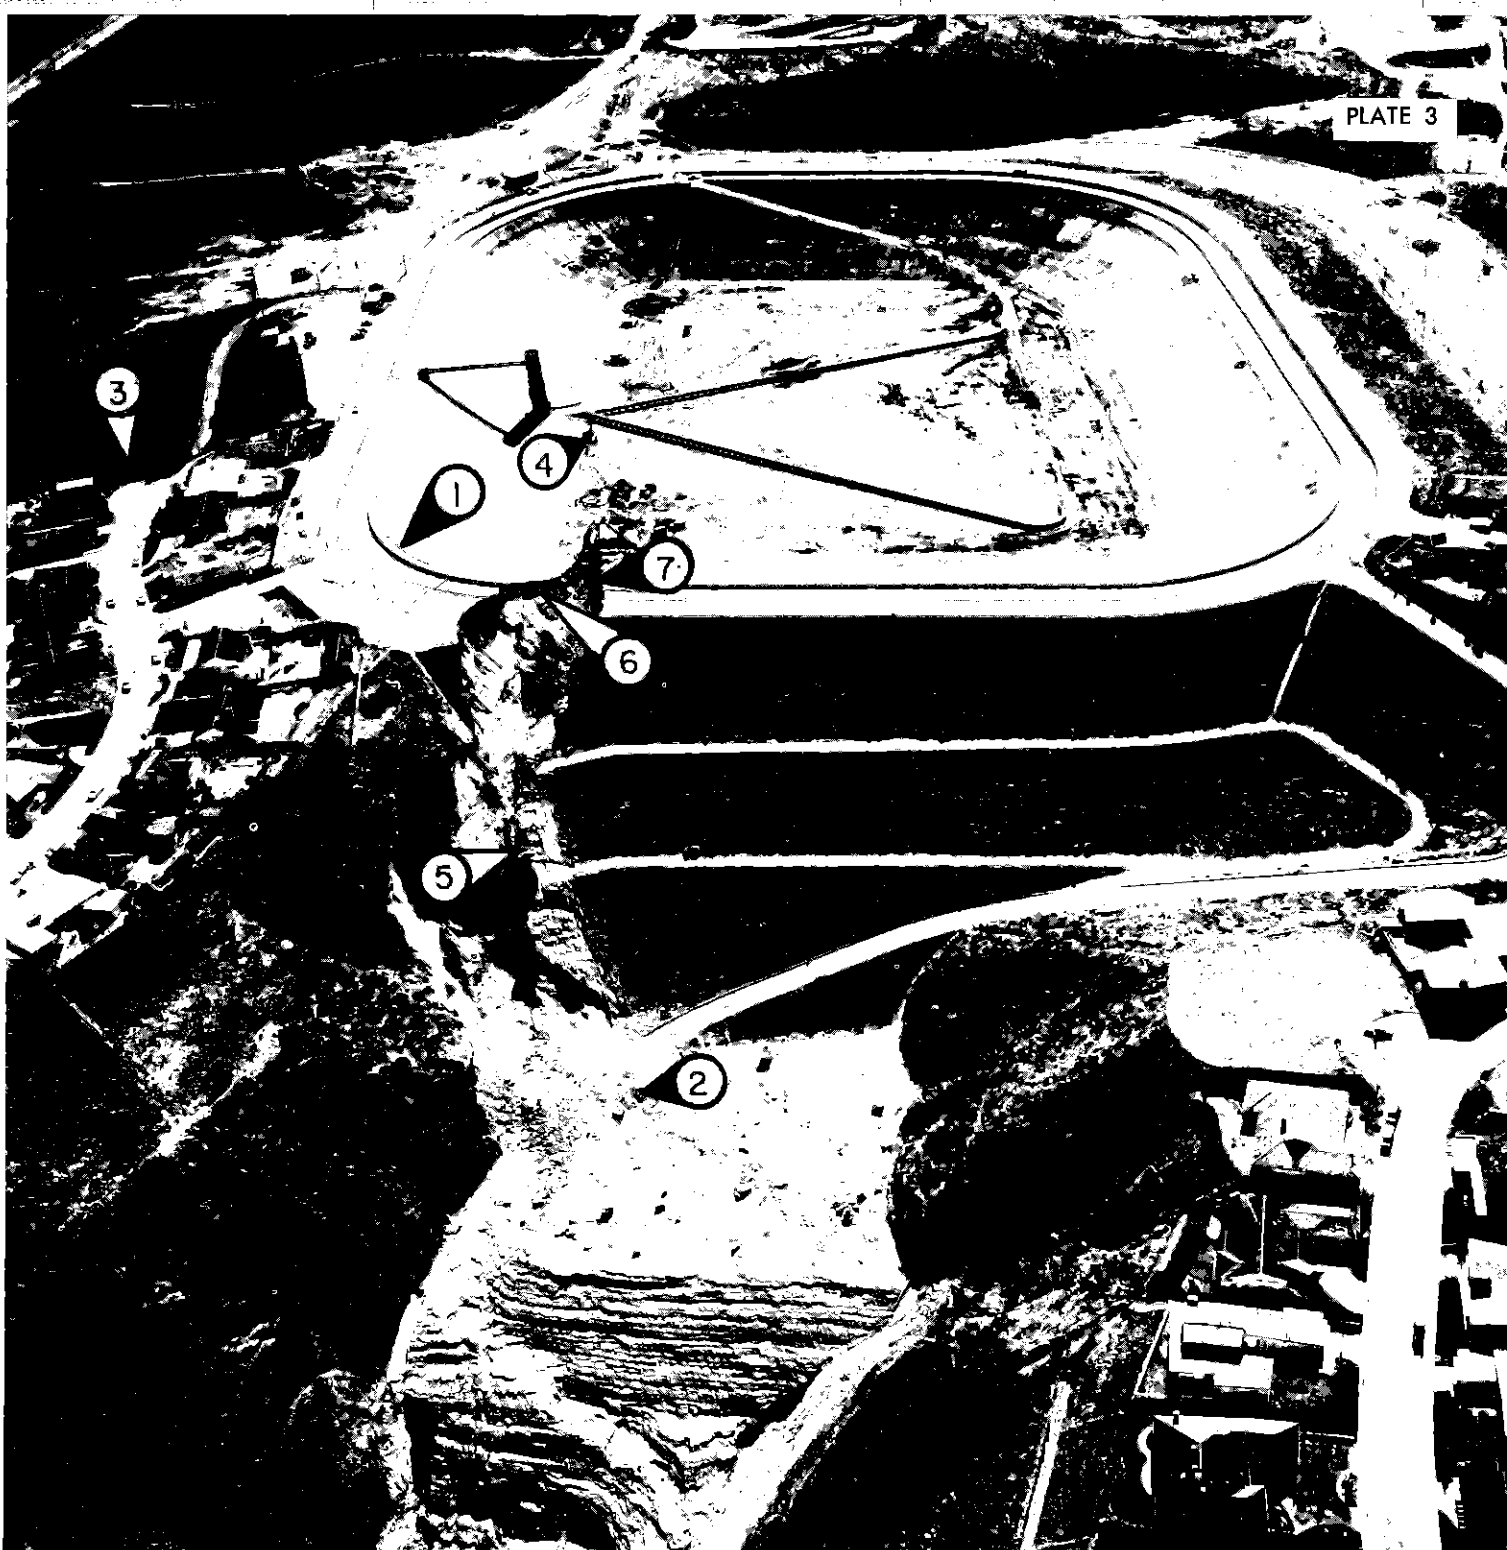
EVENTS ON DAY OF FAILURE

1. Caretaker noticed an unusual sound of water at spillway intake at about 11:15 a.m.
2. At the catch basin, caretaker observed an unusually high flow of drainage water running through spillway pipe.
3. Caretaker entered inlet tunnel portal to reach drainage inspection chamber.
4. Inside the chamber, beneath the reservoir, drains were found to be discharging at an unusually high rate.
5. Leakage from reservoir was first observed on downstream side of dam at a point about 10 feet above 390 berm.
6. First surface evidence of possible breach occurred at Station 8+93.5, where a crack across the main dam opened and rapidly widened.
7. As flow through dam continued, an opening became evident on inside face of dam. The breach was complete by 3:38 p.m.

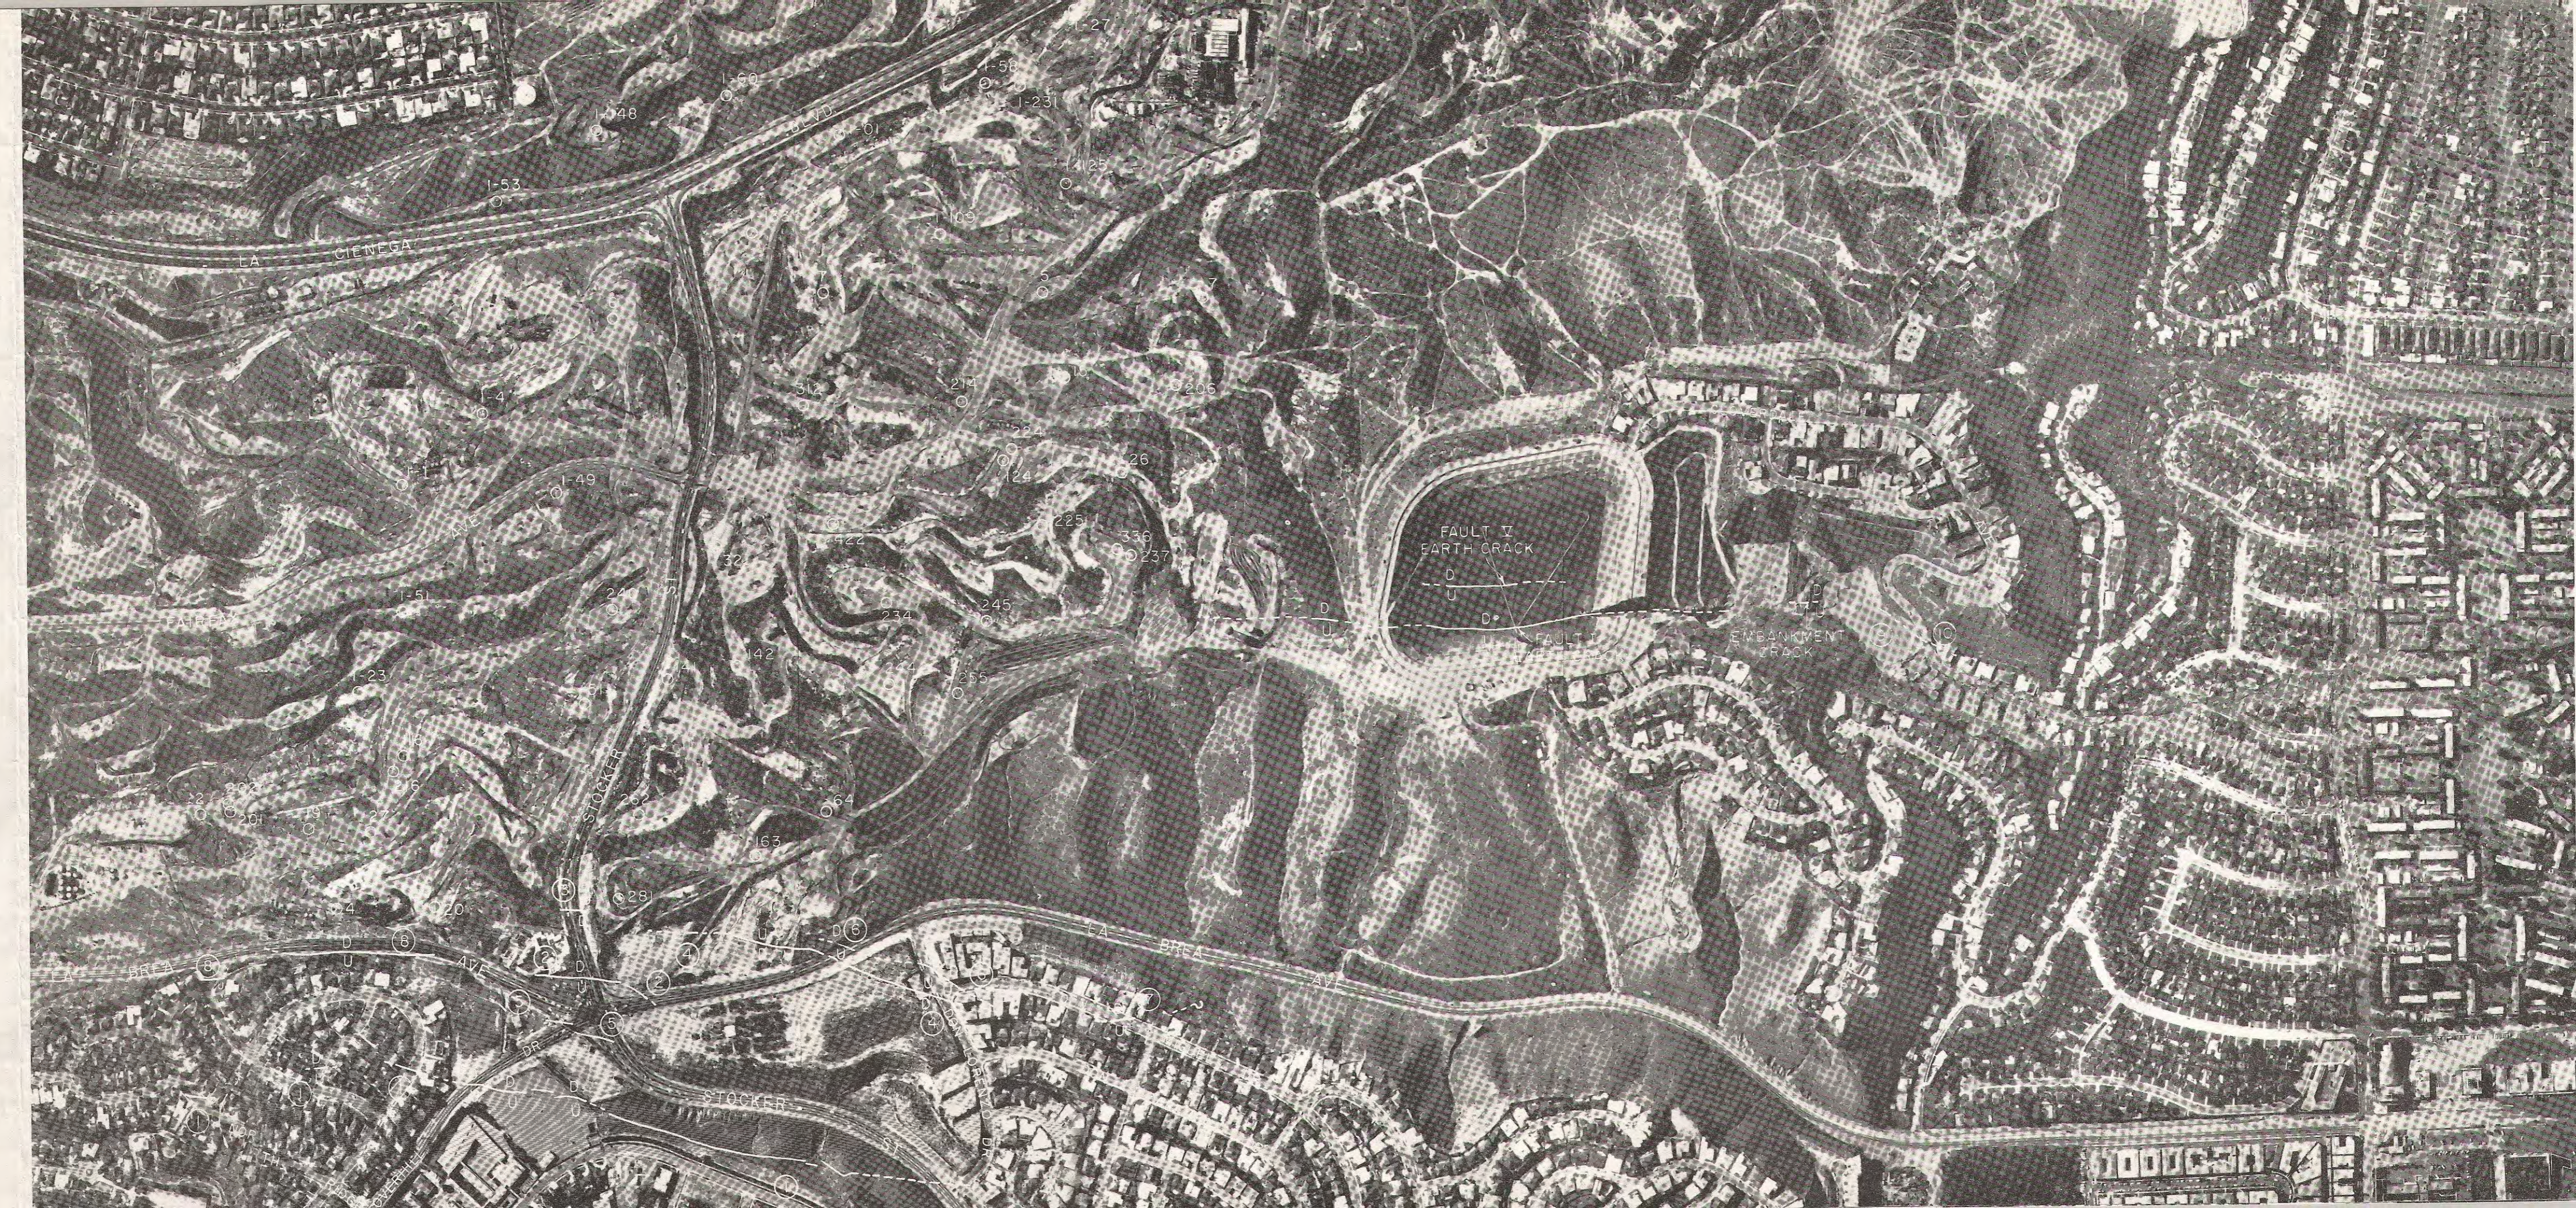
LOCATION OF EARTHCRACKS

Fault I earth crack	December 14, 1963	Reservoir and South beyond water tank (Possibly)	West side down 8"	N 8°-10° W, Dip 73°-86° W	Inspection chamber pea-gravel drain, tile drain	Crack in asphalt membrane, impervious embankment material, curb and road.
Fault V earth crack	December 1963	Reservoir only	West side down 4"	N 7° W-N 3° E, Dip 65°-72° W	Circulator lines, pea-gravel drain, tile drain	Crack in asphalt membrane, and impervious embankment material.

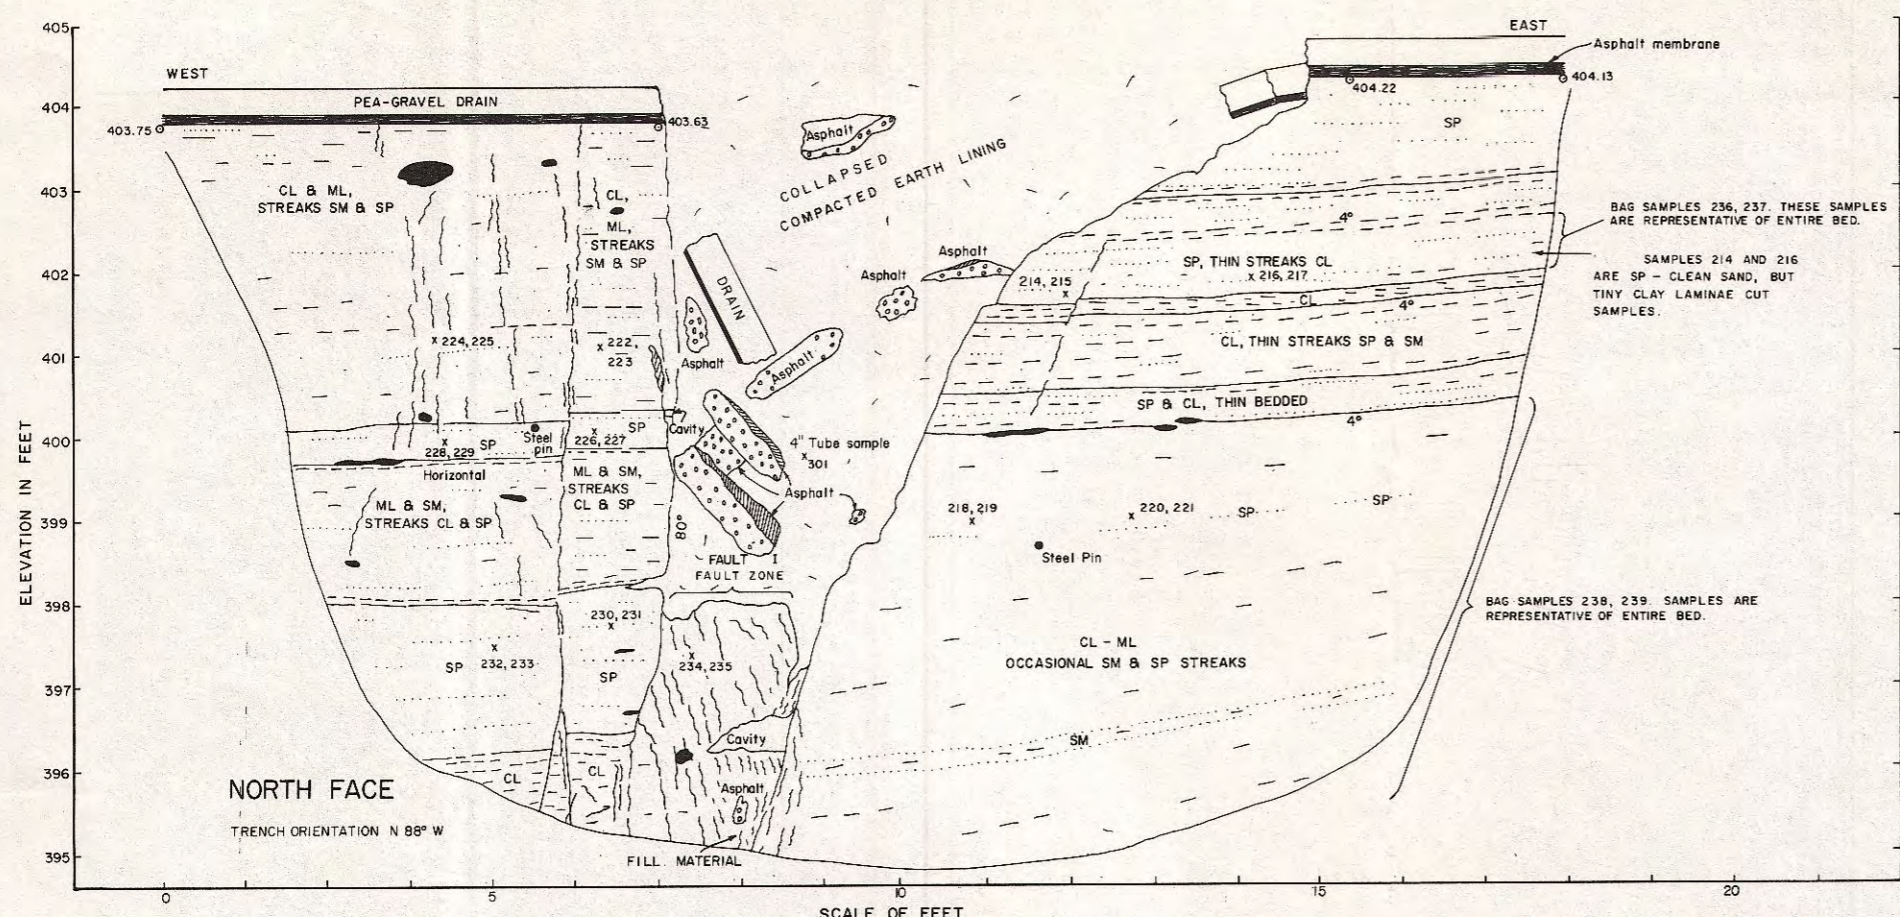
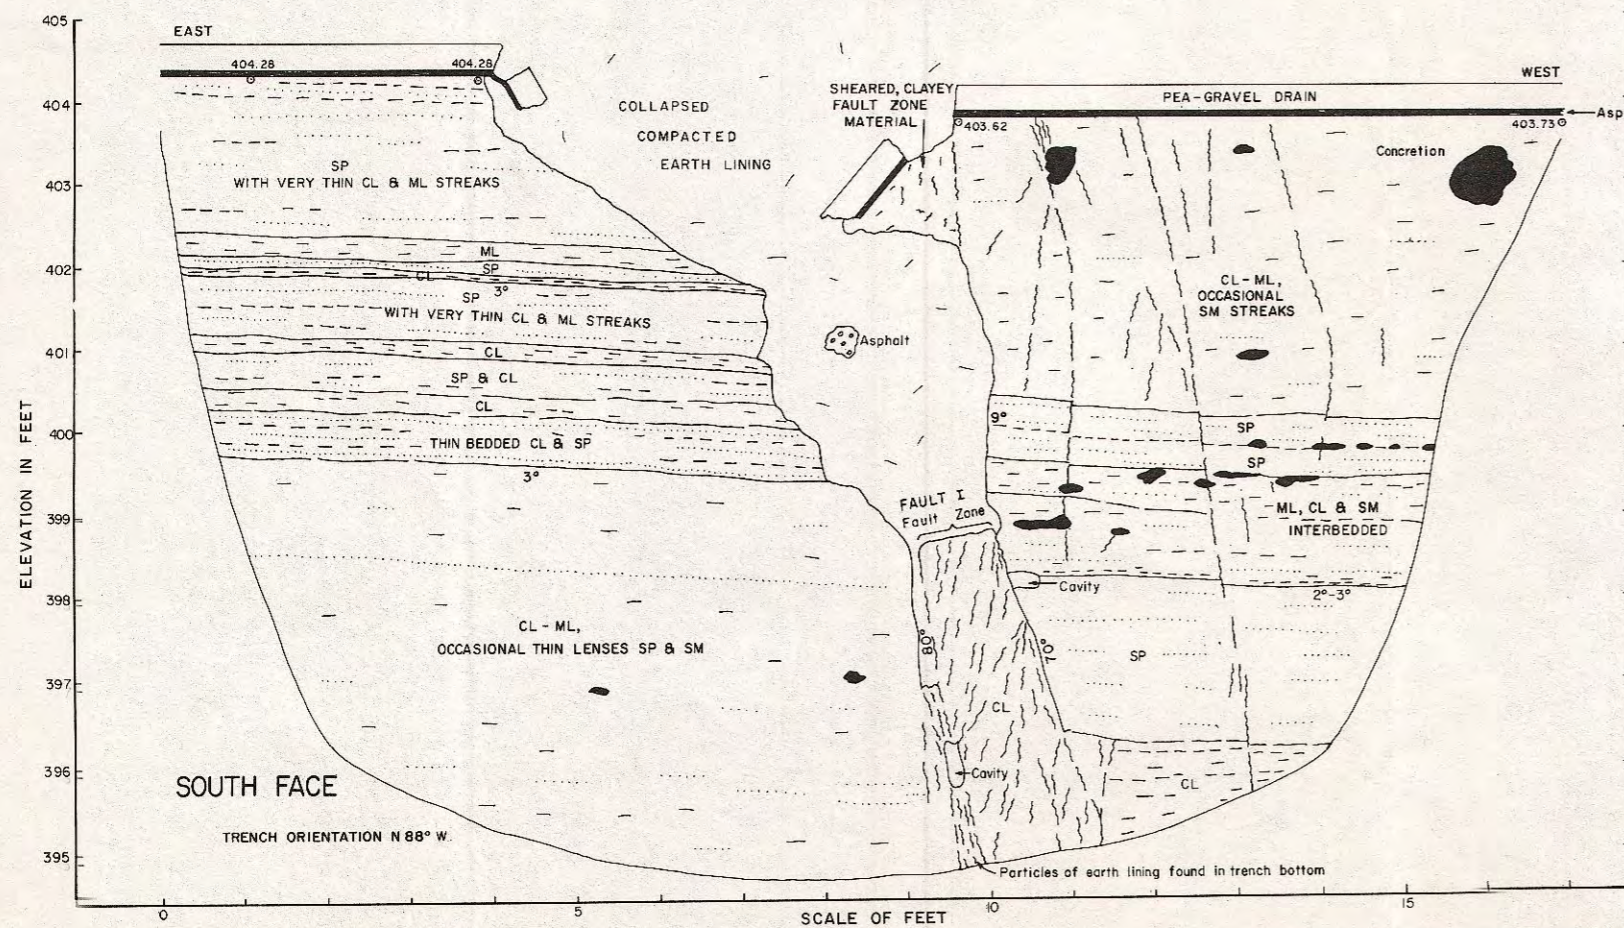
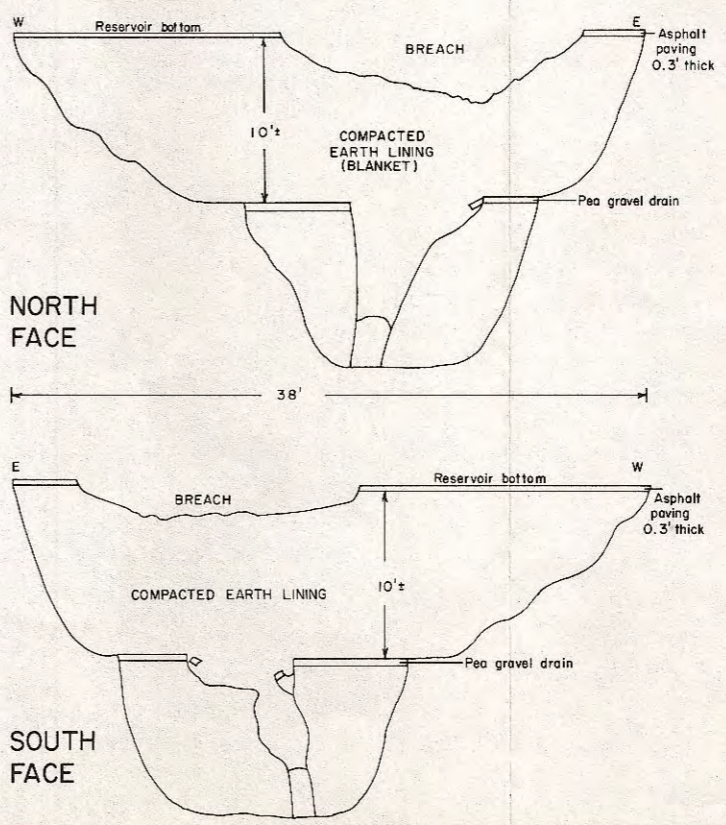
- NOTES:**
1. NEARLY ALL SHEAR FACES THIS TRENCH WERE COATED WITH SOFT, WHITE, CALCAREOUS MATERIAL.
 2. AVERAGE DIP OF FAULT THIS TRENCH 75° WESTERLY, STRIKE N 8° E. AVERAGE DIP OF BEDS 3°-4° WESTERLY, STRIKE N 75° W. SEDIMENTS THIS TRENCH ARE INGLEWOOD FORMATION.
 3. A GREAT DEAL OF FOREIGN MATERIAL IS PRESENT ALONG FAULT ZONE. THIS TRENCH IS LOCATED IN FAILURE PATH JUST ON NORTHERLY EDGE OF RESERVOIR BOTTOM.

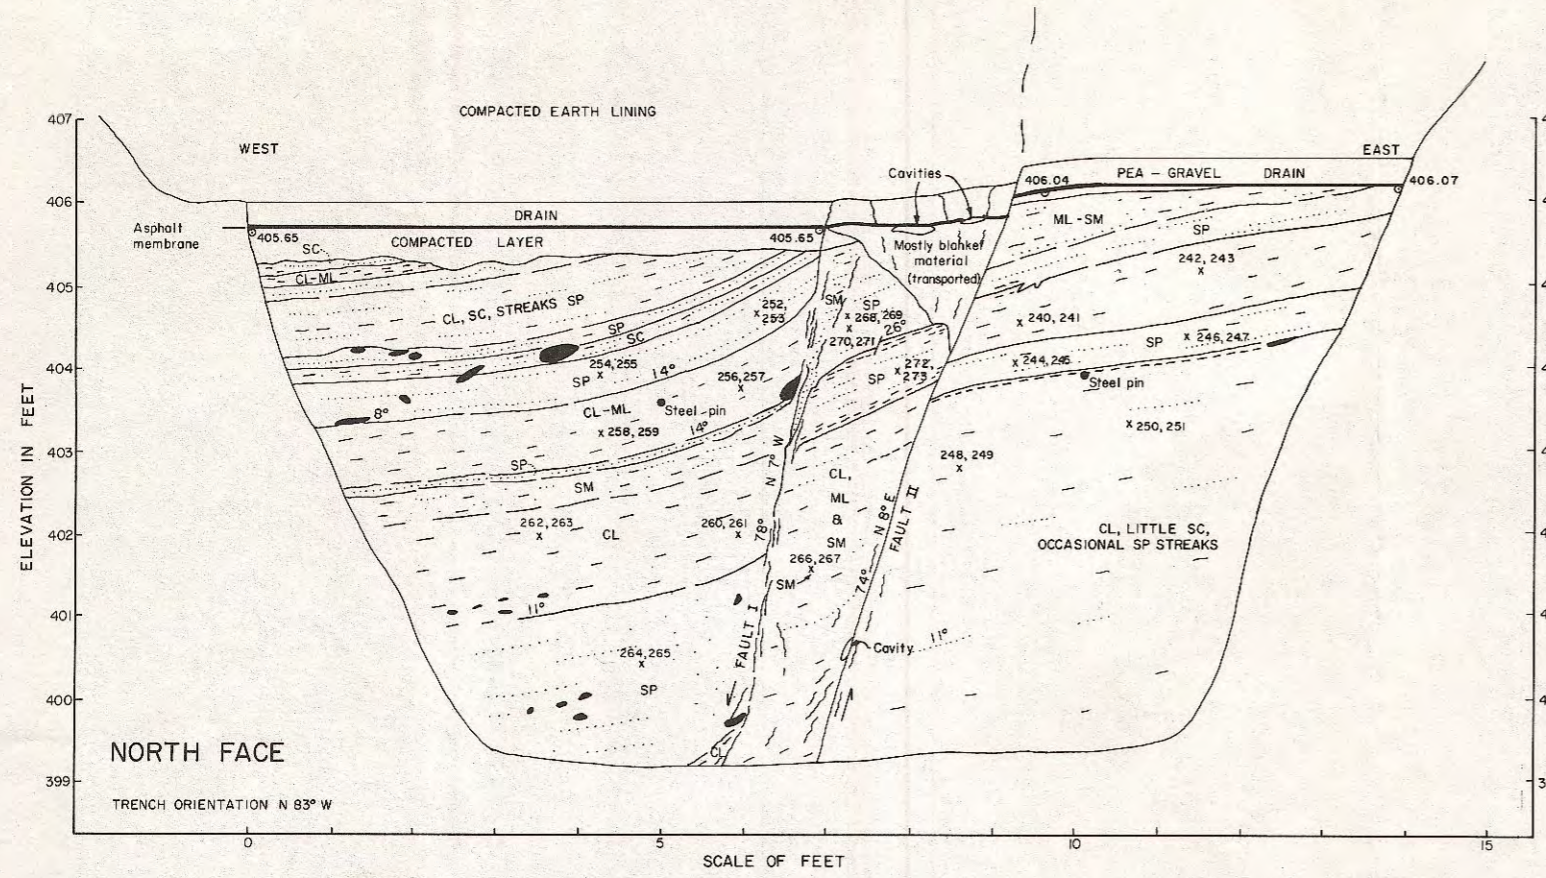
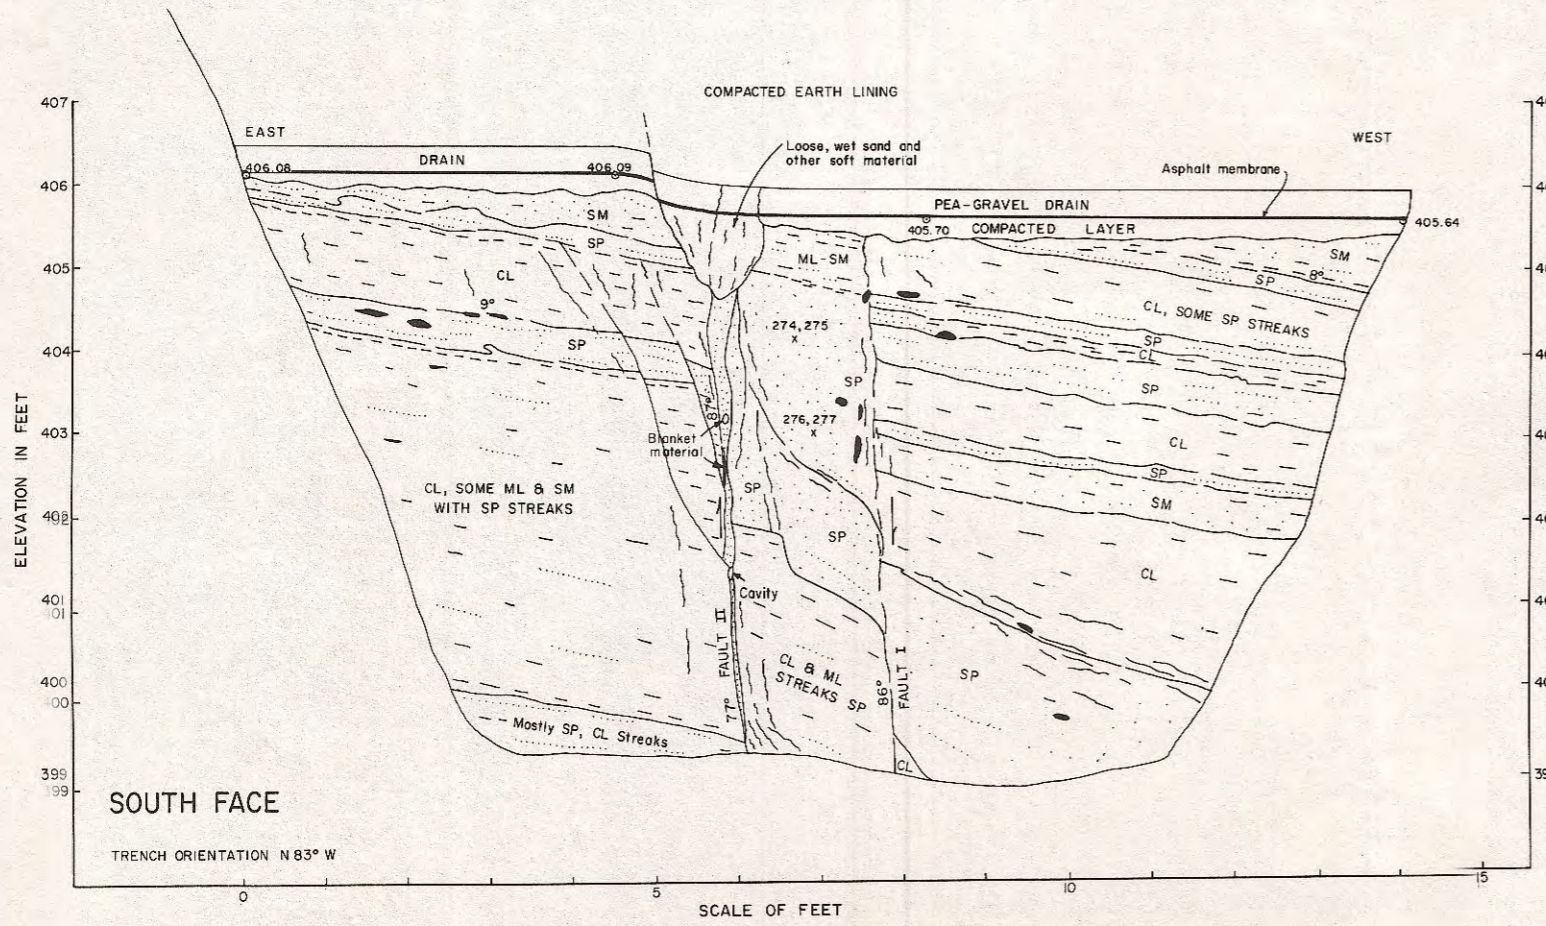
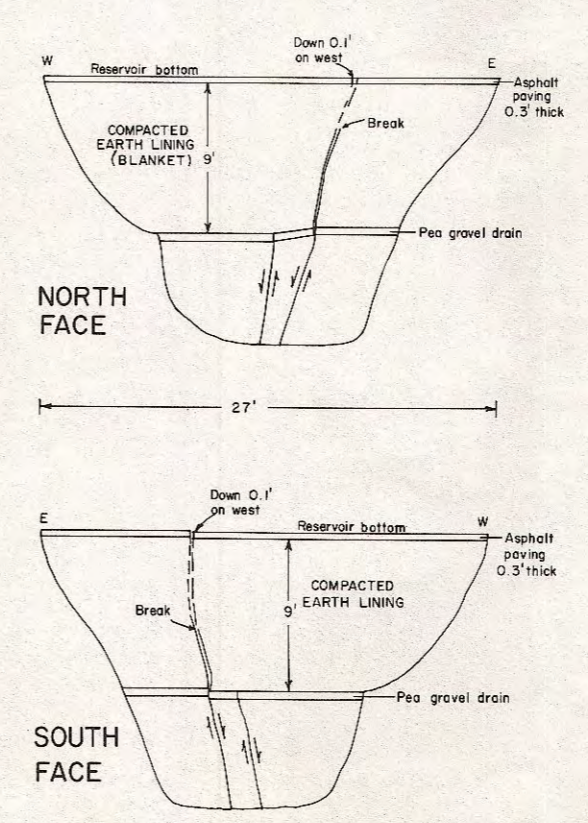
- NOTES:**
- A ZONE OF LOOSE DISTURBED MATERIAL IS PRESENT ALONG FAULT ZONE JUST BELOW PEA GRAVEL DRAIN. THIS MATERIAL IS FOREIGN AND WAS DEPOSITED - PRESUMABLY IN A VOID - AFTER COMPLETION OF RESERVOIR.
 - SEDIMENTS THIS TRENCH ARE INGLEWOOD FORMATION.

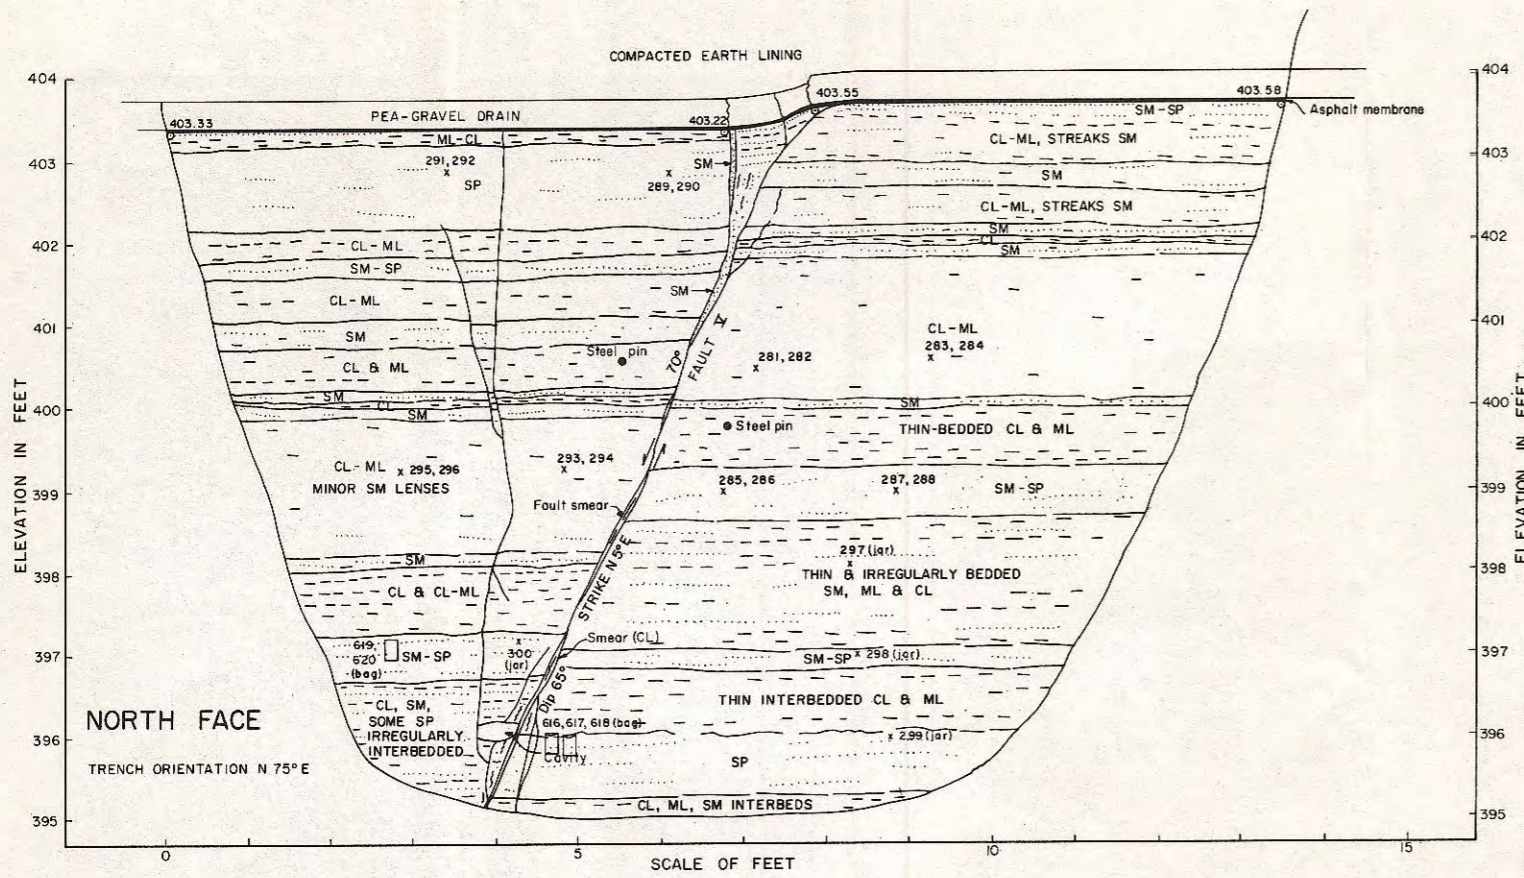
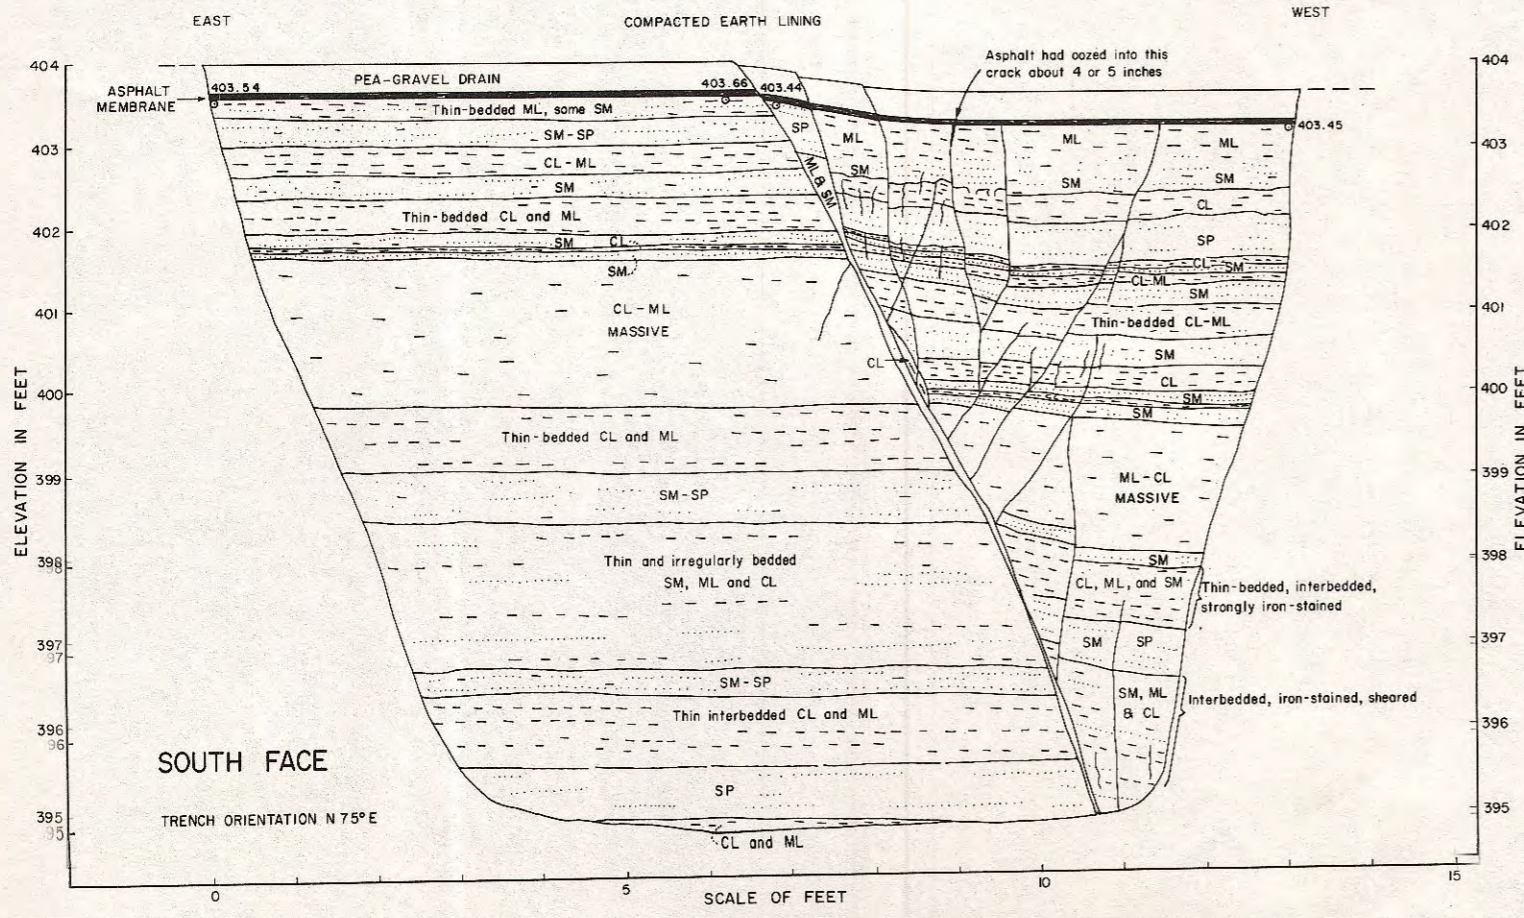
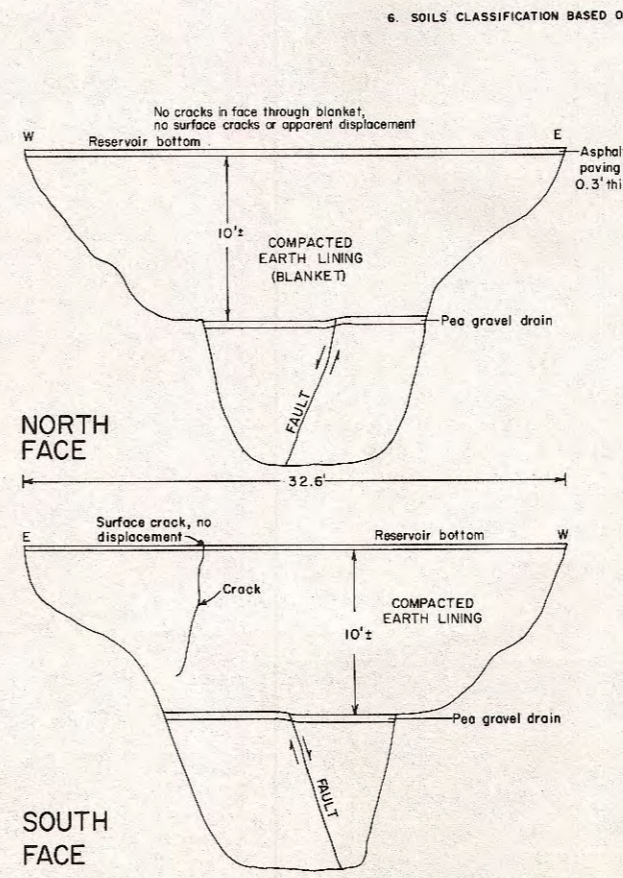
- NOTES:**
- CAVITY LOCATED NEAR BOTTOM OF TRENCH IN NORTH FACE IS ALONG FAULT ZONE AND OPENS INWARD TO A VOID ABOUT 11' LONG, 1' TO 2' WIDE AND ABOUT 3' HIGH. CAVITY DISCOVERED 1/11/64, THREE WEEKS AFTER TRENCH WAS FIRST EXCAVATED. A THIN, IRREGULAR FILM OF SECONDARY MATERIAL COVERED WALLS AND ROOF OF CAVITY.
 - AVERAGE DISPLACEMENT ALONG FAULT HERE IS 2.2'
 - DIP OF BEDS IS VERY FLAT WITH PERHAPS 2° - 3° DIP TO NORTHWEST.
 - IRON OXIDE STAINING IS VERY COMMON, PARTICULARLY IN SOME CLAYS AND ALONG CONTACTS OF BEDS.
 - SEDIMENTS THIS TRENCH ARE INGLEWOOD FORMATION.

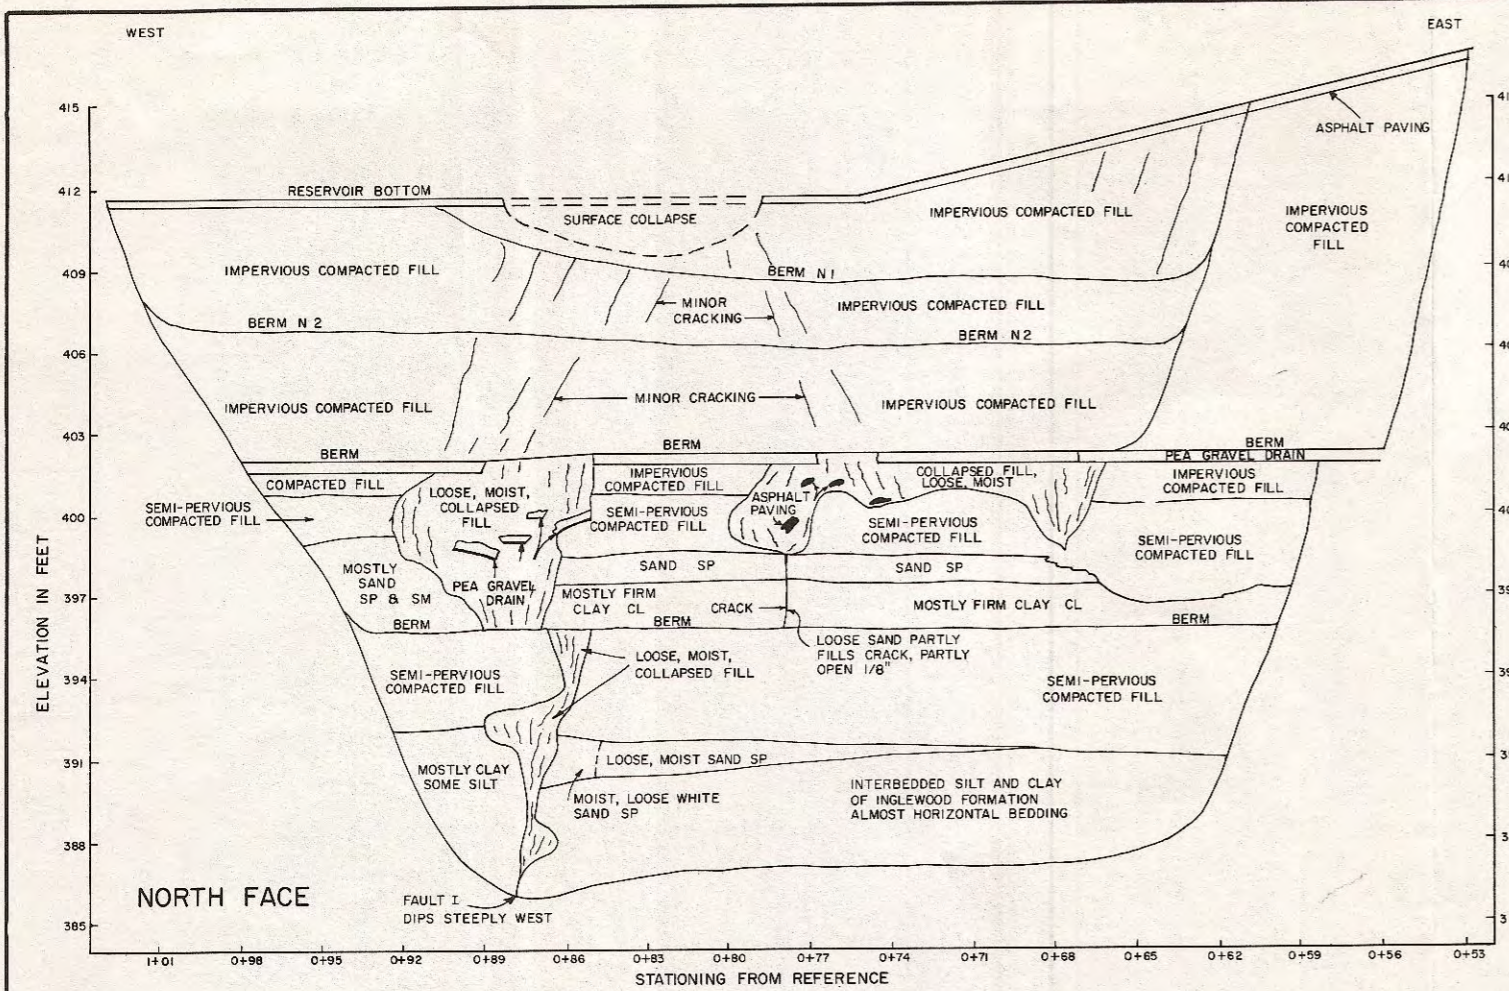
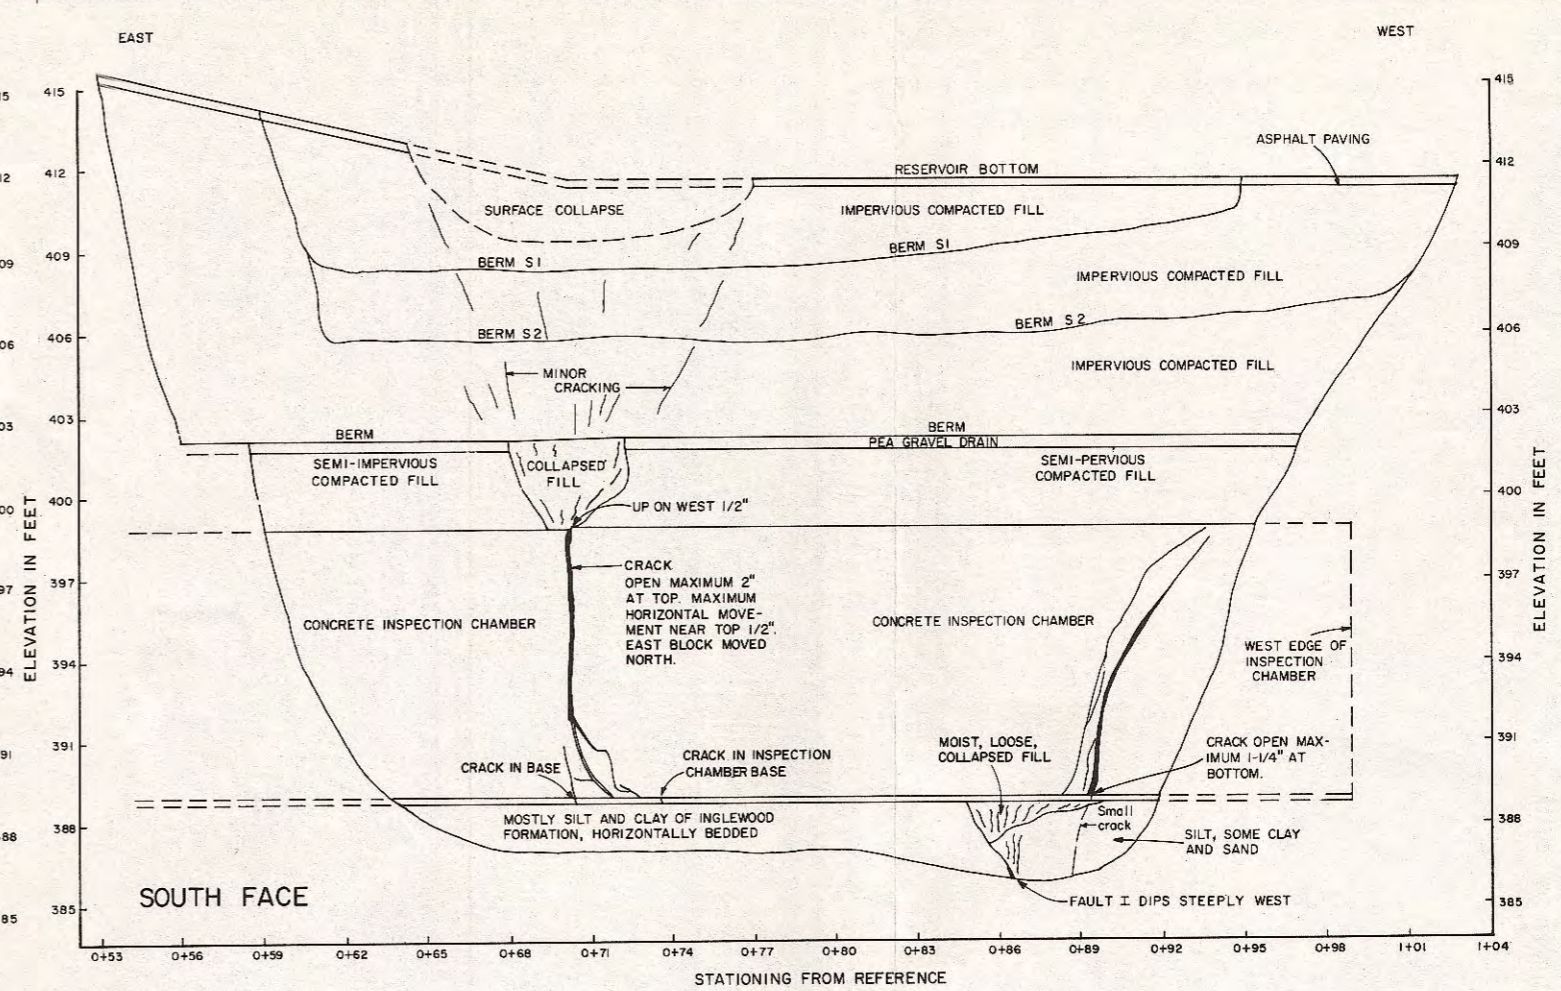
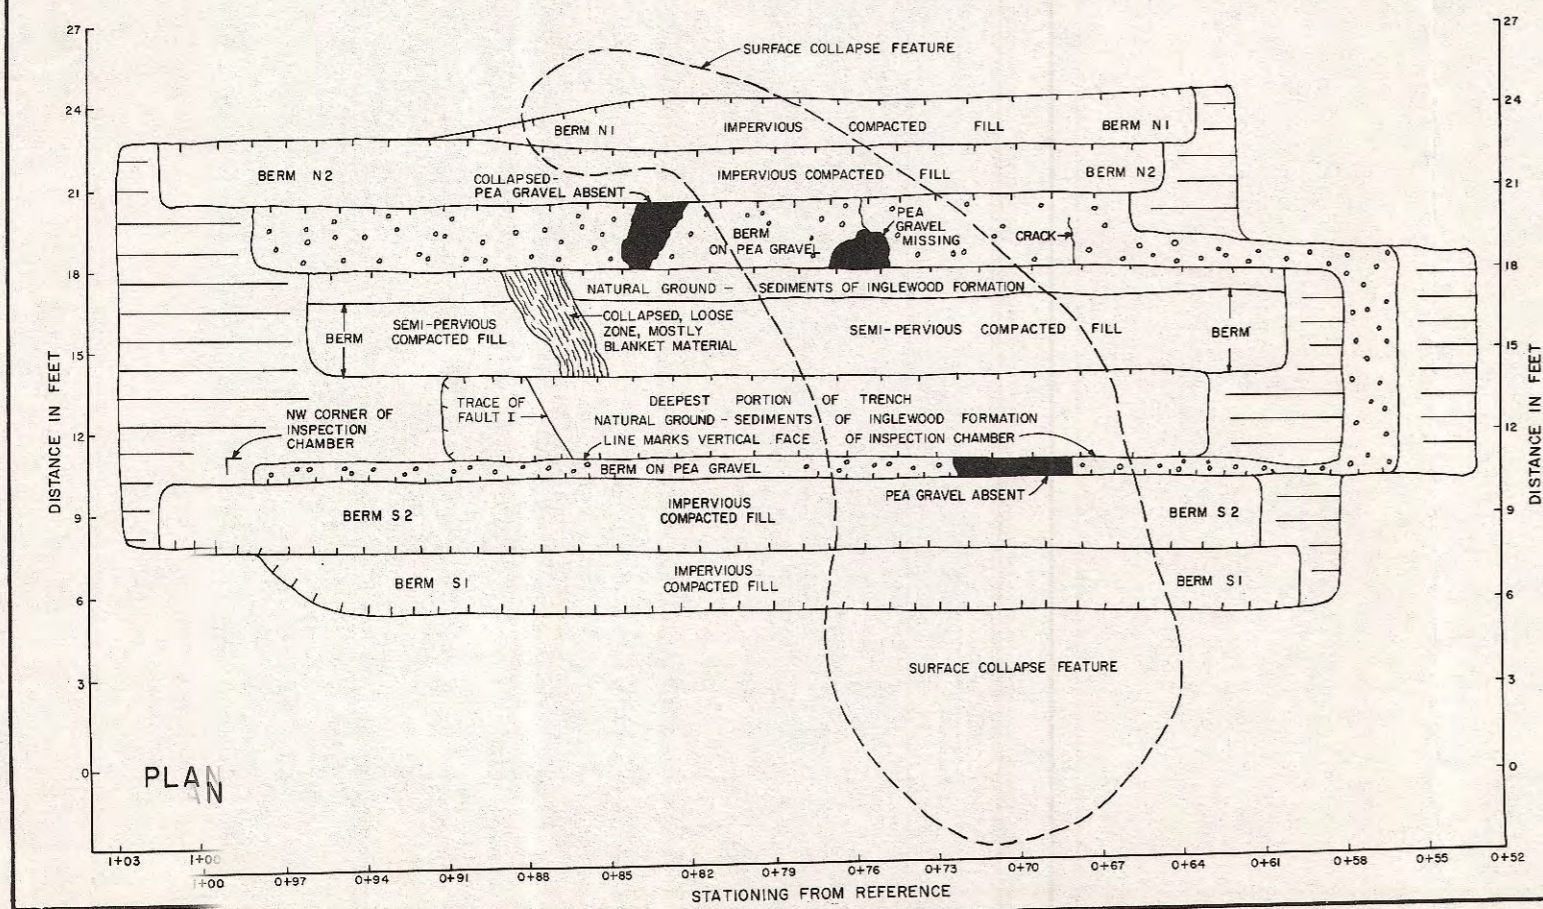
STATE OF CALIFORNIA
 THE RESOURCES AGENCY
 DEPARTMENT OF WATER RESOURCES
 INVESTIGATION OF FAILURE
 BALDWIN HILLS RESERVOIR
LOG OF EXCAVATION No. 7B

- NOTES**
1. THIS TRENCH WAS EXCAVATED WITH A GRADALL ON MARCH 11-14, 1964.
 2. BERMS AS SHOWN ON DRAWING WERE A RESULT OF EXCAVATION AND SHORING PROCEDURE.
