Department of Water Resources

INVESTIGATION OF FAILURE
BALDWIN HILLS RESERVOIR

APRIL 1964

Baldwin Hills Reservoir Failure Consulting Board Report

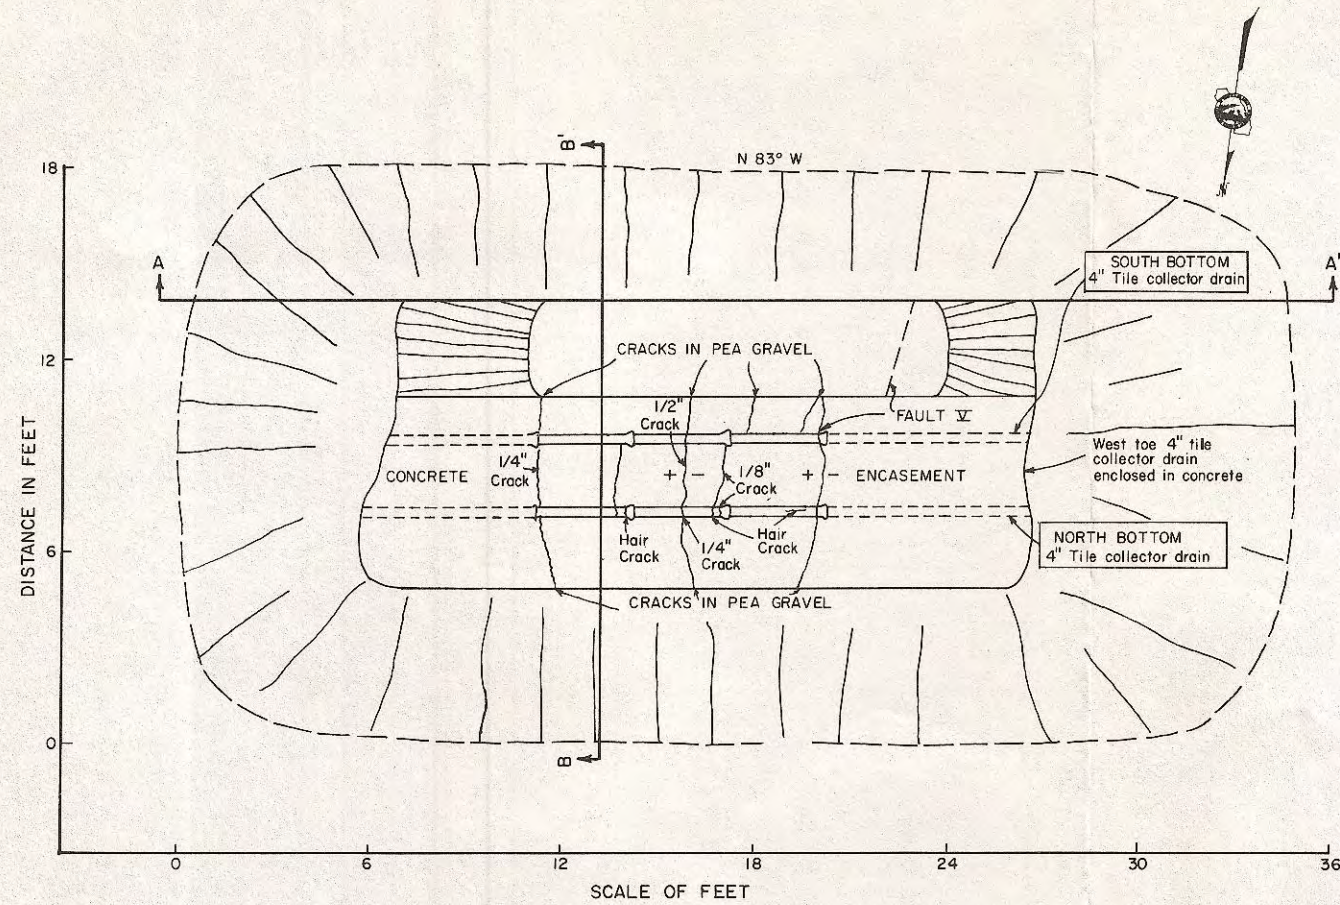
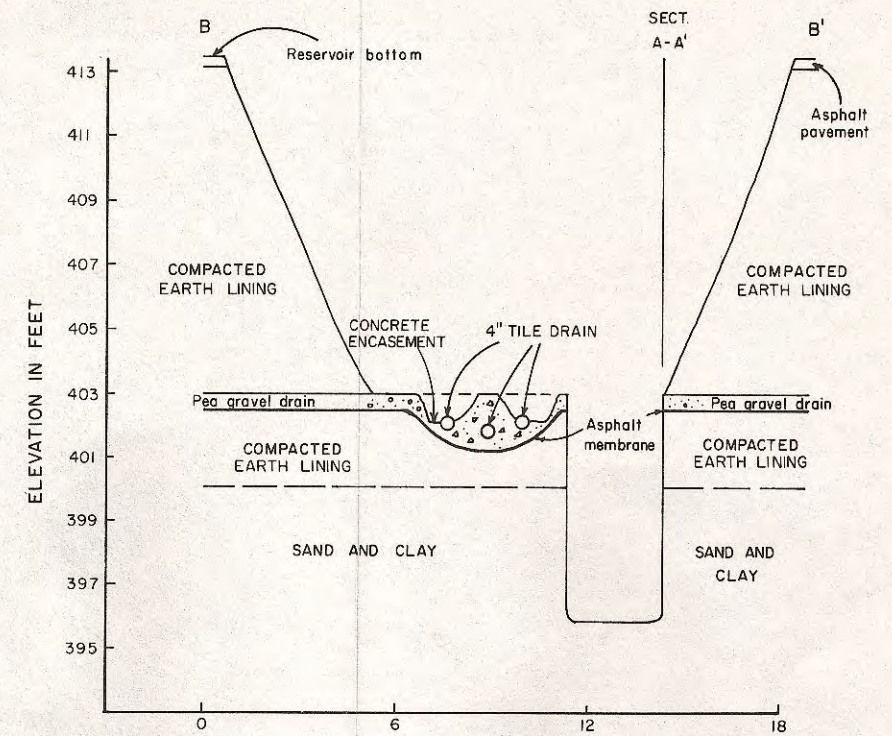
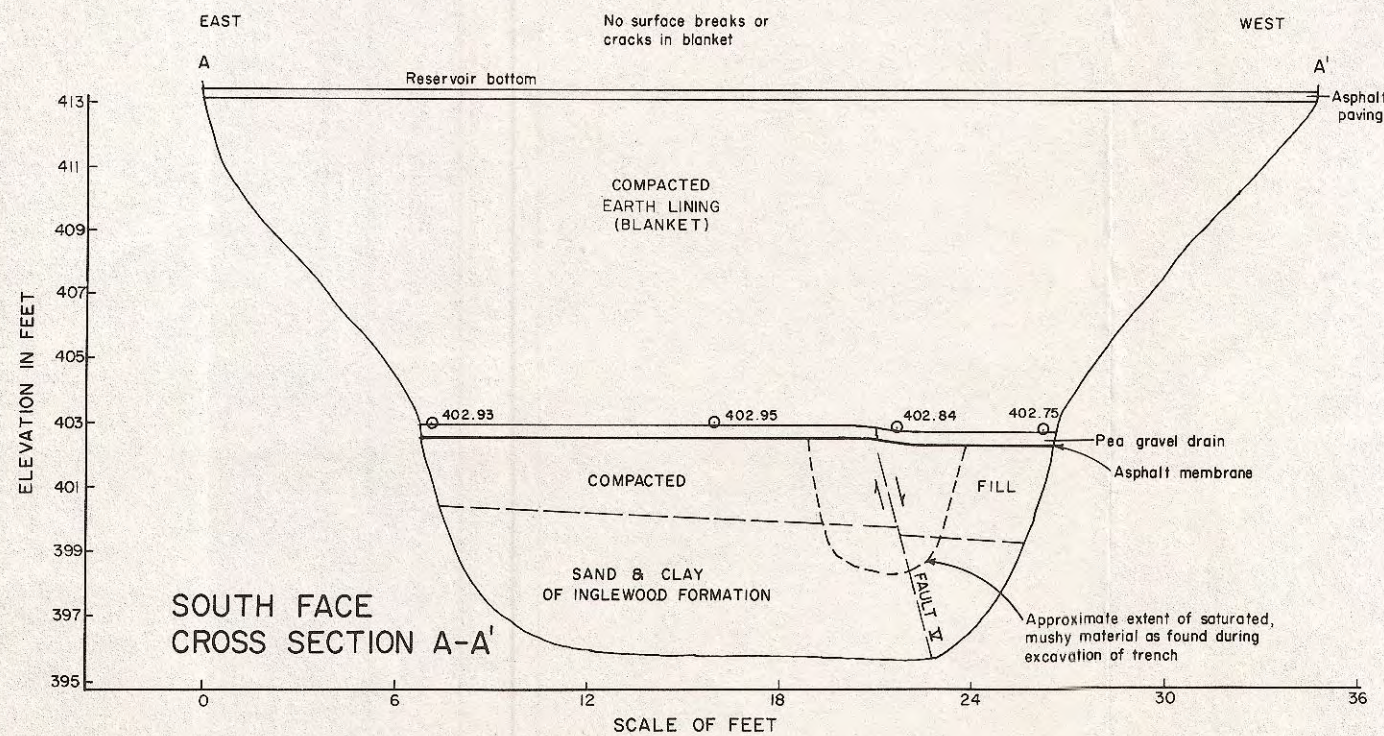
1. LIGHT-COLORED SECONDARY DEPOSITS ARE PRESENT ON CRACK FACES OF BOTH TILE DRAINS ON LARGE CENTRAL CRACK (LABELED 1/2" CRACK WHERE CRACK CROSSES CONCRETE ENCASEMENT). THIS SECONDARY DEPOSIT INDICATES THE CRACK HAS EXISTED FOR SOME TIME.
2. ON SECTION A-A' SATURATED, MUSHY MATERIAL IS LABELED. THIS OCCURRENCE INDICATES MOISTURE WAS GETTING THROUGH SEALING MEMBRANE INTO FOUNDATION.
3. TRENCH WAS EXCAVATED WITH A GRADALL.

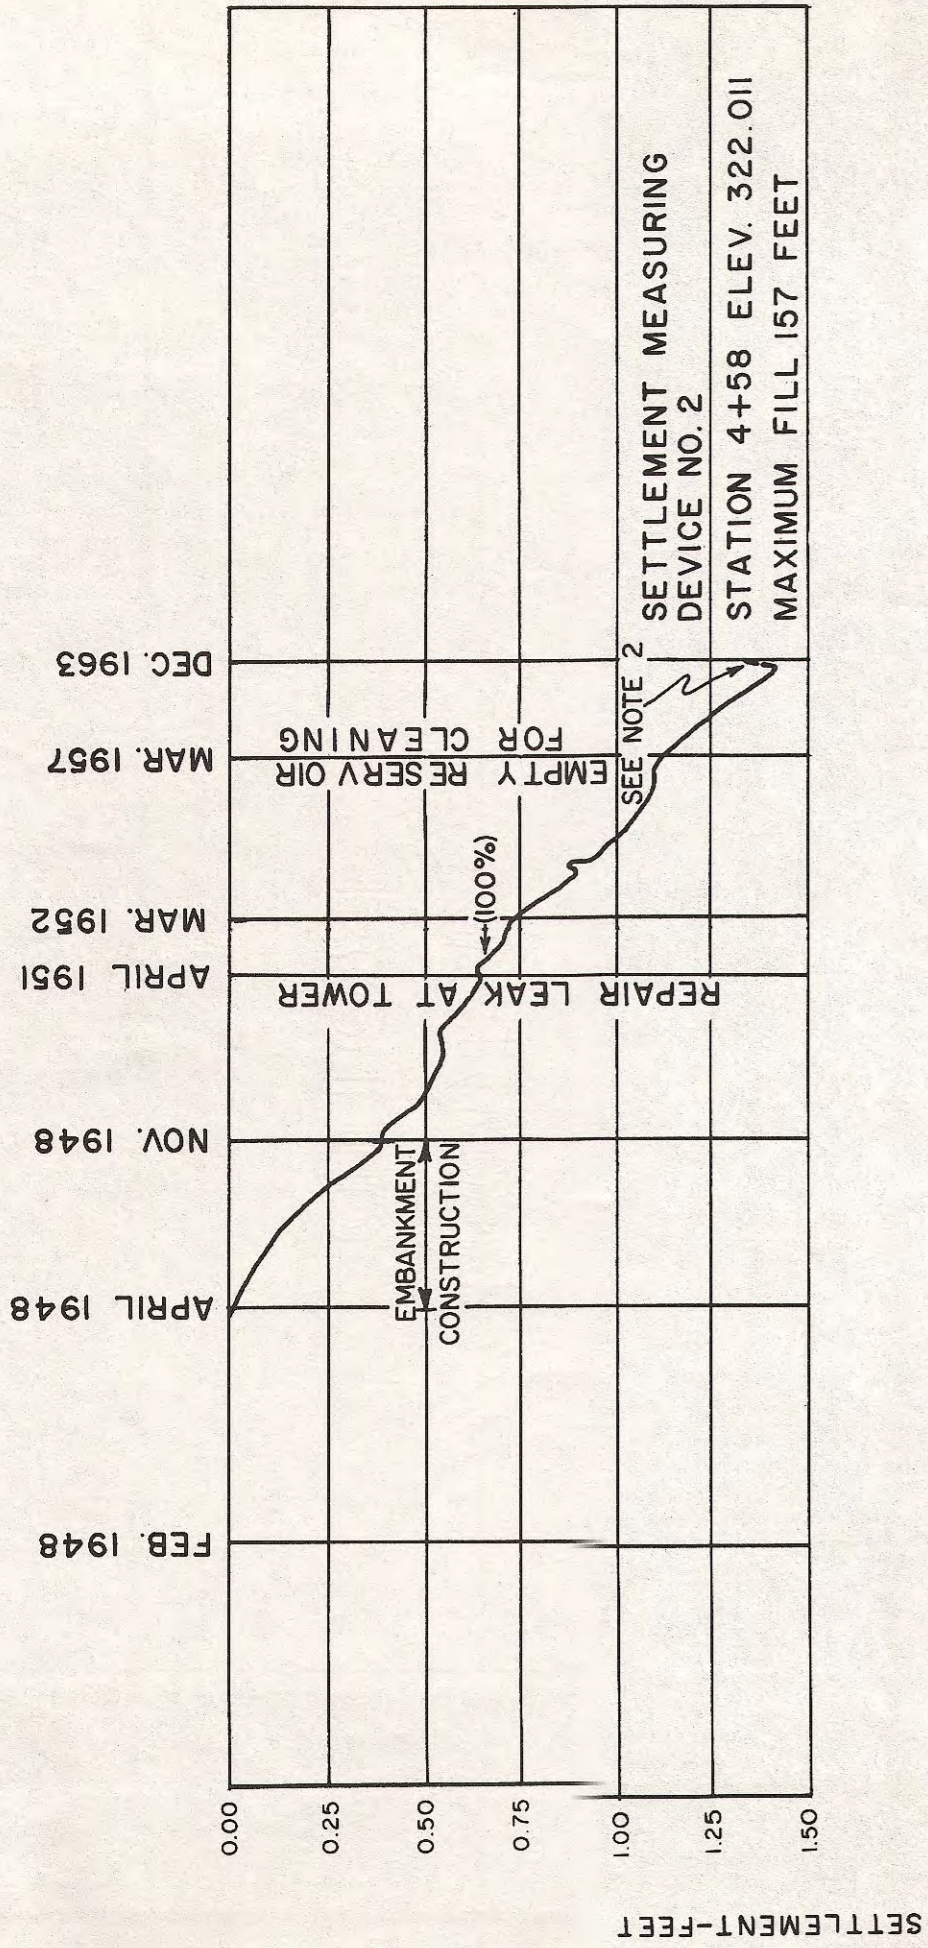
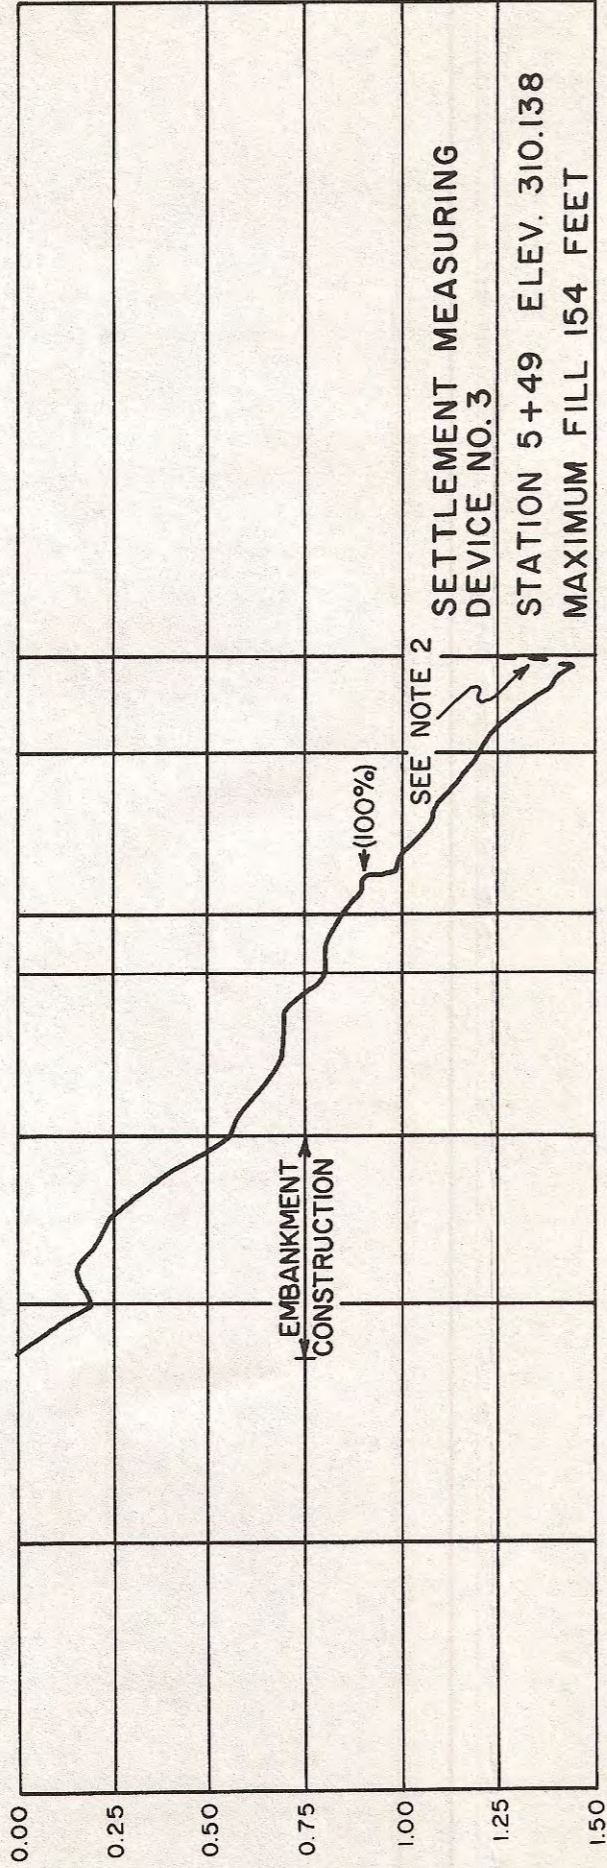
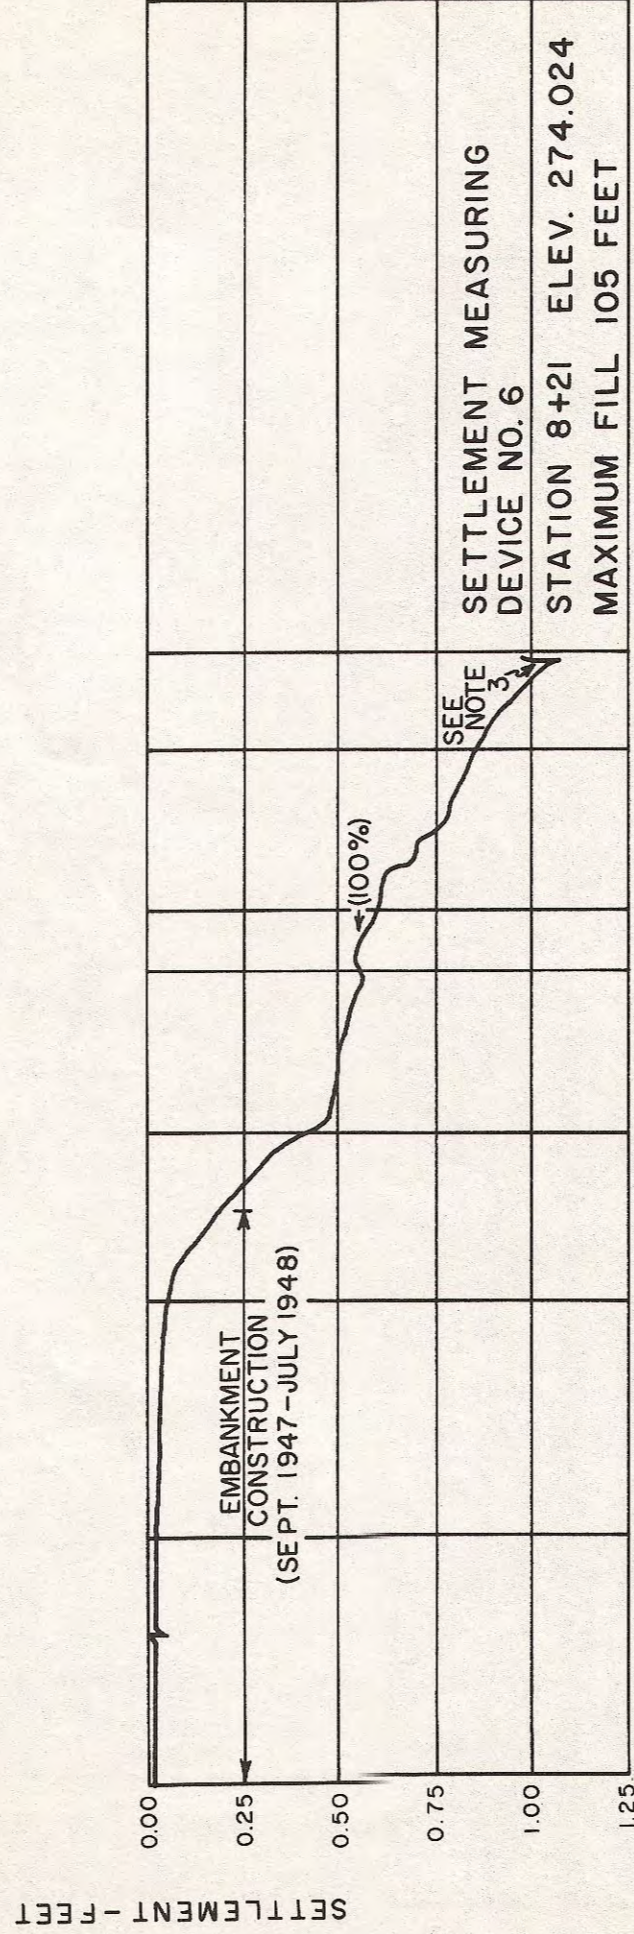
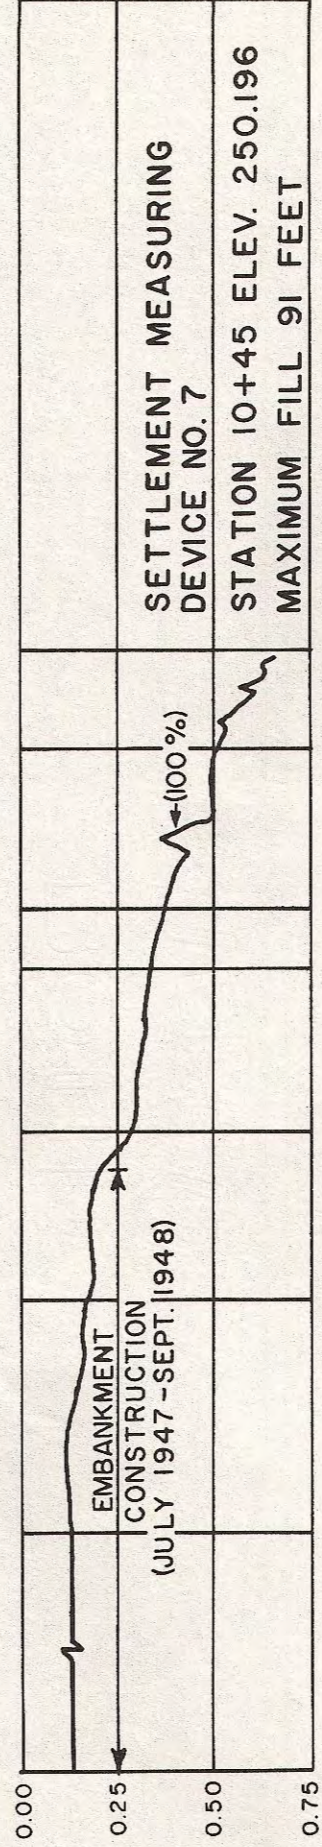
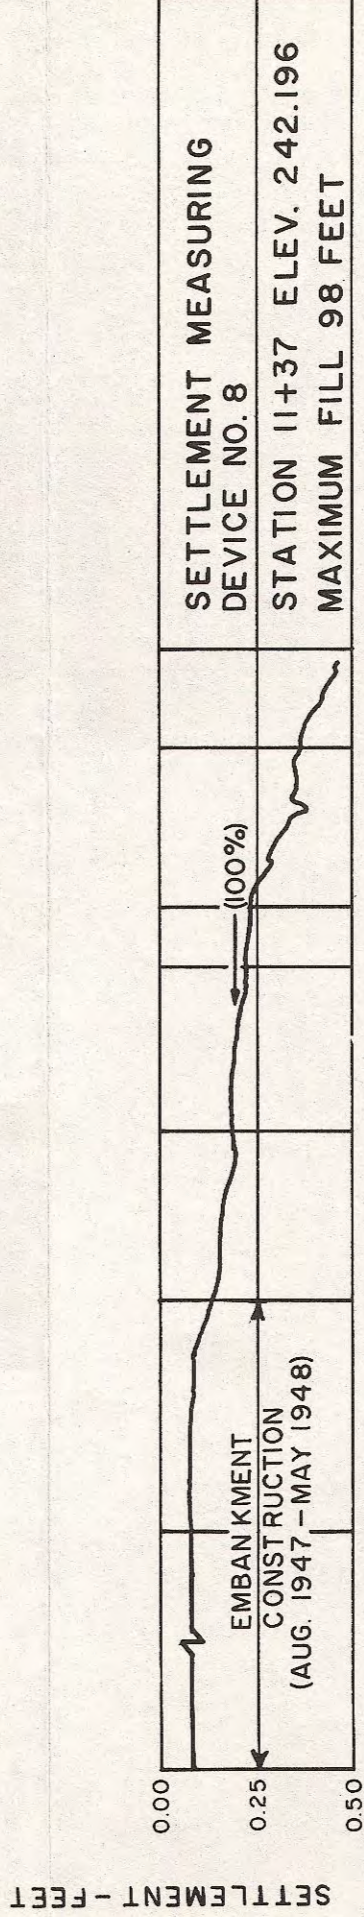
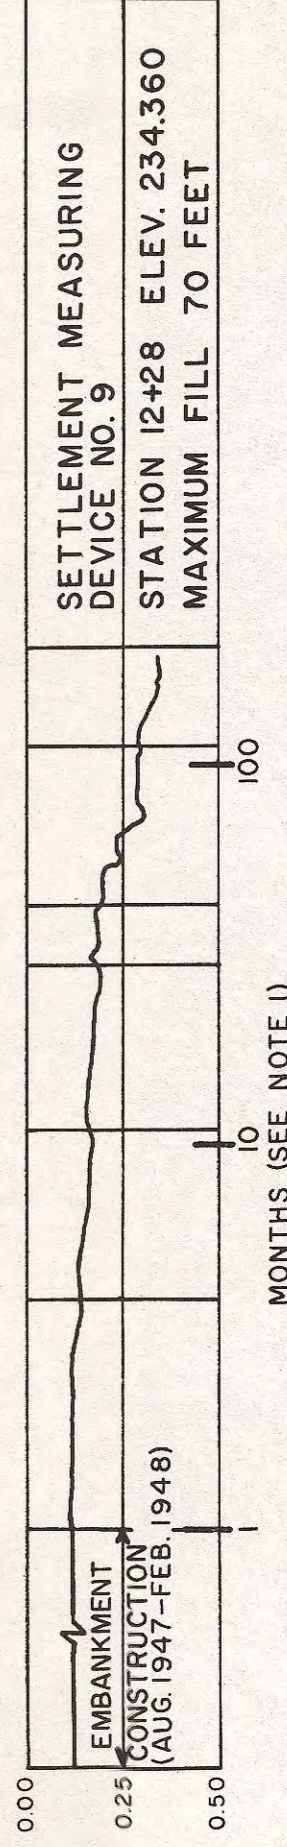
RECORD OF FOUNDATION SETTLEMENT UNDER MAIN DAM

During construction of the main dam, foundation settlement measuring devices had been placed at nine selected stations along the 12-inch drain. (Plate 13)

1. FOR CONVENIENCE OF PLOTTING TIME SCALE THE BASE MONTH HAS BEEN ARBITRARILY SELECTED AS JANUARY 1948.
2. POST-FAILURE READINGS MAY BE INACCURATE, MANOMETER LINES WERE SEMI-CLOGGED FROM INUNDATION AFTER FAILURE.
3. POST-FAILURE READING ASSUMED RELIABLE.
4. FOR LOCATION OF THESE POINTS SEE PLATE 13
5. ELEVATION DATUM IS PBM 40-C
