Bonasa Breaks Ranch Dam

Dam Failure and Hydrologic Report

Asotin County, Washington

August 2017

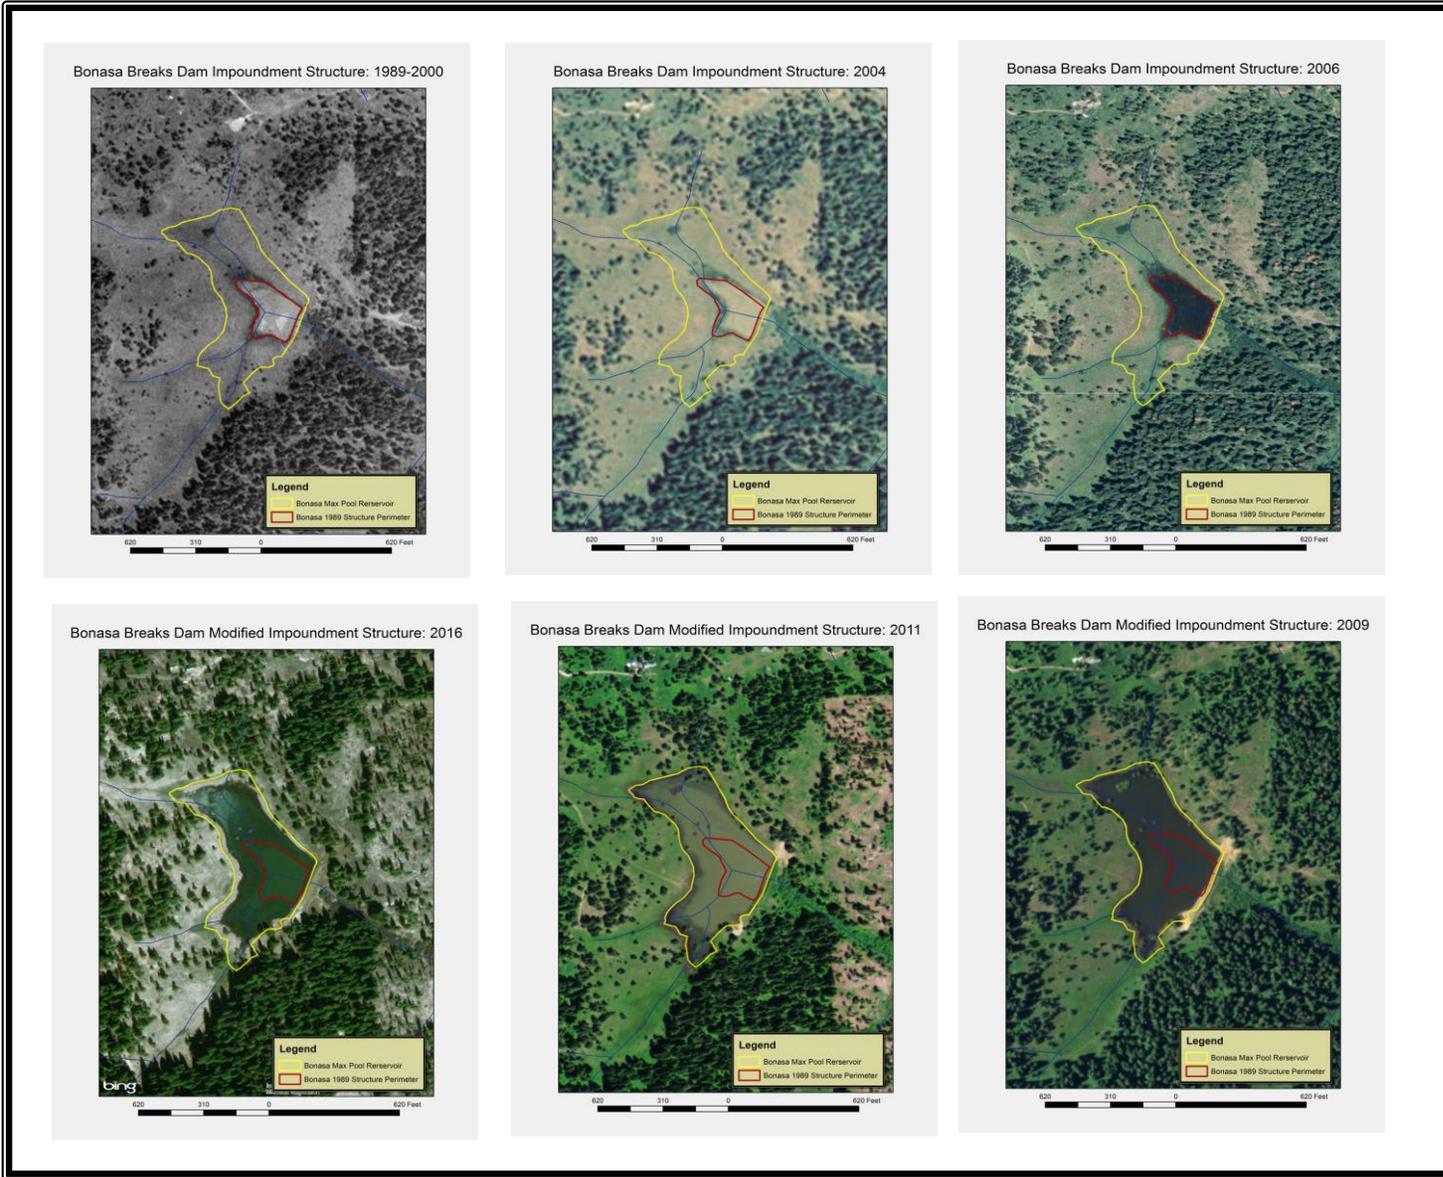
Figure 2. Bonasa Breaks Ranch Dam: Impoundment development (Clockwise from upper left corner)

It is not known when the original dam was built or what function it originally served. The current owner's representative said it has existed at the site since at least the 1960s and is now used for fish rearing and recreation. DSO records contains only cursory information about the impoundment, derived from GIS orthophotos established before the mid-2000s and there has been no DSO involvement or oversight prior to the breach. Orthophotographic records indicate that a rudimentary structure has existed at this location for a number of years, although its impoundment of water appears to be seasonal and, up to at least 2006, on a much smaller scale than the volume impounded before the 2017 breach (Figure 2).

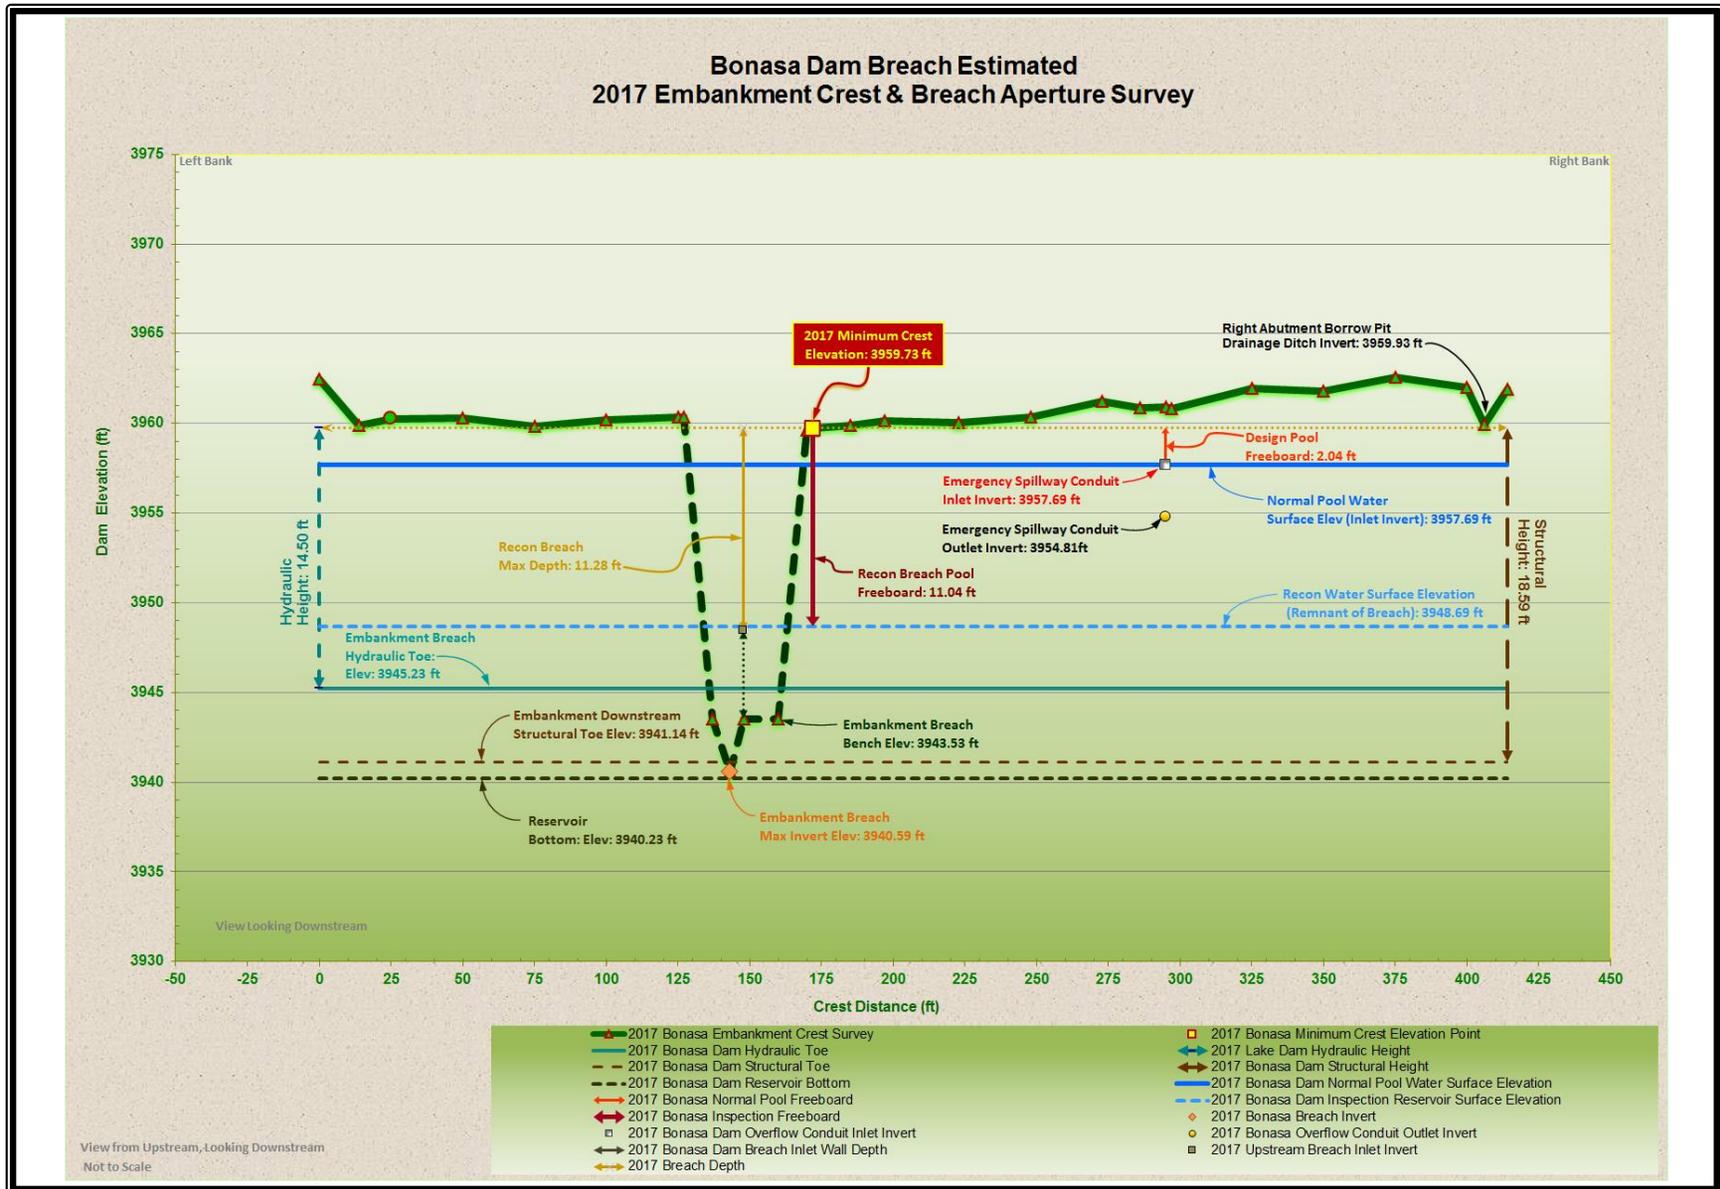
Figure 5. Bonasa Breaks Ranch Dam post breach crest survey

DSO engineers performed a survey of the embankment crest, breach aperture, and embankment cross section profile (Figure 5 & Figure 16). The BBR Dam is a homogeneous earthfill embankment rising 18.6 feet above original grade (approximate structural elevation 3941.1 feet based on the approximate normal pool rim (estimated from GIS: 10-m DEM) to the lowest surveyed crest elevation of 3959.7 feet. A hydraulic height (depth of the maximum lens of water that could be released) was determined from the embankment survey to be 14.5 feet.

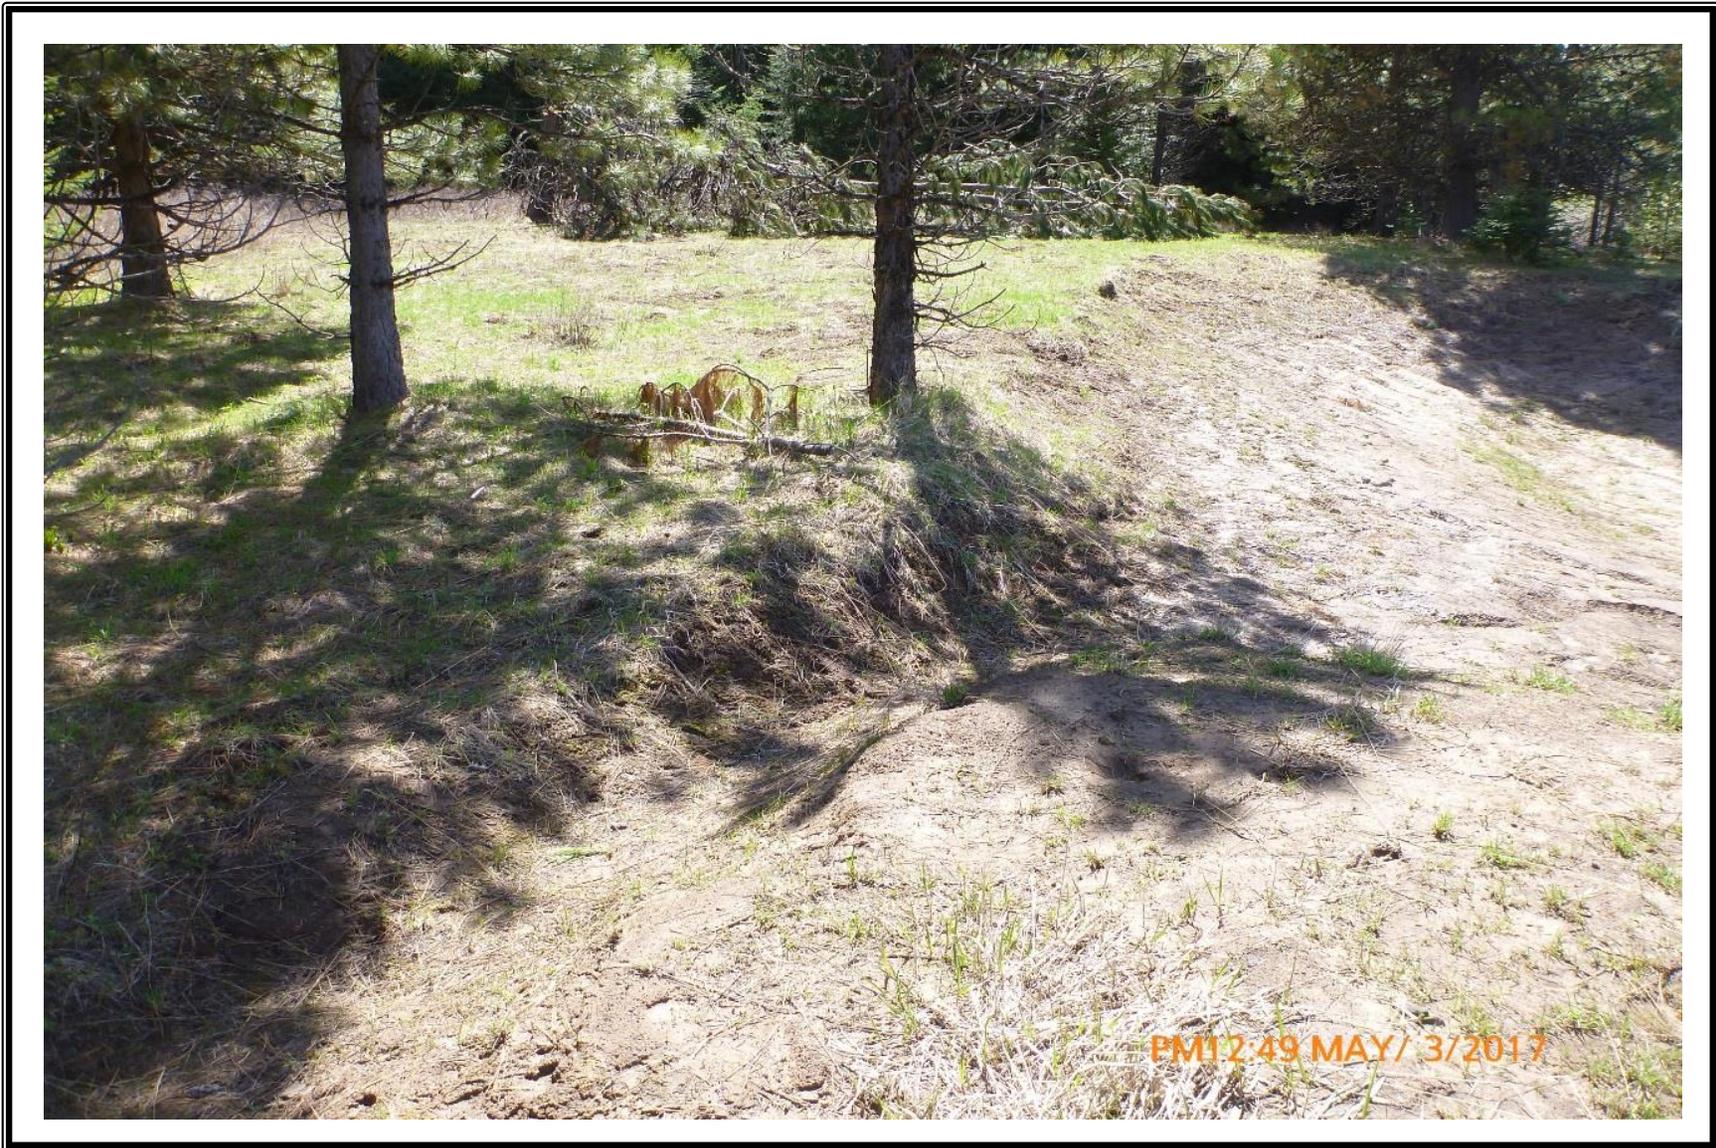
Figure 15. Channel on right abutment

- An unlined trapezoidal channel was excavated on native ground adjacent to the right abutment (Figure 15). This channel is approximately 10 feet wide at the top, 1-2 feet wide at the bottom, and 2 feet deep, with an invert elevation of approximately 3959.7 feet. This channel would not have functioned as an emergency overflow spillway, since its invert elevation is equivalent to the minimum crest elevation. Thus it would have offered no contribution to the ability of the dam to pass the inflow design flood and still maintain a design freeboard. Therefore, DSO considered this feature unrelated to dam design and operation.

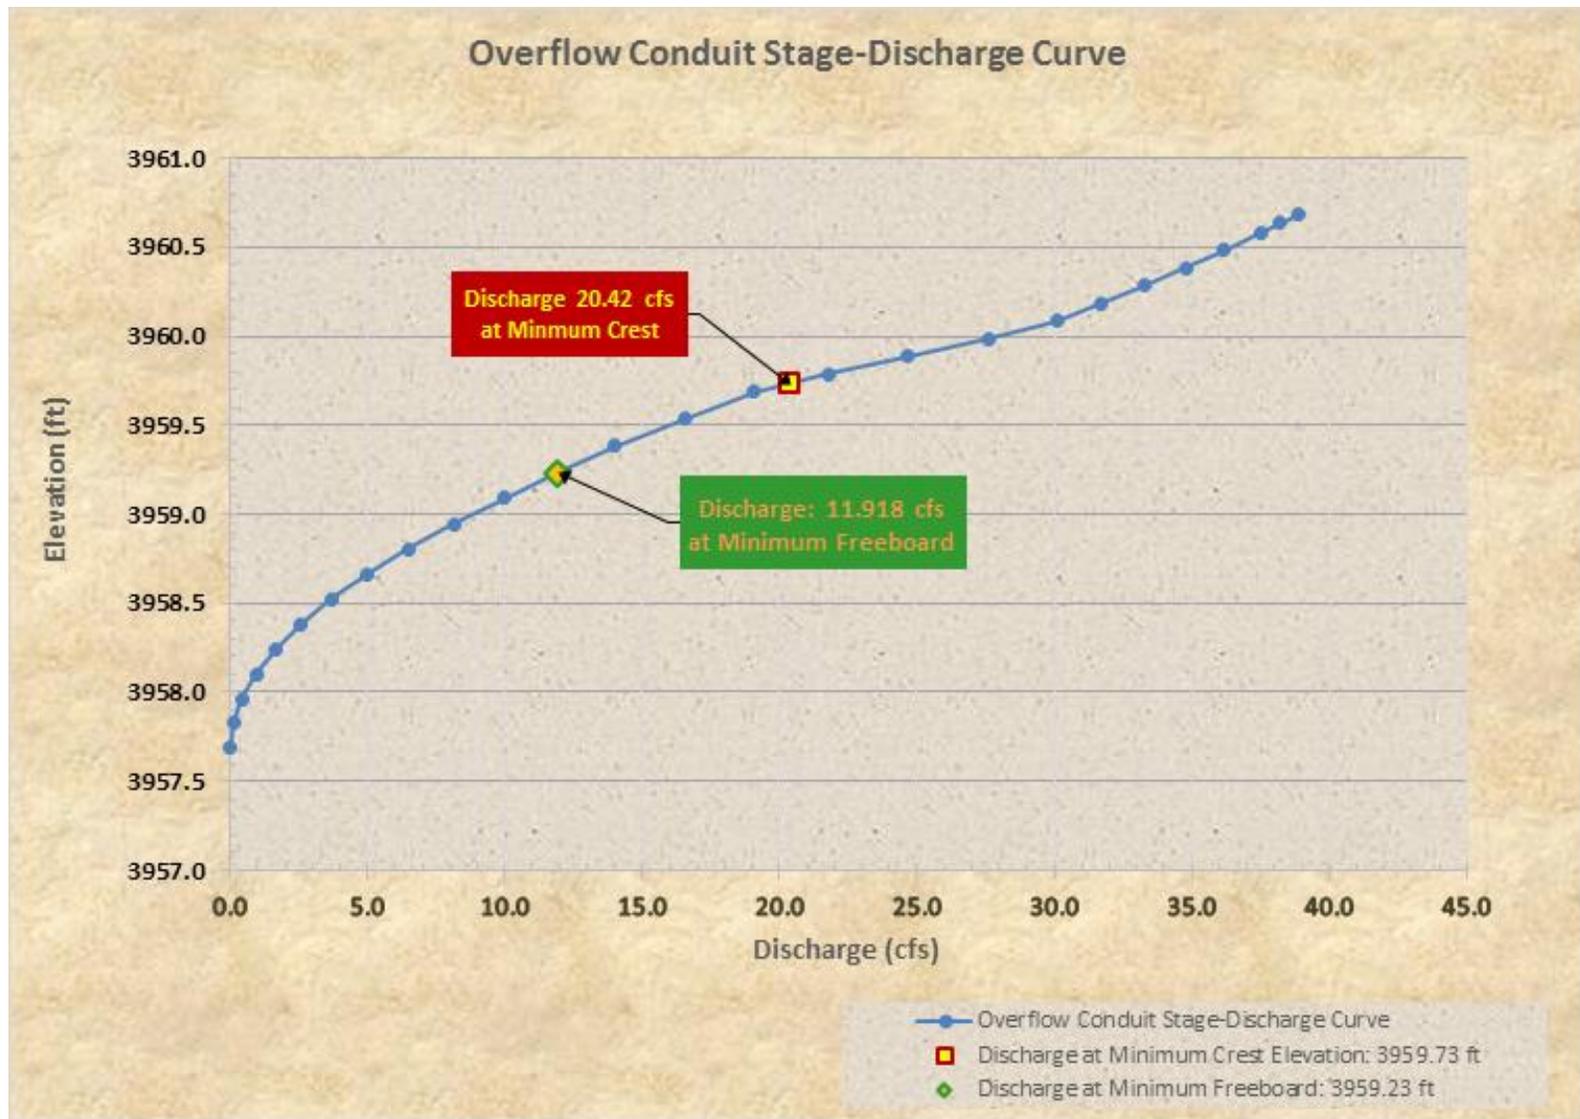
Figure 19. Bonasa Breaks Ranch Dam: Overflow spillway conduit stage discharge curve

Spillways. The principal spillway for BBR Dam is a 3-foot diameter corrugated metal pipe located approximately 120 feet from the south abutment. The inlet invert overflow elevation is 3957.69 feet. The outlet discharges to the downstream toe area of the dam, with an outlet invert elevation of 3954.81 feet. An analysis of the conduit capacity under sequential reservoir elevations (head) produces a defining Stage-Discharge Curve (Figure 19). With the reservoir water level at the dam crest, the principal spillway has a hydraulic capacity of 20.4 cfs. At the minimum freeboard the spillway has a capacity of only 11.9 cfs.
