VIII. Fuse Plug Design, Construction and Activation

B. Fuse Plug Construction.

a) Surficial Geology along the Silver Lake Fuse Plug (Dike No.2) Channel

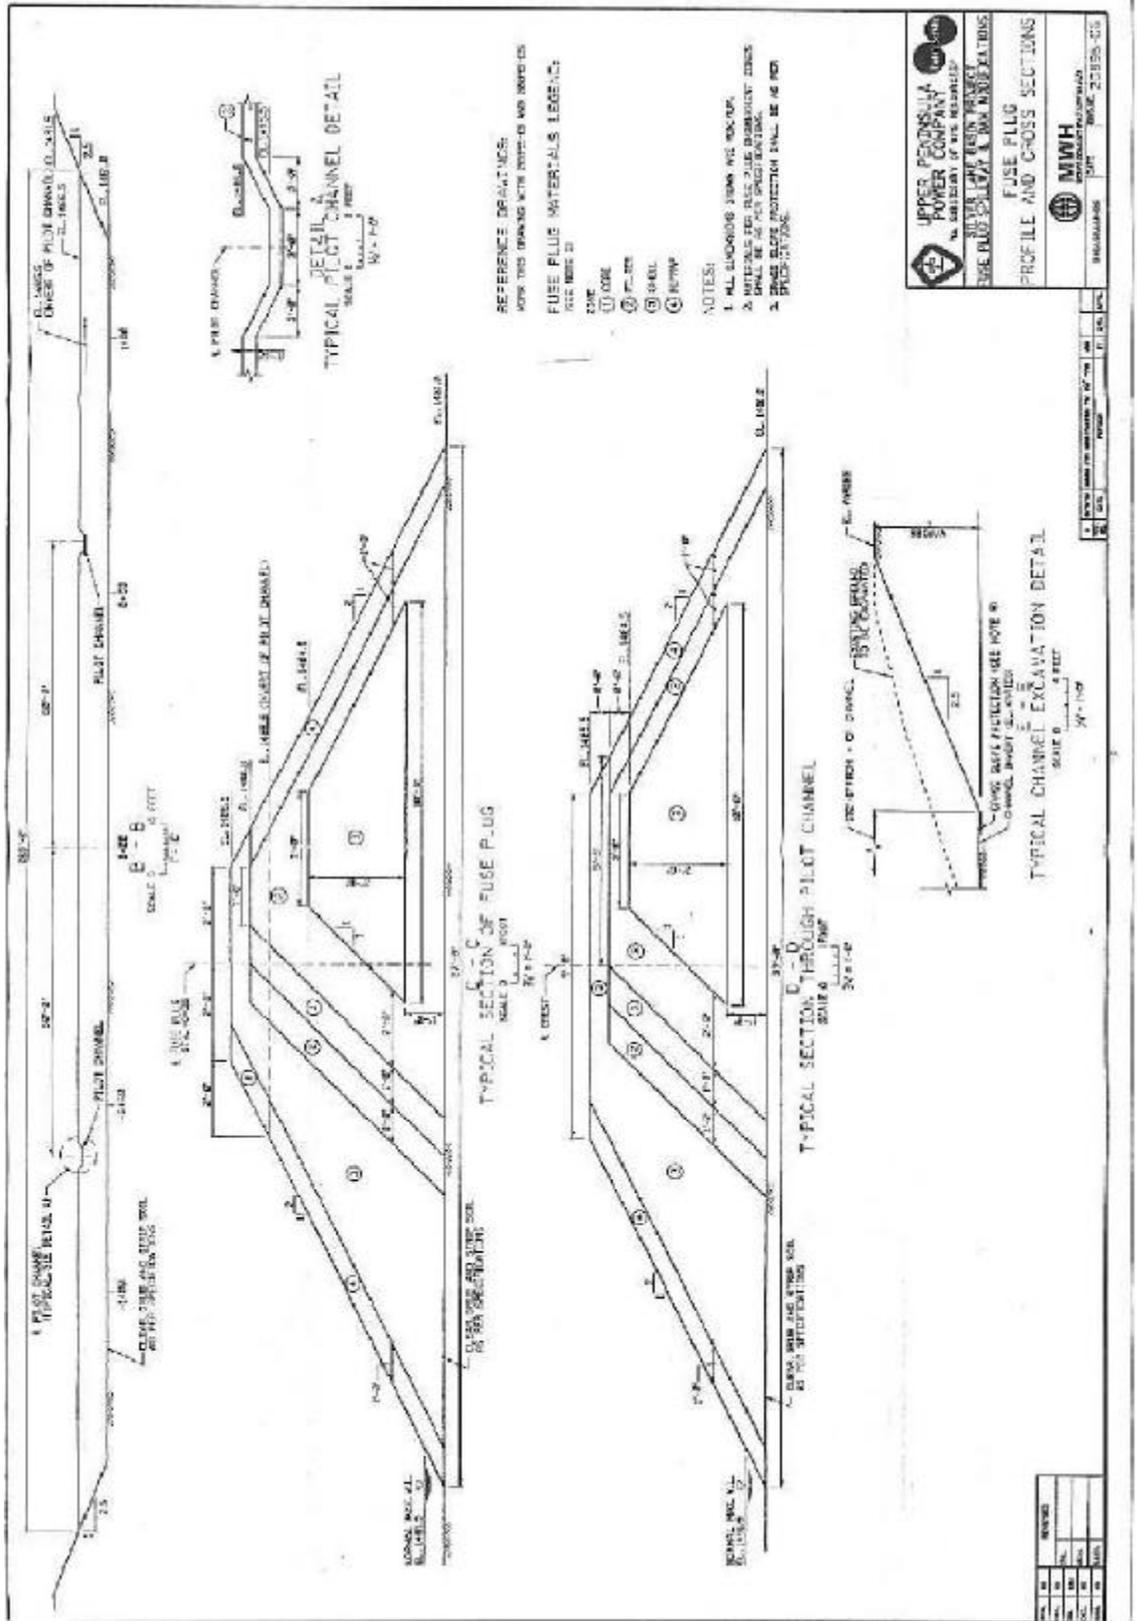
PROFILE A-A

As noted on the design and as-built fuse plug cross section and pilot channel cross section drawings, the top of the design fuse plug is elevation 1486.5 feet and the pilot channel elevation is 1485.5 feet respectively. As-constructed survey of the fuse plug dike indicates the two pilot channels to have invert elevations of 1,485.37 and 1,485.28 feet, approximately 1.5 to 2.6 inches below the design elevation of 1,485.5 feet. When these fuse plug elevations are compared to the elevation of the concrete ogee spillway crest elevation of 1486.25 feet, it becomes obvious that the concrete ogee spillway will no longer be the primary spillway. The fact the fuse plug will erode before the reservoir reaches the concrete ogee spillway crest elevation of 1486.25 feet was not discussed in the Design Report or pointed out in any other documentation that we have found. The design and as-built fuse plug cross sections and pilot channel cross sections indicate that the normal maximum water level will be 1481.5 feet. This elevation is also stated in Section 5.3 Reservoir Level, "The initial water level prior to the PMF event is at the normal maximum operating reservoir level of El. 1481.5 feet." The consultant apparently did not revised the plans and design documents to show that the normal maximum operating level was changed to El. 1482.5 feet per his letter dated September 24, 2001, which was enclosed with the licensee's September 27, 2001 letter to FERC.
