Report of the Expert Panel on the Technical Causes of the Failure of Feijão Dam I

December 12, 2019

EXECUTIVE SUMMARY

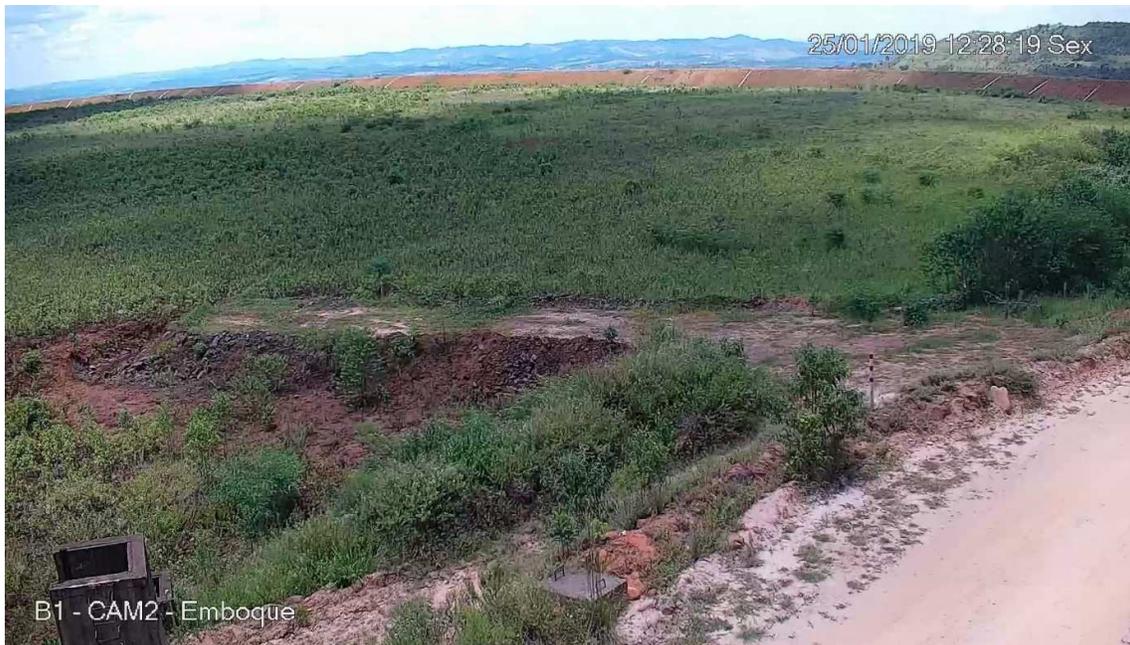
Figure 13: Just Prior to the First Observed Deformation, as Captured by CAM2

CAM2 confirmed that the initial failure was relatively shallow and started just behind the crest. CAM2 also clearly shows the regression of the failure into the stored tailings, eventually stopping close to natural ground, as seen in Figures 13 through 17. CAM2 also shows that after each failure slice, the failed material appears to become a heavy liquid.

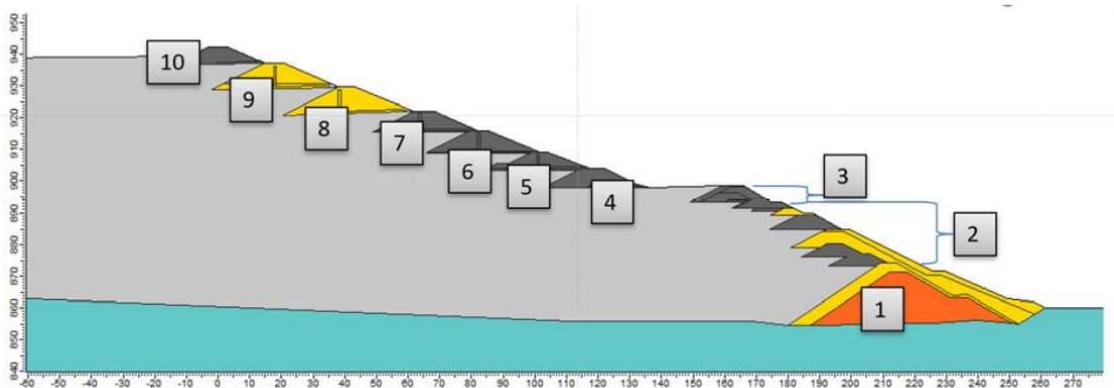
Figure 19: Dam I Cross-section, Showing Raisings and Stages of Construction⁸

Dam I was constructed over a 37-year period from 1976 to 2013 in 15 stages, corresponding to 10 raises. A summary of the history is shown in Table 1, and the raises and stages are illustrated schematically in the cross-section in Figure 19. As shown in Figure 19, the Fourth Raising was set back compared to the previous three raisings, resulting in the straightening and modification of the dam centerline. The setback reduced the overall slope of the dam but moved the upper portion of the dam over weaker, finer tailings and brought water closer to its face. Having water closer to the face also can limit surface drying of the deposited tailings from exposure to sun and wind. No new raisings were constructed after 2013, and the placement of tailings ceased in July 2016.

Upstream construction resulted in movement of the crest upstream over time, as illustrated in Figure 19. Using this method, the dam was constructed to a total height of 86 m (toe to crest), with a final crest elevation of 942 meters above mean sea level (m msl) and a crest length of 720 m. The height of each raising varied from 5 m to 18 m. The upstream and downstream slopes of the berms constructed in each raising varied from 1.5 horizontal to 1 vertical (1.5H:1V) to 2.5H:1V; however, slopes of 2H:1V were used in most cases.

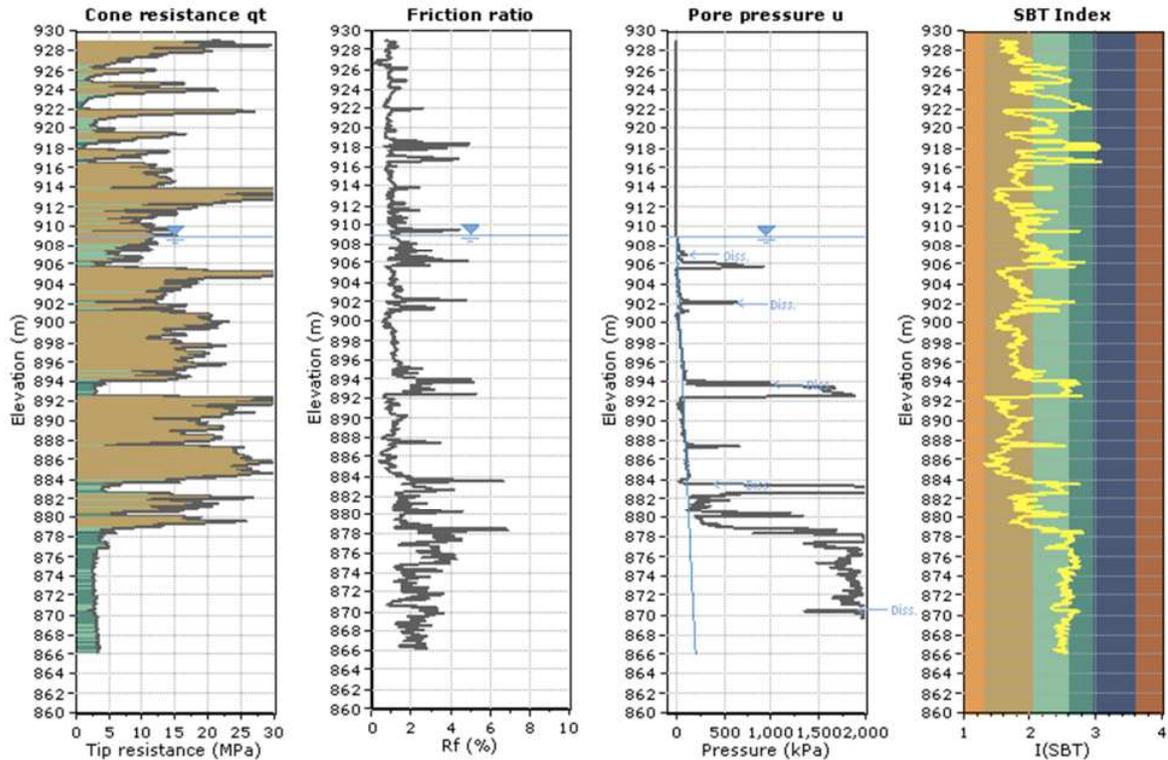
Figure 22: Example CPTu Profile for PZE-29-35

elevation of 872 m msl. The CPTu shown in Figure 22 illustrates the predominately coarse tailings with thin layers of fine tailings.

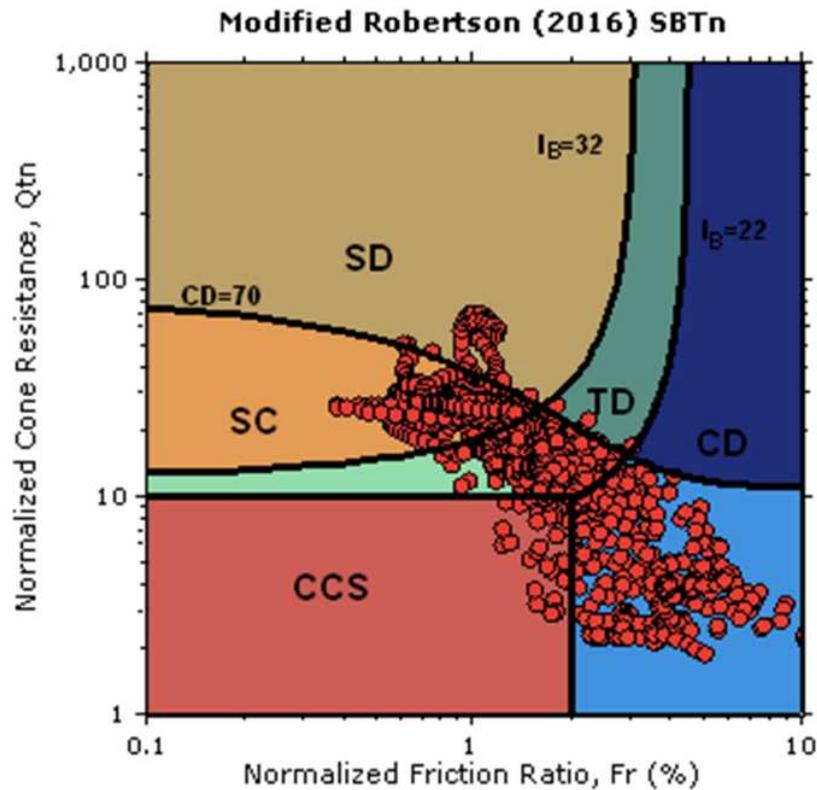
Figure 23: Example CPTu (PZE-29-35, from Elevation 910 m msl to 878 m msl)

The CPTu results indicate that the tailings are predominately loose and contractive at large strains, consistent with other hydraulically deposited tailings. Figure 23 shows an example CPTu (PZE-29-35) on the modified soil behavior type chart¹² to illustrate that the tailings below the water level (in this case, those collected between elevation 910 m msl to 878 m msl) are contractive at large strains. The CPTu data shown in Figure 23 were normalized using an appropriate high unit weight for the tailings and the measured downward piezometric gradient.

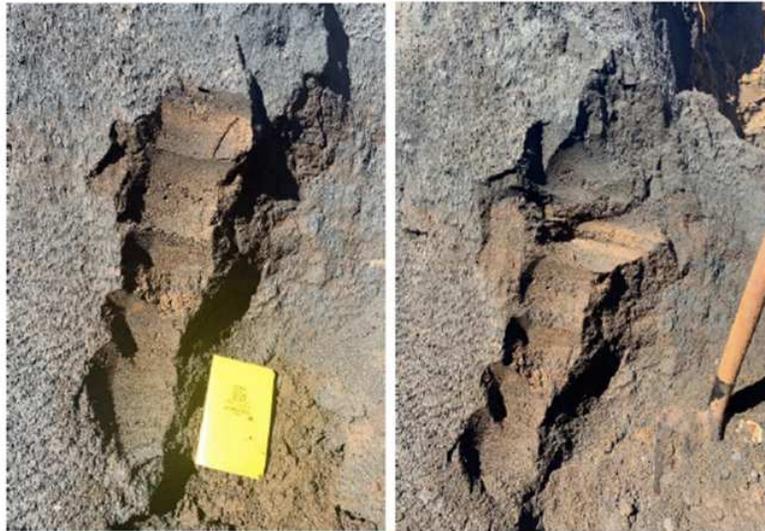
Figure 28: Coarse Tailings Sample Locations S6a (Left) and S6b (Right)

The bulk samples of coarse tailings were taken from exposed surfaces of intact tailings that represent beach tailings from previous raises below the final dam, as shown on Figure 27. The samples were obtained from an exposure that was estimated to be below the Seventh Raising at the right abutment. Figure 28 shows the distinct thin layering in the coarse tailings sample locations.

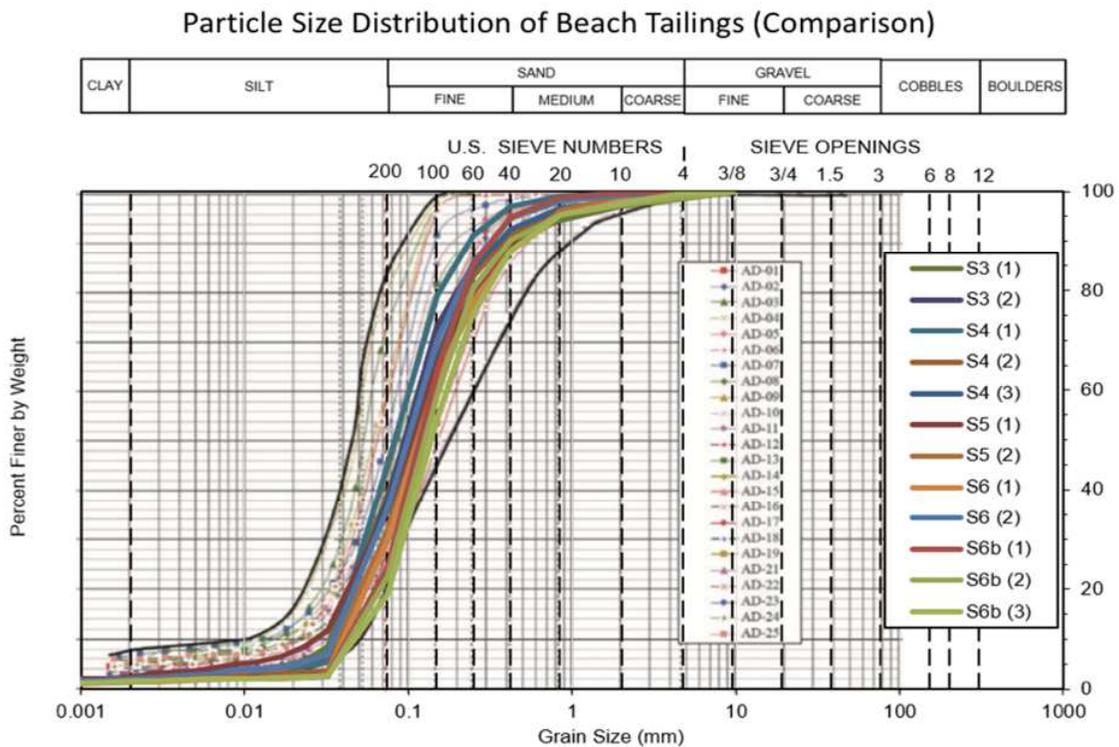
Figure 30: Comparison of Particle Size Distribution Curves from the 2019 Samples with Pre-failure Historical Data

The index testing confirmed that the coarse tailings are poorly graded and have a fines content (based on 0.075 mm sieve size) between 20% and 50%, and are non-plastic. The fine tailings under the dam have a fines content between 50% and 90%. The slimes are more well graded with essentially 100% fines content and PI of around 18%. Figure 30 shows a comparison between the coarse tailings particle size distribution curves collected in 2019 and some historical curves, and shows that the 2019 samples are similar to historical samples collected under the pre-failure dam.

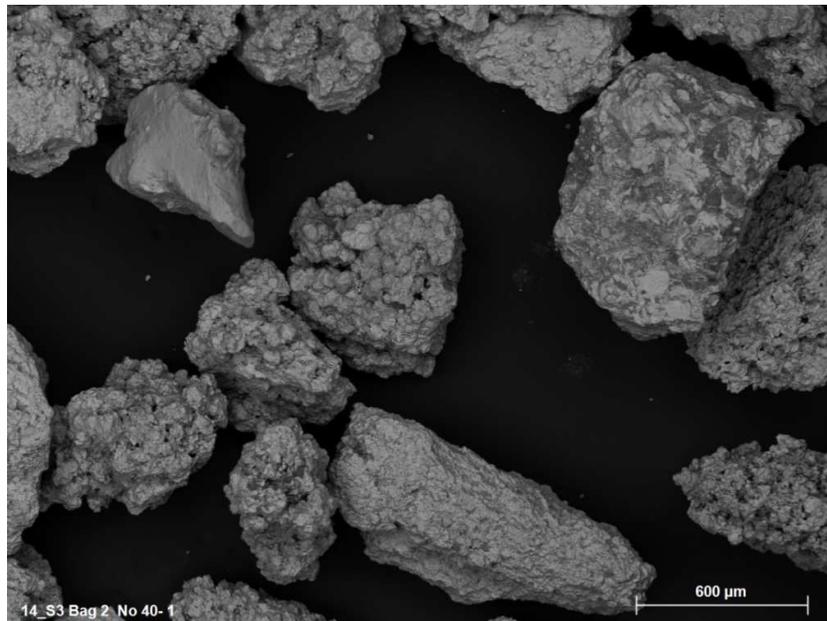
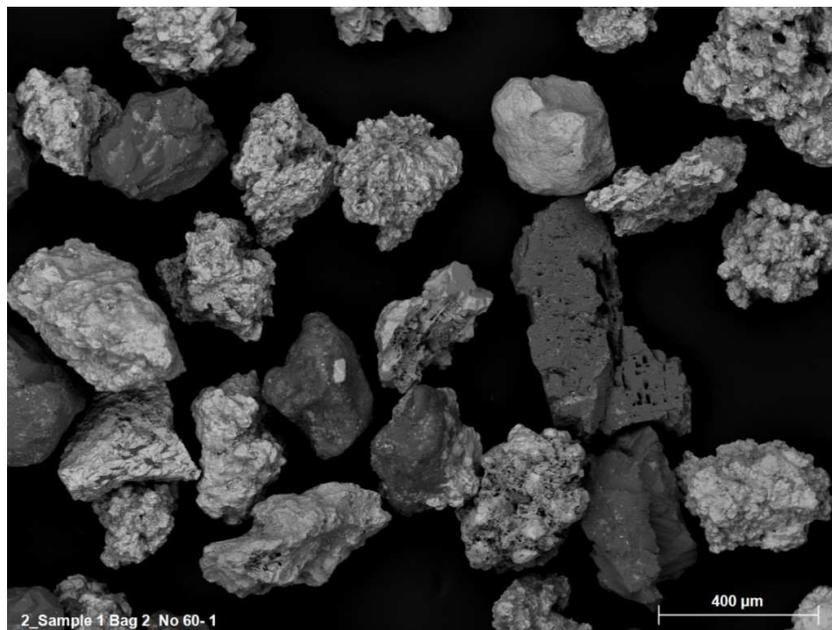
Scanning electron microscope (SEM) images were taken of samples of coarse tailings and slimes from the June 2019 field program to qualitatively assess particle structure, angularity, and other parameters at the microscopic level. Example images are shown in Figures 31 (coarse tailings) and 32 (slimes). The SEM images confirm the high iron content and show that the particle shape is similar for both materials and that the grains are typically sub-angular to angular with rough, often pitted surfaces. Additional SEM images were taken to study the interaction between particles and showed evidence of bonding between particles, shown in Figures 33 and 34. The nodules shown in Figure 33, and highlighted in Figure 34, are composed of iron oxide. The bonding appears to be derived from clay-size iron oxide. It appears that oxidation of the iron produces bonding between particles.

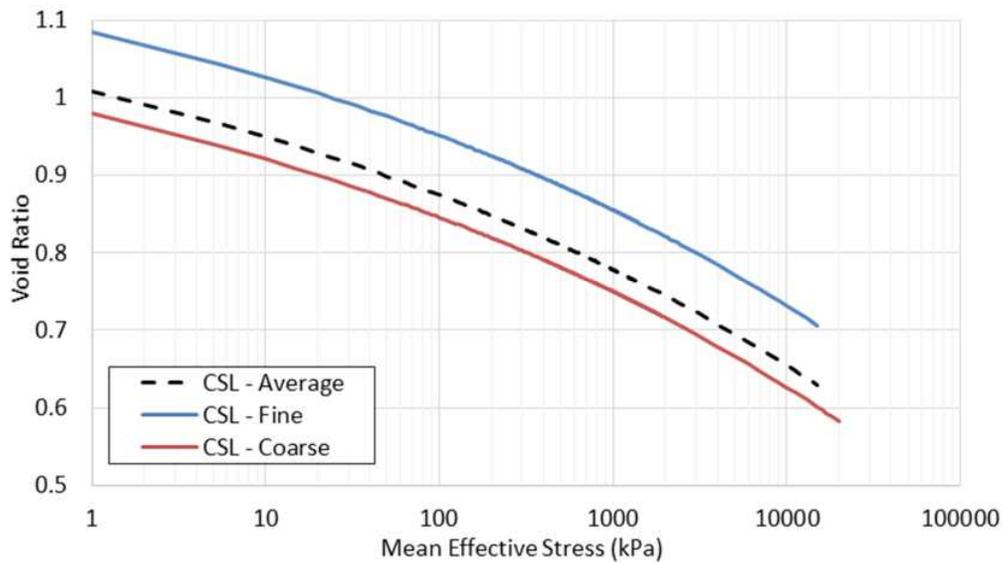
Figure 36: Comparison of CSLs for the Representative Tailings Tested

The shape and location of the CSLs, shown in Figure 36, are consistent with the similar grain characteristics (shape, angularity) and mineralogy of the tailings tested, even though the mean particle size varies. The ϕ'_{cs} for each gradation was also very similar with an average value of 34 degrees.

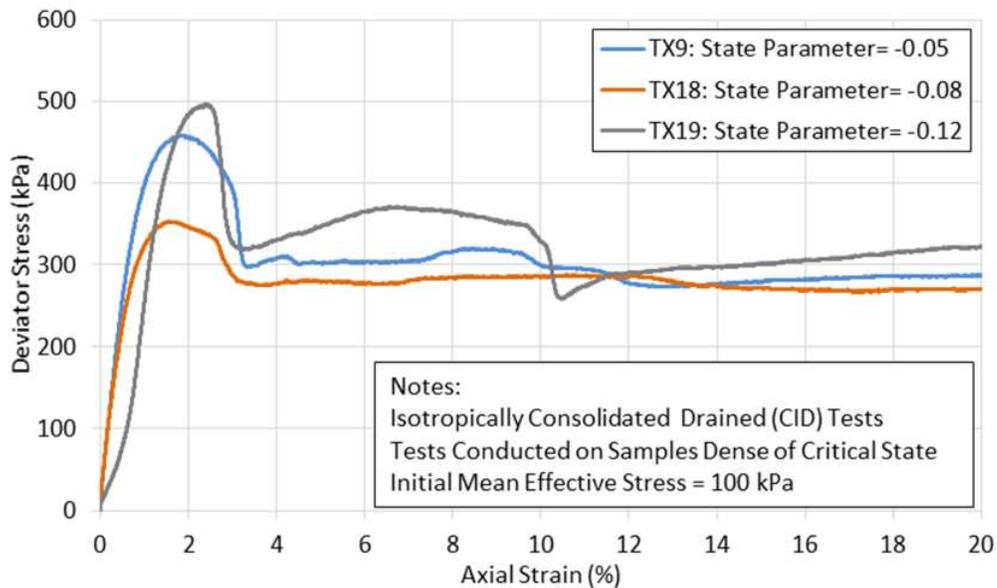
Figure 37: Comparison of Isotropically Consolidated Drained Triaxial Tests on Average Gradation Samples at Different State Parameters that are Dense of CS

Figure 37 compares the results of isotropically consolidated drained (CID) triaxial tests on average gradation samples consolidated to the same effective stress (100 kPa) but prepared to different state parameter (ψ) values (void ratio) that are dense of CS. The rapid strength loss and the peak strength is inconsistent with the state (void ratio) of the samples (e.g., the looser state ($\psi = -0.05$) has a similar peak strength as the densest state ($\psi = -0.12$)).

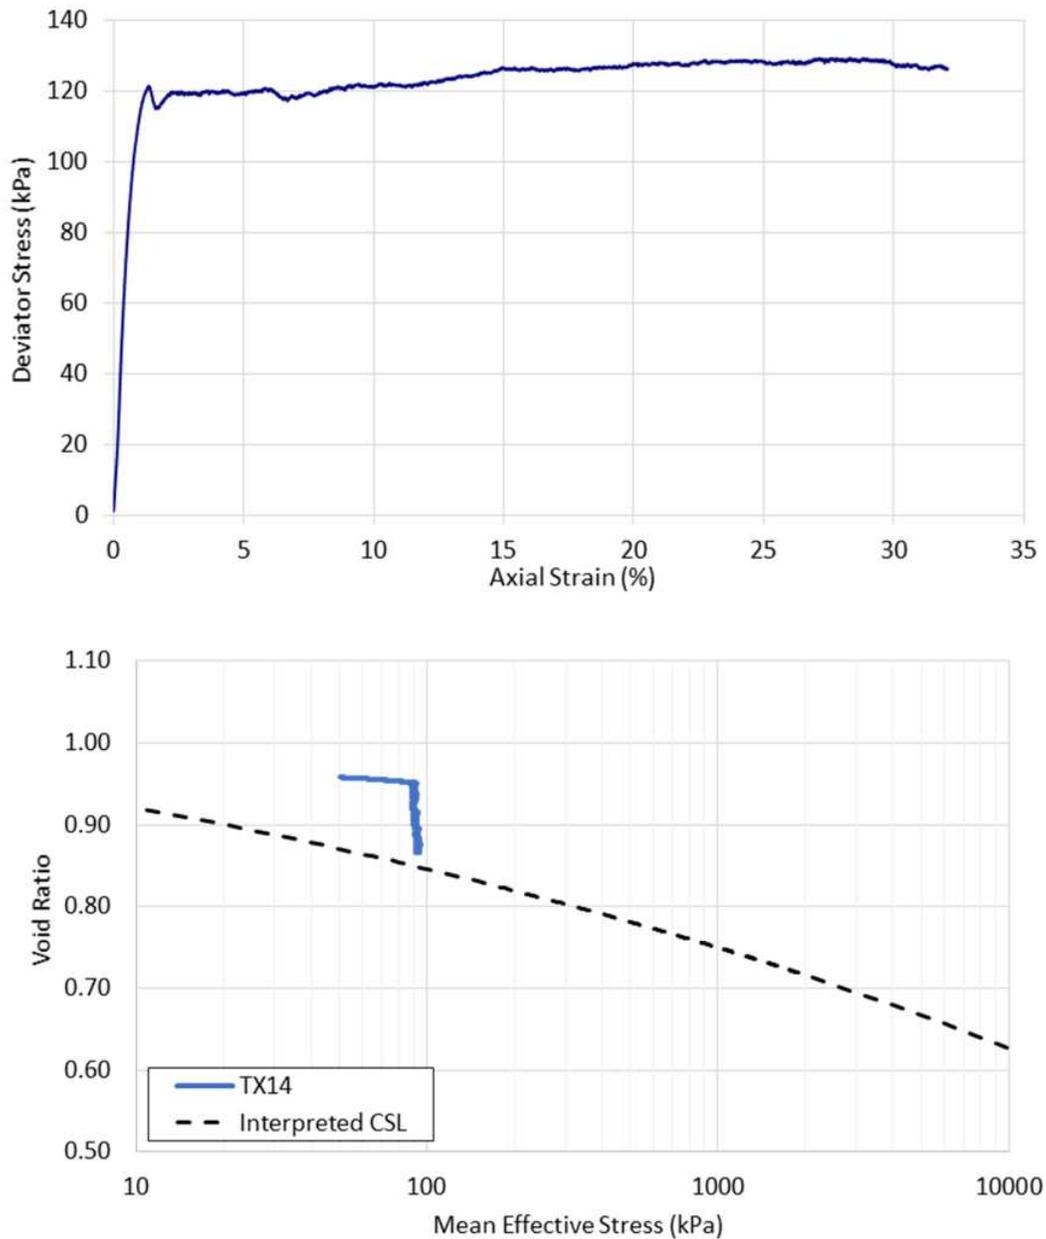
Figure 38: CID Triaxial Test Result on an Average Gradation Sample Consolidated to 50 kPa Prepared to a State Loose of CS ($\psi = +0.09$)

Figure 38 shows the test result of a CID triaxial test on an average gradation sample consolidated to 50 kPa and prepared to a state that is loose of CS ($\psi = +0.09$). For a sample that is loose of CS, the expected behavior would be for the sample to show a gradual increase in deviator stress (q) combined with a gradual decrease in volume to CS. However, this test showed a very stiff response to peak q at an axial strain of about 1%, followed by an abrupt reduction (collapse) in volume at a constant mean effective stress (p') and q .

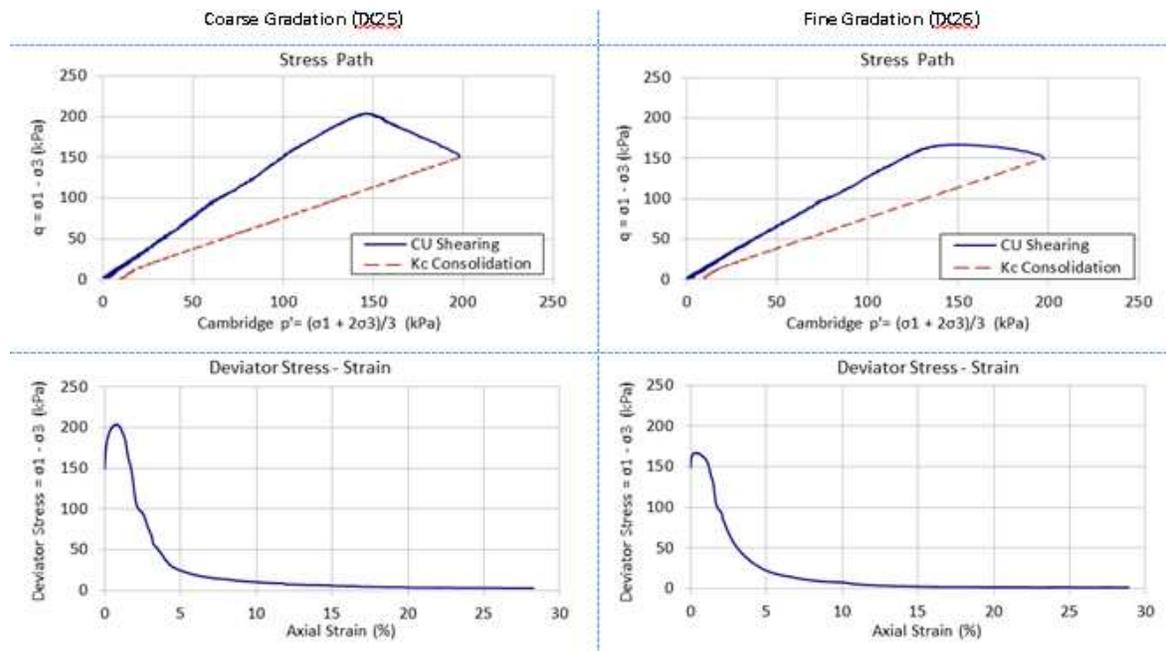
One anisotropically consolidated undrained (CAU) triaxial test was performed on fine and coarse gradations to assess the undrained response of a loose sample of these gradations to identify whether they are similar. Both samples were anisotropically consolidated to a mean effective stress of 200 kPa and a ratio of horizontal to vertical effective stress, K_0 , of 0.5 before starting the undrained loading. The fine and coarse samples were prepared to the same state parameter of $\psi = +0.07$. The results of these tests appear in Figure 39, which shows that both samples generated an extremely brittle response during the undrained loading. The samples failed at 0.3% and 0.8% axial strain for the fine and coarse gradations, respectively. The peak strength ratios ($S_{u(\text{peak})}/p'$) for the fine and coarse gradation samples were 0.42 to 0.51, respectively (equivalent to $S_{u(\text{peak})}/\sigma'_v = 0.26$ and 0.34). The residual strength ratios ($S_{u(\text{residual})}/p'$) for the fine and coarse gradation samples were 0.005 to 0.01, respectively. These peak strength ratios are significantly higher than empirical estimates based on CPTu data, such as those of Olson and Stark (2002), and the residual (or liquefied) strength ratios are significantly lower than empirical estimates, such as those of Robertson (2010). The test results also confirmed that the fine and coarse gradations behave in a similar manner during undrained shear.

Figure 39: Results of CAU ($K_0 = 0.5$) Strain-controlled Triaxial Tests (Coarse and Fine Gradations)

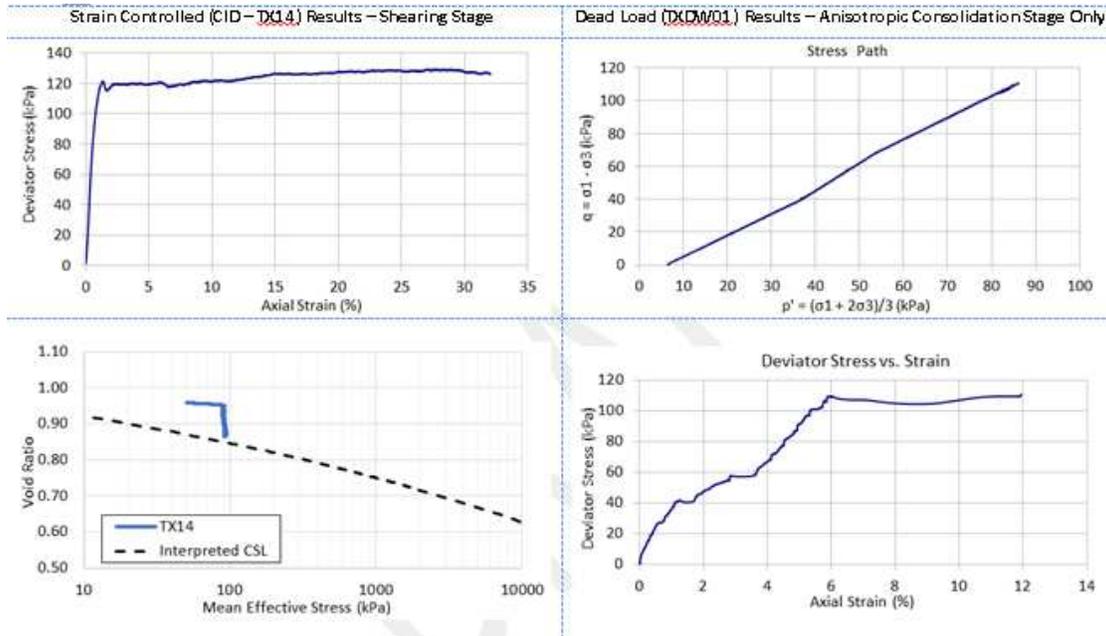
Two triaxial load-controlled tests using dead loads (TXDW) were completed for comparison with the strain-controlled tests. Both tests were completed on the coarse gradation sample. The first test (TXDW01) was completed as a drained test and was intended to replicate test TX14, which was a strain-controlled CID test carried out at an initial p' of 50 kPa and a state parameter of +0.09 (Figure 40). The CID test (TX14) showed an abrupt reduction in volume at around 1% strain, at a constant p' and q . The purpose of the equivalent load-controlled test (TXDW01) was to see if this volumetric reduction would lead to pore pressure generation and

strength loss under dead load conditions. The equivalent dead load test was anisotropically consolidated to stresses approaching those at which TX14 failed; however, the sample failed in a rapid manner at smaller stresses. The rapid nature of the failure indicates it occurred undrained. The load-controlled test also showed significant creep under constant q .

Figure 40: Comparison Between an Isotropically Consolidated Strain-controlled Test (CID-TX14) and Anisotropically Consolidated Load-controlled Test (TXDW01) with the Same State ($\psi = +0.09$) and Coarse Gradation

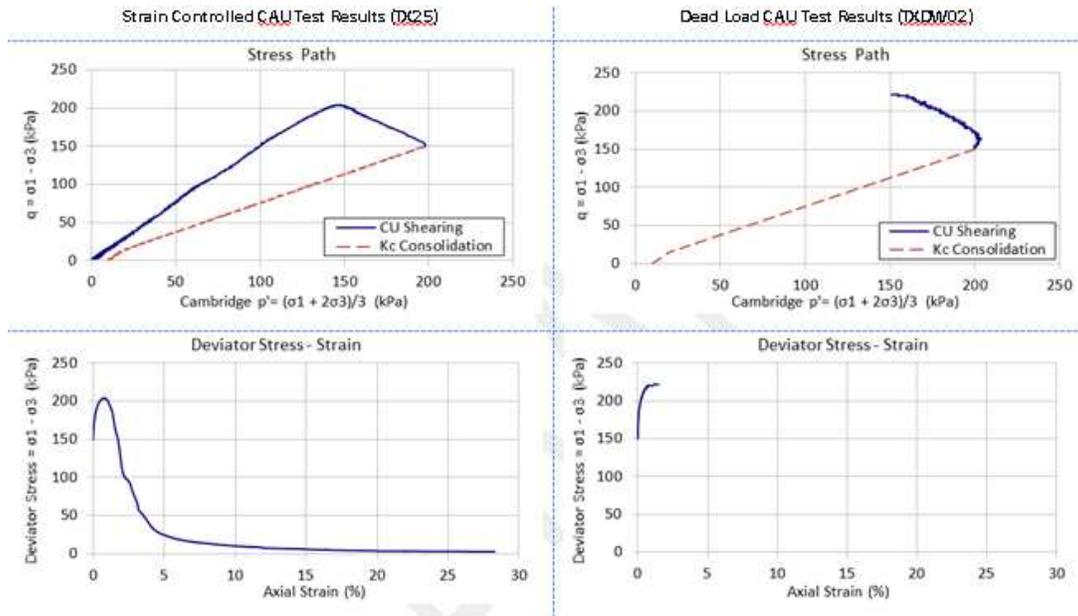
The second dead load test (TXDW02) was carried out for comparison with the anisotropically consolidated strain-controlled undrained (CAU) test (TX25) completed at an initial p' of 200 kPa and a K_0 of 0.5, as shown in Figure 41. Except for the dead weight load application, TXDW02 was completed in exactly the same manner as TX25. The load-controlled test (TXDW02) failed at an axial strain of 0.7% and a peak undrained shear strength ratio of 0.55. The residual (liquefied) strength ratio of this sample could not be measured because the failure occurred in a rapid manner and produced complete failure of the sample. The brittle response, peak undrained shear strength ratio, and small strain to peak were similar for both tests, illustrating general consistency across testing methods.

Figure 41: Comparison Between an Anisotropically Consolidated Strain-controlled (CAU-TX25) and Load-controlled Test (CAU-TXDW02) with Same State ($\psi = +0.09$) and Coarse Gradation

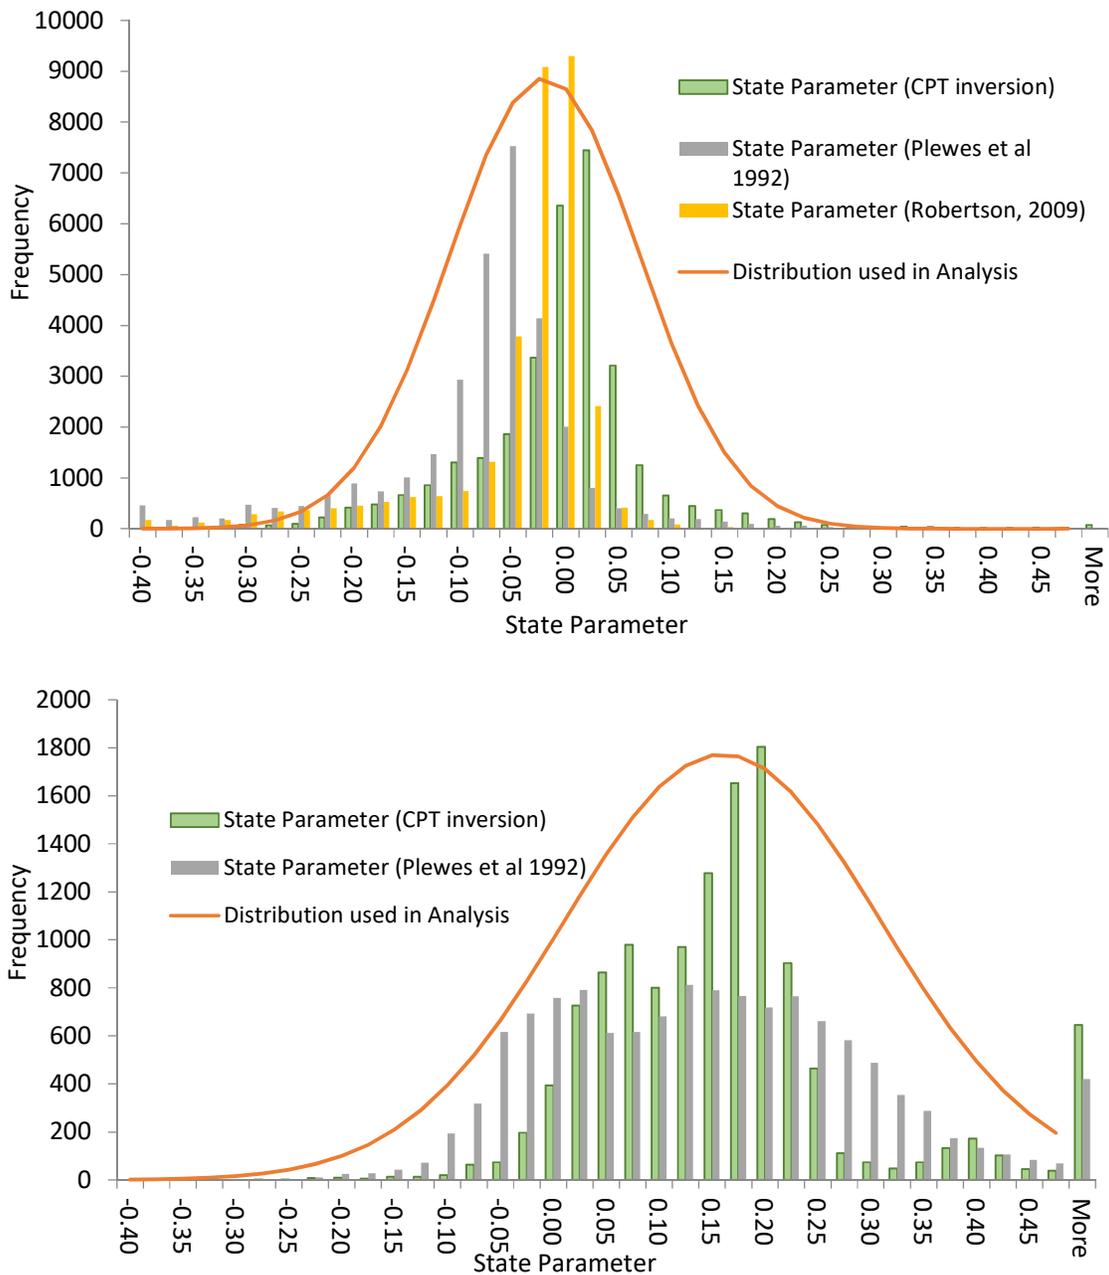
The estimation of *in situ* state followed four different approaches. Initial estimates were made using the empirical method suggested by Robertson (2010), but it was recognized that the unusual mineralogy of the tailings would likely make these estimates unreliable. A second approach was applied using the laboratory bender element (Vs) results combined with the field measured Vs values. However, this methodology was questionable due to the lack of sensitivity to variations in the *in situ* Vs measurements. A third approach was applied using the method suggested by Plewes et al. (1992), since this method allows input of the specific CSL parameters, which were available from the advanced laboratory testing. However, this too presents reliability issues since the mineralogy and other properties of the tailings are different than the historical data used to develop the relationships. The final approach applied was the full inversion of the CPTu results using CS parameters obtained from the advanced laboratory testing and applying the approach suggested by Jefferies and Been (2016). This involves using cavity expansion to obtain estimated state parameters from CPTu. This has the ability to account for the unique material behavior captured in the advanced laboratory testing. This final approach was considered to be the most reliable. A summary of the estimated state parameters for the coarse and fine gradations is shown in Figure 42, along with histograms used in the analysis. The resulting average state parameters are -0.02 for the coarse gradations and +0.16 for the fine gradations. All methods show that the fine tailings have a looser state than the coarse tailings.

Figure 42: Cumulative Distribution of State Parameters for Coarse and Fine Gradations

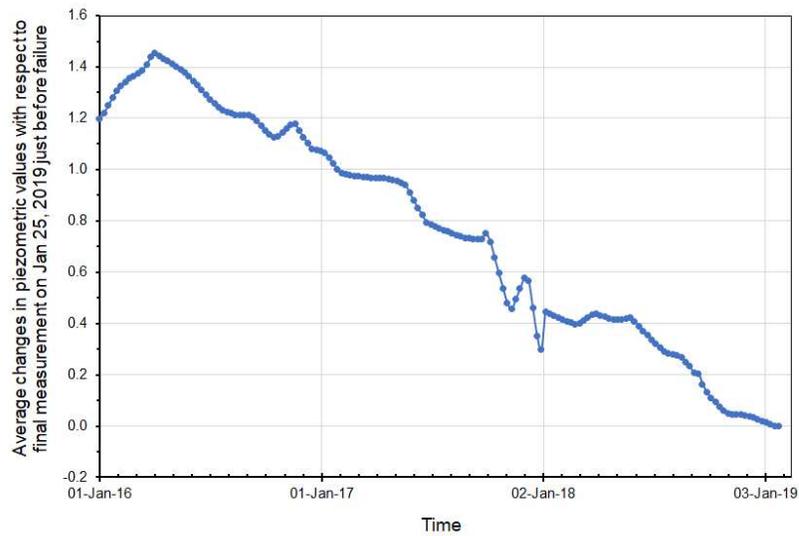
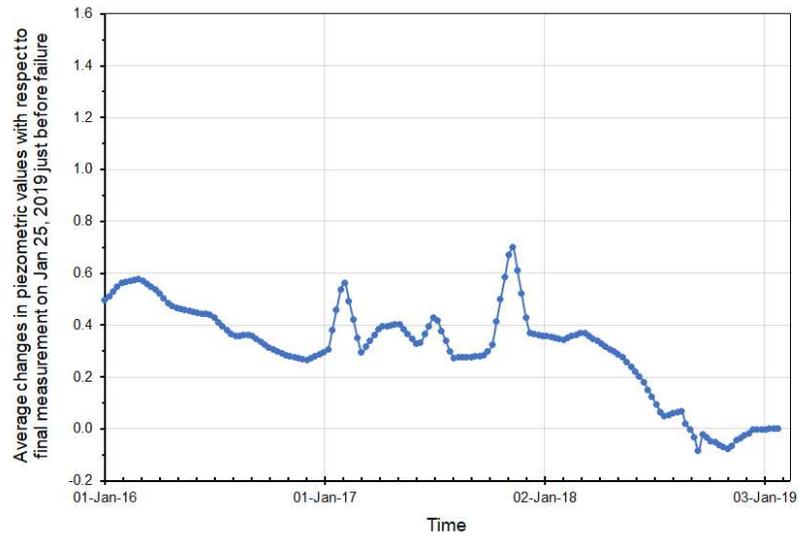
Figure 45 shows that there was a gradual decline in the mean water level since 2016. The decline was about 1.4 m for the installations above the setback (900 m msl) and about 0.5 m for the installations on or below the setback. This observation is attributed to a slow net drawdown of water after tailings deposition ceased in 2016. The water appears to be draining from the upper portions of the dam toward the lower portions. The drawdown also creates an increasing unsaturated zone in the upper portions of the dam. Figure 45 also shows minor short-term increases in water level that appear to be linked to responses during the wet seasons.

a) Changes in Piezometers and Water Level Indicators Above 900 m msl

b) Changes in Piezometers and Water Level Indicators Below 900 m msl

Figure 45: Mean Piezometric and Water Levels Relative to Final Measurements on January 25, 2019

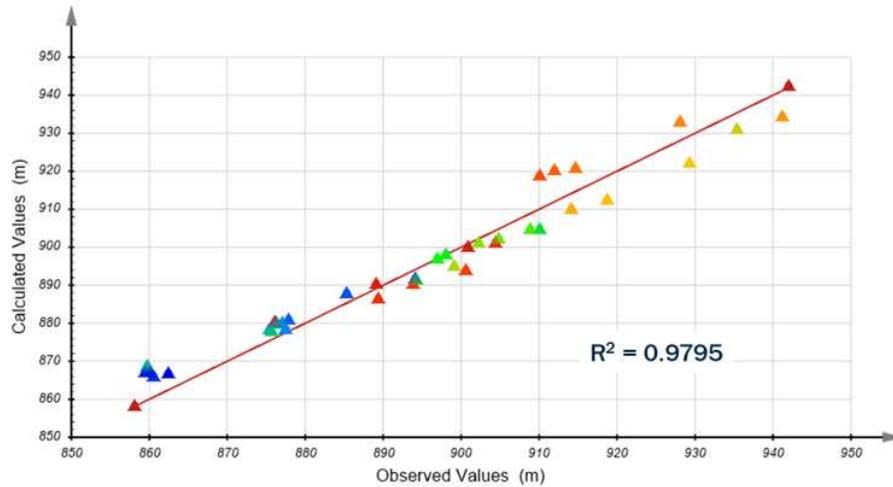
Figure 46: Calculated Versus Observed Piezometer Values for a 2D Seepage Model on Cross-section 3-3

A strong correlation was found between the measured and computed water levels that provides confidence in the accuracy of the 2D saturated/unsaturated seepage model.

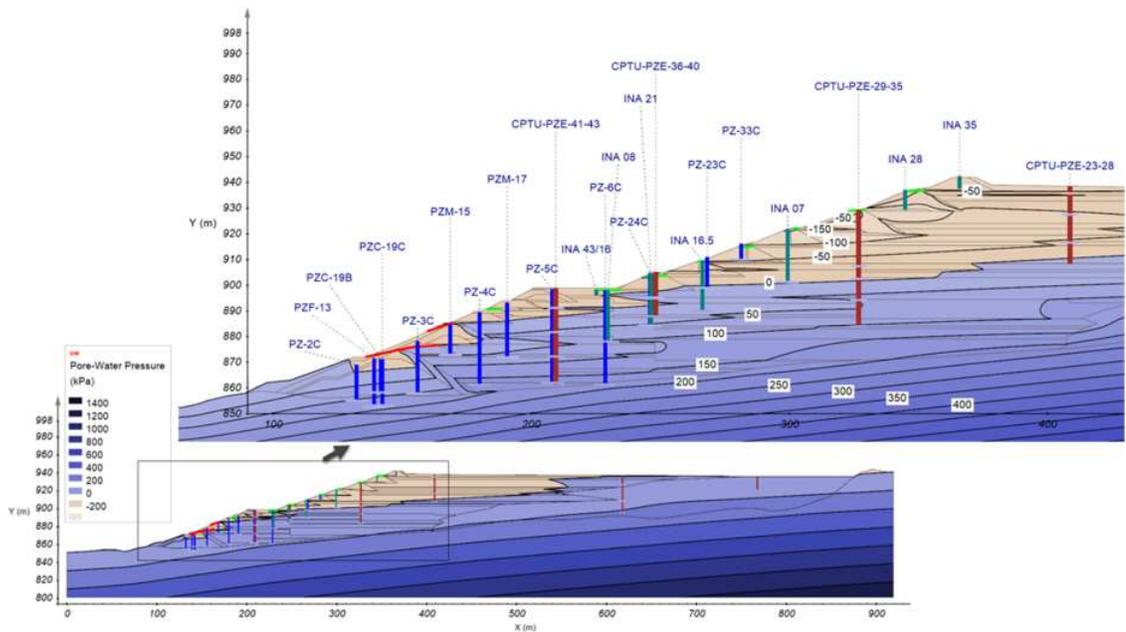
Figure 47: Computed Water Pressures from the 2D seepage model for Cross-section 3-3

The effect of poor downward drainage and restricted flow at the berms is clearly apparent in the results of the simulation presented in Figure 47. The water level shown in Figure 47, which matches the piezometer readings as well as the CPTu dissipation measurements, is high in the toe region of the dam and below the setback. The seepage analysis shows that a significant portion of the dam was saturated with a high water level, especially in the toe region.

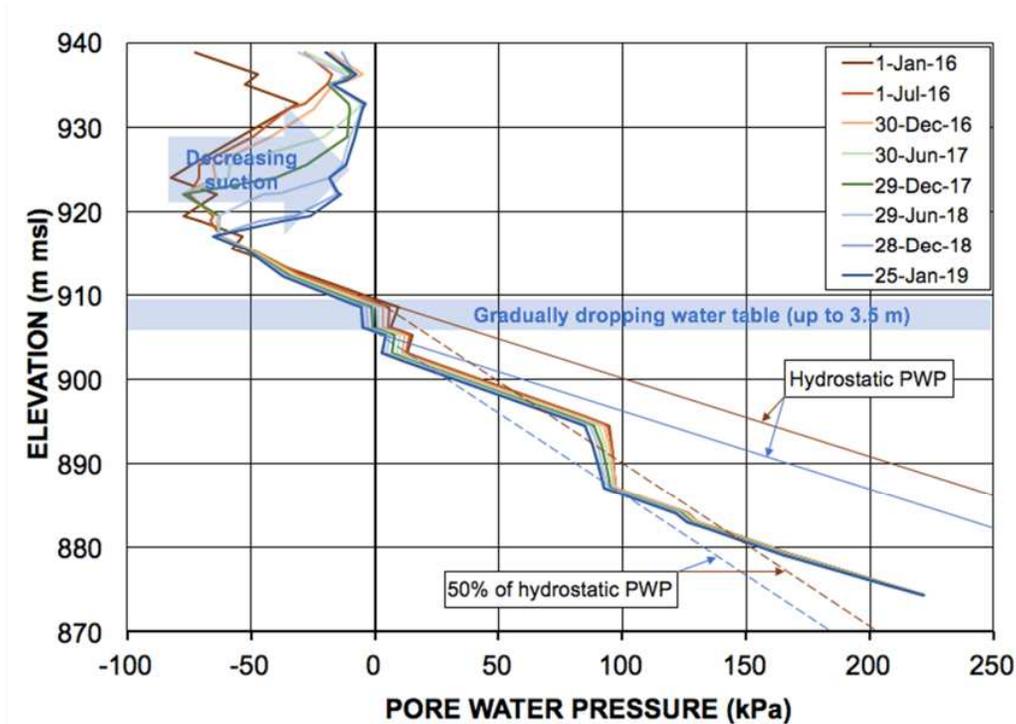
2D computer analyses, using rainfall data from January 2016 to January 2019, were carried out to evaluate changes in soil suctions above the water level. Figure 48 shows an example profile at a location near the crest of the dam at cross-section 3-3 and shows that the computed values of suctions in the unsaturated zone decrease significantly as rainfall infiltrates the unsaturated materials. The loss in suction associated with infiltration is in the order of 50 kPa, which in turn reduces the unsaturated shear strength in this zone by about 10 kPa to 15 kPa. The impact of this loss of strength in the unsaturated zone is discussed further in Section 8. Figure 48 also illustrates that the average water pressure below the water level can be approximated by a 50% hydrostatic pressure profile.

Figure 48: Pore-water Pressure Profile Beside Top Berm on Cross-section 3-3

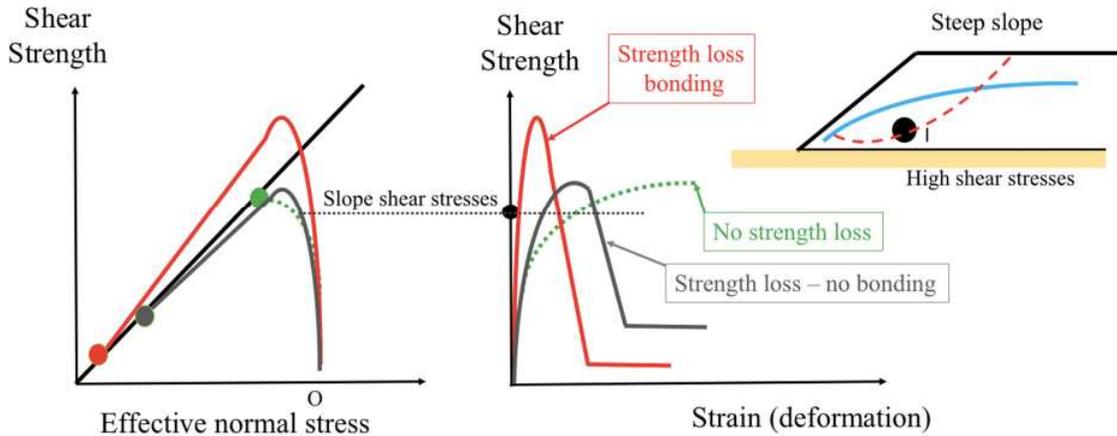
Figure 49 schematically shows the different approximate stress-strain and stress-path responses for soils that have no strength loss, strength loss with no bonding, and significant strength loss due to bonding. Materials that have no strength loss will typically show significant deformation prior to failure. Materials that have strength loss with no bonding show less deformation before failure compared to the materials with no strength loss. Materials that have significant strength loss due to bonding tend to show very little deformation before failure and require very little strain to trigger the strength loss.

Figure 49: Schematic Comparison in Behavior Between Soil that has No Strength Loss, Soil with Strength Loss, and Either No Bonding or with Bonding
