# **Dam Safety Incident Report**

## **Benson Creek Rainfall-Runoff Model Results**

### **Benson Creek Flood, August 2014**

### **Okanogan County near Twisp, WA**

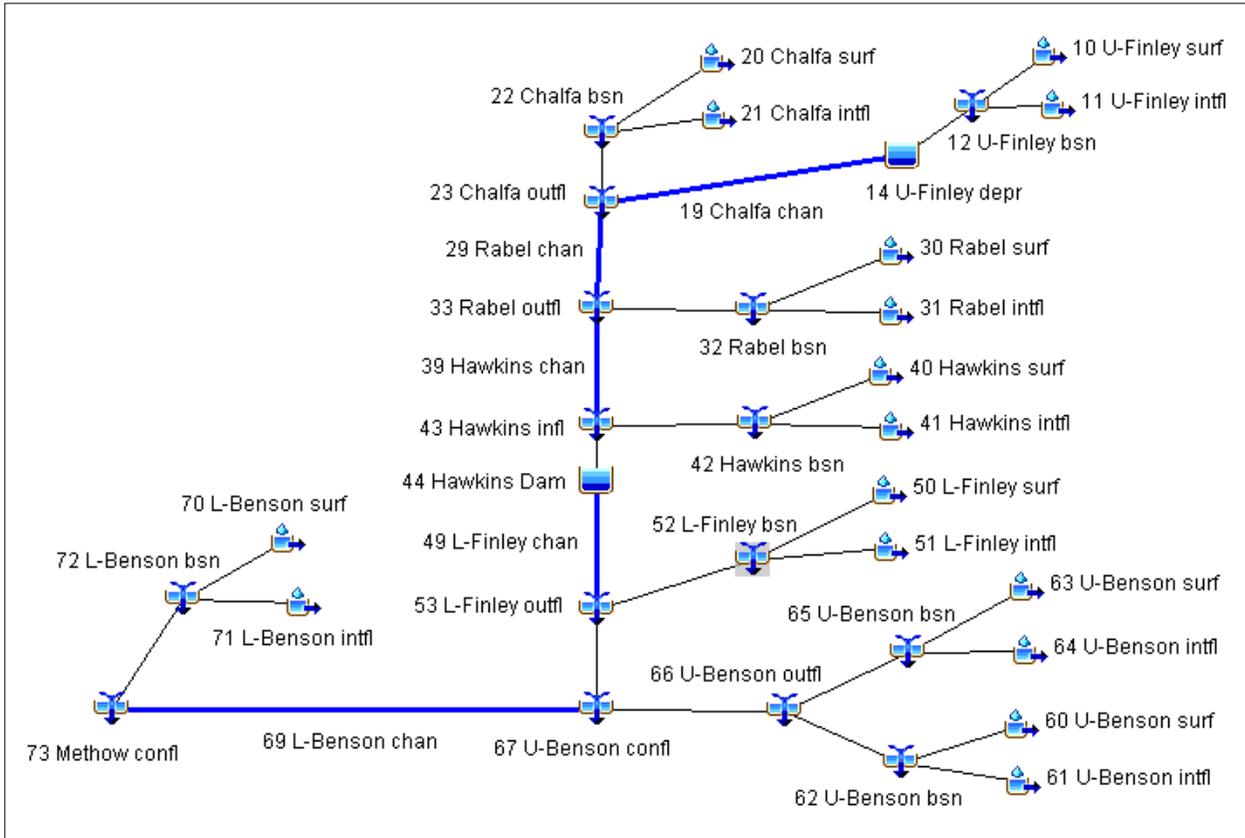
HEC-HMS network for Benson-Finley basin model

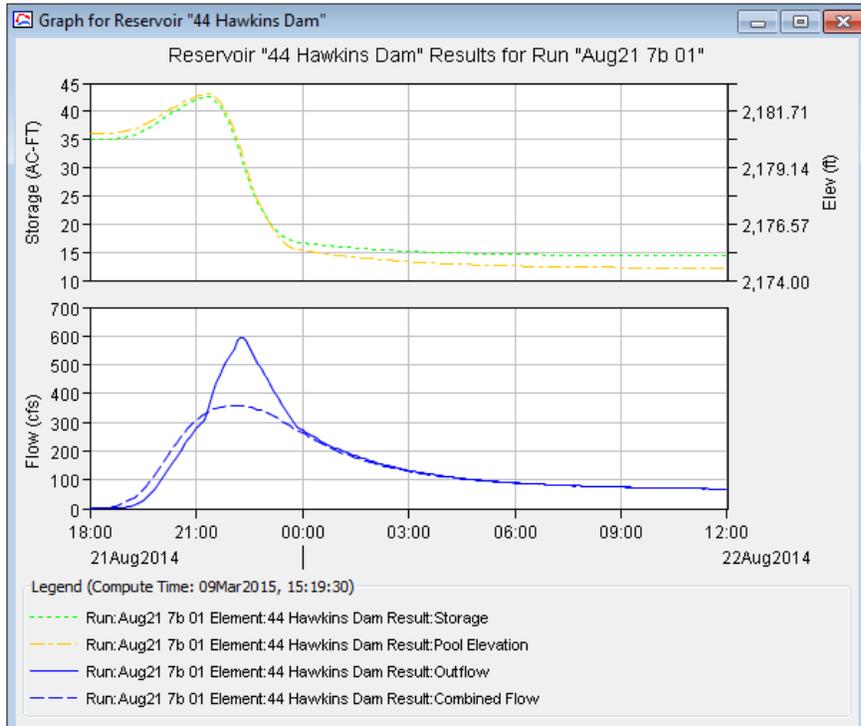
### 5. Outflow from Hawkins Dam

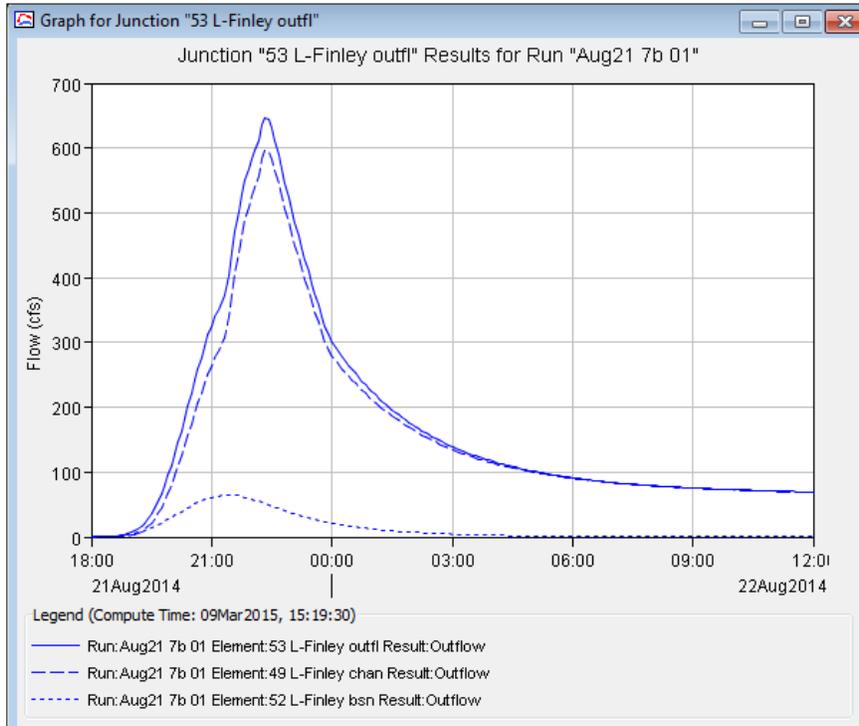
Model predictions are that the peak discharges in Finley Canyon and Benson Creek all occurred between 10:15 and 11:00 pm, about 4¼ to 5 hours after the storm began. In Lower Finley Canyon below Hawkins Dam, the peak discharge is calculated at 647 cfs, slightly less than the peak discharge out of Upper Benson Creek (664 cfs). The peak flow of 647 cfs is 58% higher than the non-failure scenario for peak flow in Lower Finley Canyon. Comparison of these flows with stage-discharge curves for three locations in Lower Finley Canyon found that, on a relative basis, the increased flow depths are 20% to 35% higher than the non-failure scenario.

## 7. Outflow from Lower Finley Canyon

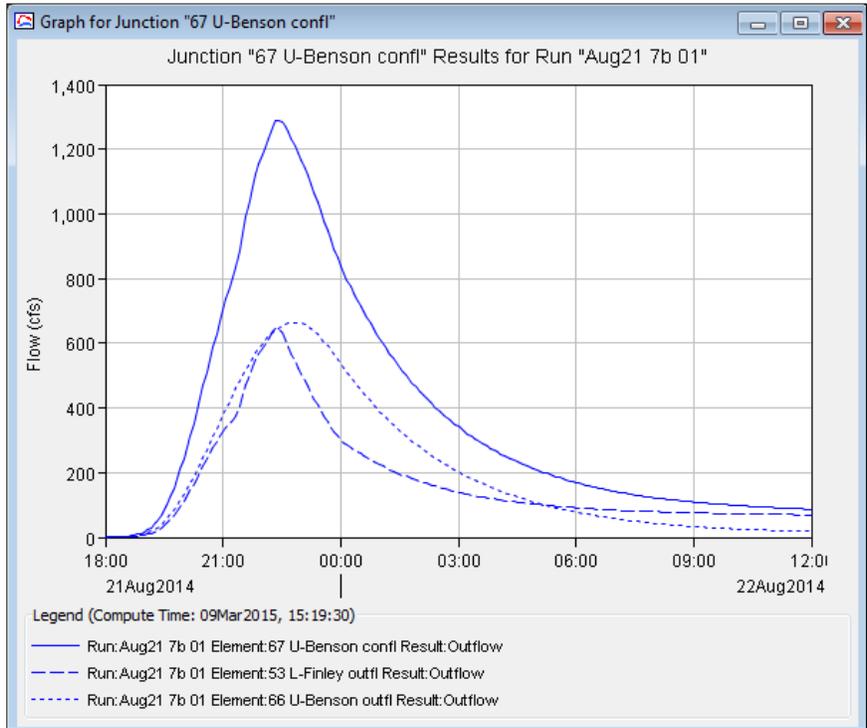
In Benson Creek below the Finley Canyon outfall, the peak discharge is calculated at 1291 cfs. This peak flow is 22% higher than the non-failure scenario for peak flow in the upper reach of Lower Benson Creek within a mile of the Finley Canyon outfall. Comparison of these flows with stage-discharge curves for three locations in this reach of Benson Creek found that, on a relative basis, the increased flow depths are about 8% higher than the non-failure scenario.

### 9. Combined flow into Lower Benson Creek
