Hurricane Matthew in North Carolina Dam Risk Management Assessment Report

FEMAP-1090 / DR-4285-NC / May 2017

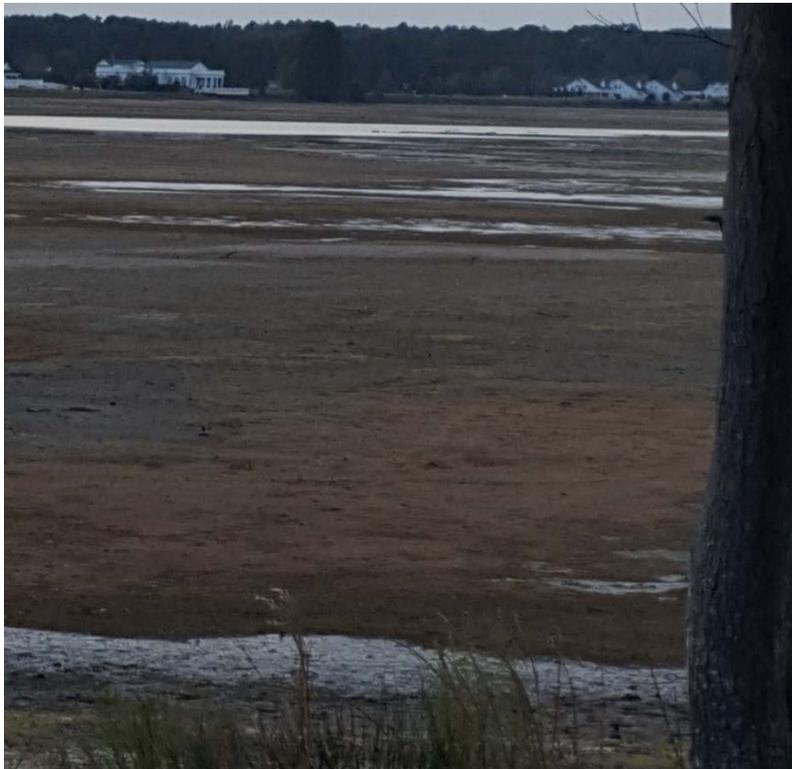
Figure 8.7 Woodlake Dam drained reservoir October 27, 2016; Credit: NC DEMLR

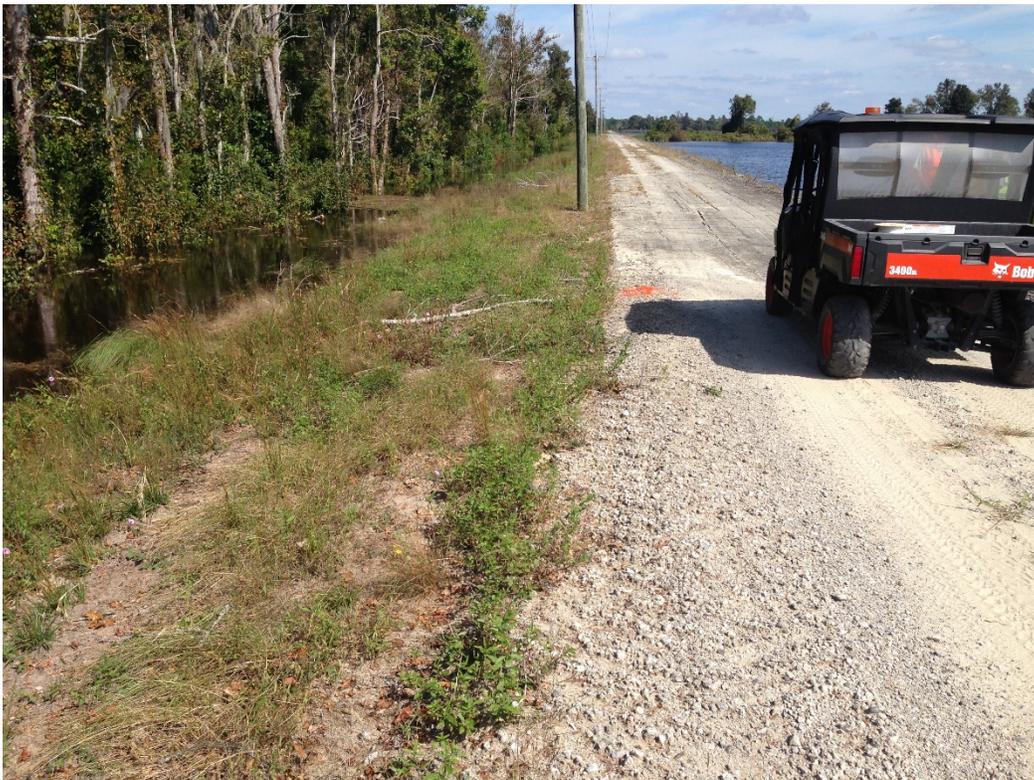
The owners of Sutton Cooling Pond activated their EAP due to concerns of a potential overtopping from the rising Cape Fear River. The Cape Fear River never overtopped this dam, but came within one foot of doing so. No breach occurred at this dam and consequently it is not in Appendix A.

Figure 8.9 Sutton Cooling Pond on right (river on left); Credit: NC DEMLR

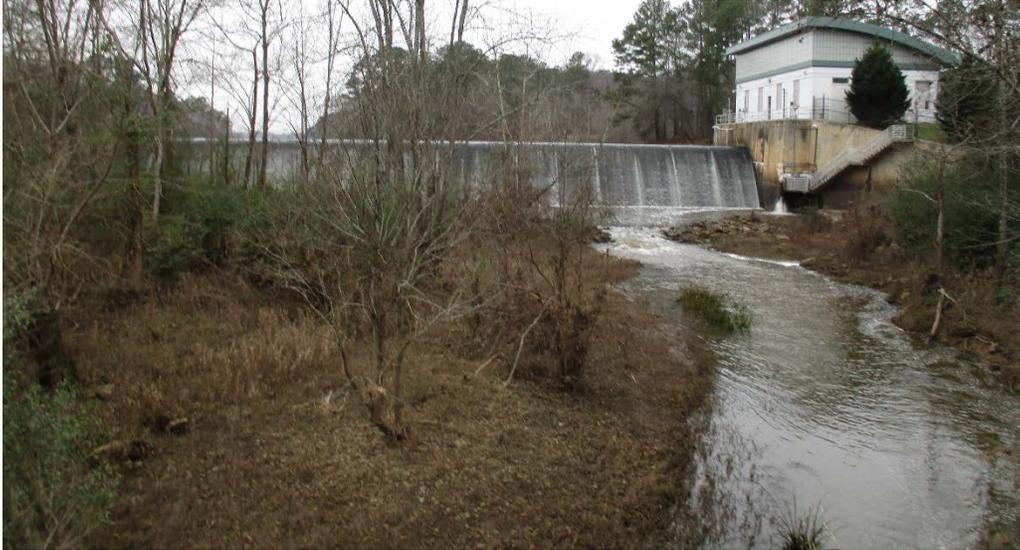
Figure 8.10 Lake Benson Dam

During this event, the North Carolina Governor received a call concerning this structure. The Governor contact NC DEQ DEMLR in the NC EOC. NC DEQ DEMLR shared the EAP for this dam with the state and local emergency managers. The owner of this dam, the local government, activated the EAP due to the lake level rising to within one foot of overtopping the dam. The local emergency managers coordinated evacuations of the population downstream of the dam. The dam did not overtop or breach. It is not in Appendix A.

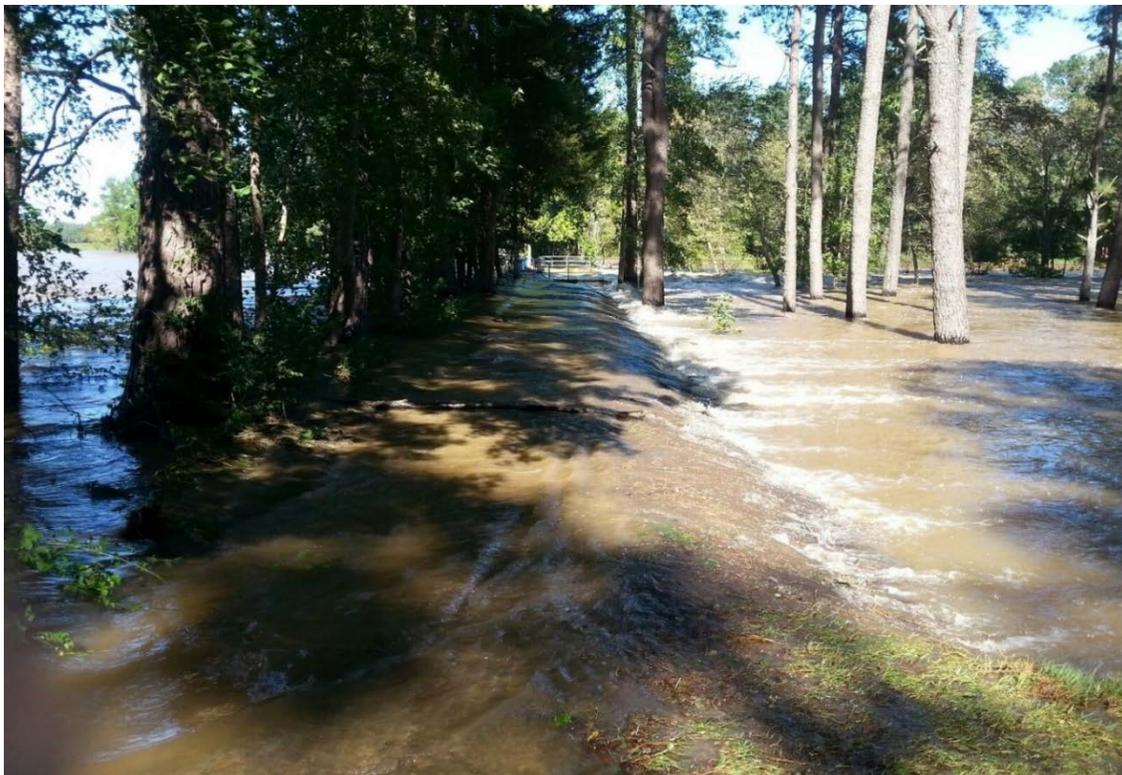
The upstream dam, Silver Lake Dam, breached during this event (see Appendix A). Lake Wilson Dam overtopped due to the flood waters. Due to concerns regarding Lake Wilson Dam overtopping, the local government coordinated evacuations downstream of Lake Wilson Dam. This dam did not breach and is therefore not in Appendix A.

Figure 8.11 Lake Wilson Dam overtopping

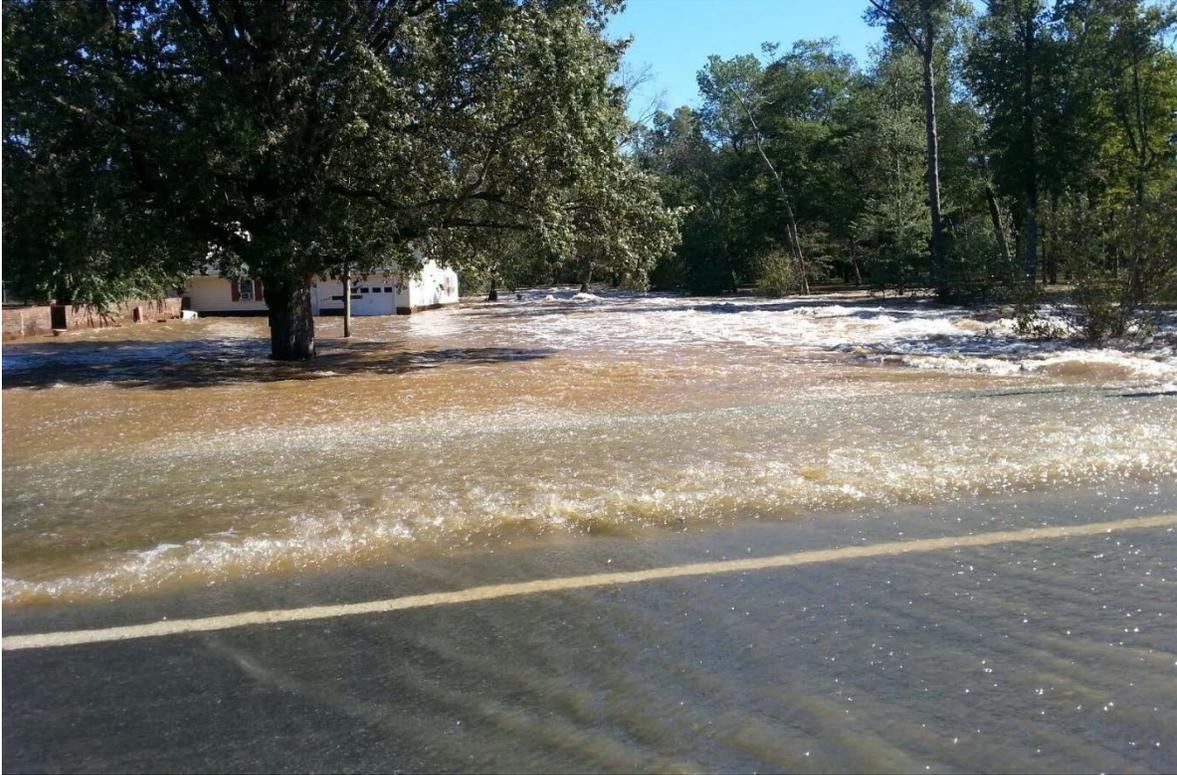
Figure 8.12 Consequences of Flooding and Lake Wilson Dam overtopping Credit: NC
DEMLR

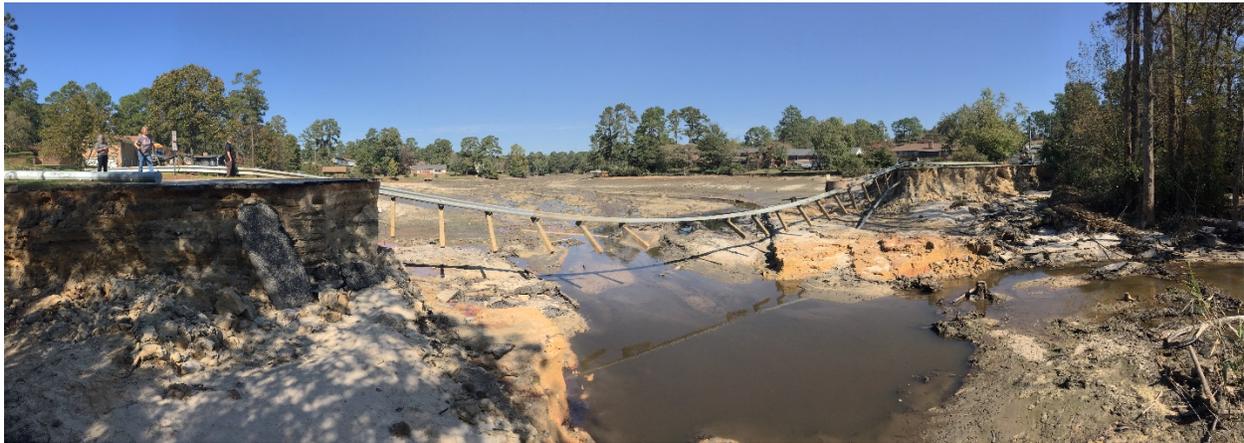
Figure A4.5: Arran Lake Dam post-event photo; Credit: NC DEMLR

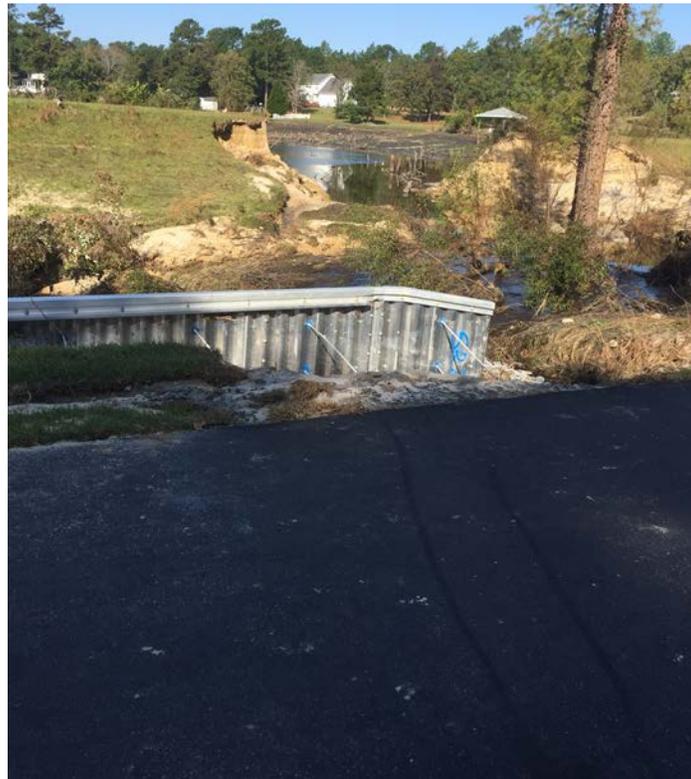
Figure A8.4: Mount Vernon Estates Dam post-event photo; Credit: NC DEMLR

- On 4/7/16 a Notice of Inspection was sent to the owner of the dam by NC DEQ DEMLR noting the same issues of vegetation. Trash and woody debris in the same areas as noted in past inspections was also noted in this inspection. Two new items

noted on the inspection were seepage at the toe of the dam, and soil erosion on the left and right of the principal spillway. The owner was alerted to the fact that continued seepage at the toe of the dam as well as soil erosion could result in the failure of the dam. The letter asked the owner to repair the noted items and continue proper maintenance to ensure a safe dam.

- Consider determining the percent PMP and flood recurrence interval experienced at this dam location.
- Consider this dam for further analysis to determine the capacity of the spillway / outlet work system in relation to the flood event that occurred.
- Consider this dam for comparison of dam breach modeling results (HEC-RAS, DSS-WISE, FLO-2D, etc.) to high water mark inundation downstream.
- Consider assessing the dam for probable failure mode as a result of this event.
- Consider this dam for further assessment of the design and construction of the dam and any major rehabilitations, including the design and construction standards at the time.
- Consider this dam for further research into whether or not the recommendations provided in the last NC DEQ DEMLR inspection were addressed.
- Consider collecting and documenting dam breach parameters for this dam.

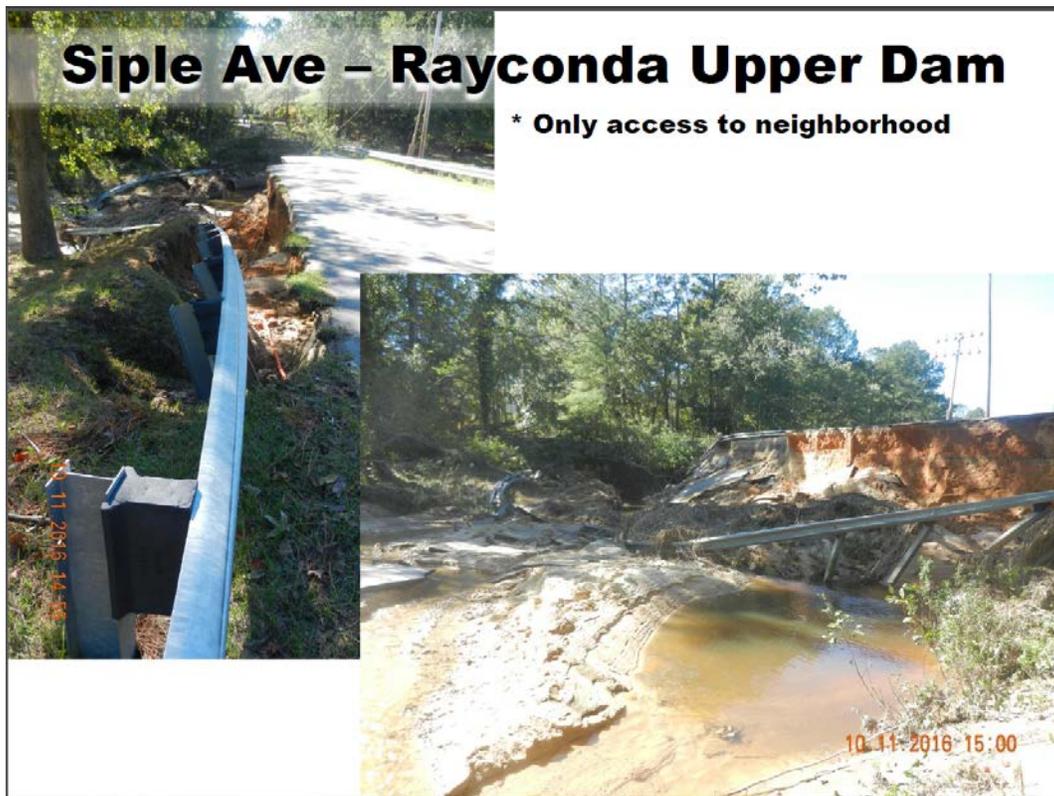
Figure A10.4: Rayconda Upper Dam post-event photo; Credit: NC DEMLR

- The NID and the North Carolina dam inventory have the condition as being "Poor".
- NC DEQ DEMLR inspection highlights:
 - 8/20/2004 – A letter from NC DEQ DEMLR stating a Notice of Deficiency for the Rayconda Upper Dam was sent to owner of dam and a copy sent to NC DOT noting that *"dam is a High Hazard Dam, that in event of dam failure Siple Avenue would incur damage, vehicle traffic on road would be endangered, and access to homes would be restricted."* An inspection of the dam found in part: significant erosion and sloughing off of downstream slope in center portion of dam starting at edge of SR 3380 and extending to barrel pipe outlet. The letter stated that repairs to the dam were needed.

- 2/14/2012 – A Dam Safety Inspection report notes in part: vegetation has been mowed, there are old slides and depressions, trees and brush have been mowed and cut but debris was left on the slope, there is wetness at the toe of the dam, a noted seepage could be in the bottom of the drain - rust colored water with an oily sheen was noted, also the outlet pipe in the Principal Spillway is completely submerged.

- Consider this dam for comparison of dam breach modeling results (HEC-RAS, DSS-WISE, FLO-2D, etc.) to high water mark inundation downstream.
- Consider assessing the dam for probable failure mode as a result of this event.

- Consider collecting and documenting the dam breach parameters at this dam.
- Consider assessing and documenting the dam site for tree and woody vegetation and any contributions this may have had in the failure, such as root systems in the embankment.

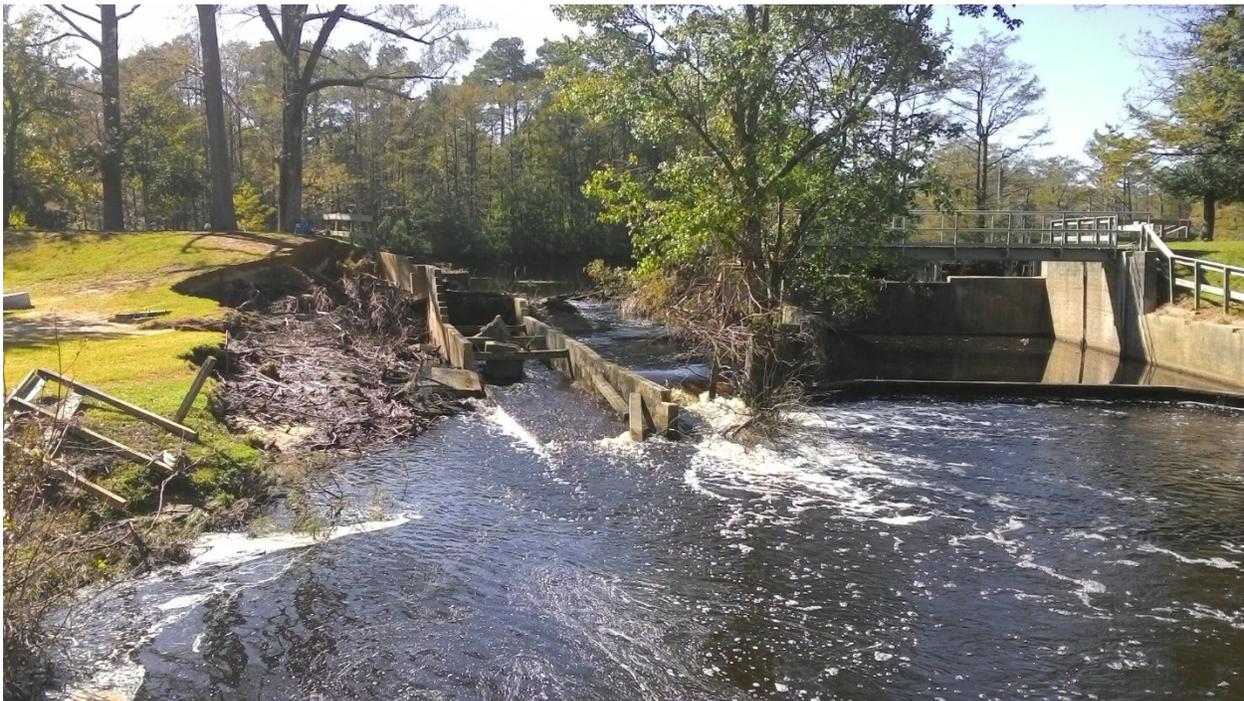
Figure A15.5: Tull Mill Pond Dam post-event photo; Note trees on embankment and tree root system within embankment
Credit: NC DEMLR

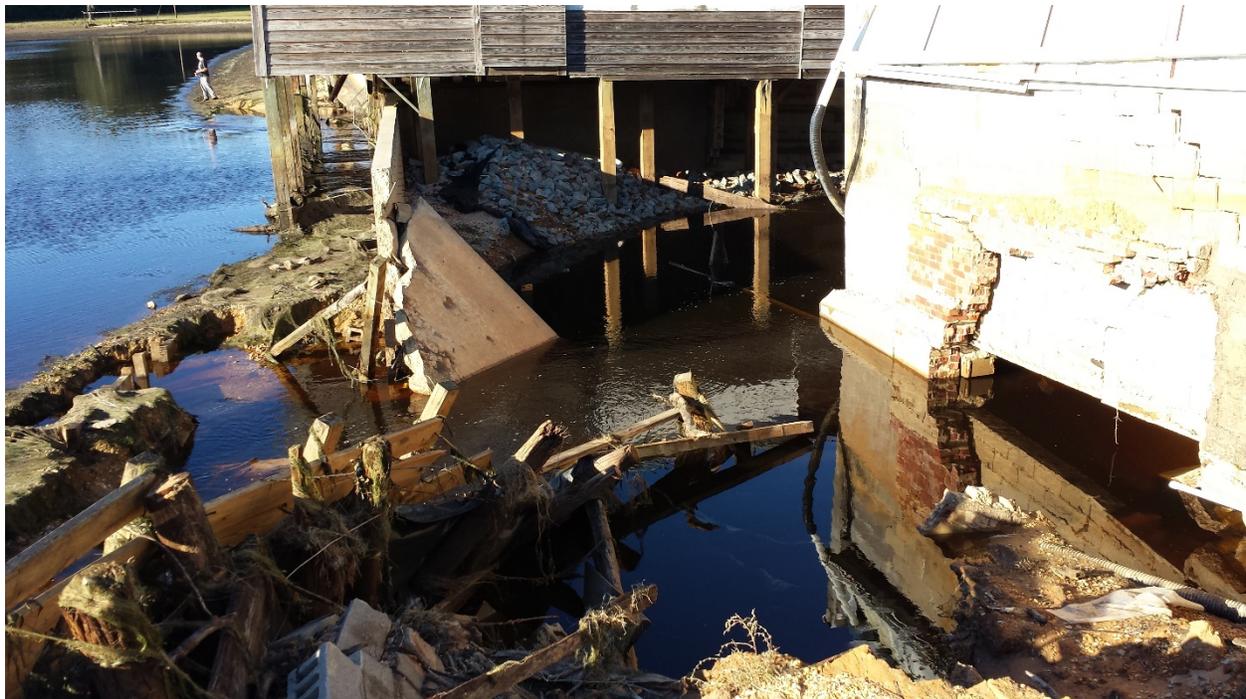
Figure A17.4: House Autry Dam post-event photo;

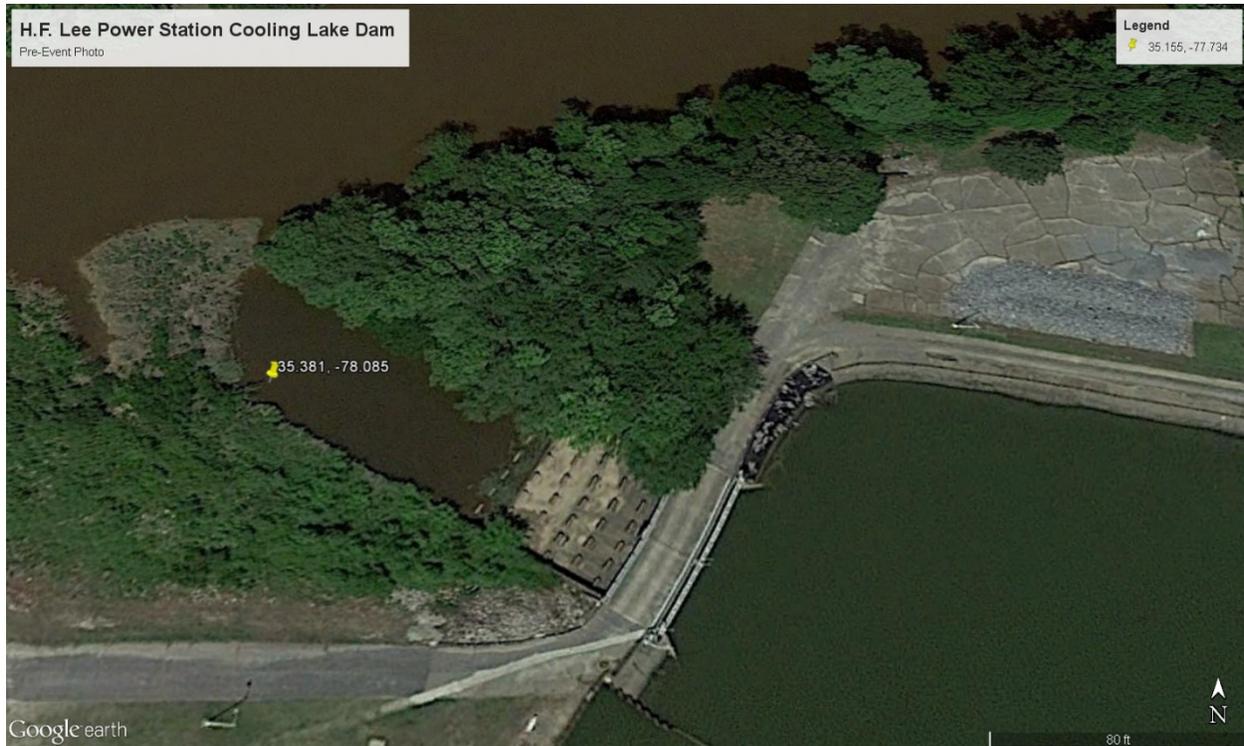
Figure A19.1: H.F. Lee Power Station Cooling Lake Dam pre-event photo; Credit: Google Maps

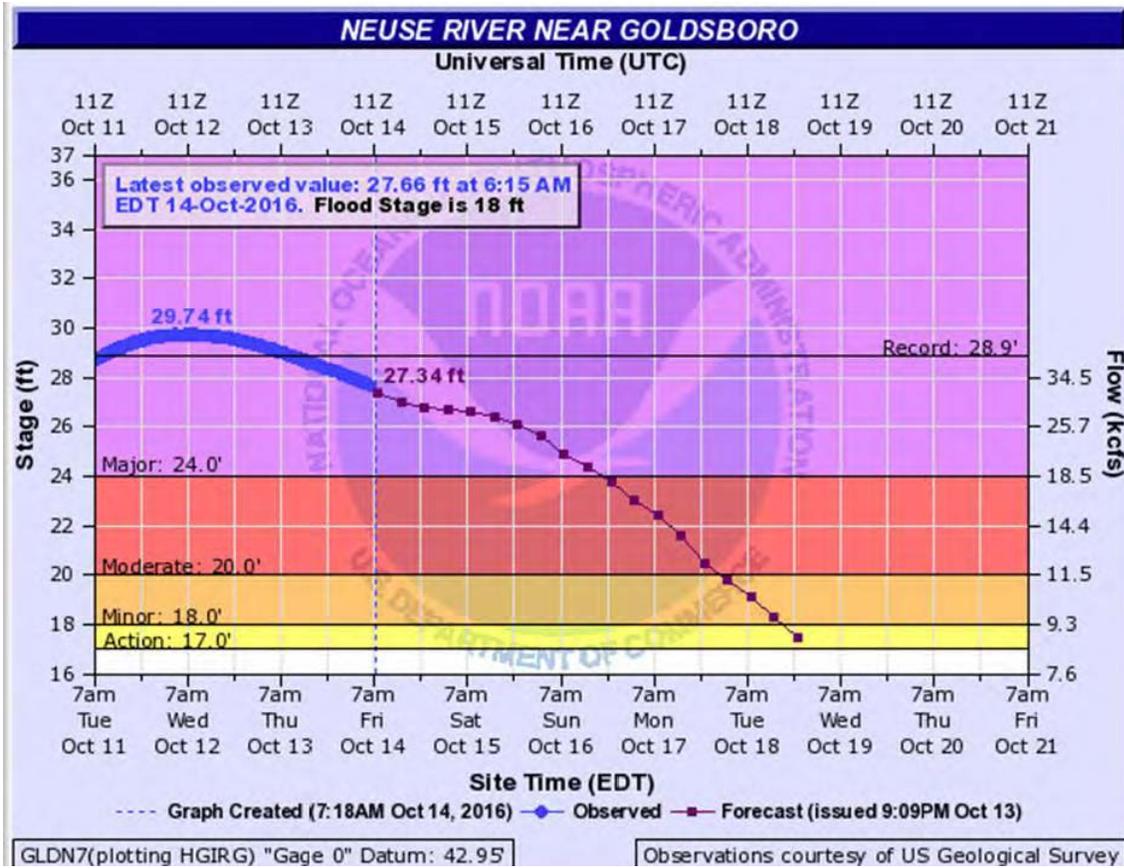
Figure A19.4: USGS gage data near H.F. Lee Power Station Cooling Lake Dam

- NOAA National Weather Service recorded an observed a 7-day precipitation of 8"-10" in the area of this dam.
- USGS gage data shows that the Neuse River near this dam reached record flood levels. The Neuse River initially entered the cooling lake through the emergency spillway and then overtopped the dam.

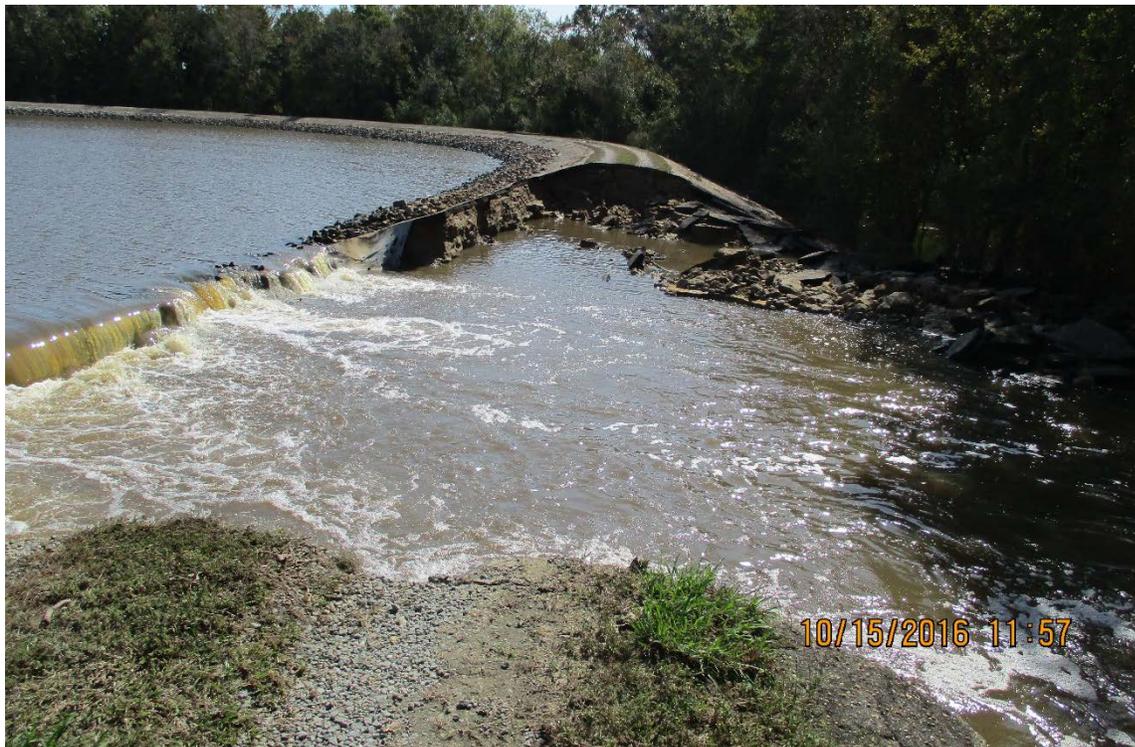
Figure A19.5: H.F. Lee Power Station Cooling Lake Dam post-event photo; Credit: NC DEMLR

- *Duke Energy will works with DEQ to get the necessary permits for a permanent repair of this breach.*
- The following are conditions noted in a Notice of Deficiency (NOD) from NC DEQ DELMR dated June 1, 2016:

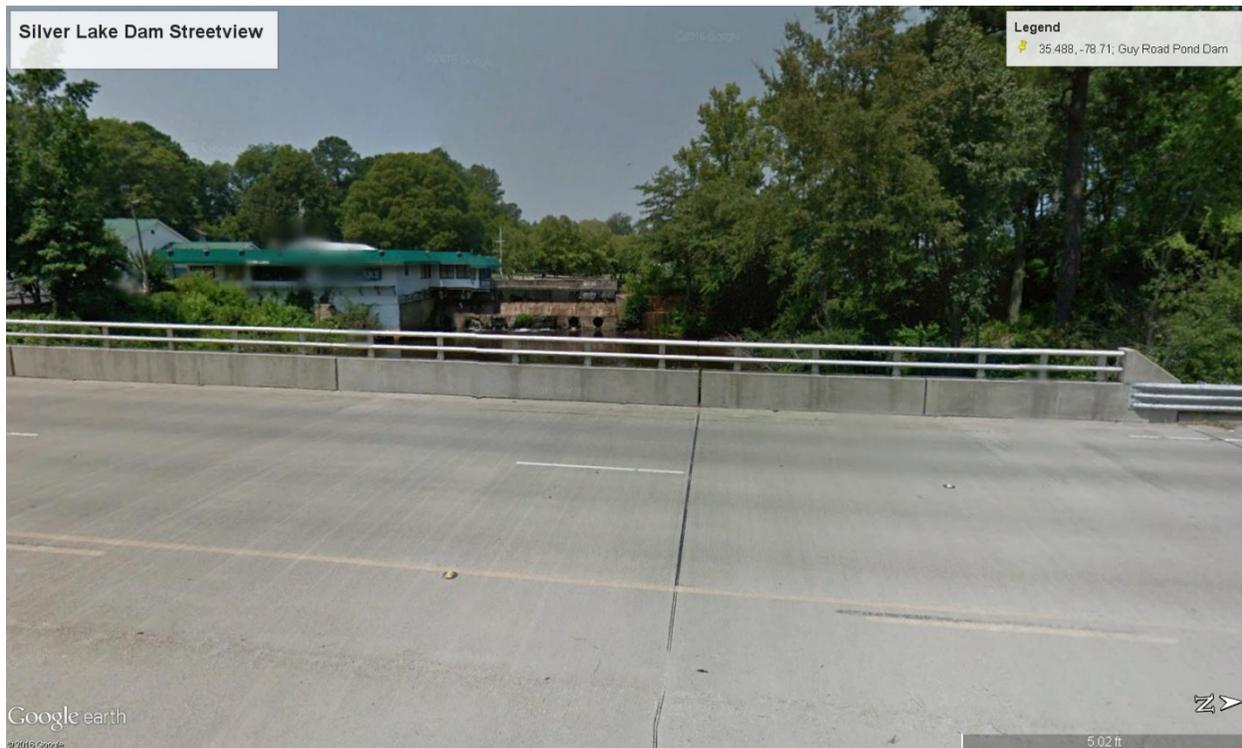
Figure A20.1: Silver Lake Dam pre-event photo; Credit: Google Maps Streetview
