INVESTIGATION OF FAILURES OF EDENVILLE AND SANFORD DAMS

Independent Forensic Team

FINAL REPORT

Investigation of Failures of Edenville and Sanford Dams

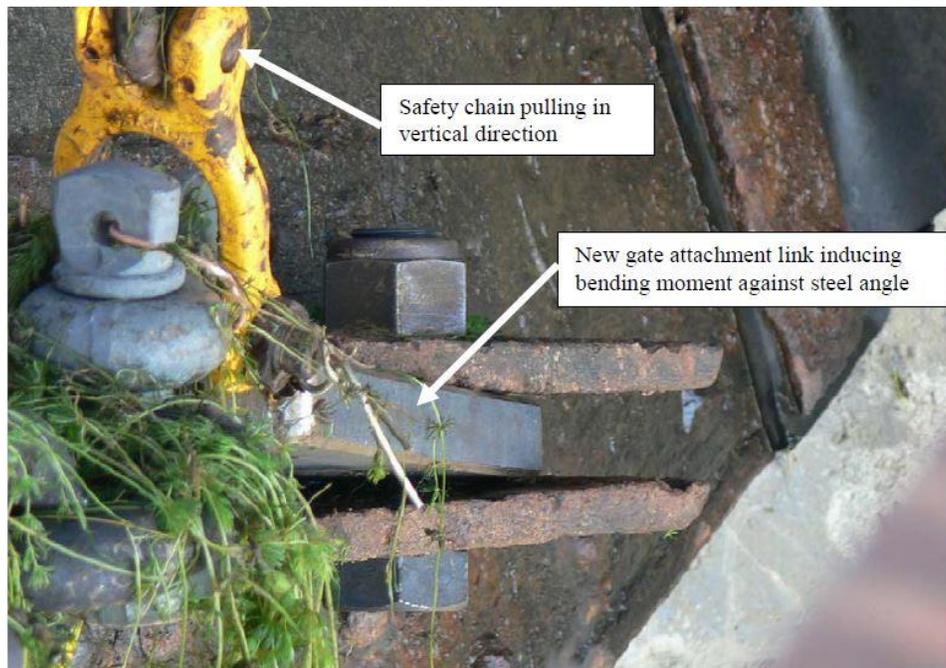
Figure 2-9: A-Frame Induced Bending at Connection to Gate (Spicer 2019)

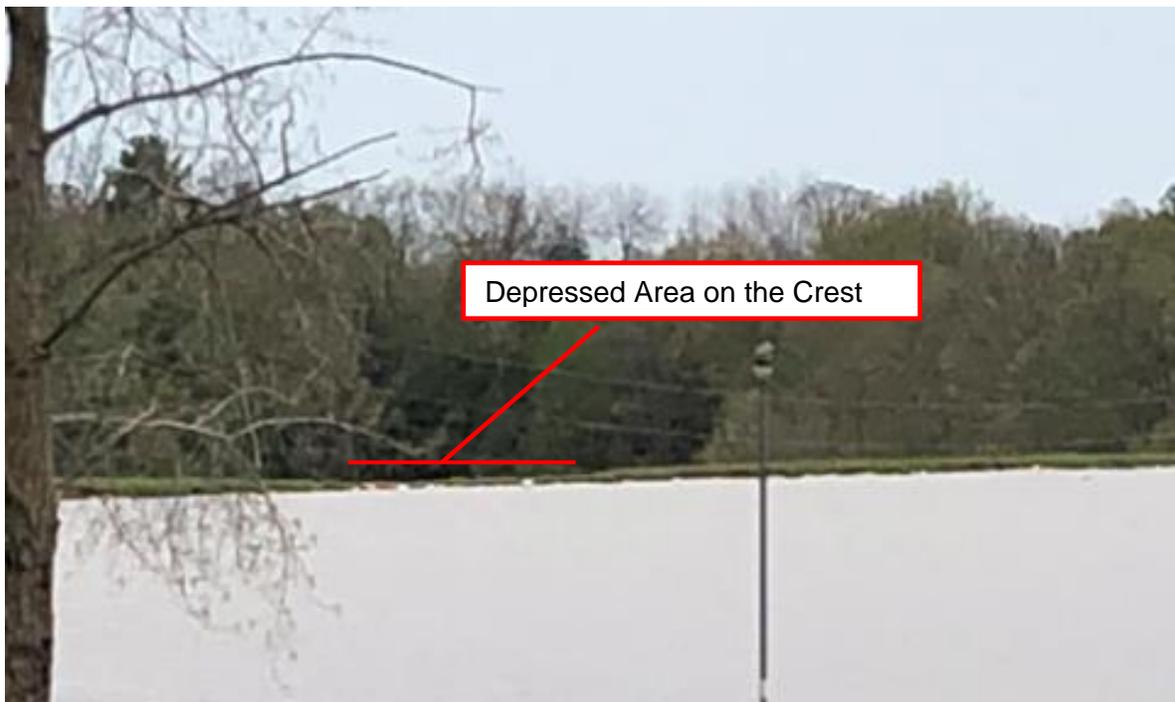
Figure 3-2: Photograph Showing Depression in the Crest of the Edenville Left Embankment at 5:20 P.M., Tuesday, May 19, 2020

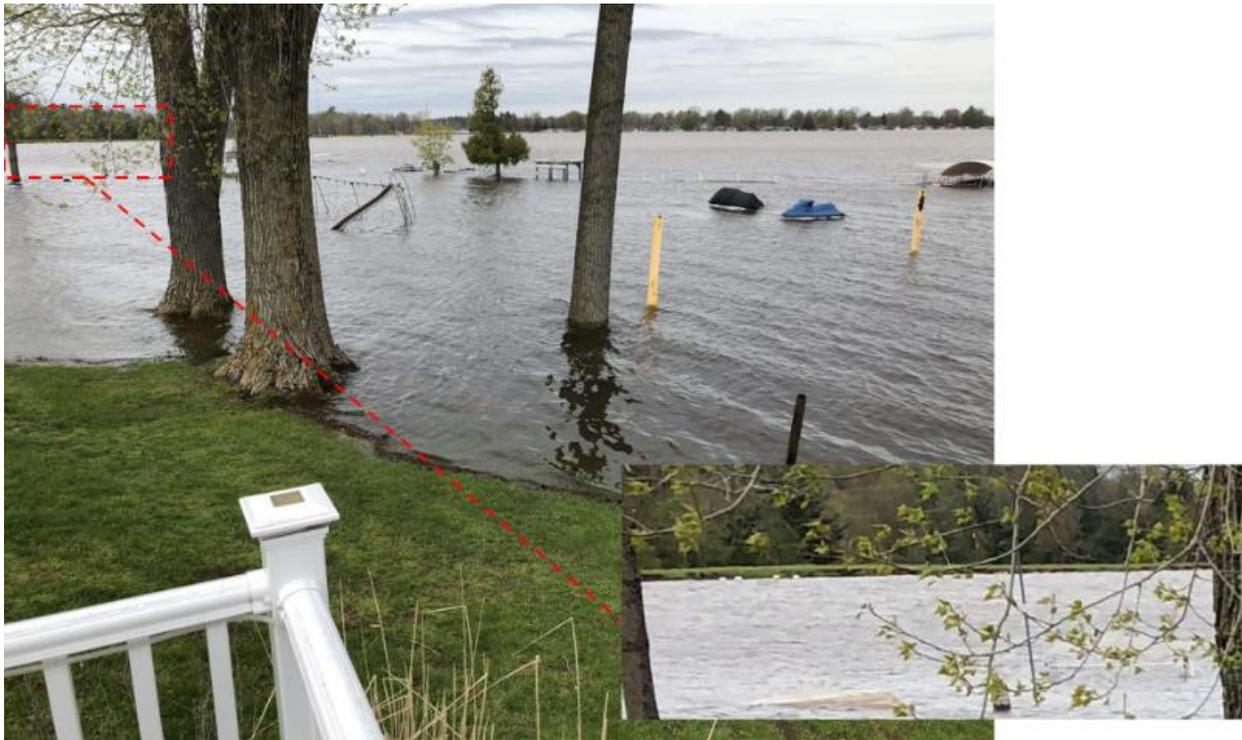
Figure 3-3: Photograph Showing the Crest of the Edenville Left Embankment at 2:52 P.M., Tuesday, May 19, 2020

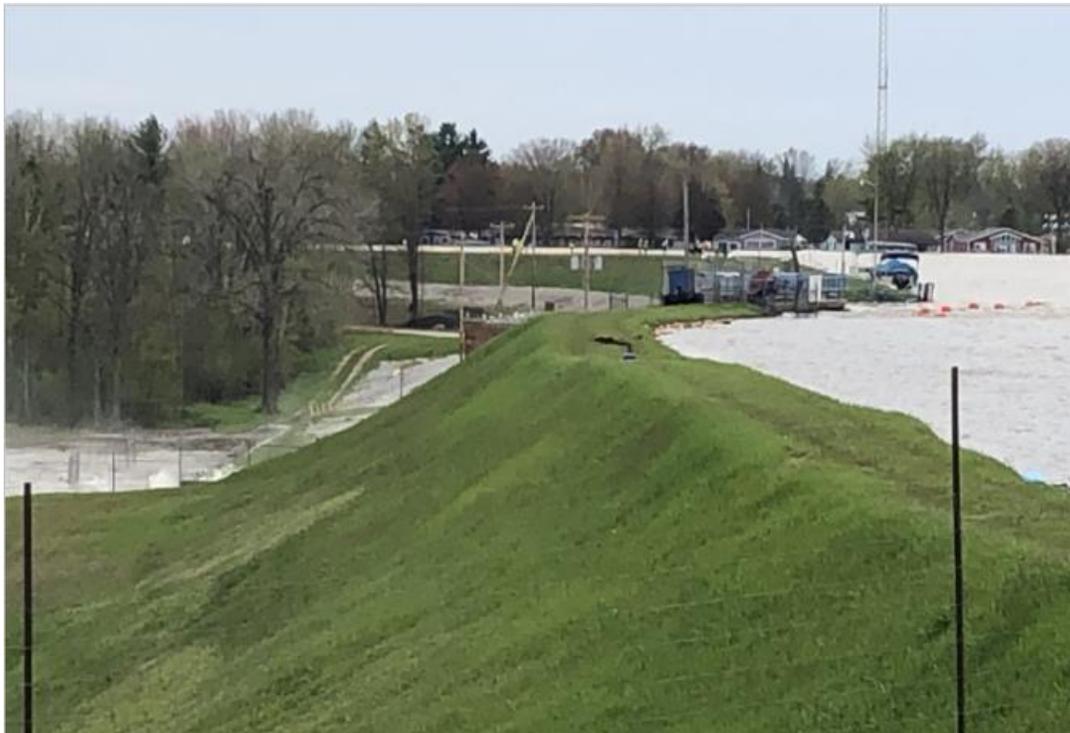
After observing the depression in the crest, several residents walked to the Consumers substation located downstream of the Edenville left embankment. The photograph of the downstream side of the embankment in Figure 3 was taken at 5:31 p.m. that day. The photograph shows the depression in the crest, but otherwise does not show any significant signs of distress in the embankment. Figure 3 shows a lighter-colored area near the toe of the embankment at the ultimate failure location. The IFT considered the possibility that this light color might indicate seepage, but after reviewing other photographs and talking with eyewitnesses, the IFT concluded that the light color did not appear to be seepage. Historical photographs showed significant variability of color on the face of the embankment. However, because Figure 3 is a distant view of the embankment, the possibility that the color difference represents seepage cannot be ruled out.

Figure 3-4: Photograph Showing the Downstream Side of the Edenville Left Embankment at 5:31 P.M., Tuesday, May 19, 2020

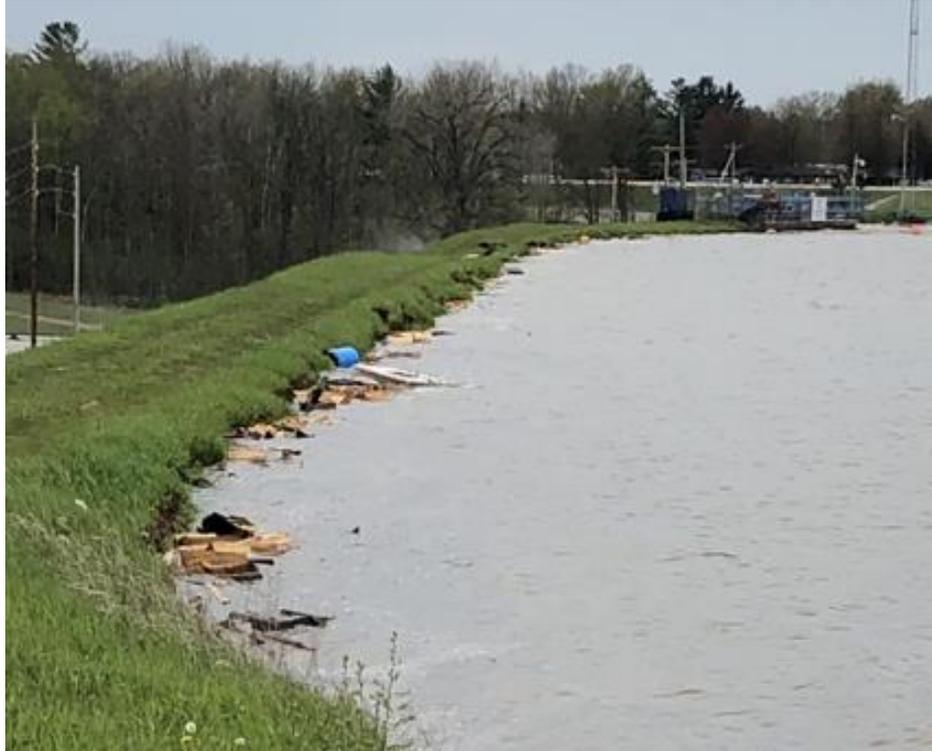
Figure 3 shows a view of the depression in the crest from upstream at 5:33 p.m. The photograph in Figure 3 also shows the erosion that had occurred on the upstream slope of the embankment.

Figure 3-5: Enlarged Photograph Showing the Upstream Side of the Edenville Left Embankment at 5:31 P.M., Tuesday, May 19, 2020

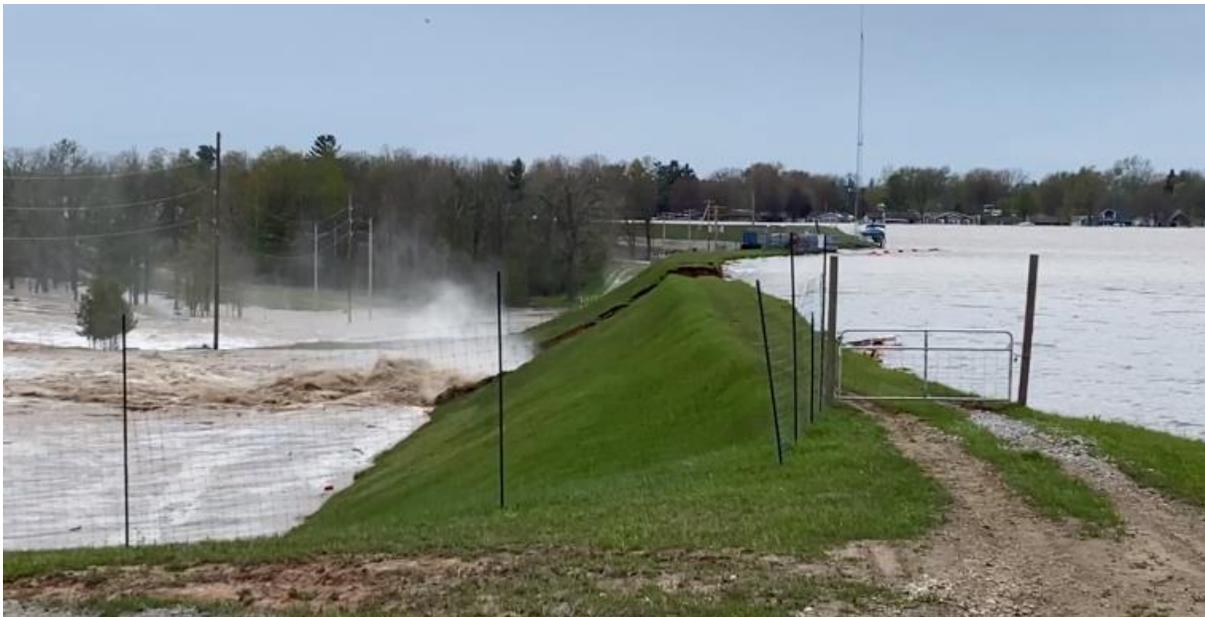
Figure 3-14: Enlarged Still Image from Dam Failure Video at 36 Seconds

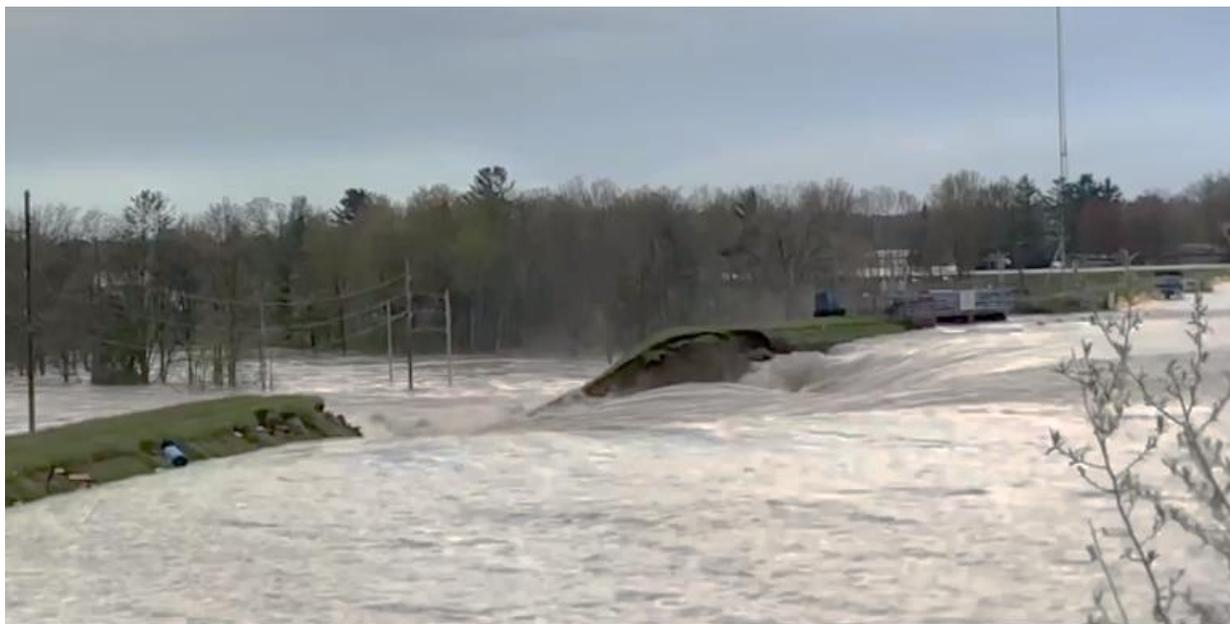
Figure 3-16: Edenville Left Embankment Breach at 6:24 P.M. on Tuesday, May 19, 2020

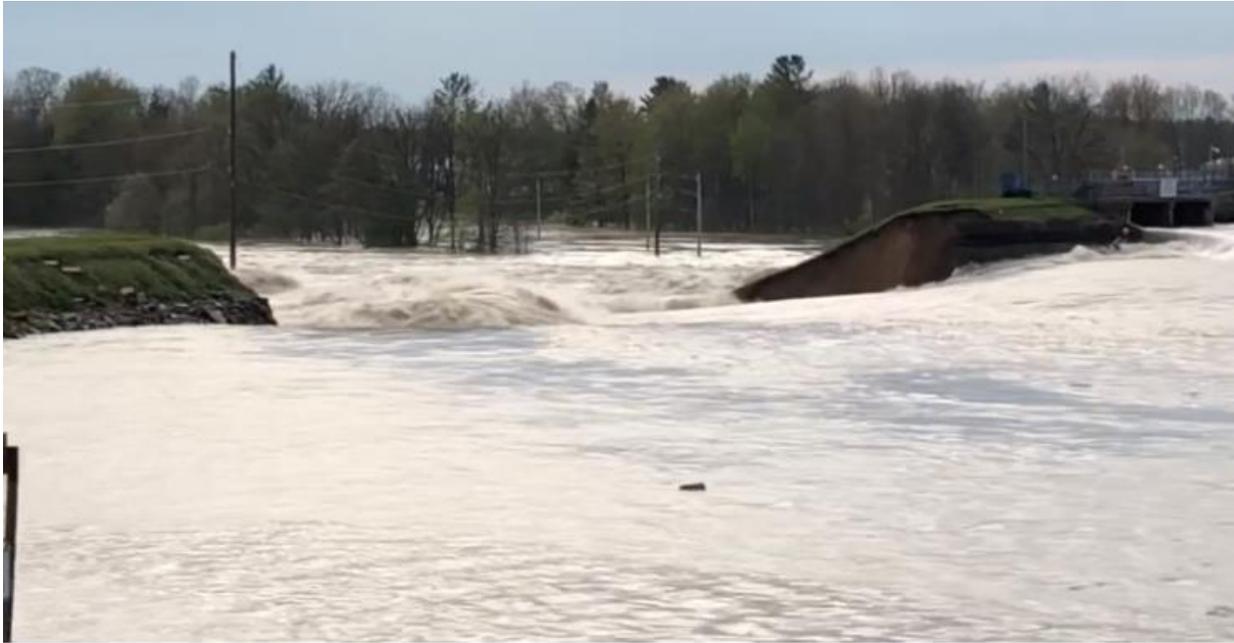
Figure 3-17: Edenville Left Embankment Breach at 7:13 P.M. on Tuesday, May 19, 2020

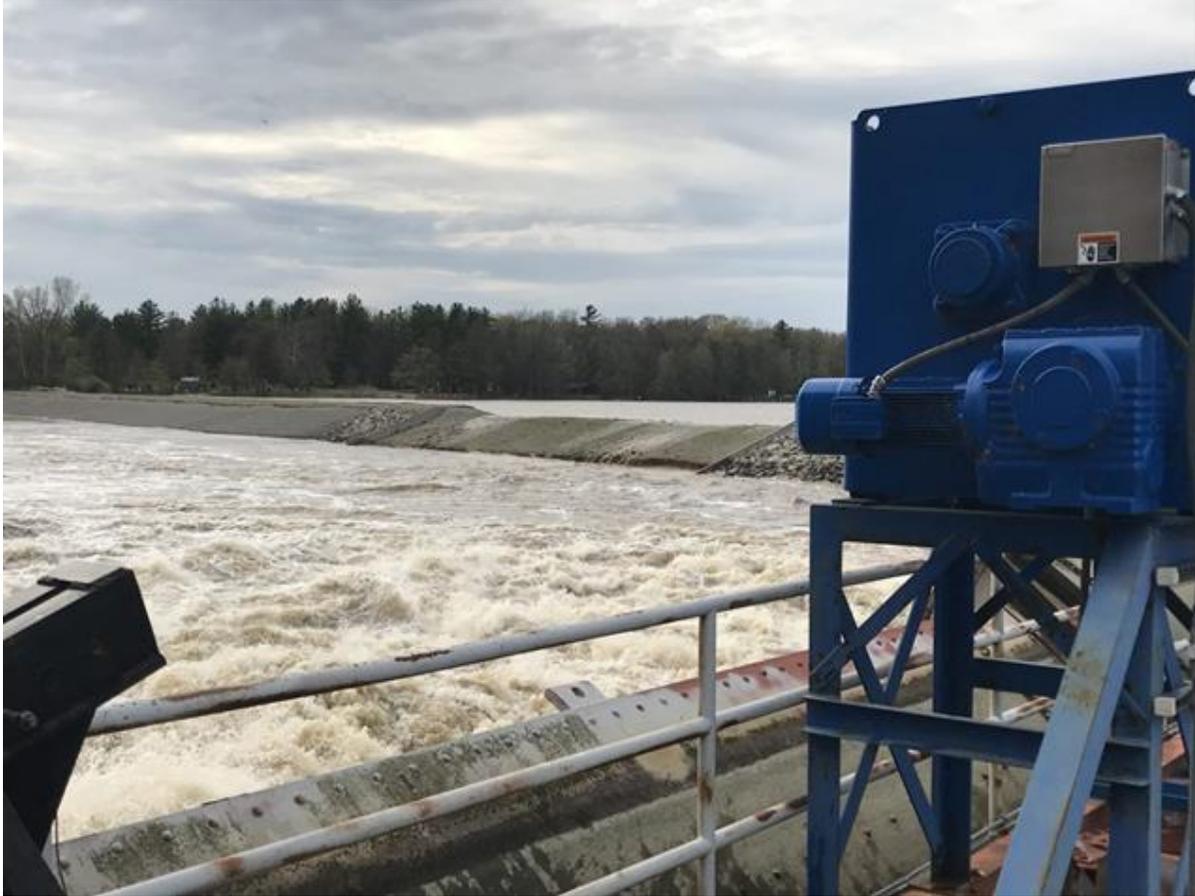
Figure 3-21: Initial Overtopping of Fuse Plug at about 7:19 P.M. (photo courtesy of EGLE)

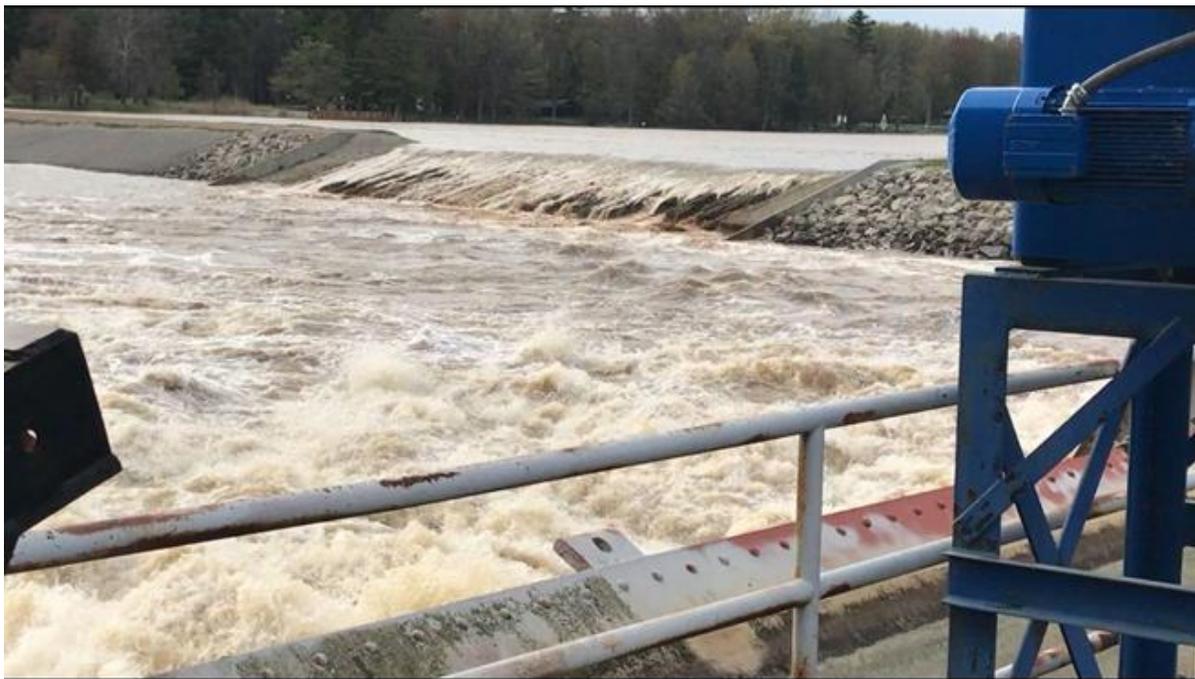
Figure 3-22: Erosion of Fuse Plug Embankment and Head Cutting at about 7:25 P.M. (photo courtesy of EGLE)

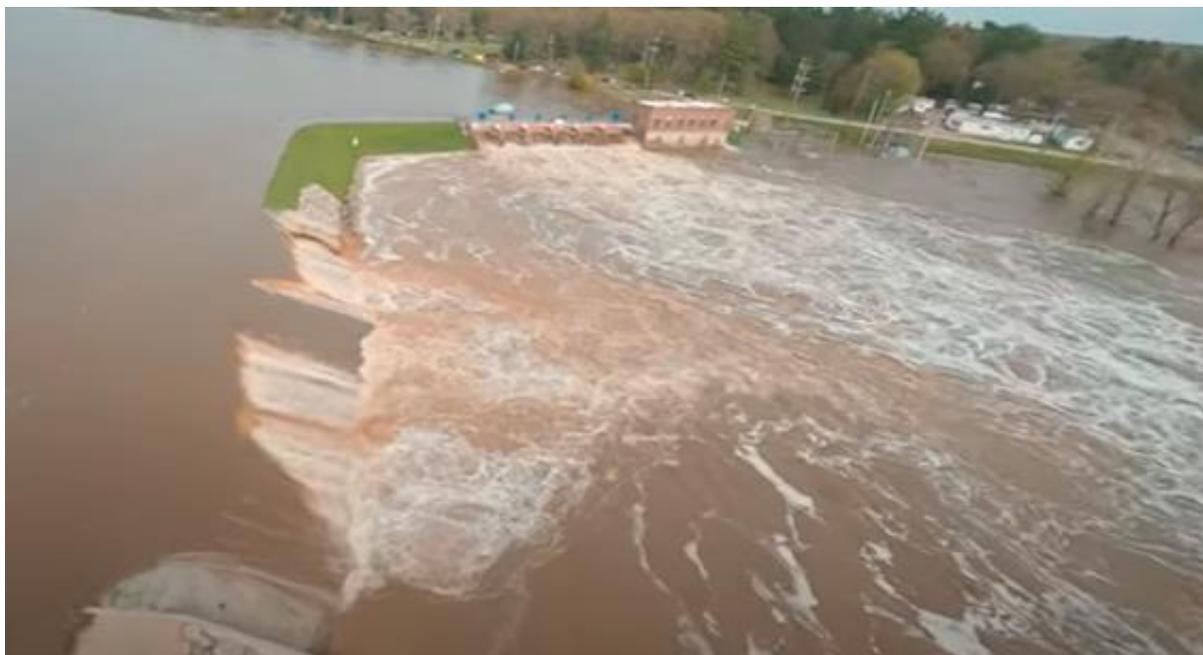
Figure 3-23: Still Image from Drone Video Approximately 7:46 P.M., Just Before the Initial Embankment Overtopping

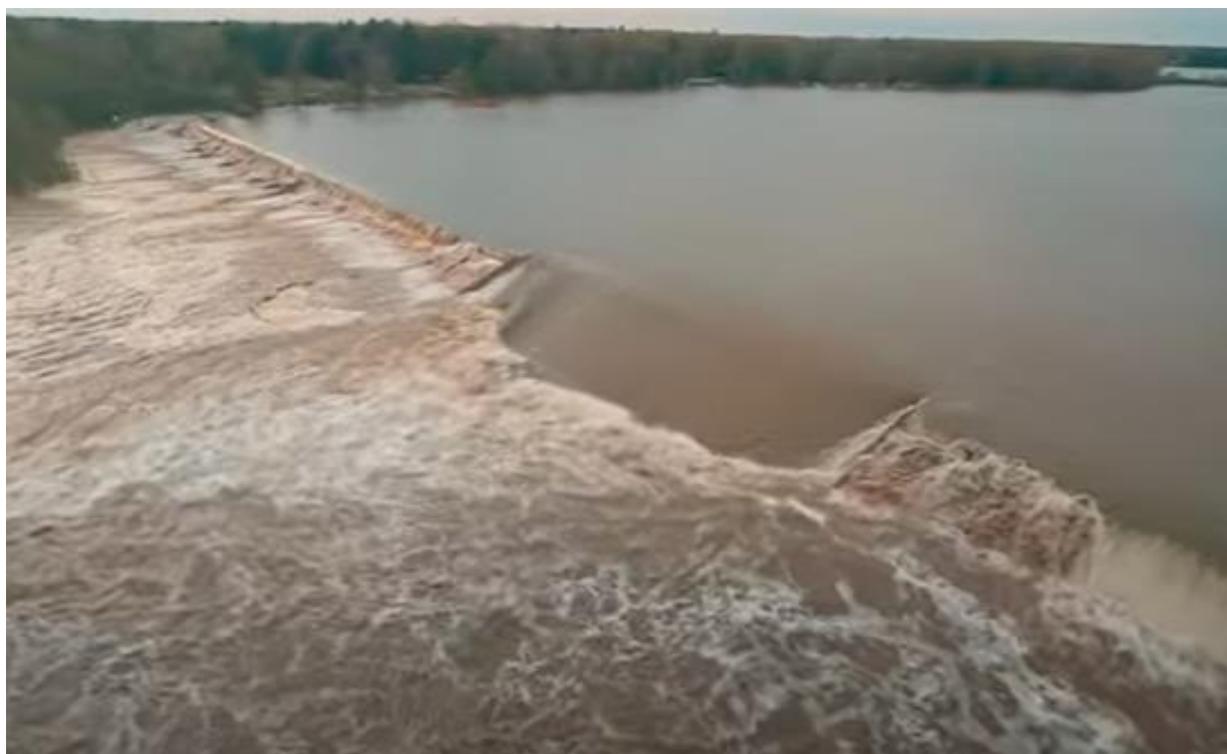
Figure 3-24: Still Image from Drone Video at Approximately 8:11 P.M. (Note almost complete washout of fuse plug and entire embankment being overtopped.)

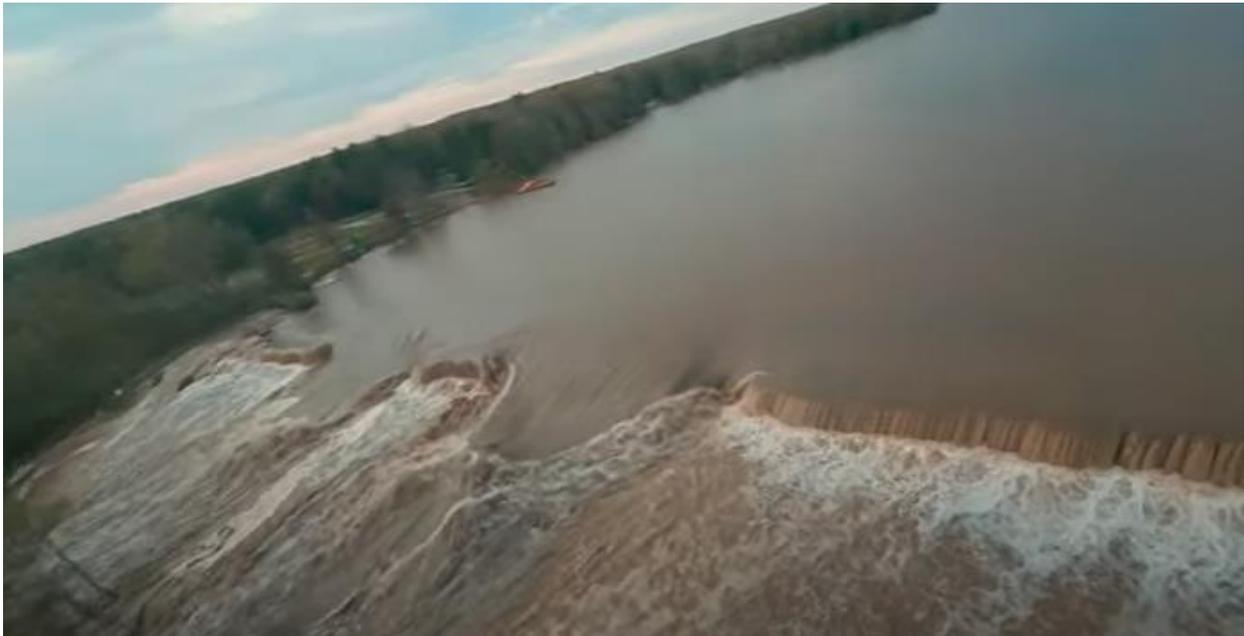
Figure 3-25: Still Image from Drone Video at Approximately 8:20 P.M. with Breach Beginning along Sections of Right Embankment.

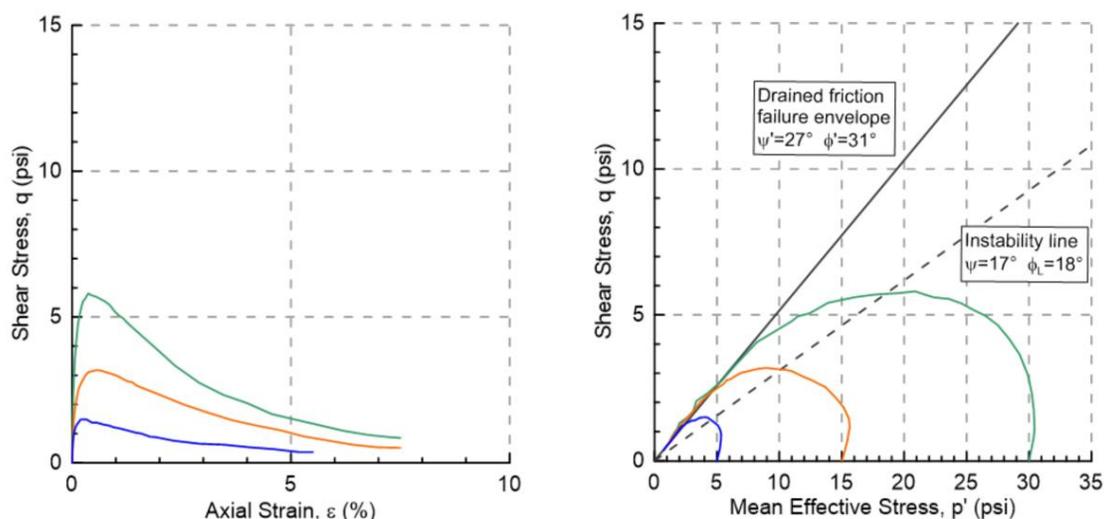
Laboratory tests on specimens from a bulk uniform fine sand sample collected from the left breach face show dramatic brittle, strain-weakening collapse behavior when the sand is loose. Figure 4 shows the results of undrained triaxial strength tests on three specimens of the sand compacted to 30 percent relative density, to represent a loose state, and consolidated to different confining pressures. The left side of the

figure shows stress-strain curves for the three specimens. All three curves show brittle stress-strain behavior like that shown in Figure 4. The right side of Figure 4 shows stress paths for the three specimens. All three specimens show peak undrained shear strengths at stress states well below the drained frictional envelope of 31 degrees, followed by large increases in pore water pressure and dramatic decreases in strength, similar to the behavior illustrated in Figure 4. Consequently, these test results show that a sand sample taken from the left embankment, when it is loose, exhibits the stress-strain characteristics necessary for static liquefaction.

Figure 4-4: Laboratory Undrained Triaxial Test Results for Edenville Dam Uniform Fine Sand Sample at 30 Percent Relative Density¹⁶

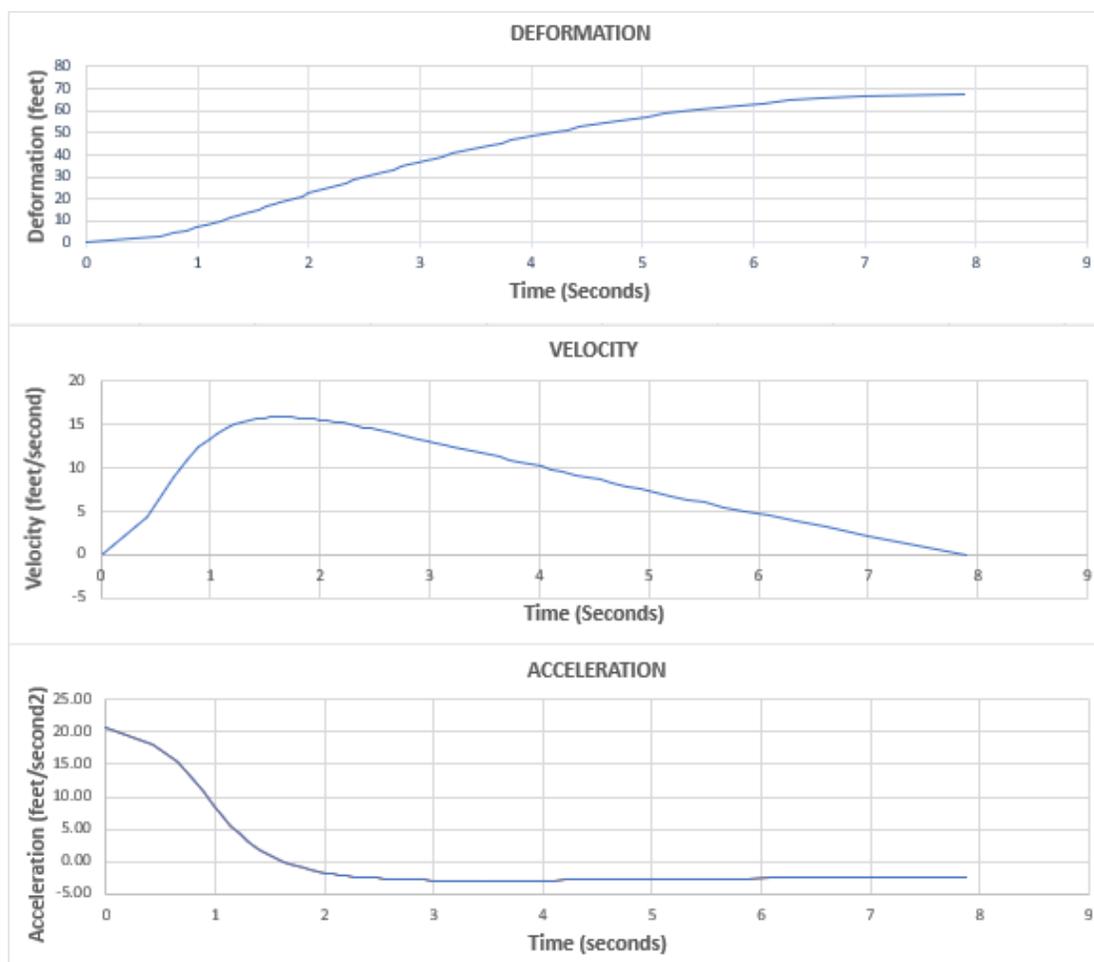
The IFT also completed a kinetic analysis of a possible static liquefaction failure scenario for the Edenville left embankment, using the simplified procedure originally proposed by Davis et al. (1988). This procedure consists of calculating accelerations, velocities, and deformations for a potential failure mass within the embankment. A travel path for the center of gravity of the mass is assumed, and the initial acceleration is based on the force imbalance created by the reduction of strength to the steady-state or residual strength. The changes in accelerations, velocities, and deformations are calculated incrementally in time steps. The results are shown in Figure 4 as plots of deformation, velocity, and acceleration versus time. An ASCE investigation team completed pixel tracing analysis on the failure video and concluded that the failure mass reached a velocity of about 5 meters per second, or 16.4 feet per second (ft/sec) (ASCE 2021), which is reasonably close to the 15.8 ft/sec resulting from the simplified kinetic analysis. In addition, the displacement time of about 7.9 seconds from the kinetic analysis is similar to the failure time interpreted from the dam failure video. Consequently, the results of the kinetic analysis support the plausibility of a static liquefaction failure.

Figure 4-5: Results of Kinetic Calculations for Possible Static Liquefaction Failure of Edenville Left Embankment

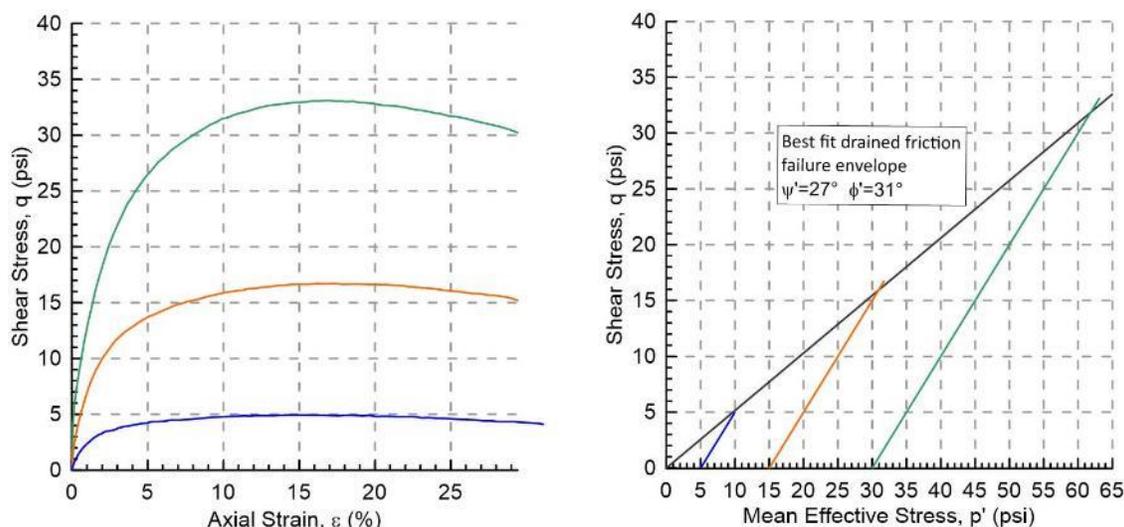
However, a failure of this type is not consistent with the kinetics of the observed behavior. Drained triaxial strength tests were completed on specimens from the bulk sample used for the undrained strength tests presented in Figure 4. These specimens were also prepared at 30 percent relative density and consolidated to three different confining stresses. The results are shown in Figure 4. The stress-strain curves, on the left side of Figure 4, do not exhibit brittle, strain-weakening behavior, but rather show ductile behavior, with little or no decrease in strength from the peak strength. Without brittle, strain-weakening behavior, it is not possible to create the force imbalance needed to generate the observed accelerations and velocities during the failure. No evidence was found indicating that any other materials in this embankment would have brittle, strain-weakening stress-strain behavior.

Therefore, if the soils behaved in a drained manner, with ductile stress-strain behavior, it would be expected that the instability failure would be progressive—a rise in pore water pressure dropping the factor of safety below 1.0 and causing enough deformation to restore stability, followed by further rise in pore water pressure causing further slumping, with this process continuing and ultimately leading to enough deformation to cause failure through overtopping or internal erosion. The observed characteristics of the failure are not consistent with this mechanism, and the IFT judged this mechanism to be implausible as the primary cause of the failure.

Figure 4-6: Laboratory Drained Triaxial Test Results for Edenville Dam Uniform Fine Sand Sample at 30 Percent Relative Density

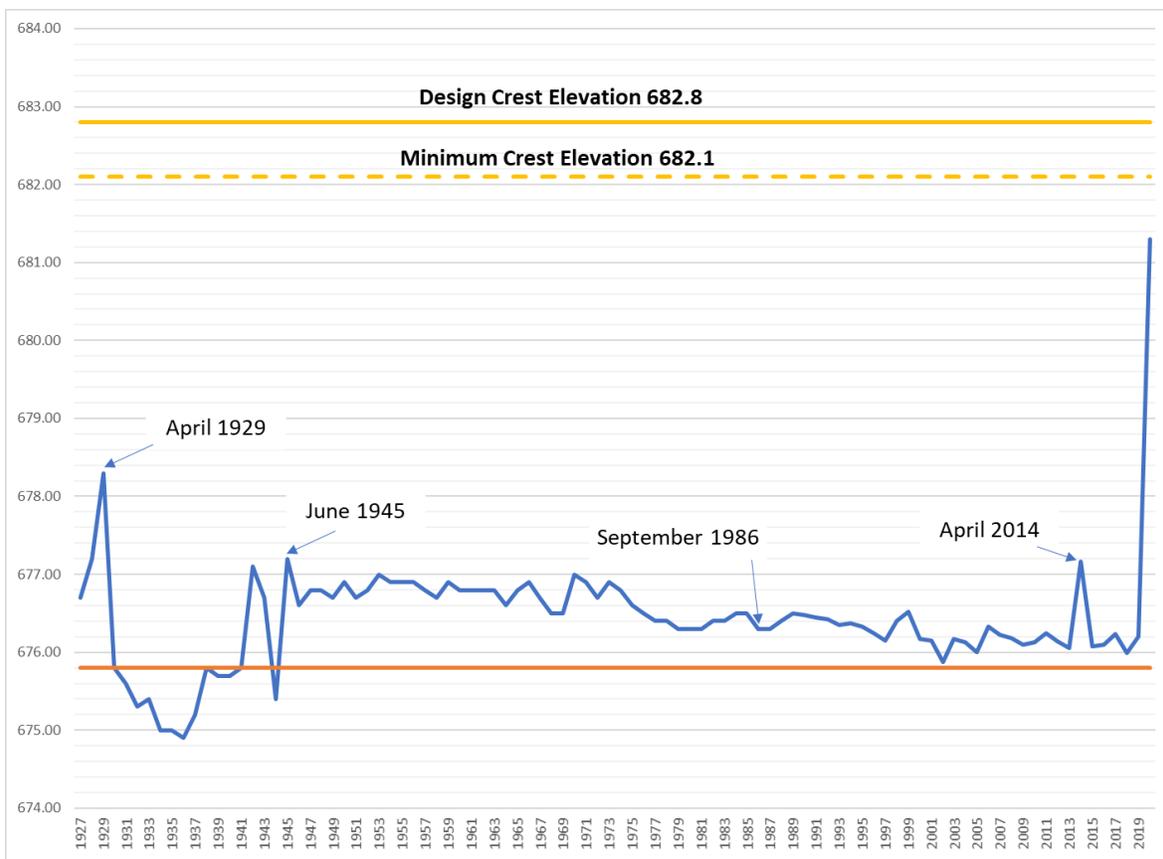
Available lake level records indicate that over a period of almost a century, Wixom Lake rarely rose significantly above the FERC-established normal lake level of El. 675.8, even prior to FERC regulation, as shown in Figure 5. In fact, there were only 4 years when the lake rose 1.4 feet or more above El. 675.8 – in 1928, 1929, and 1945, and during the failure in 2020. In 2014, the lake level rose by 1.36 feet, just short of 1.4 feet. There were 22 years when the lake rose more than 1 foot and less than 1.4 feet; however, all of those years except one (2014) were before the implementation of the FERC lake level requirements. As can be seen in Figure 5 maximum yearly lake levels were generally slightly higher before 1975 than since that time, likely reflecting in part the less restrictive lake operations.

Figure 5-1: Annual Maximum Wixom Lake Levels 1927 through 2020

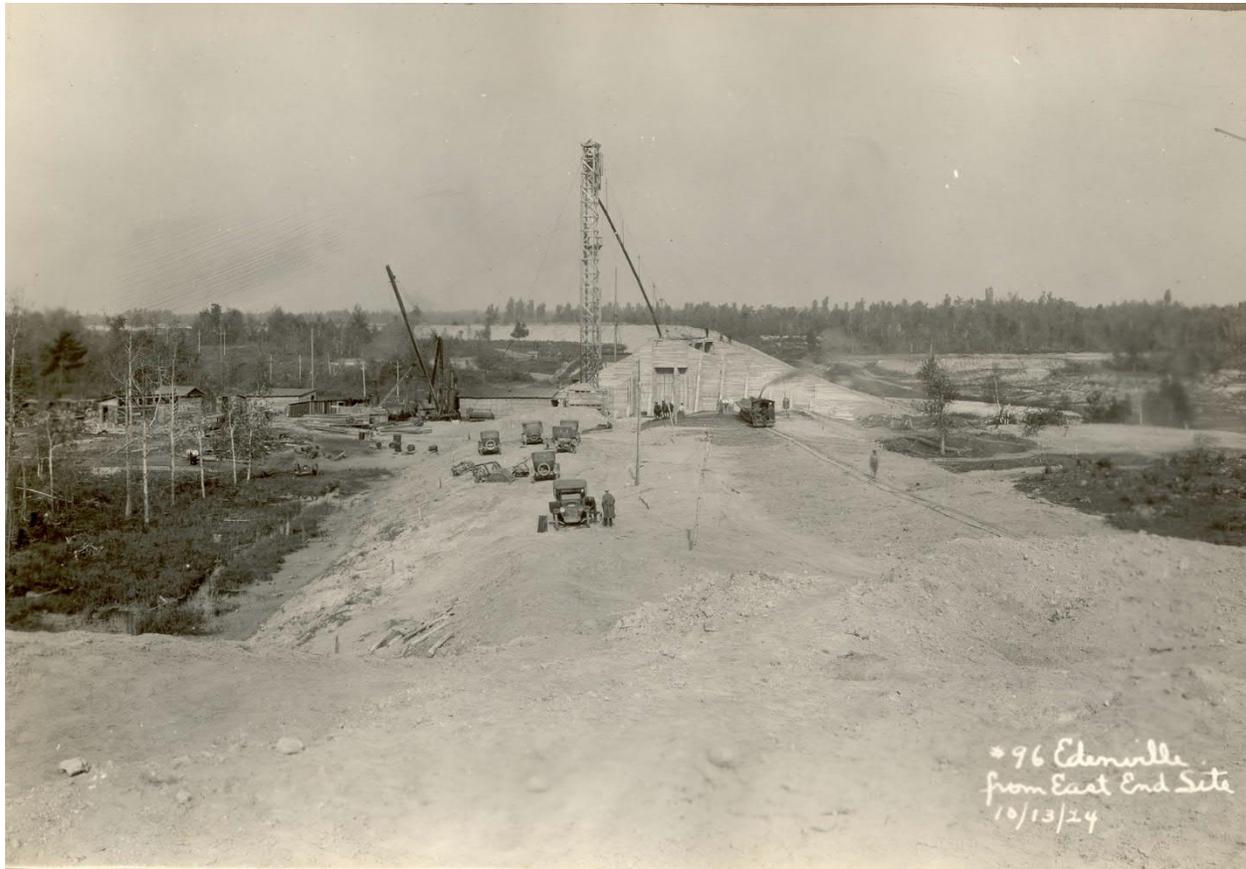
Fill placed in Edenville east (left) embankment. Note the apparent color variation between upstream and downstream areas of the embankment. (October 1924)

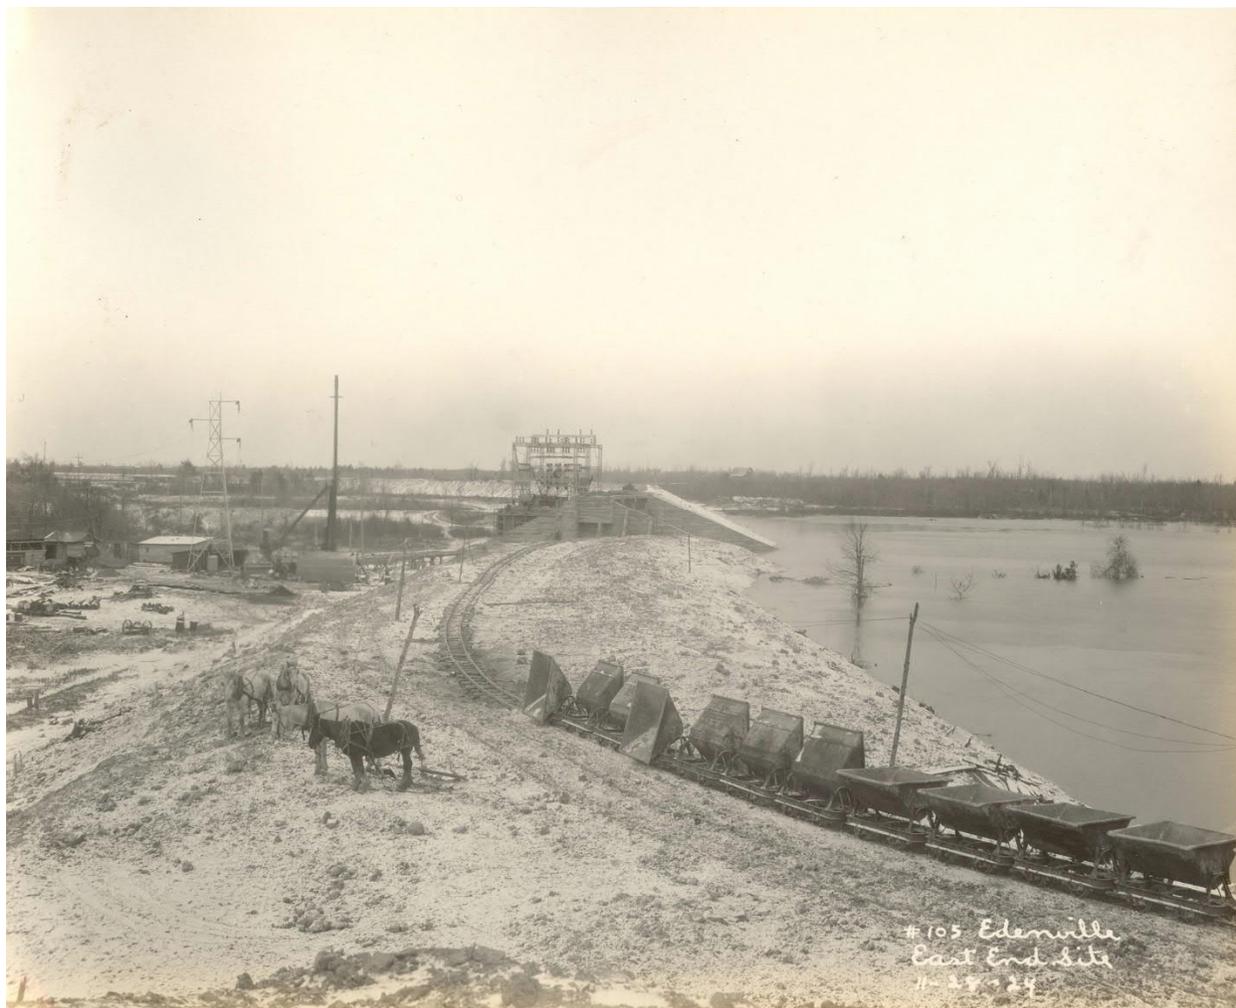
Fill placed in Edenville east (left) embankment. Note material previously stockpiled in the background is no longer visibly present. Note cold-weather fill placement on snow-covered ground. Note rising lake level in comparison to earlier photo. (November 1924)

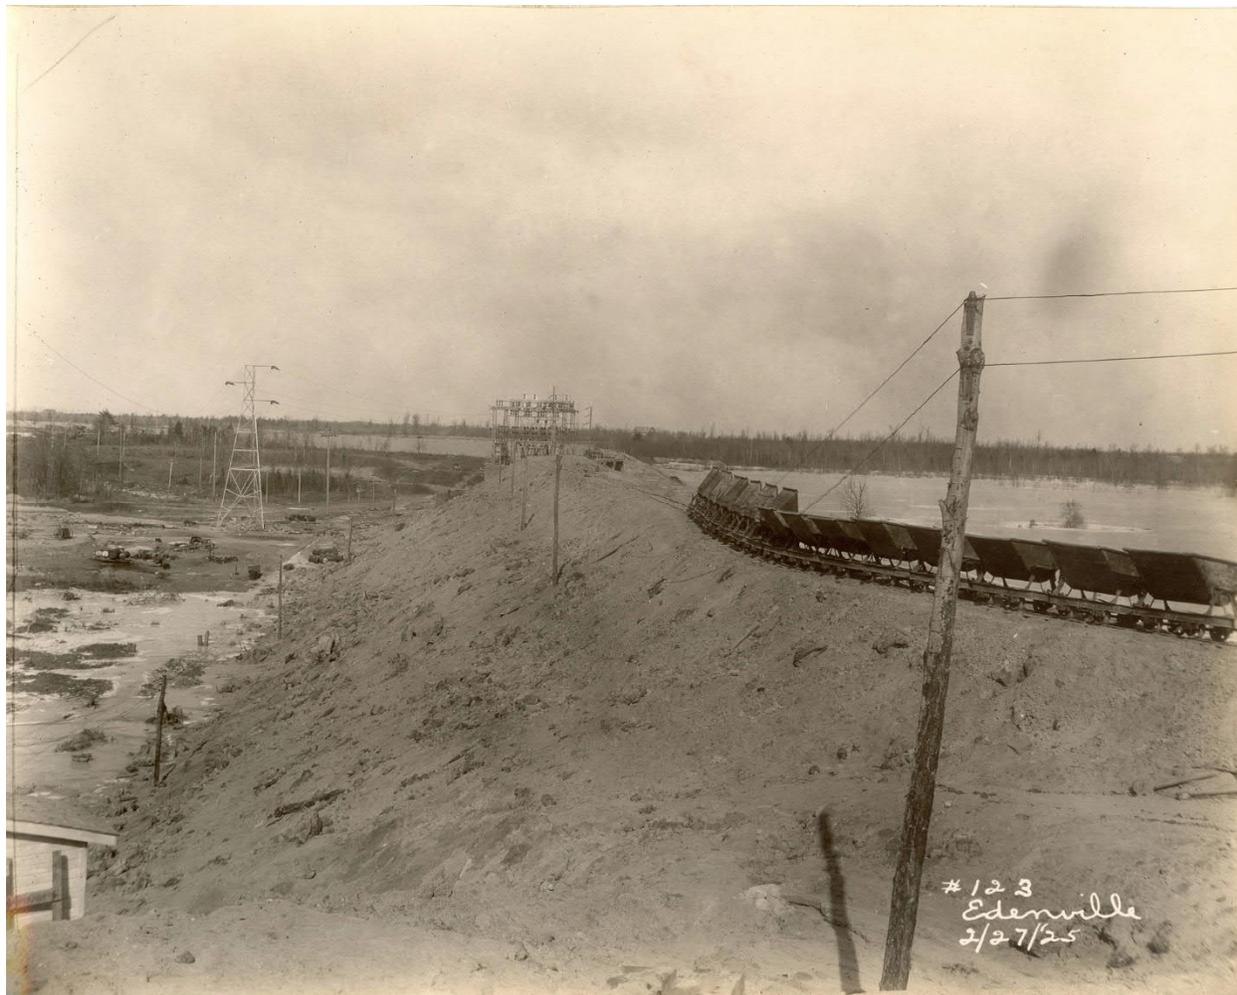
Fill placed in Edenville east (left) embankment near top-out elevation. Note what appears to be a slightly steeper slope near the top elevation. Note lake level in right background of photo. Note water along downstream toe (later construction memos [April 1925] will note that the downstream toe of this embankment is dry). (February 1925)
