INVESTIGATION OF FAILURES OF EDENVILLE AND SANFORD DAMS

Independent Forensic Team

FINAL REPORT

Investigation of Failures of Edenville and Sanford Dams

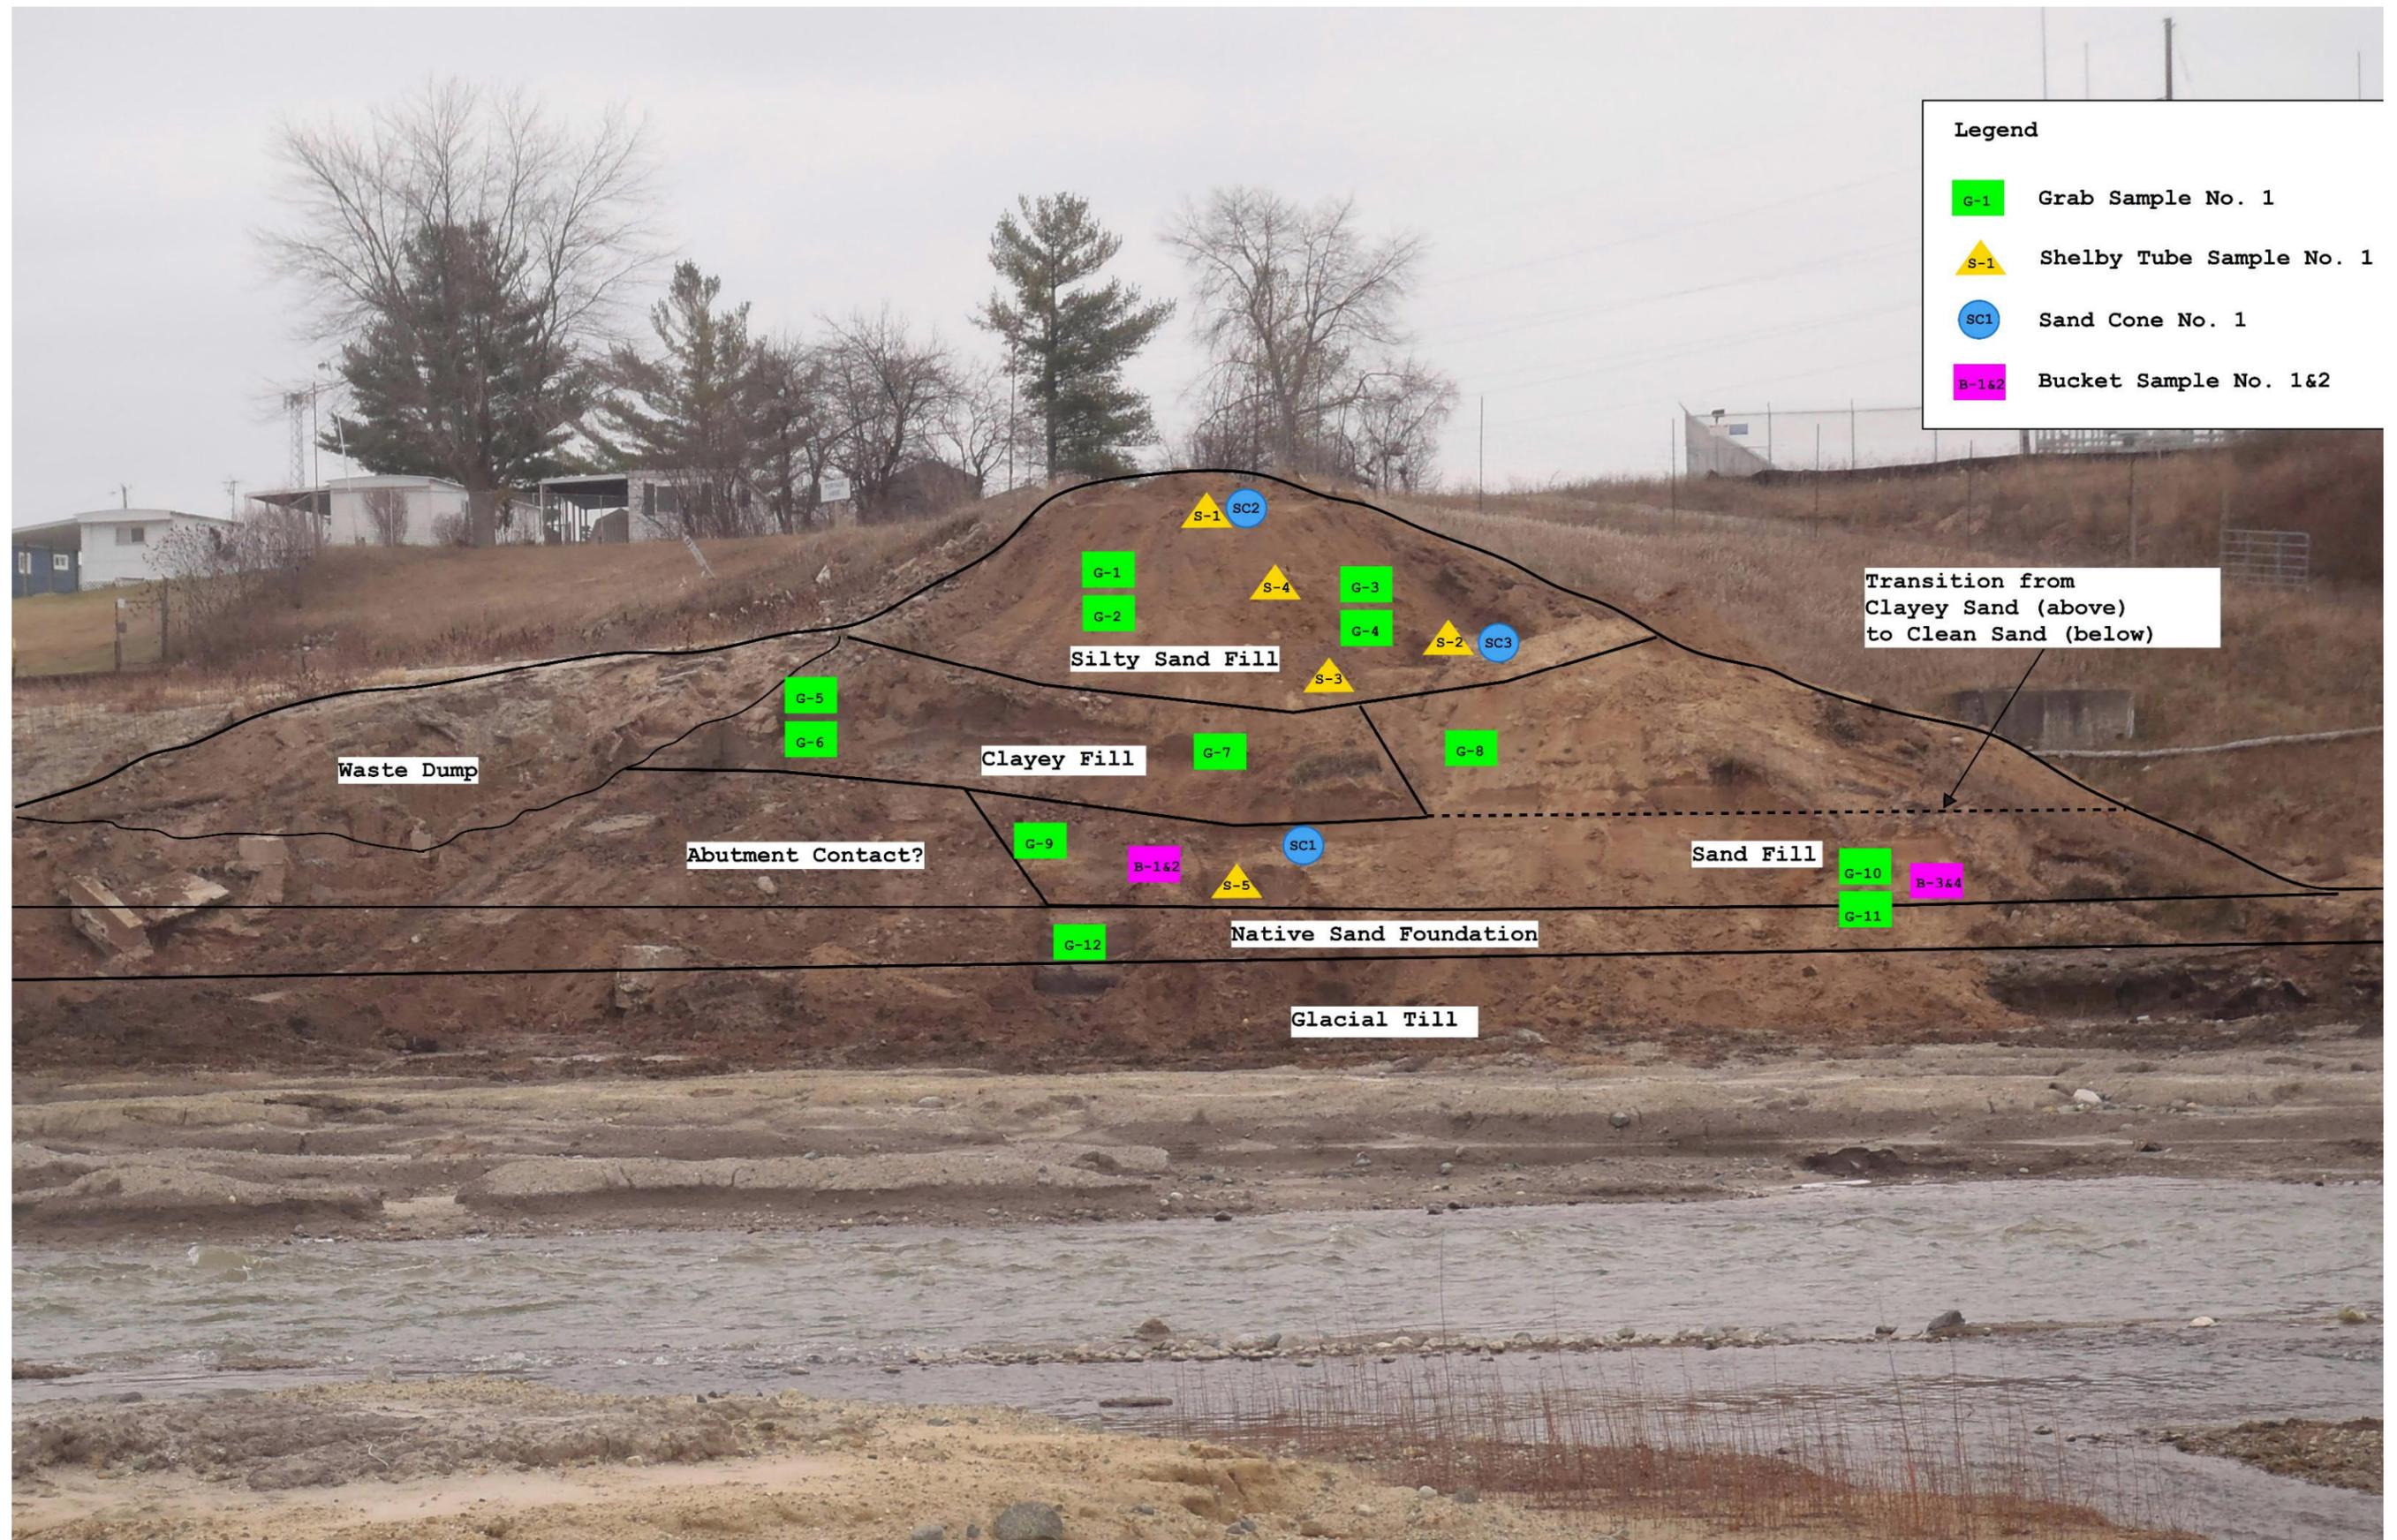
Figure E-8: Left Breach Remnant Sample Location

Based on the findings of the field investigation, it is apparent that the internal cross section was not consistent along the length of the Edenville left embankment. The IFT reviewed the logs of the borings completed in 2005 and 2010 near the breach location, which included layers of silty sand and silt, clay, native sand, and glacial till (hardpan). The IFT found the left breach remnant to be similar to the borings. The boring logs did not appear consistent with the mapped right breach remnant, which was primarily clay fill. Therefore, the IFT focused the laboratory investigation on the samples from the left breach remnant. The locations of samples obtained from the left breach remnant are shown in Figure E-8.

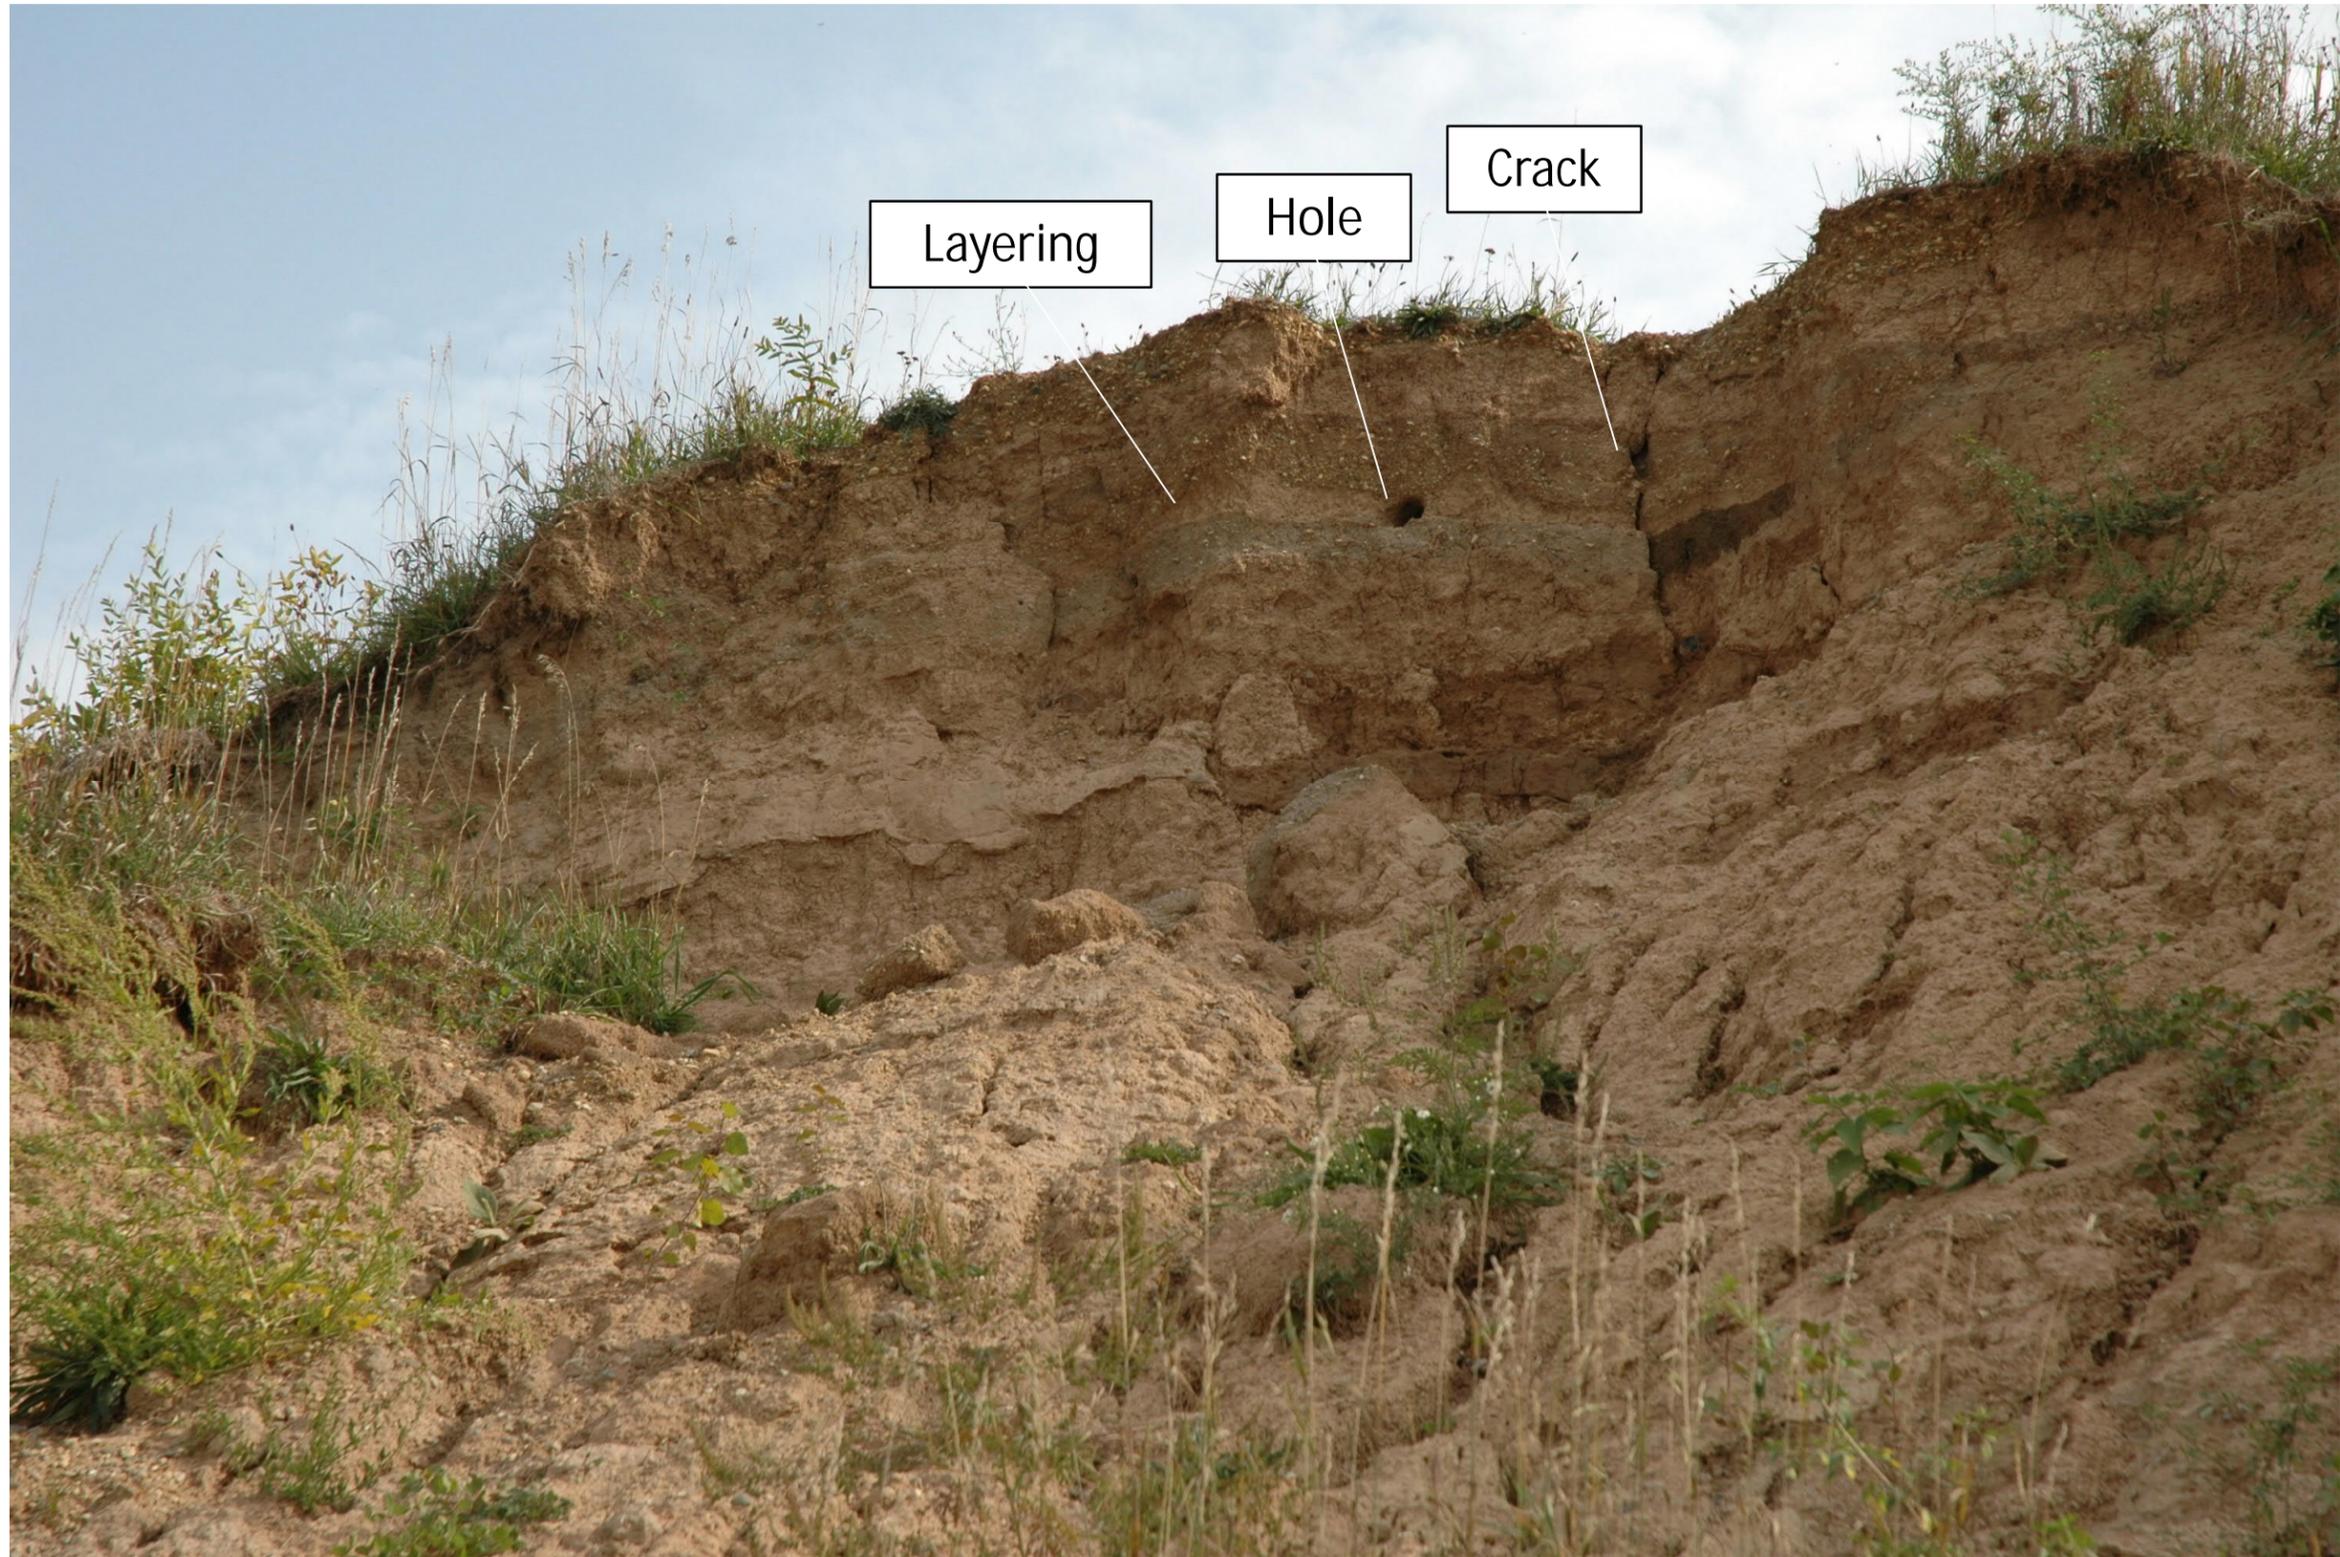
- Exhibit E-2 shows the embankment fill variability and layering at the crest of the left breach remnant. The source of the hole visible near the crest is uncertain and may be a result of previous sampling by others or animal activity. The cause of the cracking visible near the embankment crest is also uncertain. It is postulated that the cracking occurred during or after the breach, as there were no observations of cracking exposed at the crest in earlier inspections. Some layers exhibited higher moisture content and appeared wetter than others.

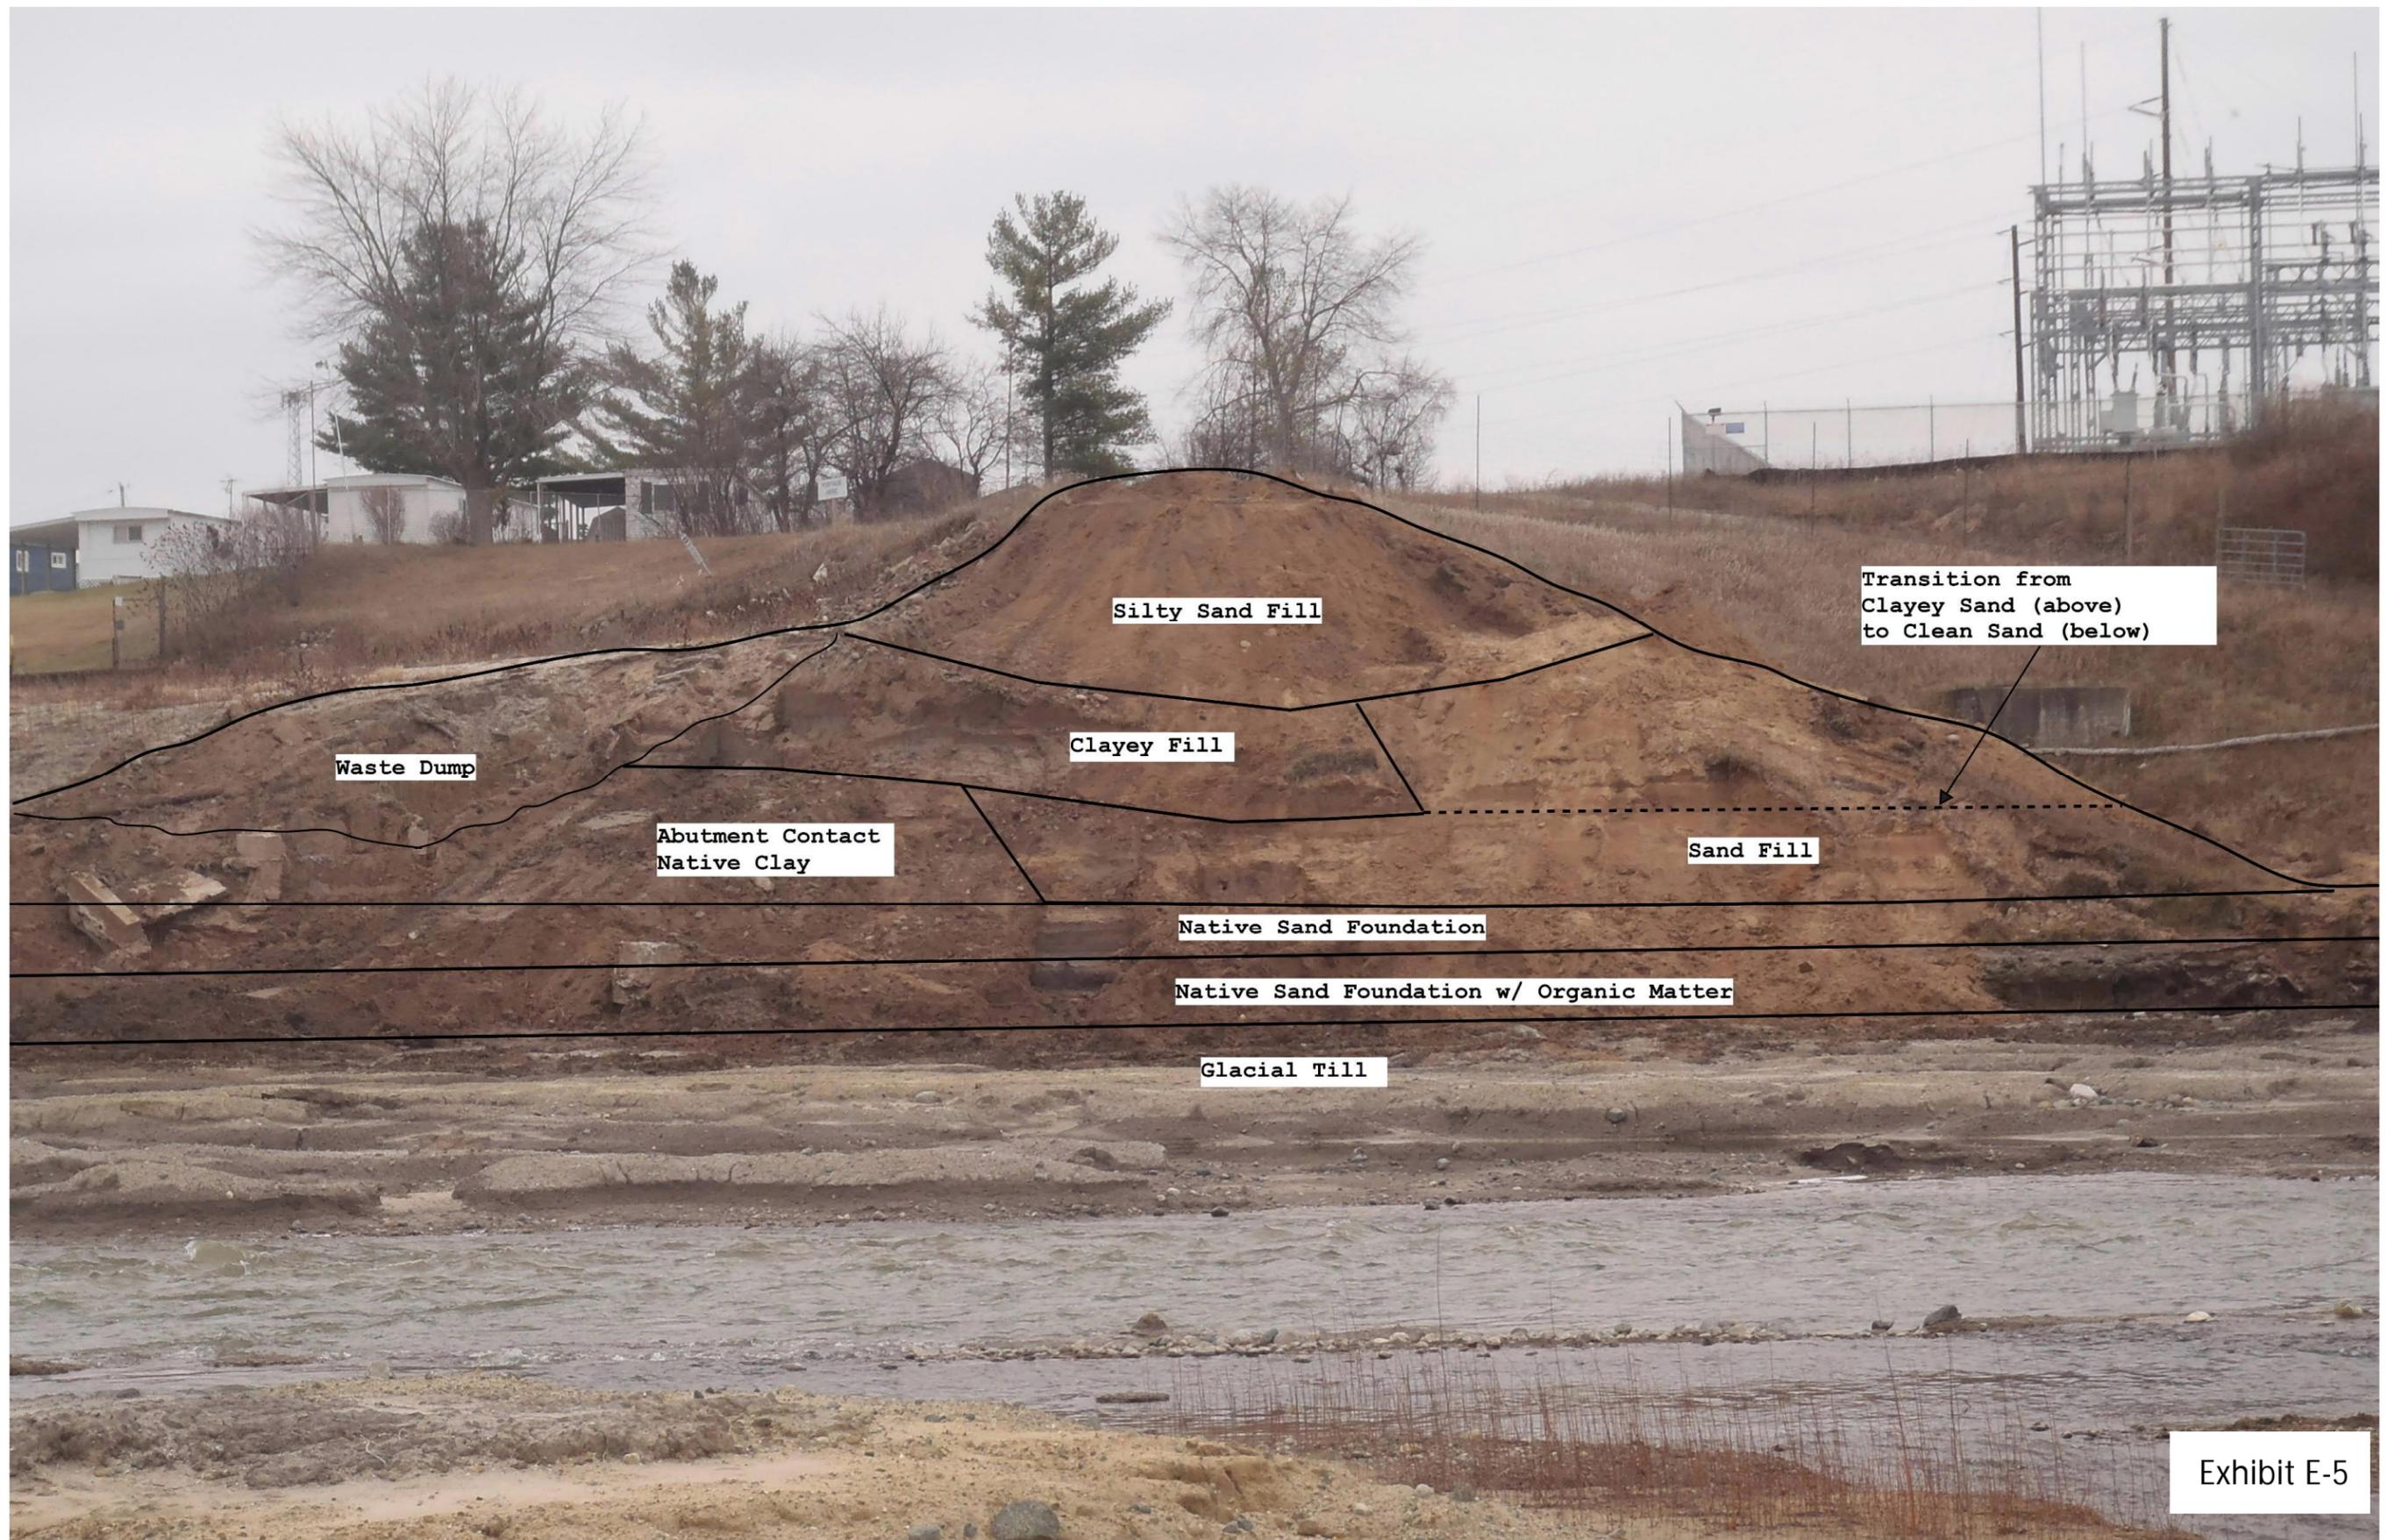
- Exhibit E-5 shows a view of the entire left breach remnant, with approximate material boundaries identified by the IFT.
- The upper 15 feet of the embankment, near the crest, consists of a silty sand fill, and is shown on Exhibits E-6 to E-7. The fill was found to be quite heterogeneous, with visible pockets of silts and sands as well as some clay nodules. In general, the fill consisted of light brown, moist, loose, fine to medium silty sand fill with occasional clay nodules (USCS classification SM). There was no apparent difference in the upstream versus downstream fill.

Silty Sand Fill

Transition from Clayey Sand (above) to Clean Sand (below)

Native Sand Foundation

Glacial Till

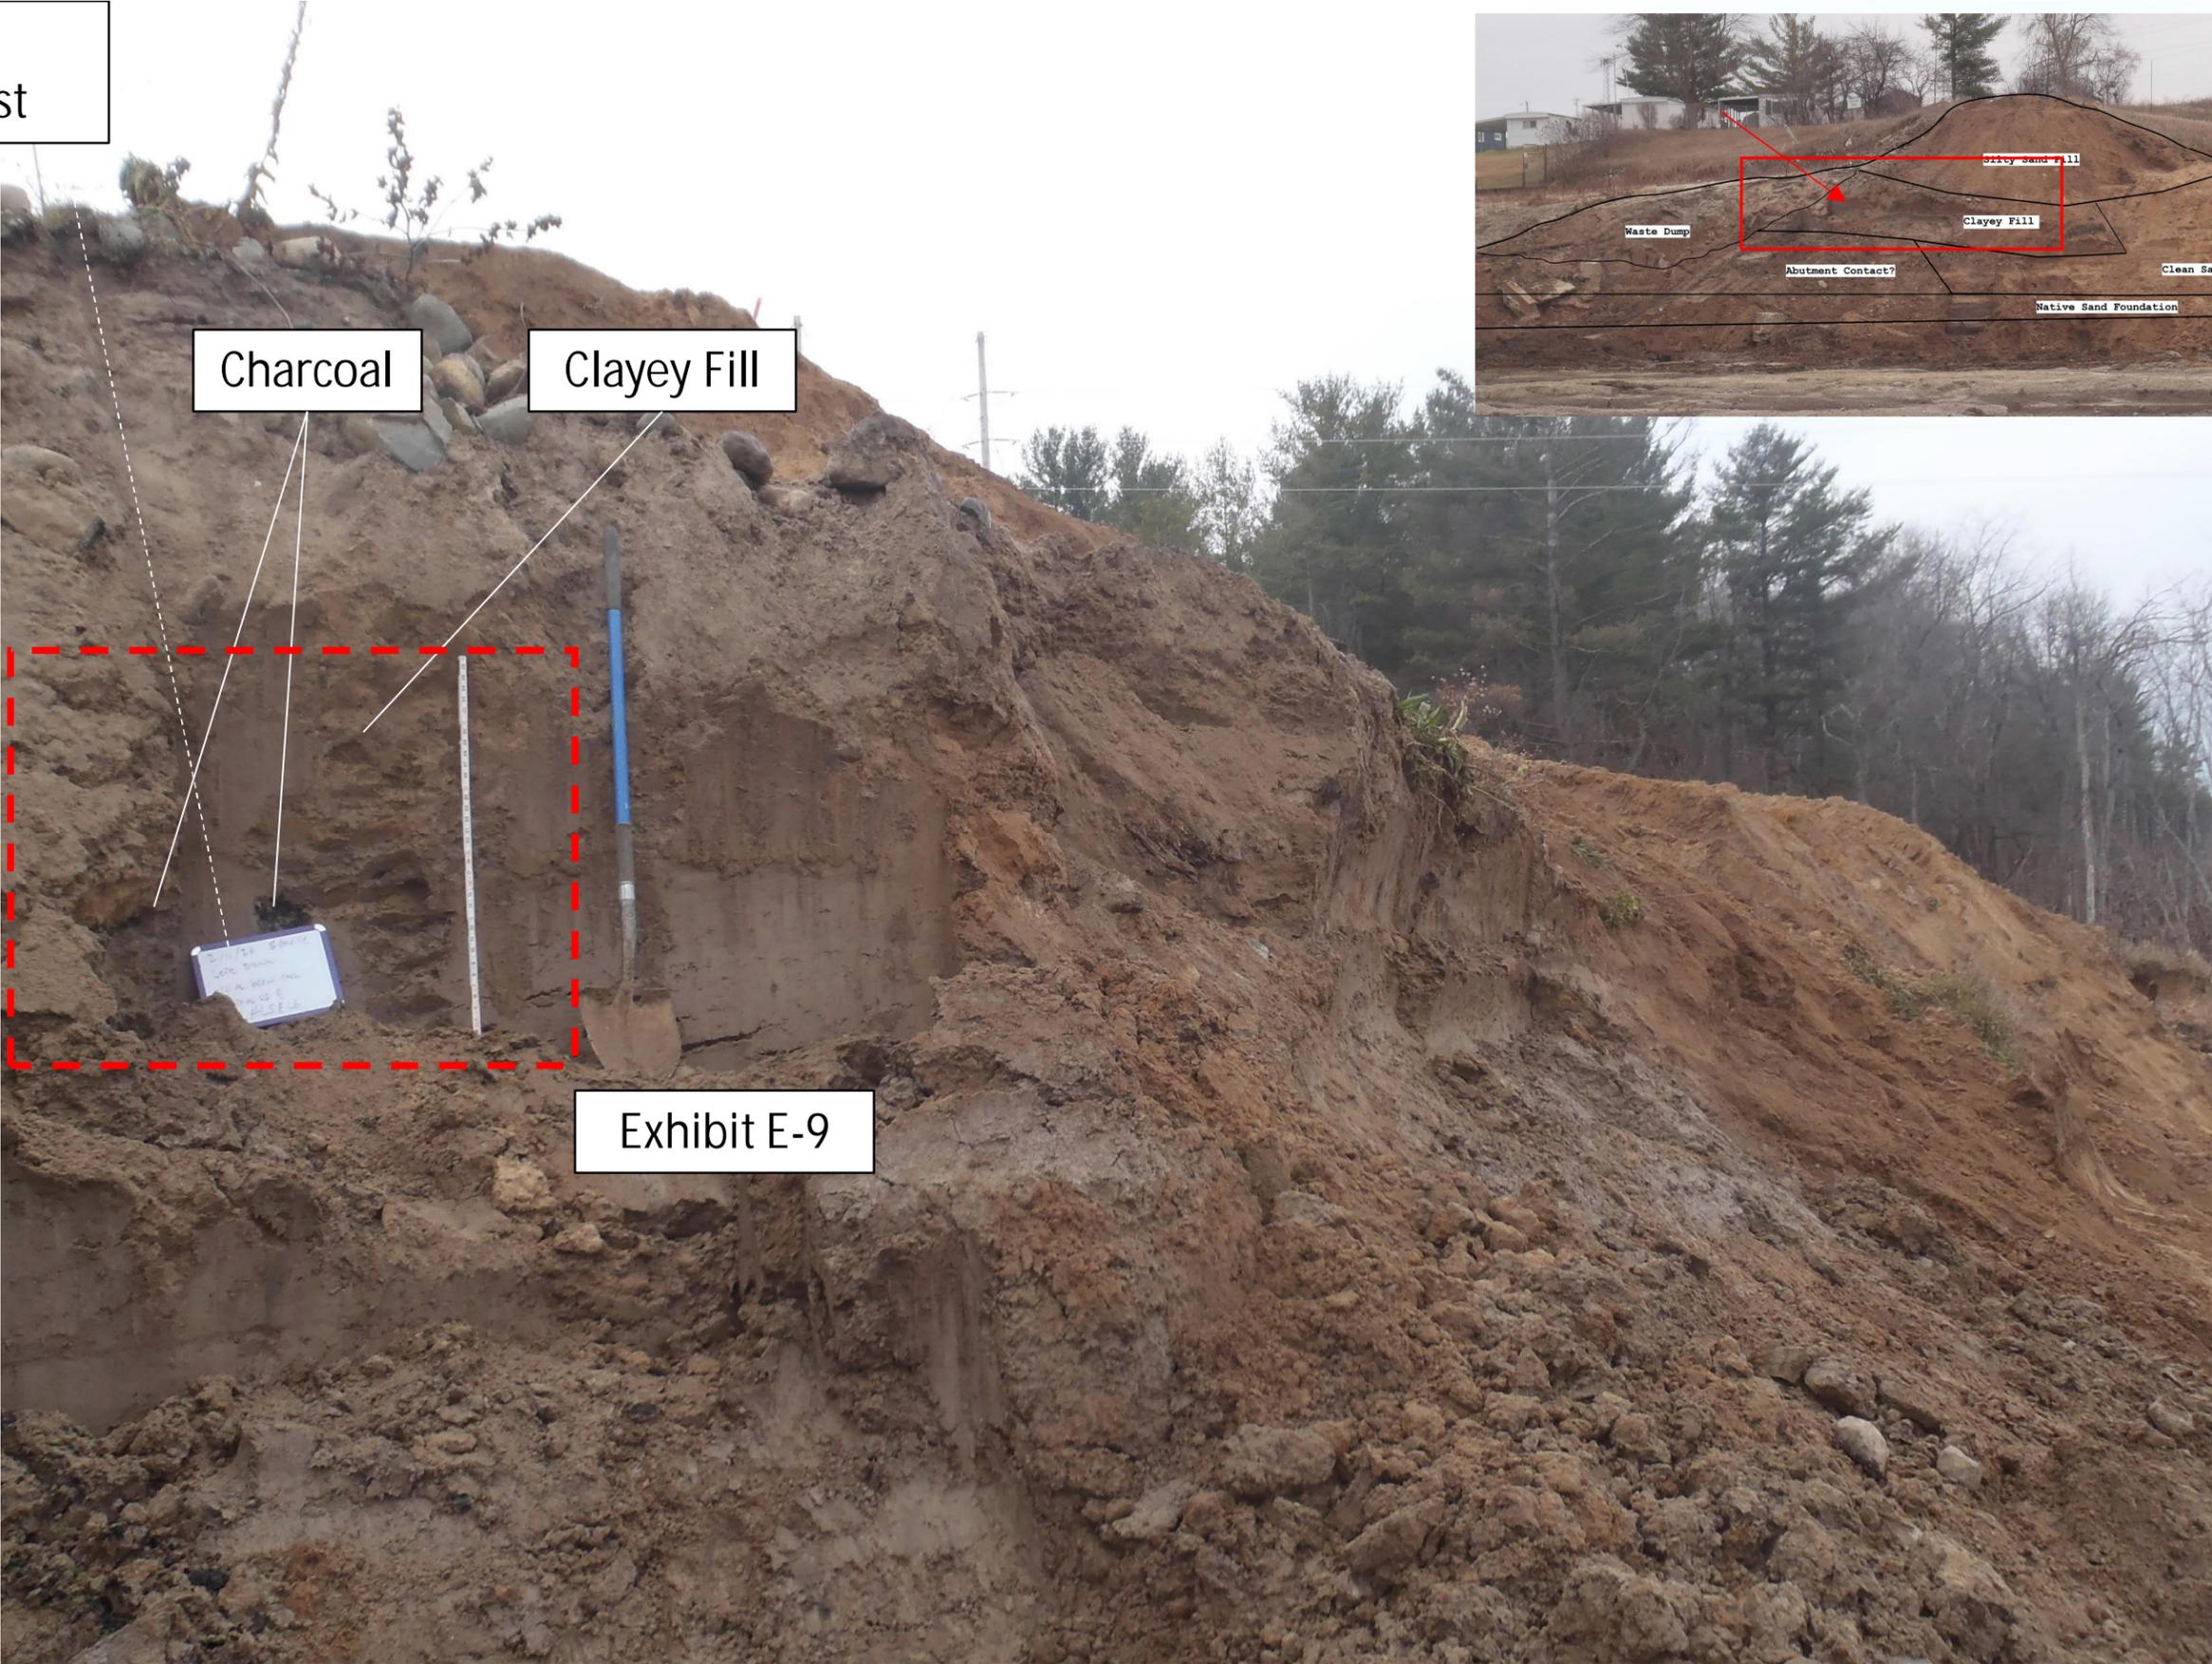
Exhibit E-9

- The upstream section of the lower part of the embankment consists of a clayey fill underlain by a native clayey foundation material under the upstream slope, as shown in Exhibits E-8 to E-9. An approximately 3-foot-long layer of charcoal was observed, interpreted to delineate the fill (above) from the native abutment (below). The clayey fill generally consisted of brown and gray, moist, stiff, sandy clay with occasional gravel (USCS classification CL). The native clay abutment foundation generally consisted of gray, moist, stiff, lean clay (USCS classification CL). The clayey fill extended slightly downstream of the centerline, as shown in Exhibit E-5.

Charcoal

Clayey Fill

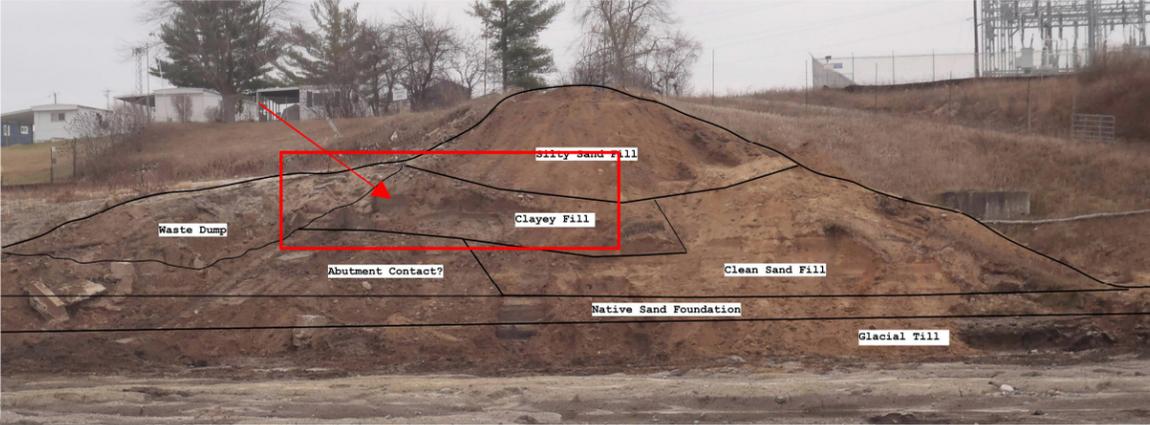
Exhibit E-8

Waste Dump

Silty sand fill

Glacial Till

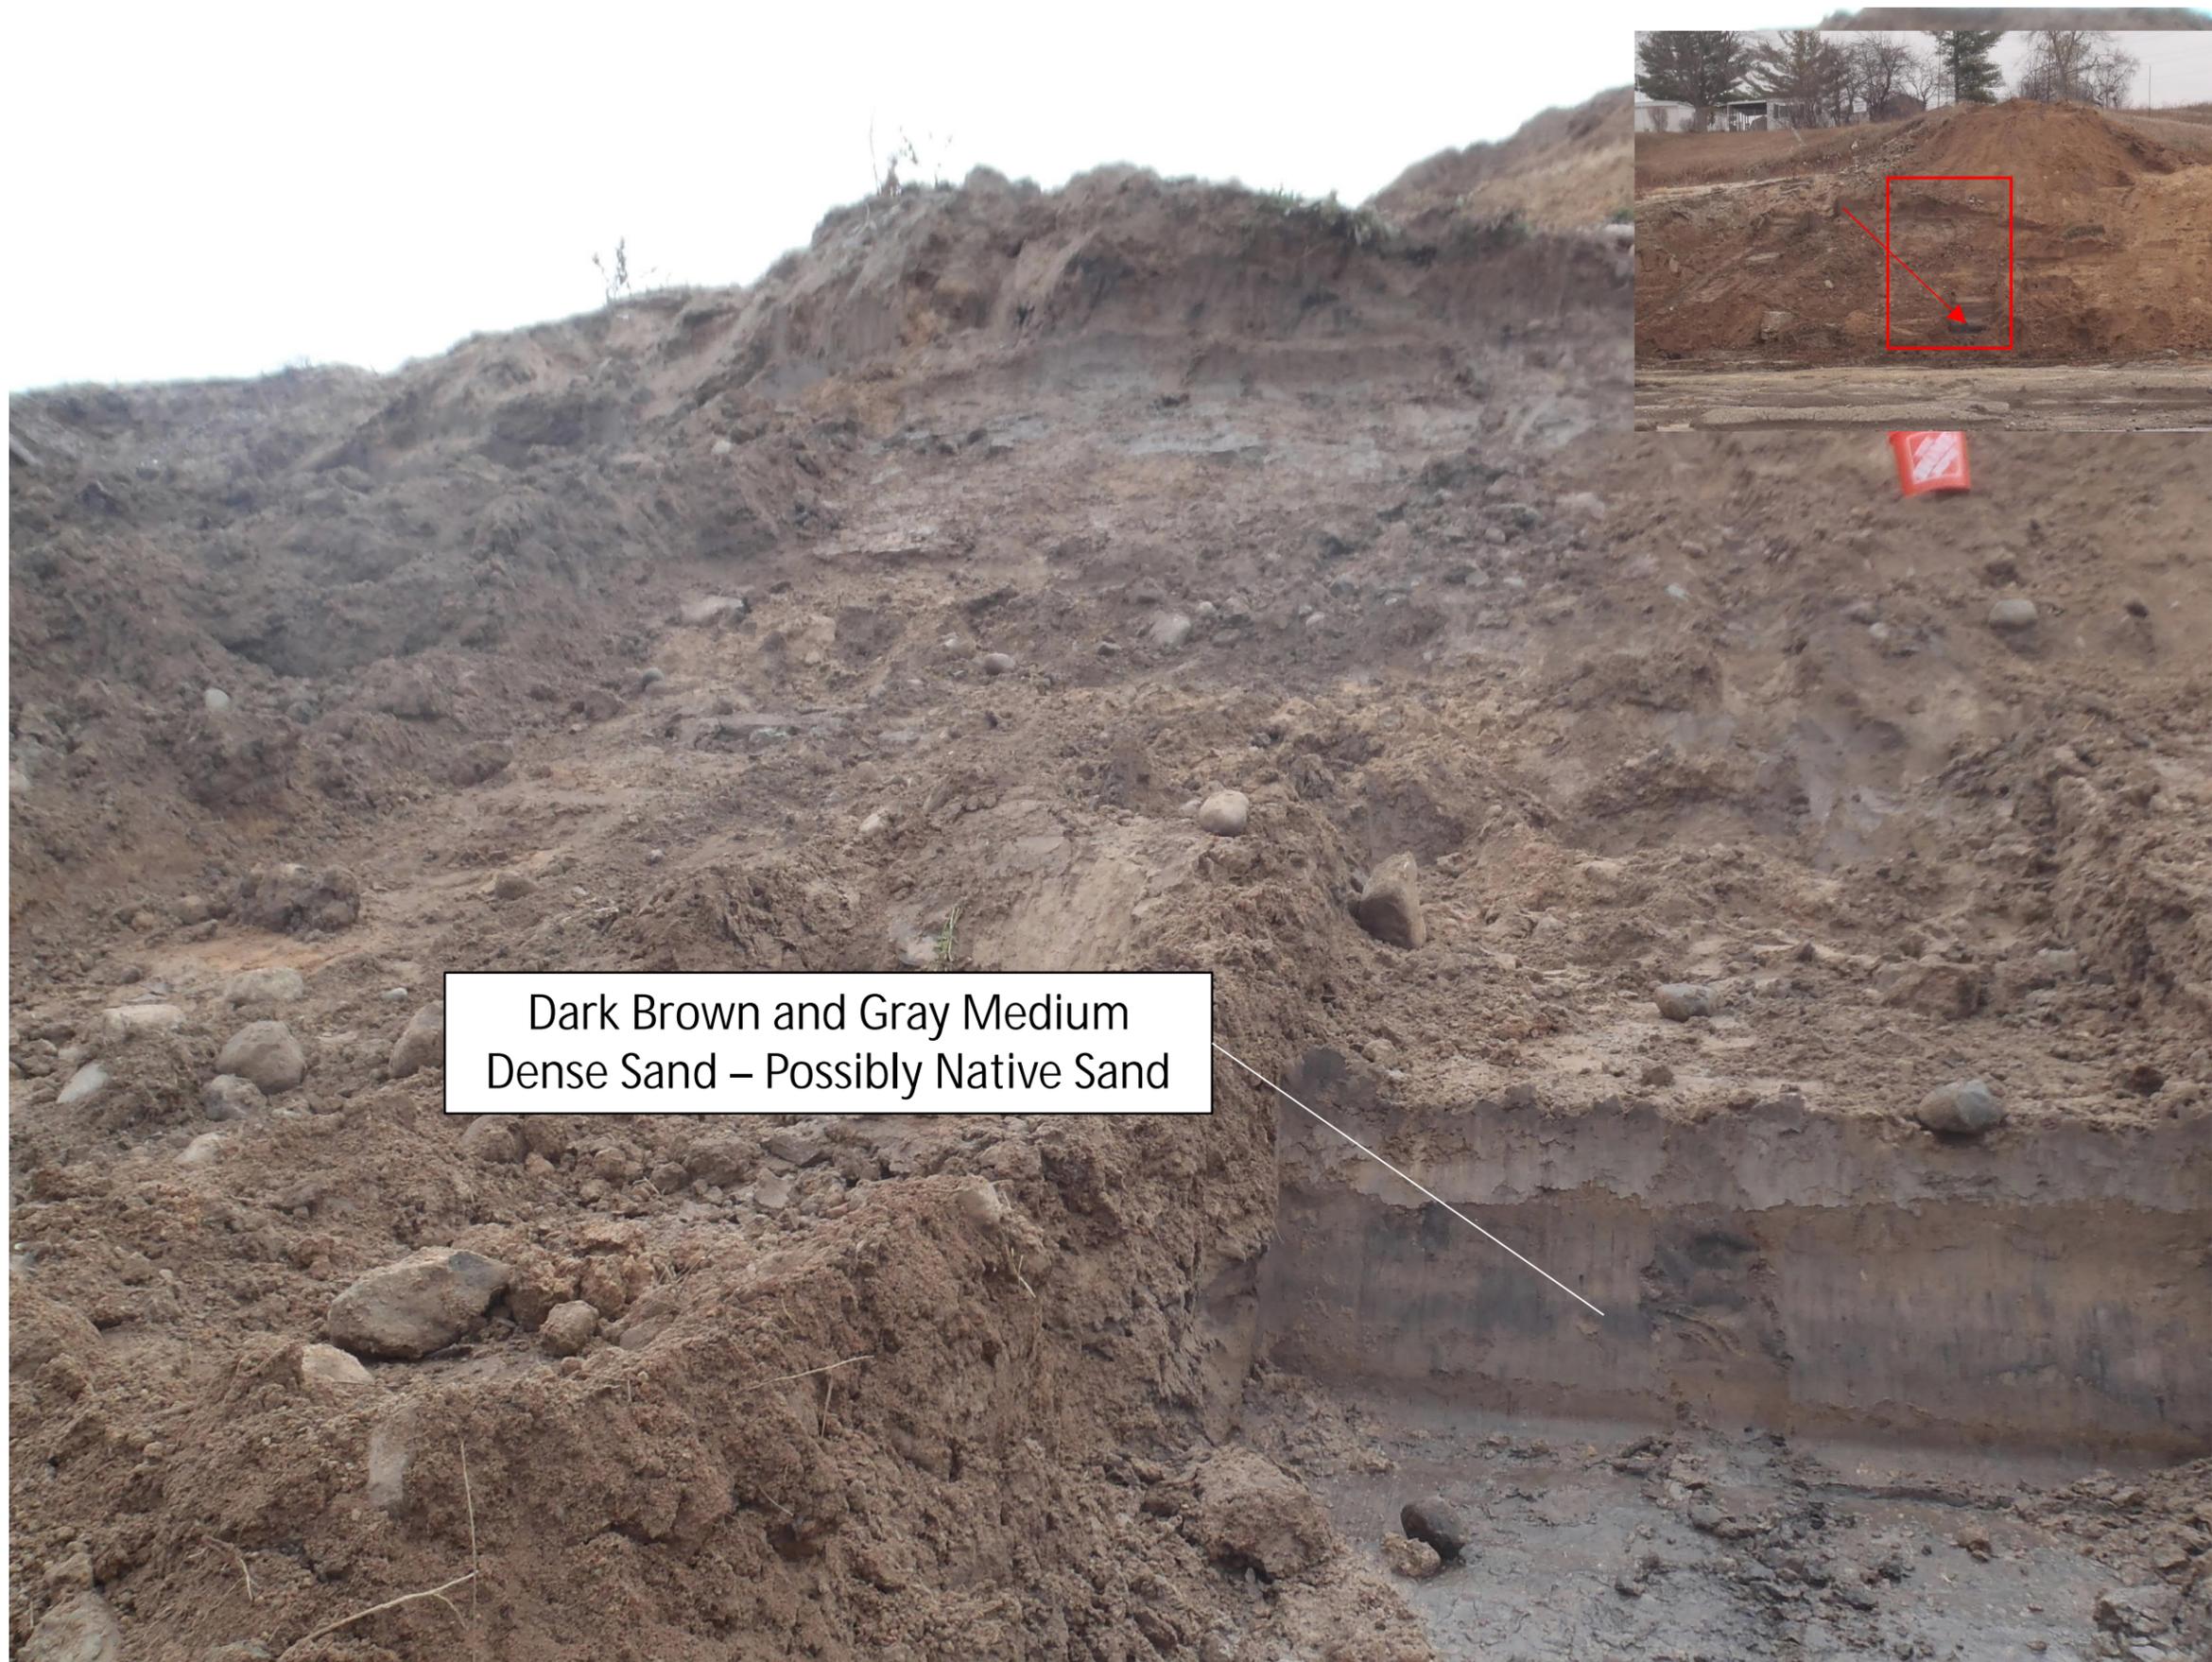
- A native sand layer was observed at the base of the embankment, which appeared to extend from upstream to downstream. The native sand foundation generally consisted of dark brown and gray, wet, medium dense to dense, sand with little silt (USCS classification SP-SM) and is shown in Exhibit E-16.

Dark Brown and Gray Medium
Dense Sand – Possibly Native Sand
