INVESTIGATION OF FAILURES OF EDENVILLE AND SANFORD DAMS

Independent Forensic Team

FINAL REPORT

Investigation of Failures of Edenville and Sanford Dams

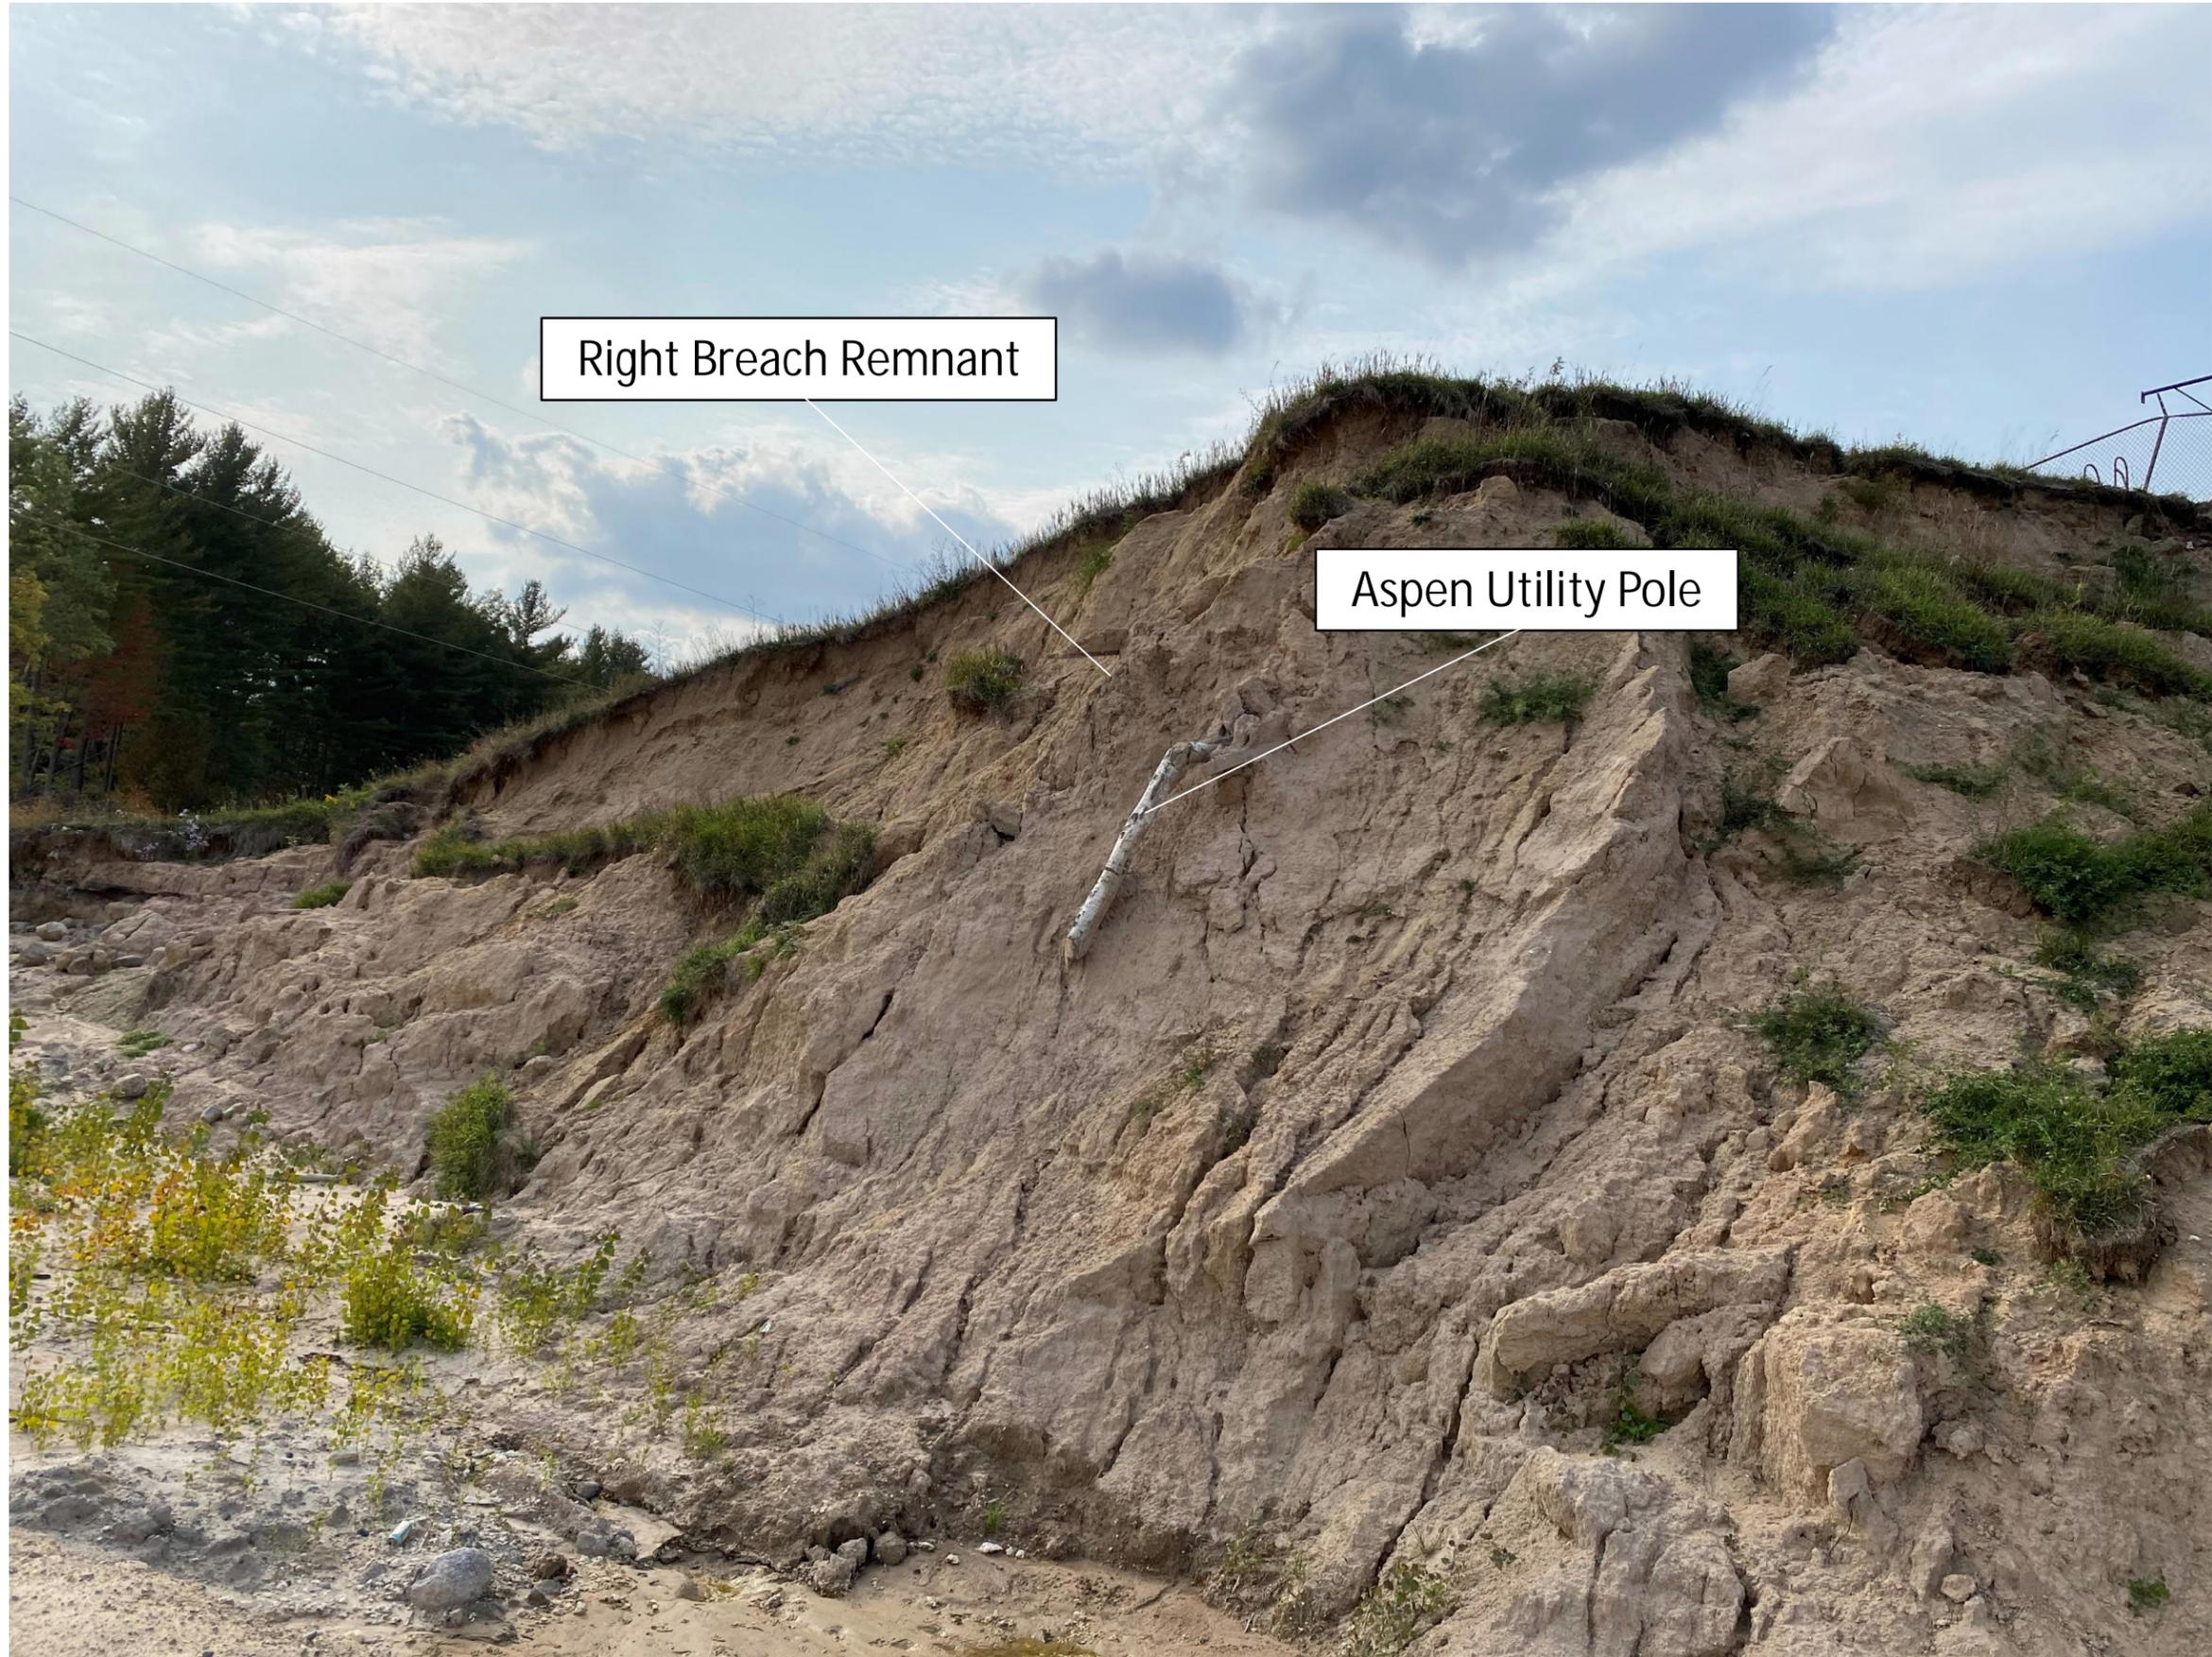
Right Breach Remnant

- Exhibit E-17 shows the right breach remnant, observed during the September 2020 site visit.
- Exhibit E-18 shows a view of the mapped right breach remnant with approximate material boundaries identified by the IFT. The right breach face consisted primarily of clay fill with a 5- to 8-foot-thick layer of sand fill on the outer slopes and crest. The clayey fill generally consisted of brown and gray, moist, stiff, sandy clay with occasional gravel (USCS classification CL) and is shown in Exhibit E-19. The silty sand fill generally consisted of a light brown, moist, loose, silty sand (USCS classification SM).

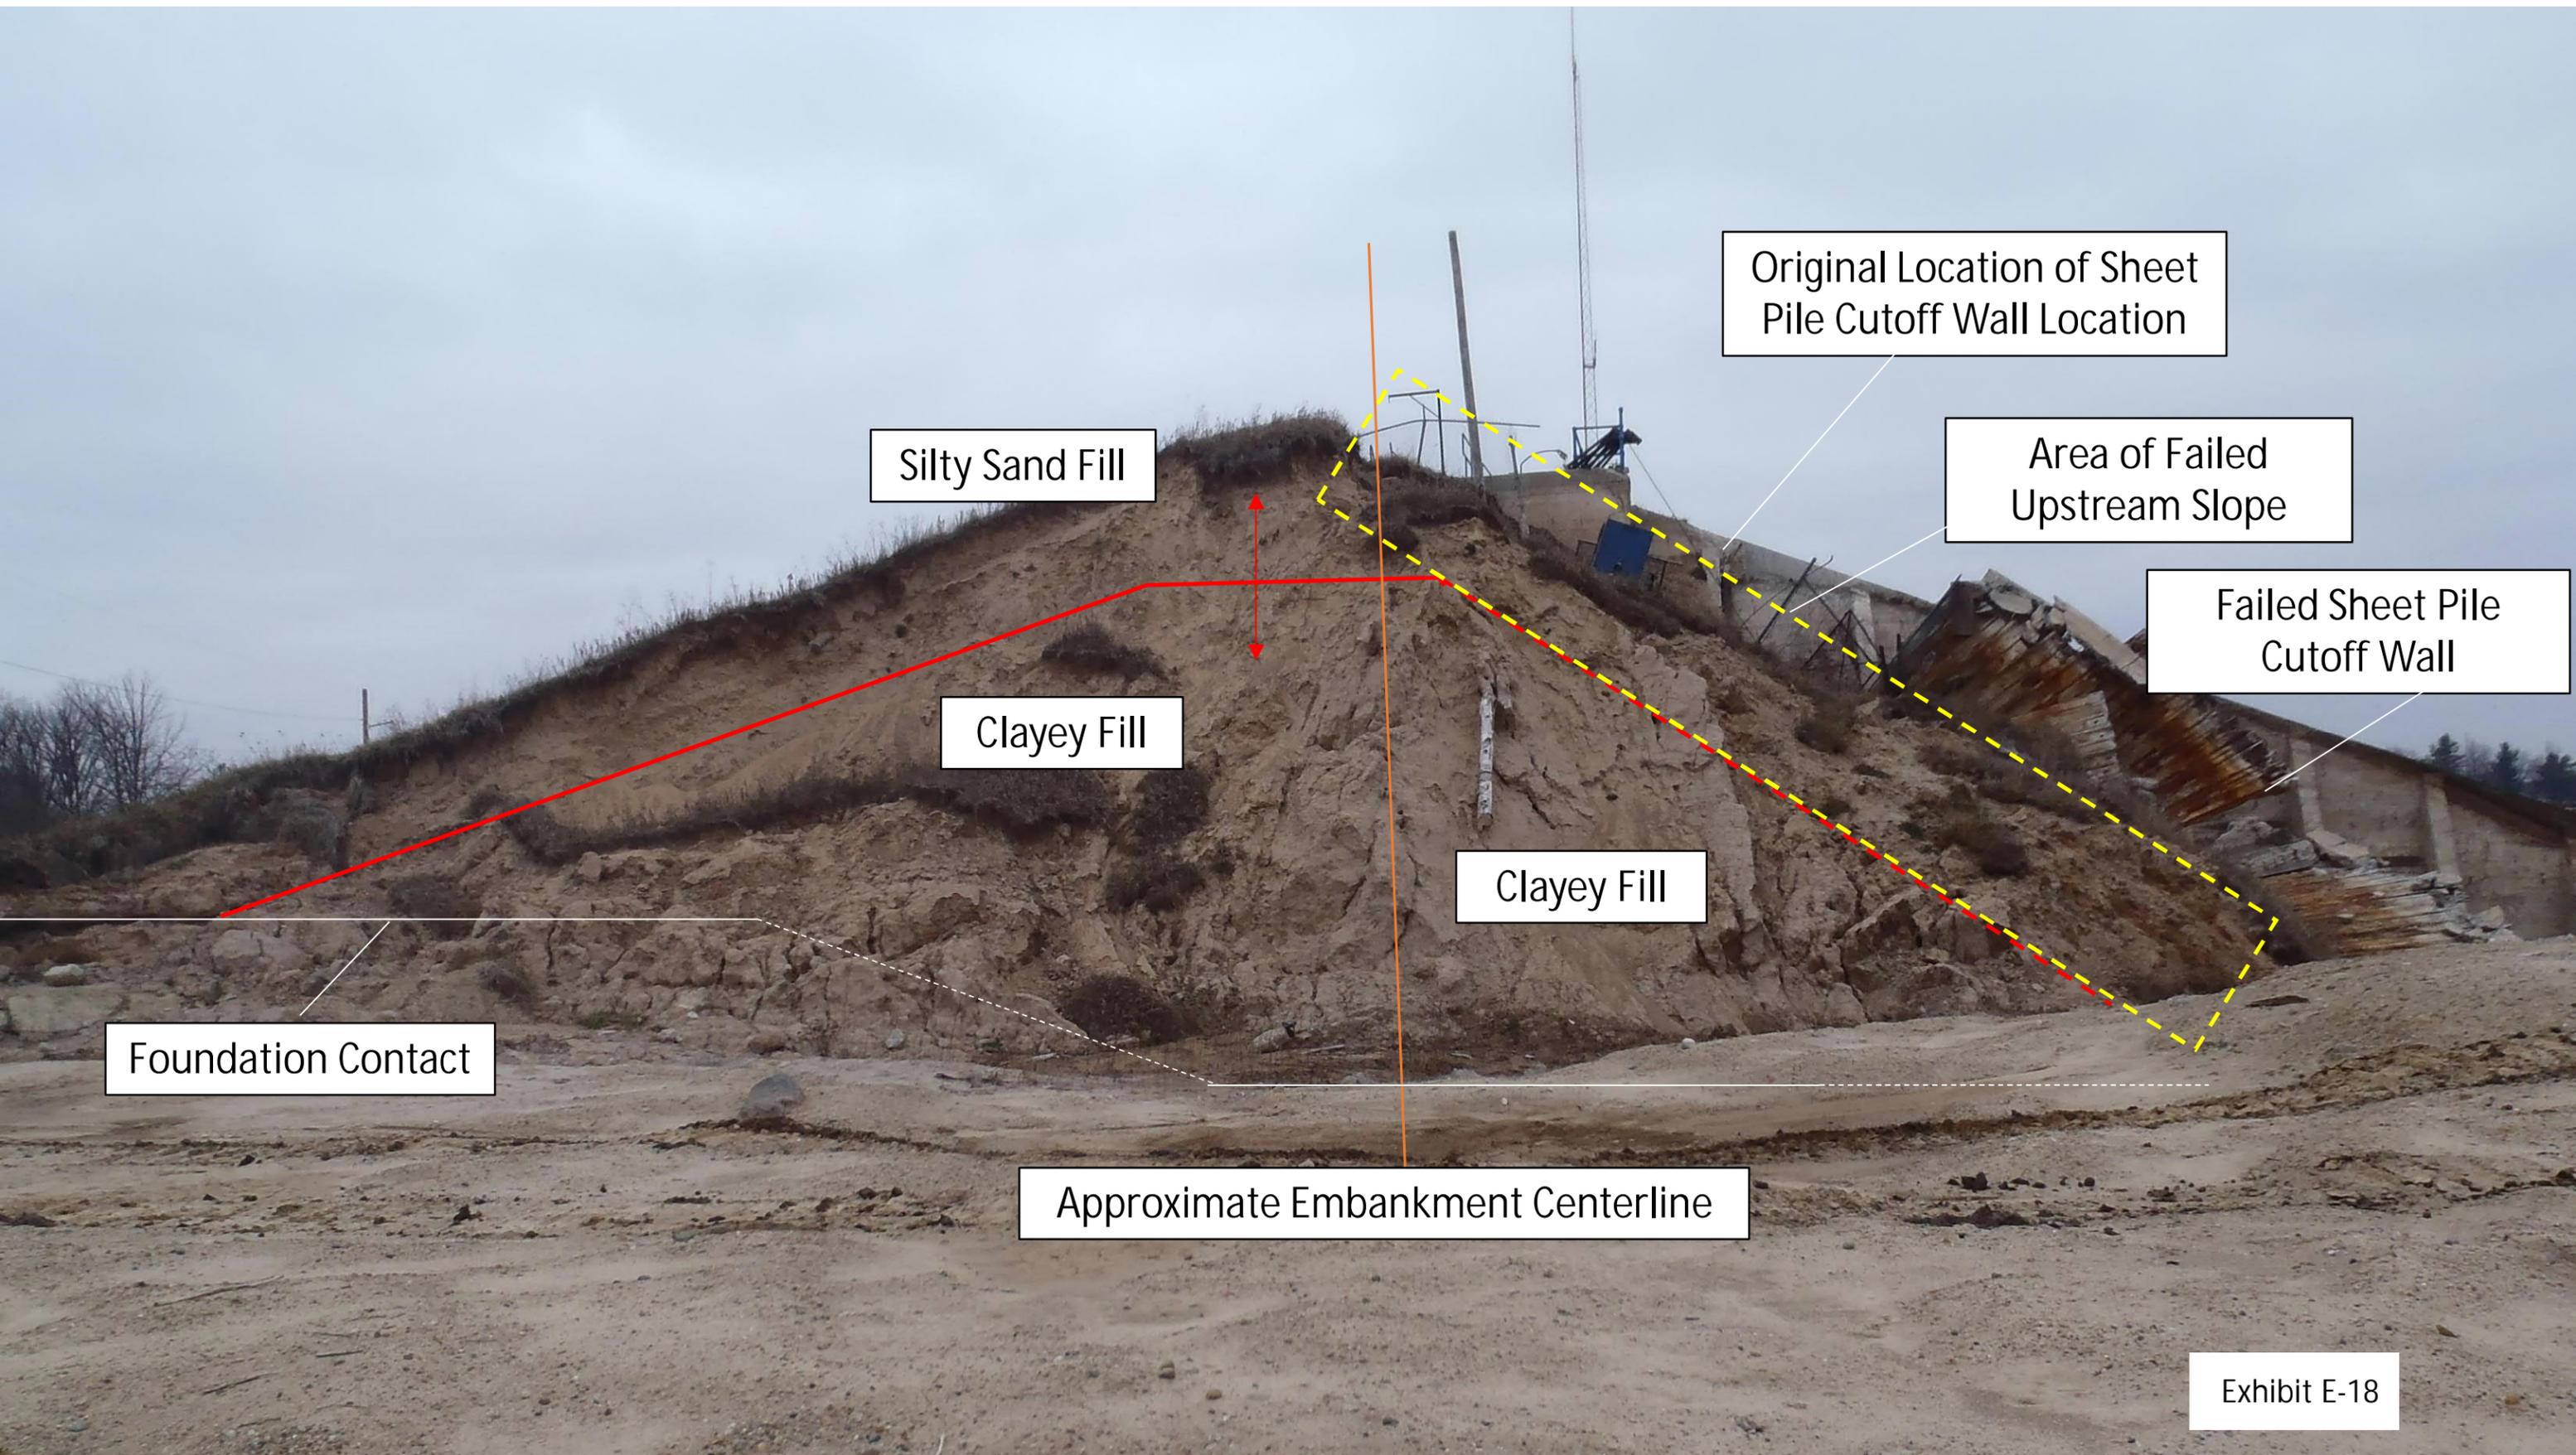
Area of Failed Upstream Slope

Failed Sheet Pile Cutoff Wall

Foundation Contact

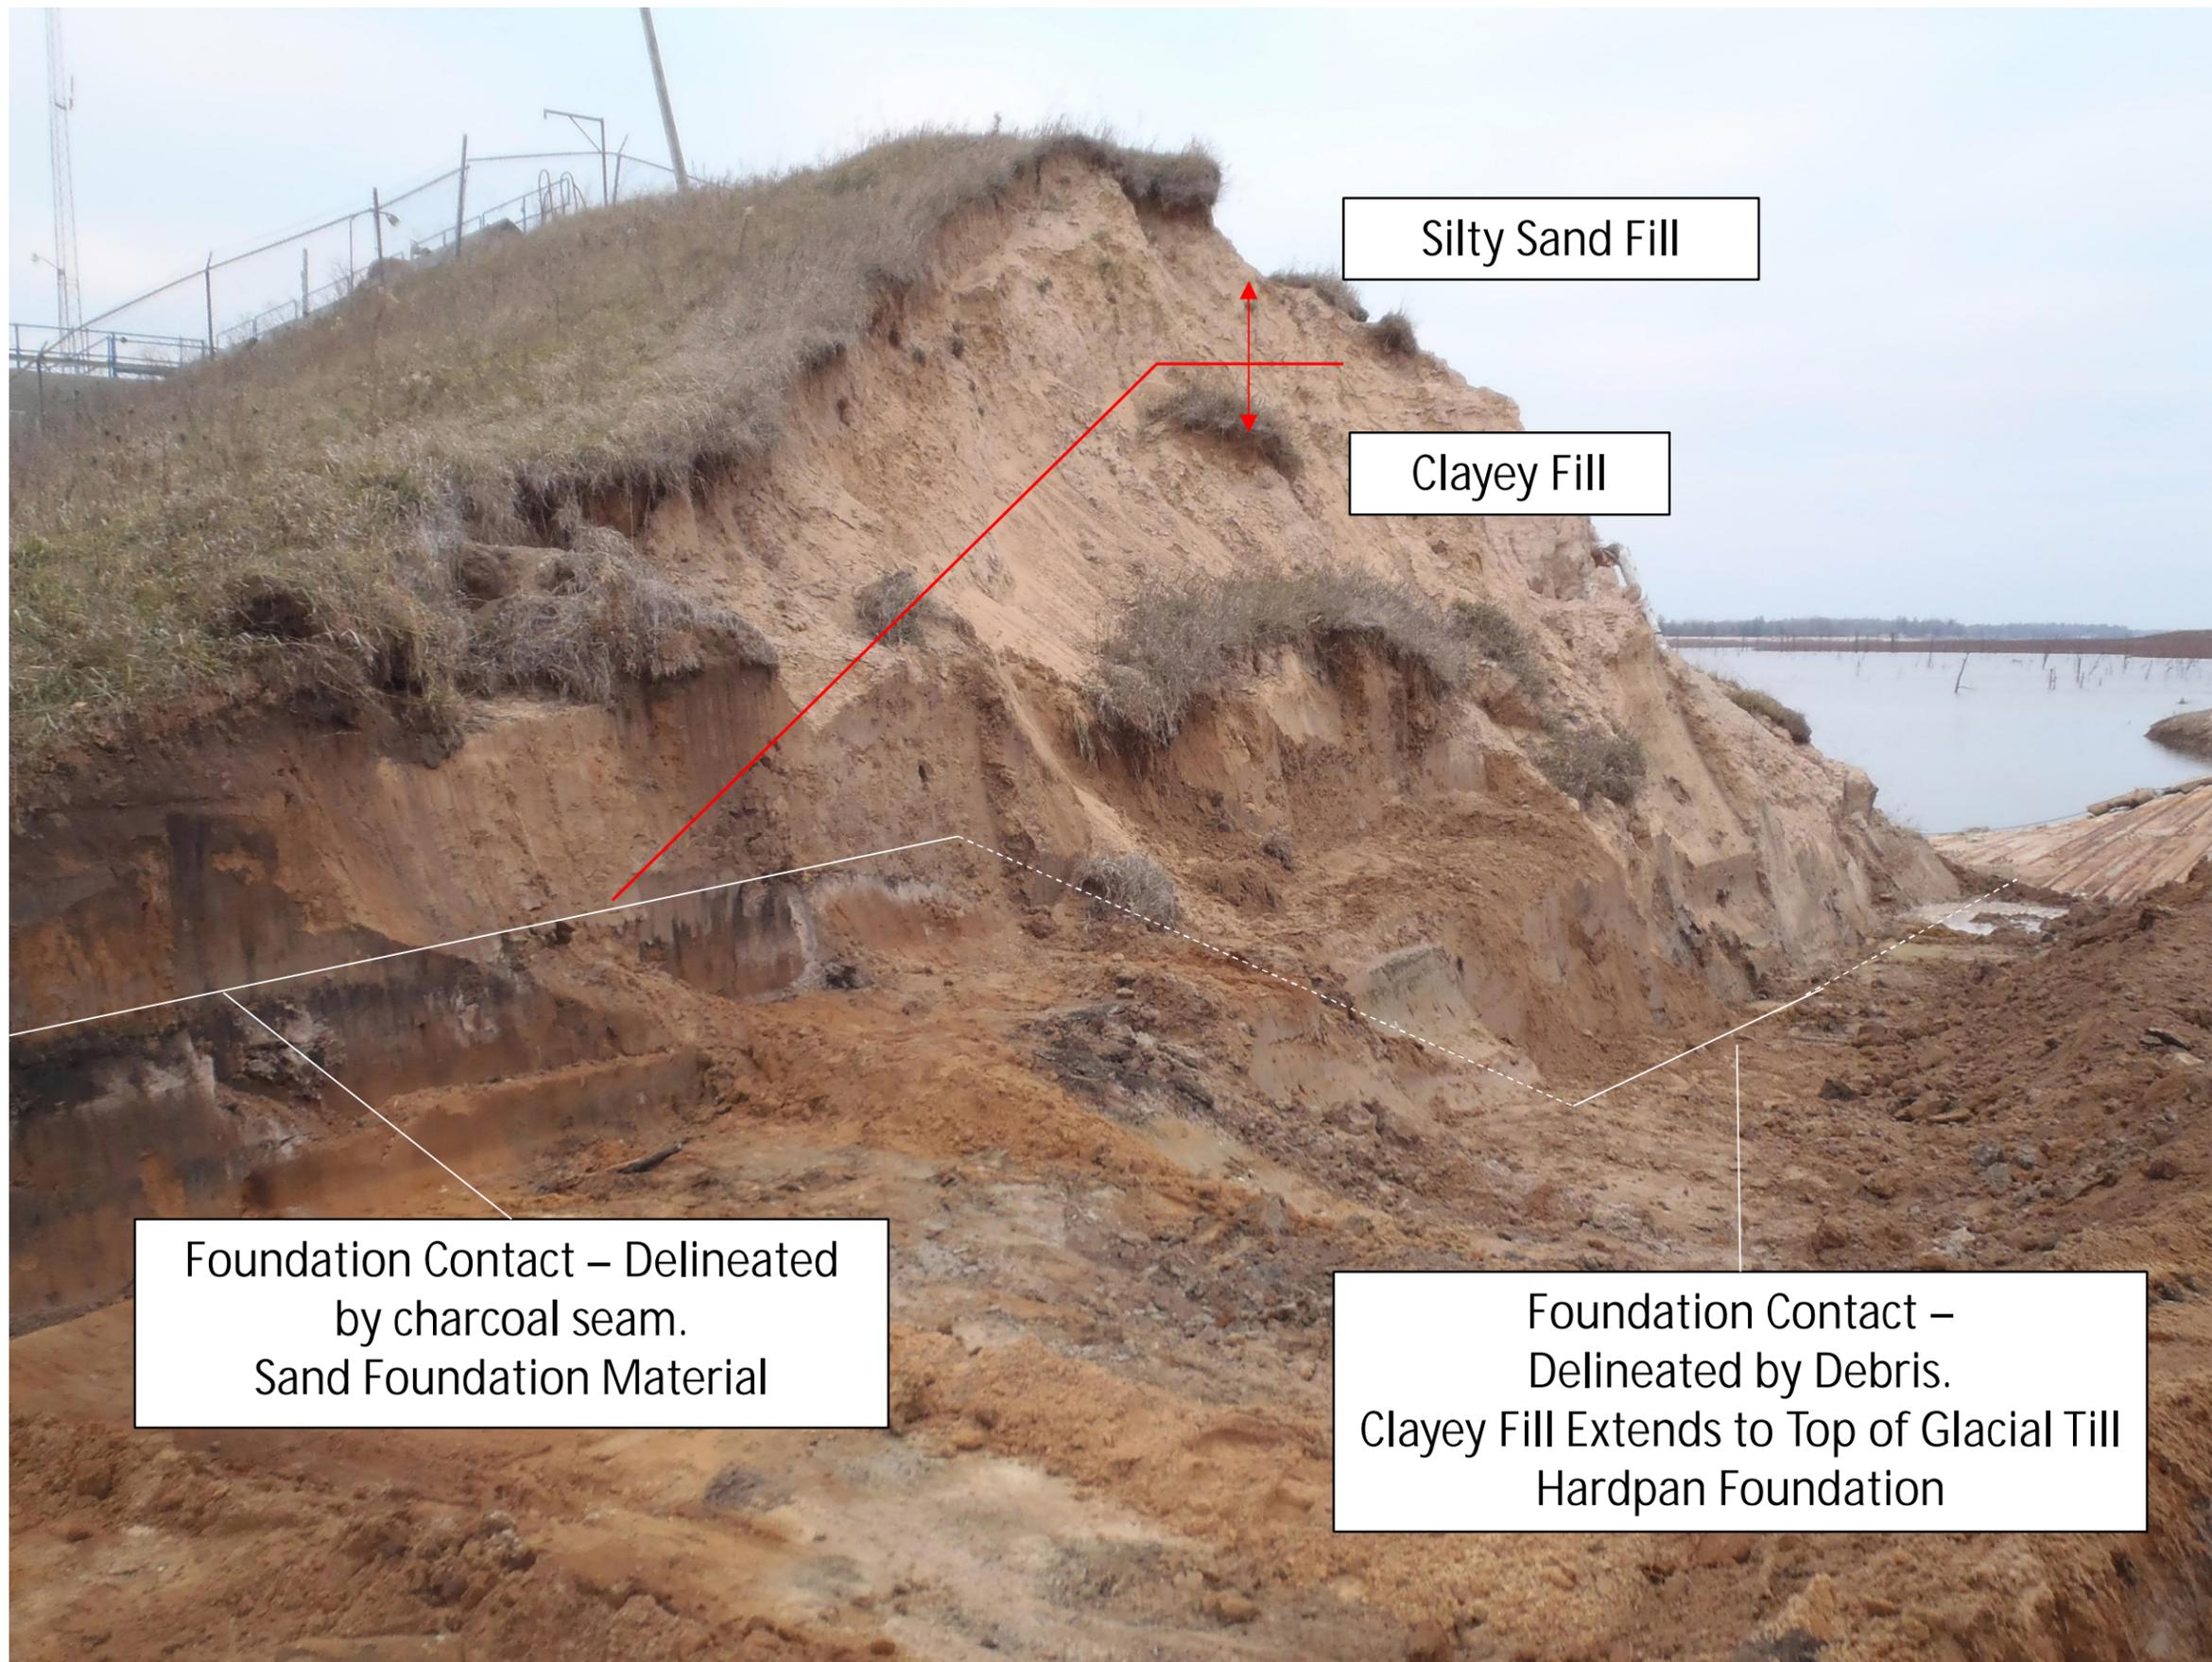
Foundation Contact – Delineated by charcoal seam.
Sand Foundation Material

Foundation Contact – Delineated by Debris.
Clayey Fill Extends to Top of Glacial Till
Hardpan Foundation

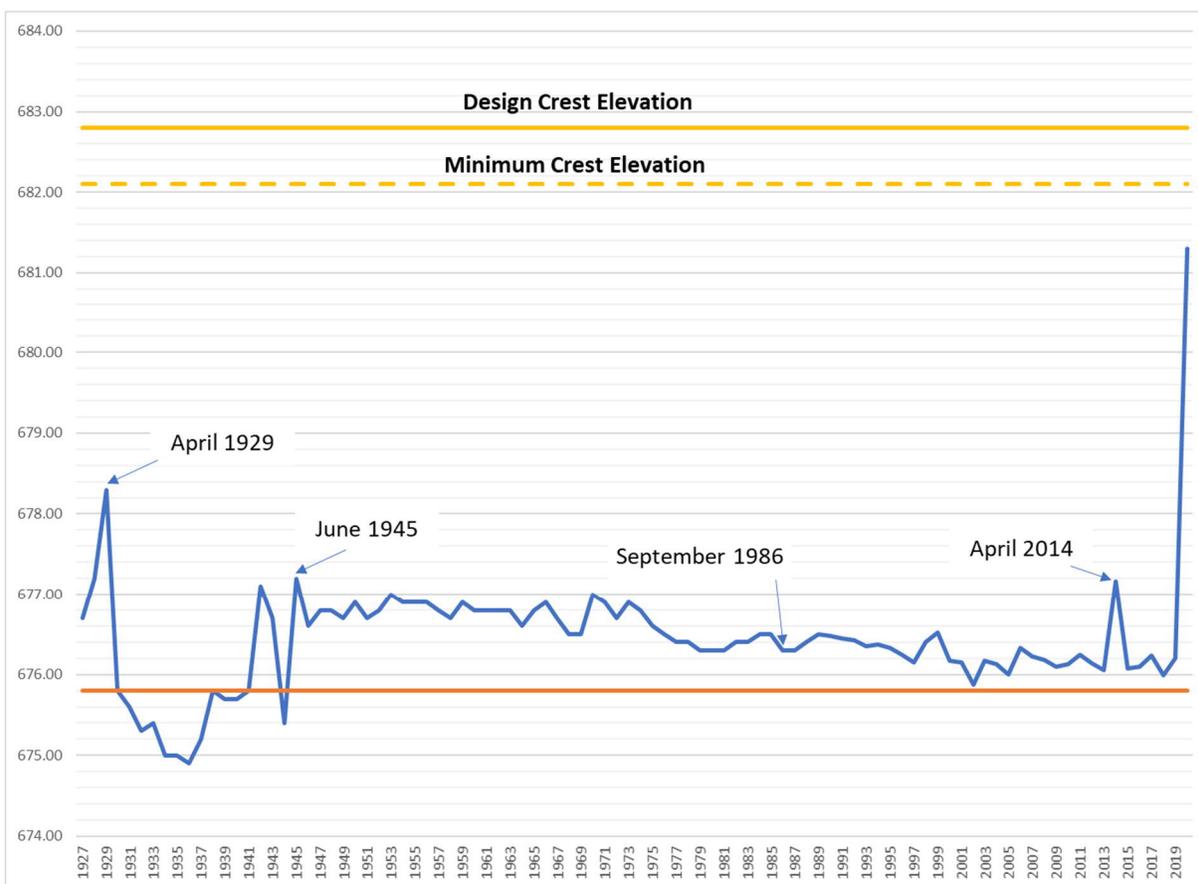
Figure F1-1: Annual Maximum Wixom Lake Levels from 1927 through 2020

Despite the apparently less stringent lake level limitations prior to FERC licensing, available records indicate that Wixom Lake (the reservoir impounded by Edenville Dam) rarely rose significantly above the FERC established normal pool level of Elevation (El.) 675.8, as shown in Figure F1-1. In fact, there were only 4 years when the reservoir rose 1.4 feet or more above El. 675.8 – in 1928, 1929, and 1945, and during the failure in 2020. In 2014, the lake level rose by 1.36 feet, just short of 1.4 feet. There were 22 years when the reservoir rose to greater than 1 foot and less than 1.4 feet; however, all of those years except one (2014) were before the implementation of the FERC lake level requirements. As can be seen in Figure F1-1, maximum yearly lake levels were higher before 1975 than since that time, likely reflecting in part the less restrictive peak power operations in earlier years.

A few comments regarding the historic Wixom Lake data are appropriate. The IFT is not certain that the available information on Wixom Lake levels is entirely complete. The information available to the IFT consisted of a spreadsheet with the highest annual lake levels and some handwritten records regarding lake levels. Boyce Hydro reported to the IFT that the spreadsheet was created after Boyce Hydro became the project owner. The spreadsheet was compiled from available data by part-time Boyce Hydro employees. When the IFT compared spreadsheet entries with the handwritten records, some discrepancies were found. For example, the spreadsheet indicated a maximum water level of El. 678.8 for 1930. When those handwritten records were reviewed, it was found that the lake levels for the referenced date were actually below the normal pool level when the reservoir was being operated in a drawdown condition over winter. The actual maximum water level for 1930 was estimated to be at normal pool level. Discrepancies of lesser magnitudes were found for 1927, 1928, and 1929. When discrepancies were found, the information from the handwritten logs was used. It should also be noted that the 2015 Consultant’s Safety Inspection Report for Edenville Dam (Purkeypile 2016) states that the flood of record occurred on June 3, 1945, with a Wixom Lake level 2.4 feet above the normal pool level. According to the IFT’s interpretation of the available information, the pool of record prior to May 2020 actually occurred in April 1929 at 2.5 feet above normal pool level, and the 1945 maximum pool level was only 1.4 feet above the normal pool level.

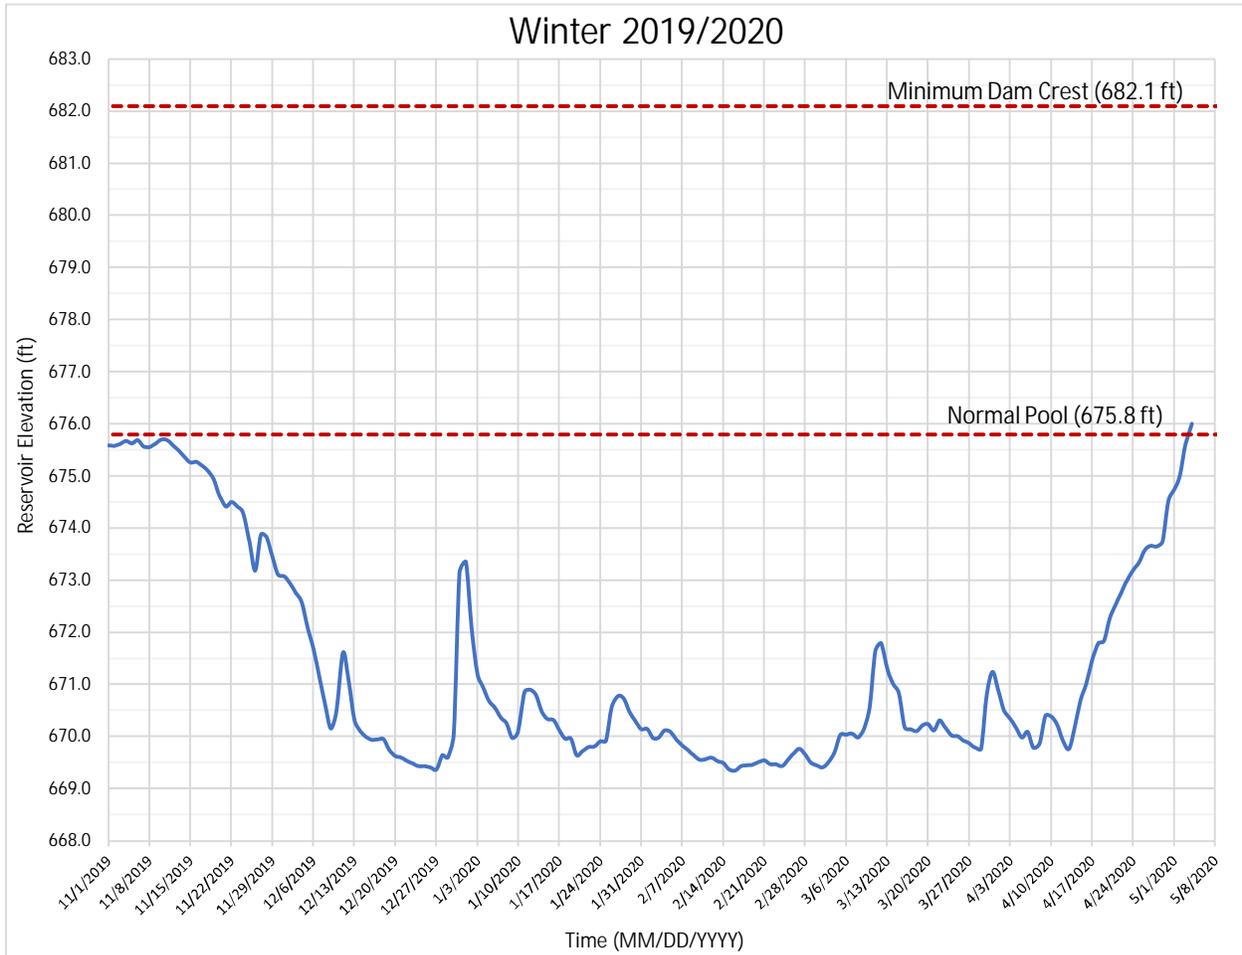
Figure F1-3: Wixom Lake Levels - November 1, 2019, through May 4, 2020

Wixom Lake water level to normal summer pool elevation of 675.8 (North American Vertical Datum of 1988) during the spring 2020.” On May 4, 2020, the lake level reached 676.0 feet, 0.2 foot above normal pool level.

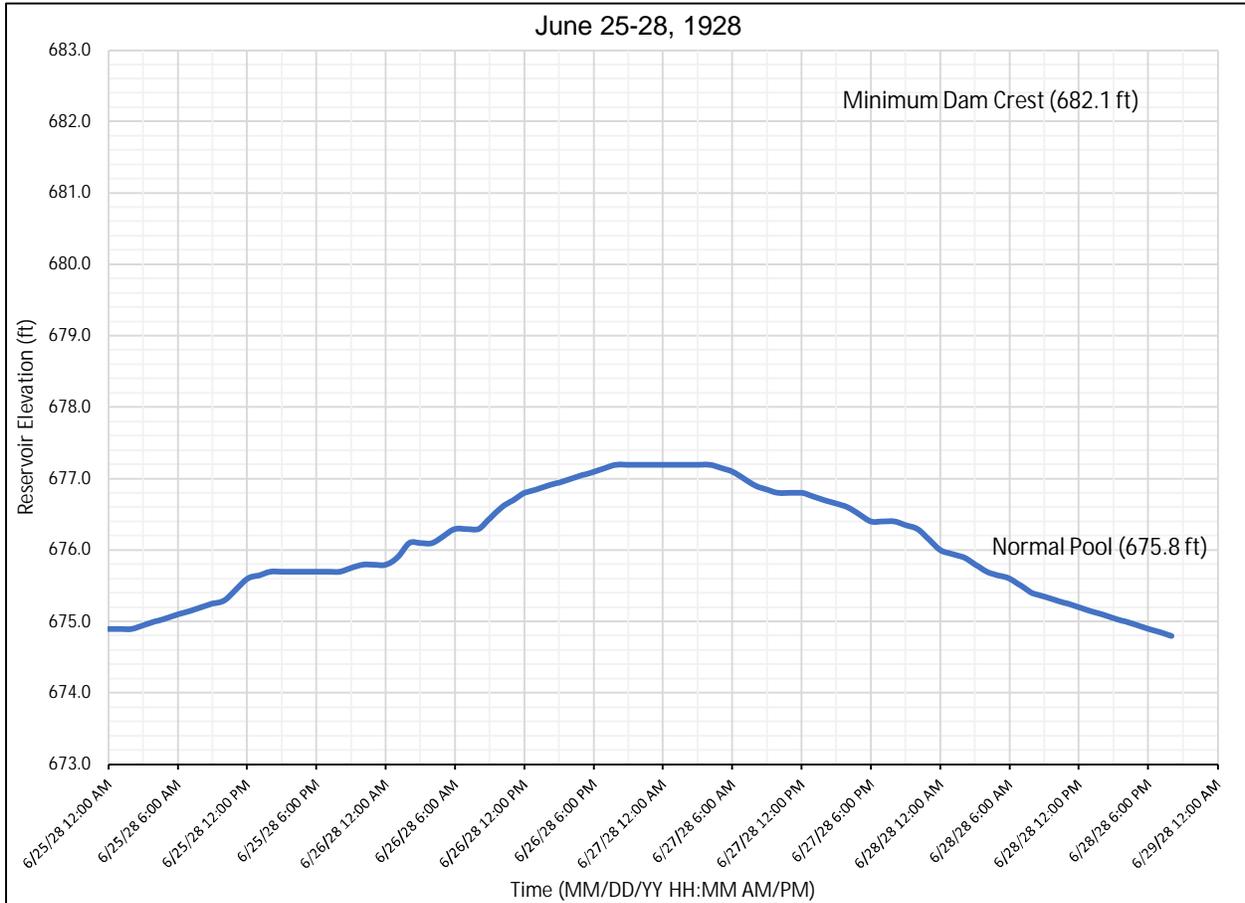
Figure F1-4: Wixom Lake Levels from June 25 through 28, 1928

Figure F1-4 shows the lake levels for the June 1928 event as obtained from Boyce Hydro record log information. The level of Wixom Lake began to rise above normal pool at midnight on June 25 and returned to normal pool at 3:00 a.m. on June 28. By noon on June 26, all six gates at both spillways were opened to 7.5 feet and the lake level had reached El. 676.8. At 4:00 p.m. on June 26, the powerhouse was at 100 percent discharge capacity, with the lake at El. 676.8. Five of the six gates were open 7.5 feet, and Gate 3 at the Tobacco spillway was open 4.5 feet. The maximum lake level was 677.2 feet (1.4 feet above normal pool) at 6:00 p.m. on June 26.

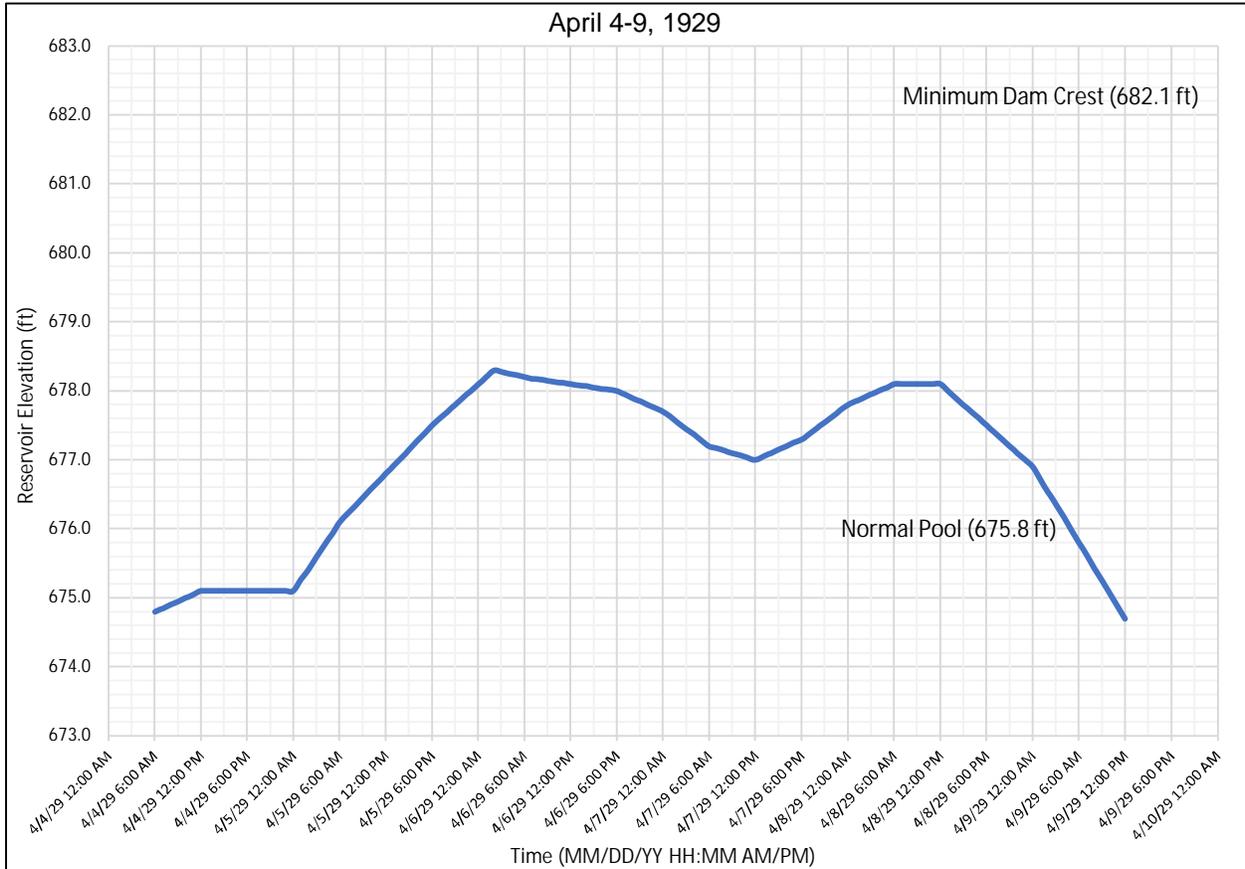
Figure F1-6: Wixom Lake Levels from April 4 through 9, 1929

Wixom Lake began to rise above normal pool at 5:00 a.m. on April 5 and reached El. 676.2 at 6:00 a.m. April 5, with all six gates open to 7.5 feet. At 7:00 a.m., the powerhouse was at 100 percent capacity. The maximum lake level of El. 678.3 feet was recorded on April 6 at 2:00 a.m. Figure F1-6 is a time history of Wixom Lake levels for the April 1929 event as obtained from Boyce Hydro record log information. The lake level stayed above normal pool for approximately 6 days. The maximum lake level was 2.5 feet above normal pool level, the pool of record, until the May 2020 event. Additional precipitation totaling 0.69 inch occurred on April 9 and 10, 1929.

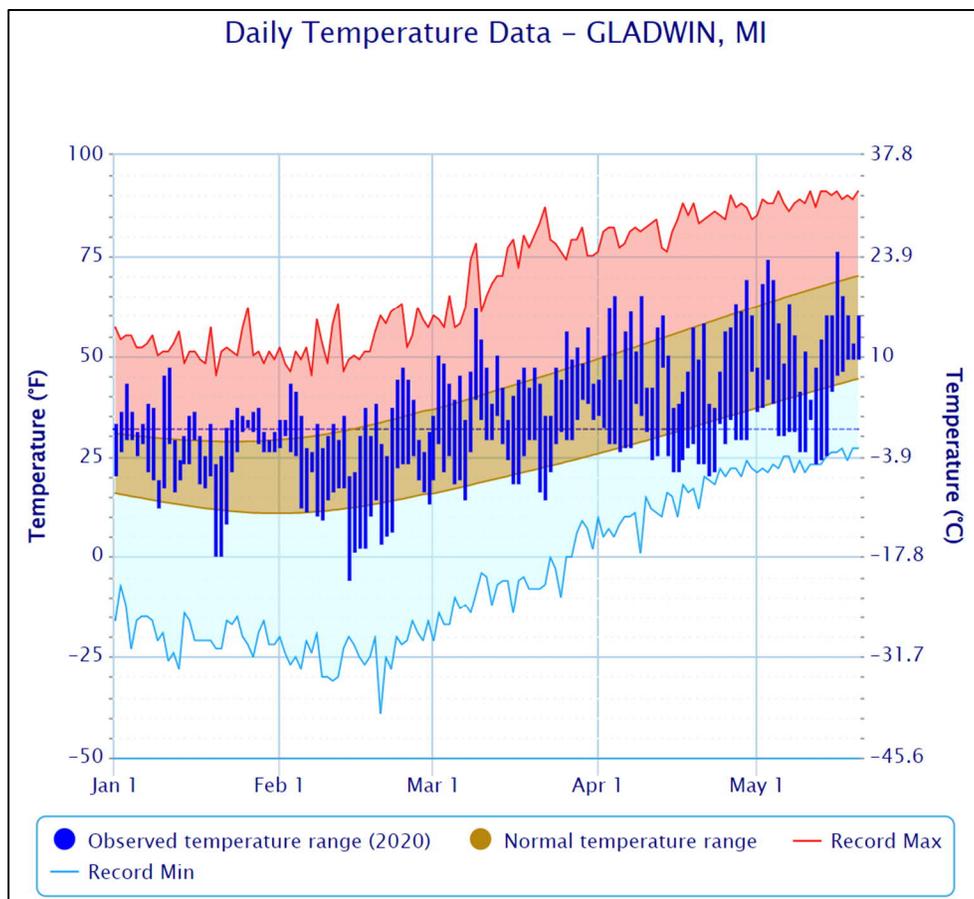
Figure F1-22: Gladwin Daily Temperatures before the May 2020 Event

The Tittabawassee River watershed experienced large temperature differentials through the 2020 “water year” prior to the May 2020 event (shown in Figure F1-22). This had the potential to result in ground freezing and thawing conditions that could impact runoff. Specifically, if the soil was even partially frozen, the soil infiltration could be greatly reduced and therefore the runoff would be increased.

From May 5 to 14, 2020, the daily minimum temperatures at the Gladwin weather station were near or at record lows, and below freezing for several days. In shaded areas like conifer forests and swamps, the temperatures could be expected to be lower than the recorded temperatures at the Gladwin weather station. In addition, shading of the forest floor can reduce the rate of frost thaw occurring within the soil. These influences could have resulted in either the persistence of ground frost within the soil profile or some surface ground freezing, either of which could have been sufficient to perch rainfall infiltration and produce a saturated condition at the surface that would increase the runoff. Temperatures after May 14 increased to above 32 degrees for the rest of the month.

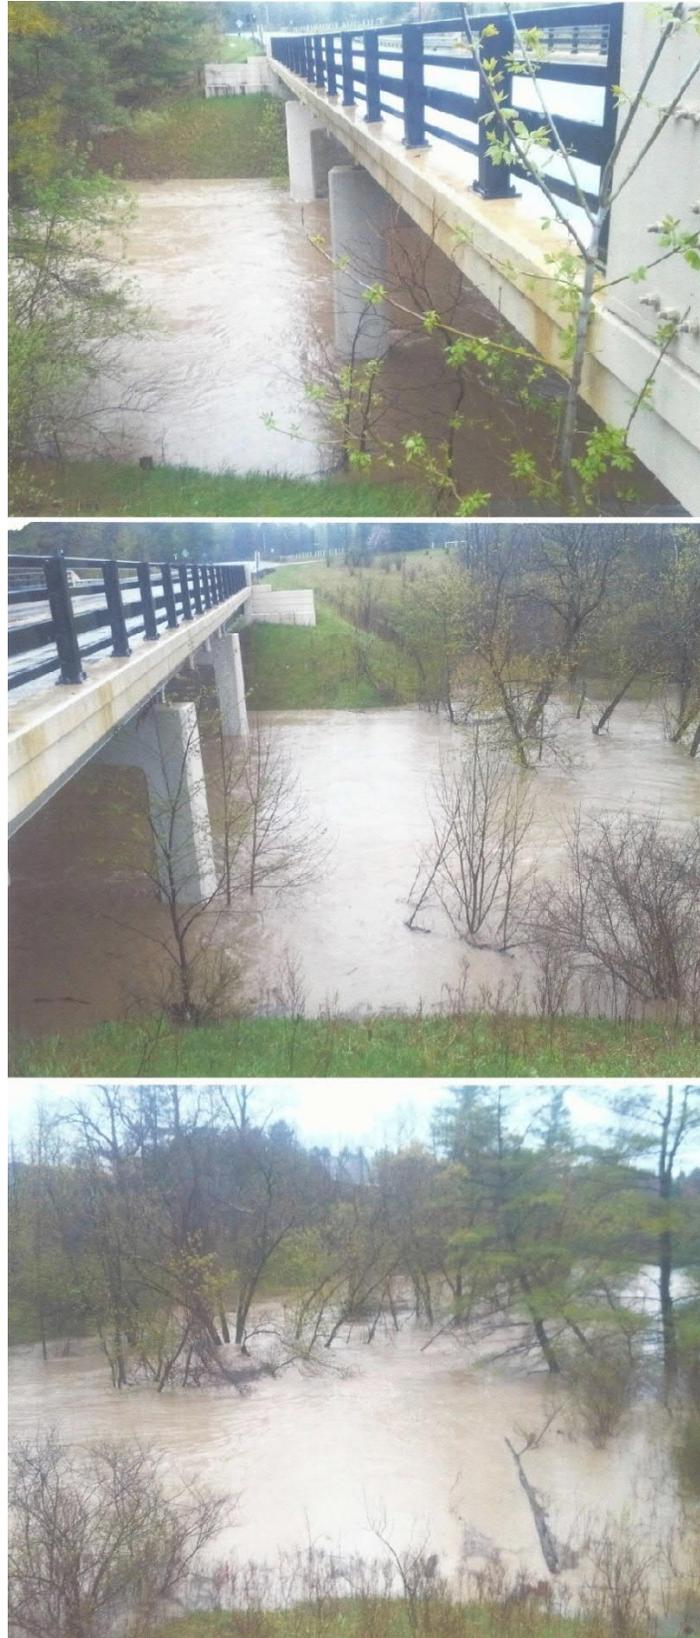
Figure F1-24: Sugar River at M-30 Highway Bridge on May 18, 2020

Figure F1-24 shows the Sugar River at the M-30 highway bridge just upstream of Smallwood Lake experiencing high flows and inundating trees. Figure F1-25 shows floodwaters overtopping a roadway upstream of Secord Dam on May 18, 2020.

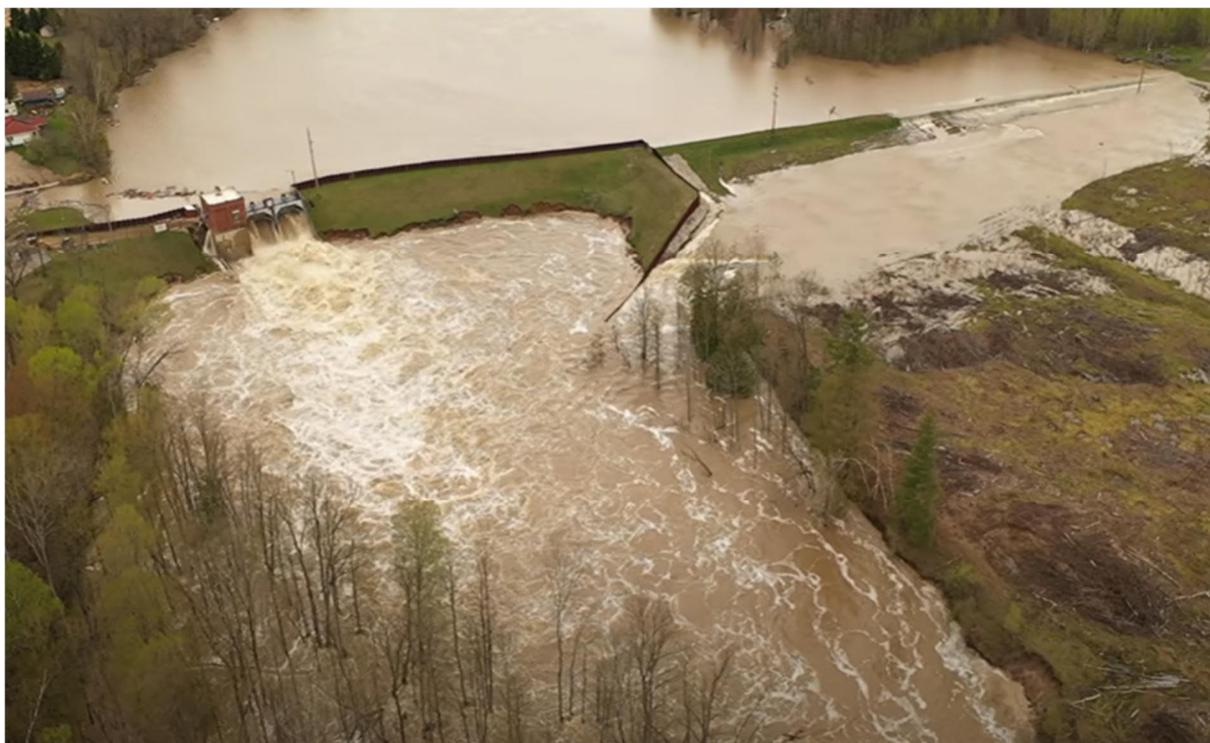
Figure F1-26: Smallwood Dam Showing Flow over the Auxiliary Spillway

Figure F1-26 shows flow going over the auxiliary spillway that was used to check flow depth at the spillway, and gate openings were also used to aid the calibration process. Outflow from Smallwood Dam then gets modeled as inflow into Edenville Dam. Figure F1-27 shows the Tobacco spillway on May 21, 2020.

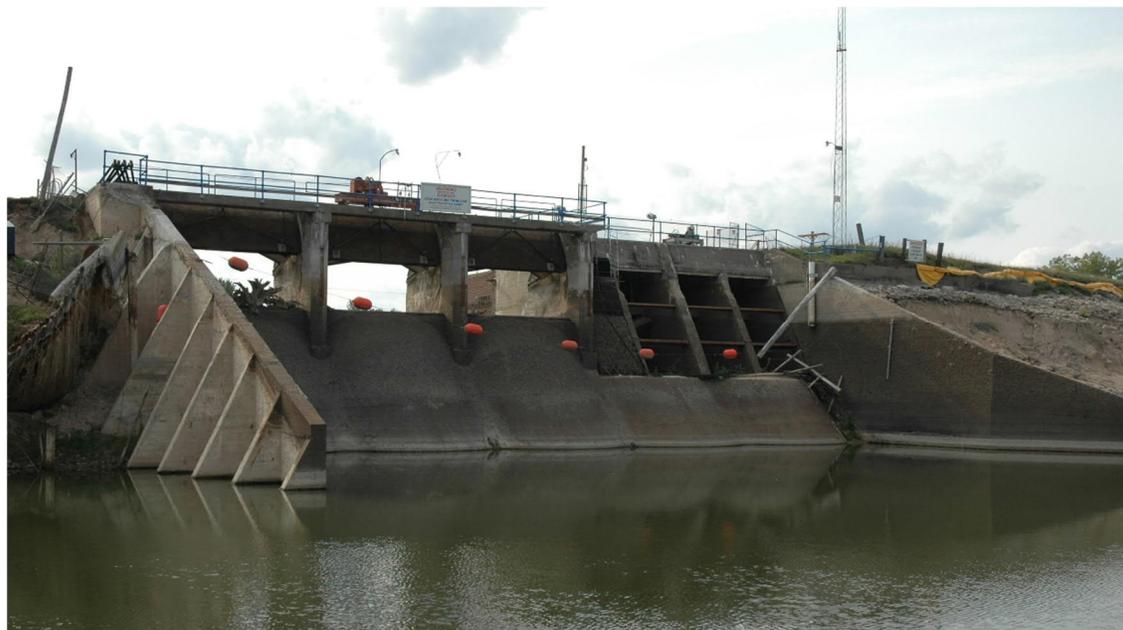
Figure F1-28: Edenville Spillway – September 2020

Figure F1-28 and Figure F1-29 show the gate openings at the Edenville and Sanford Dams, respectively. The photographs were taken by the IFT team during a site visit in September 2020.

During the May 2020 event, the gates at Edenville Dams were opened to only about 7 feet. If the gates were fully opened to 10 or more feet, it is estimated that the peak Wixom Lake level would have been about 1.1 feet lower than the lake level at the time of the failure, at an elevation of 680.2 or 4.4 feet above normal pool.

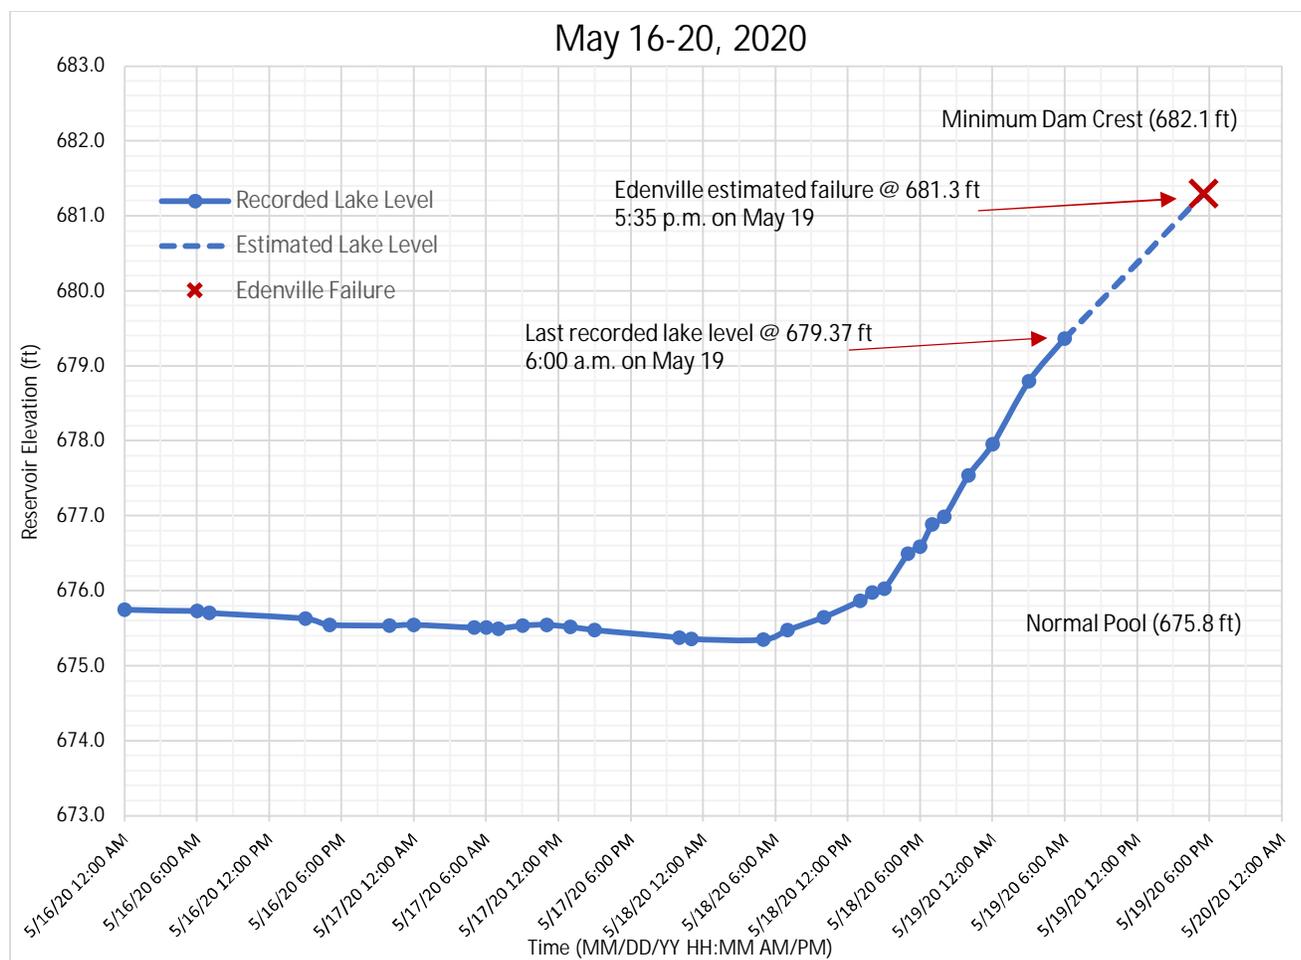
Figure F1-30: Wixom Lake Levels from May 16 to 19, 2020

To estimate the inflow to Wixom Lake, the flow from the USGS stream gage at Beaverton was routed through the Tobacco River and added to the routed flow through the Tittabawassee River from the Smallwood Dam; this flow was also added to the flow from other contributing subbasins to Wixom Lake. Therefore, the existing watershed parameters that produce the lake levels depict the watershed at that time. If portions of the watershed had frozen ground, the parameters would have been adjusted to obtain the lake levels that were recorded given the frozen ground. The model was calibrated such that the watershed parameters present specifically during the May 2020 storm event are captured by the model, and all characteristics that influenced the response of the watershed are therefore factored into the calibration. Figure F1-30 shows the Wixom Lake levels for the May event as obtained from Boyce Hydro record log information and estimated beyond available log information. The peak inflow to Wixom Lake was estimated to be 24,500 cfs and the estimated lake elevation was 681.3 feet at the time of failure.
