INVESTIGATION OF FAILURES OF EDENVILLE AND SANFORD DAMS

Independent Forensic Team

FINAL REPORT

Investigation of Failures of Edenville and Sanford Dams

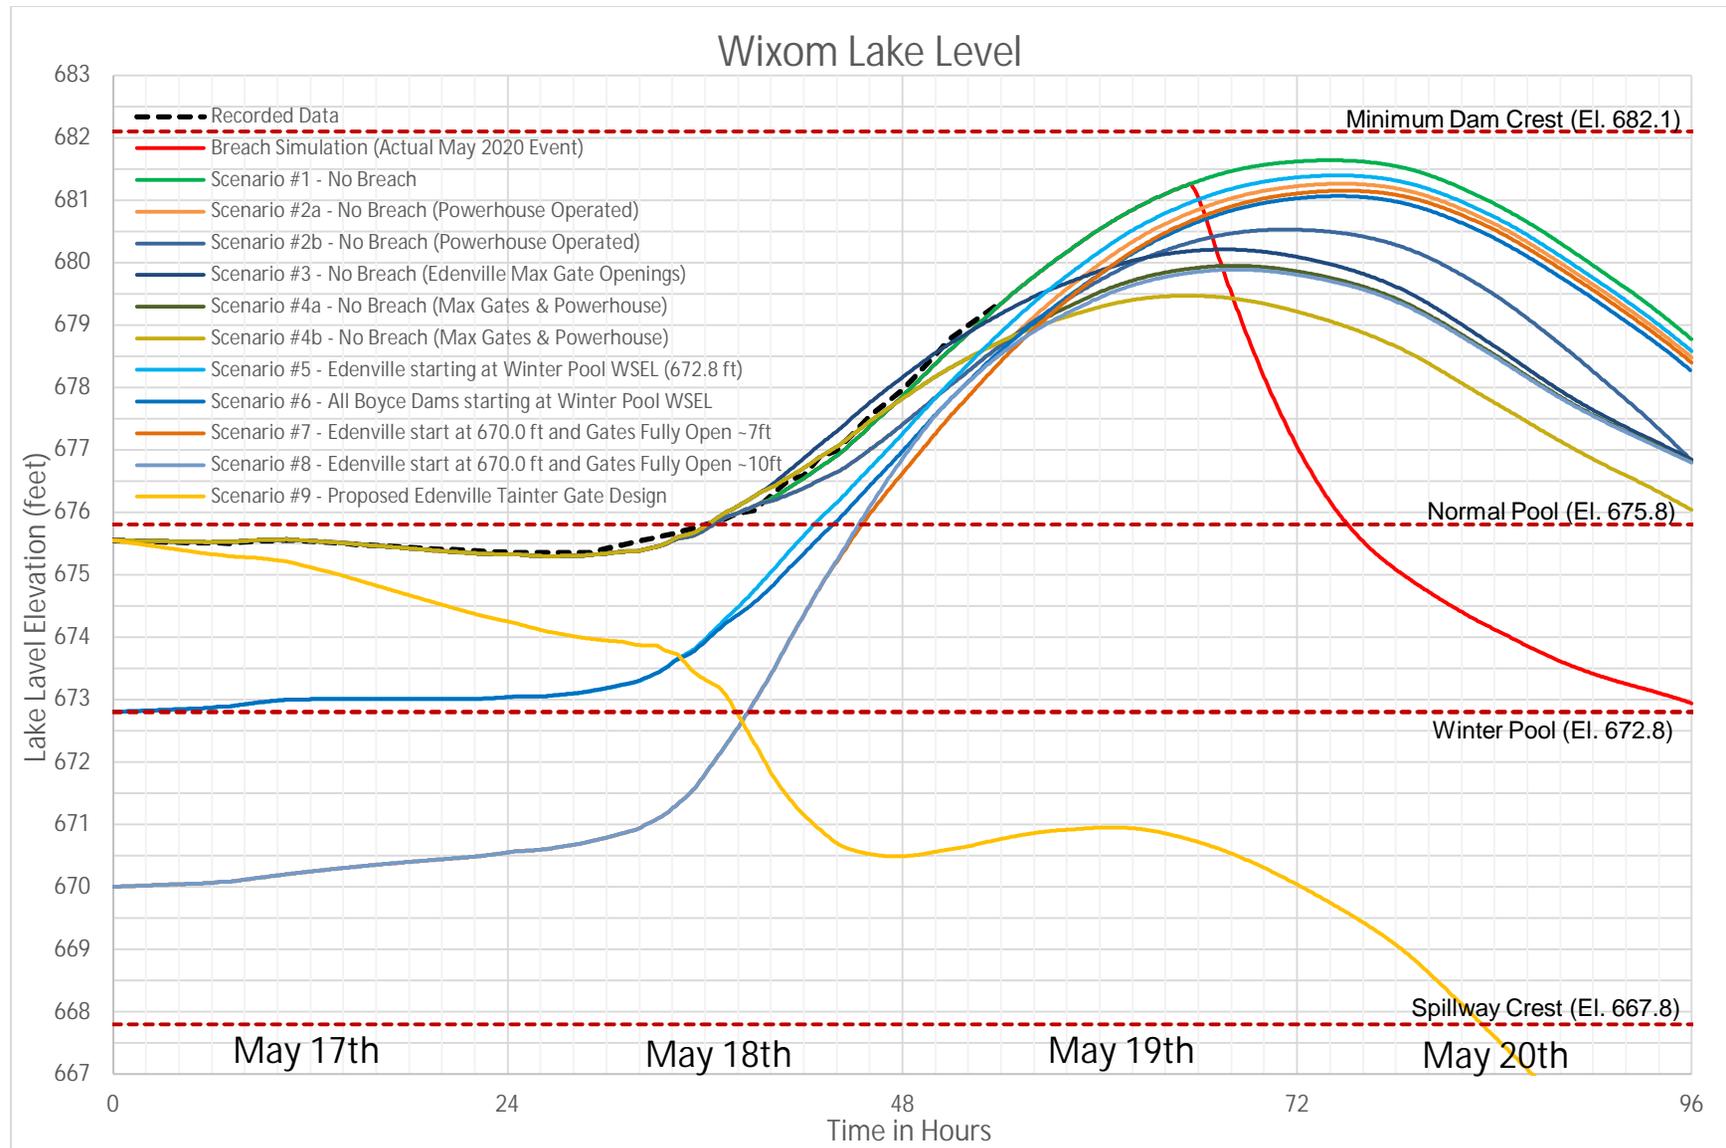
Figure F1-34: Model Simulation Results of Hypothetical Operational Scenarios for May 2020 Event

A series of hypothetical operational scenarios were evaluated using the calibrated hydrologic and hydraulic model developed to reproduce the May 2020 storm event. These scenarios were evaluated to assess the sensitivity of lake levels to various operational parameters and evaluate potential counterfactual “what if” scenarios. The results of the various scenarios considered are summarized in Table F1-11 and Figure F1-34. It should be noted that the accuracy of the model is limited by the modeling assumptions incorporated in the computer software used for the modeling, the resolution and accuracy of the available rainfall data, the resolution and accuracy of the land characteristics data available for the watershed, and the data available for calibrating the model.

During the May 2020 event, the gates at Edenville Dams were opened to only about 7 feet. If the gates were fully opened to 10 or more feet, it is estimated that the peak Wixom Lake level would have been about 1.1 feet lower than the lake level at the time of the failure, at an elevation of 680.2 or 4.4 feet above normal pool.

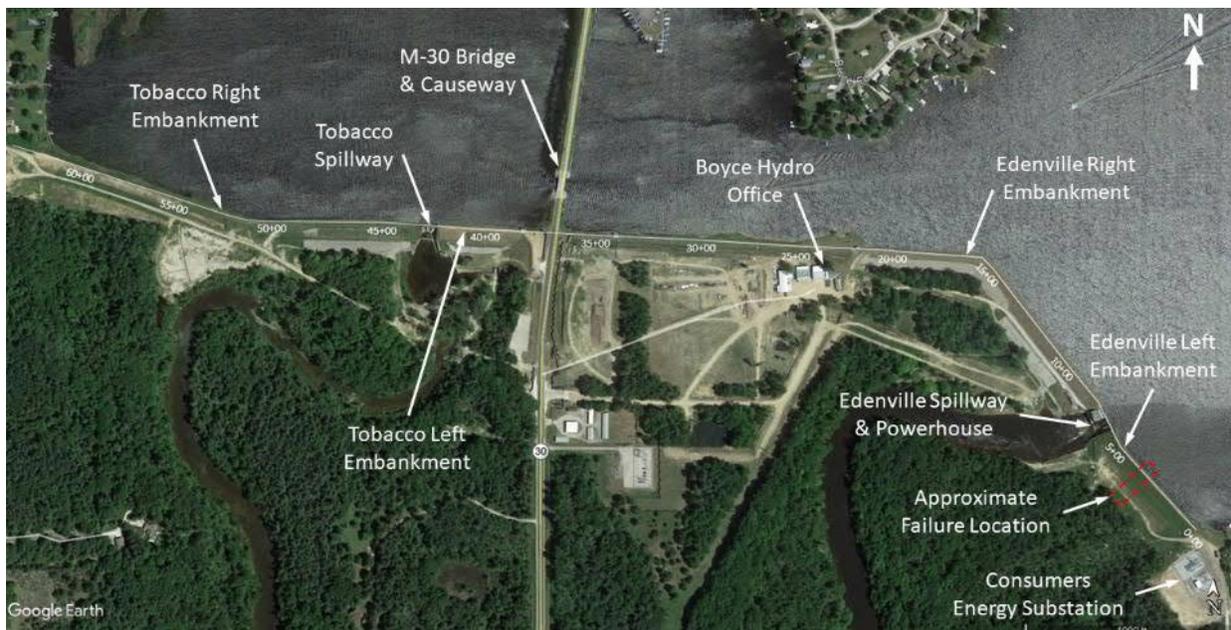
Figure F2-1: Edenville Dam Configuration

At the time of the May 2020 failure, Edenville Dam consisted of four earthfill embankments, two gated concrete spillways, and a powerhouse—all constructed across the Tittabawassee and Tobacco Rivers in Michigan and totaling more than 6,000 feet in length, as shown in Figure F2-1.

Figure F2-1 identifies the four embankments: Edenville left, Edenville right, Tobacco left, and Tobacco right embankments. The May 2020 failure occurred at the Edenville left embankment.
