REPORT TO  
U.S. DEPARTMENT OF THE INTERIOR AND STATE OF IDAHO  
ON  
**FAILURE OF TETON DAM**

BY  
INDEPENDENT PANEL TO REVIEW CAUSE OF TETON DAM FAILURE

DECEMBER 1976

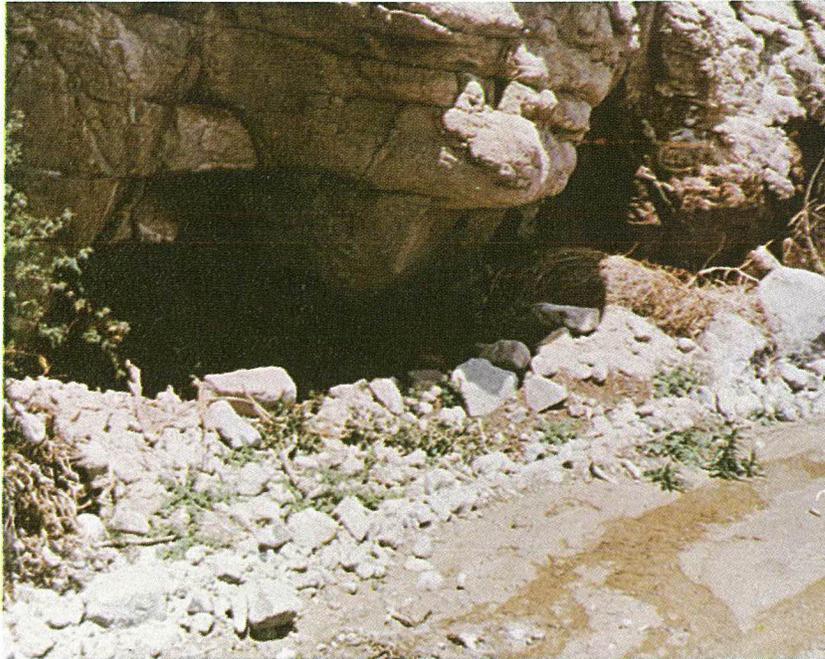
On June 3, 1976, several small seeps in the rhyolite (volcanic rock) appeared about 1400 to 2000 feet downstream from the toe of the dam in the north abutment wall. The water was clear and all of these seeps totaled about 100 gallons of water per minute. This was felt to be a good sign because the dam was being filled and it indicated the water table gradient was acting in a normal manner. The water was clean enough to drink and if there had been a problem the water would have been turbid. I felt the area should be monitored by sight inspections and other mechanical means, the latter of which were never put into effect. I took pictures of the seepage [Figs. 2-3 and 2-4] and reported the matter to the E&R Center, Bureau of Reclamation, Denver, Colorado.

**Fig. 2-3.** North canyon wall about 1300 feet downstream from Teton Dam. Clear water from several small seeps flowing about 60 gpm. June 3, 1976..

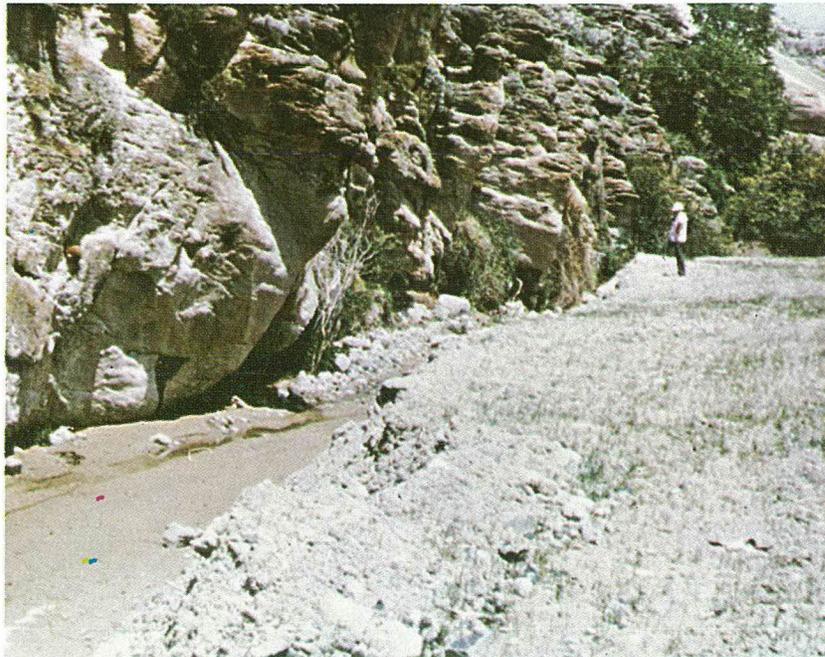
**Fig. 2-4.** North canyon wall about 1500 feet downstream from Teton Dam. Clear water flowing from rhyolite about 40 gpm. June 3, 1976.

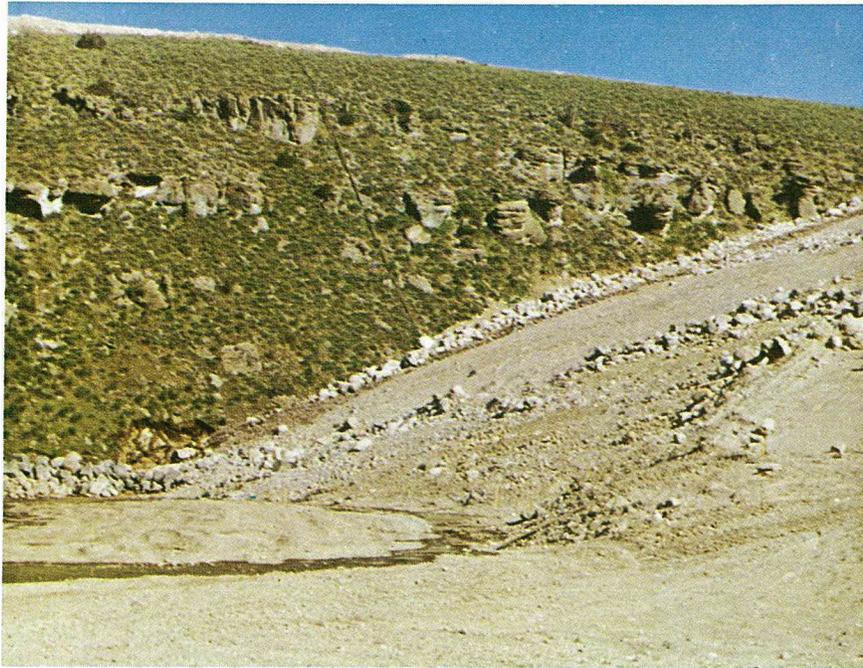
**Fig. 2-5.** Muddy flow at about El. 5045 at right downstream toe estimated 20 to 30 cfs (9,000 to 13,500 gpm) 8:30 a.m. June 5, 1976.

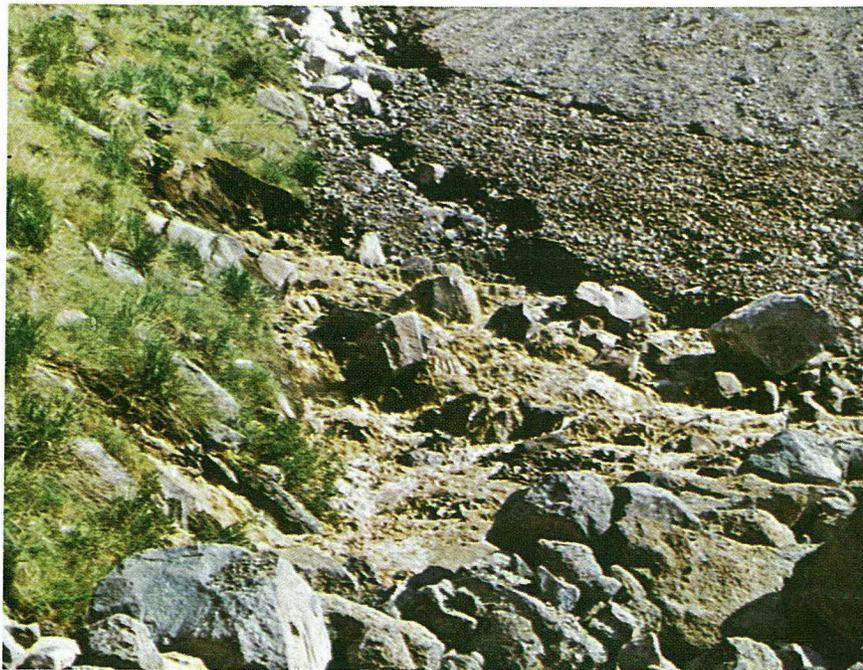
**Fig. 2-6.** Close-up of leak shown in Fig. 2-5. Muddy flow through rock on right abutment at about El. 5045. 8:30 a.m. June 5, 1976.

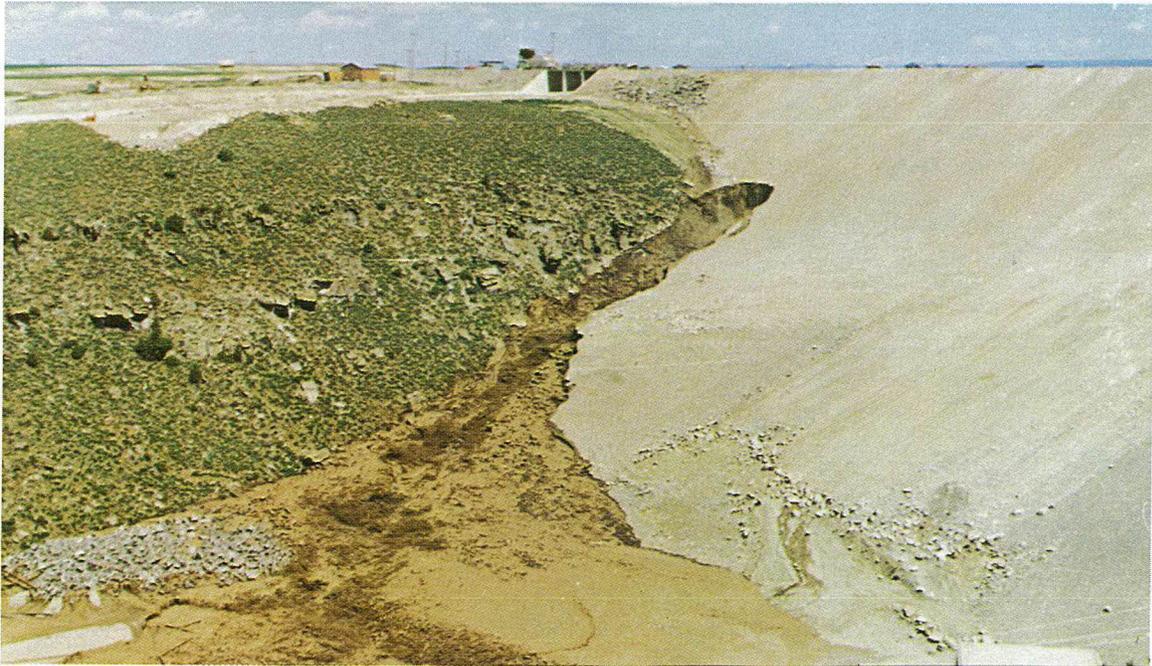
**Fig. 2-10.** Dozers lost in hole. About 11:20 a.m. June 5, 1976.

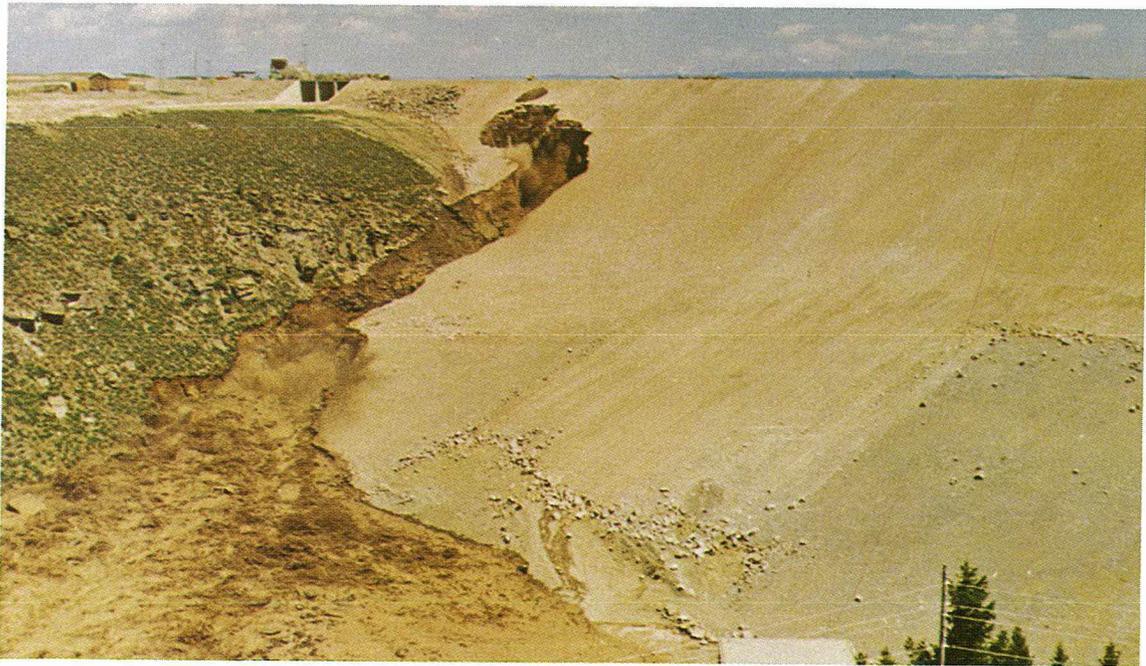
Fig. 2-12. Second hole in face of dam. A few minutes after 11:30 a.m. June 5, 1976.

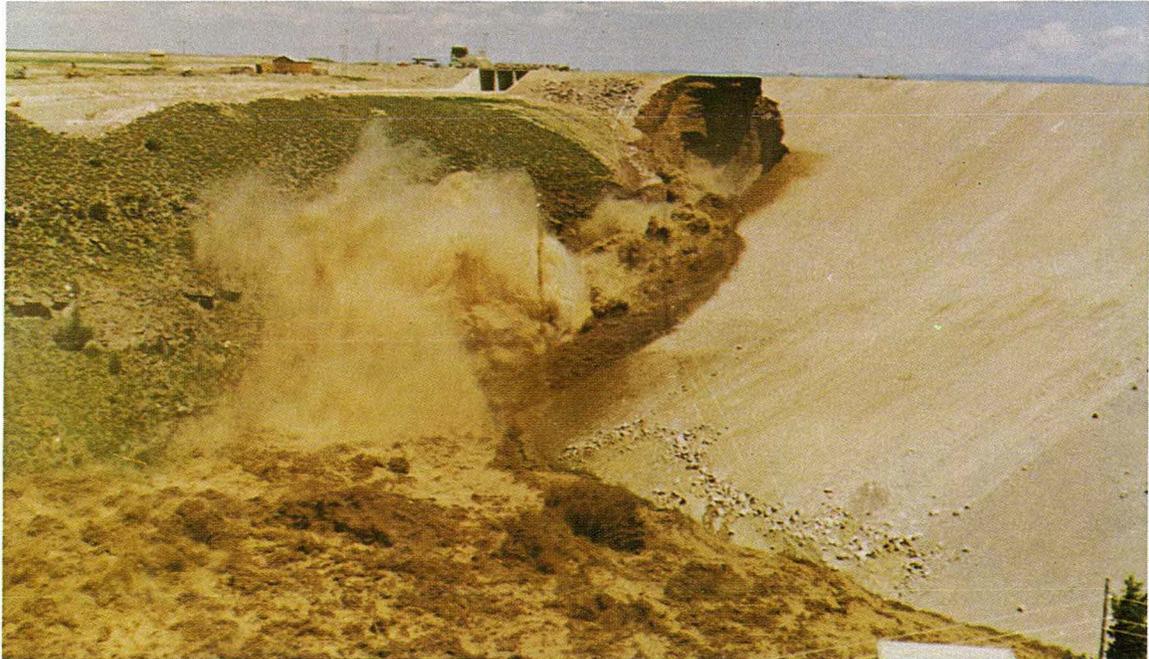
Fig. 2-14. Dam crest breaching. 11:55 a.m. June 5, 1976.

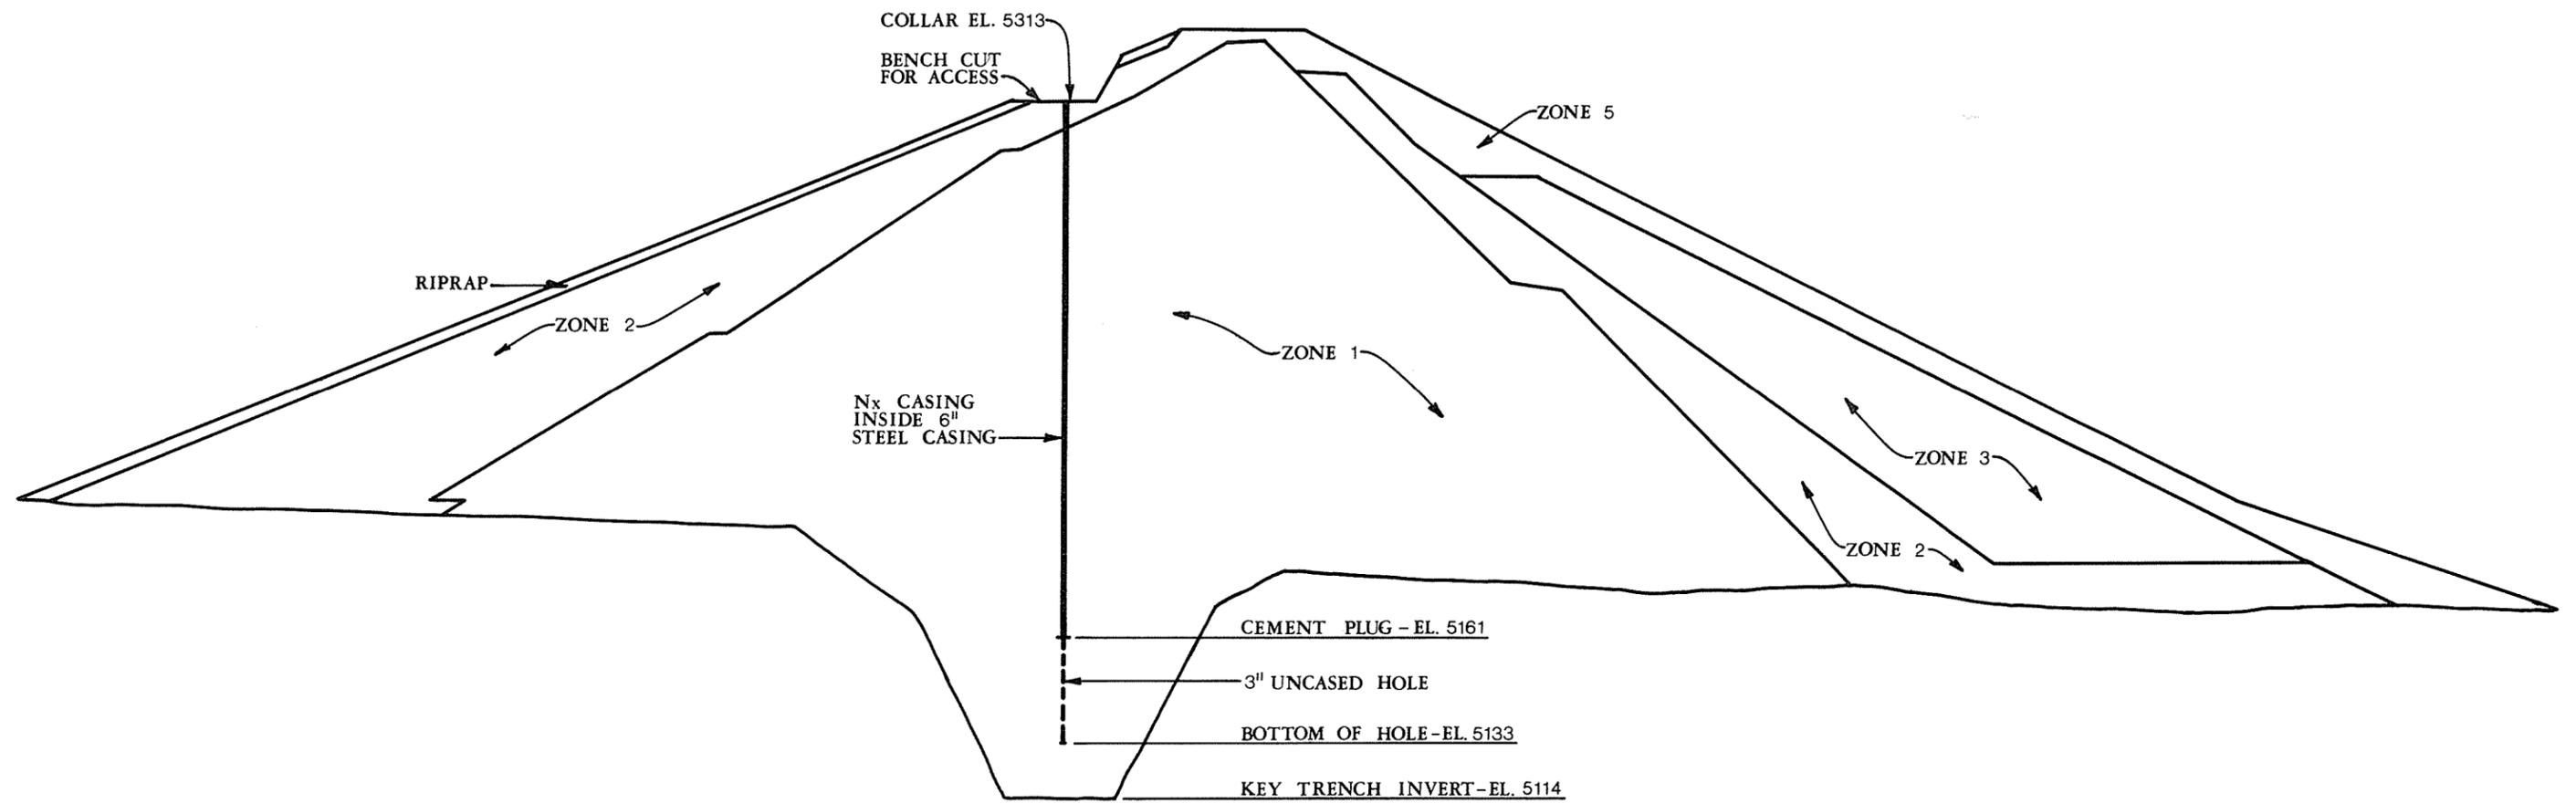
FIG. 3-6. U. S. DEPARTMENT OF THE INTERIOR — STATE OF IDAHO  
INDEPENDENT PANEL TO REVIEW CAUSE OF TETON DAM FAILURE

At Sta. 26+00 it was believed that the hole could be safely wash-bored to 150 ft and the plug set at that depth (Fig. 3-6). However, at 101.3 ft (El. 5211.7) a sudden loss of drill water occurred. Fracturing is believed to have occurred at that elevation and head. Through a misunderstanding, drilling of the hole continued to a depth of 150 ft with continued loss of drilling water and the injection of several thousand gallons of water into the adjacent soil. A 3-in. plastic pipe was sealed in the hole with the cement plug and the hole was extended for 39 ft beyond by drilling with air. Soil wetted by the previous drill water loss became lodged behind the drill bit and in forcefully freeing the drill string the plastic pipe was pulled from the plug. The hole was temporarily abandoned.

The hole at Sta. 26+00 which had been originally cased to 150 ft with 6-in. casing was restored by sealing Nx casing with a new plug at 152 ft and by cleaning out the original 39-ft-long hole extension with the split spoon drive sampler for 28 ft. The hole was then tested. Although some sloughing of the hole may have taken place during the test, the average head was assumed measured to the midheight of the restored hole, or El. 5147. The results are shown on Fig. 3-8 and indicate that the Zone 1 fill was fractured when the water surface was 20 ft below the top of the hole, or El. 5293.

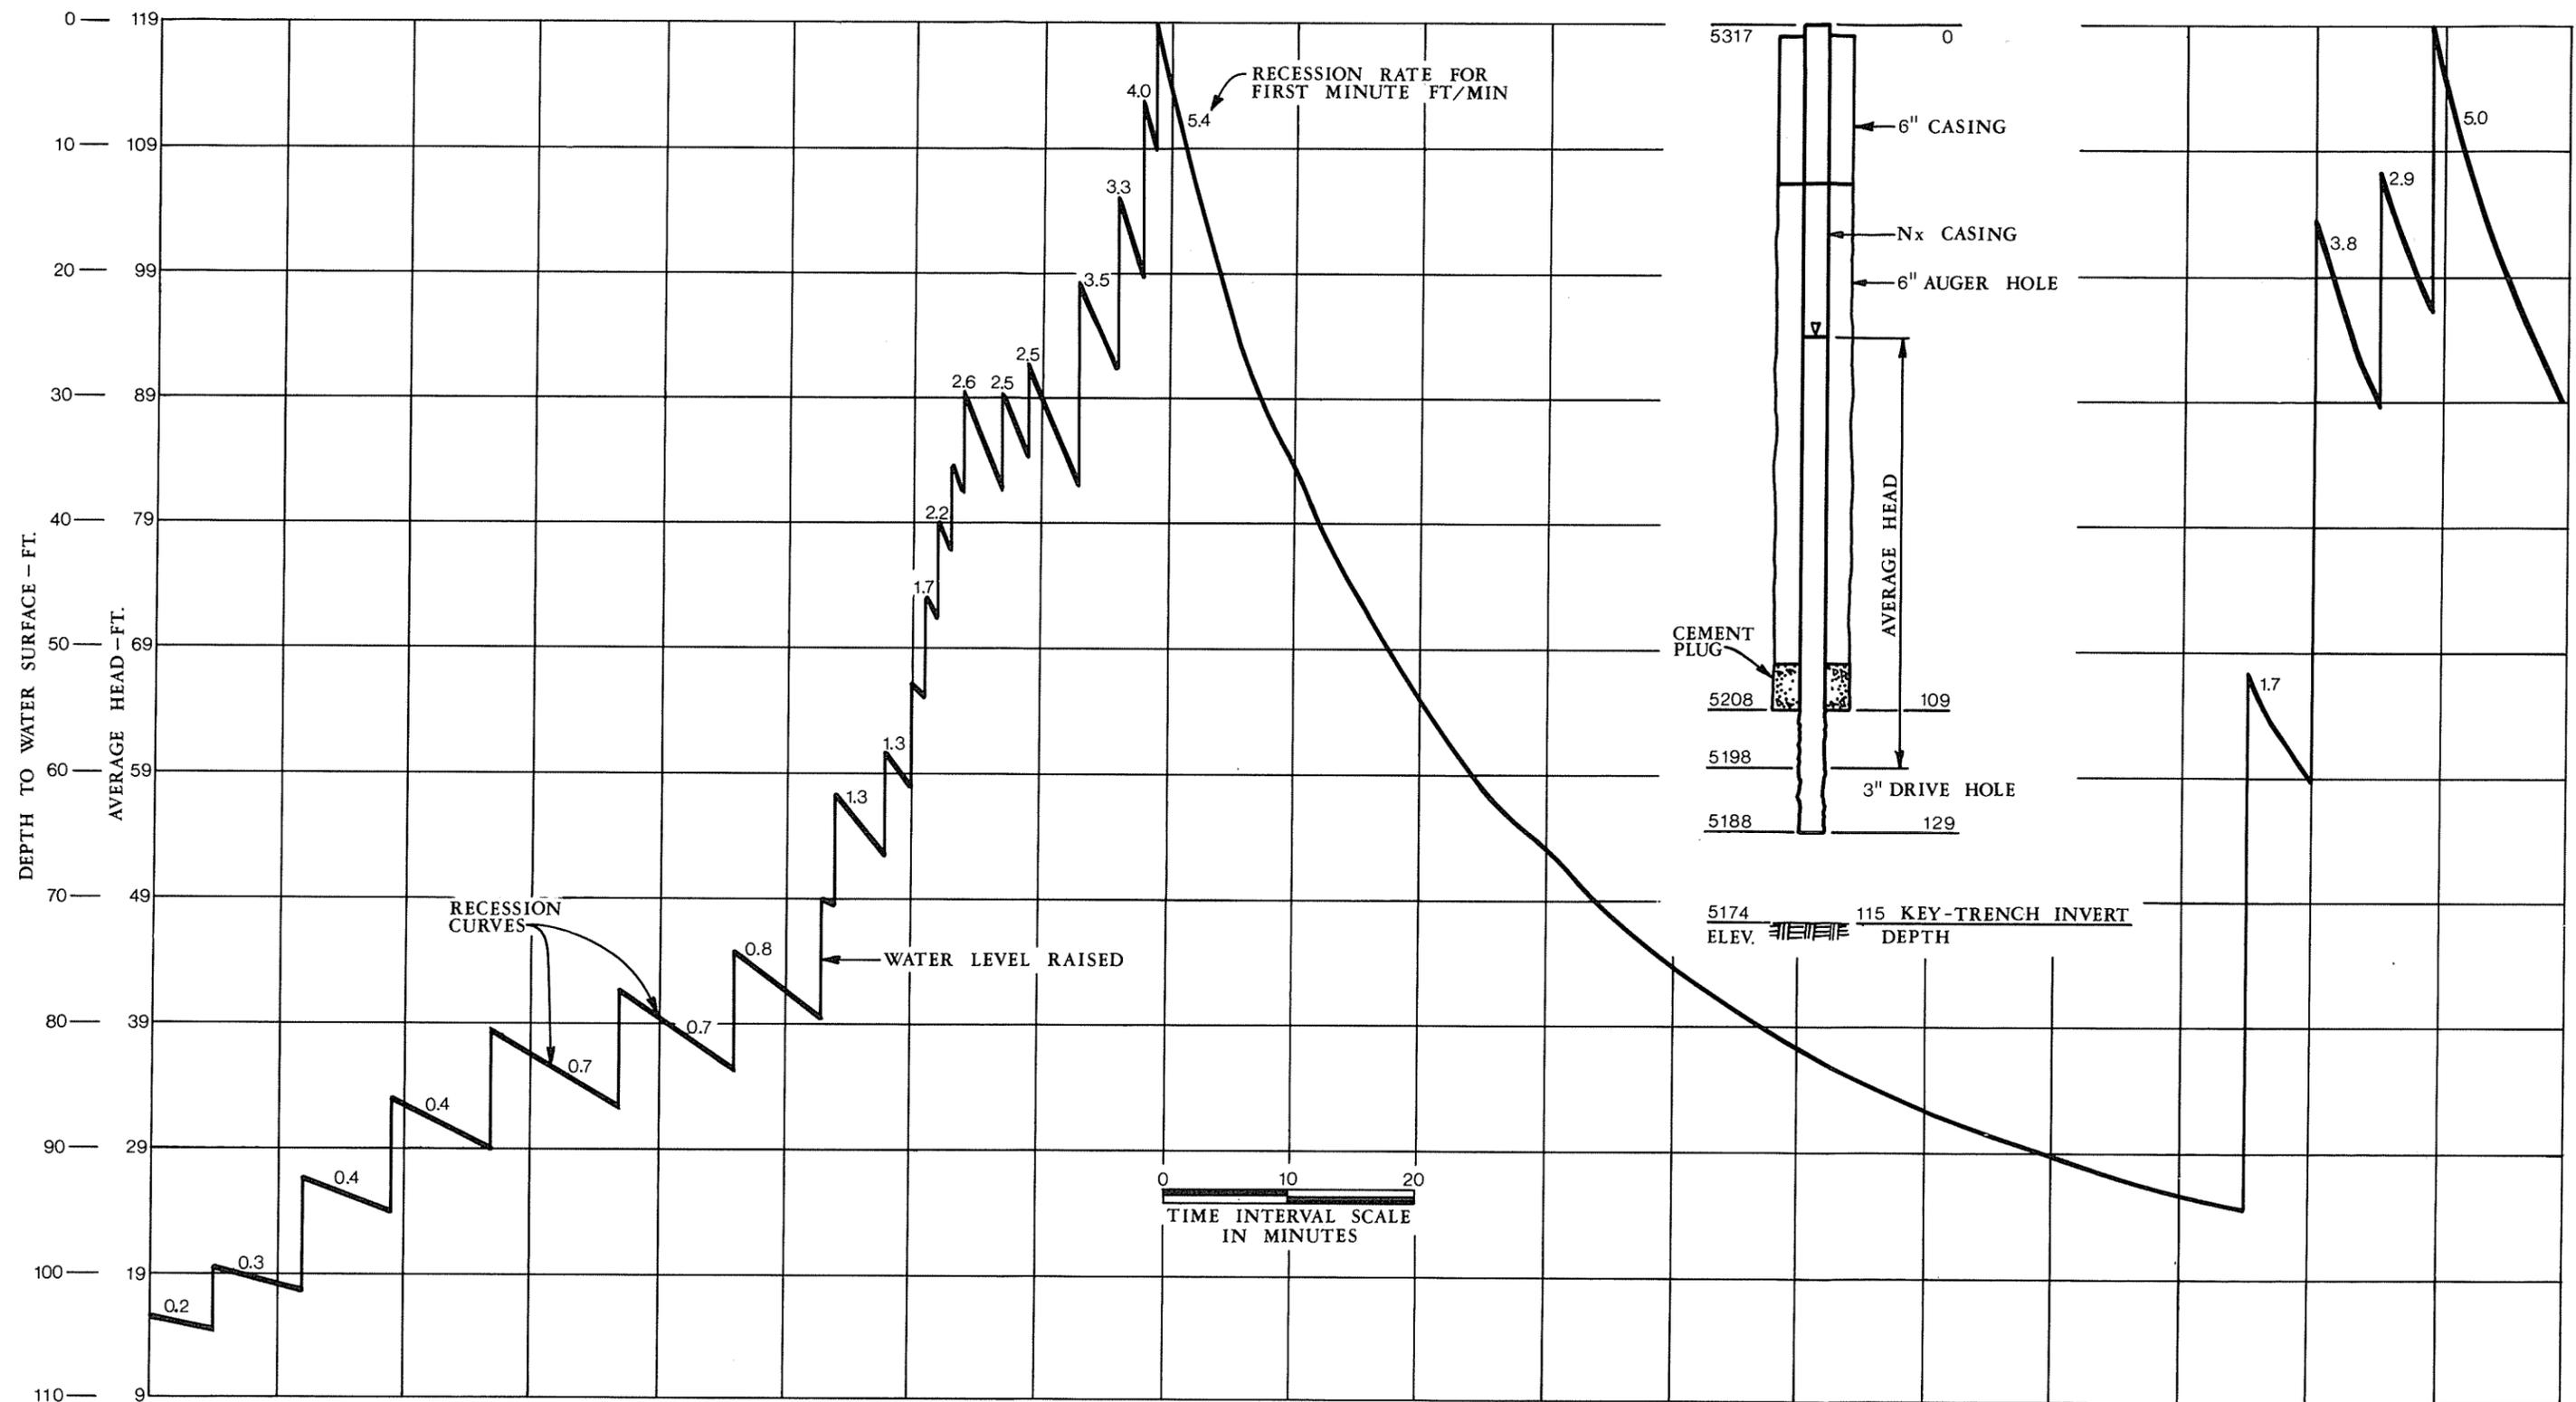
FIG. 3-7.

Because Sta. 13+70 had also been analyzed and because Sta. 27+00 was analogous, a third test hole was located at that station and augered 109 ft to El. 5210. Nx casing was sealed in the hole at that elevation, and the hole was extended 20 ft with a split spoon drive sampler. The hole was then incrementally pressured as previously described. The test results are shown on Fig. 3-7.

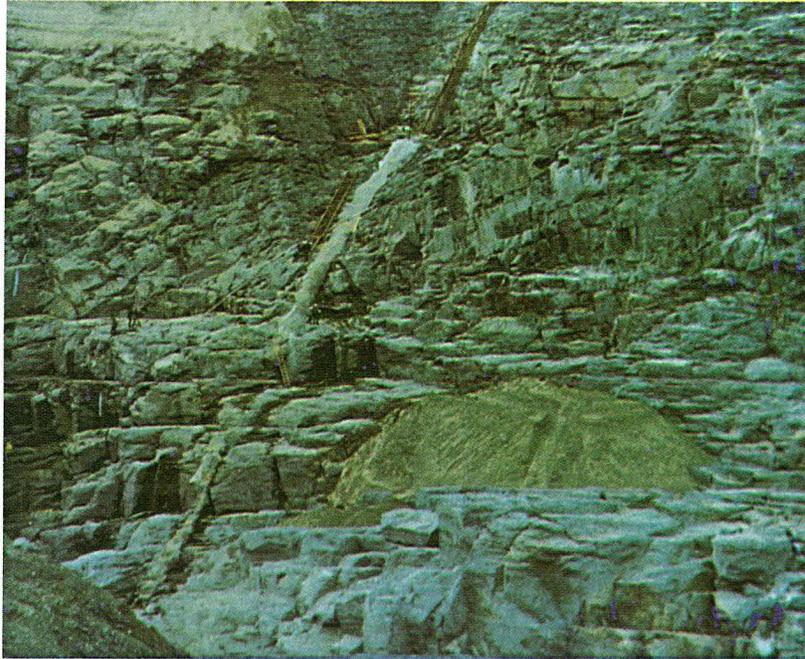
The removal of all the loose soil covering the right abutment revealed the post-failure condition of the grout cap (Fig. 3-9). The cap was found intact and continuously in position from the spillway to Sta. 13+96. Between Stas. 13+96 and 14+26, the cap was entirely missing (Fig. 3-10). However, the original rock invert of the trench in which the cap concrete had been placed was undisturbed, as shown by the preservation of the original line drill holes. Three prominent, nearly vertical joints, striking approximately N20°W, cross this gap, the ends of which appeared to be determined by the presence of the two joints at the ends of the gap (Fig. 3-11). A 2-in. open vertical fracture striking S68W (Fig. 3-12) crosses the alignment beneath the cap at Sta. 13+90. This fracture was ponded for a joint transmissibility test and is identified as U13 in Table 3-1.

**Fig. 3-9** Post-failure exposure of the grout cap

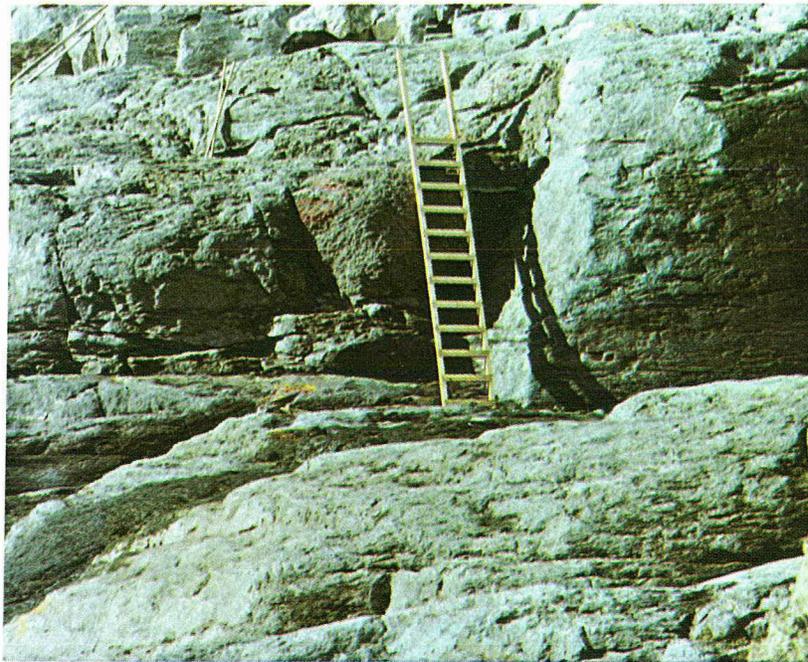
**Fig. 3-10** Grout cap severed at Sta. 13+96 and missing to Sta. 14+26. Open fracture shown in Fig. 3-12 is behind the ladder

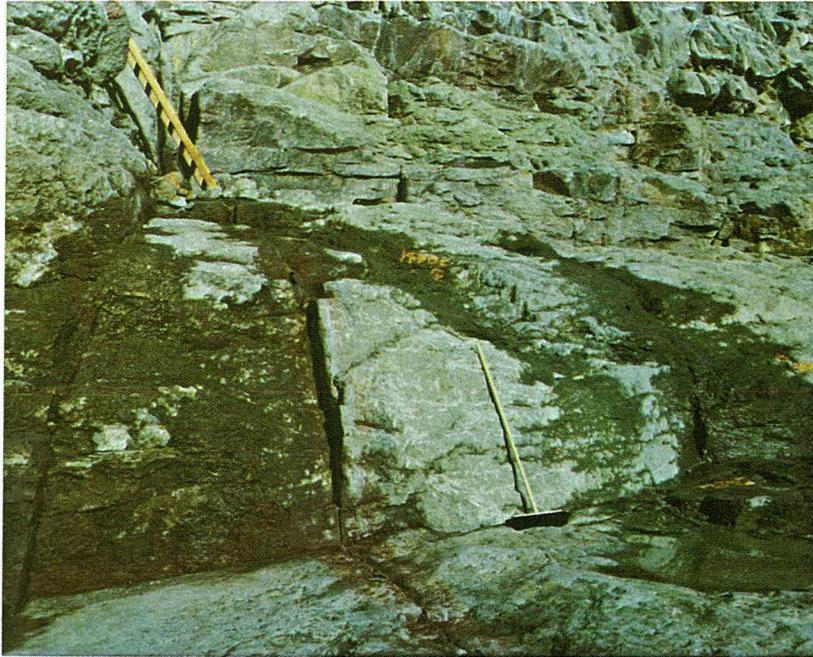
**Fig. 3-11** Three vertical joints crossing alignment where grout cap is missing between Stas. 13+96 and 14+26

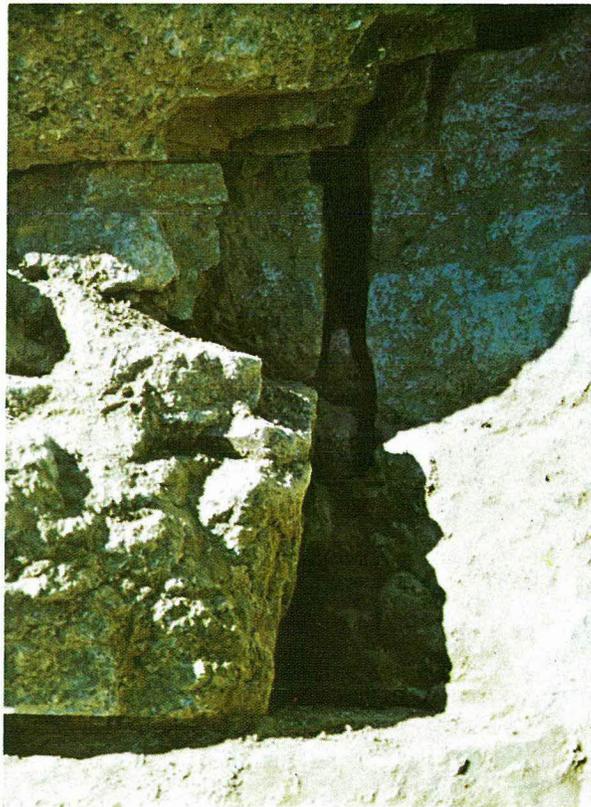
**Fig. 3-12** 2 in. open fracture crossing grout cap alignment near Sta. 13+90 (see Fig. 3-10 for location)

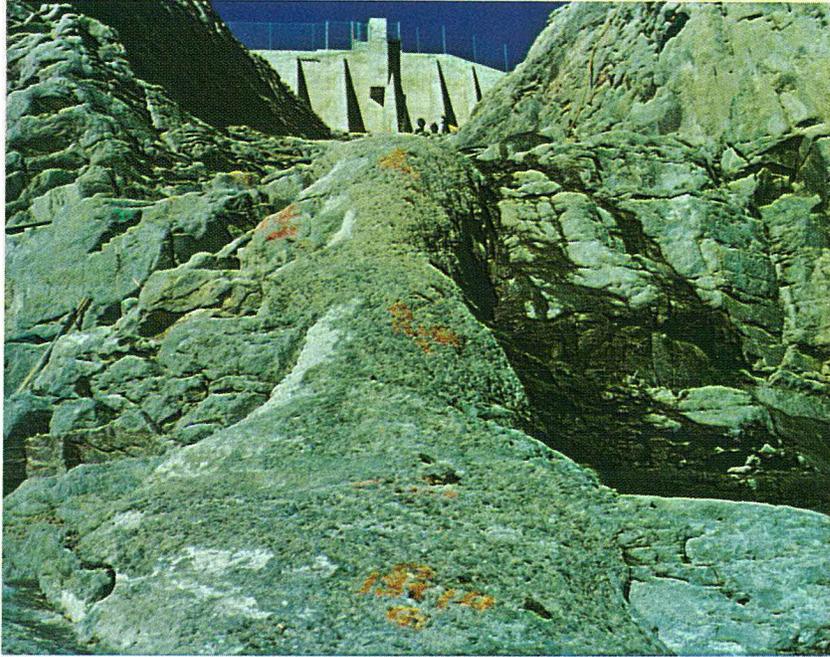
Between Stas. 13+30 and 13+96 (Figs. 3-13, 3-14, and 3-15) where the original side walls of the key trench were washed away during the failure, the cap exhibited a remarkable degree of resistance to the failure forces as evidenced by the large amount of rock plucking immediately adjacent both upstream and downstream and the surface erosion of the concrete.

**Fig. 3-13** Rock structure along grout cap alignment Stas. 13+30 to 13+96

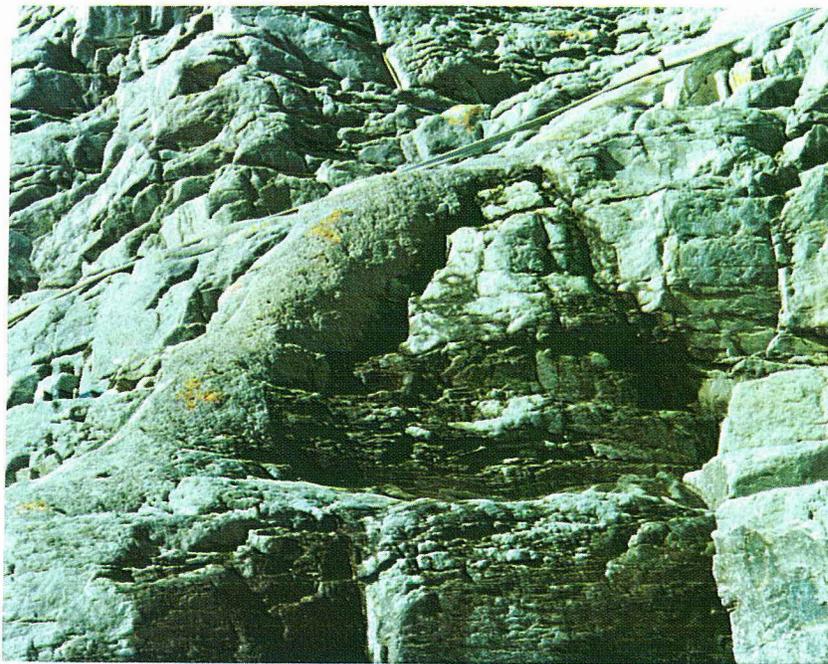
**Fig. 3-14** Rock structure along grout cap alignment Stas. 13+30 to 13+96, upstream profile

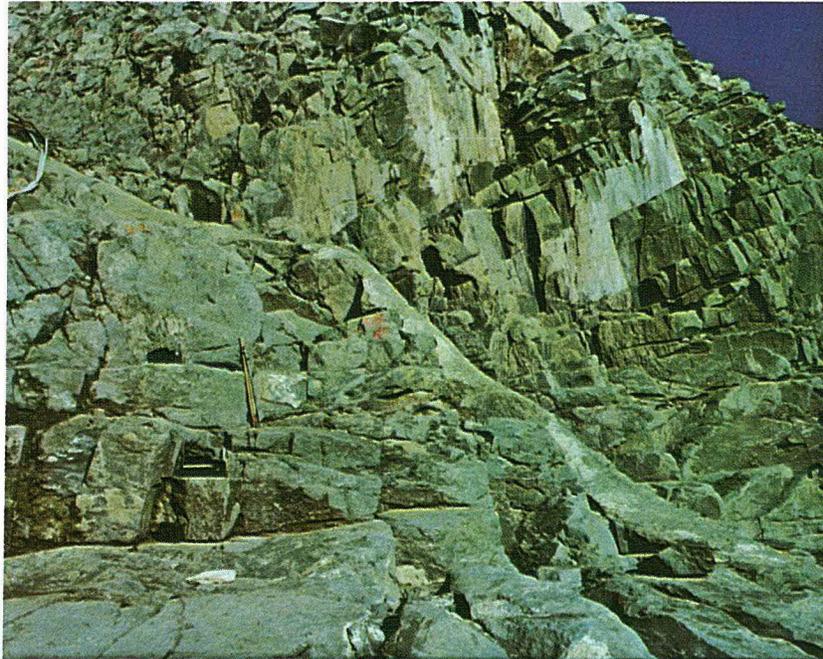
**Fig. 3-15** Rock structure along grout cap alignment Stas. 13+30 to 13+96, downstream profile

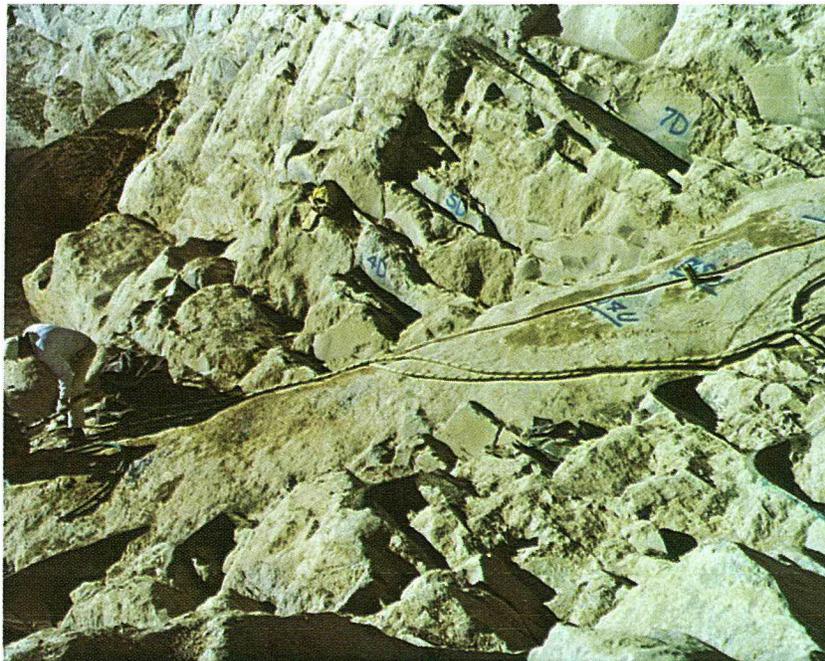
**Fig. 3-16** Test ponds for joint transmissibility tests, looking downstream

The transmissibility characteristics of the rock foundation at the grout cap were first tested under a low gravity head by constructing small impoundments with mortar and stone over selected joints and fractures (Fig. 3-16). The ponds and joint traces were cleaned with air and water. The volume of the ponds and any loss rates were determined by metering water into the ponds. The dip, strike, and submerged length of each joint were measured. Twelve ponds were prepared upstream and four downstream of the grout cap between grout cap Stas. 12+93 and 13+96 (Fig. 3-17). These ponds were not in contact with the cracks in the grout cap. Also, as previously reported, one vertical joint (U13) where exposed by rock plucking over a considerable height below the top of the grout cap near Sta. 13+90 was tested by constructing a vertical riser against the rock face and about the joint (Fig. 3-18). The loss rate results and associated data for these tests are shown in Table 3-1.

The tests revealed that water could pass freely through the shallow joints and fractures beneath the grout cap at several locations in the vicinity of grout cap Stas. 13+27, 13+30, and 13+90 under the low gravity heads imposed by the tests.

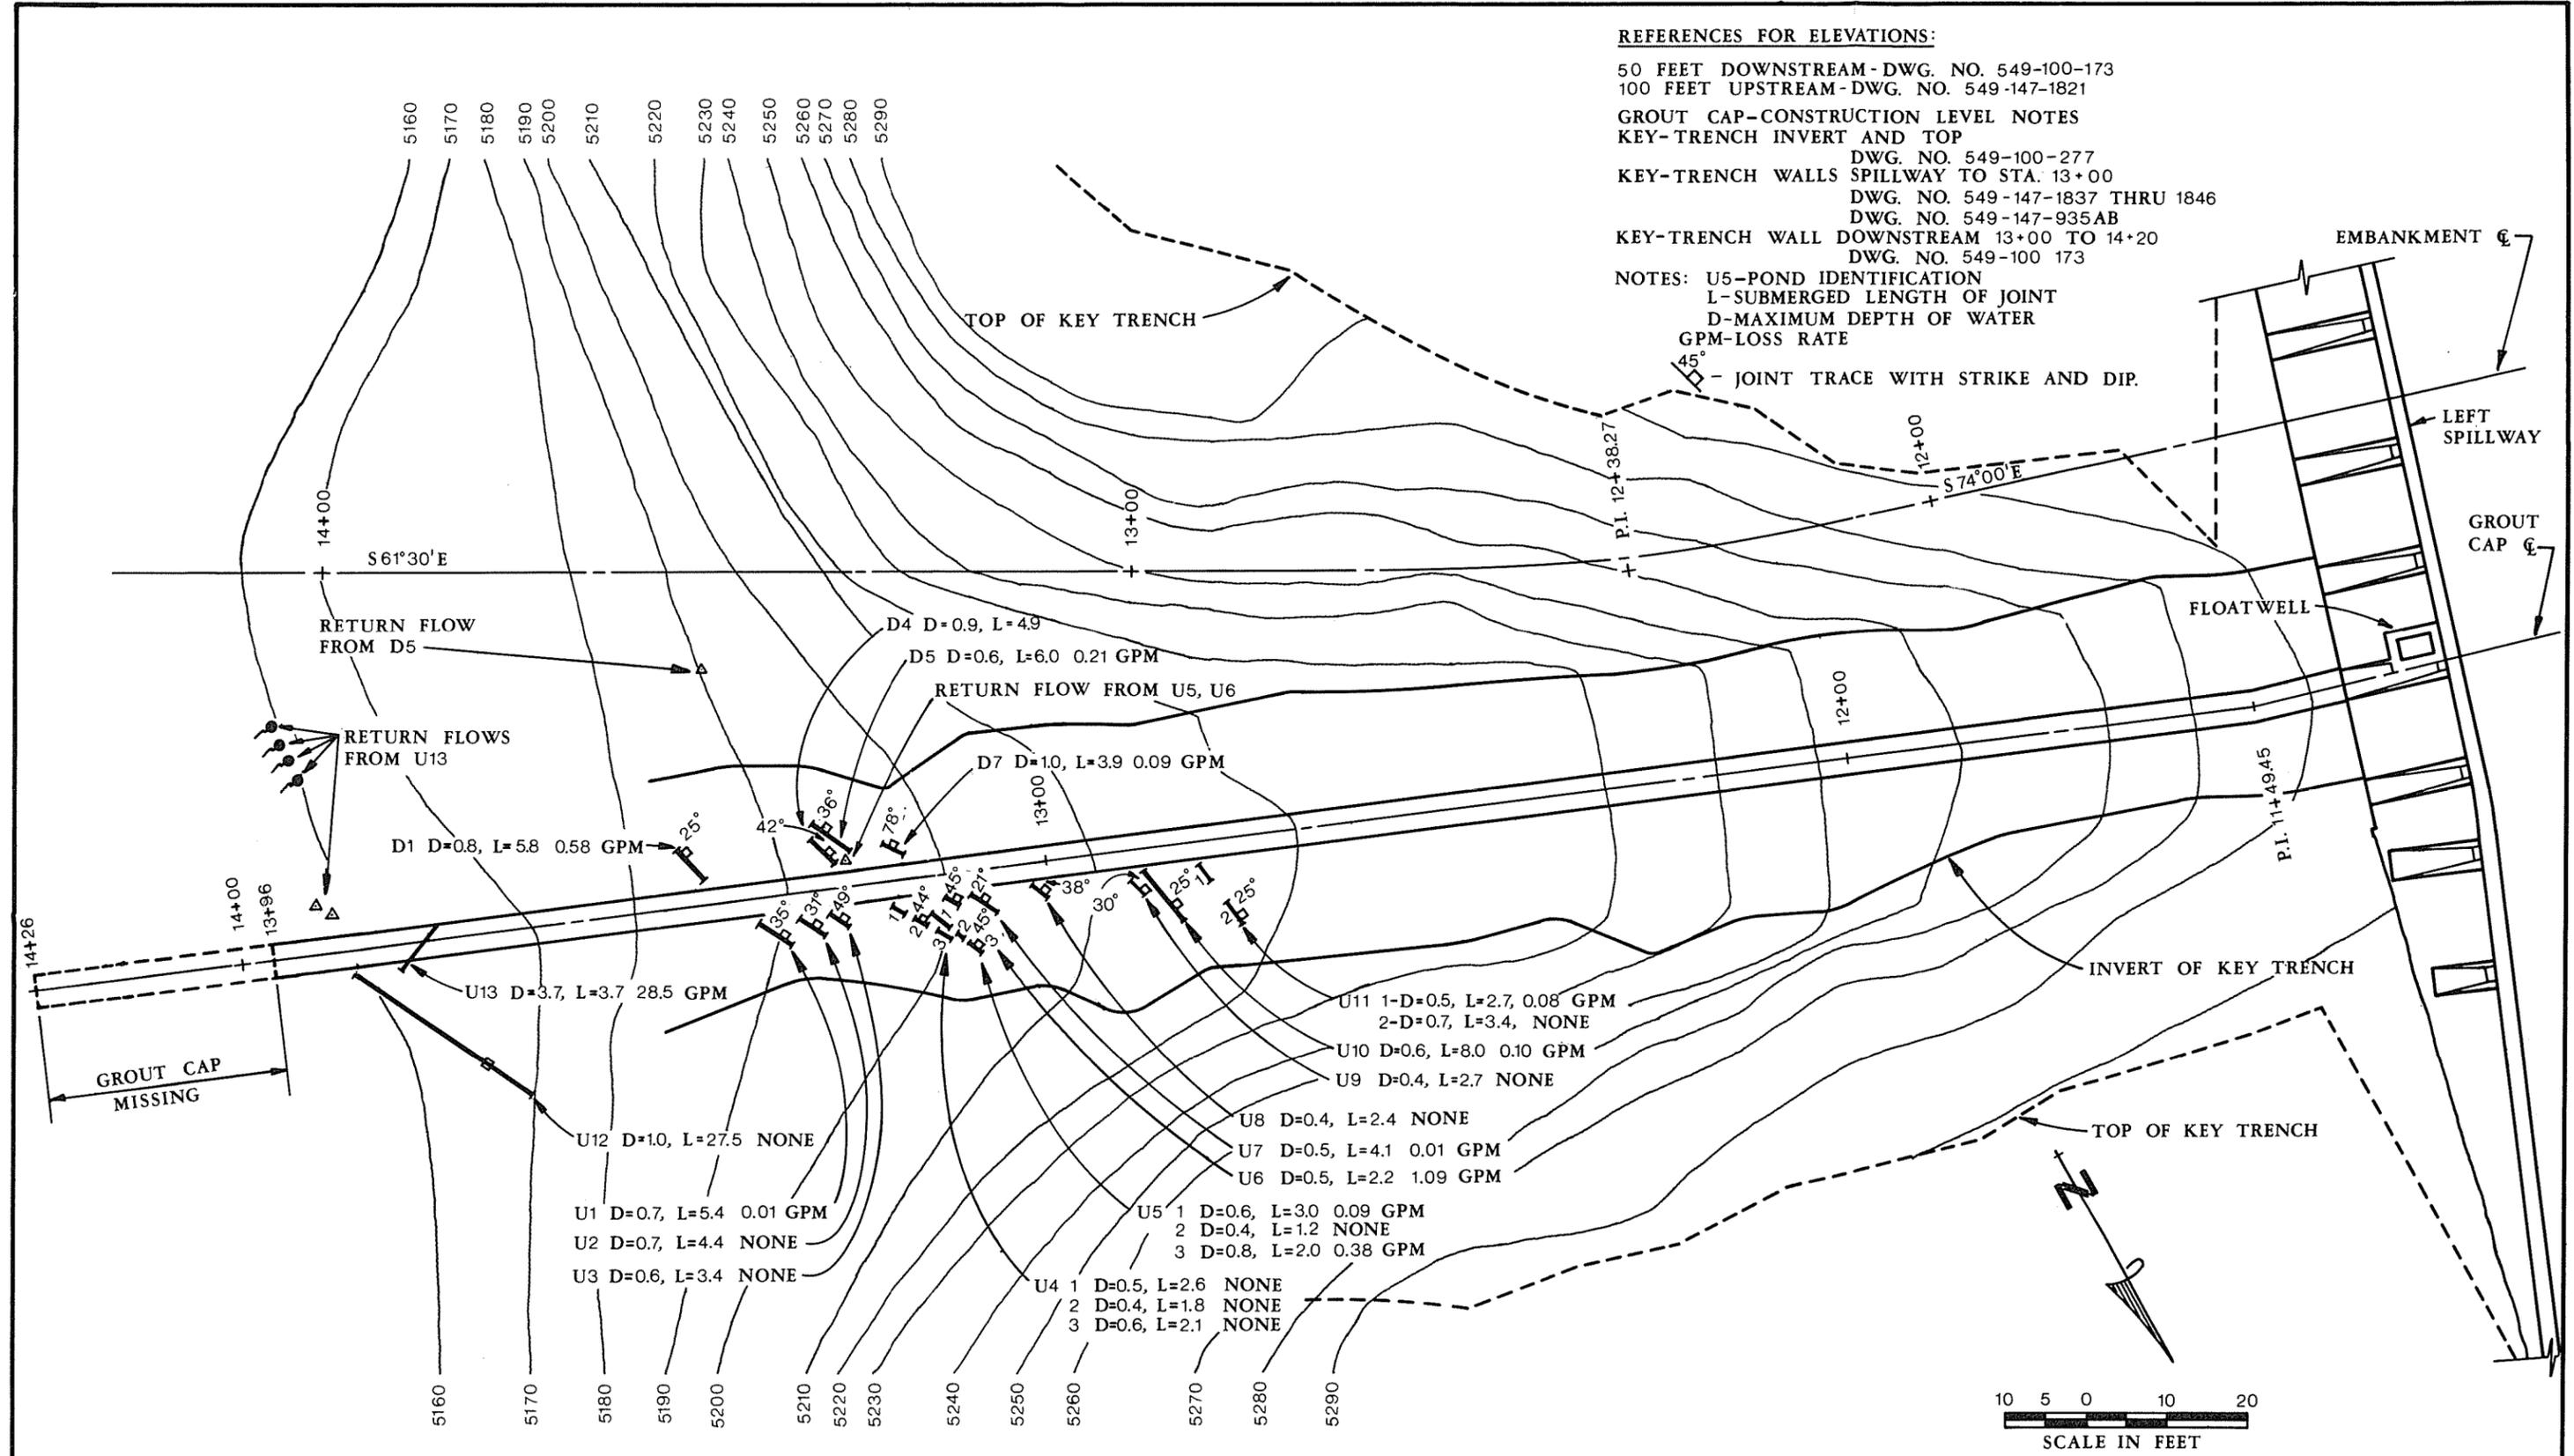
**FIG. 3-17**

**JOINT TRANSMISSIBILITY TESTING**

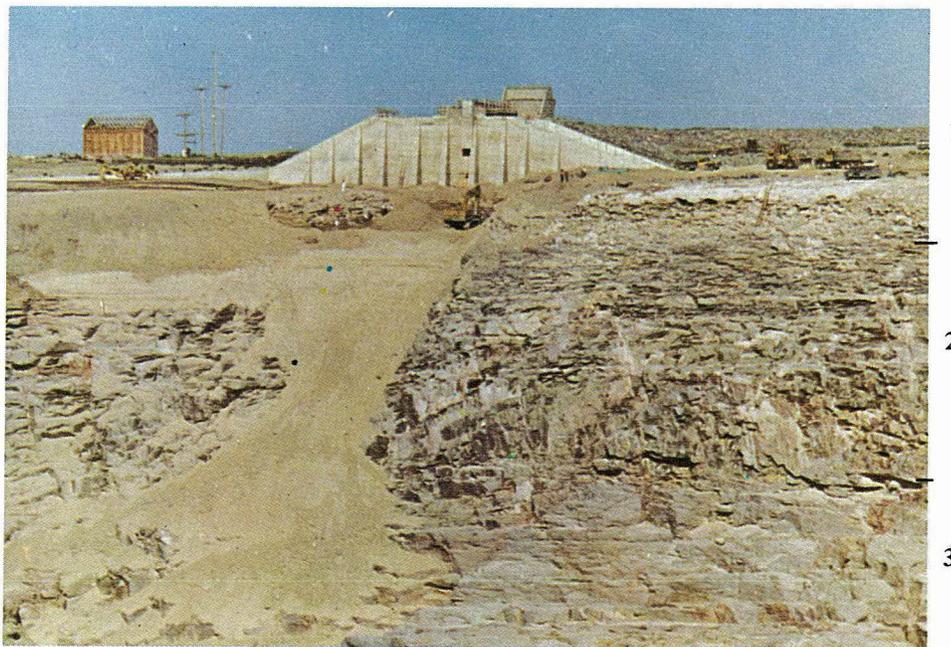
The three separate units of welded ash-flow tuff identified in the right wall of the canyon upstream of the dam are apparent in Fig. 5-9. They are described as follows:

**Fig. 5-9** The ash-flow tuff upstream of dam axis is divided into three units (post-failure photo)

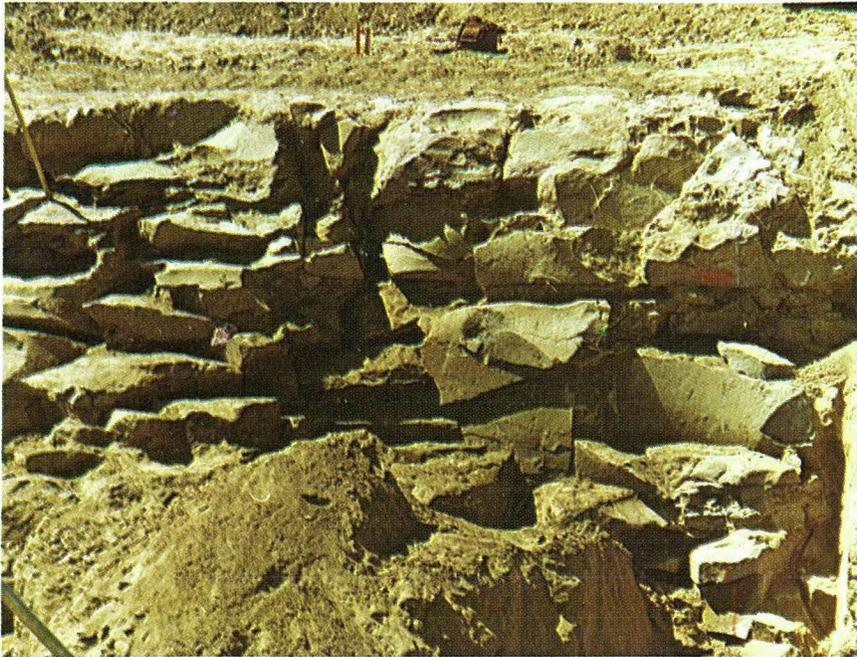
Unit 1, the uppermost layer, consists of lenticular and tabular plates mainly 2 to 6 in. thick, but some are up to 18 in. thick (Fig. 5-10). The plates are nearly horizontal and parallel the joint foliation in the rock. Open partings between plates are  $\frac{1}{4}$  in. to 2 in. wide. Some are coated with calcite layers up to  $\frac{1}{4}$  in. thick. Caliche and silt fill some of these openings in the upper 5 to 6 ft of the unit. High angle joints are scarce.

**Fig. 5-10** Slab-like structure in Unit 1 of ash-flow tuff exposed in rim of downstream wall of keyway in right abutment. (post-failure photo)

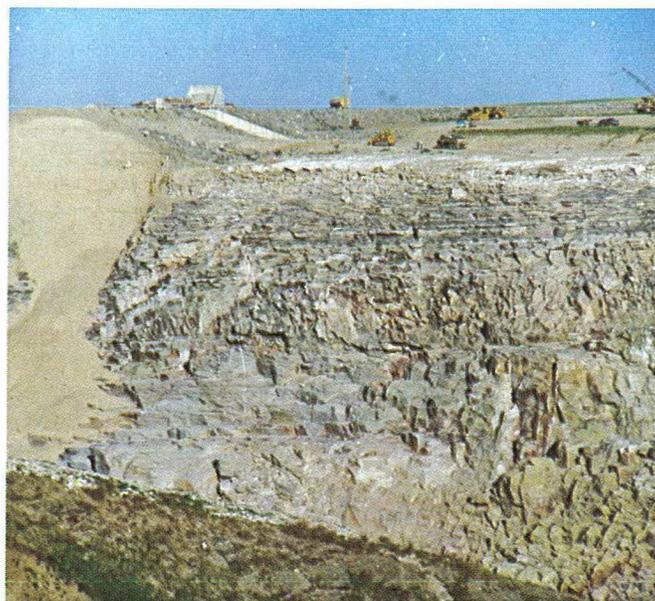
UNIT 2

**Fig. 5-11** Joint pattern in Unit 2 of ash-flow tuff, right wall of canyon upstream from key trench. (post-failure photo)

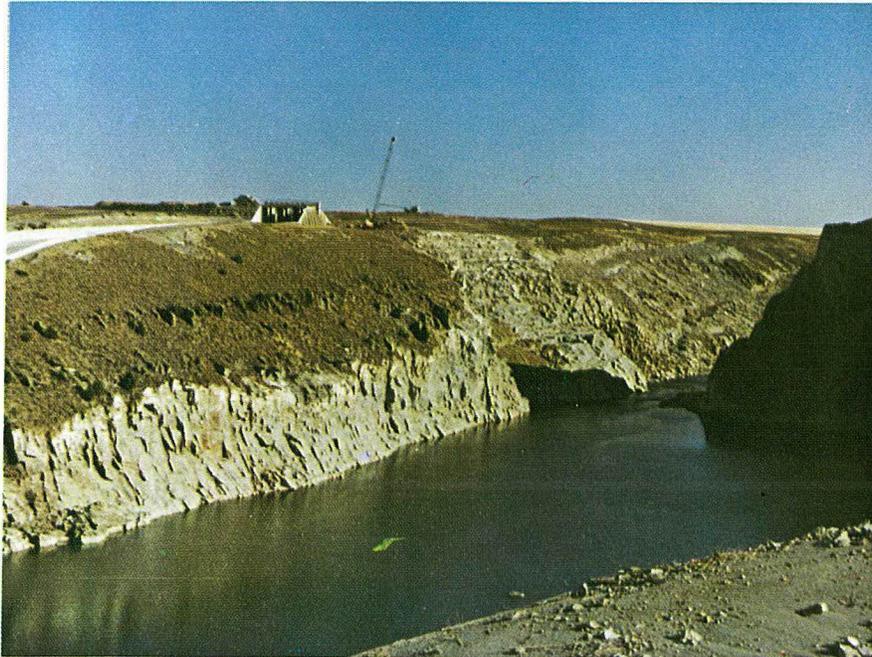
**Fig. 5-12** Prominent vertical joints in right wall of canyon downstream of the axis of the dam. (post-failure photo)

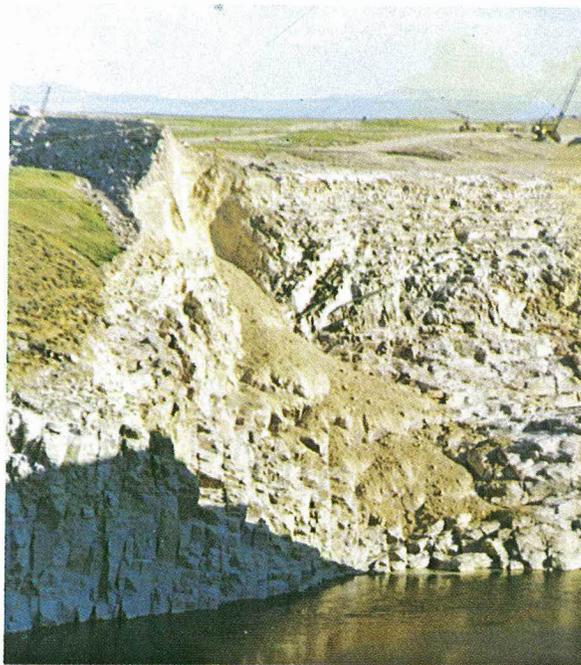
**Fig. 5-13** Transition from predominantly flat-lying to near-vertical jointing occurs near axis of dam. (post-failure photo)
