REPORT TO  
U.S. DEPARTMENT OF THE INTERIOR AND STATE OF IDAHO  
ON  
**FAILURE OF TETON DAM**

BY  
INDEPENDENT PANEL TO REVIEW CAUSE OF TETON DAM FAILURE

DECEMBER 1976

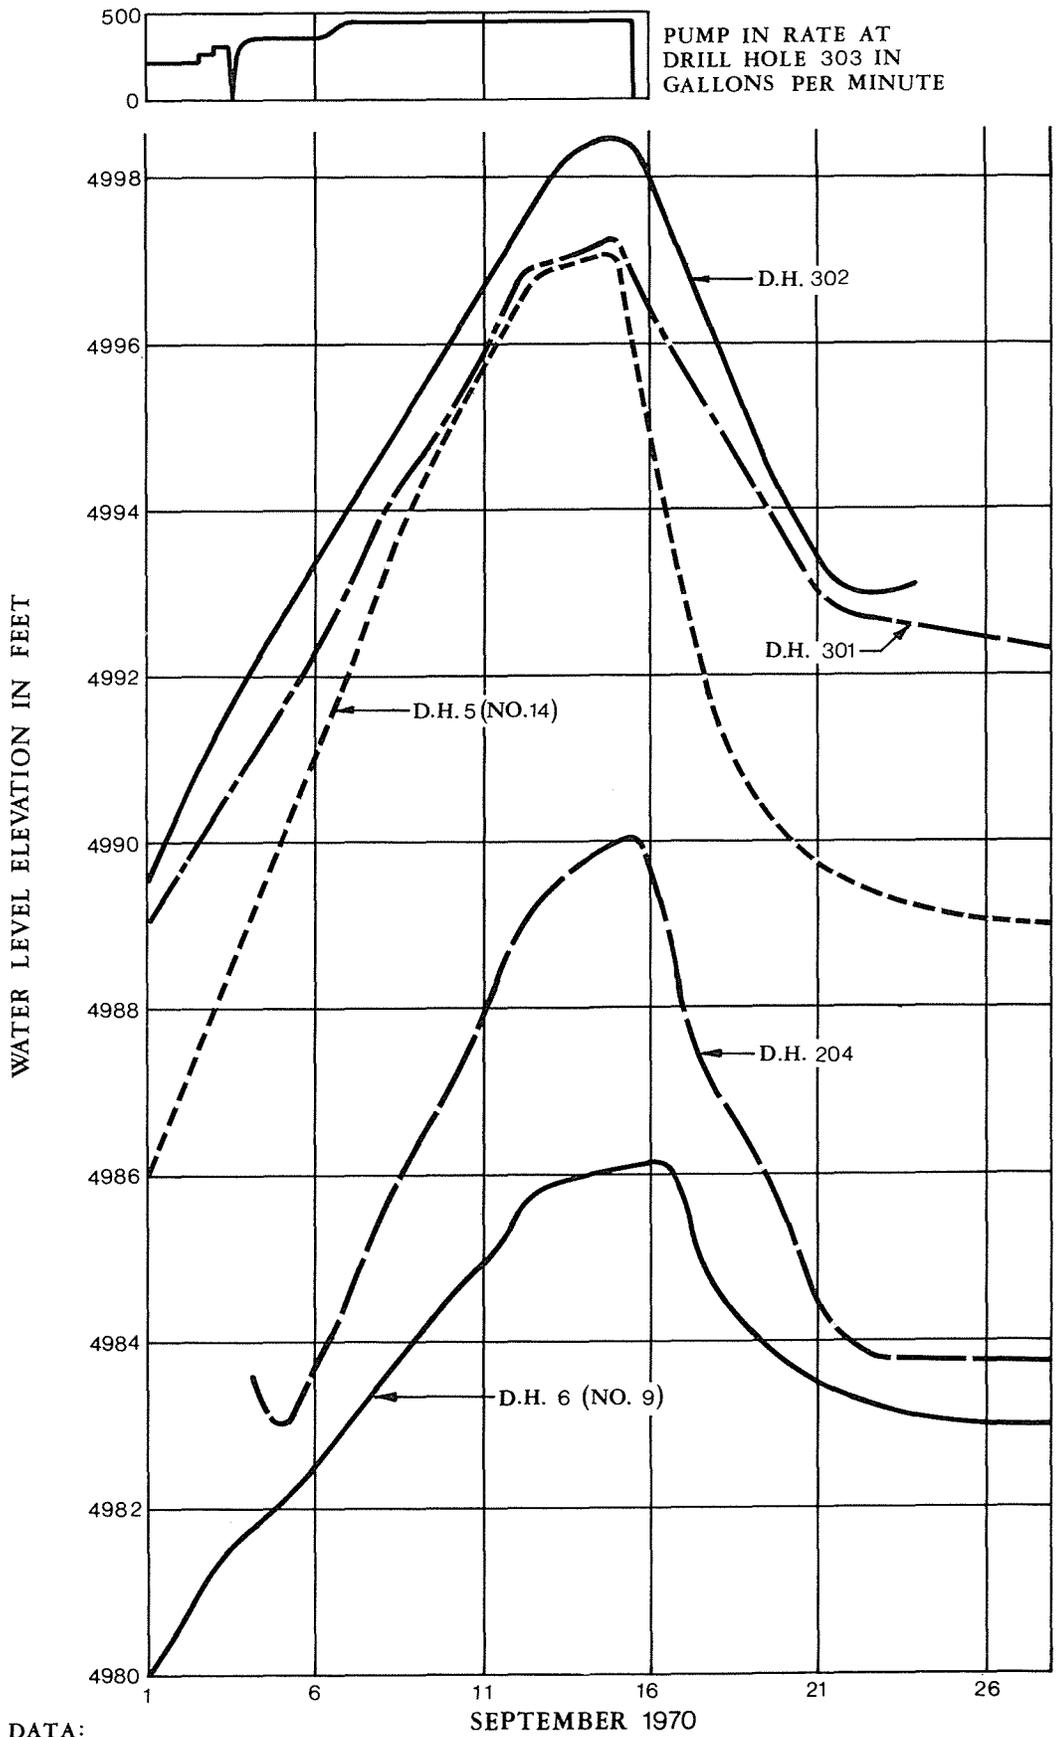
FIG. 5-14. U. S. DEPARTMENT OF THE INTERIOR — STATE OF IDAHO  
INDEPENDENT PANEL TO REVIEW CAUSE OF TETON DAM FAILURE

### EFFECT OF PUMP-IN TEST AT DRILL HOLE 303 ON WATER LEVELS IN NEIGHBORING DRILL HOLES

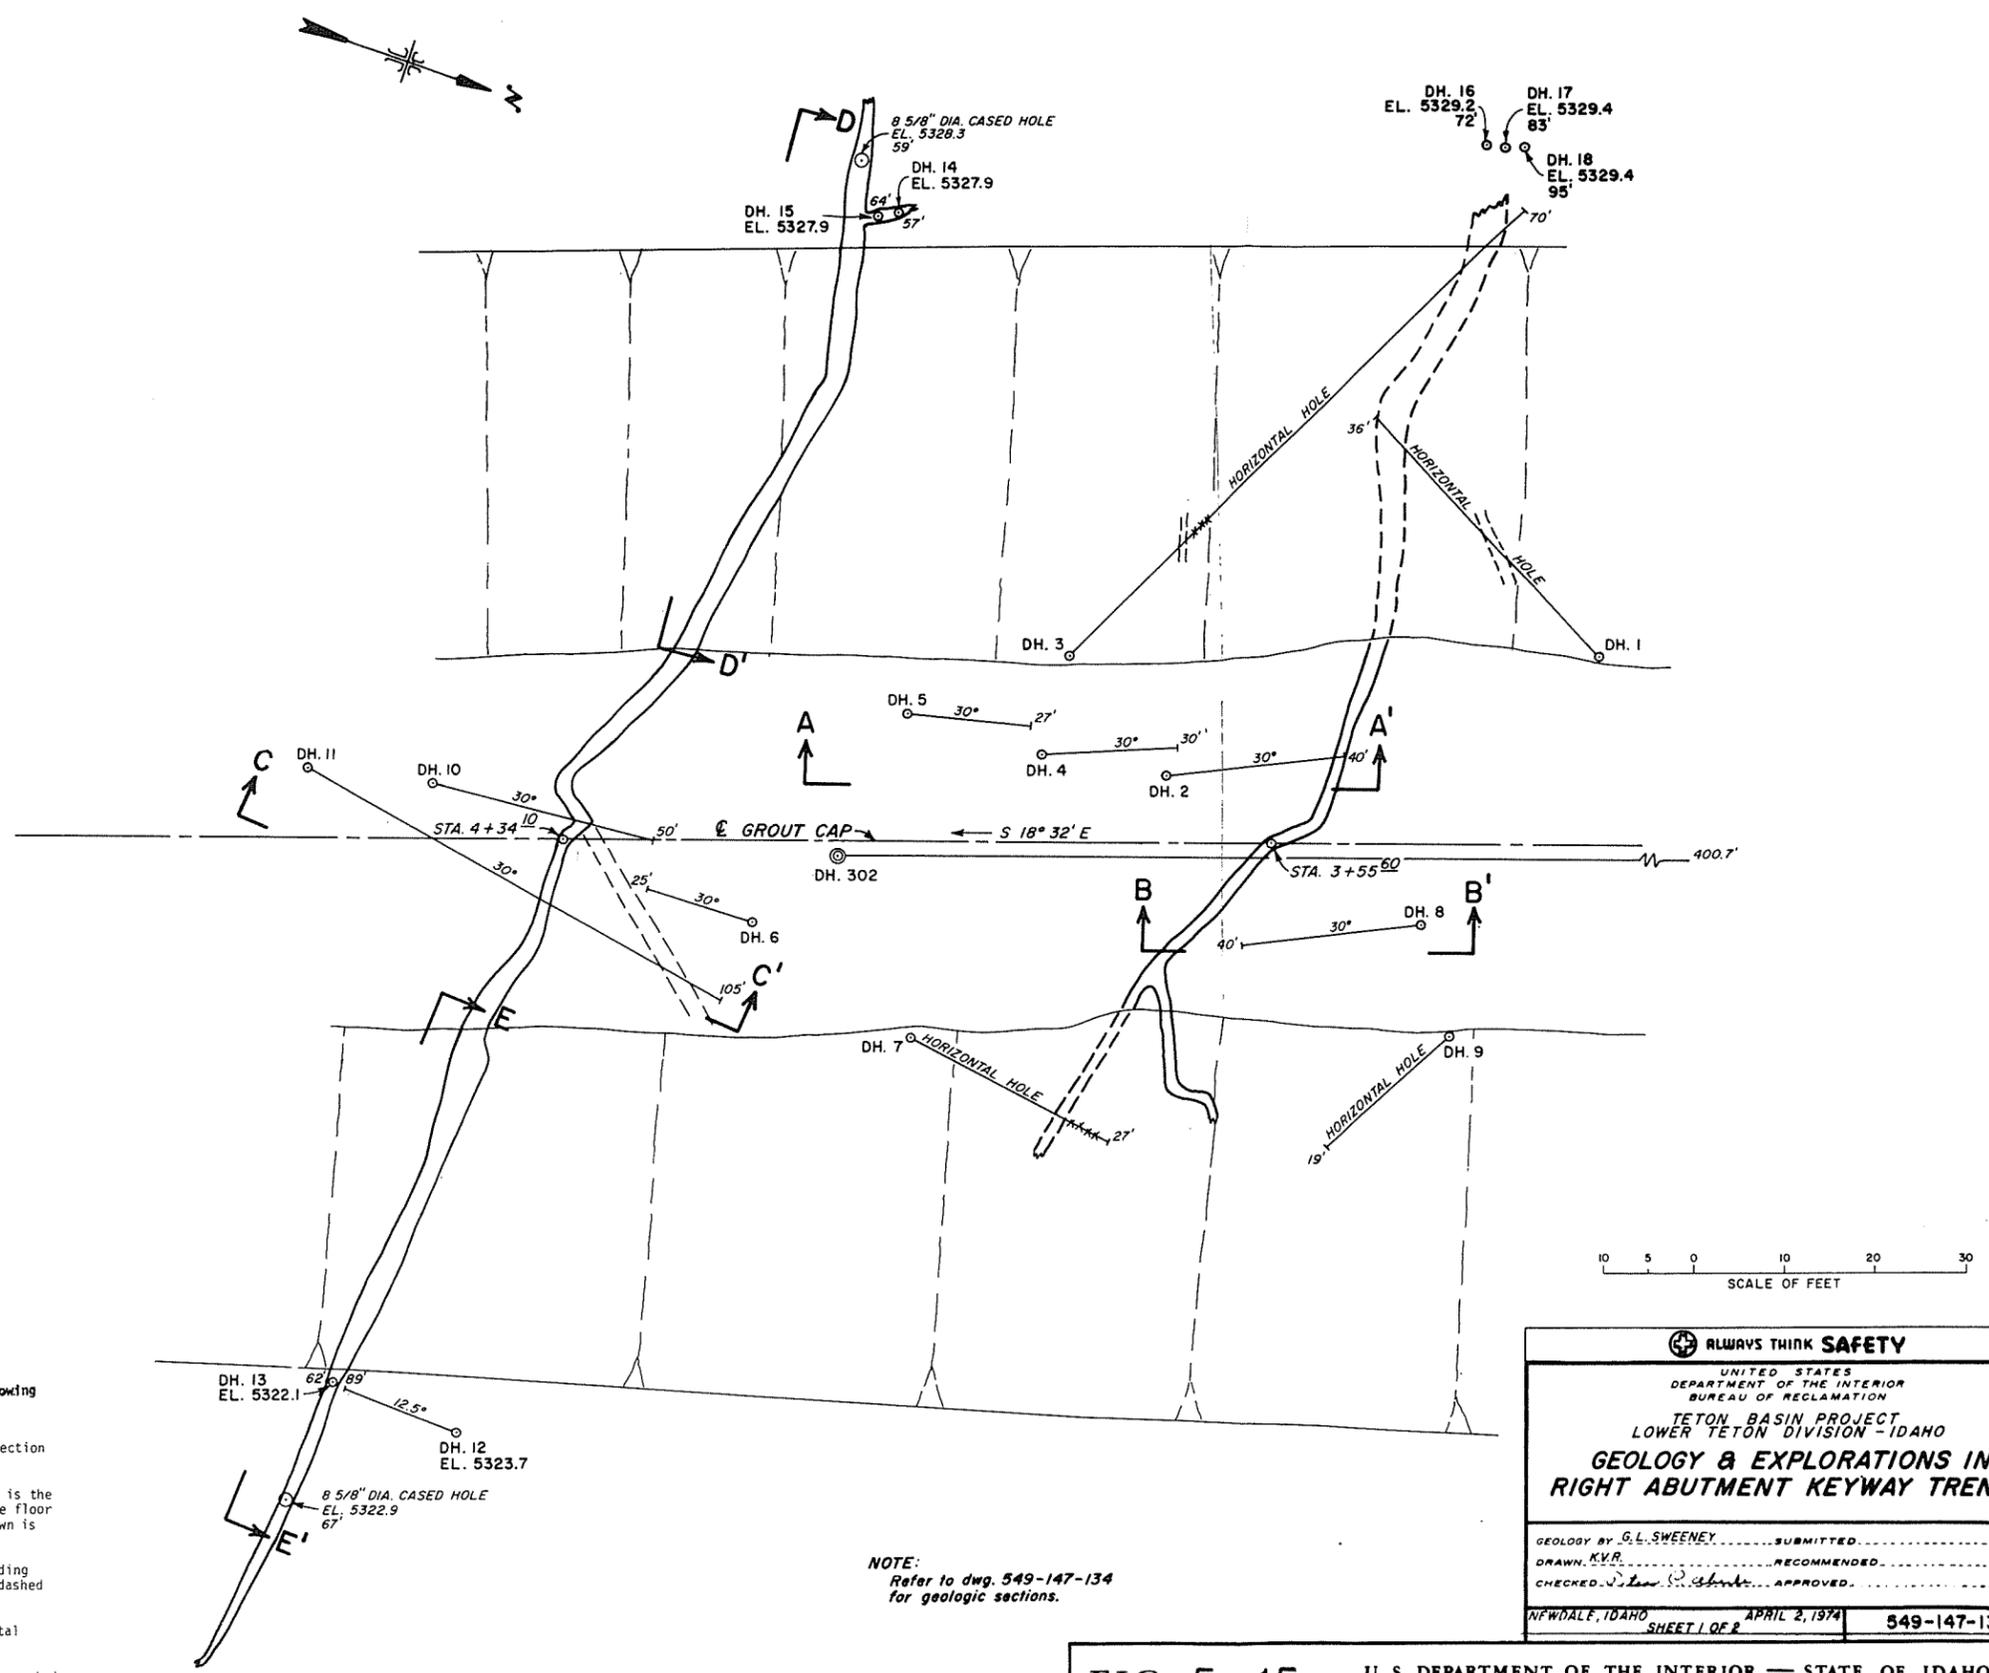
**FIG. 5-15.** U. S. DEPARTMENT OF THE INTERIOR — STATE OF IDAHO  
INDEPENDENT PANEL TO REVIEW CAUSE OF TETON DAM FAILURE

During excavation of the dam foundation, large openings were uncovered in left and right abutment key trenches. Near the right end of the dam, two large fissures were exposed near Stas. 3+55 and 4+34. These are shown in plan and cross-section in Figs. 5-15 and 5-16. Figs. 5-17 and 5-18 show the exterior and interior of the fissure near Sta. 4+34. Both fissures trend generally east-west and cross the axis.

Extensive fissures were exposed in the foundation of the dam during excavation for the key trench near Stas. 3+55 and 4+34. These are described in Chapter 5. Treatment entailed drilling 8-in.-diam holes into the cavities from ground surface through which high-slump concrete was poured, Figs. 5-15 and 5-16, Sections D-D<sup>1</sup> and E-E<sup>1</sup>.

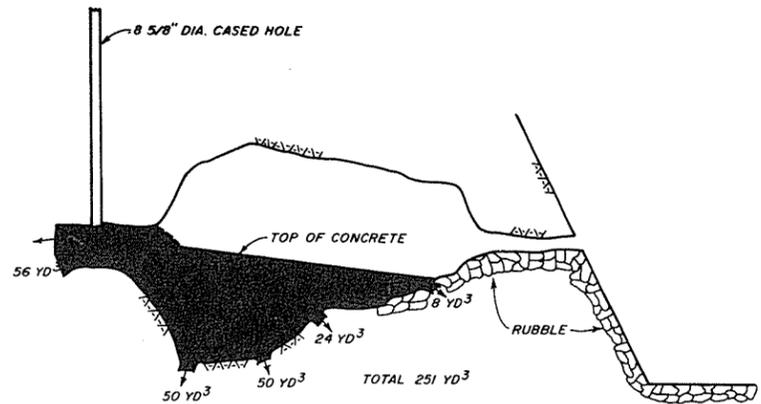
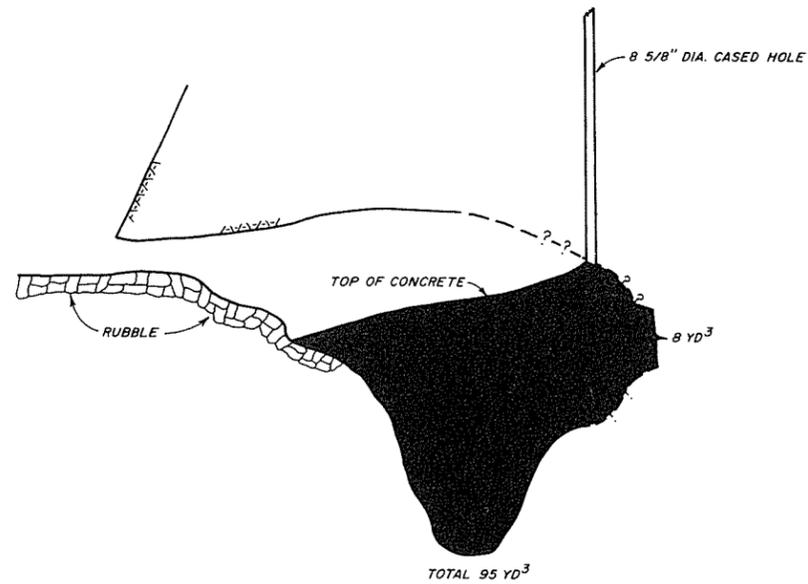
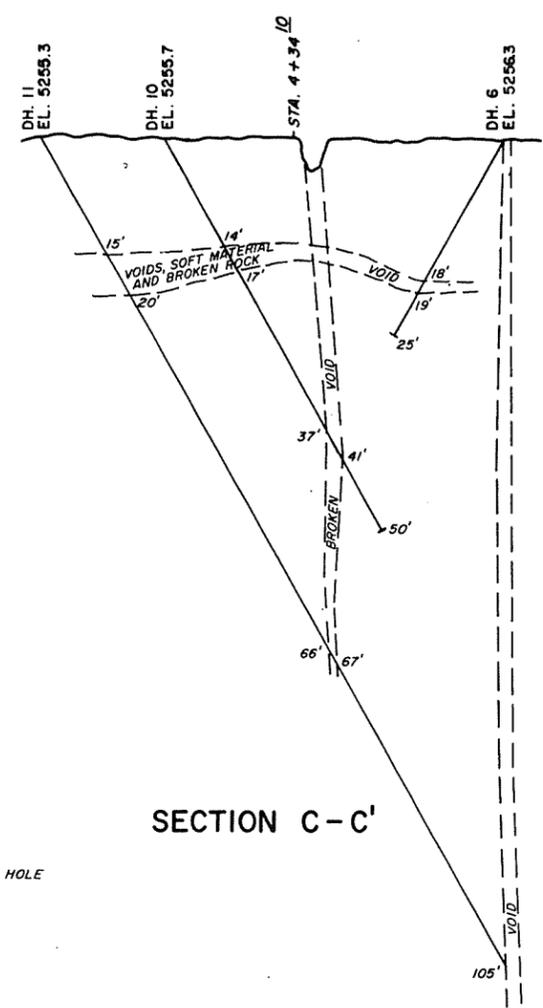
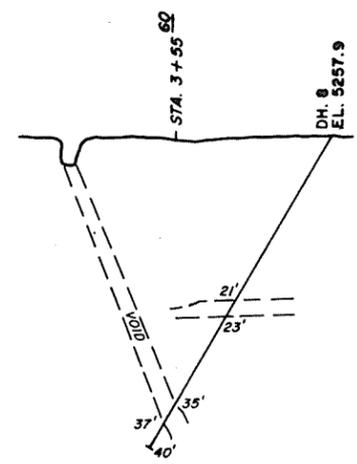
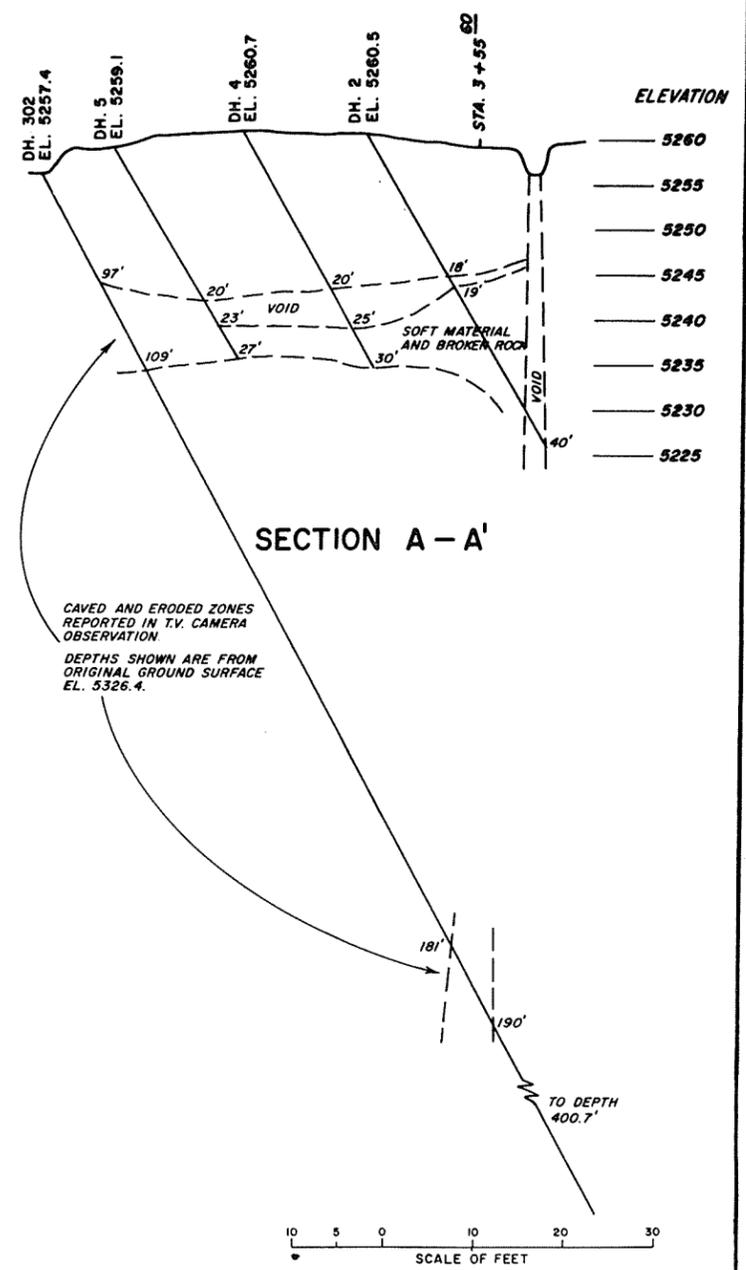
FIG. 5-16. U. S. DEPARTMENT OF THE INTERIOR — STATE OF IDAHO  
INDEPENDENT PANEL TO REVIEW CAUSE OF TETON DAM FAILURE

Rock outline in fissure openings estimated.

The interior of the fissure at Sta. 3+55 was not examined since it was too narrow to permit entry. High-slump concrete was poured into both fissures during project construction. (Fig. 5-16 and Appendix B document dated August 25, 1976.) The extent to which the uppermost parts of the cavities may have been sealed by this procedure is uncertain. However, the concrete-rock contact was drilled at three points during post-failure exploration, and in each instance the rock cores obtained displayed a tight bond between grout and rock (Chapter 3).

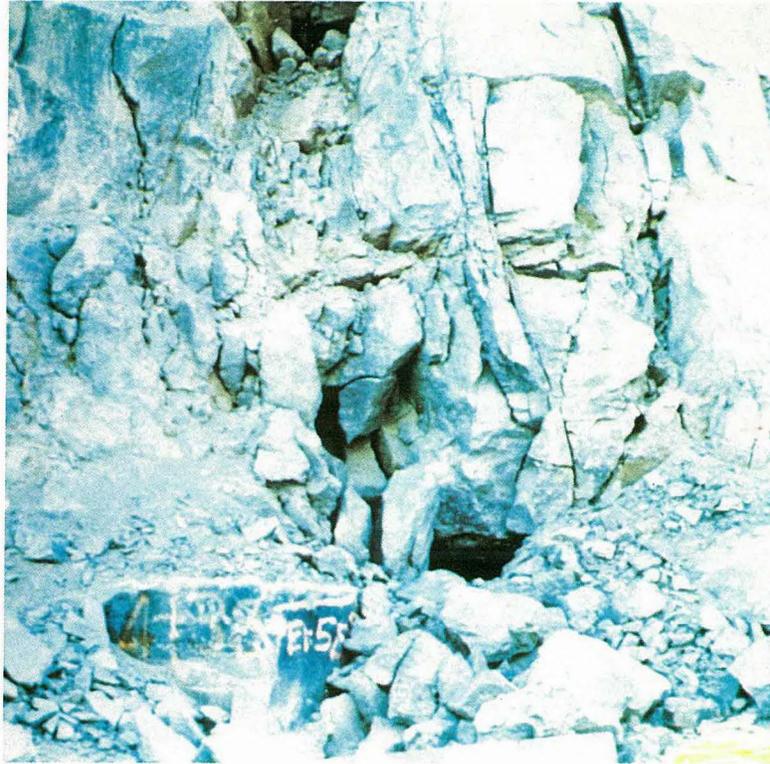
Fig. 5-17 Rock fissure near Sta. 4+34 discovered during excavation of key axis trench of the dam. Crevice extends through axis of dam for nearly 100 ft both upstream and downstream. (1974)

The fissure near Sta. 4+34 was entered and explored by a Bureau of Reclamation employee for a distance of about 100 ft both downstream and upstream of the dam axis and an estimated 100 ft below the key trench invert. An interview with him is summarized in a memorandum dated November 16, 1976, contained in Appendix B. He described the cavity downstream as fairly consistently about 4 ft wide with a floor strewn with angular blocks of rock measuring up to 4 or 5 ft on a side. Upstream from the keyway, the roof and floor of the cavity were reported lined with stalactites and stalagmites up to 3/8 in. in diameter. About 100 ft upstream from the keyway wall the fissure pinched and turned so that the end could not be seen. It was reported that in winter vapor could be seen emerging from the downstream segment and that this segment was warm and could be entered in winter without a coat. Conversely, upstream of the keyway the air was reported to be cold. The end of the downstream segment was blocked by a large rock "the size of a pickup truck." A room or passage could be seen beyond, but the opening into it was too small to enter. In one place the cavity walls were described as covered with a red coating "which rubbed off on our clothes."

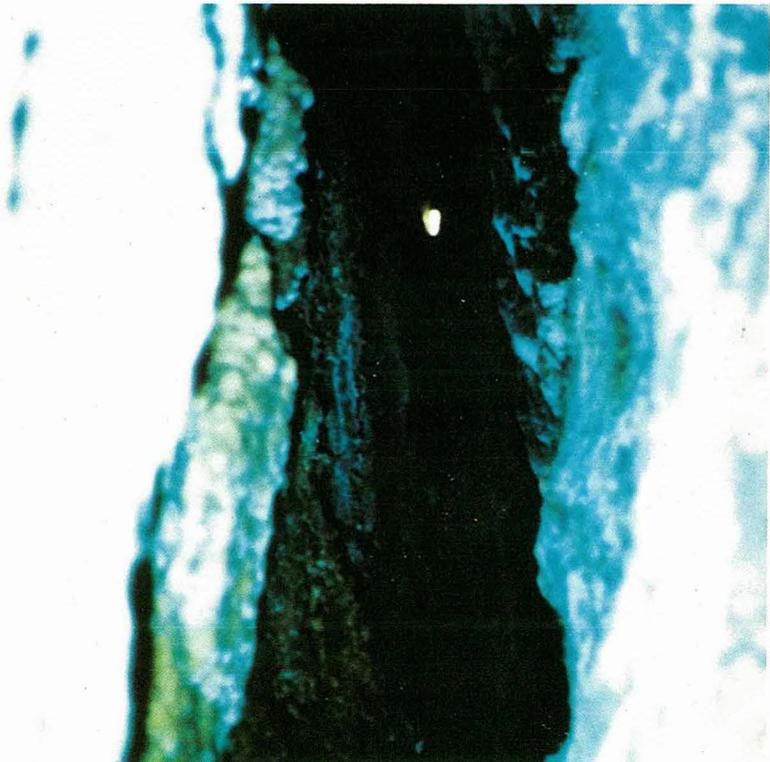
Fig. 5-18 Interior of fissure shown in Fig. 5-17. Photo taken 10 ft from upstream wall of key trench. Spot in background is light from a bulb suspended through a 6-in. vertical drill hole located about 25 ft from camera. (1974)

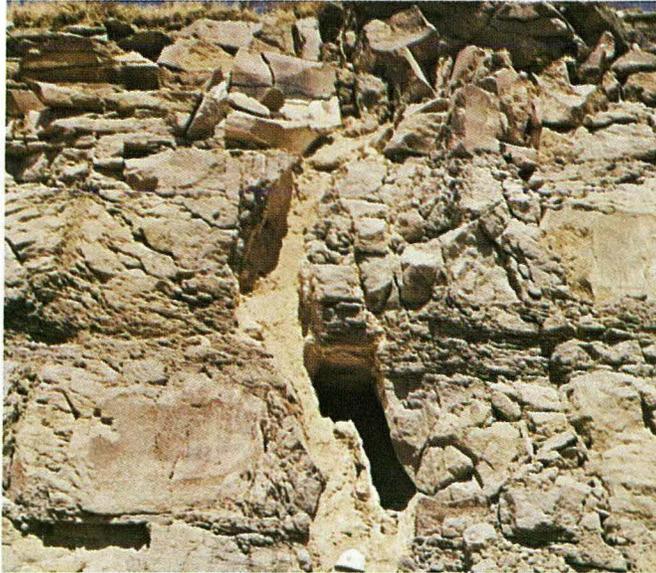
Several other large fissures are exposed in the right wall of the canyon, one-eighth to one-quarter-mile upstream from the dam (Figs. 5-19 and 5-20). The walls of a few of these openings are curved and parallel with configurations such that opposite walls "fit" like the mating pieces of a jigsaw puzzle.

**Fig. 5-19**      Opening in upper right wall of Teton Canyon  
1/8 to 1/4 mile upstream from dam. (post-failure  
photo)

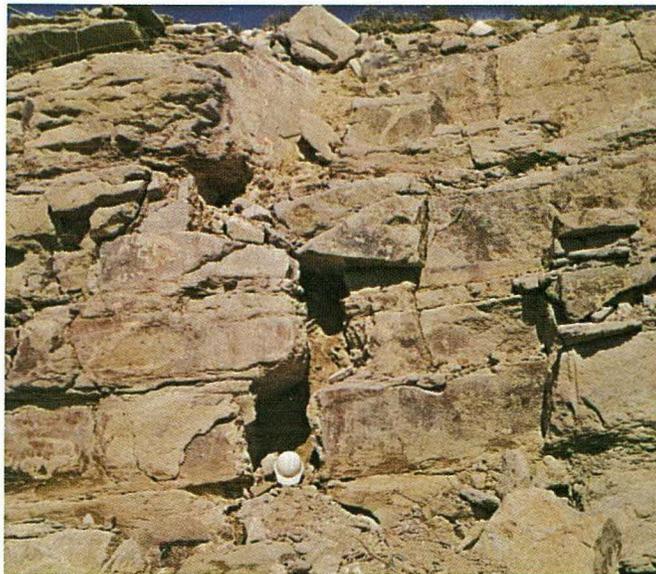
**Fig. 5-20**      Joint in right wall of Teton Canyon 1/8 to 1/4  
mile upstream from dam. (post-failure photo)

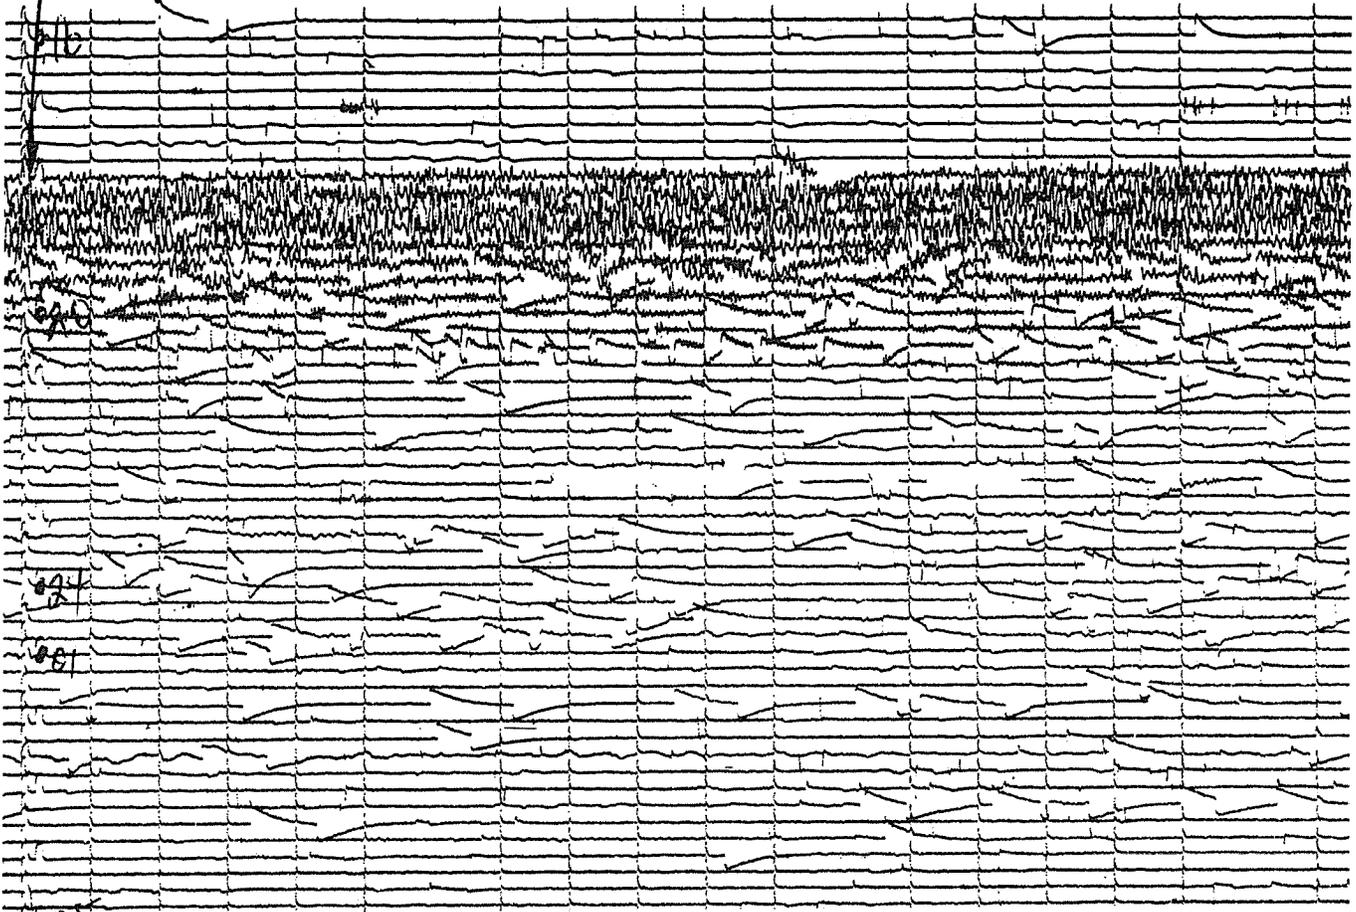
### PORTION OF SEISMOGRAM FROM STATION GMI

SEVEN-IN. LONG SEGMENT FROM 30 IN. CIRCUMFERENCE CONTINUOUS RECORD.  
SUCCESSIVE HORIZONTAL LINES REPRESENT ONE COMPLETE REVOLUTION OF THE  
SEISMOGRAPH DRUM, AN INTERVAL OF 15 MIN. AS REPORTED TO THE PANEL, BY A  
REPRESENTATIVE OF THE USGS, THE GROUND MOTION RECORDED HERE IS  
DISTINCT FROM THAT OF AN EARTHQUAKE.

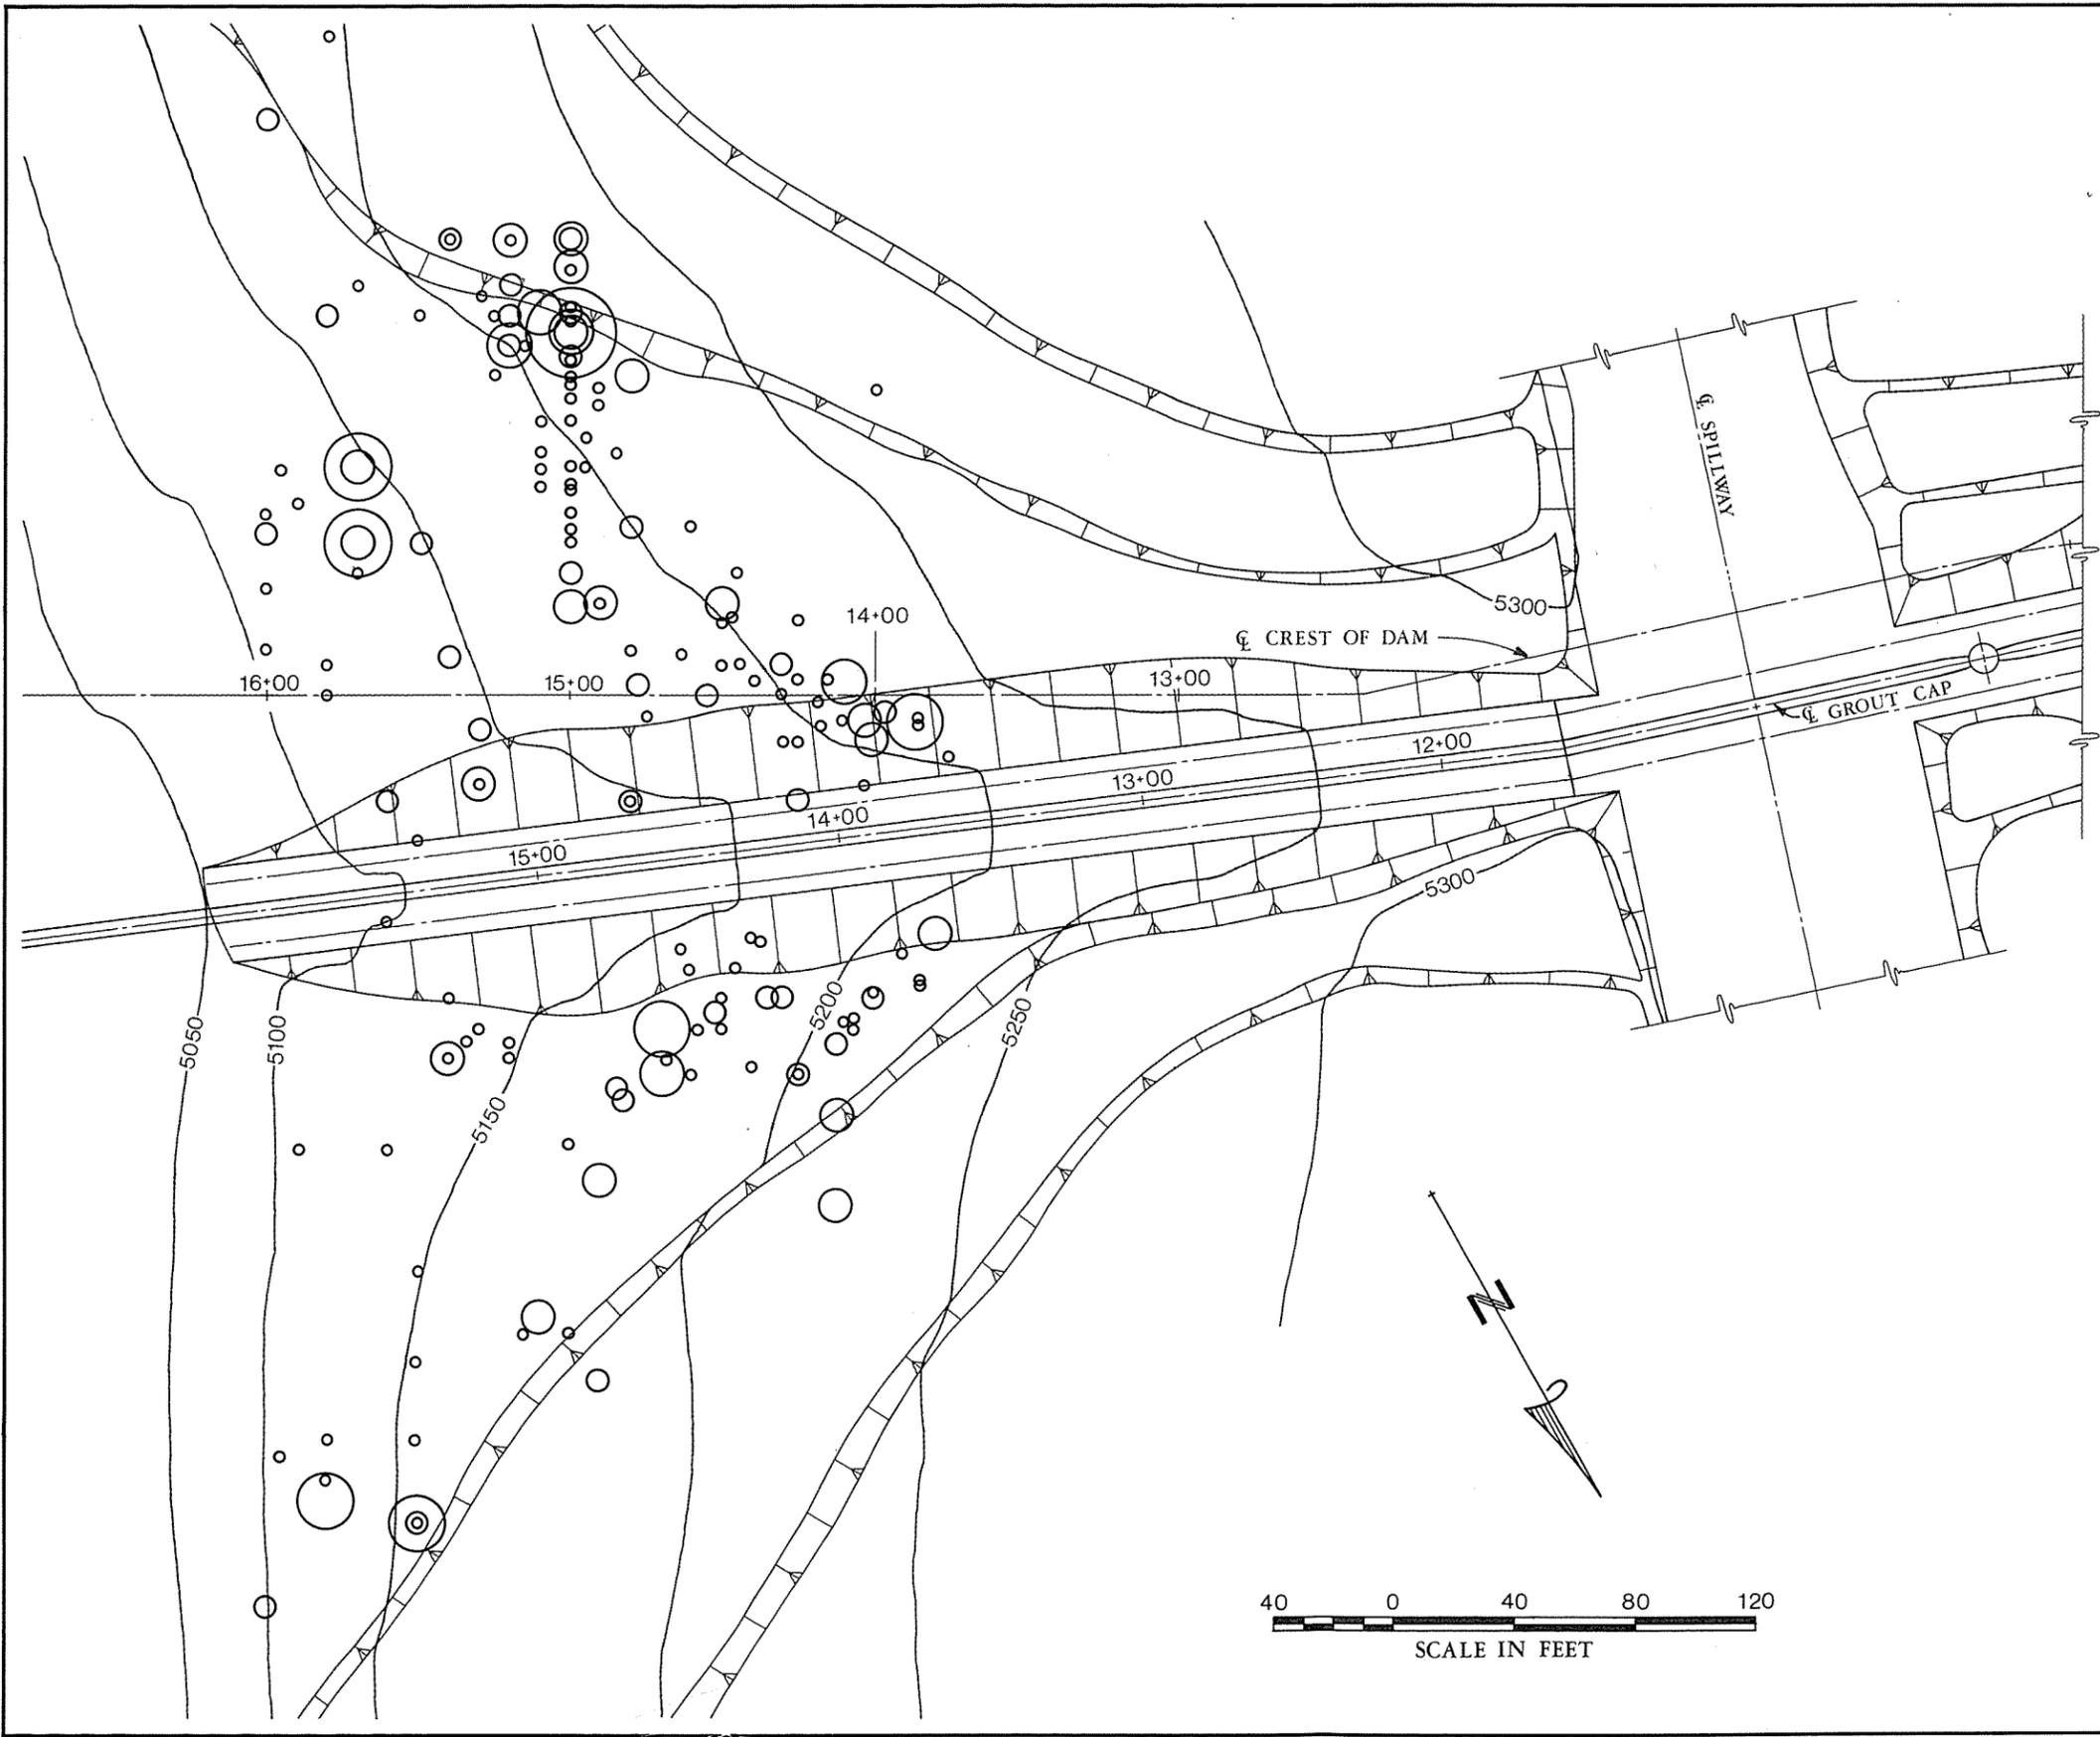
**FIG. 9-1.**

A review of the drawings and specifications has failed to show that it was expected to treat open bedrock joints at the Zone 1-to-bedrock contact with slurry concrete. USBR Project Office records show, however, that a total of about 1830 cu yds was placed at the instigation of that office (Fig. 9-1). This was accomplished principally by pouring slurry into open joints and the more obviously open cracks. This procedure was discontinued above about El. 5210. Fig. 9-1 illustrates the extent of slurry grout or concrete placement on the side slopes of the key trench and in the stripped bedrock areas upstream and downstream from the key trench on the right abutment, principally beneath Zone 1. It is particularly evident on Fig. 9-1 that, in the failure area, significantly large open joints existed at the top of the downstream face of the key trench at axis Sta. 14+00 and near the downstream toe of Zone 1 opposite Sta. 15+00, where slurry takes totaled 100 or more cu yds.

These large takes under gravity placement conditions identified the rock as being extremely pervious, indicating that grave incompatibility existed between the highly erodible Zone 1 fill and its underlying intensely jointed foundation.

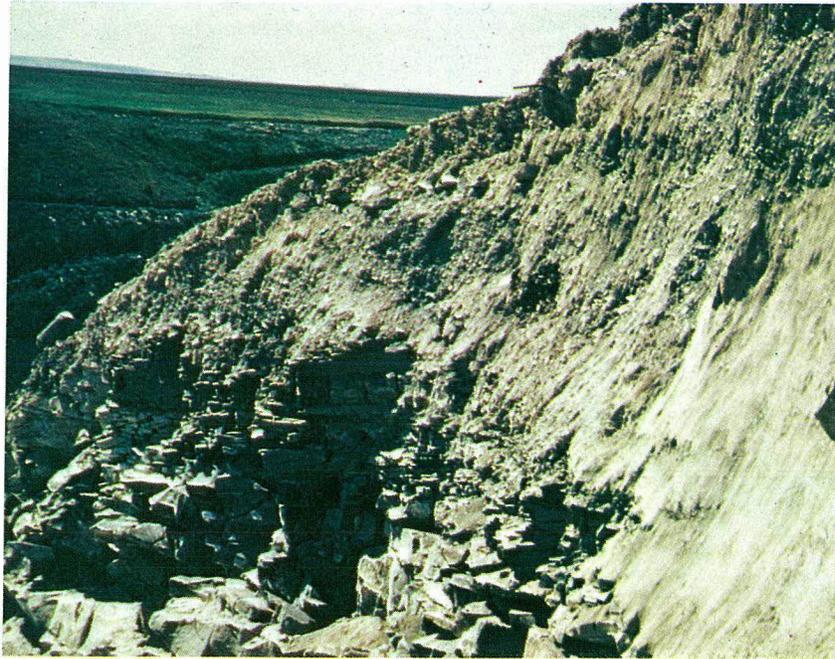
Fig. 9-2 Foundation formation and contact beneath zone 2 and zone 5

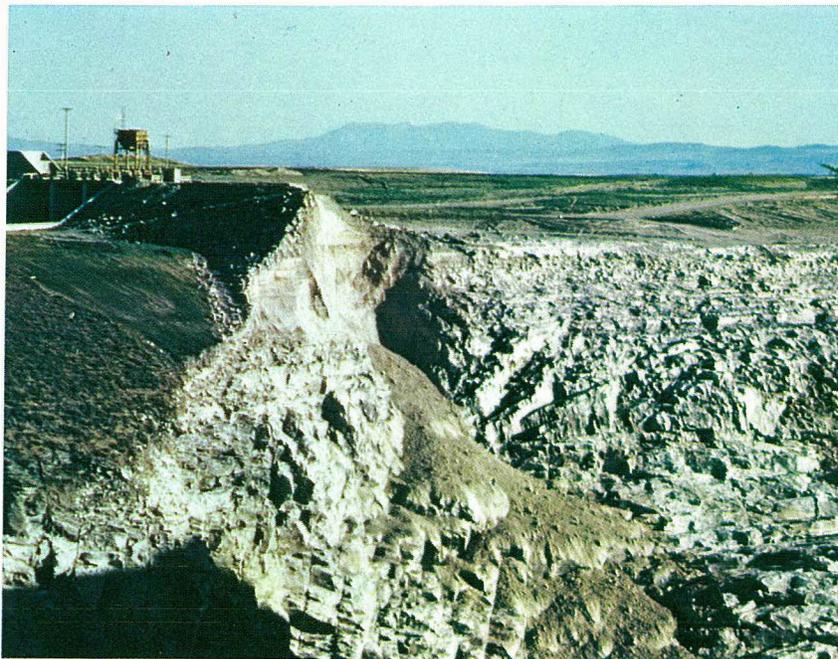
Fig. 9-3 Foundation formation and contact beneath zone 2 and zone 5

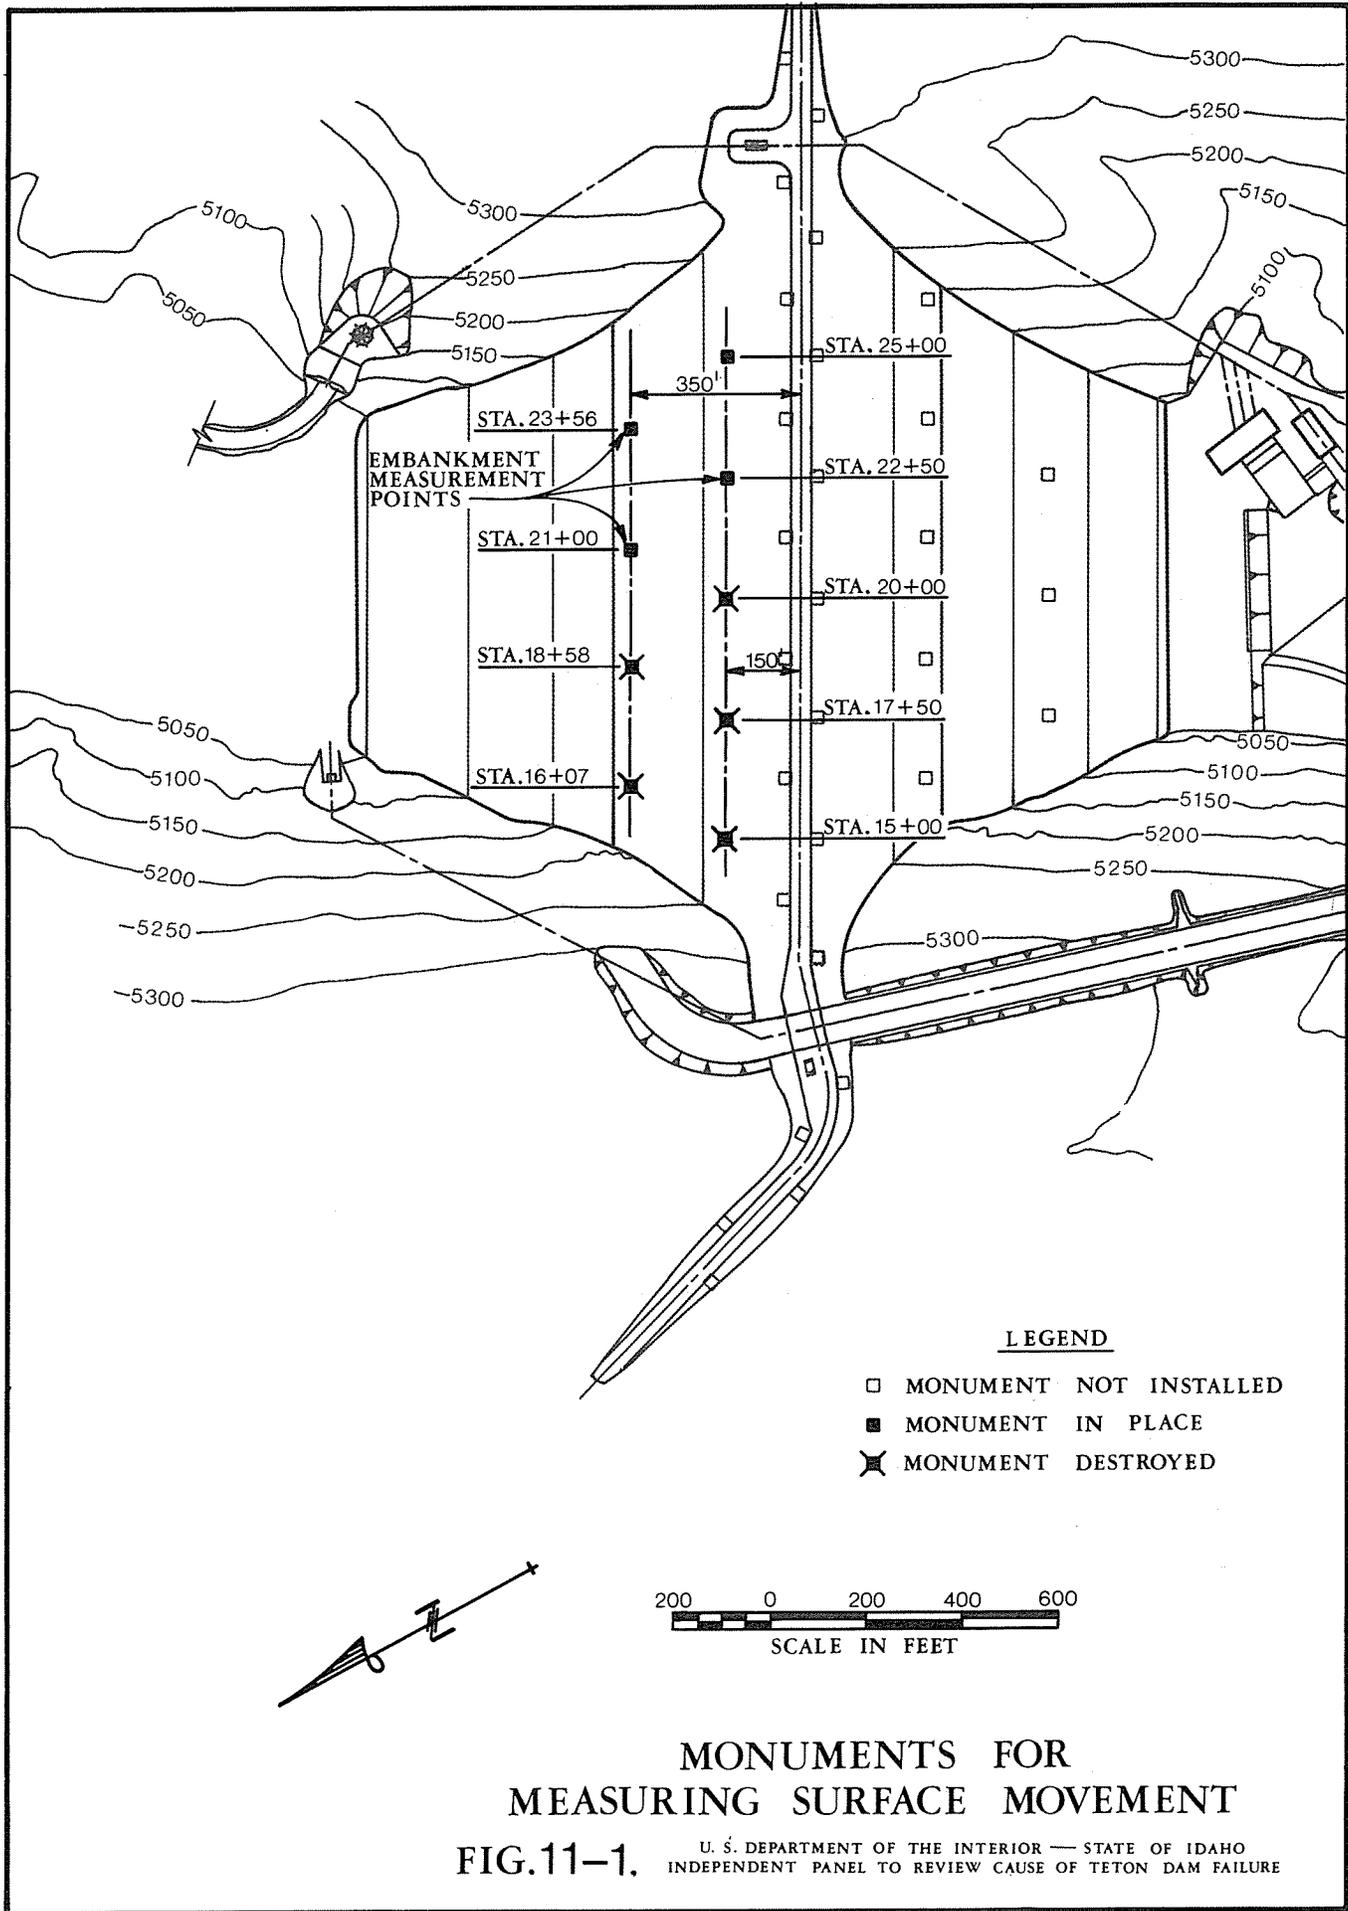
**FIG. 11-1.** U. S. DEPARTMENT OF THE INTERIOR — STATE OF IDAHO  
INDEPENDENT PANEL TO REVIEW CAUSE OF TETON DAM FAILURE

On June 5, 1976, only nine of the upstream points had been installed and were being monitored. Five of these points were destroyed when the dam failed. As shown in Fig. 11-1, none of the downstream points were placed.

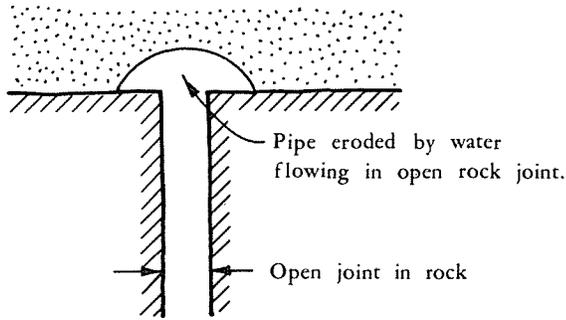
Fig. 12-1

The mechanism of erosion under these conditions is illustrated by Fig. 12-1, in which is depicted an idealized joint in the bottom of the key trench. The joint is not sealed by dental concrete or slush grout; consequently, horizontally flowing water under pressure would attack the base of the fill and begin to form a pipe. If the joint occurred at a step in the rock surface, Fig. 12-2, the erosion would occur even more readily because of the reduction of stresses in the reentrant corner due to arching, as will be discussed in greater detail in the next section, and because of the likelihood of poor compaction of the fill in the corner. Furthermore, under high water pressure, the pipe is likely to enlarge by separation of the fill from the rock surface, as illustrated in Figs. 12-2 and 12-3. Conditions corresponding to Figs. 12-1 and 12-2 have been observed in the key trench near Sta. 14 + 00 as documented in Chapter 3; indeed, several instances of overhanging as well as near-vertical steps were noted.

Pipe eroded by water flowing along open joint

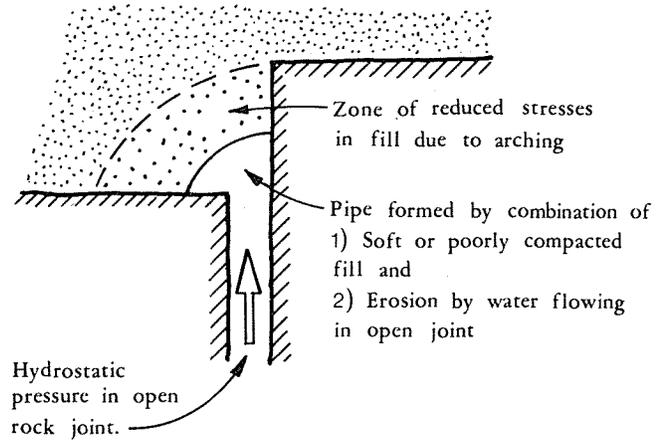
Fig. 12-2

Pipe eroded by water flowing along re-entrant step in rock

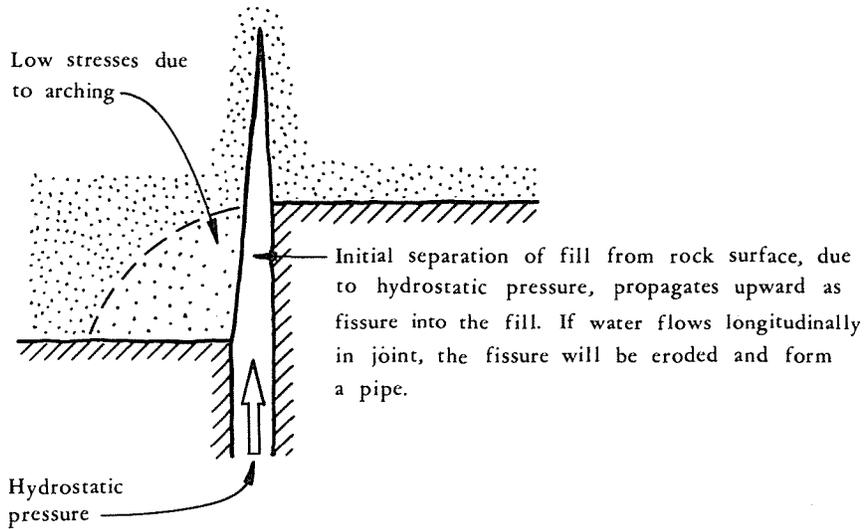
Fig. 12-3

Fissure in fill produced by hydrostatic pressure in rock joint along re-entrant step

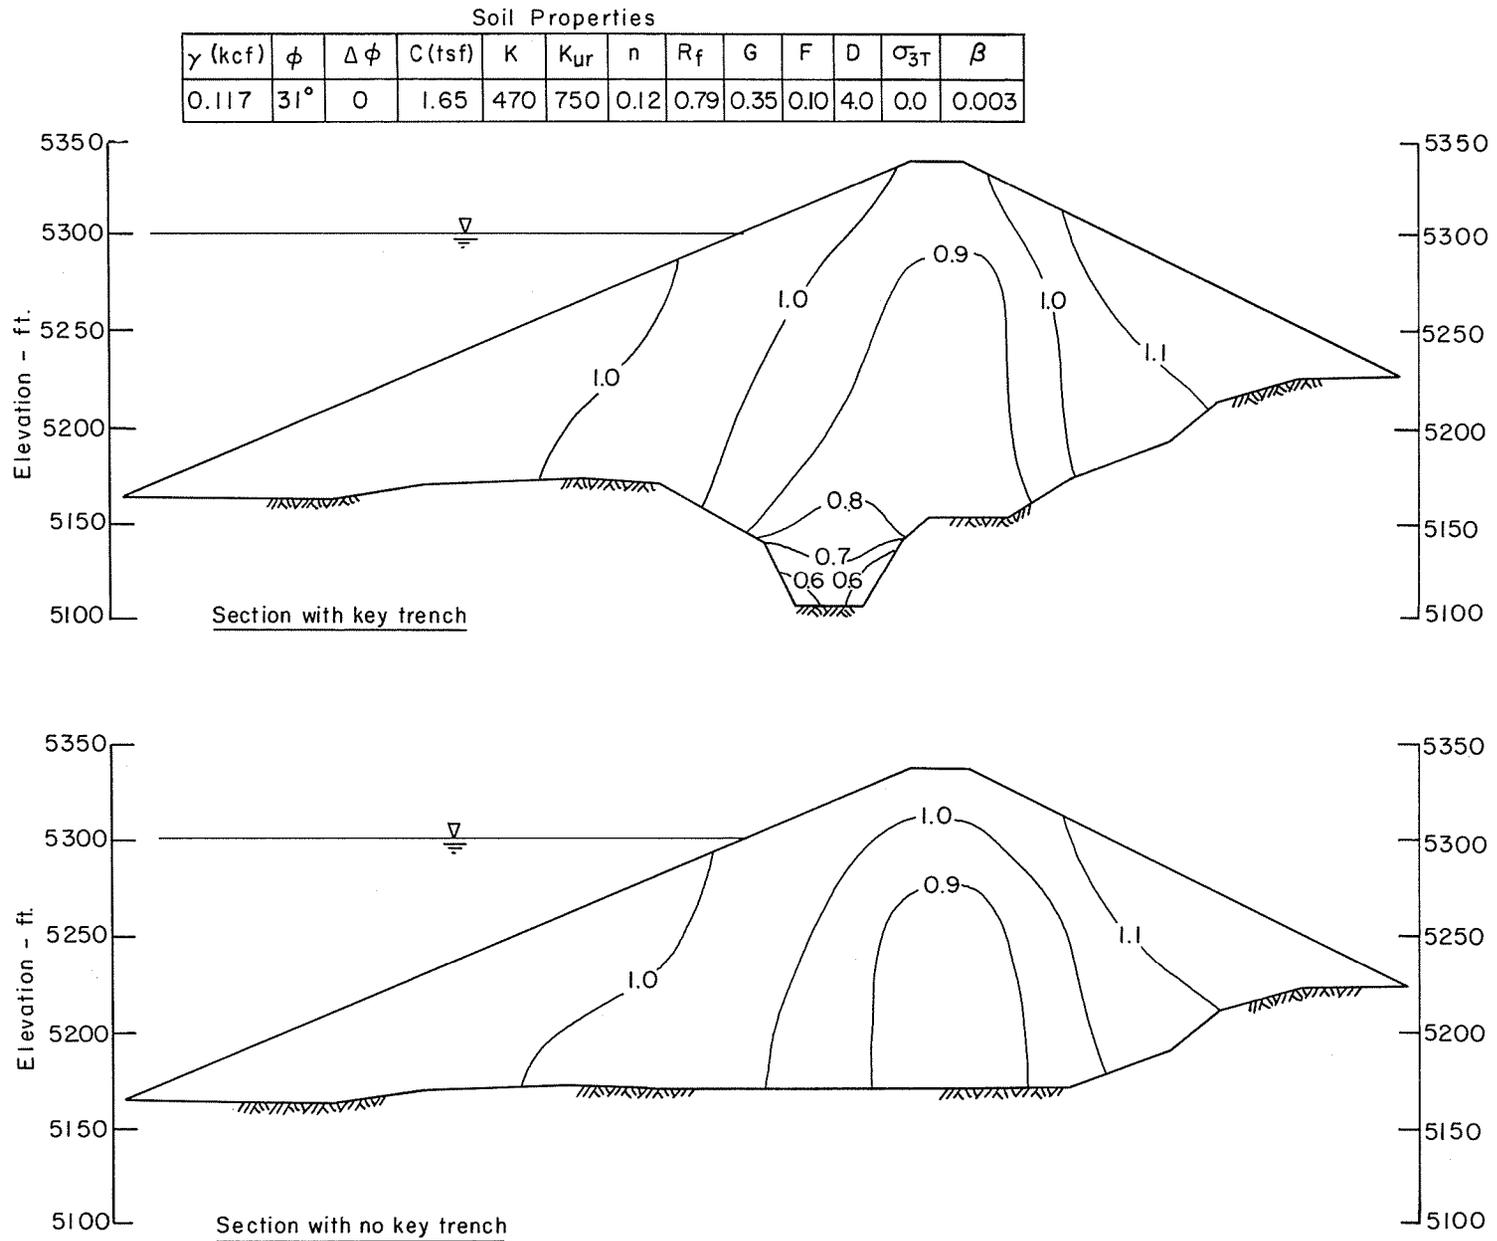
FIG. 12-9

The values of vertical normal stress throughout the embankment and key-trench fill are shown as fractions of overburden pressure in Fig. 12-9 for Sta. 15+00. For comparison, the figure also shows

CONTOURS SHOWING RATIO OF VERTICAL STRESS IN EMBANKMENT TO OVERBURDEN PRESSURE FOR CONDITIONS WITH AND WITHOUT KEY TRENCH AT STA. 15+00 - BEFORE WETTING OF SOIL IN KEY TRENCH
