REPORT TO  
U.S. DEPARTMENT OF THE INTERIOR AND STATE OF IDAHO  
ON  
**FAILURE OF TETON DAM**

BY  
INDEPENDENT PANEL TO REVIEW CAUSE OF TETON DAM FAILURE

DECEMBER 1976

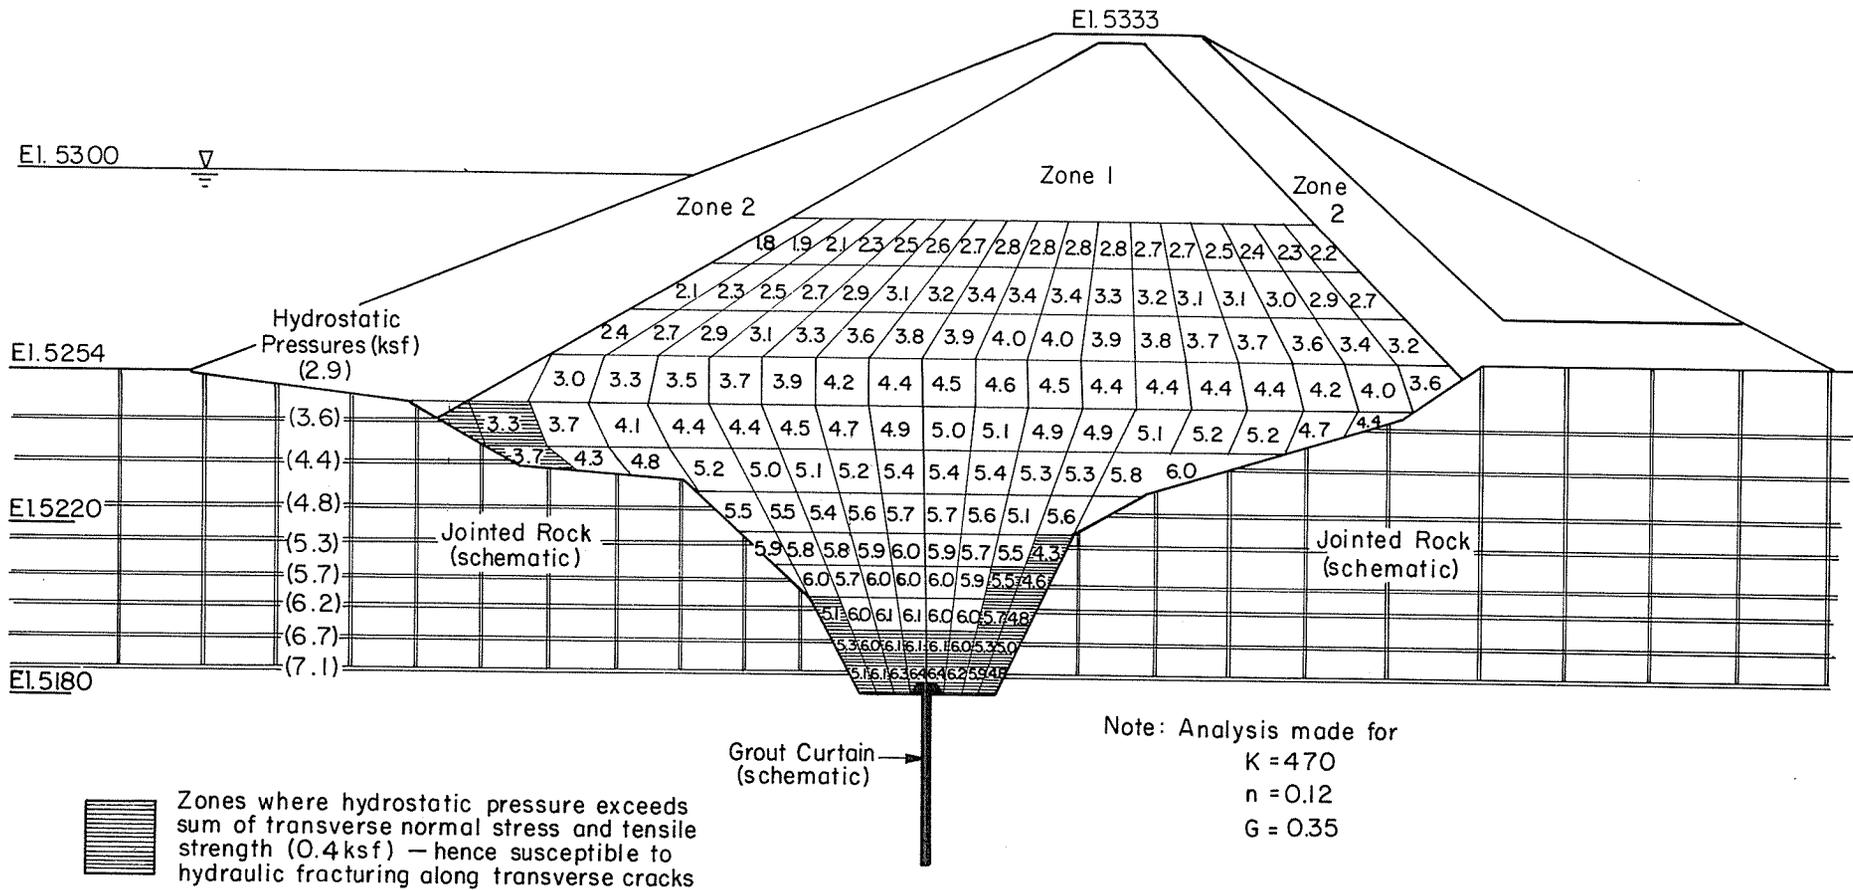
FIG.12-II COMPUTED VALUES OF MINOR PRINCIPAL STRESS IN PLANE OF SECTION STA. 13+70

hydraulic fracturing than actually existed. Even so, allowing for some reduction in water pressure due to seepage, sufficient disparity exists between water pressures and lateral soil stresses at sections such as Stas. 13+70 and 15+00 to enable fracturing to occur. This would be accentuated as the key-trench fill became saturated and arching effects became more pronounced.

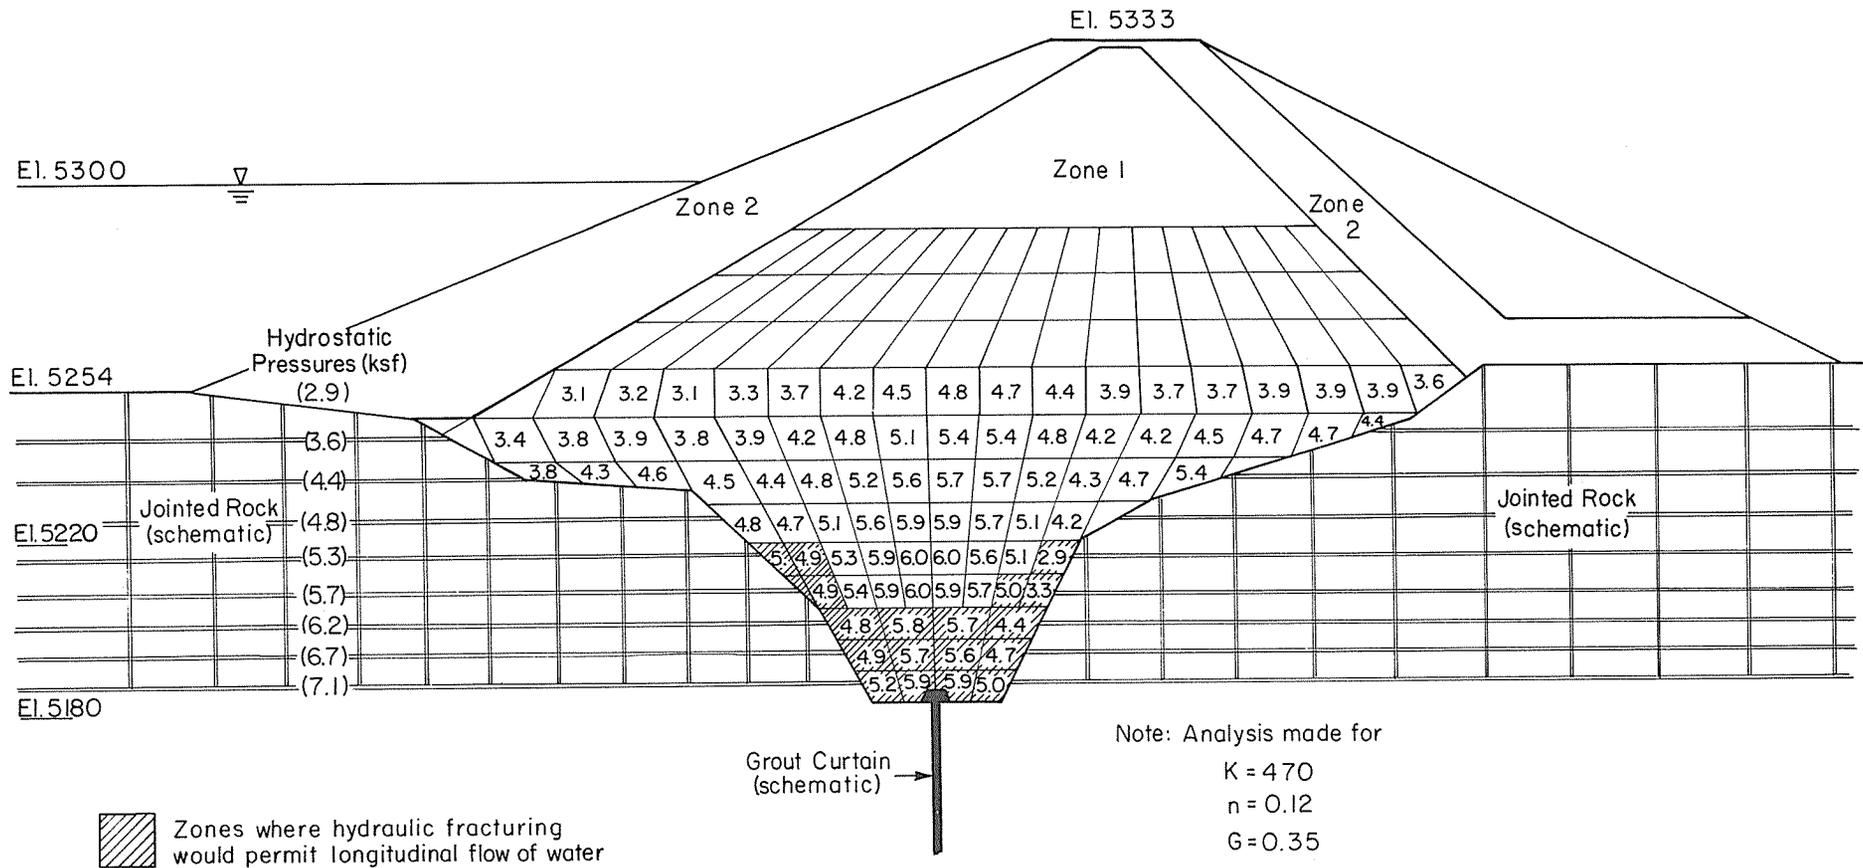
FIG.12-12 COMPUTED VALUES OF NORMAL STRESS ON TRANSVERSE SECTION IN ksf STA.13+70

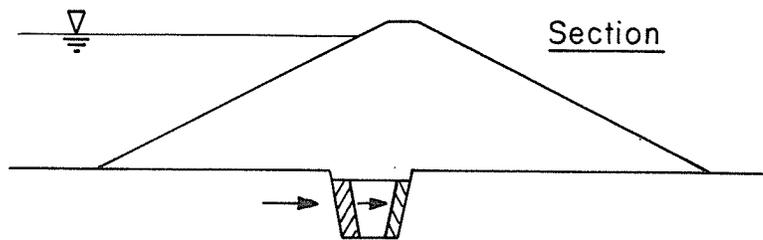
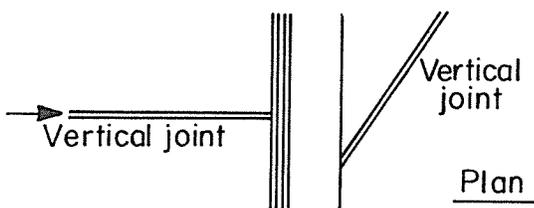
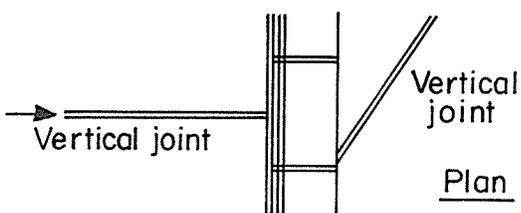
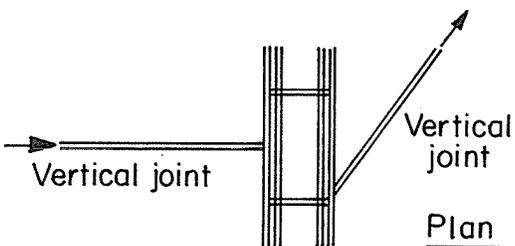
FIG. 1

In a coincident or second step (step 2 in Fig. 1) the water pressures thus developed would tend to produce multiple fractures along transverse planes with low normal stresses acting on them due to the arching action of the fill over the soil in the key trench. This would provide access for the water to the downstream face of the key trench.

Once this stage was reached, further fracturing could occur along minor principal planes for soil elements adjacent to the downstream wall of the key trench, again permitting the water to flow longitudinally until it found a convenient egress through open joints in the downstream rock. Erosion along the resulting flow path would ultimately lead to a piping failure of the embankment as discussed in a later section.

1. Flow in vertical upstream joint to face of key trench followed by longitudinal hydraulic fracturing of fill near face of trench allowing water to spread along face

2. Transverse hydraulic fracturing producing multiple fractures through soil in key trench and giving water access to downstream side of trench (may occur before Step 1)

3. Longitudinal hydraulic fracturing of soil near downstream face of key trench allowing water to spread along face and find egress through open downstream joints in rock

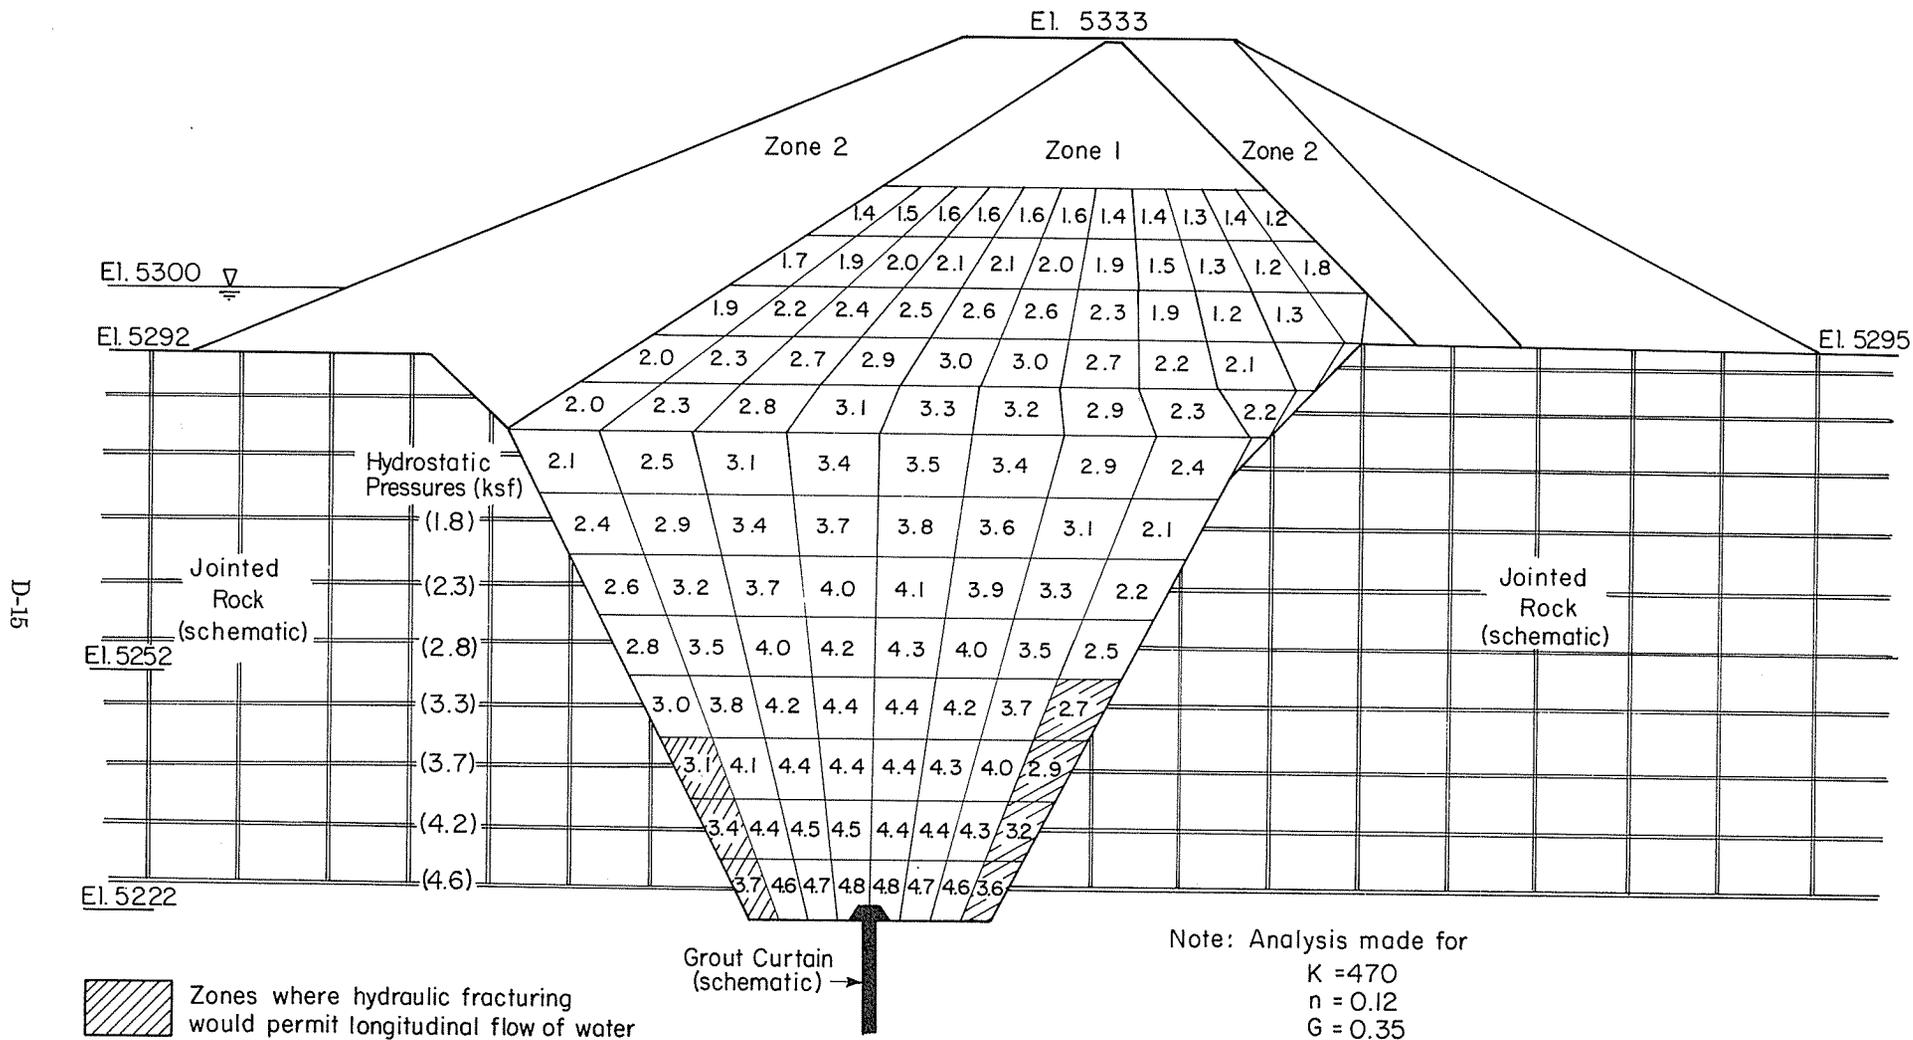
A comparison of these stresses is shown in Fig. 7. Values of the minor principal stress developed in different elements of the finite element mesh are shown directly in the elements in ksf units and the hydrostatic water pressures assumed to develop in a highly jointed rock for a reservoir level of 5300 (the elevation at the time the dam failed) are shown adjacent to the elements in parentheses. It may be seen that for this section hydraulic fracturing of the type described above is only indicated for the outer rows of elements in the bottom part of the trench (shown shaded) and elements on the downstream side would only fracture if full hydrostatic pressure could develop in this area. In these elements and zones, however, the analyses would indicate the onset of hydraulic fracturing which could be expected to propagate from any point of initiation in a longitudinal direction, providing the possibility of full hydrostatic pressures developing over a substantial area near the lower part of the upstream face of the key trench. The resulting fractures are illustrated schematically in Fig. 9.

FIG. 7 COMPUTED VALUES OF MINOR PRINCIPAL STRESS IN PLANE OF SECTION ksf STA. 12+70

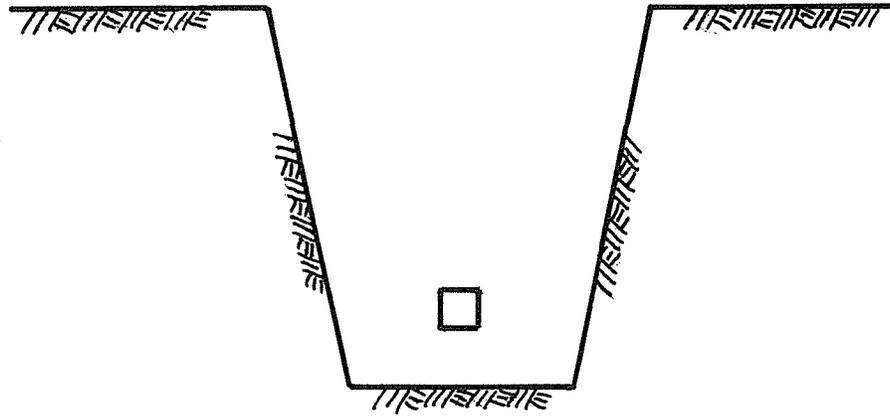
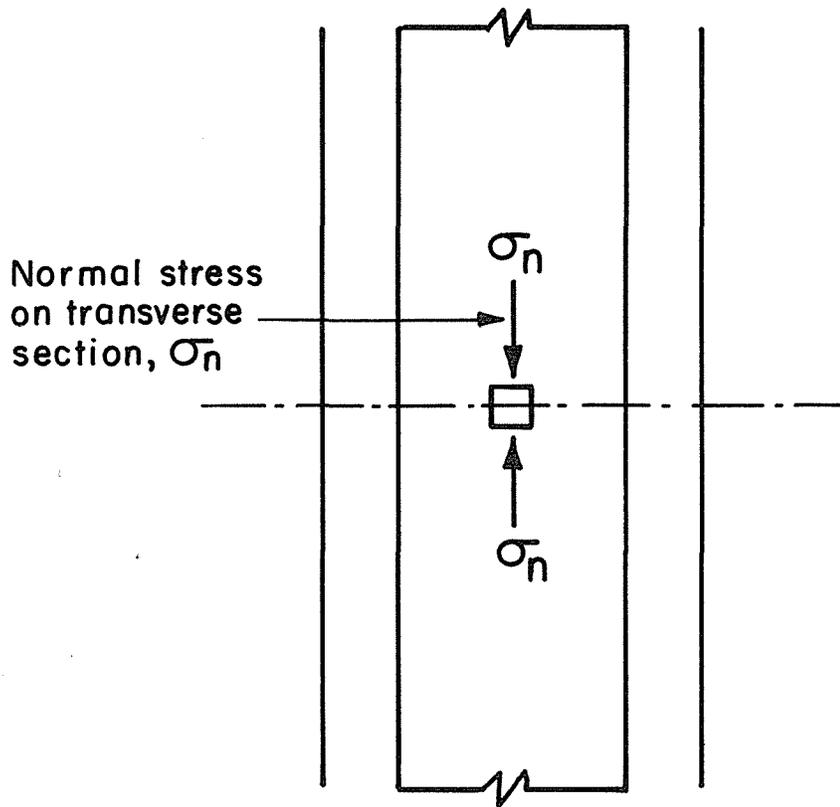
With regard to the possibility of hydraulic fracturing in the transverse direction it is necessary to compare the hydrostatic water pressures with the sum of the normal stress on the transverse section and the tensile strength of the soil as illustrated in Fig. 10. A comparison of the computed normal stress on the transverse plane with the full hydrostatic pressures is shown in Fig. 11. It may be seen that the analysis indicates that the stresses developed at all elevations in this section would be sufficient to preclude the possibility of transverse fracturing.

Transverse fracturing occurs if  $u > \sigma_n + t_s$

**FIG. 10** MECHANISM FOR TRANSVERSE FRACTURING IN KEY TRENCH

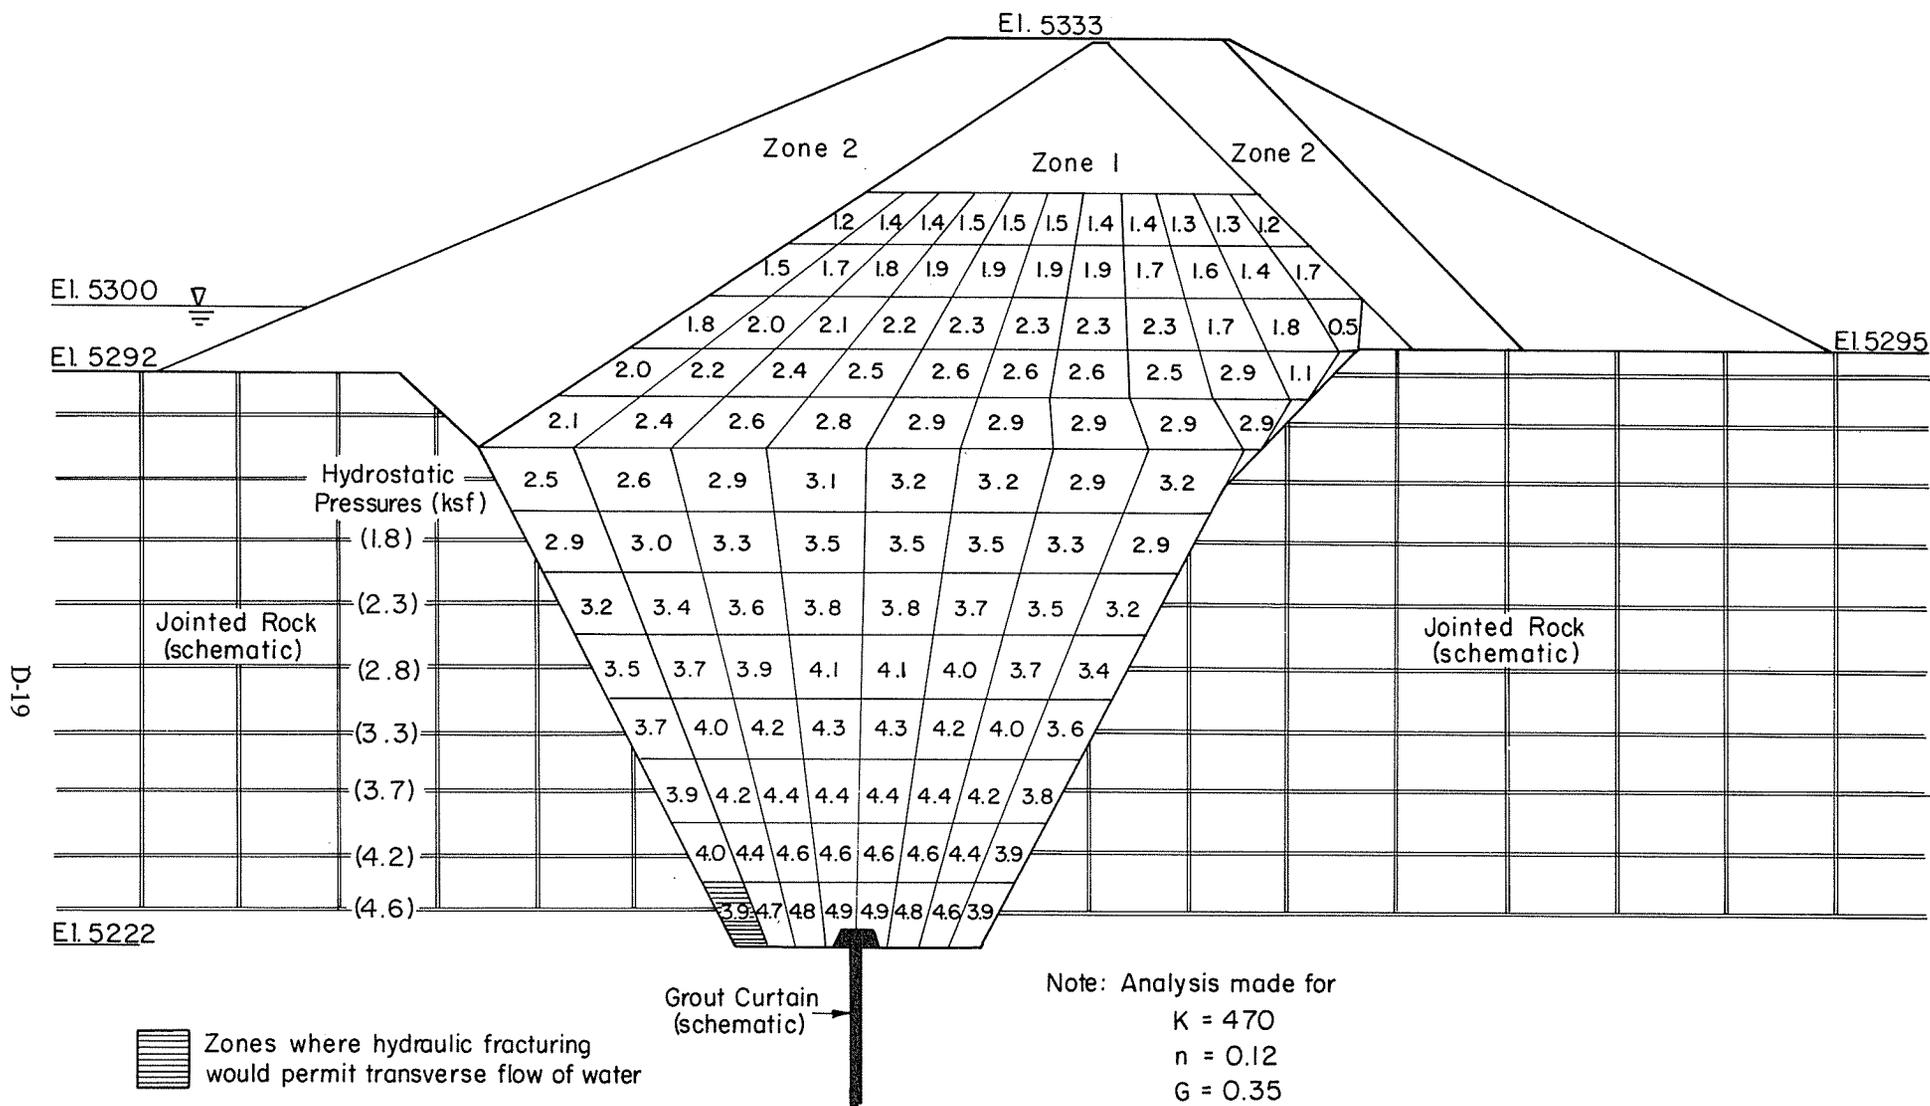
FIG. II COMPUTED VALUES OF NORMAL STRESS ON TRANSVERSE SECTION ksf STA. 12+70

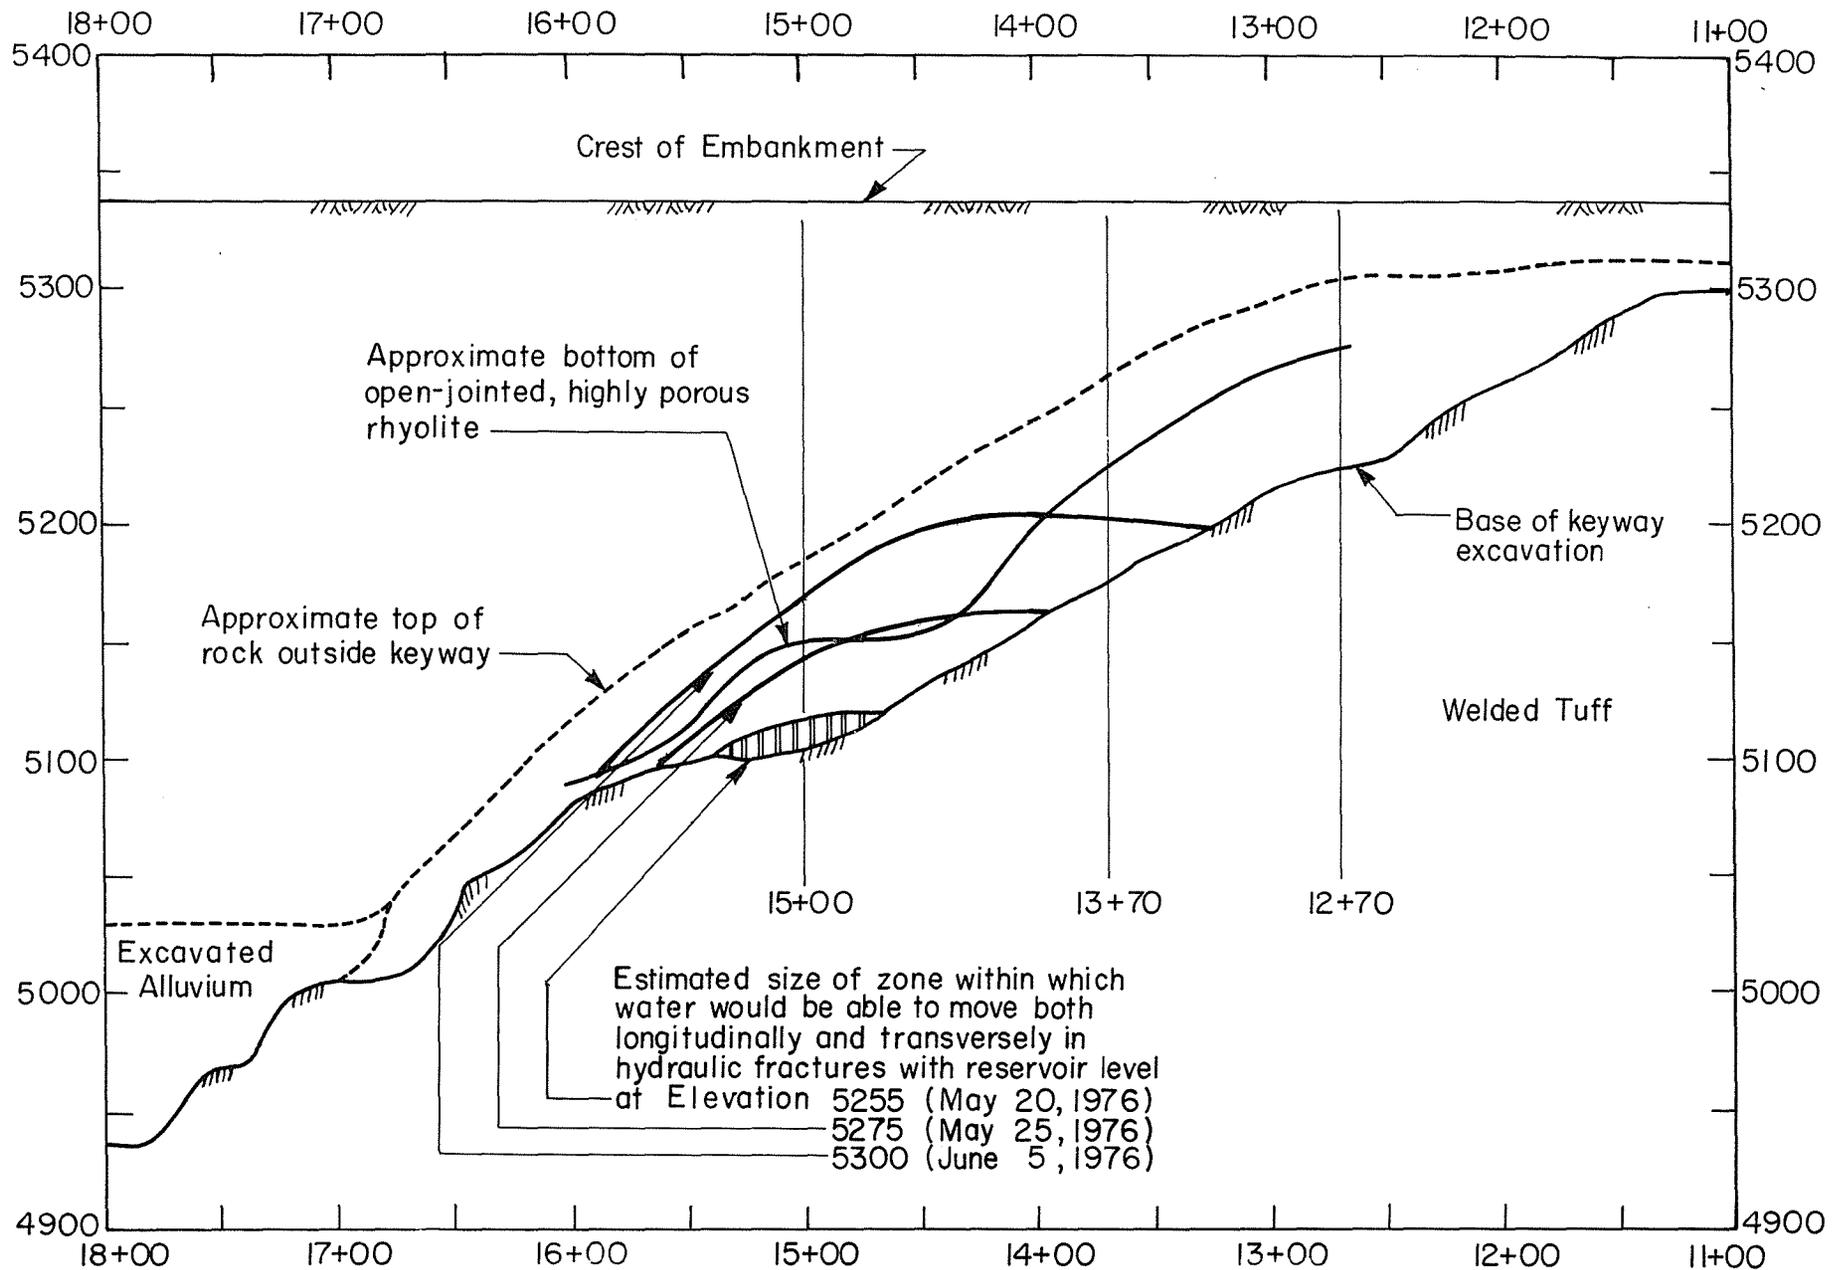
FIG. 16

For example with the reservoir level at El. 5255 (as it was on May 20, 1976) the hydrostatic water pressures in the upstream jointed rock would only be sufficient to cause hydraulic fracturing in the bottom 10 ft of the key trench at Station 15+00 and none at all for Stas. 13+70 and 12+70. This condition is best illustrated by the longitudinal section drawn through the centerline of the key trench on the right abutment shown in Fig. 16. The analysis indicates only a very small zone in the vicinity of Sta. 15+00 where the water could move horizontally and vertically through hydraulically-induced fractures on this date, May 20, and for a reservoir level of 5255.

Figs. 16, 17 and 18 provide an excellent summary of the extent of the potential zone of hydraulic fracturing, as estimated from the results of the preceding analytical studies. It is interesting to note that they only indicate the development of a substantial zone of vulnerability due to this cause in the 10 days before failure actually occurred and that the location of the indicated zone of fracturing coincides closely with the zone in which piping finally developed (between about Stations 13+50 and 15+00).

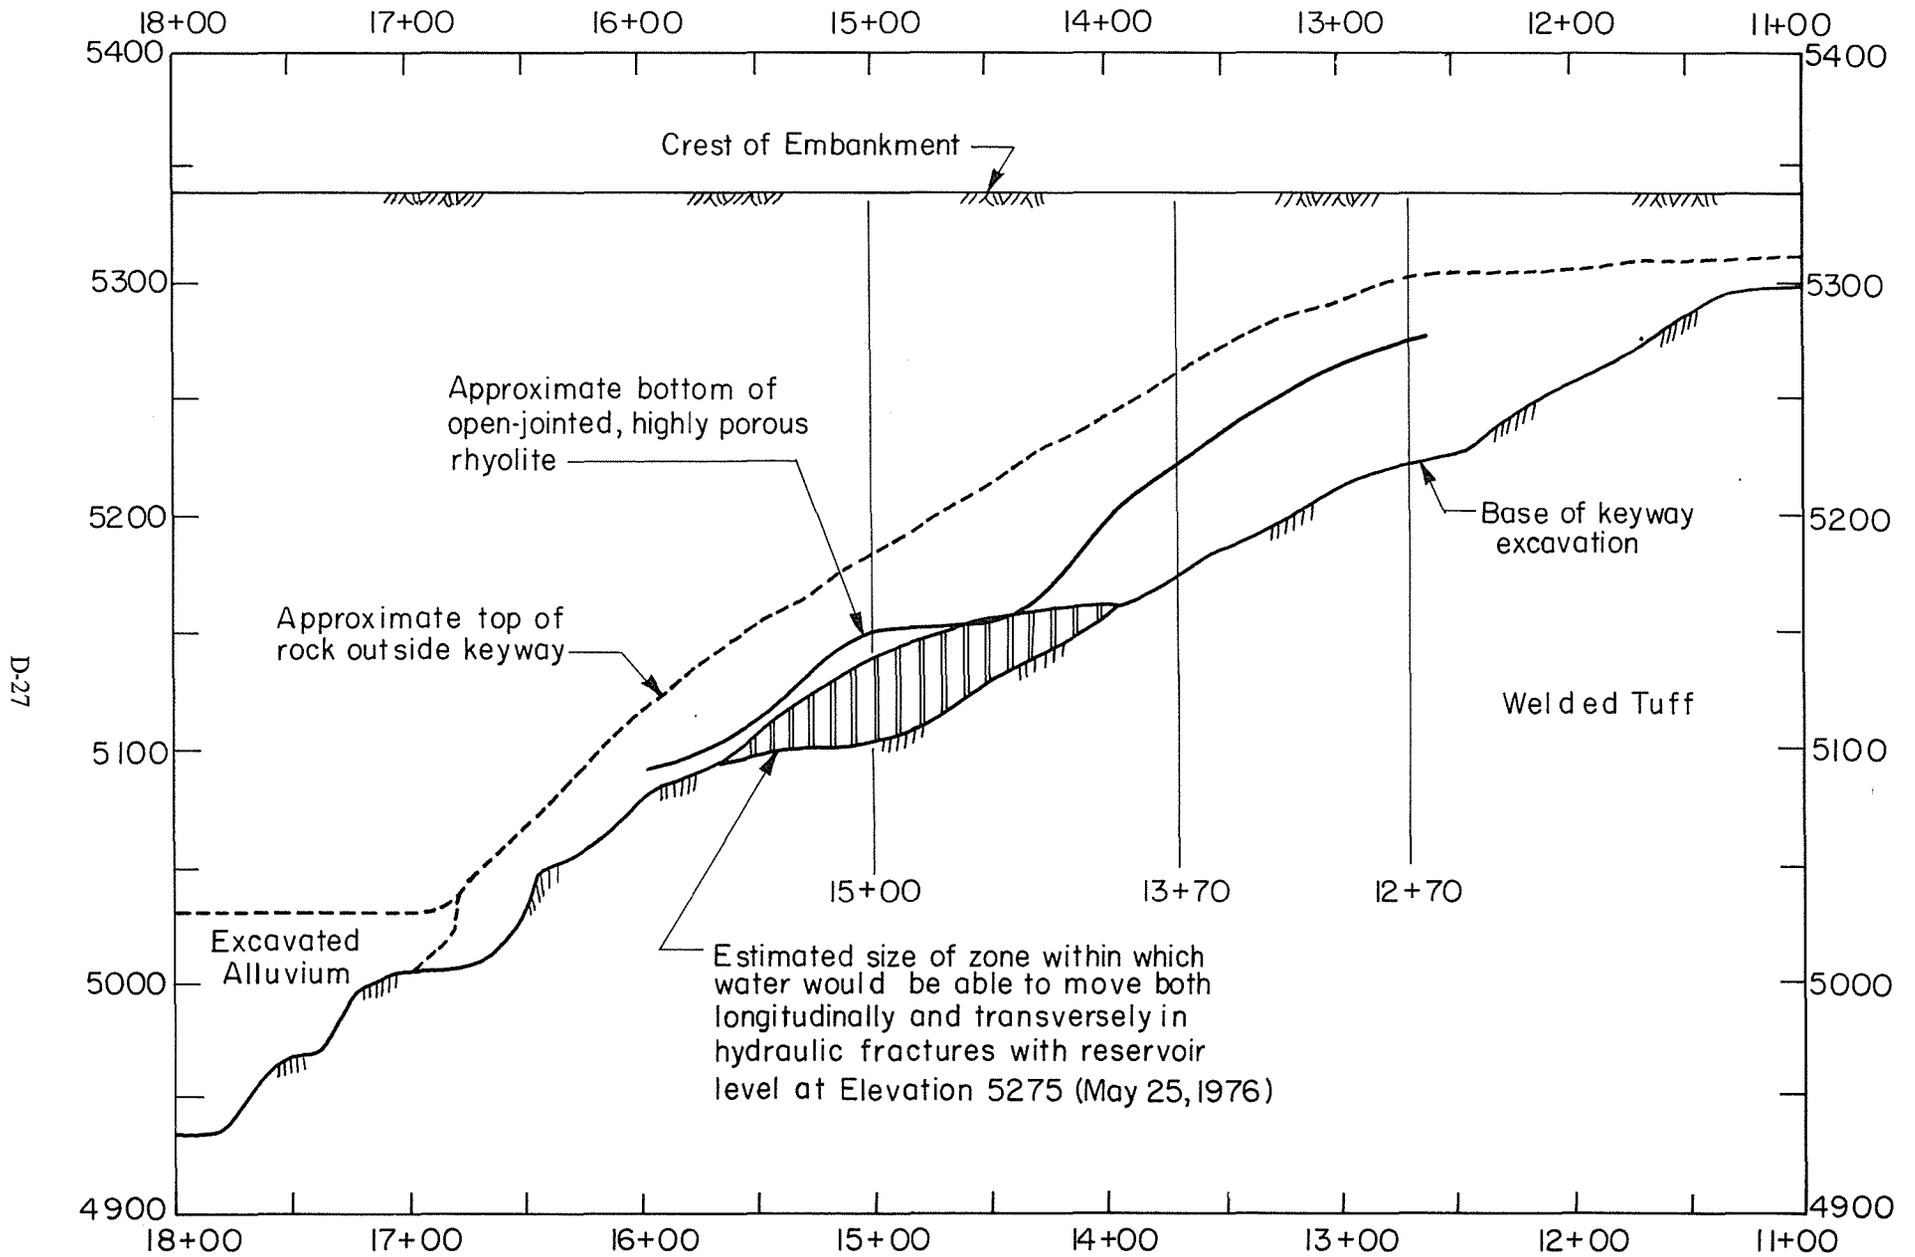
As the water level rose, the extent of the zone in which fracturing could occur naturally increased, but reference to Figs. 11 and 12 will show that even when the reservoir level rose to El. 5275 hydraulic fracturing would still not yet have developed at the bottom of the key trench at Station 13+70. This reservoir elevation was reached on May 25, 1976 and Fig. 17 shows the estimated extent of the zone of hydraulic fracturing in the key trench on this date.

**FIG.17** LONGITUDINAL SECTION THROUGH CENTER LINE  
CREST AND GROUT CAP

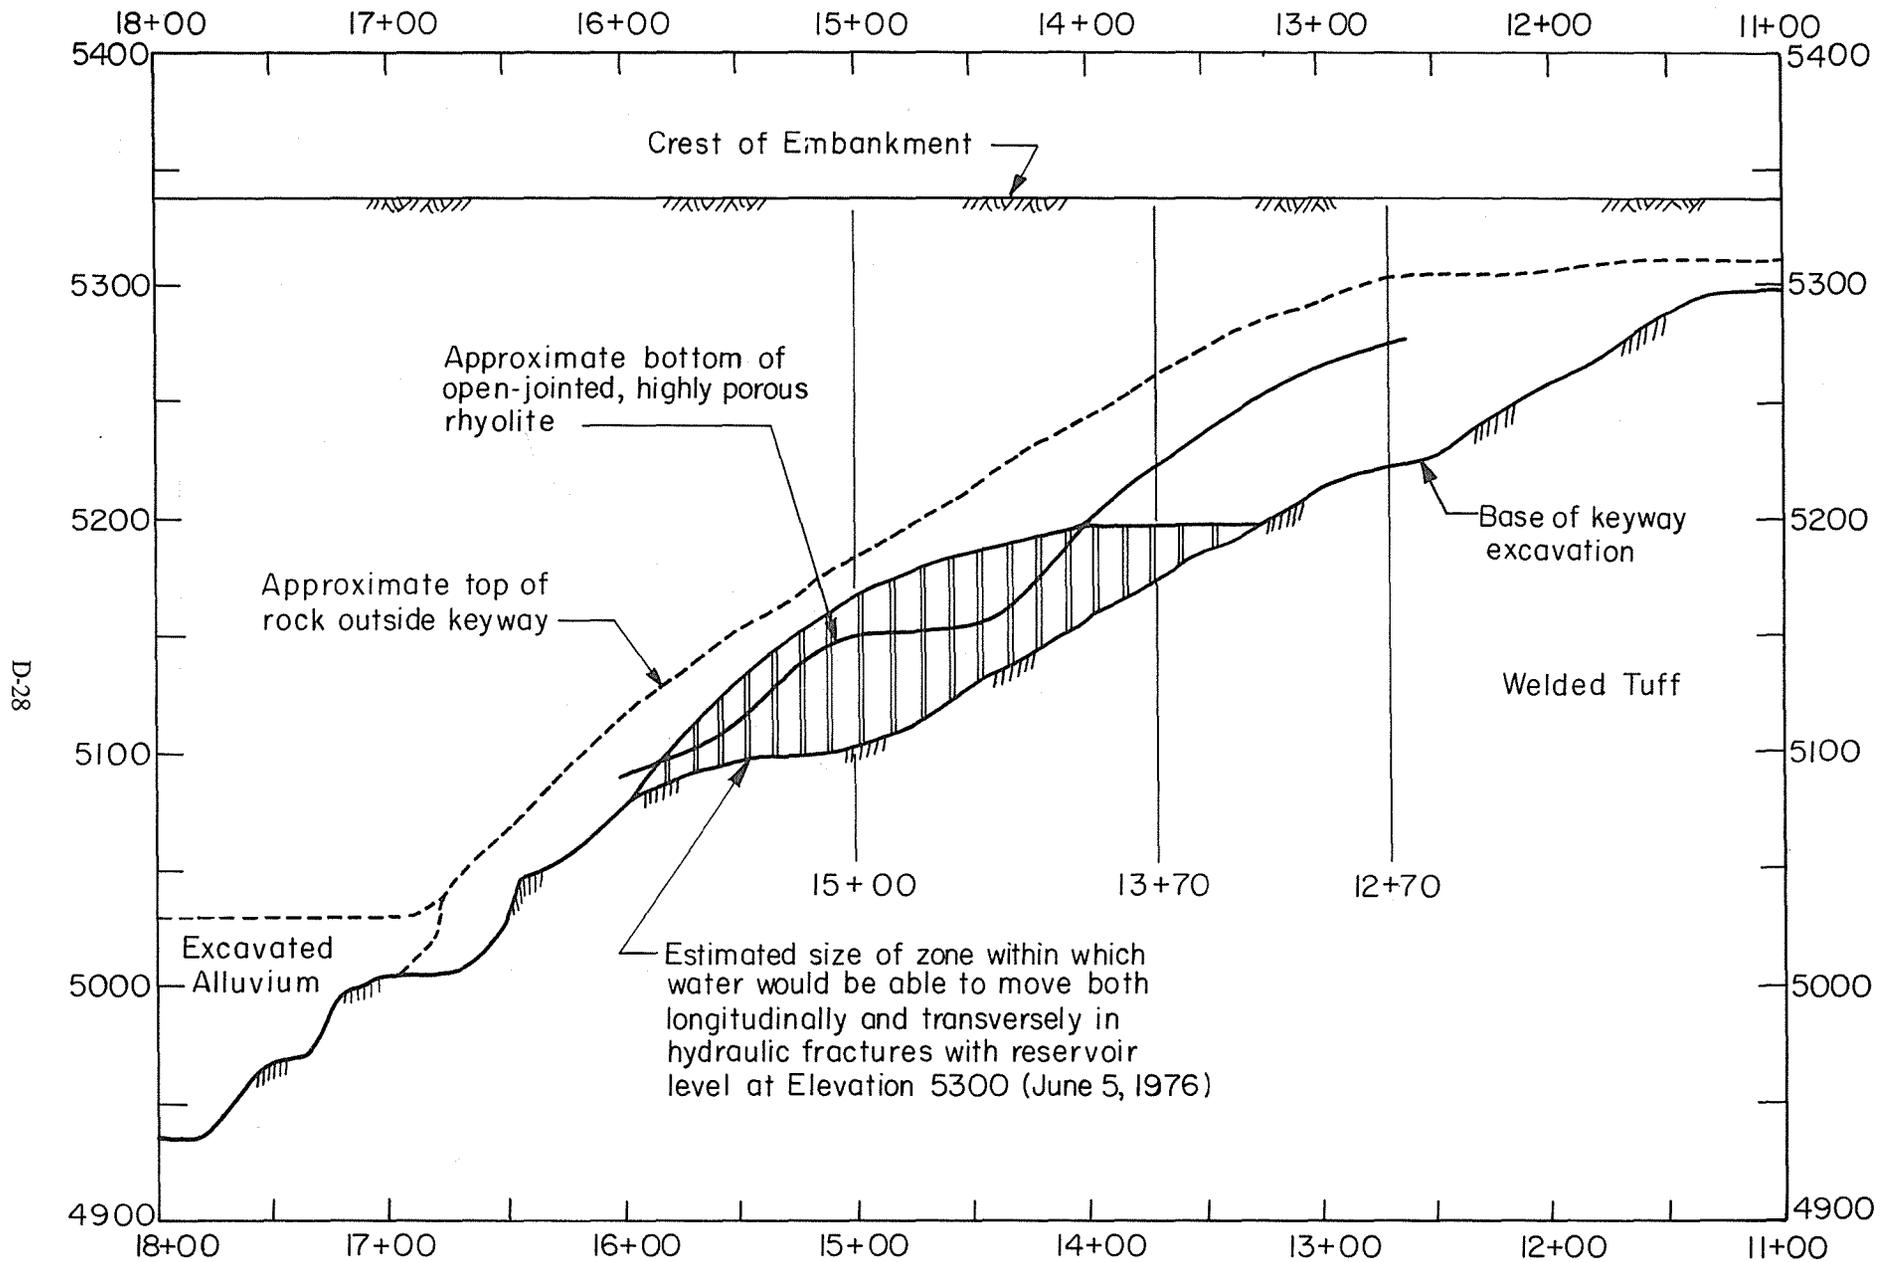
Finally, by the time the reservoir reached El. 5300 on June 5, 1976, transverse hydraulic fracturing would become possible in the bottom section of the key trench at Station 13+70 and it would extend to a greater height at Sta. 15+00 as shown in Fig. 18. Note however that it is never likely to occur beyond about Sta. 16+00 because the key trench downslope of that station was either very shallow or non-existent, and it does not seem likely that it would develop upslope of about Station 13+20 because the stress conditions beyond that point are unfavorable to its development.

**FIG.18** LONGITUDINAL SECTION THROUGH CENTER LINE  
CREST AND GROUT CAP

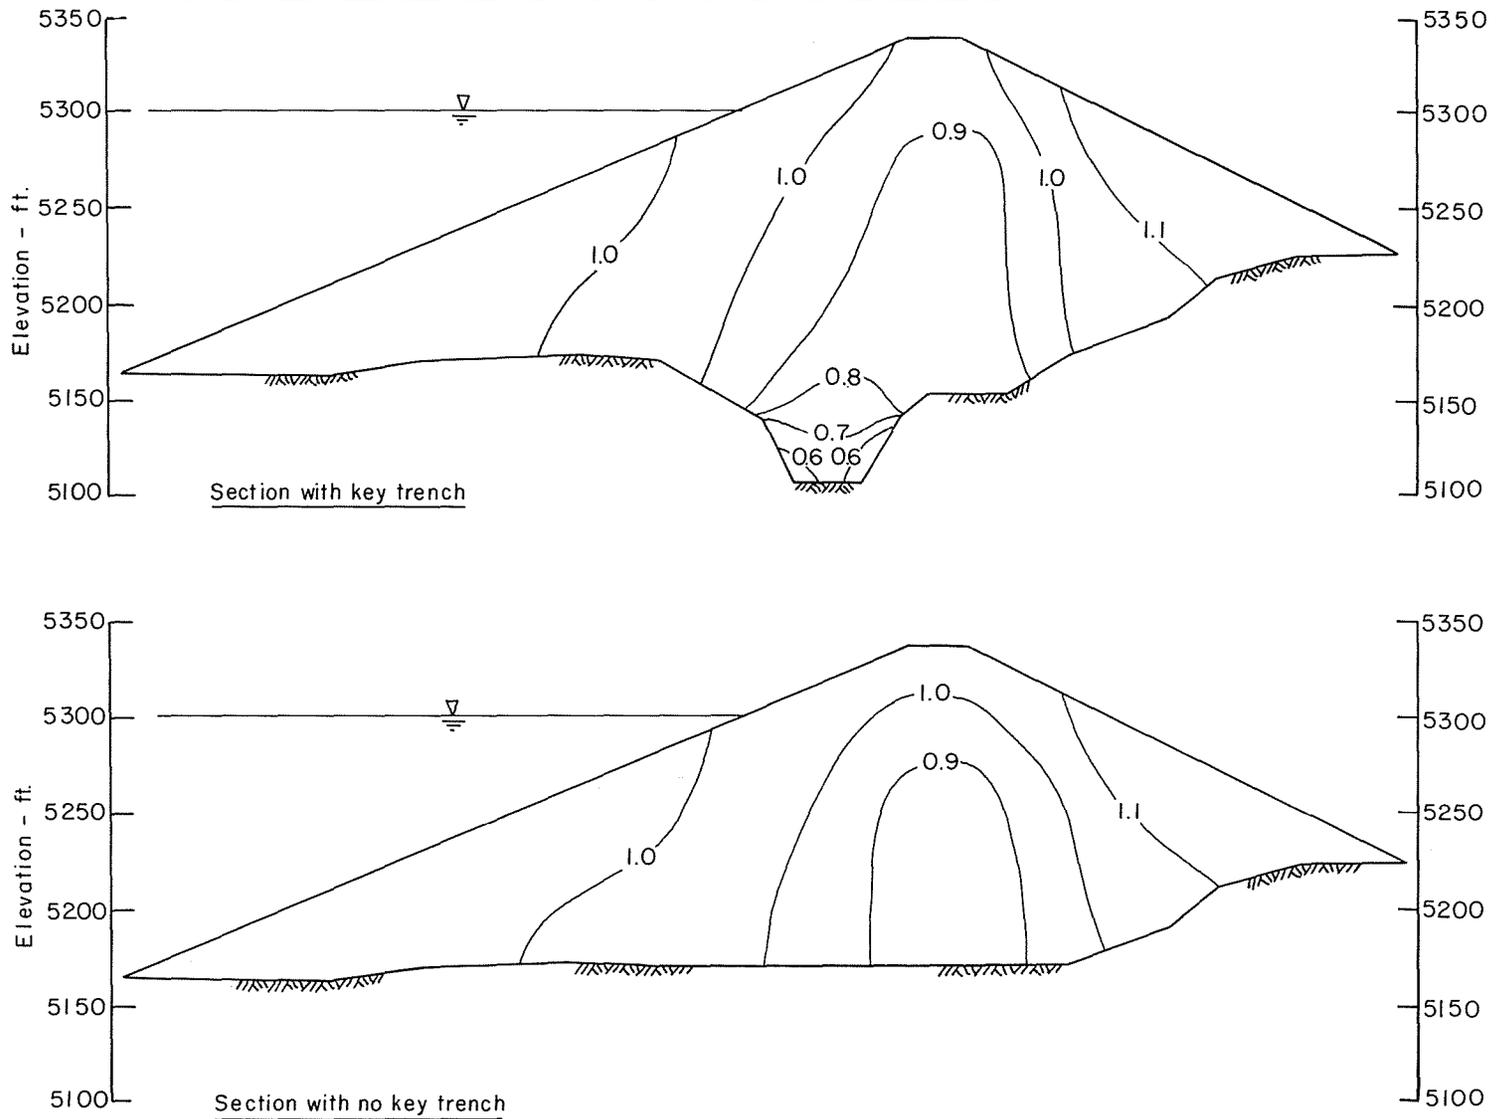
FIG. 19

CONTOURS SHOWING RATIO OF VERTICAL STRESS IN EMBANKMENT TO OVERBURDEN PRESSURE FOR CONDITIONS WITH AND WITHOUT KEY TRENCH AT STA. 15+00-BEFORE WETTING OF SOIL IN KEY TRENCH

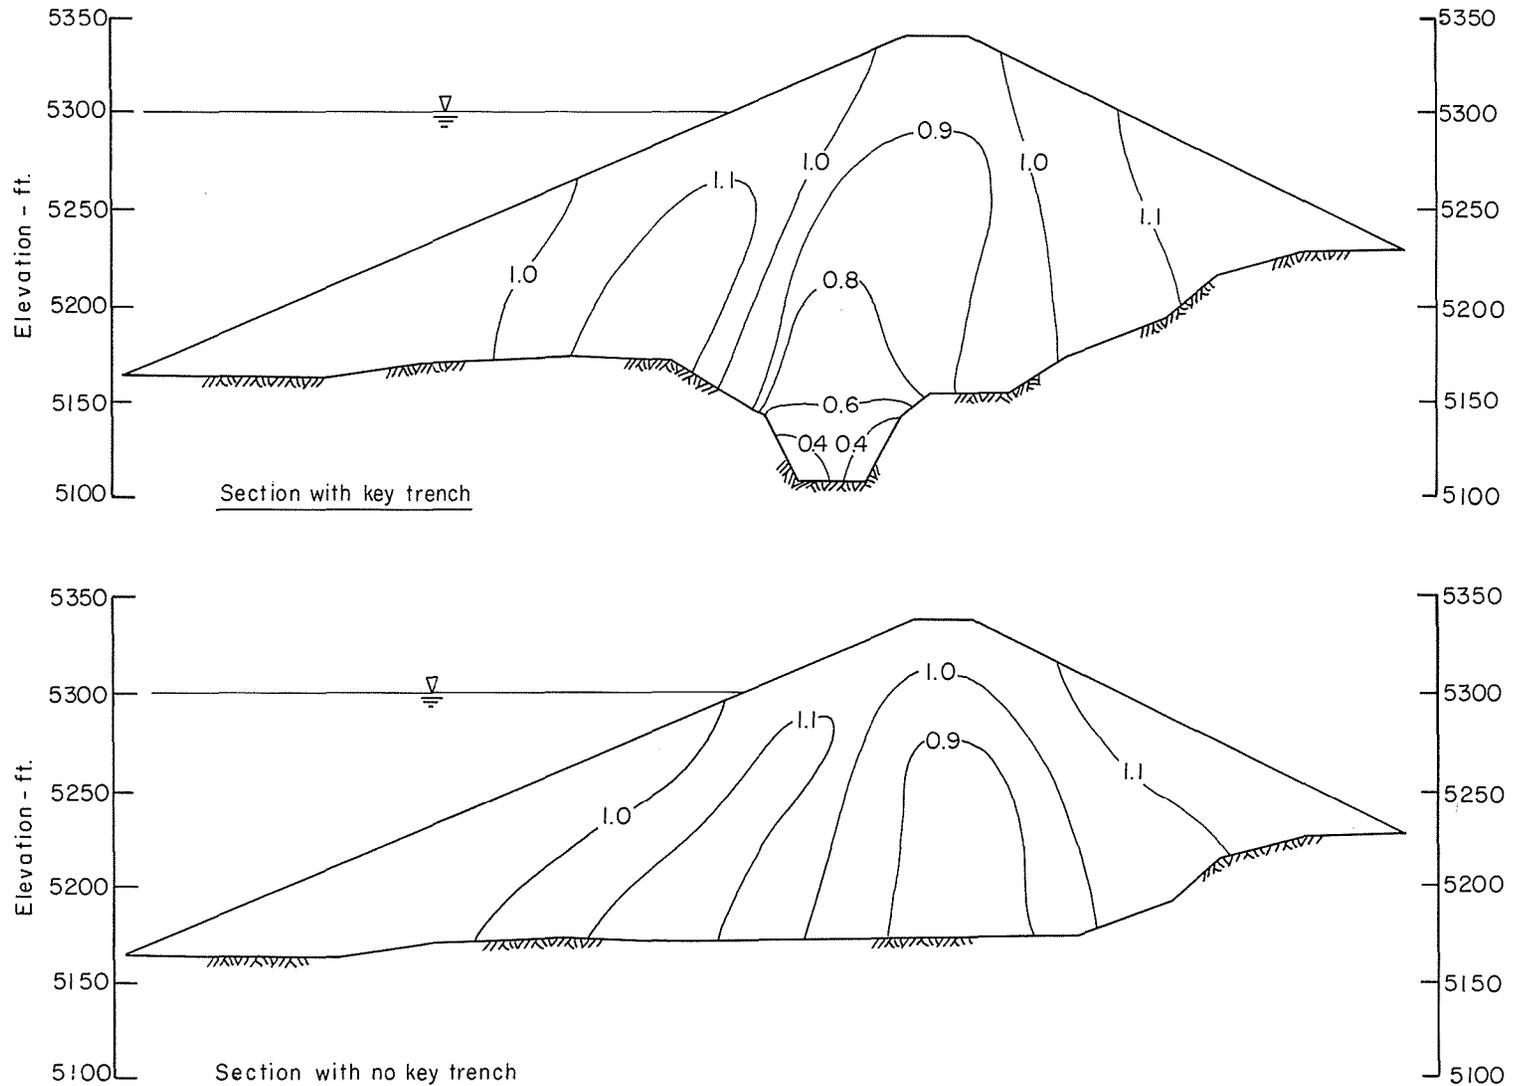
FIG.20 CONTOURS SHOWING RATIO OF VERTICAL STRESS IN EMBANKMENT TO OVERBURDEN PRESSURE FOR CONDITIONS WITH AND WITHOUT KEY TRENCH AT STA.15+00-AFTER WETTING OF SOIL IN KEY TRENCH
