REPORT TO  
U.S. DEPARTMENT OF THE INTERIOR AND STATE OF IDAHO  
ON  
**FAILURE OF TETON DAM**

BY  
INDEPENDENT PANEL TO REVIEW CAUSE OF TETON DAM FAILURE

DECEMBER 1976

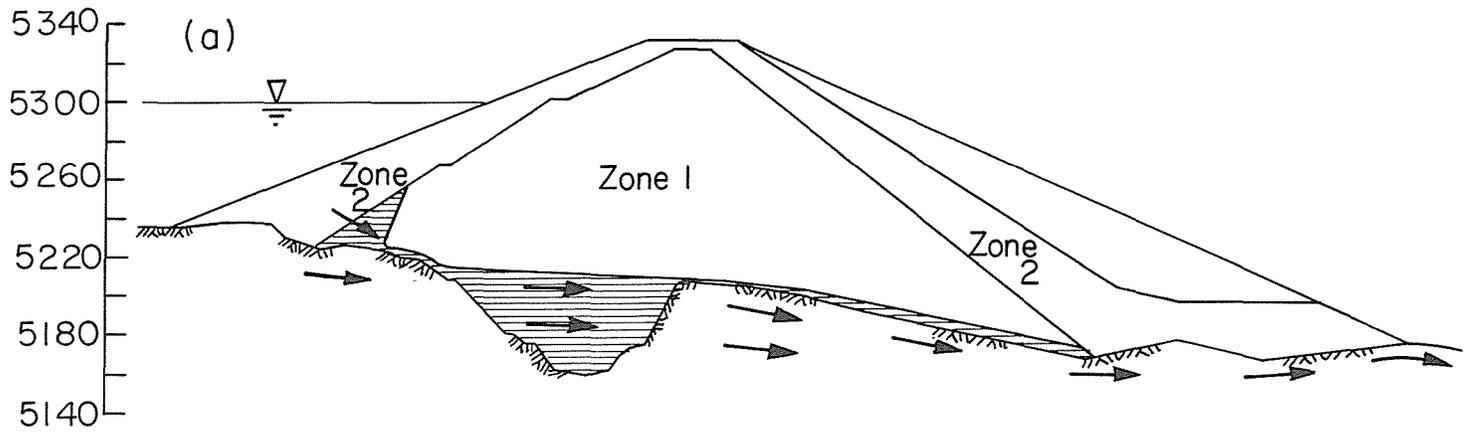
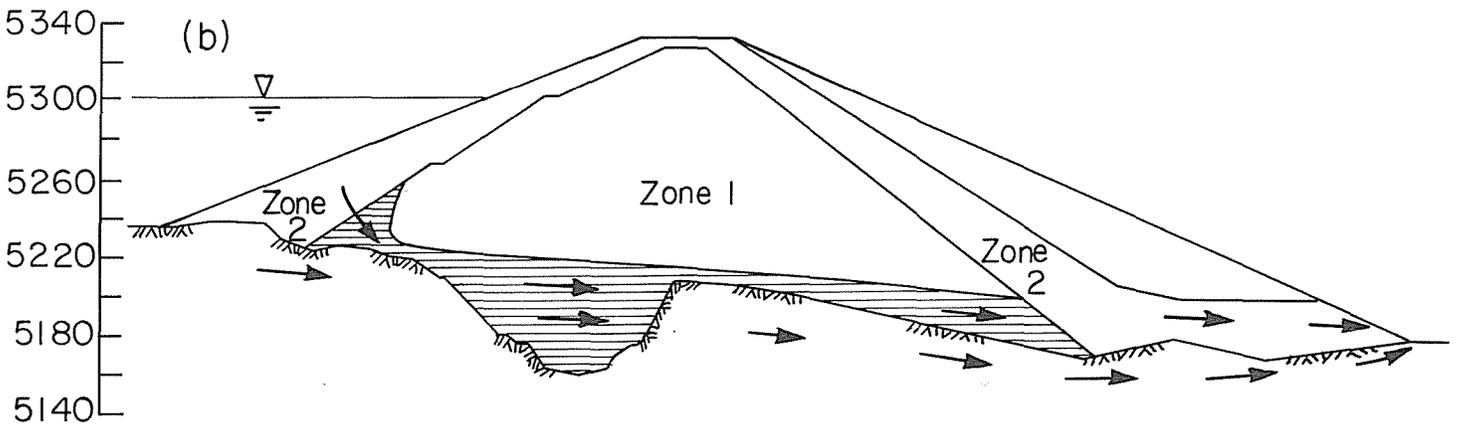
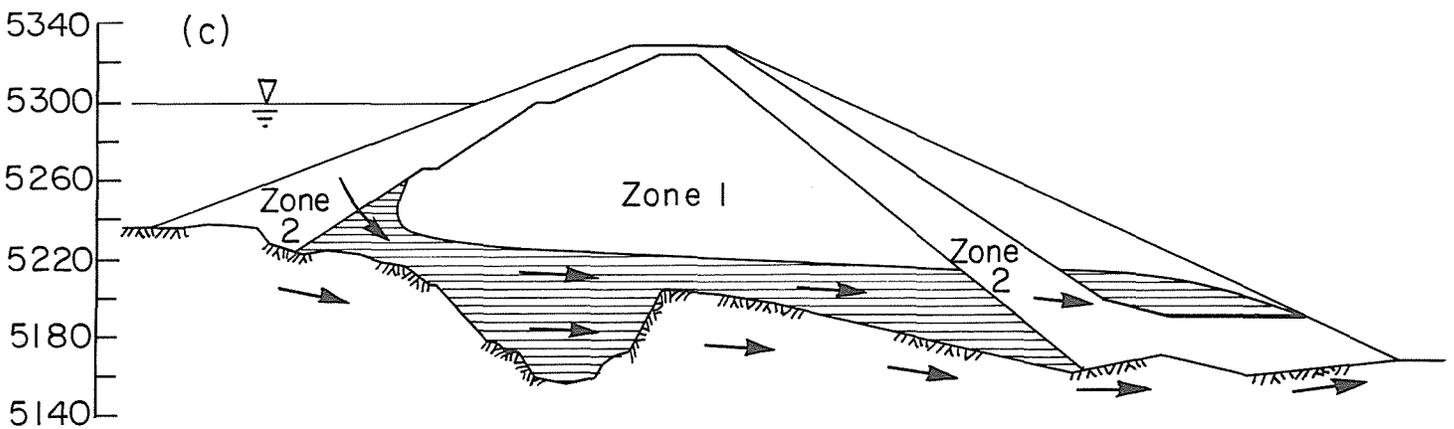
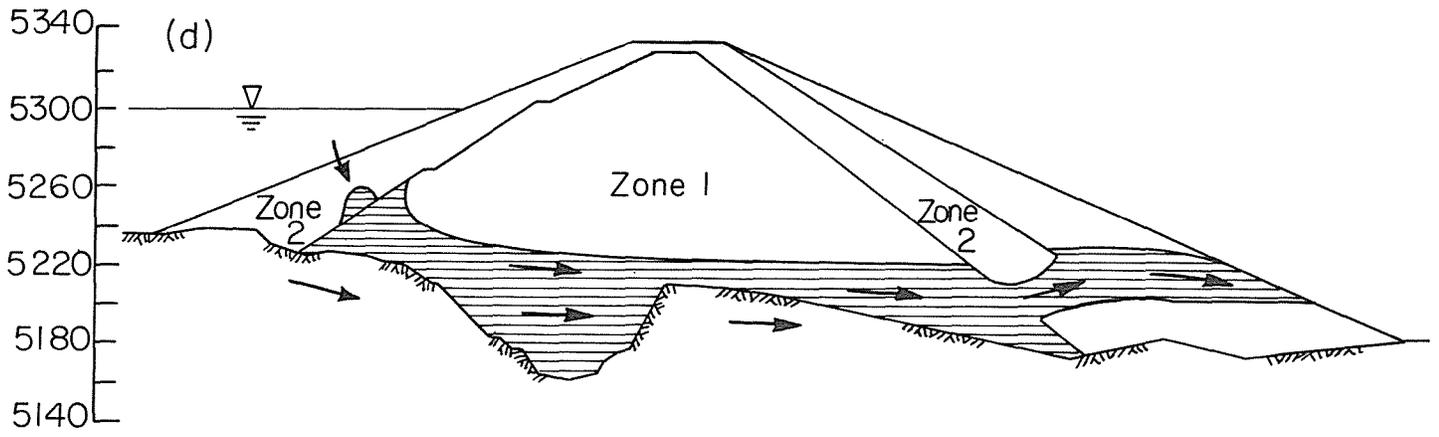
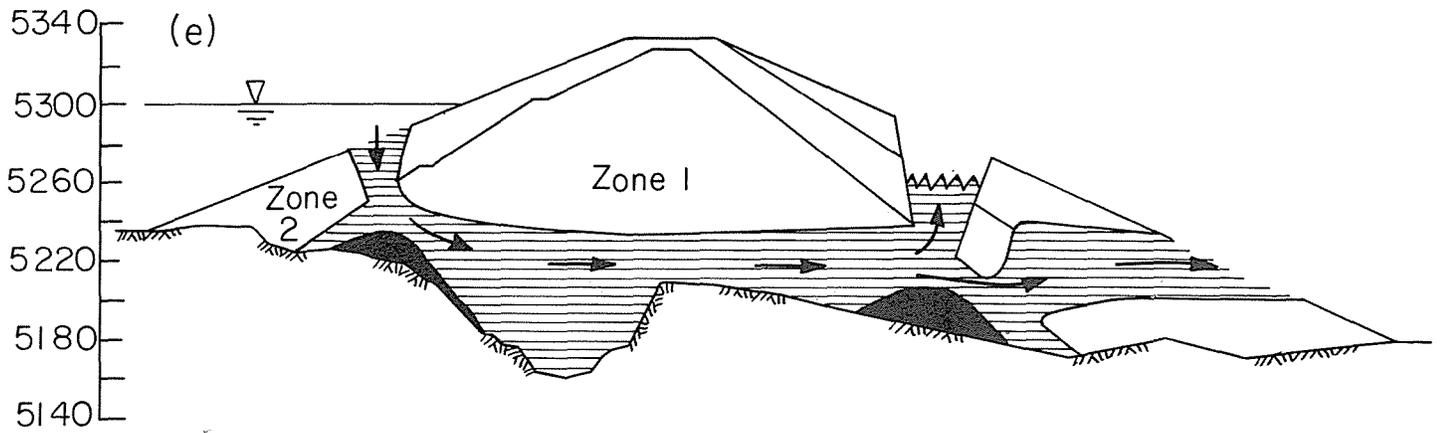
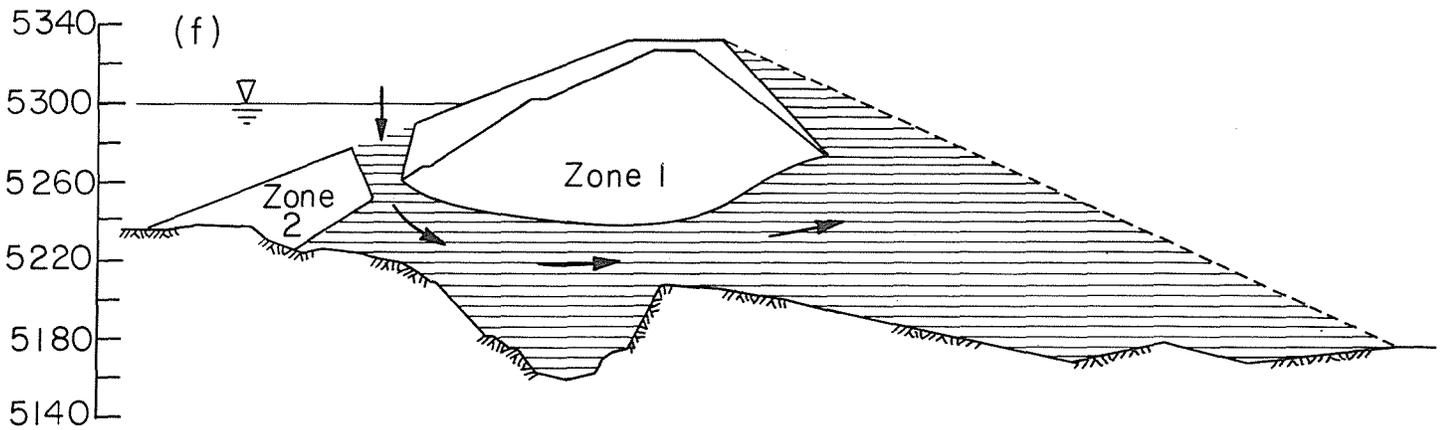
Progressive erosion led to continued increase in the size of the channel along the base of the dam, and perhaps some erosion of the soil above Zone 2 as shown in Fig. 23(c), until finally the water pressure was sufficiently great to break suddenly and violently through the Zone 2 fill and erupt on the face of the dam as shown in Fig. 23(d).

Beyond this point the progressive formation of sinkholes, both upstream and downstream, as illustrated in Fig. 23(e), provided an ever-accelerating mechanism for internal erosion, finally leading to complete breaching of the dam as illustrated in Fig. 23(f).

(A, B, C, OF F) **FIG. 23** CONCEPTUAL MECHANISM OF PROGRESSIVE FAILURE ALONG SECTION A-B-C

**FIG. 23** CONCEPTUAL MECHANISM OF PROGRESSIVE FAILURE ALONG SECTION A-B-C

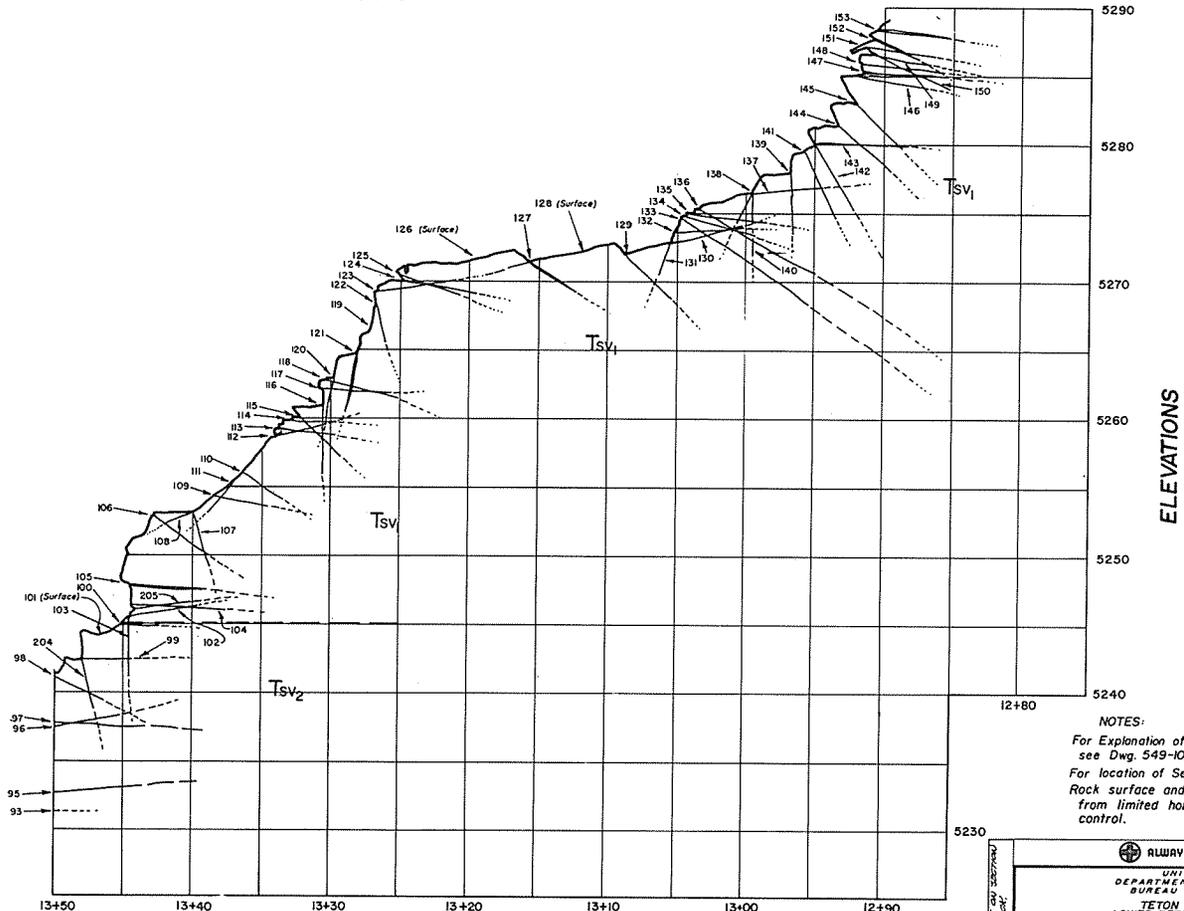
The joints shown from Sta. 12+80 to about Sta. 13+30 are the major continuous joints in Tsv<sub>1</sub>. Not depicted are the numerous closely spaced, discontinuous and lenticular, near horizontal joints that characterize the unit as notably platy.

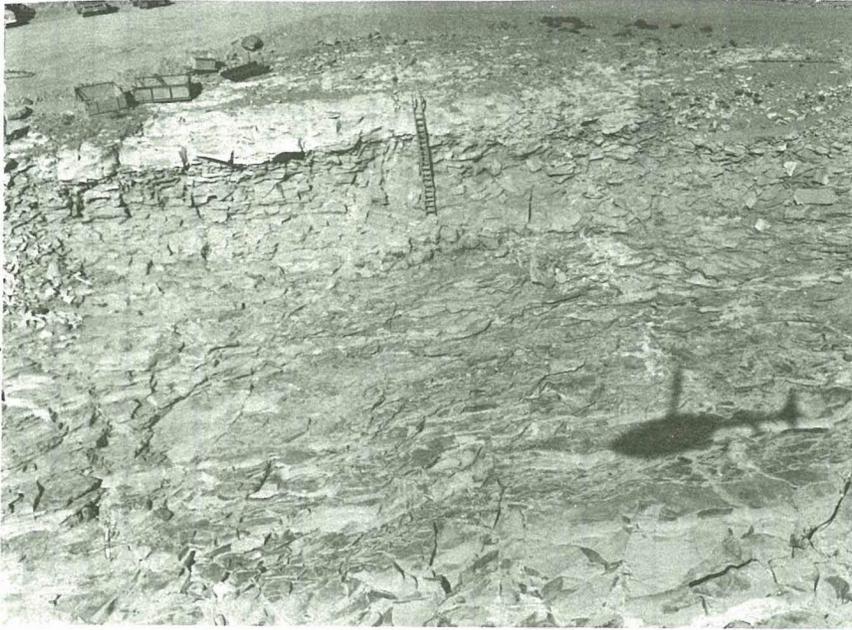
**Fig. E-1** Right wall of Teton Canyon upstream of dam axis showing intensive jointing in uppermost rock zone. (post-failure)

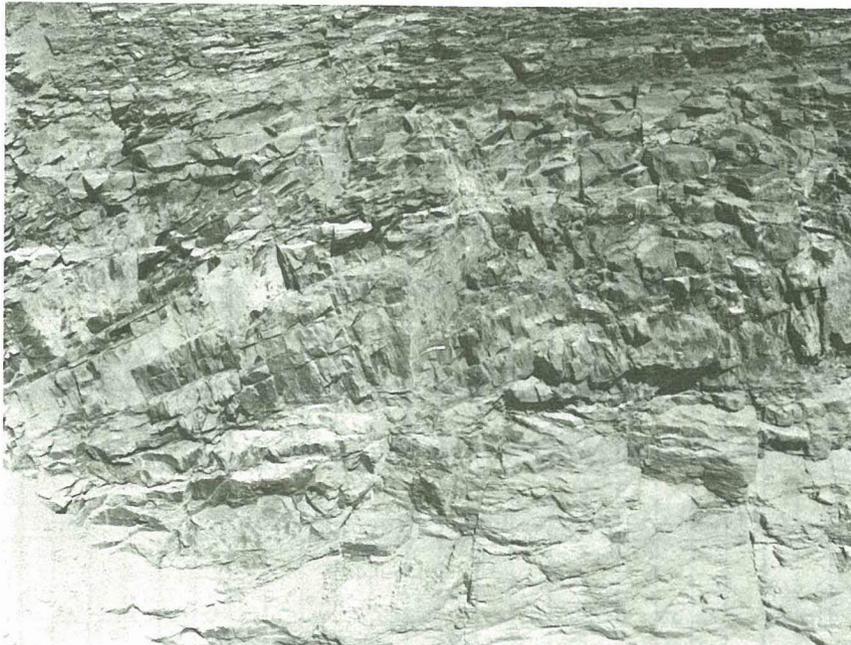
**Fig. E-2** Ash-flow tuff in right wall of Teton Canyon upstream of key trench. Note near-horizontal planes of separation. (post-failure)

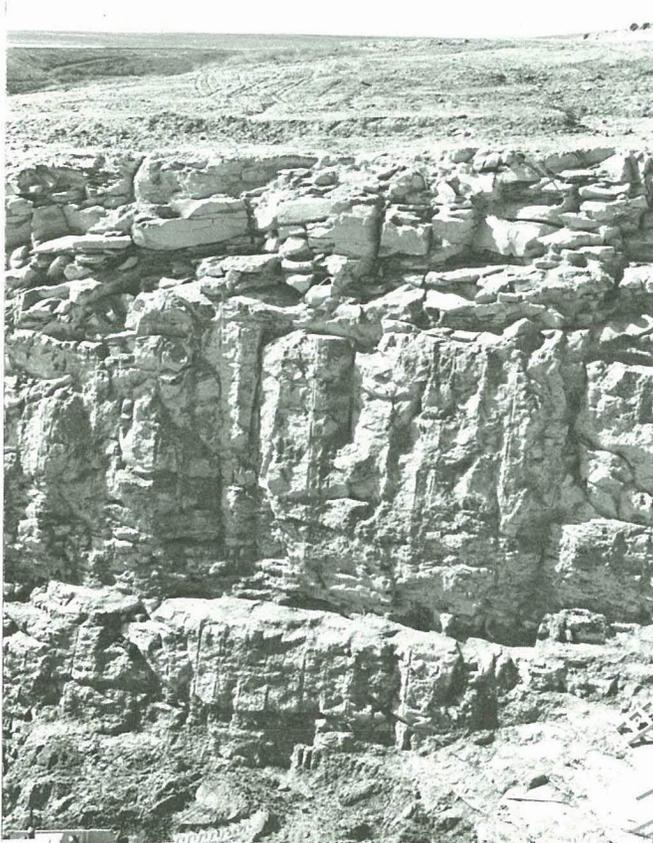
**Fig. E-5** Downstream face of key trench in right abutment. (post-failure)

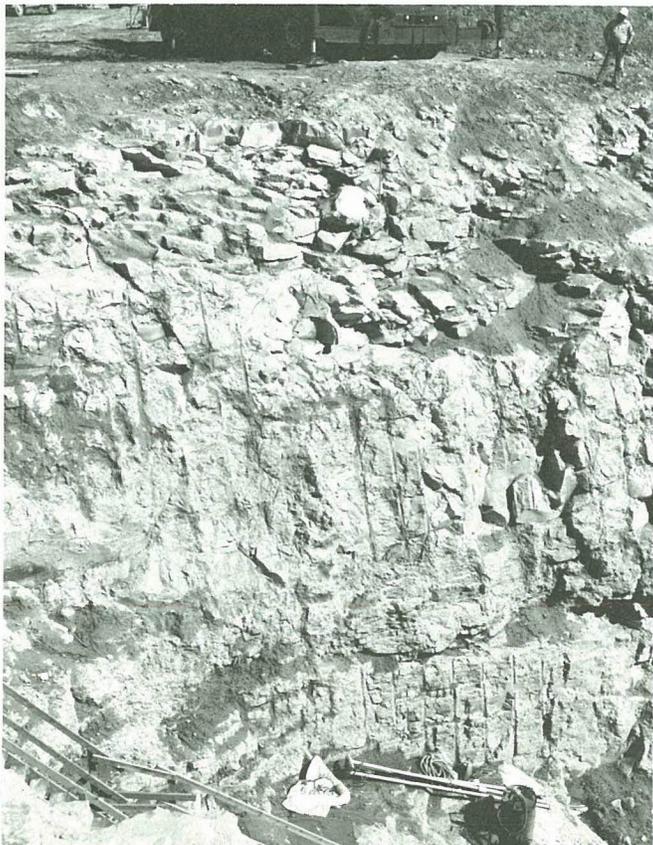
**Fig. E-6** Upstream face of key trench in right abutment. (post-failure)

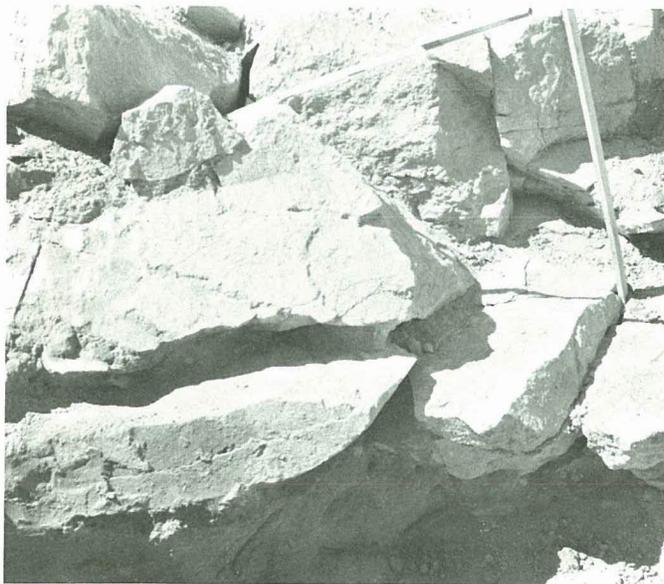
**Fig. E-8** Intensively jointed ash-flow tuff in downstream  
face of right abutment key trench at El. 5290.  
(post-failure)

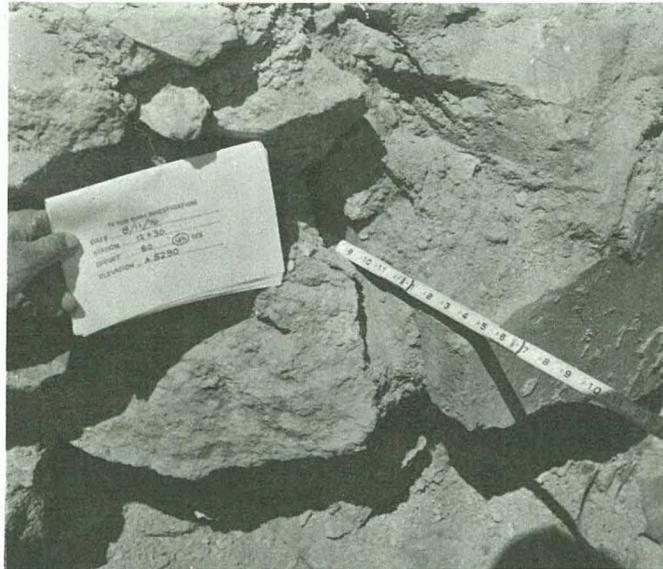
**Fig. E-9** Open joint in upstream face of right abutment key trench at Sta. 12+40, El. 5290. (post-failure)

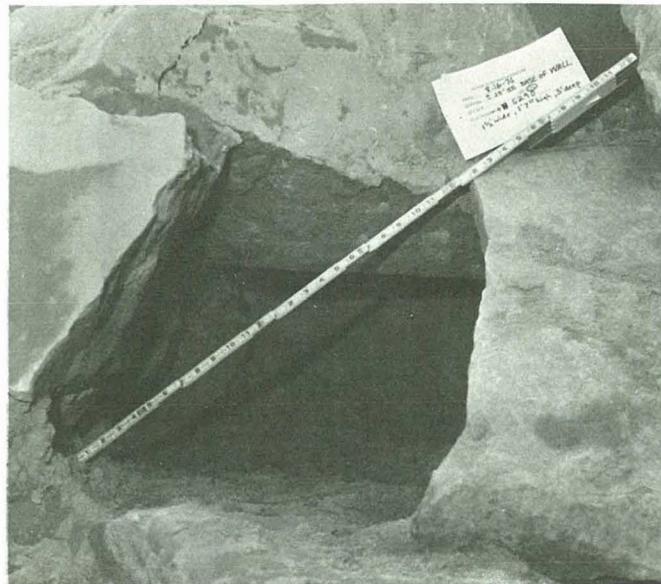
**Fig. E-10** Open joint in downstream face of right abutment key trench at El. 5290. (post-failure)

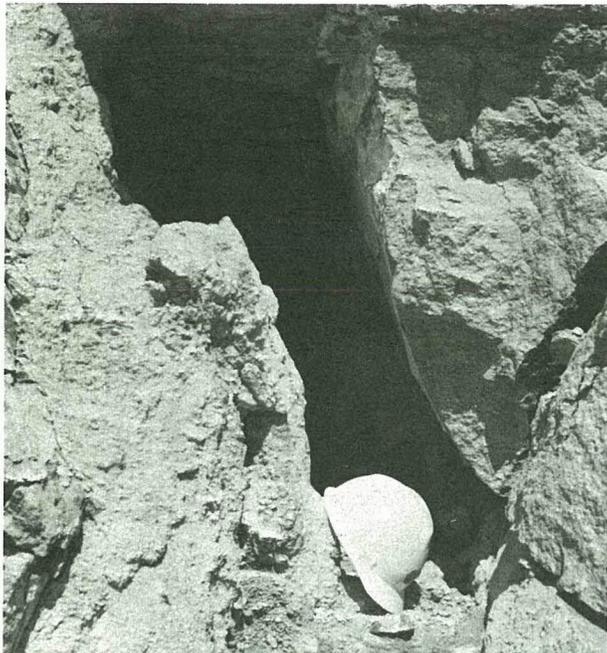
**Fig. E-19** Fissure at rim of right wall of canyon 1/8 to 1/4 mile upstream from dam. (post-failure)

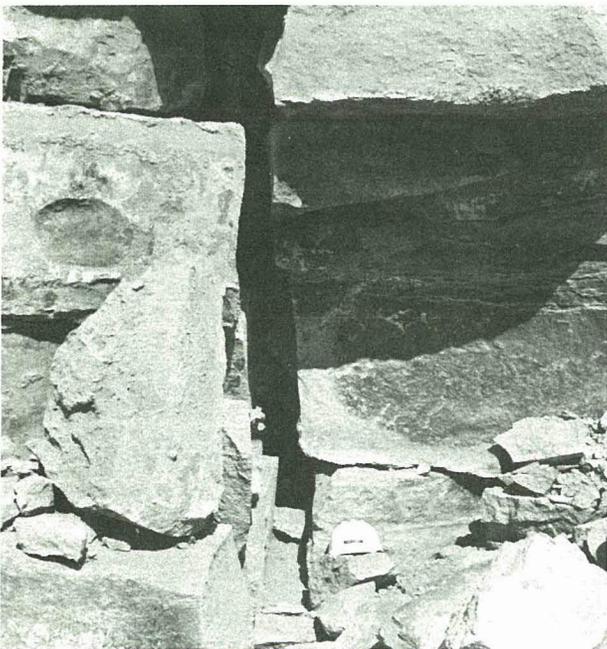
**Fig. E-20** One of several large fissures near rim of canyon right wall 1/8 to 1/4 mile upstream from dam. (post-failure)

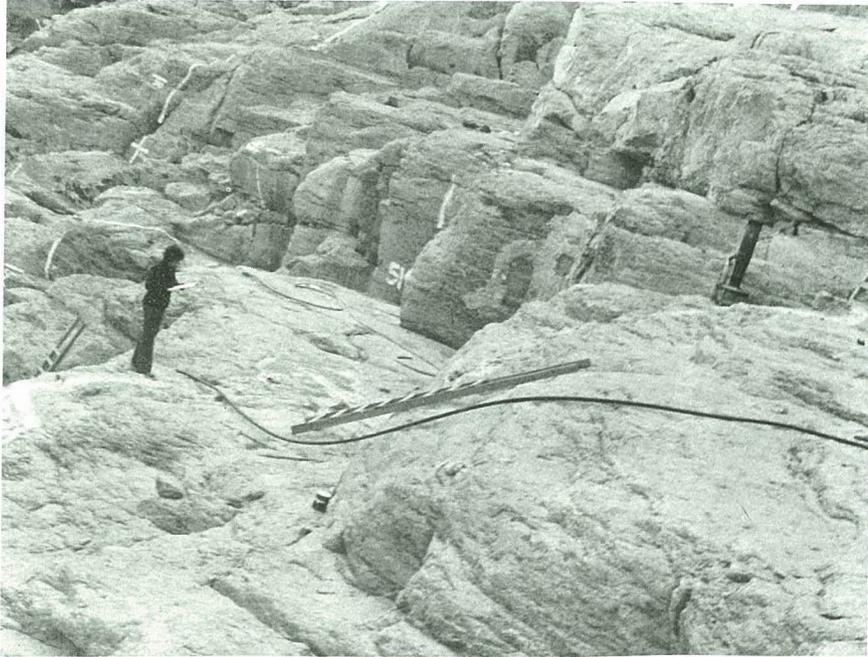
Fig. E-21 Prominent rock joints in vicinity of missing grout cap segment — bottom of photo. (post-failure)

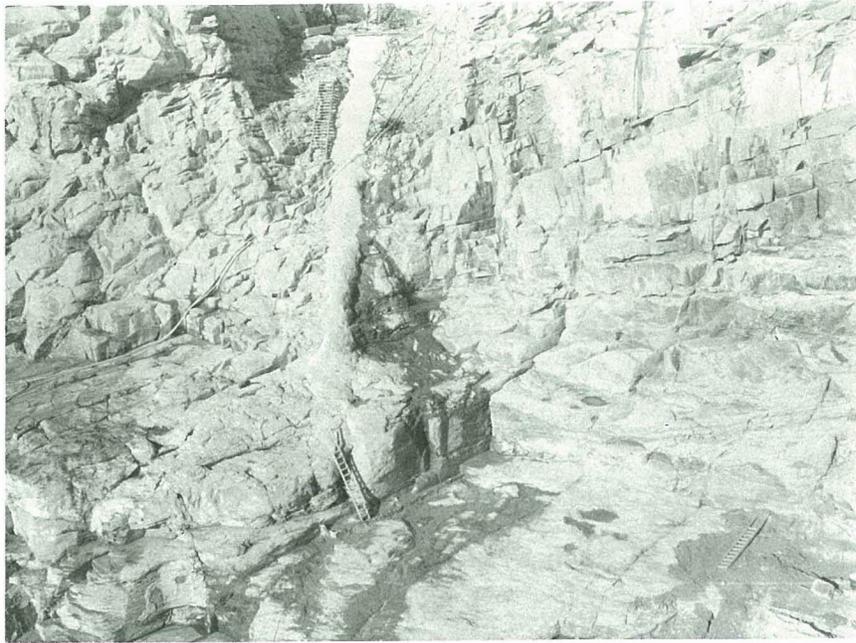
**Fig. E-23** Joint system near missing segment of grout cap Sta. 14+00 behind ladder in lower center. (post-failure)

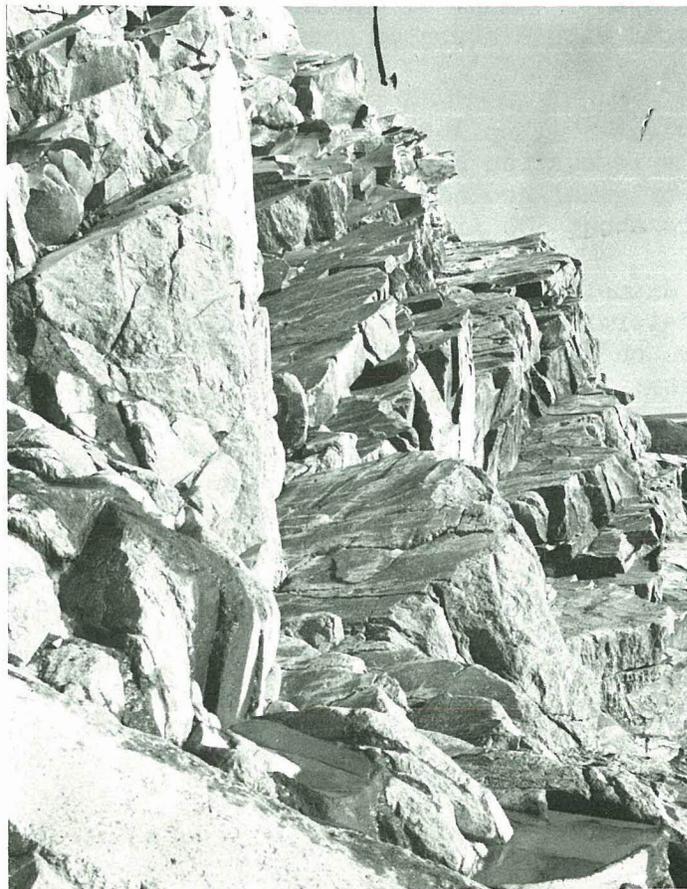
**Fig. E-24** View across grout cap toward prominent joint near Sta. 13+30. (post-failure)
