REPORT NO.
EERC 73-2
June 1973

ANALYSIS OF THE SLIDES IN THE SAN FERNANDO DAMS DURING THE EARTHQUAKE OF FEB. 9, 1971

H. BOLTON SEED
K. L. LEE
I. M. IDRIS
F. MAKDISI

State of California Department of Water Resources
Los Angeles Department of Water and Power
National Science Foundation

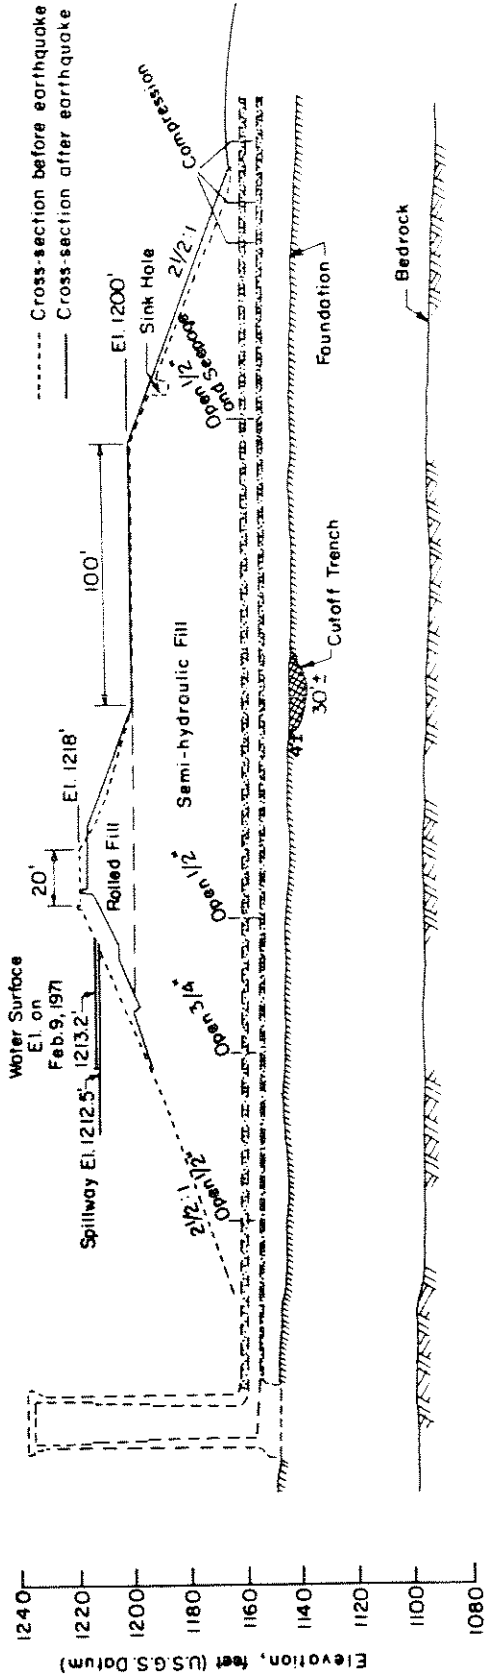
Fig. II-4 CROSS-SECTION THROUGH UPPER SAN FERNANDO DAM.
(After L.A. Dept. of Water and Power)

Shortly after the earthquake the interior of the outlet conduit was surveyed to determine the extent of damage. The results of this survey are shown on the cross section through the dam in Fig. II-4. In the central and upstream portion, there were several $1/2$ to $3/4$ inch cracks indicating extension movement in this zone. Near the toe of the dam there were compression failures in the conduit. The nature and direction of the movements at the conduit as indicated by these observations were generally the same as those observed from the surface. However, the magnitude of the cumulative movements at the conduit level was considerably less than the observed 5 ft. movement at the crest, indicating that the major movements either occurred within the fill above the conduit, or the fill slipped along the outside edge of the conduit. The first possibility is considered to be the most probable.

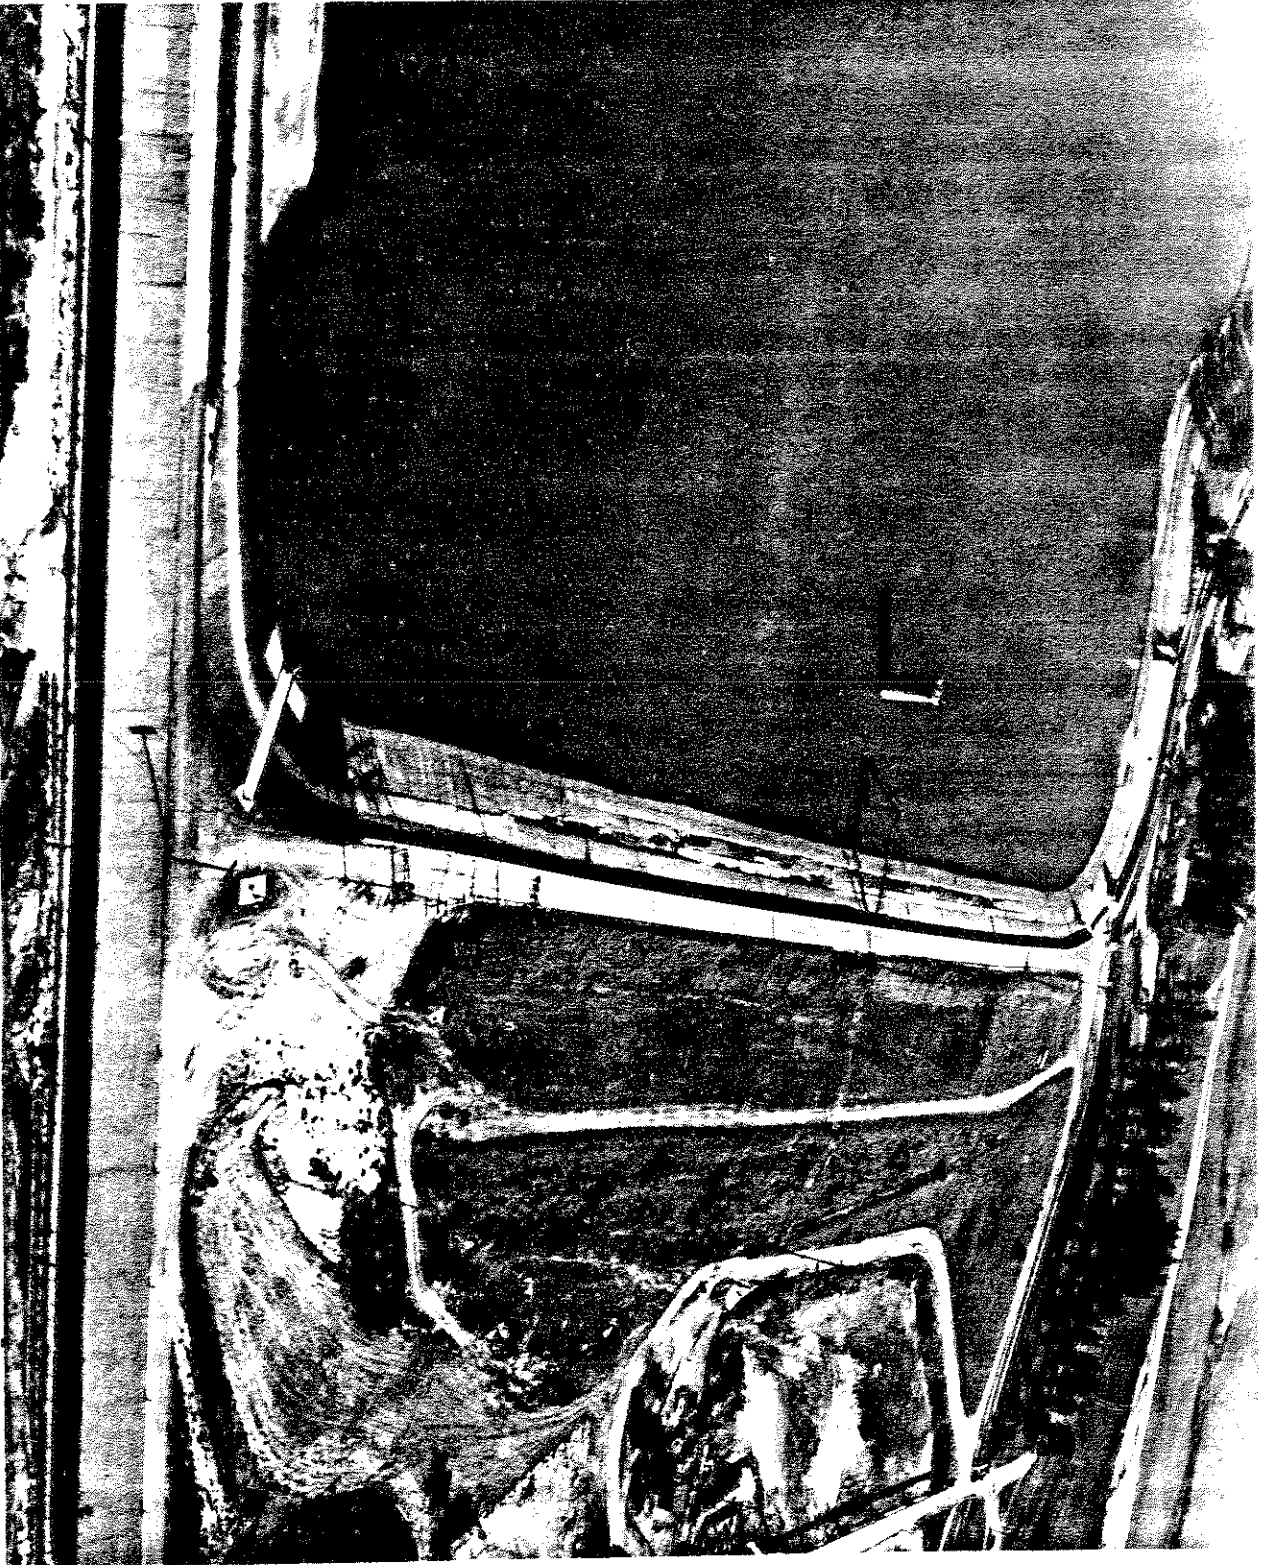
An aerial view of the Upper Dam taken some 12 days after the earthquake is shown on Fig. III-5. Severe longitudinal cracks are clearly evident running almost the full length of the dam on the upstream slope. At the time of the earthquake the water level in the reservoir was above these cracks so that they were only visible after the reservoir level had been drawn down. These cracks resulted from a general downstream movement and settlement of the top portion of the dam with respect to the foundation. Subsequent surveys showed that at the center line, the crest moved downstream about five feet and settled vertically about three feet (see Fig. II-4).

FIG. III-5 VIEW OF UPPER SAN FERNANDO DAM AFTER EARTHQUAKE.
(Photograph by Department of Water Resources, Feb. 21, 1971)

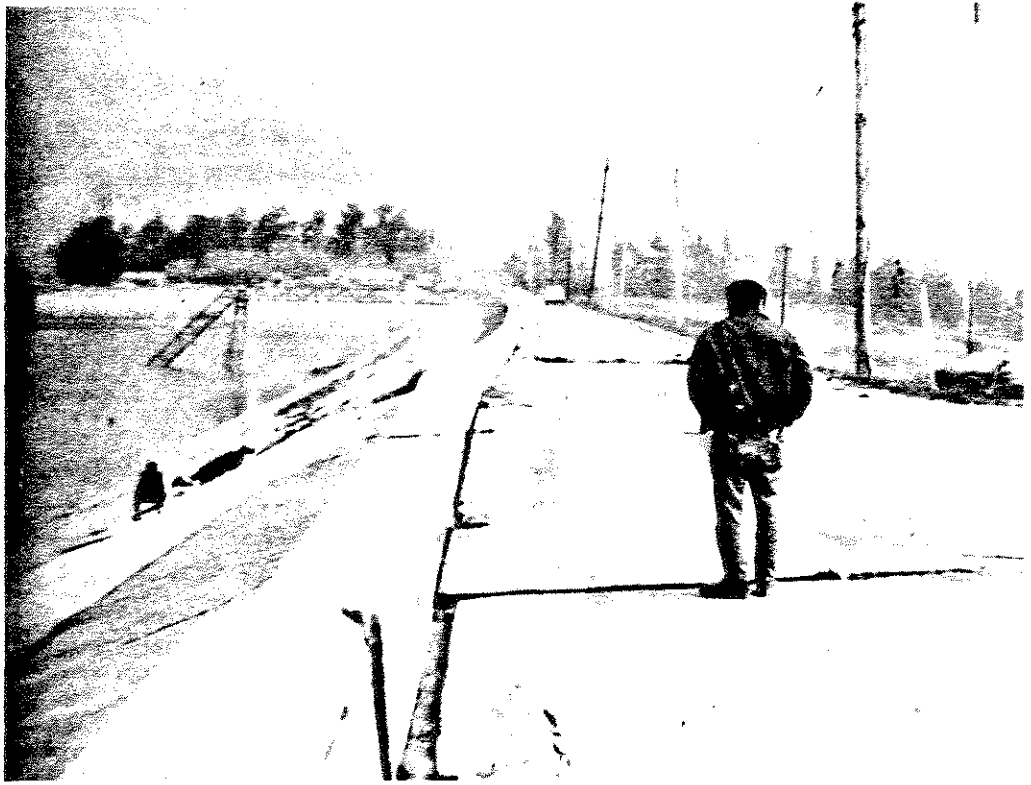
A close-up view from the ground along the crest of the dam showing the bowing of the parapet wall resulting from the downstream movements is shown on Fig. III-6 and a close-up view of the upstream cracks is

FIG. III-6 DEFORMATION OF PARAPET WALL RESULTING FROM DOWNSTREAM MOVEMENT OF EMBANKMENT

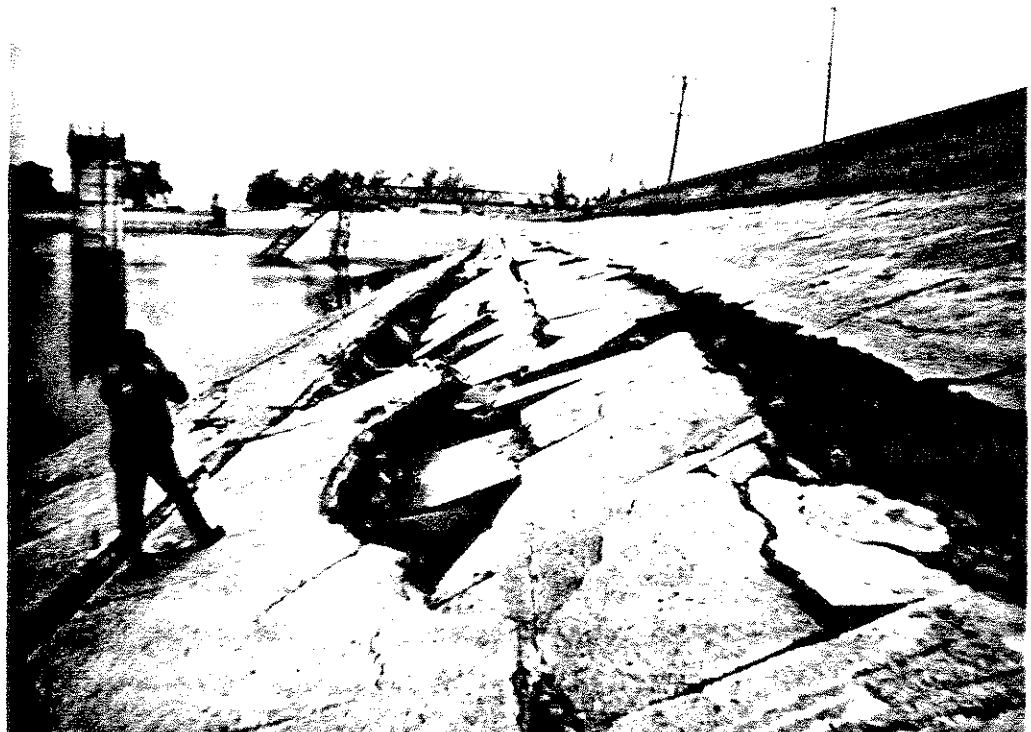
FIG. III-7 SLIDE SCARPS ON UPSTREAM FACE OF EMBANKMENT

presented in Fig. III-7. These cracks appear to be multiple shear scarps at the outer edge of the fill.

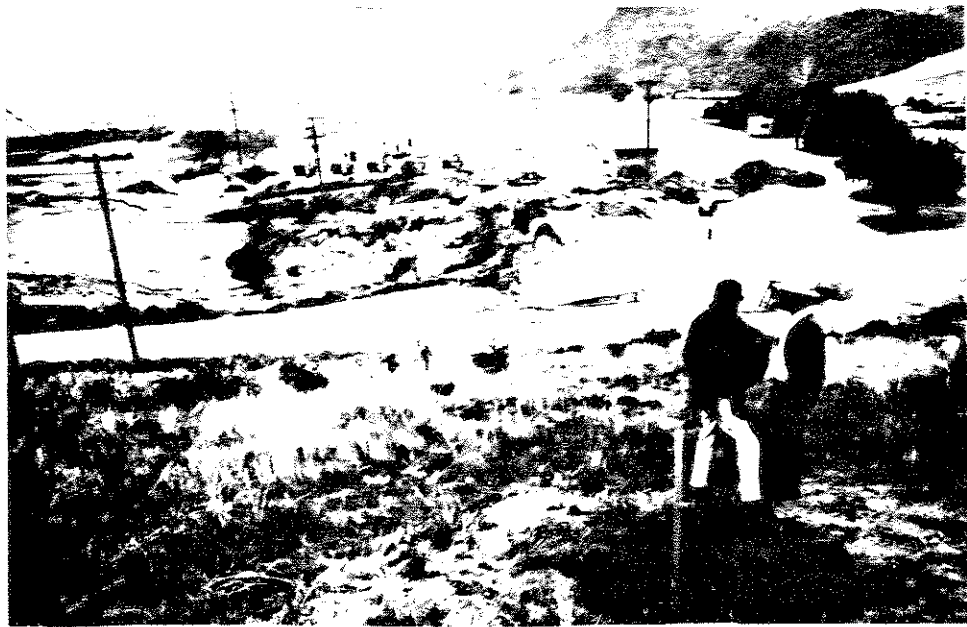
Other surface features indicating the nature of damage within the dam included a large sinkhole above the downstream portion of the outlet conduit. This extended to the surface, and is shown on Fig. III-8. The location is indicated on Fig. II-4, almost directly above an open crack in the conduit. It was apparently formed by seepage and erosion through the cracks in the conduit during or immediately following the earthquake.

FIG. III-8 SINK HOLE WHICH DEVELOPED ABOVE THE OUTLET CONDUIT ON THE DOWNSTREAM SLOPE OF THE UPPER DAM.

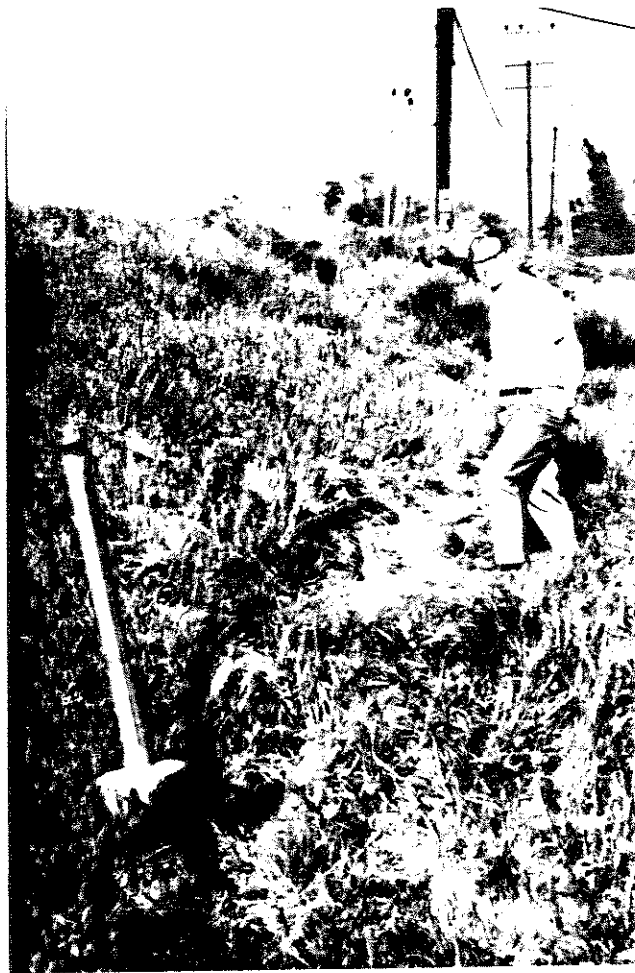
FIG. III-9 LONGITUDINAL CRACK WHICH DEVELOPED ALONG THE DOWNSTREAM SLOPE OF THE UPPER ROLLED FILL SECTION, UPPER SAN FERNANDO DAM.

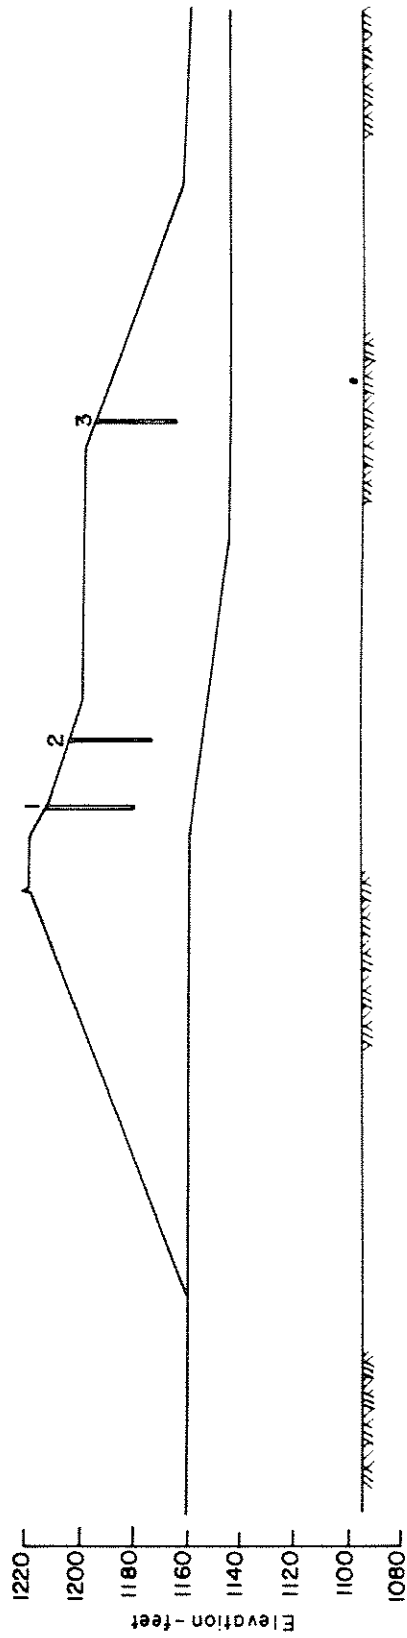
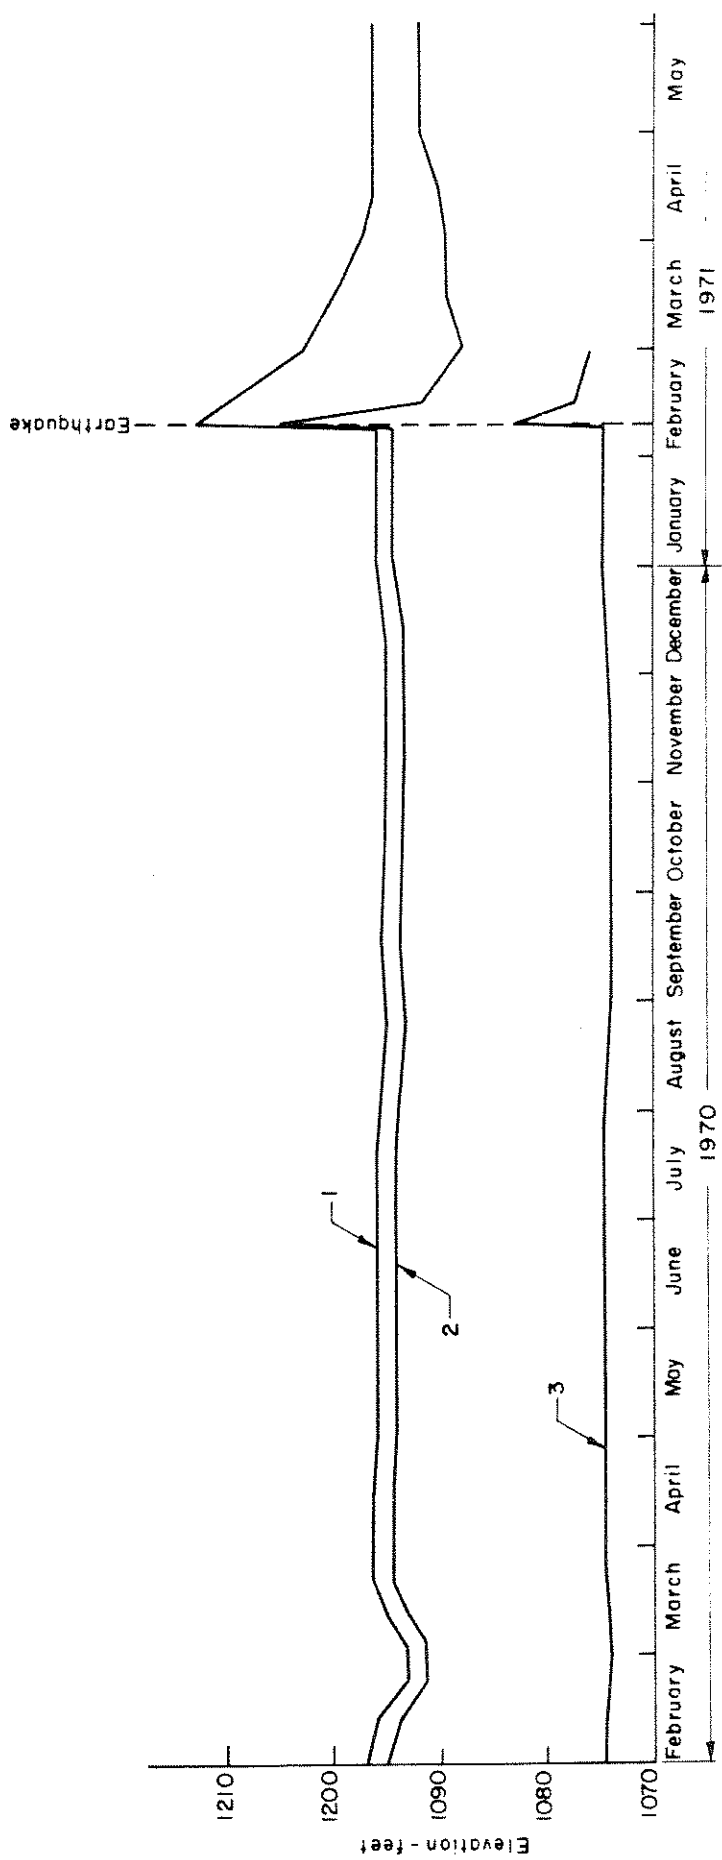
Of special interest in studying the causes of the movements described above were the observations of water level in two piezometers which had been installed in the dam for surveillance purposes prior to the earthquake. The locations of these piezometers in the cross-section and the water level changes following the earthquake are shown in Fig. III-11. The effect of the shaking was to cause an immediate increase in pore water pressure in the embankment, which slowly dissipated with time following the earthquake. As may be seen from the figure the recorded changes in pore pressure ranged from 8.5 to 17 ft of water. However the increases for piezometers 1 and 2 near the center of the embankment were so large that water spilled over the tops of the well casings and the maximum values could not therefore be measured. Furthermore since the

Fig. III-11 CHANGES IN WATER LEVEL IN PIEZOMETERS FOLLOWING THE EARTHQUAKE
 - UPPER SAN FERNANDO DAM.

first observations on these piezometers were made about 24 hours after the earthquake occurred, the actual increase in pore water pressure in piezometer 3 is likely to be substantially higher than that shown.

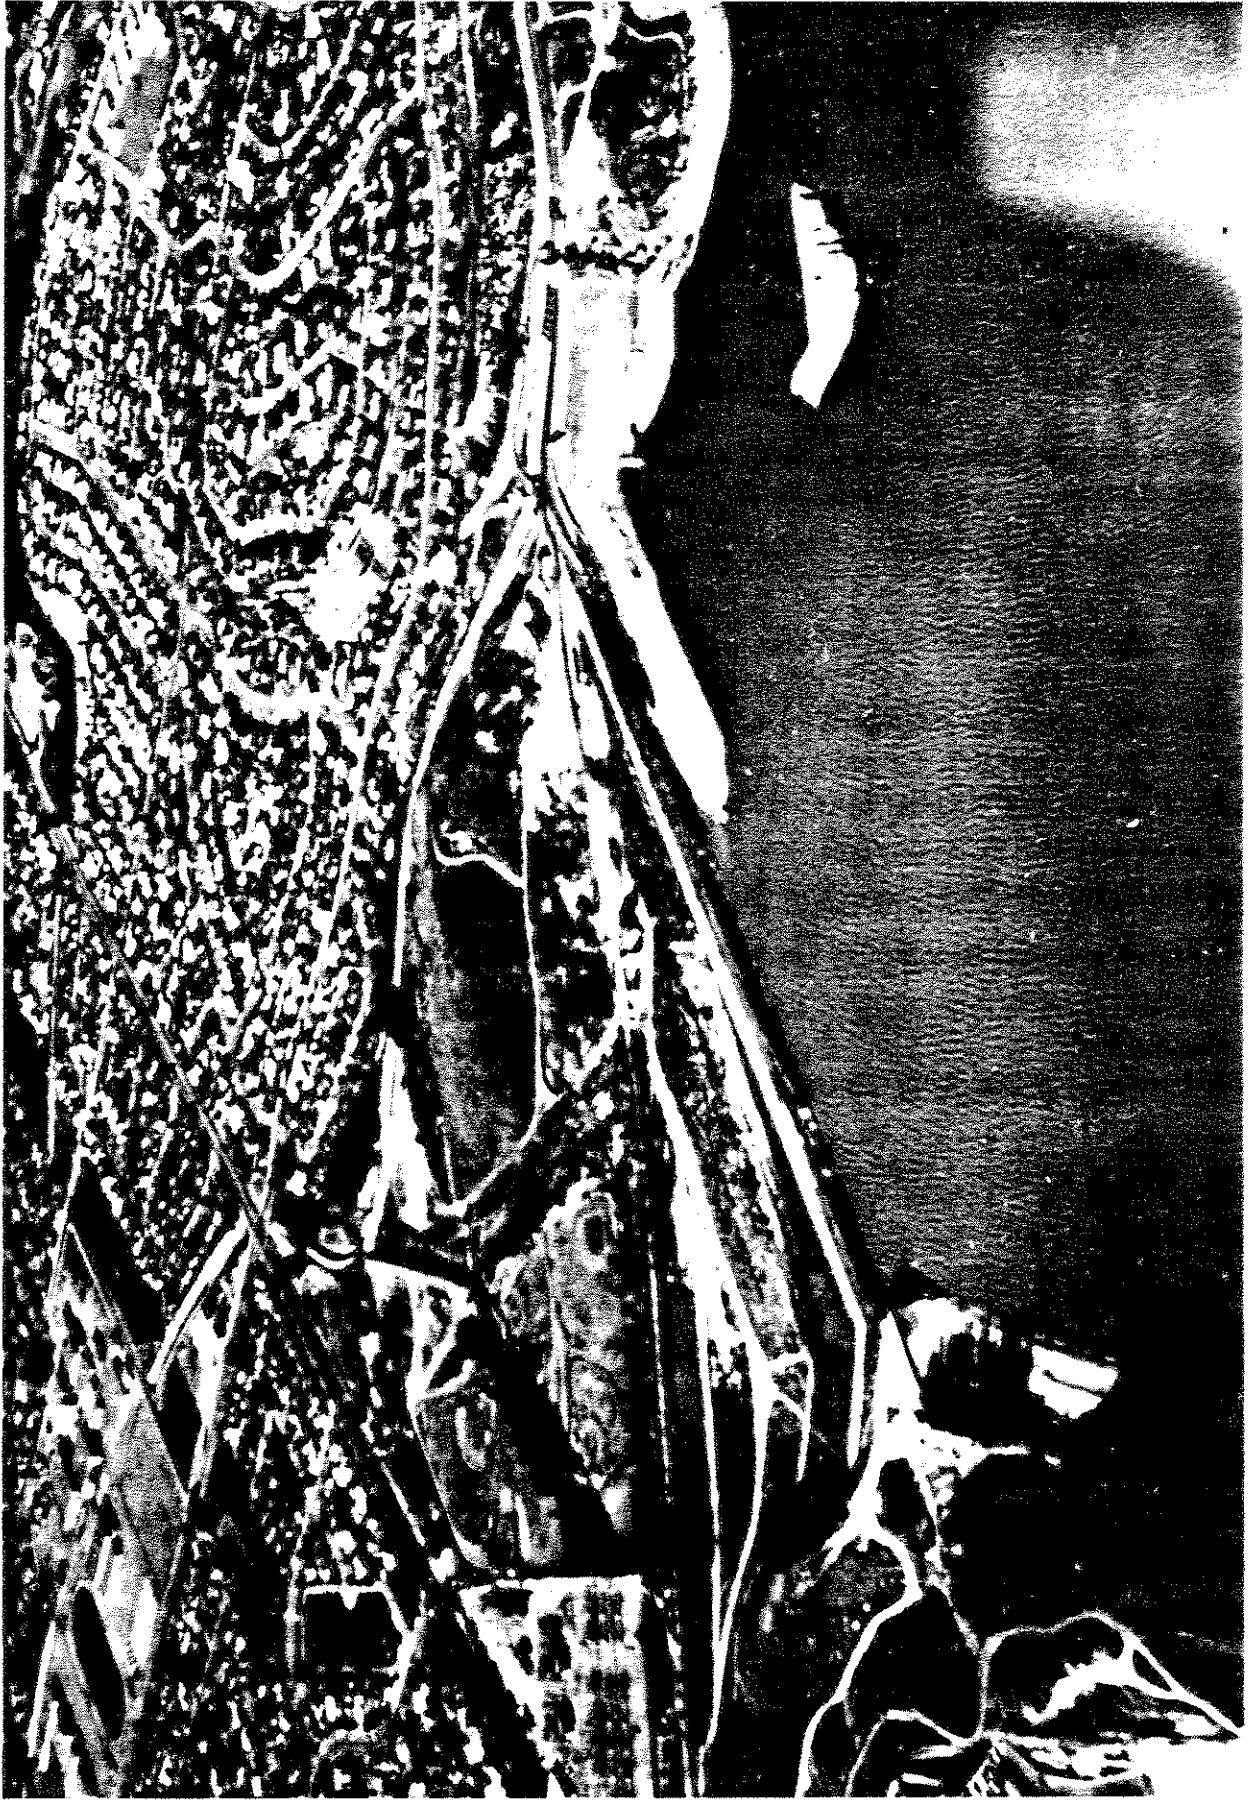
FIG. III-12 AERIAL VIEW OF LOWER SAN FERNANDO DAM SOON AFTER EARTHQUAKE

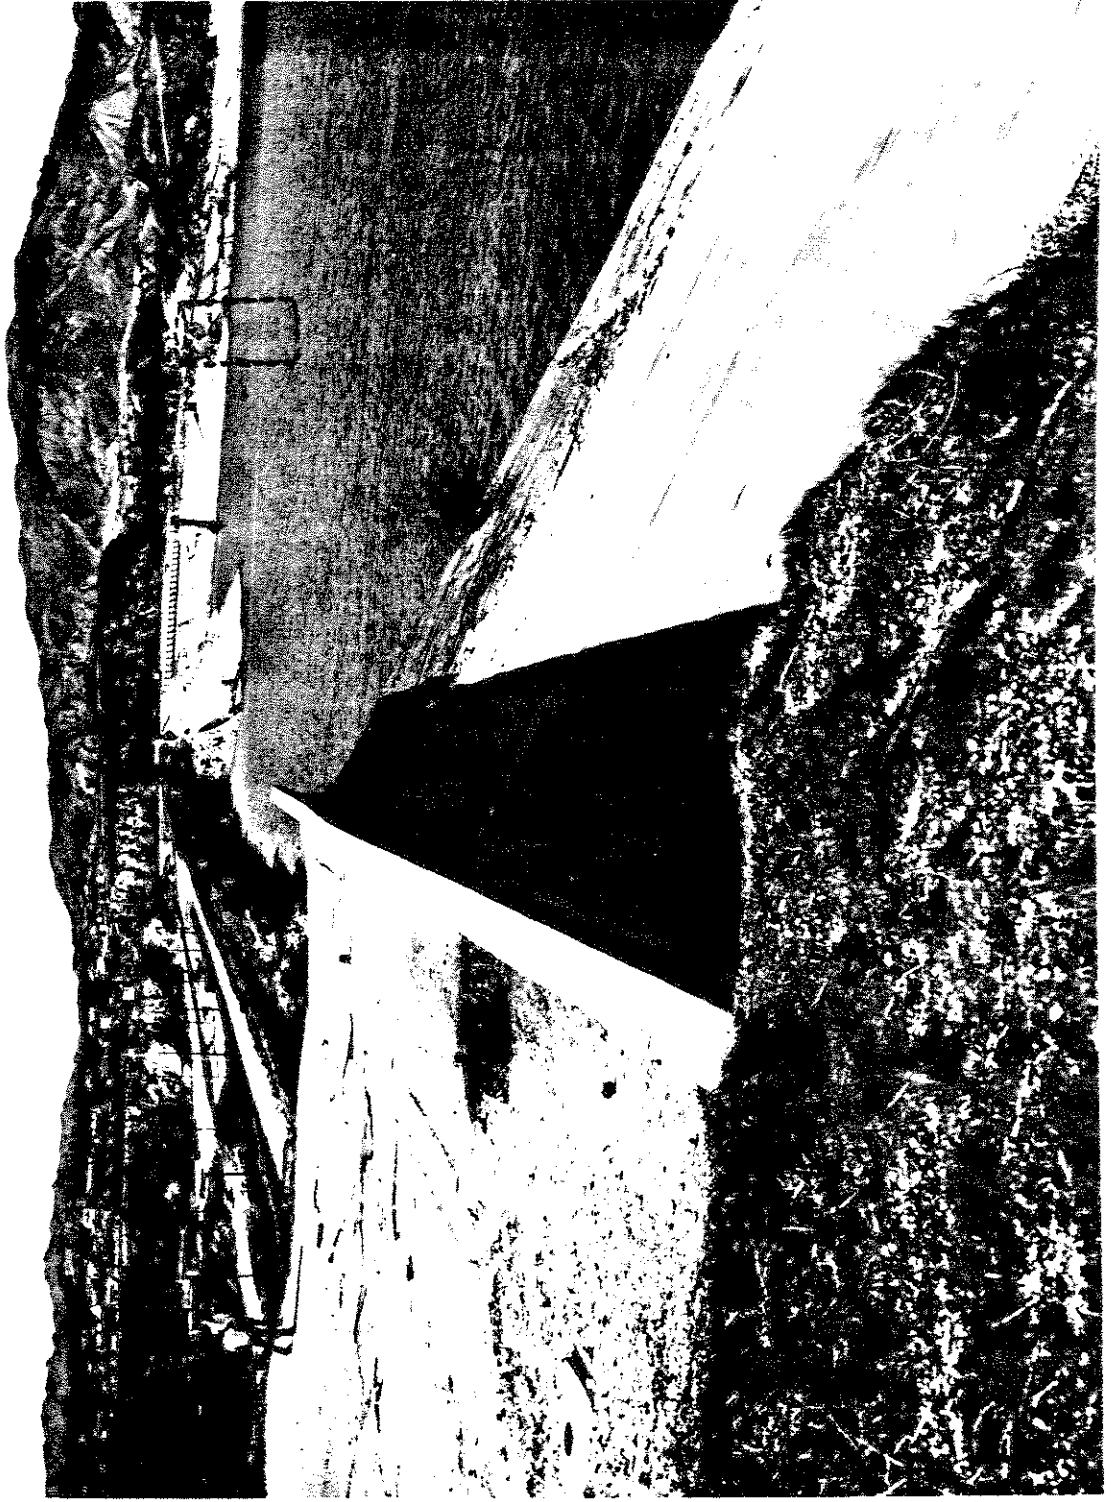
FIG. III-15 LOWER SAN FERNANDO DAM THREE DAYS AFTER THE EARTHQUAKE
(The approximate location of Outlet Tower No. 1 prior to the earthquake is indicated by the dotted outline)

In addition to removal of water through the two outlet towers some water was also drawn off through three 12 inch blow off valves reaching into the unpaved channel downstream from the dam. The U. S. Army Corps of Engineers also provided additional capacity by installing pumps to the shoreline with a total capacity of about 70 cfs. During the period when all available outlets were being used the maximum outflow from the Lower Van Norman Reservoir was about 700 cfs. Most of this water was taken into the city's water supply system and other storage reservoirs.

During the first few days following the earthquake the water level in the reservoir dropped at an average rate of about 4 ft per day. After about four days the water level had been lowered sufficiently to eliminate

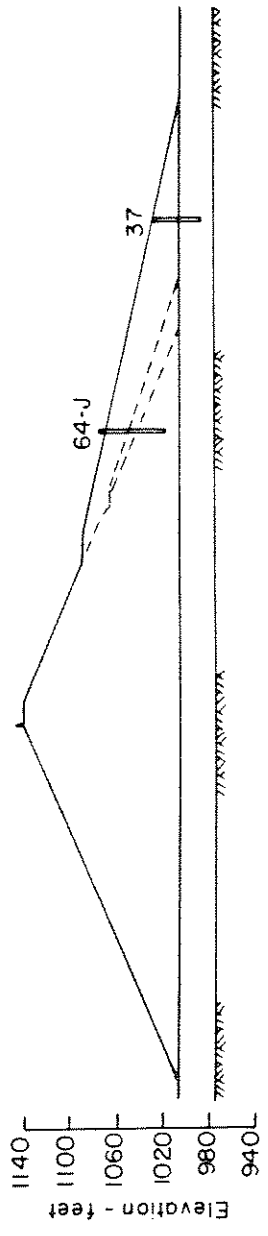
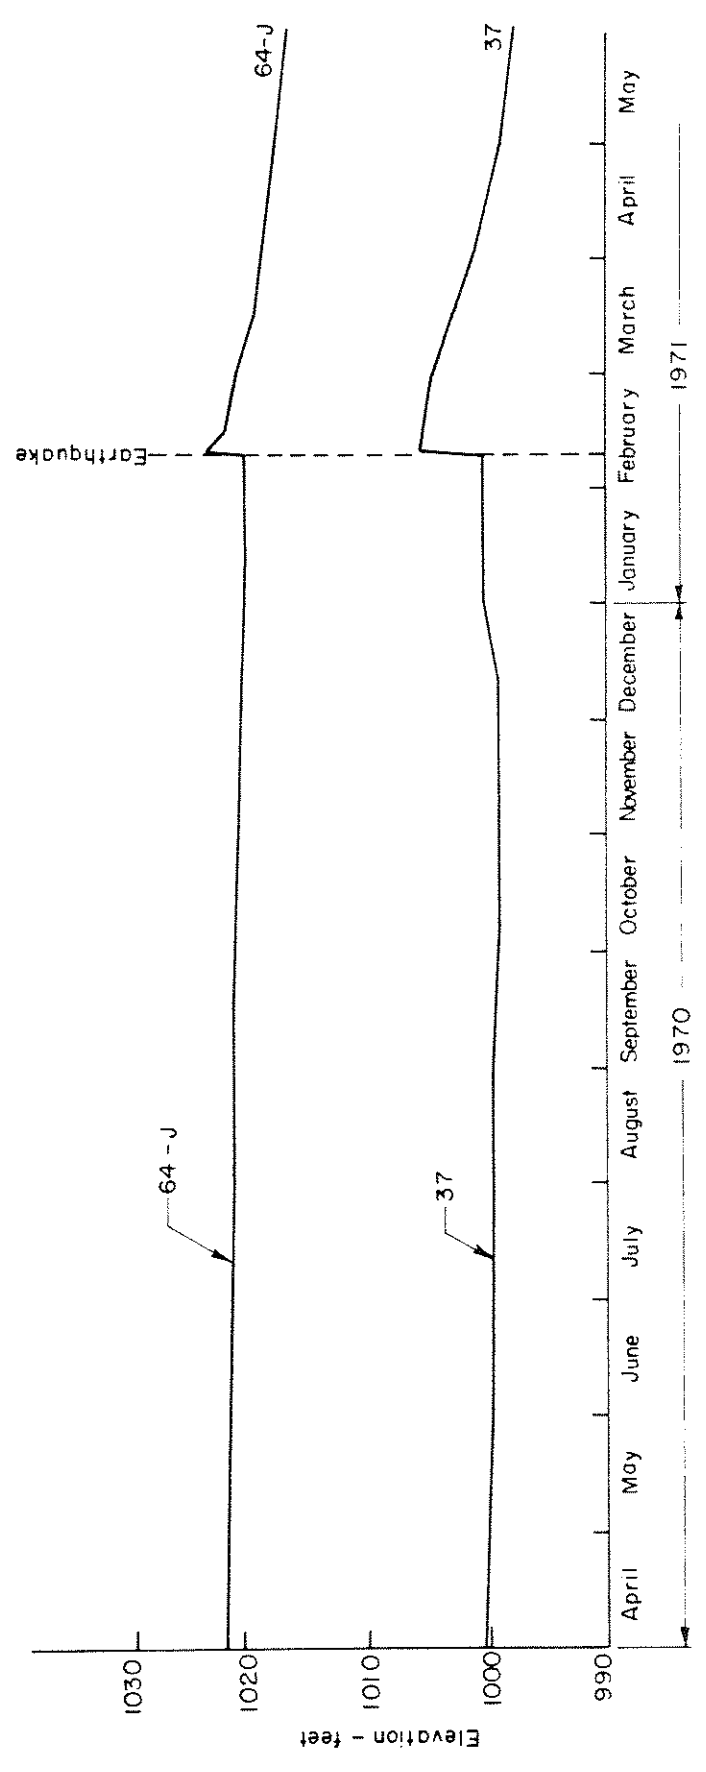
Piezometers located in the downstream portion of the embankment which was not destroyed by the movements were read and other surveillance data were taken as quickly as possible following the earthquake. It was noted that seepage had increased for a short period and several seepage flows became turbid at first but then cleared within 36 hours after the earthquake. The water levels in the piezometers showed an initial rise but then later returned to normal and slowly decreased as the water level in the reservoir was lowered. The locations of two piezometers and the observed changes in water level in them during and following the earthquake are shown in Fig. III-16. It may be seen that the recorded water pressure increases for well 37 in the foundation soil near the downstream toe of the embankment and for well 64-J with a tip located near the downstream toe of the original embankment were approximately 5 and 3 ft respectively. The actual increases in water pressure even in these locations are likely to have exceeded these values since no readings were taken until about 6 hours after the shaking had stopped. Pore water pressure changes in the upstream shell of the embankment are likely to have been much greater.

Fig. III-16 CHANGES IN WATER LEVEL IN PIEZOMETERS FOLLOWING THE EARTHQUAKE
 - LOWER SAN FERNANDO DAM.

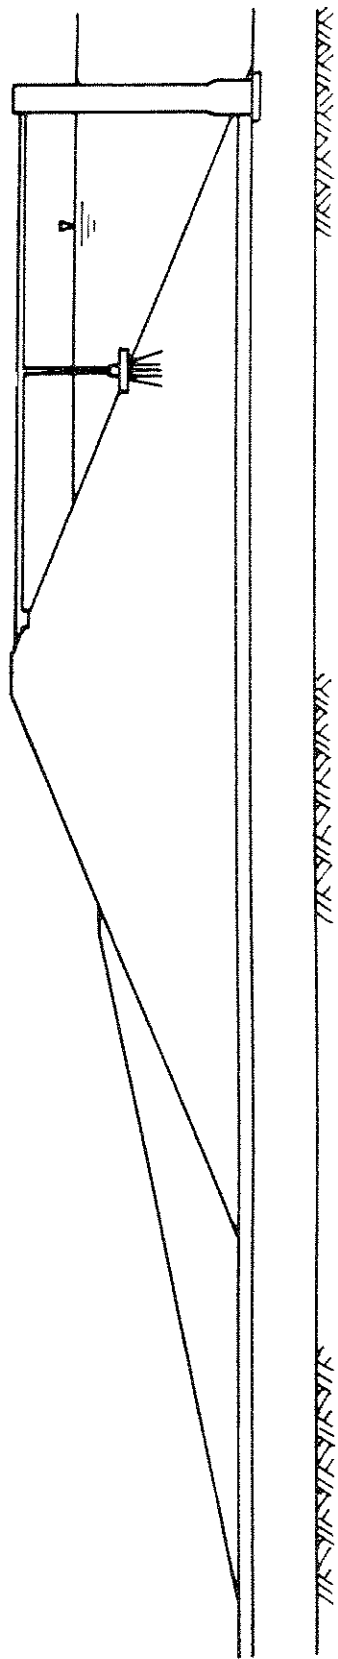
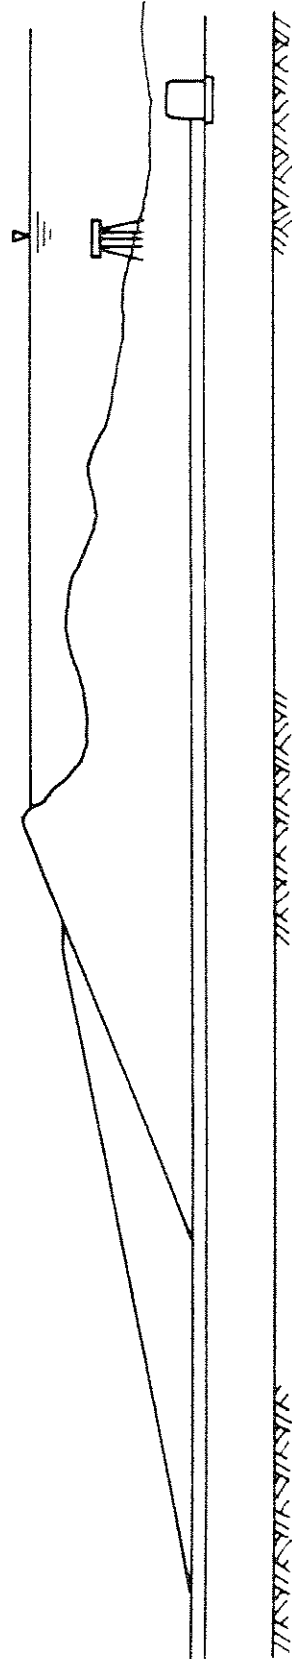
Fig. III-20 SCHEMATIC CROSS-SECTIONS NEAR CENTRAL OUTLET TOWER.

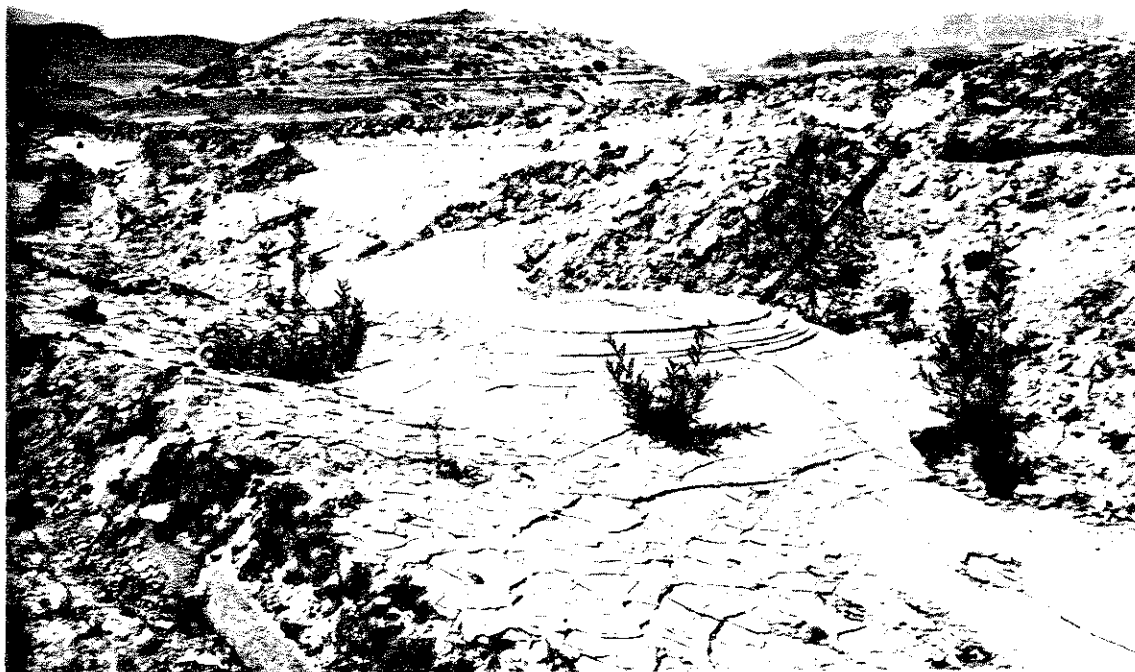
FIG. III-23 SAND BOILS IN THE DEPRESSION SCARPS NEAR THE TOE OF THE SLIDE DEBRIS, LOWER SAN FERNANDO DAM.

- (3) Large increases in water pressure in the observation wells within the embankment which later decreased with time.
- (4) The presence of sand boils which developed in the graben area near the toe of the slide where the overburden was shallow.
- (5) The nature of the toe of the slide which indicated that the material had simply flowed out over the existing reservoir sediments suggested that much of the material within the dam had been reduced to a fluid consistency.

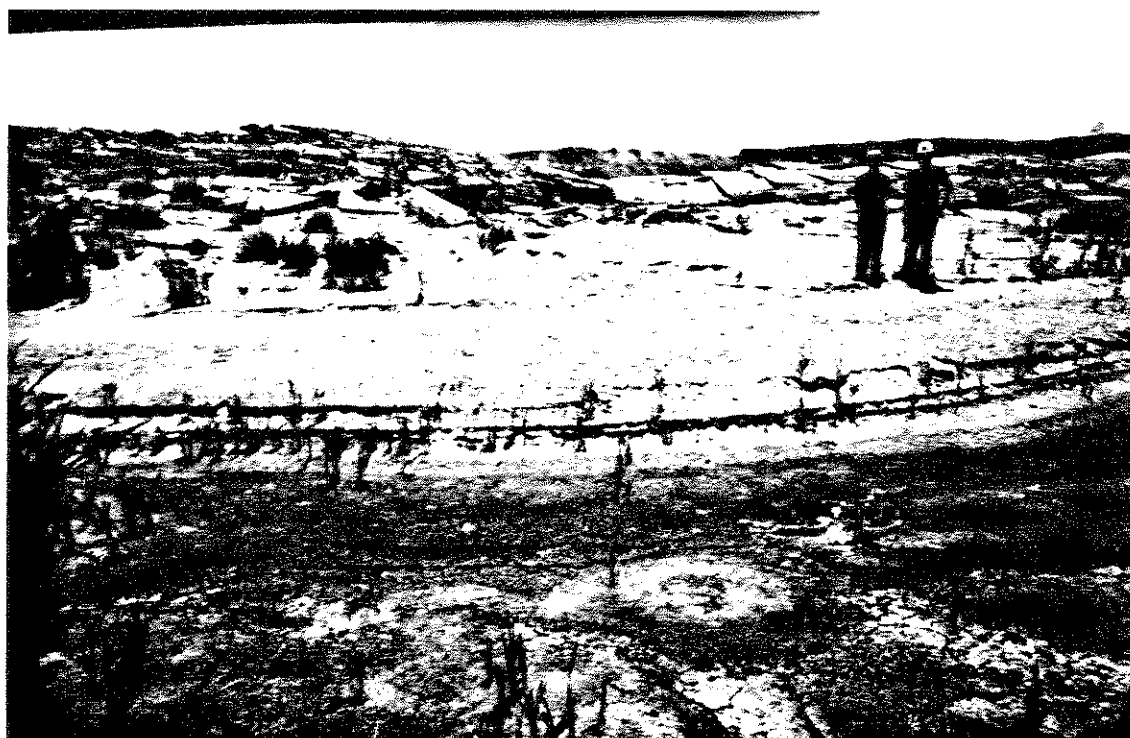
FIG. III-24 TOE OF THE SLIDE DEBRIS, LOWER SAN FERNANDO DAM.

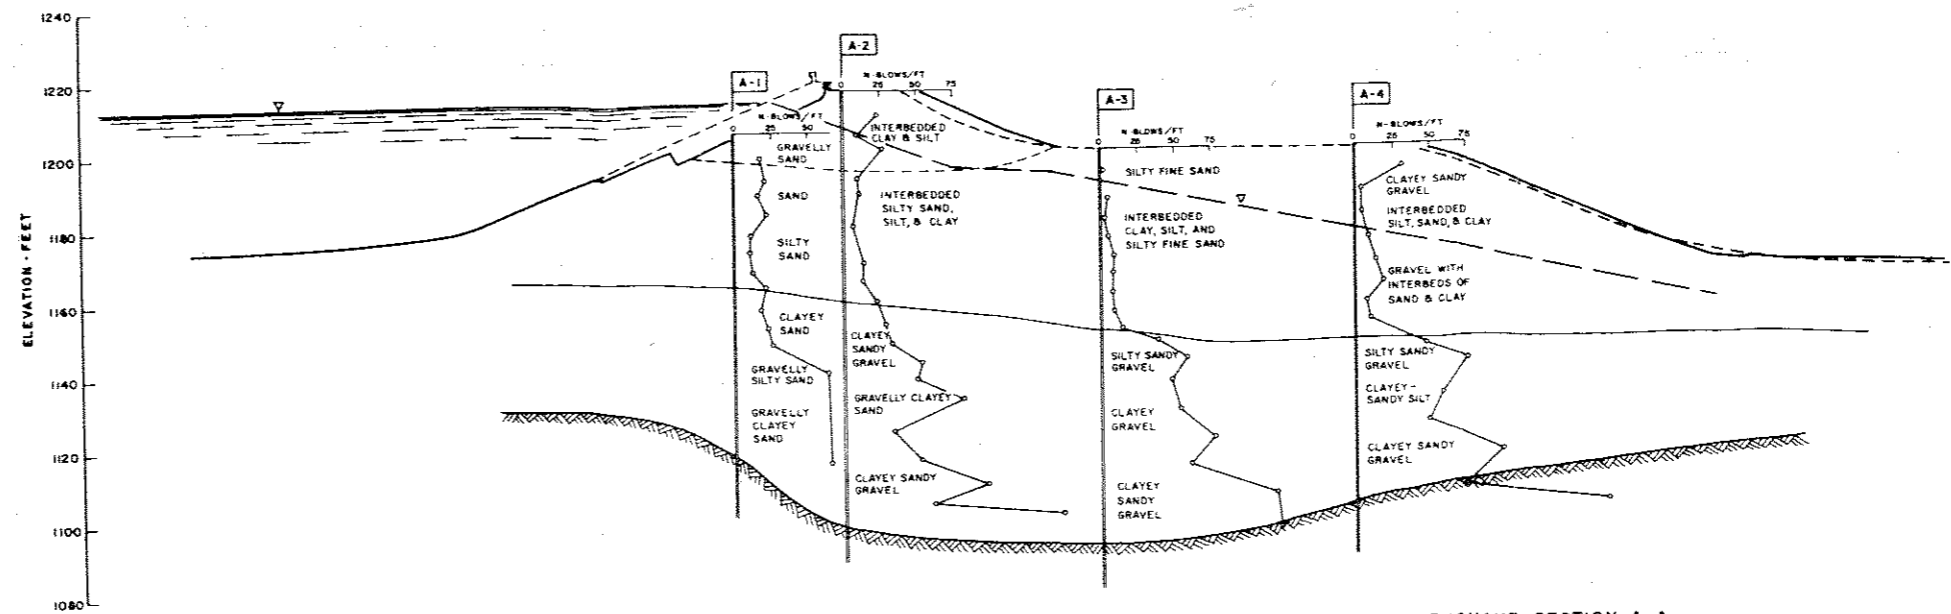
Fig IX-2 CROSS-SECTION THROUGH EMBANKMENT OF UPPER SAN FERNANDO DAM AFTER EARTHQUAKE, SECTION A-A

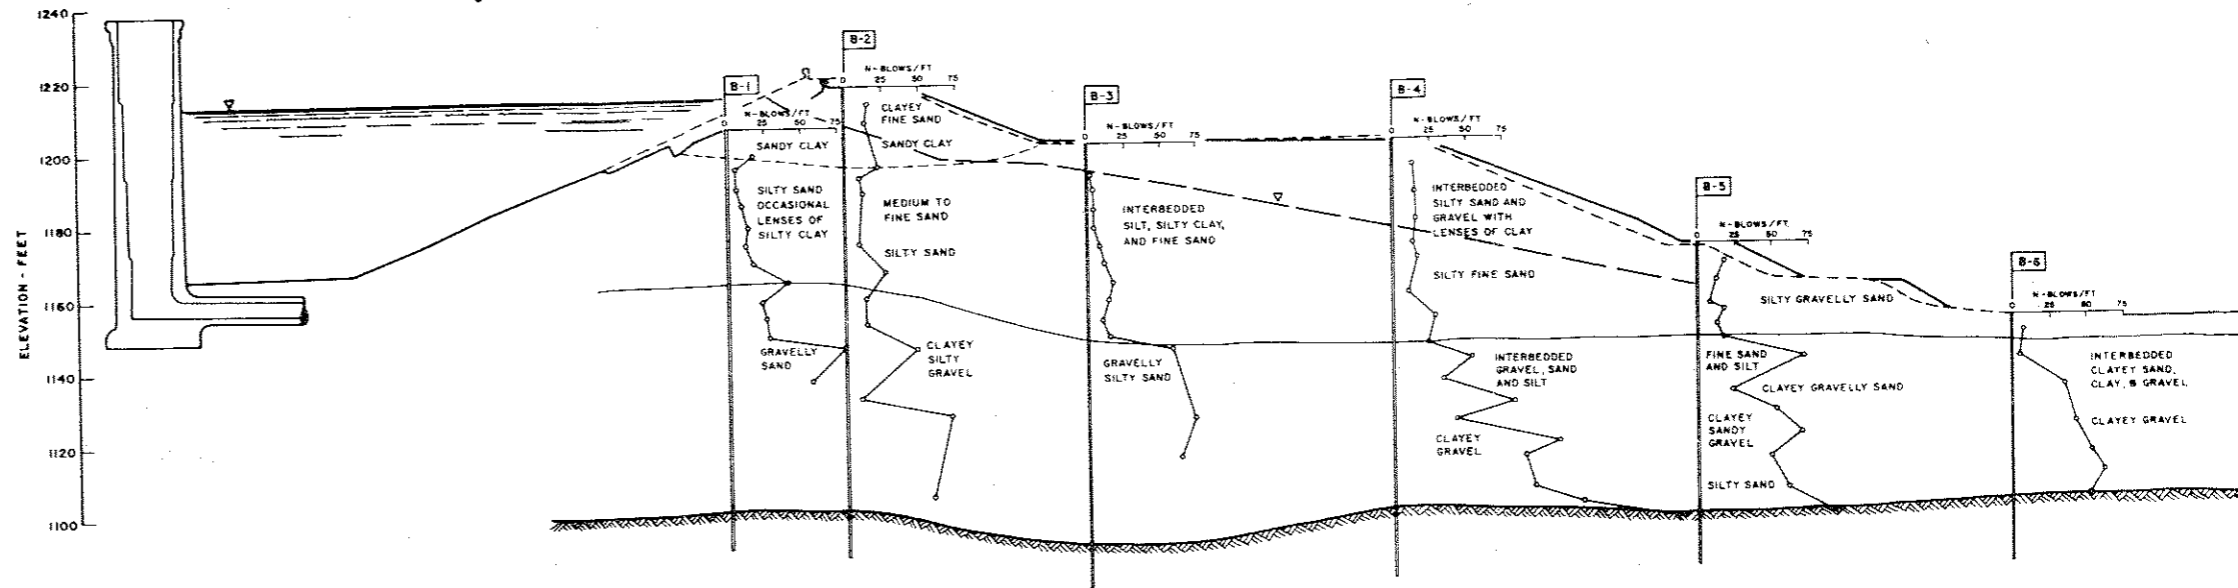
Fig IX-3 CROSS-SECTION THROUGH EMBANKMENT OF UPPER SAN FERNANDO DAM AFTER EARTHQUAKE, SECTION B-B

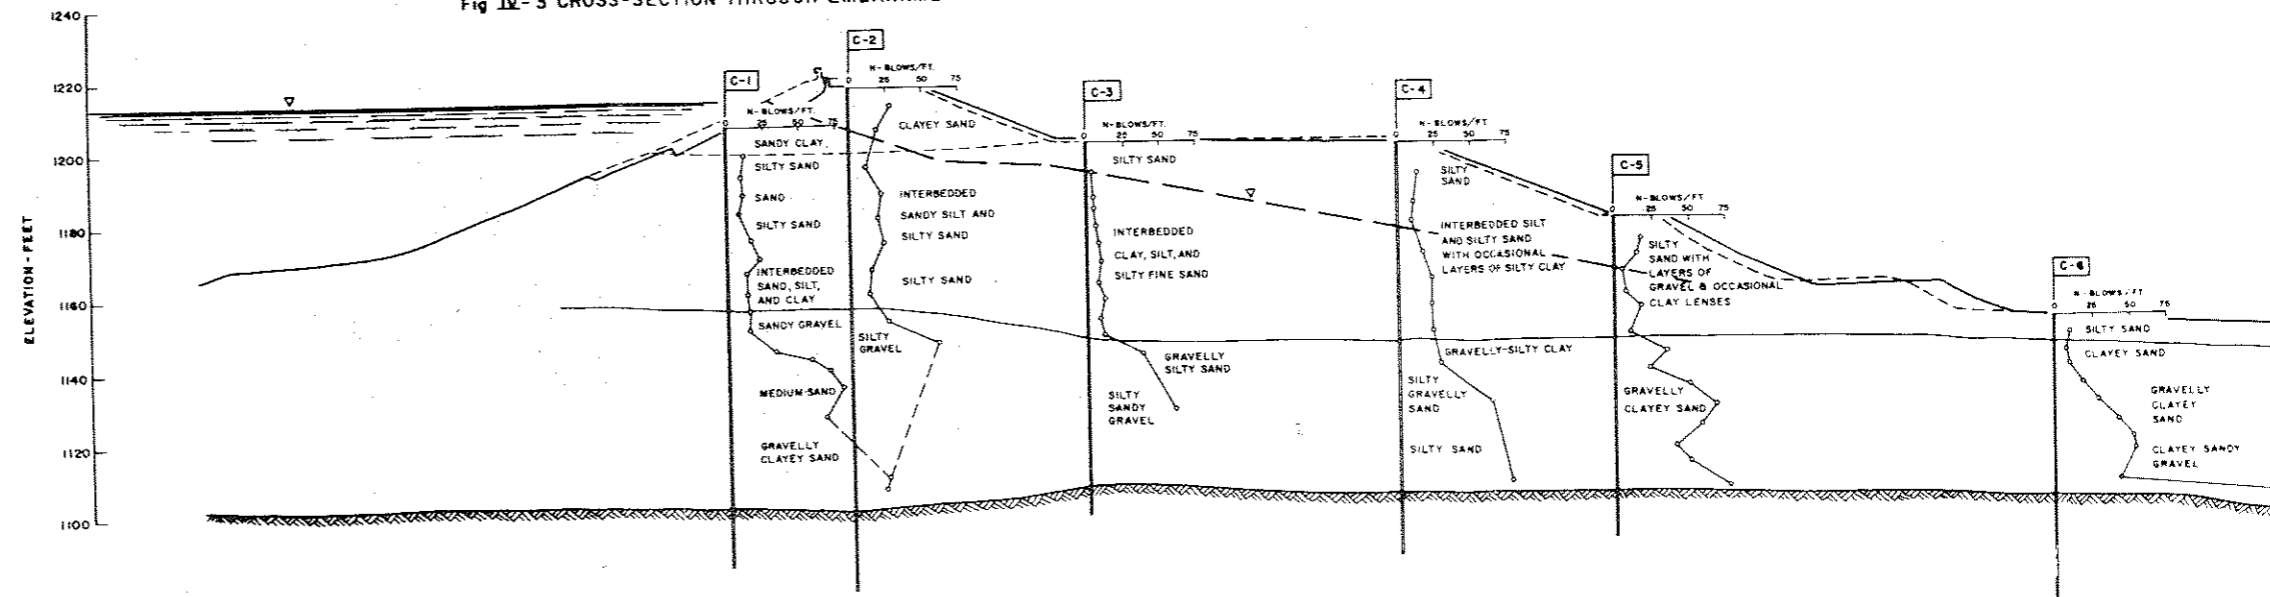
Fig IX-4 CROSS-SECTION THROUGH EMBANKMENT OF UPPER SAN FERNANDO DAM AFTER EARTHQUAKE, SECTION C-C

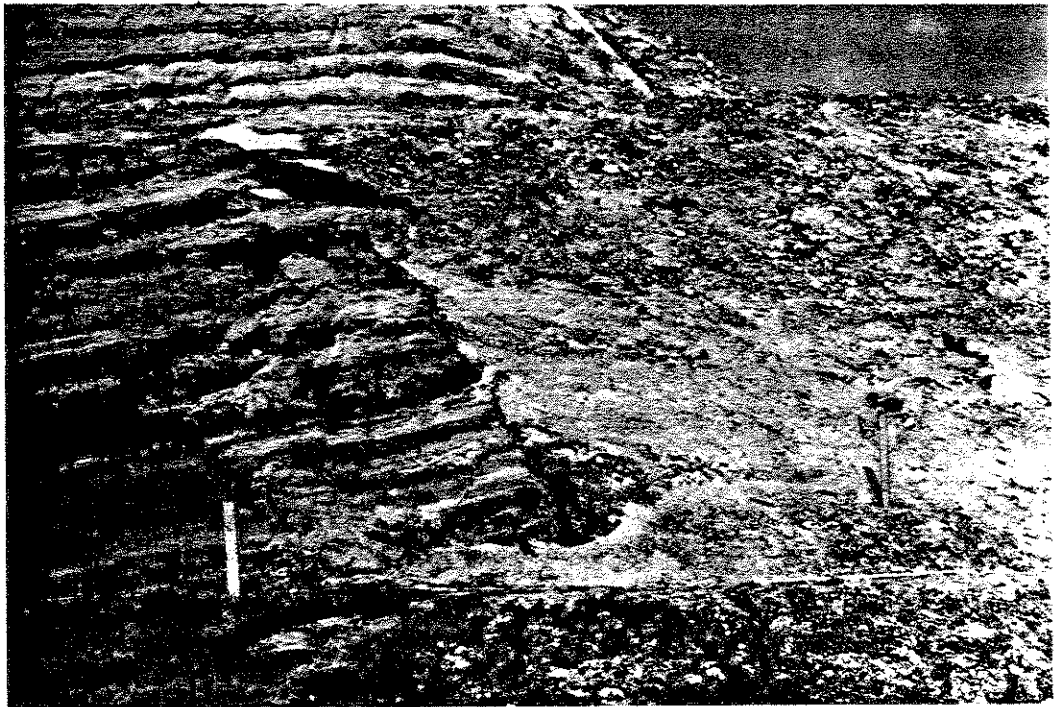
FIG. V-3 ENLARGED VIEW OF LOCATION A ON FIG. V-2
ROLLED FILL SHEARED DOWN OVER THE HYDRAULIC FILL.
