REPORT NO.
EERC 73-2
June 1973

ANALYSIS OF THE SLIDES IN THE SAN FERNANDO DAMS DURING THE EARTHQUAKE OF FEB. 9, 1971

H. BOLTON SEED
K. L. LEE
I. M. IDRIS
F. MAKDISI

State of California Department of Water Resources
Los Angeles Department of Water and Power
National Science Foundation

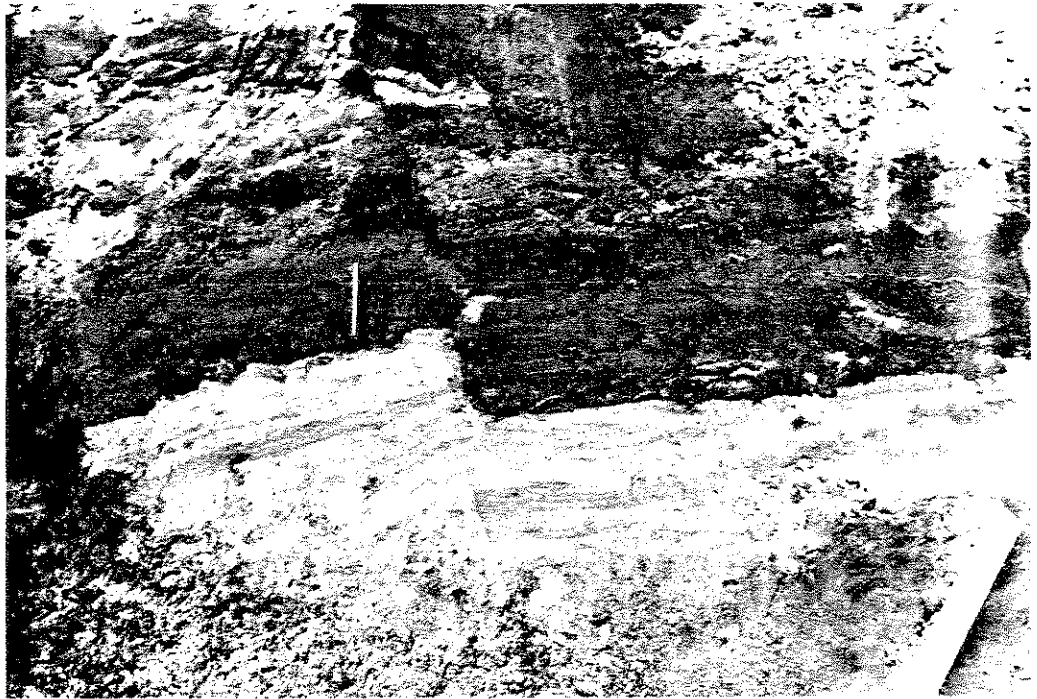
Two close-up views near location D are shown in Figs. V-7 and V-8. The dark material on top was a layer of sandy clay overlying the lighter layer of fairly clean sand. No doubt these layers were originally fairly smooth as shown in the undisturbed part of the hydraulic fill in Fig. V-1. However the movements during the slide have created shear zones through these layers of sand and clay which are clearly visible in the photograph. Although some of the cleaner sand has penetrated into cracks in the clay, the clearly defined shear zones in the light colored sands indicate that these materials did not liquefy during the earthquake. The relative movements in this zone appear to have occurred along shear surfaces rather than resulting from flow of a viscous material such as liquefied sand. However the sand-filled crack in Fig. V-3 would seem to indicate some degree of liquefaction of the sand.

FIG. V-7 ENLARGED VIEW OF LOCATION D ON FIG. V-2.
SAND HAS BEEN SHEARED AND DISTORTED IN
SLIDE MOVEMENT

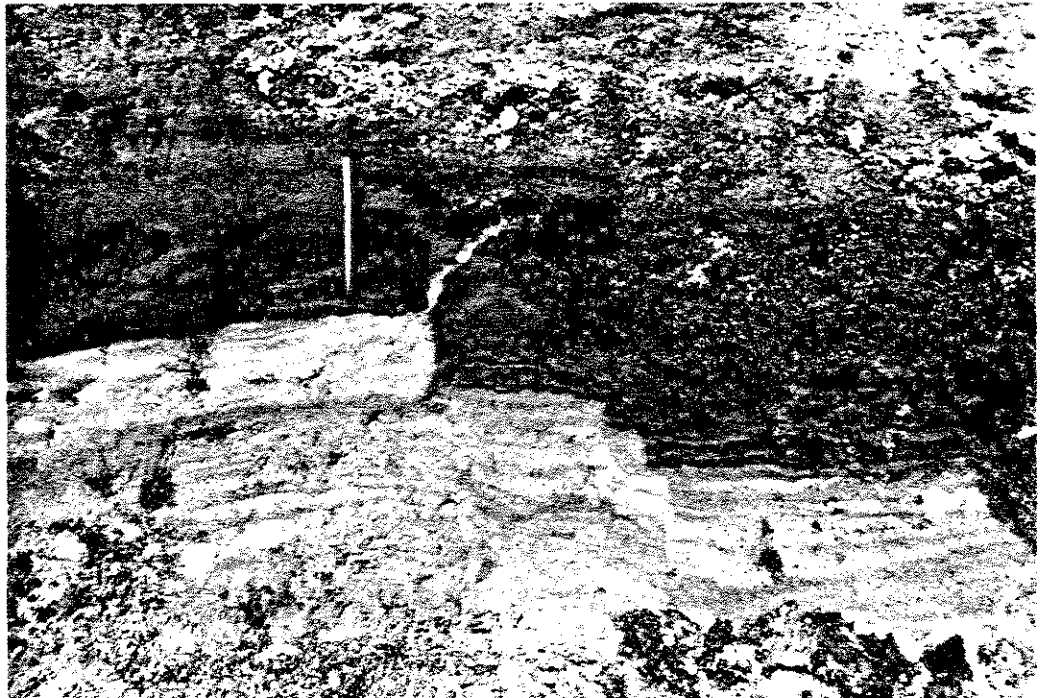
FIG. V-8 ENLARGED VIEW, NEAR LOCATION D ON FIG. V-2.
SAND LAYER IN HYDRAULIC FILL HAS BEEN
DISTORTED AND SHEARED DURING SLIDE.

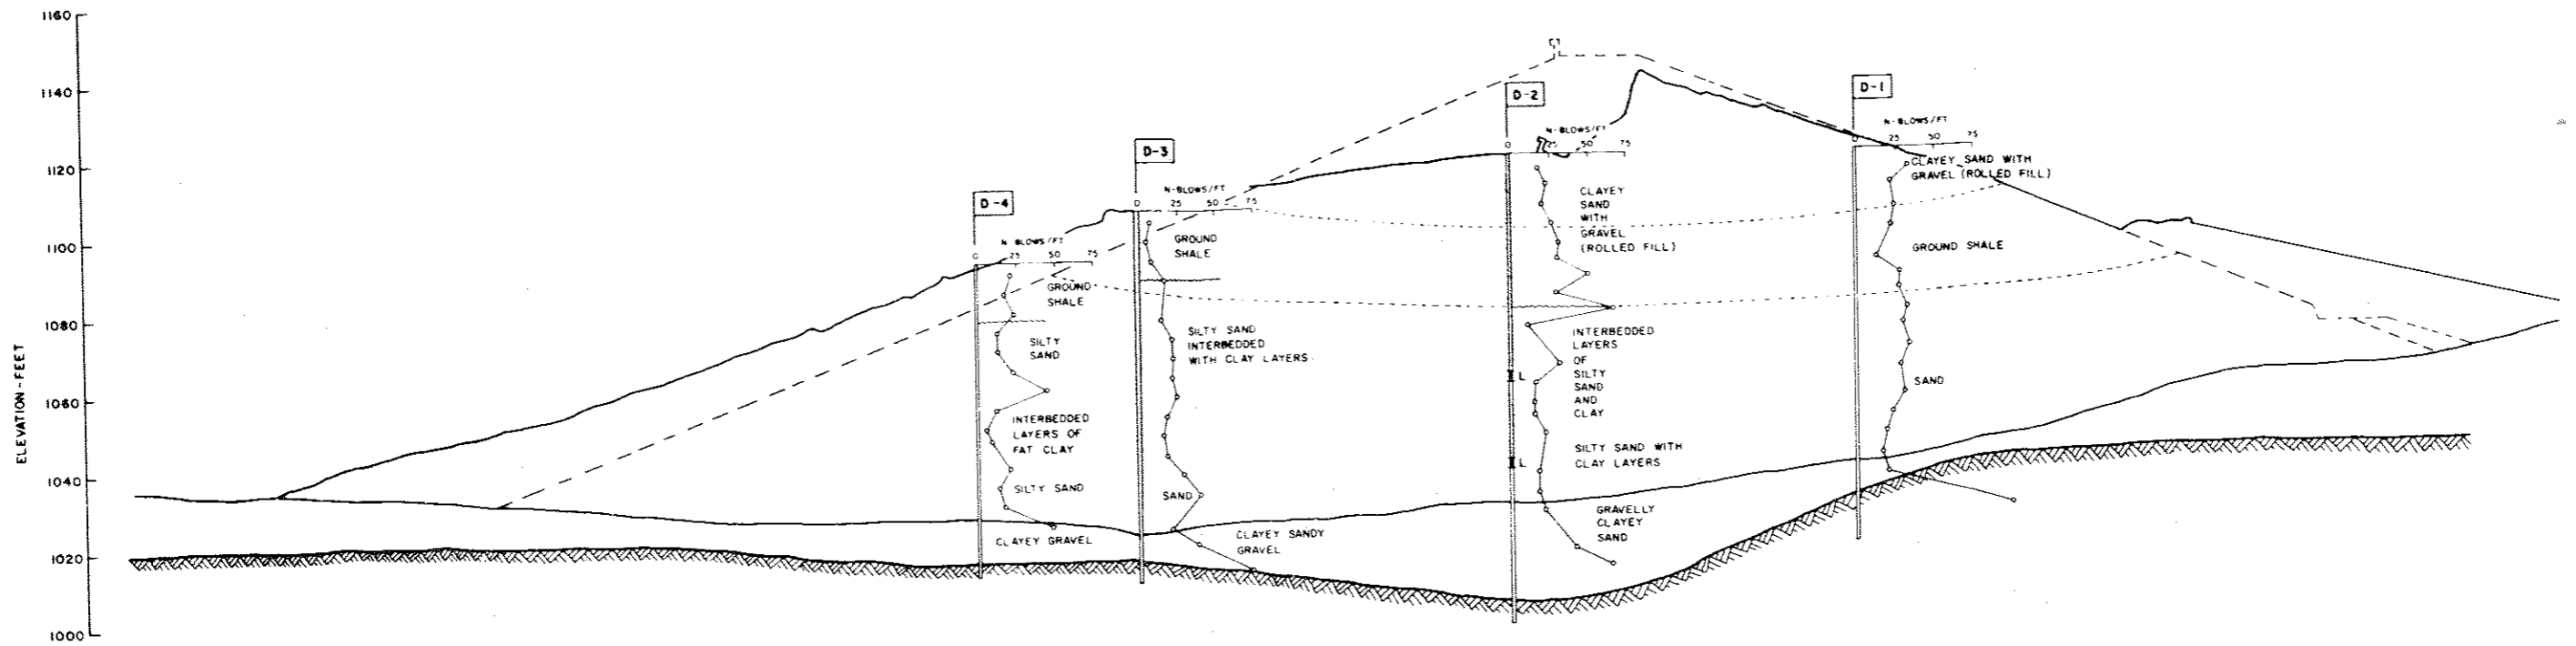
Fig. X-16 CROSS-SECTION THROUGH EMBANKMENT OF LOWER SAN FERNANDO DAM AFTER EARTHQUAKE, SECTION D-D

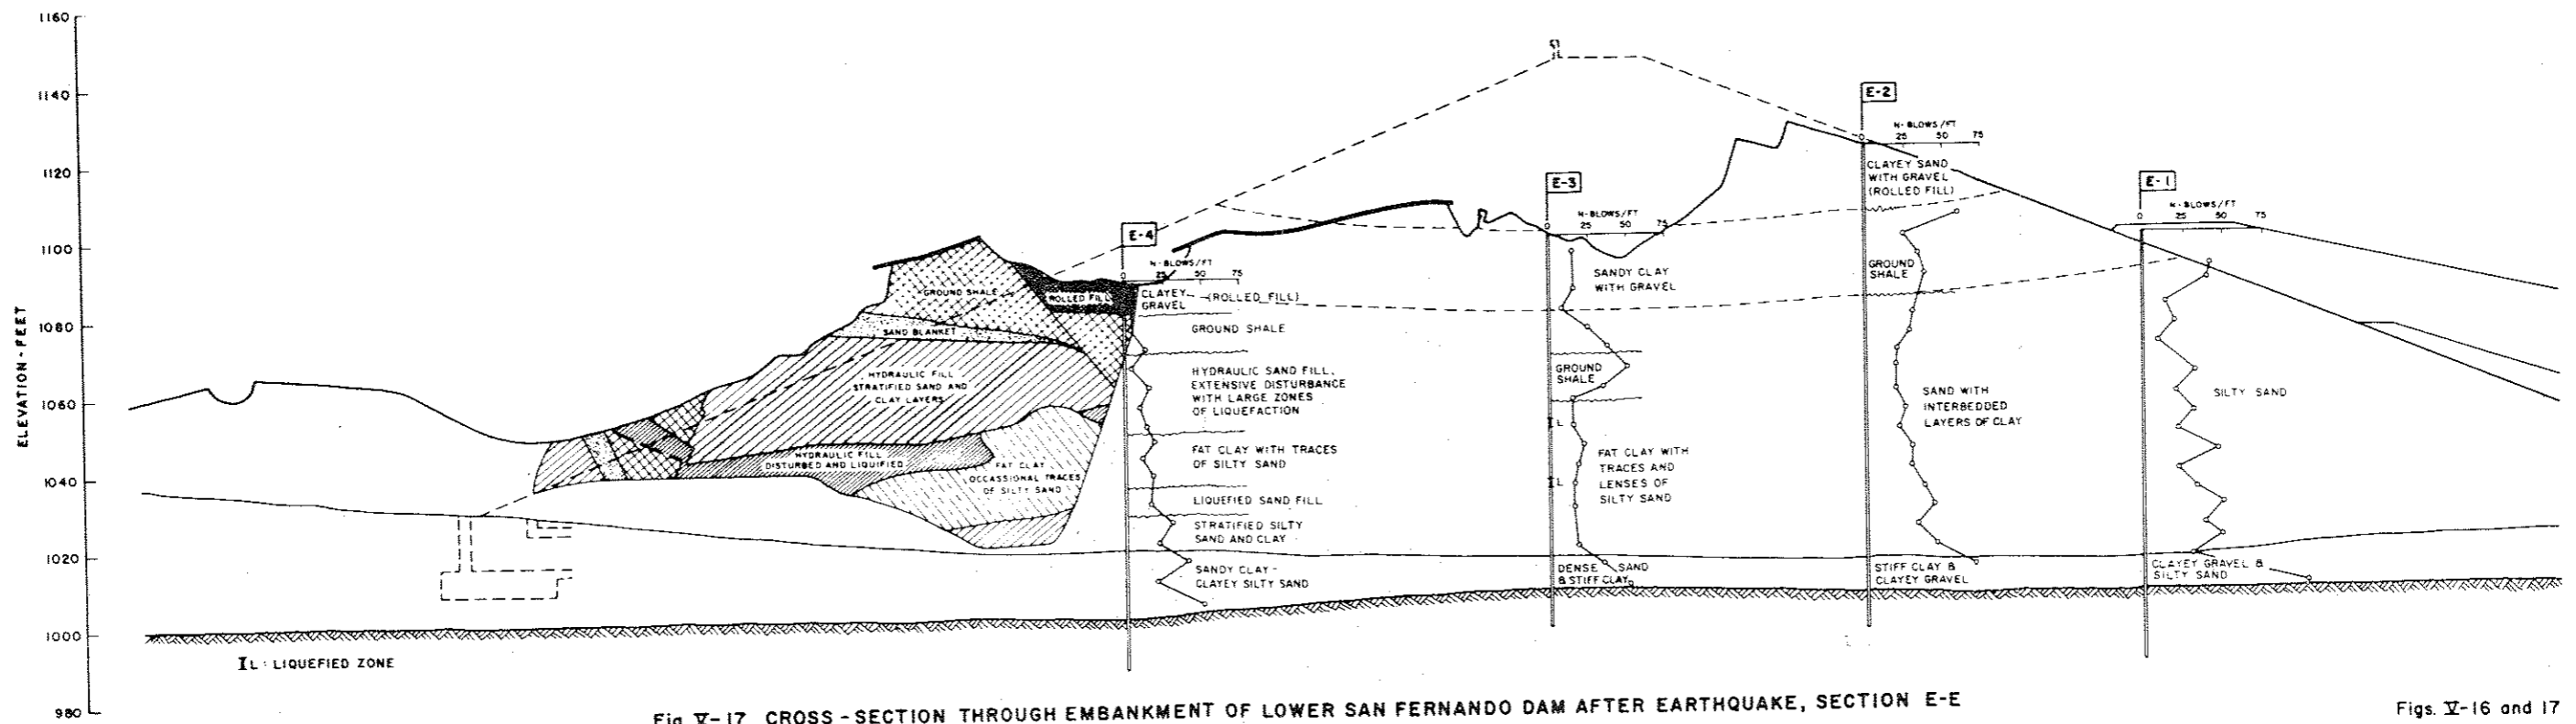
Fig. X-17 CROSS-SECTION THROUGH EMBANKMENT OF LOWER SAN FERNANDO DAM AFTER EARTHQUAKE, SECTION E-E

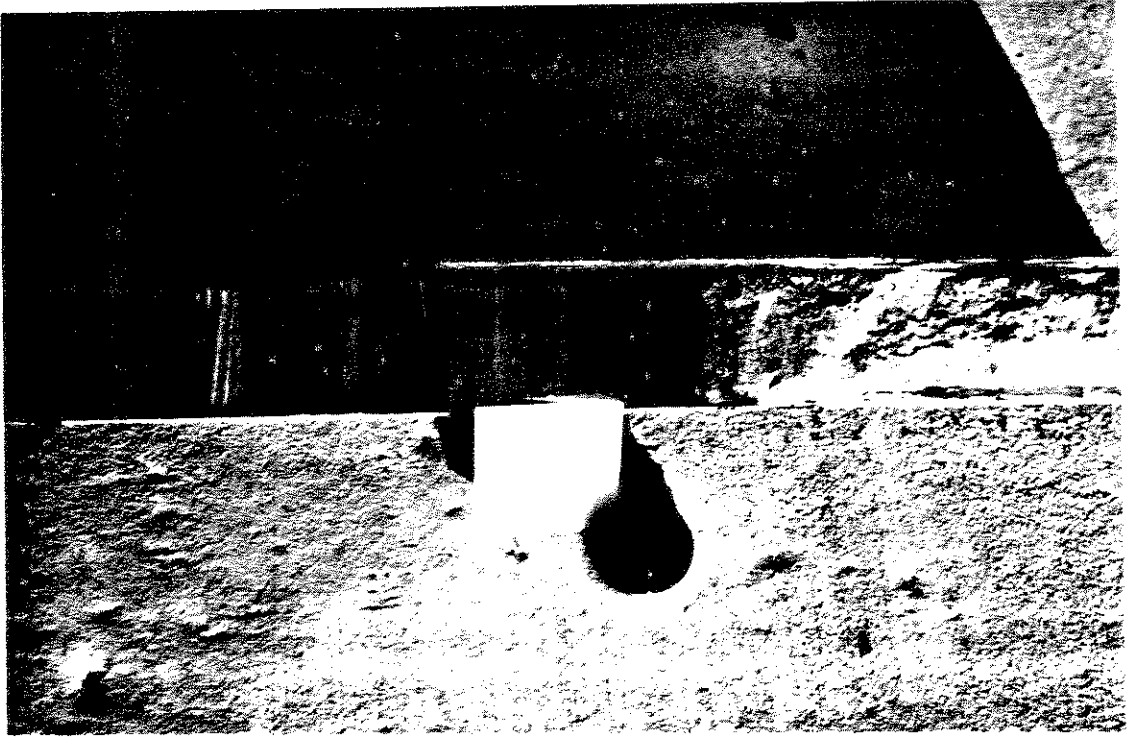
Each of the Shelby tube samples from the central and upstream holes was split open in a longitudinal direction and carefully examined for evidence of disturbance during the slide. Photographs of the soil in two of these tubes are shown in Fig. V-20. The soil in Fig. V-20a consisted of stratified hydraulic fill overlying alluvium. The contact between these two zones is clearly evident in the photograph. The hydraulic fill consisted of numerous very thin layers of silty sand sandwiched between thicker layers of clay. All of the layers were plane and well defined indicating that there had been virtually no disturbance of the soil in this zone.

(a) HYDRAULIC FILL ABOVE ALLUVIUM -
NO LIQUEFACTION.

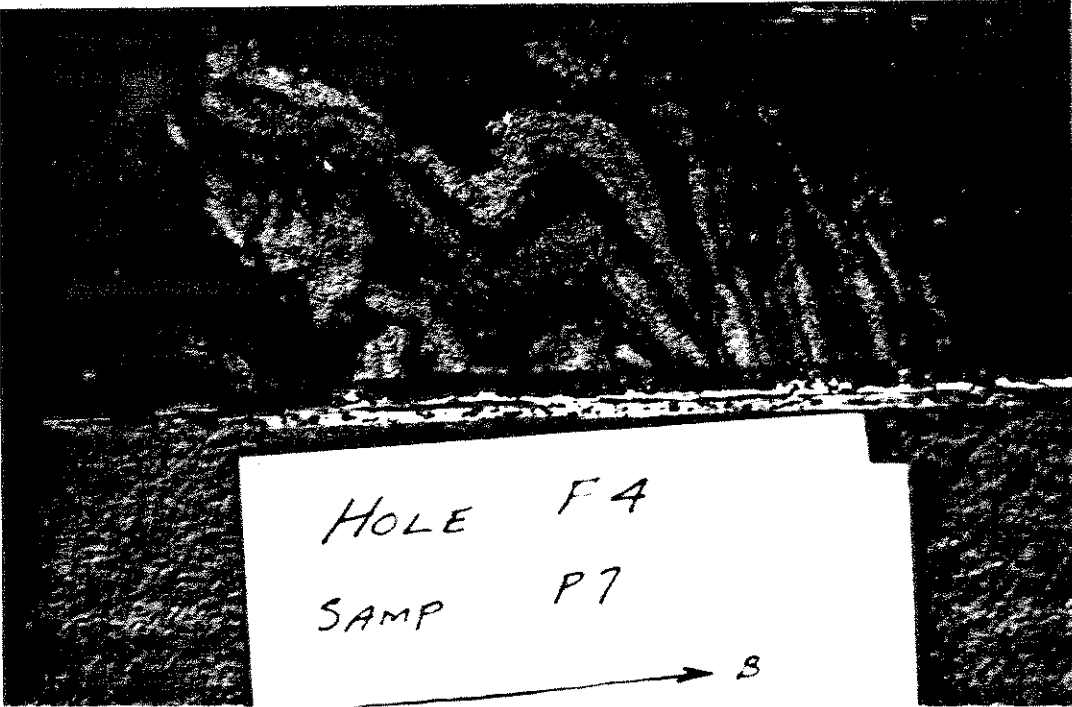
Close-up views of two other Shelby tube samples are shown in Fig. V-21. These photographs show dark streaks of clay and silty sand distorted and mixed in a zone of lighter colored sand, again indicating a large amount of disturbance. The pattern of coarse streaks within the sand shown in Fig. V-21 could only have formed if the sand had been in a very weak or liquefied condition.

(a) DARK SILTY SAND STREAKS MIXED WITH LIGHTER COLOR COARSE SAND.

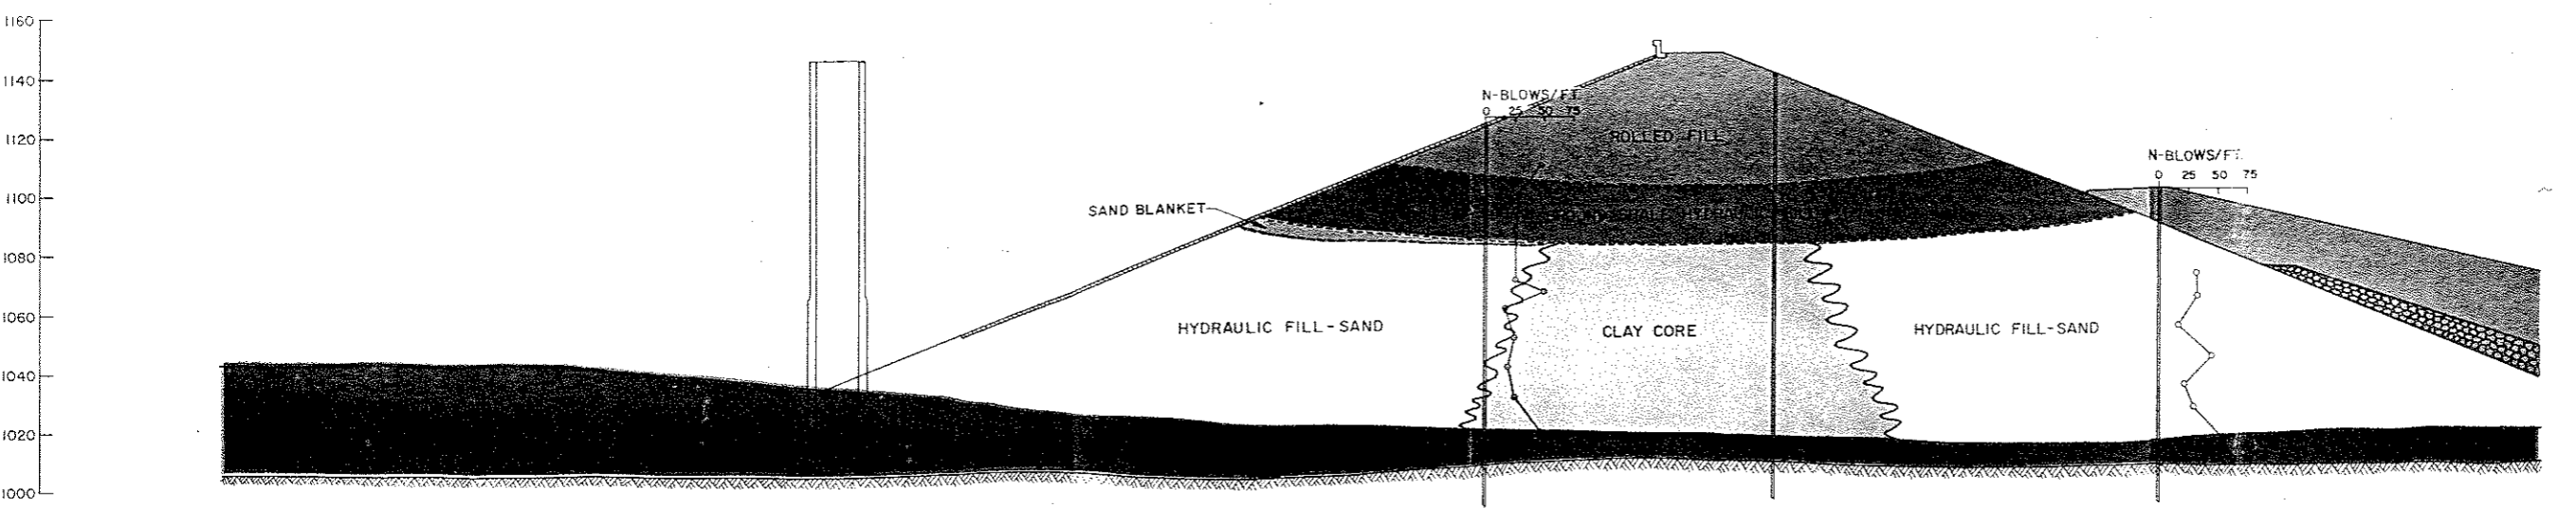
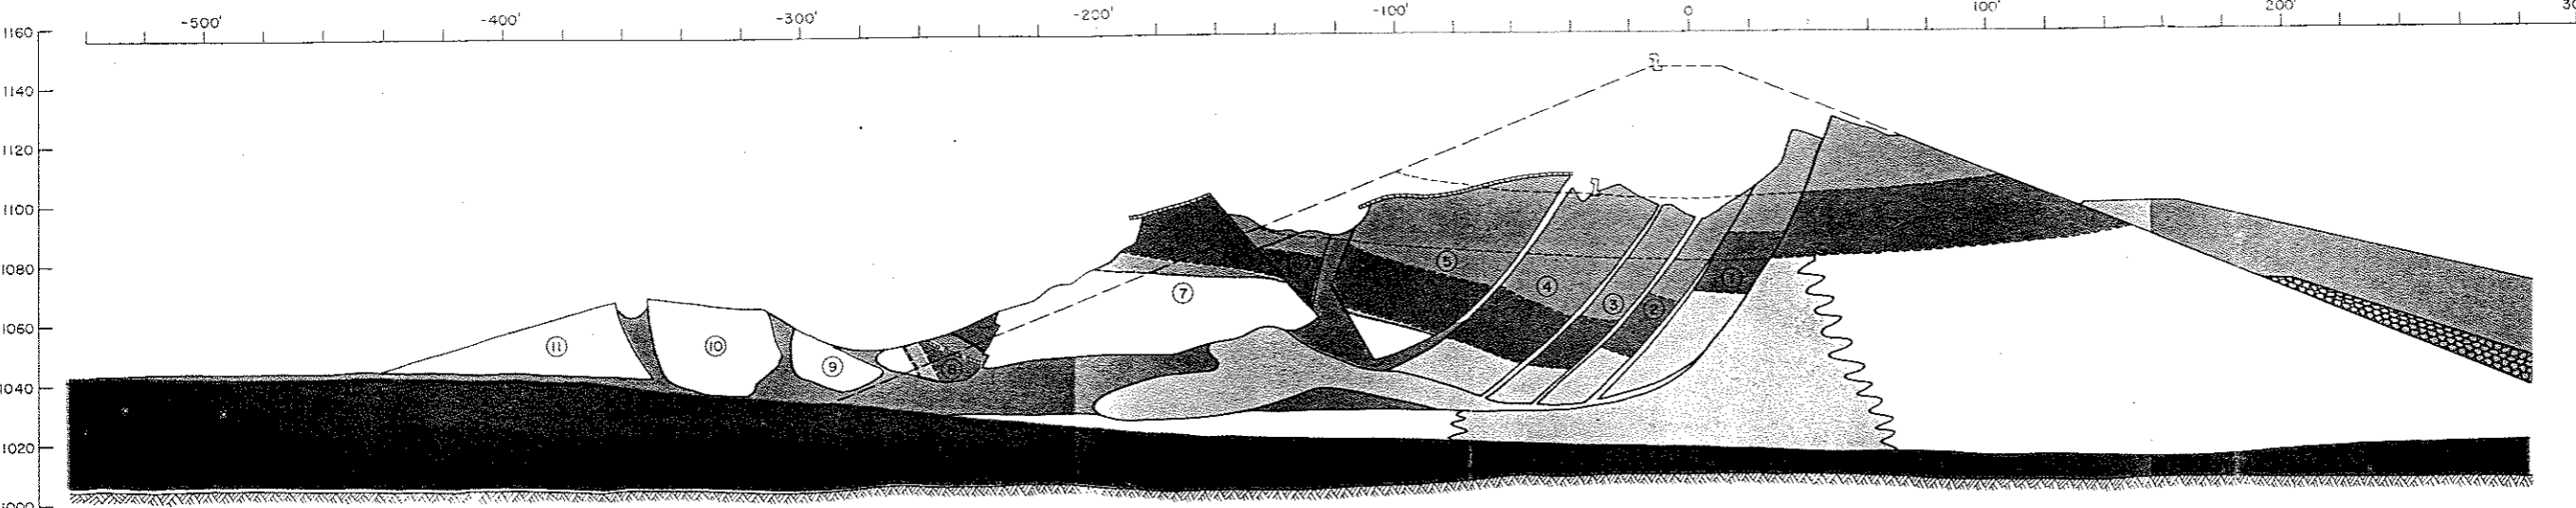
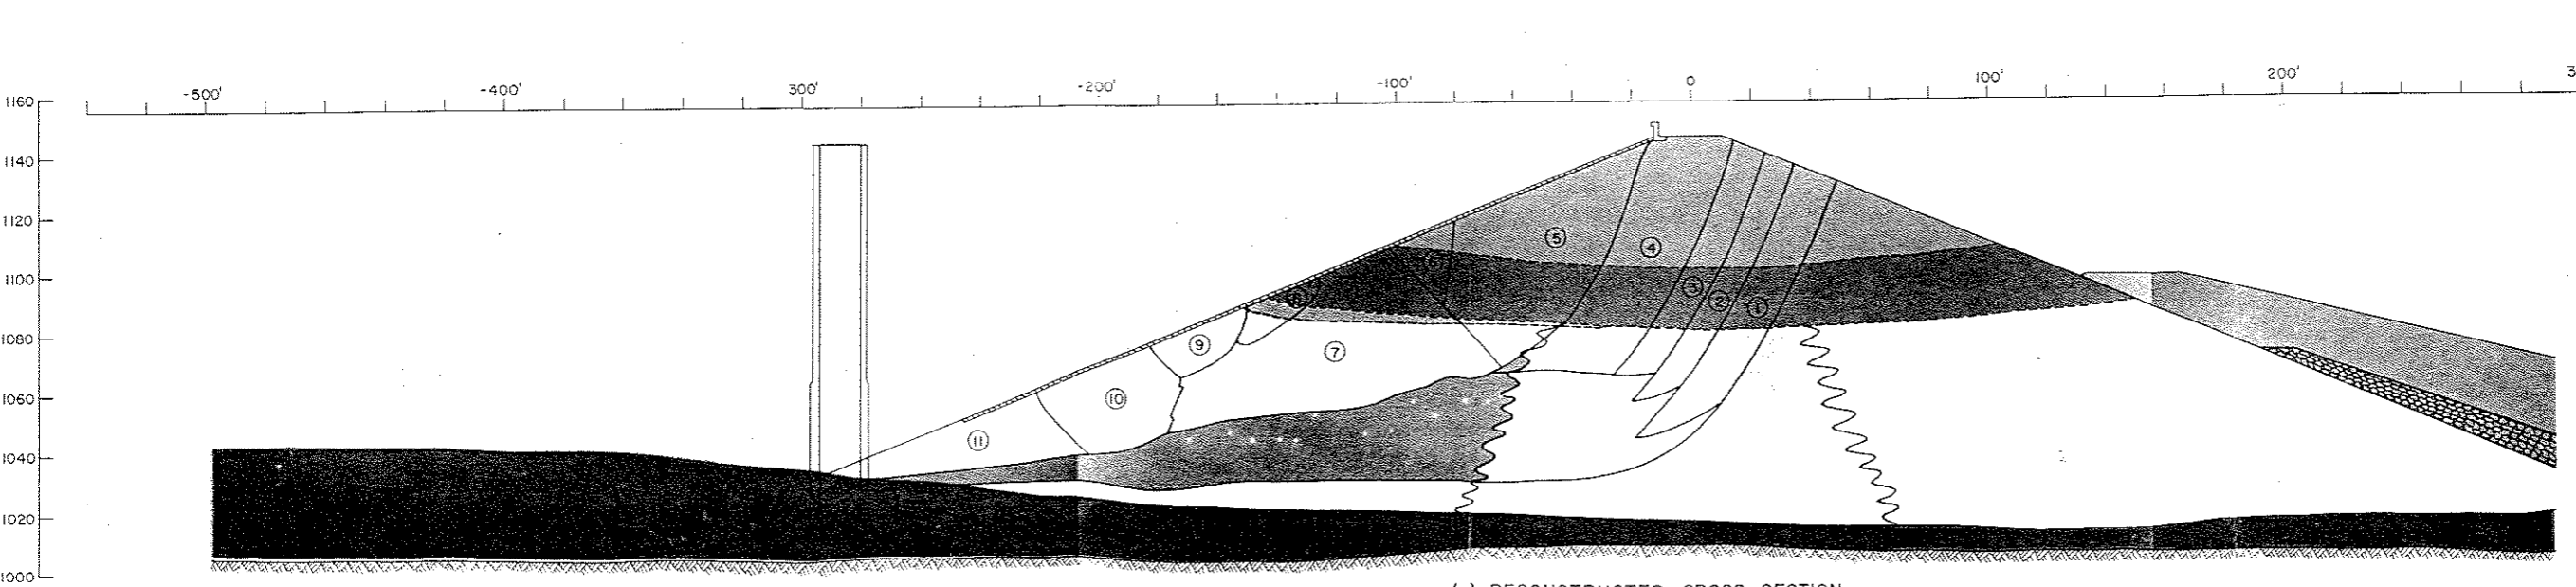
LOWER SAN FERNANDO DAM
 CROSS-SECTIONS
 THROUGH EMBANKMENT
 SECTION E-E
 PLATE 1

Consider for example the section EE shown in Plate 1. The trench section showed that a large block of soil, block number 7 in Plate 1b, had moved intact during the slide. The original position of this block in the embankment could be located in three ways:

All three of these procedures gave similar initial locations for the block and it was determined to have moved from the location shown in Plate 1c.

With the aid of the surface boundaries indicated by the original roadway across the top of the dam, the parapet wall, and the concrete slab facing for the upstream slope and the internal boundaries between different zones of soil within the embankment which could be identified from the trench section and the boring logs, it was possible to recognize the large relatively undisturbed blocks of soil numbered 1 to 11 in Plate 1b. Using techniques similar to those described above, the original positions of these blocks were then determined as shown in Plate 1c. It was found that the blocks fitted together extremely well and formed the upper part of the original embankment. However no blocks of soil could be identified as having moved from the zone colored blue along the base of the embankment in this figure. It appeared that this soil had spread throughout the slide zone, infiltrating between the large blocks of undisturbed material, extruding below the toe of the original embankment and sometimes rising to the surface within the slide zone.

Thus by reconstructing the original positions of the slide debris in this way, it was concluded that the slide must have been triggered by liquefaction of the hydraulic fill near the base of the embankment. The soil above this fill had then broken into blocks which moved laterally through distances varying from 30 to 150 feet as the sliding progressed, thereby removing support from the upstream side of the clay core. At this stage the core could no longer support the overlying mass of soil causing a secondary slide movement involving the crest of the dam and the upper part of the downstream slope. During these movements the clay core was extruded by the overlying mass of soil to form the tongue-like section shown in Plate 1.

1. The zones of liquefaction and large strains determined by the analysis (Fig. VIII-4) are in reasonable agreement with the areas believed to have liquefied (as reconstructed in Part VI - see Plate 1).
2. The mechanics of failure in the upstream shell resulting from the liquefaction of the hydraulic fill are reasonably well constructed by the analysis. A considerable zone of hydraulic fill upstream of the clay core appears to have liquefied and undergone large strains during the earthquake. The movements in this extensive zone resulted in the upstream slide.
3. The zone of liquefaction in the downstream soil was not extensive enough to cause any significant downstream movements.
4. The foundation layer (consisting of the upper alluvium and the lower alluvium) did not liquefy during the San Fernando earthquake.

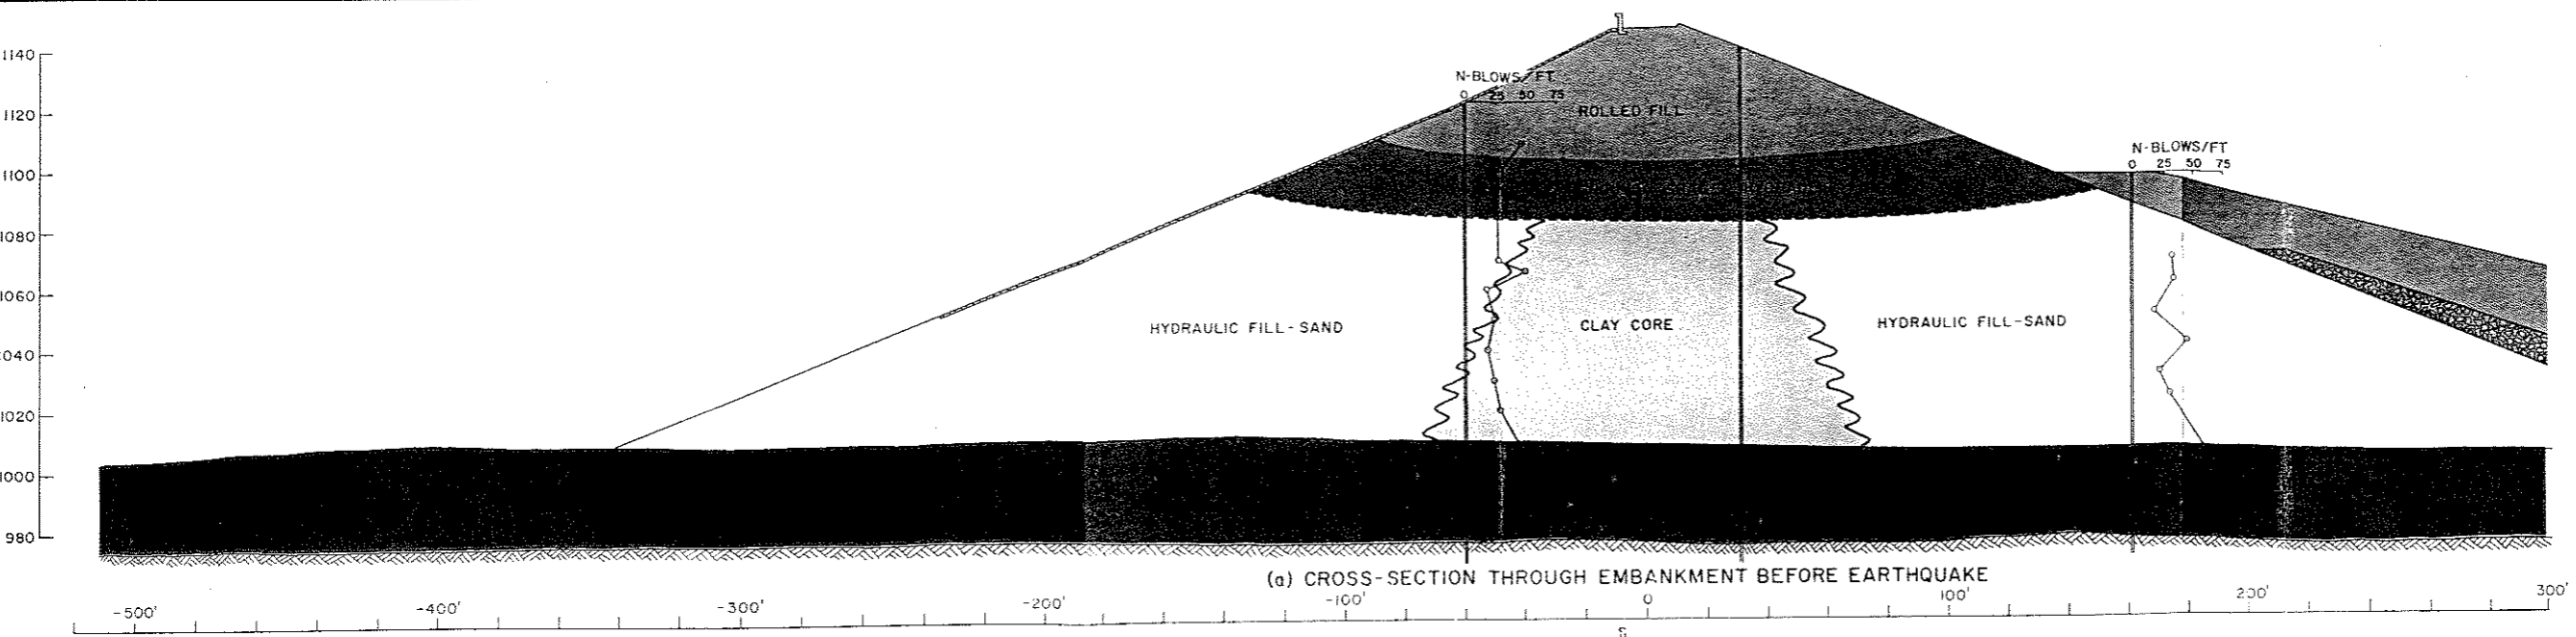
LOWER SAN FERNANDO DAM
 CROSS-SECTIONS
 THROUGH EMBANKMENT
 SECTION F-F
 PLATE 2

Similar reconstructions of the original and final locations of the soils in the slide zone along sections FF and GG are shown in Plates 2 and 3. In these cases also, the mechanics of sliding appears to be very similar to that described above with the primary zone of failure being in the hydraulic sand fill near the base of the embankment. Again the diffusion of this material throughout the slide zone provides convincing evidence that it was liquefied by the earthquake shaking. Taken in conjunction with the other evidence of liquefaction observed in the field (sand-filled cracks, sand boils, large lateral movements, extrusion of liquefied sand from the toe of the embankment) there seems to be little doubt that liquefaction of the hydraulic sand fill was the primary cause of the slide movements in this embankment.

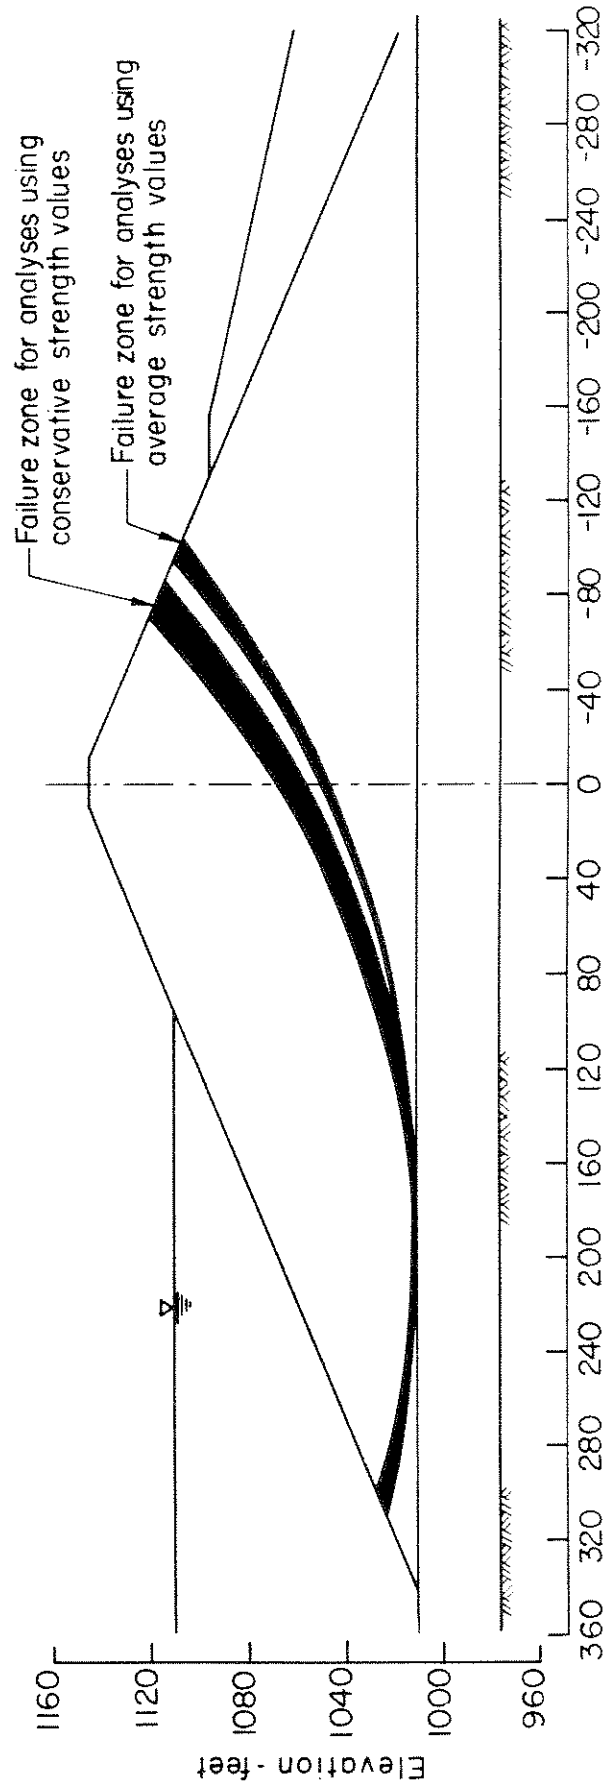
The critical surfaces of sliding determined by the analyses are shown in Fig. VII-1 and the computed factors of safety for different seismic coefficients, as determined by the conventional method of slices, are presented in Table VII-1. It may be seen that the computed locations of the most critical sliding surface are in reasonably good agreement with the position of the slide zone in the embankment, and that the analyses correctly indicate that failure would not extend into the foundation soils. However, for a seismic coefficient of 0.15, the computations indicate factors of safety ranging from about 1.22 for a conservative interpretation of the test data combined with a Mohr envelope method of data use, to about 1.61 for an average interpretation of the test data combined with the use of the τ_{ff} vs σ_{fc} strength relationship.

Since it has been common practice to interpret a computed factor of safety exceeding about 1.1 to be indicative of adequate seismic stability for an embankment, it is clear that the use of conventional pseudo-static analyses would not have predicted the failure which actually occurred.

Fig. VII-1 FAILURE ZONES INDICATED BY PSEUDO-STATIC STABILITY ANALYSES
 - LOWER SAN FERNANDO DAM.

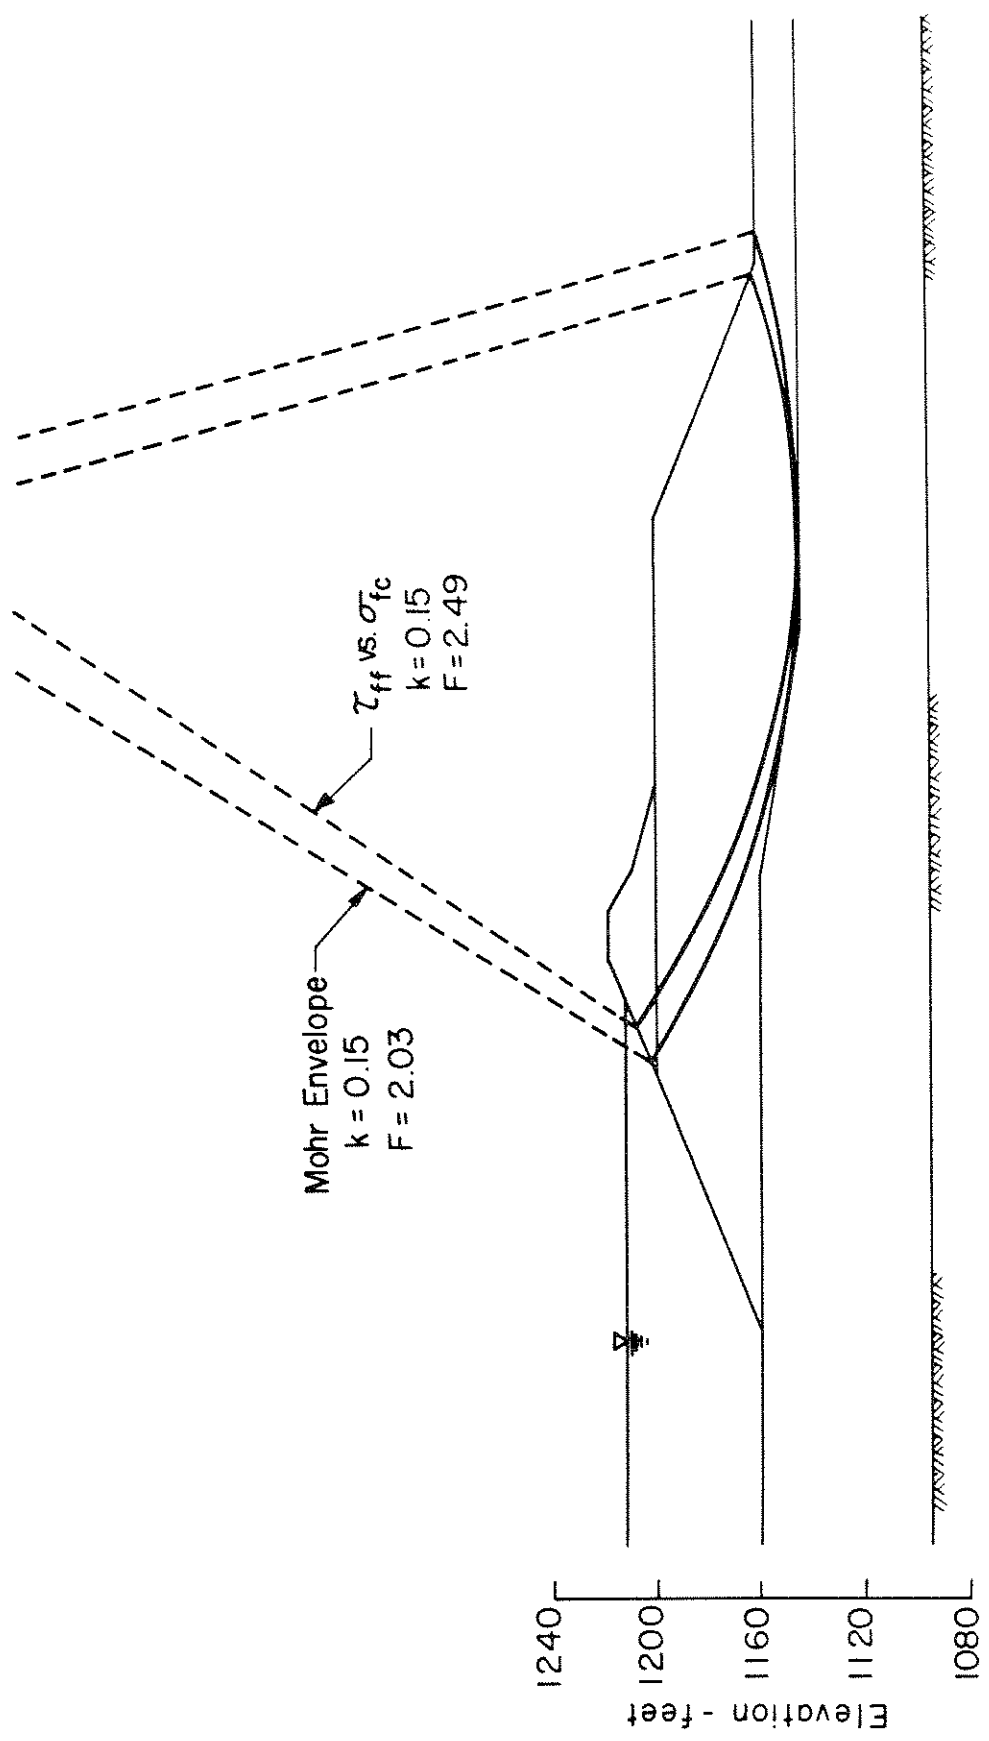
The results of the pseudo-static analyses are shown in Figs. VII-2 to VII-4 and Table VII-2. The computed position of the critical sliding surface (Fig. VII-2) is again in reasonable agreement with the observed behavior of the embankment during the earthquake, in that downstream movement occurred with the formation of scarps on the upstream face in approximately the same position as that indicated by the analysis. However for a seismic coefficient of 0.15, the computed factor of safety was about 2.0 for soil strengths determined from a standard Mohr envelope or 2.5 for strengths determined from the τ_{ff} vs σ_{fc} form of data representation. In either case the analysis indicates an ample margin of safety against slide movements developing--a result in marked contrast to the actual behavior of the embankment.

Fig. VII-2 RESULTS OF PSEUDO-STATIC ANALYSES OF EMBANKMENT STABILITY
 - UPPER SAN FERNANDO DAM.

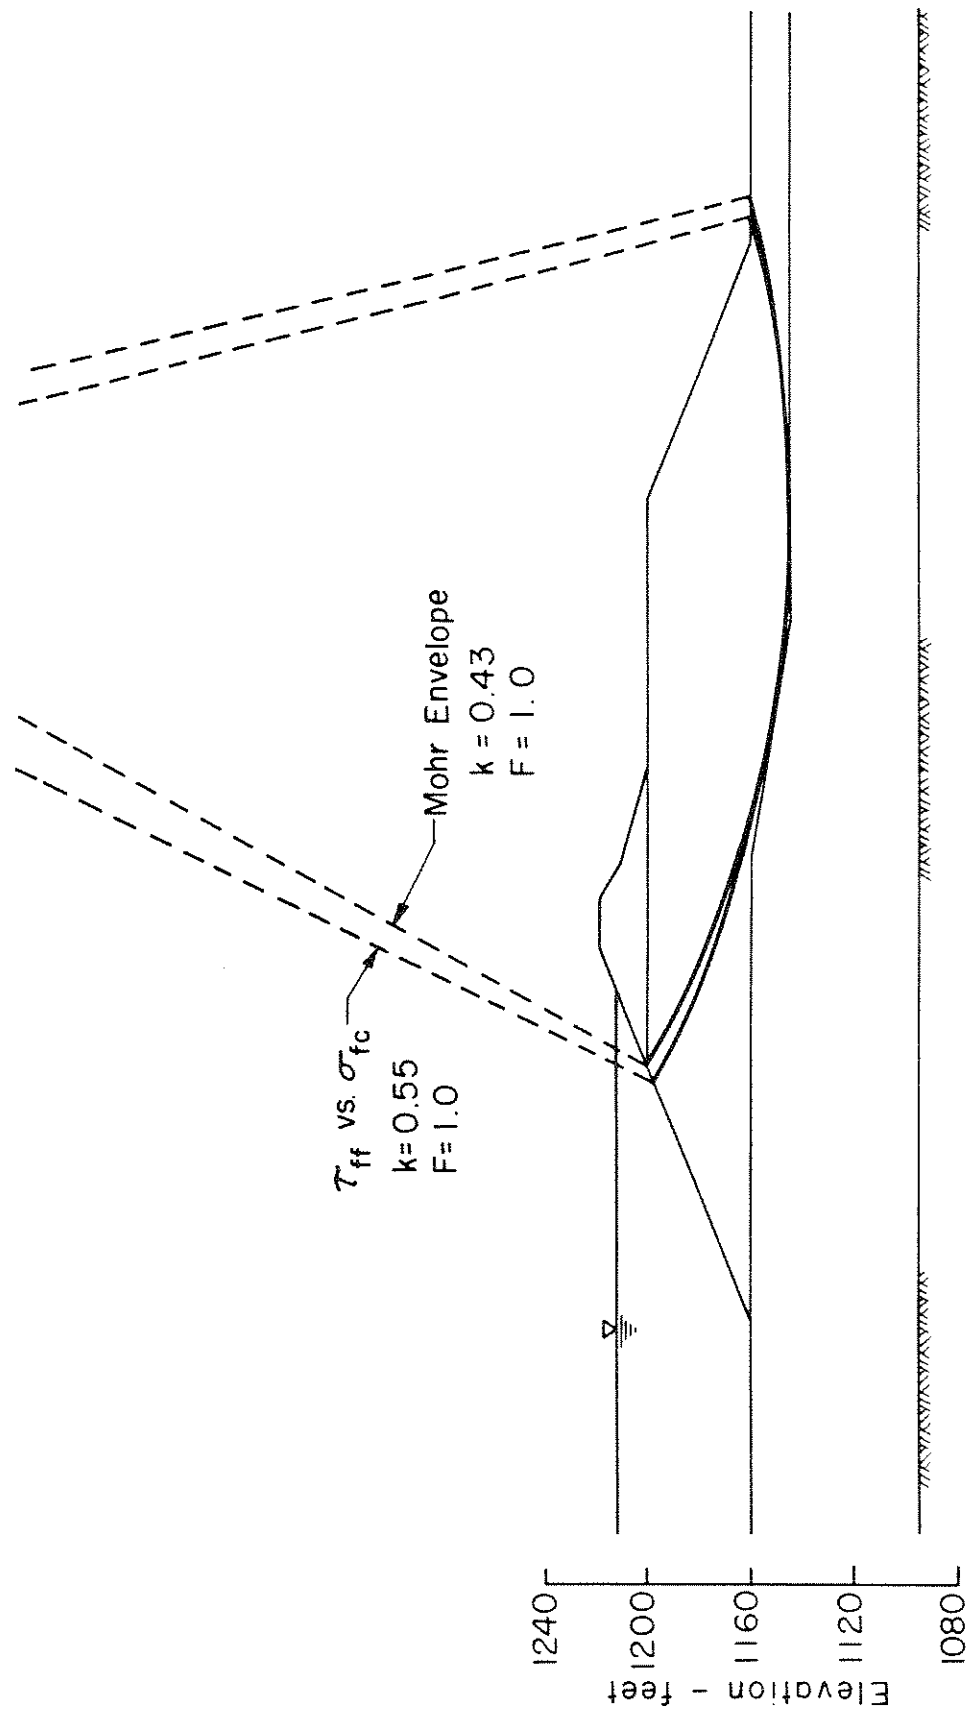
Fig. VII-3 RESULTS OF PSEUDO-STATIC ANALYSES OF STABILITY OF DOWNSTREAM SLOPE
 -UPPER SAN FERNANDO DAM.

In order to compute a factor of safety of 1.0 using the pseudo-static method of analysis, it would be necessary to use a seismic coefficient in the range 0.43 to 0.55 (Fig. VII-3), depending on how the consolidated-undrained test data is utilized in the computation procedure. These values are substantially higher than those currently used for seismic design but they are apparently necessary for the pseudo-static method of analysis to correctly indicate the performance of the Upper San Fernando Dam under the ground motion conditions which occurred in San Fernando in the 1971 earthquake.

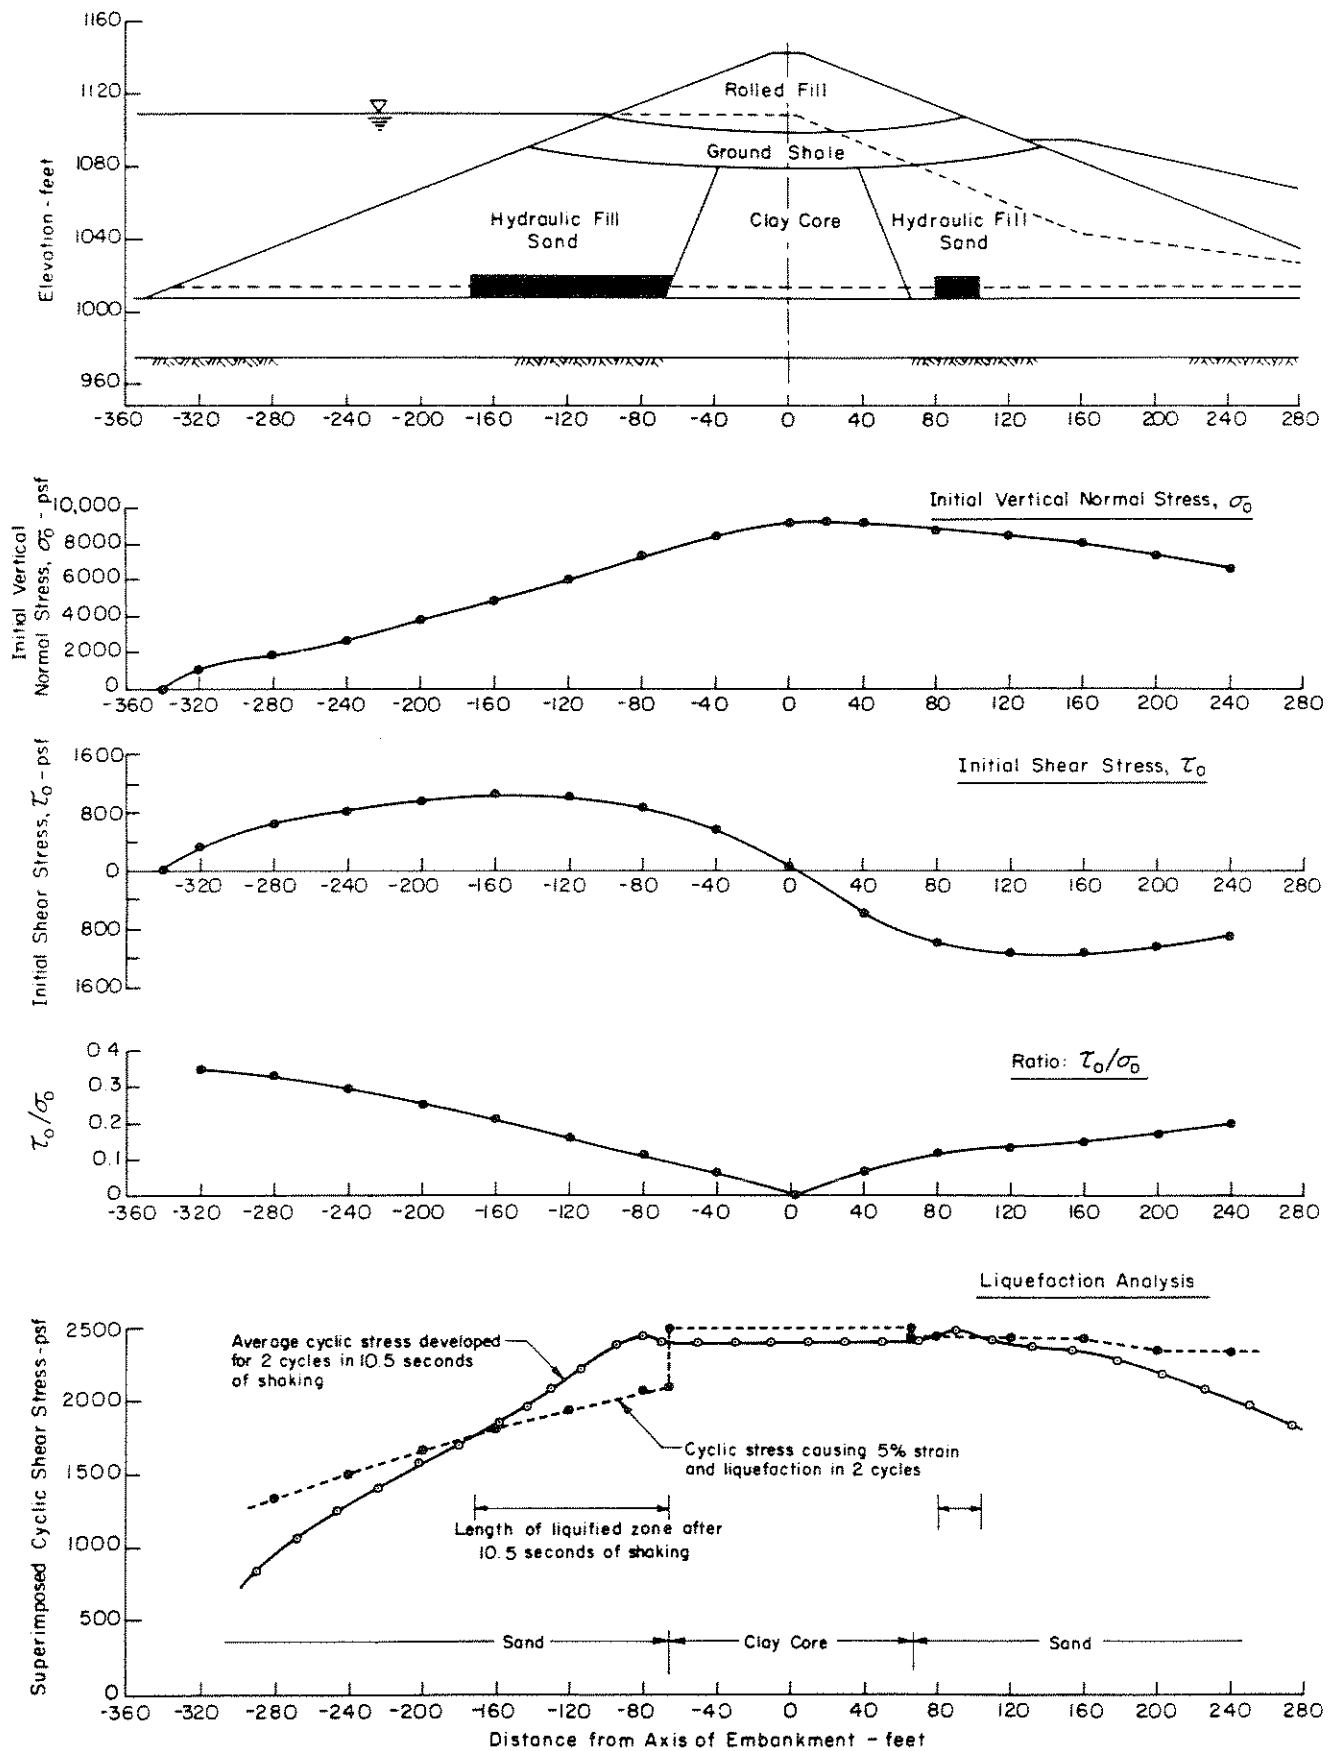
As can be noted from Fig. VIII-4, the peak accelerations (and therefore the peak stresses) occur approximately 10 or so seconds after the start of the motions. Accordingly, the liquefaction potential was initially investigated for the first 10.5 seconds of the motion. This evaluation along the base of the embankment is presented in Fig. VIII-6. The stresses induced in this section during the first 10.5 seconds of shaking were represented by 2 cycles of an equivalent uniform cyclic stress. The stresses required to cause liquefaction and 5 percent strain in 2 cycles were obtained from Fig. V-46, using the values of initial normal stress, σ'_0 , and the ratio, τ_0/σ'_0 , shown in the upper part of Fig. VIII-6. The stresses developed for 2 cycles in 10.5 seconds of shaking along the base of the embankment are compared to the stresses required to cause liquefaction in 2 cycles in the lower part of this figure. A very small zone of liquefaction (i.e., where the stresses developed during shaking exceed the stresses required to cause liquefaction) appears to develop in the downstream part of the dam. However an extensive zone of liquefaction, extending over a distance of approximately 100 ft, develops in the hydraulic fill upstream of the clay core.

Fig. VIII-6 ANALYSIS OF SOIL STABILITY ALONG BASE OF EMBANKMENT (EI. 1014') AFTER 10.5 SECONDS OF SHAKING, USING BASE MOTIONS DETERMINED FROM SEISMOSCOPE RECORD - LOWER SAN FERNANDO DAM.
