REPORT NO.
EERC 73-2
June 1973

ANALYSIS OF THE SLIDES IN THE SAN FERNANDO DAMS DURING THE EARTHQUAKE OF FEB. 9, 1971

H. BOLTON SEED
K. L. LEE
I. M. IDRIS
F. MAKDISI

State of California Department of Water Resources
Los Angeles Department of Water and Power
National Science Foundation

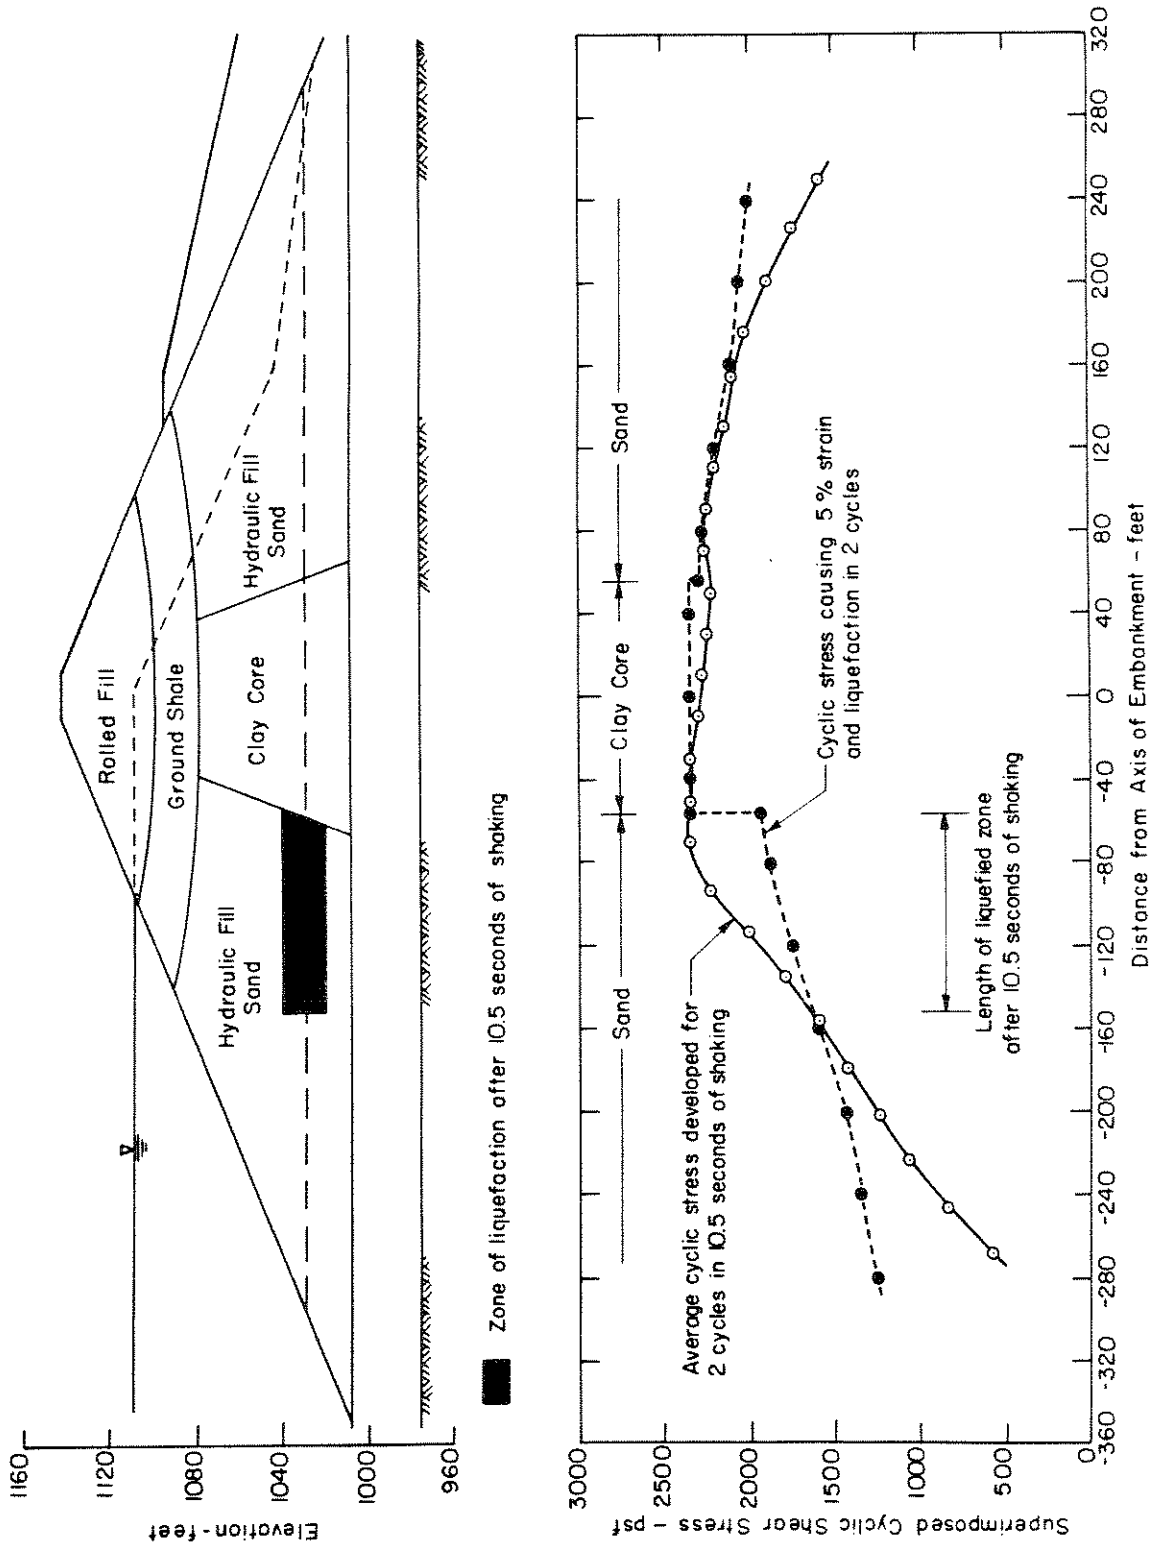
Similar evaluations for other zones of the embankment with average depths at Elevation 1030, 1050 and 1070 are shown in Figs. VIII-7, VIII-8,

Fig. VIII-7 ANALYSIS OF SOIL STABILITY ALONG PLANE AT ELEVATION 1030 FT. AFTER 10.5 SECONDS OF SHAKING, USING BASE MOTIONS DETERMINED FROM SEISMOSCOPE RECORD - LOWER SAN FERNANDO DAM.

and VIII-9, respectively. The zones where liquefaction and strains exceeding 5 percent will develop within each zone are readily determined from the results presented in these figures.

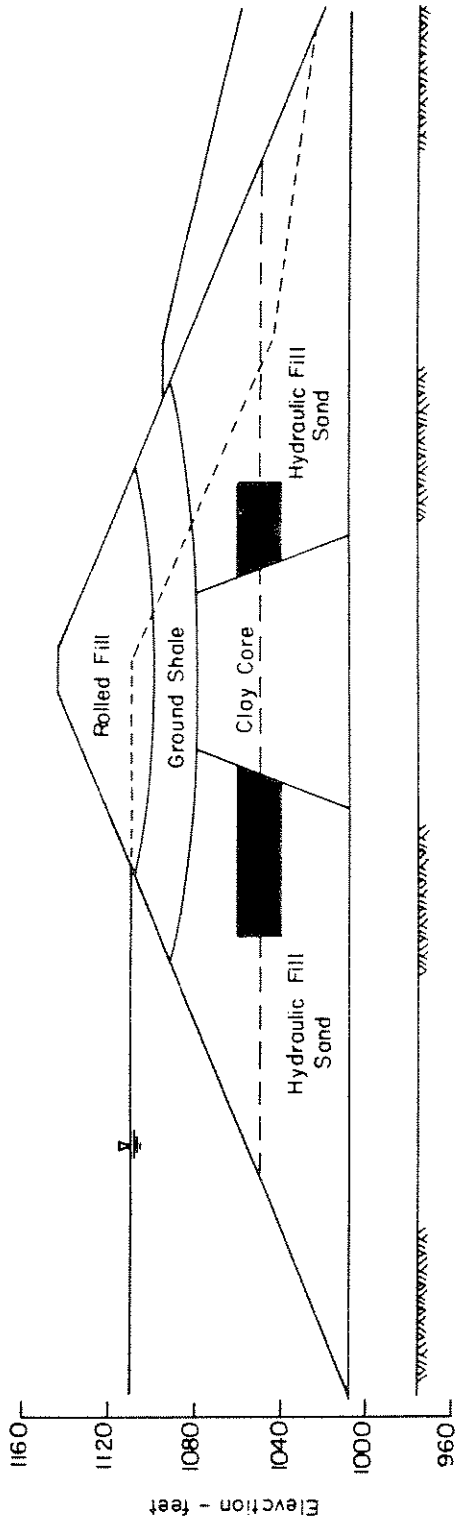
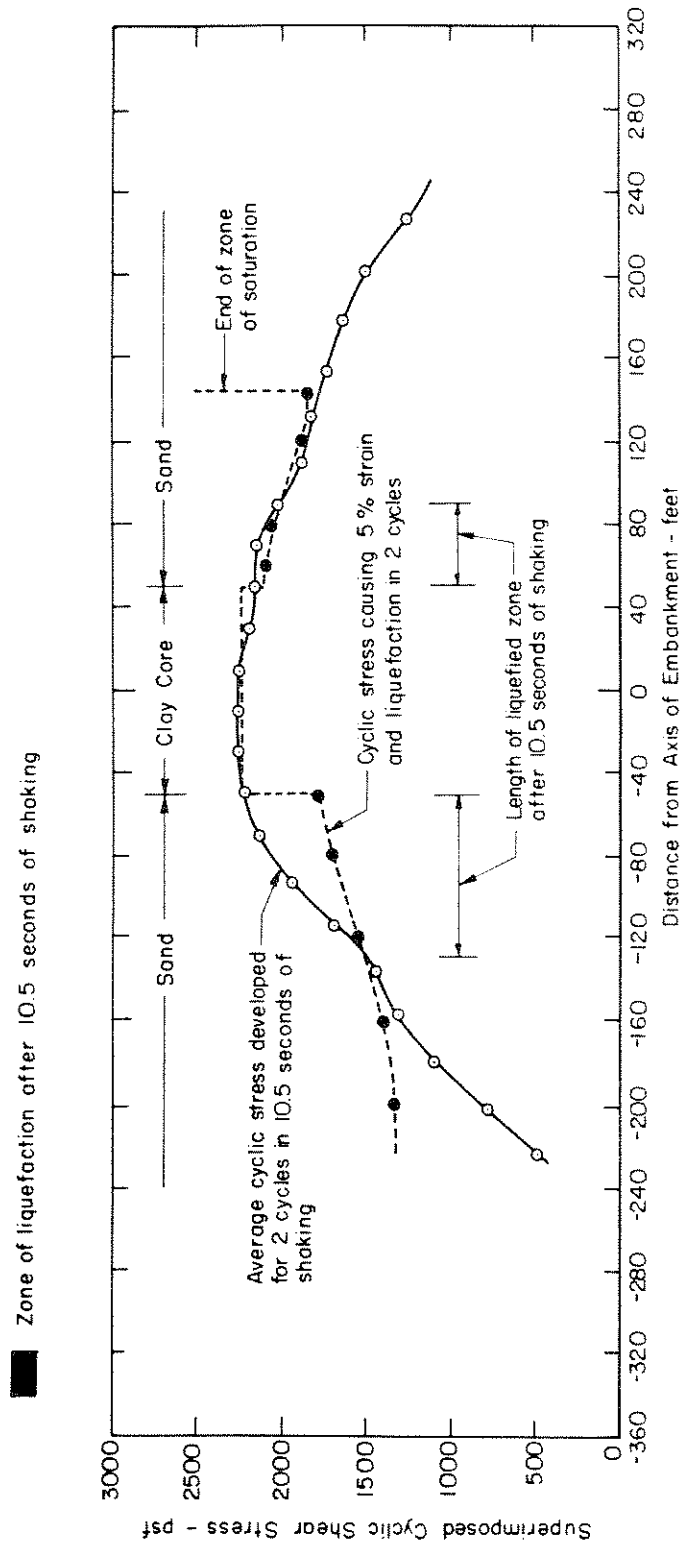
Fig. VIII-8 ANALYSIS OF SOIL STABILITY ALONG PLANE AT ELEVATION 1050 FT. AFTER 10.5 SECONDS OF SHAKING, USING BASE MOTIONS DETERMINED FROM SEISMOSCOPE RECORD - LOWER SAN FERNANDO DAM.

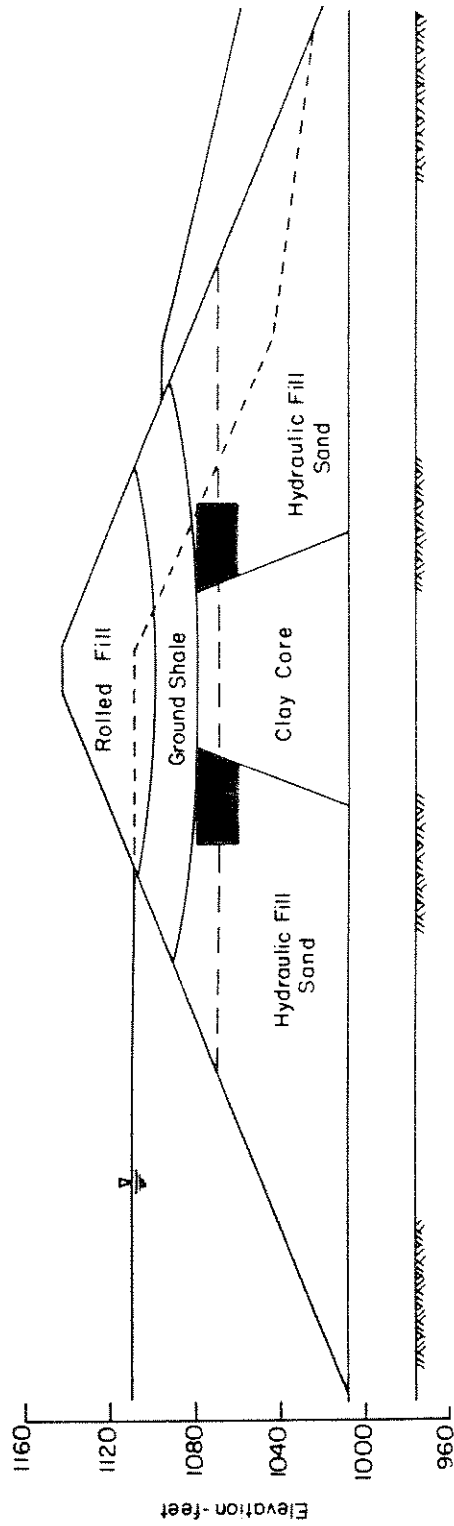
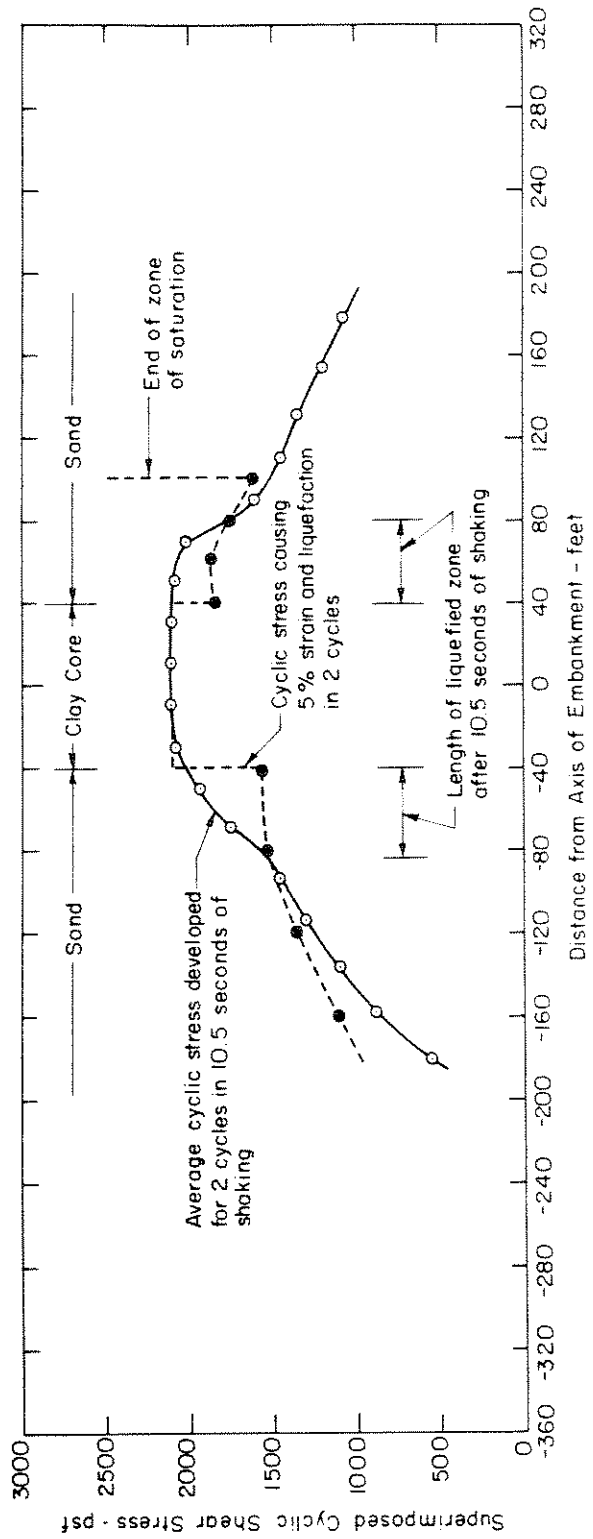
■ Zone of liquefaction after 10.5 seconds of shaking

Fig. VIII-9 ANALYSIS OF SOIL STABILITY ALONG PLANE AT ELEVATION 1070 FT. AFTER 10.5 SECONDS OF SHAKING, USING BASE MOTIONS DETERMINED FROM SEISMOSCOPE RECORD - LOWER SAN FERNANDO DAM.

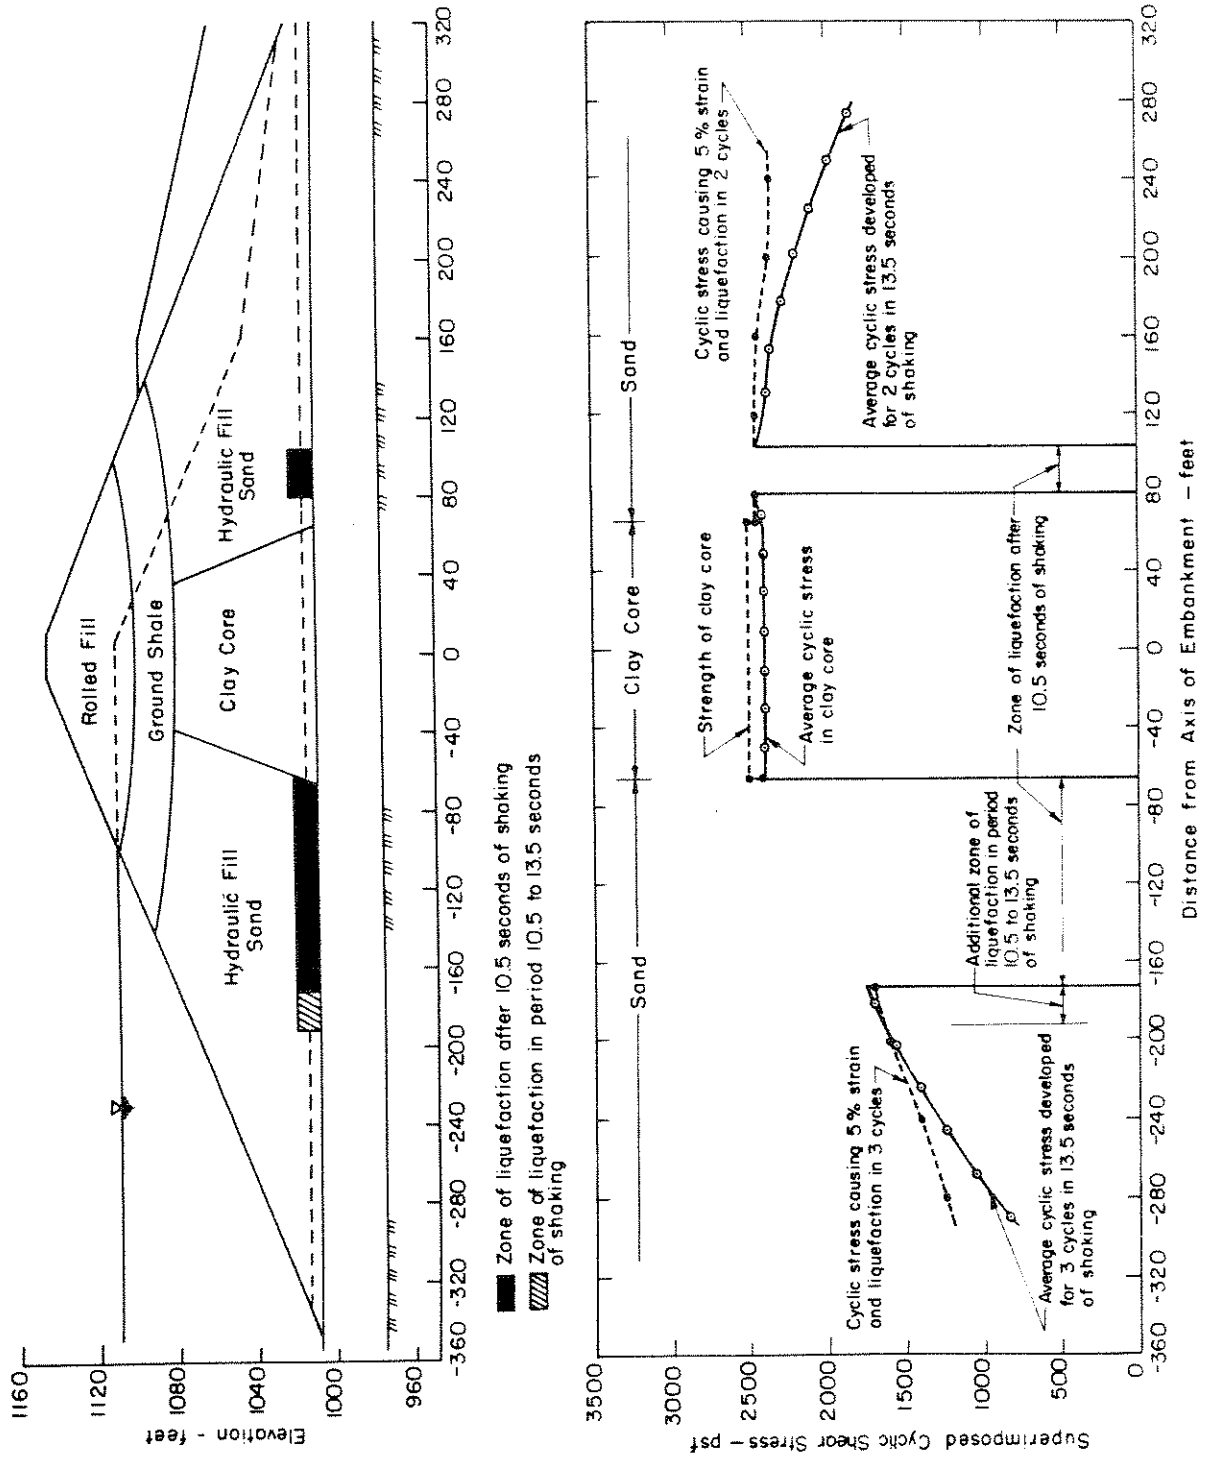
Fig. VIII-10 PROGRESSIVE LIQUEFACTION ANALYSIS ALONG BASE OF EMBANKMENT (EI. 1014') AFTER 13.5 SECONDS OF SHAKING, USING BASE MOTIONS DETERMINED FROM SEISMOSCOPE RECORD - LOWER SAN FERNANDO DAM.

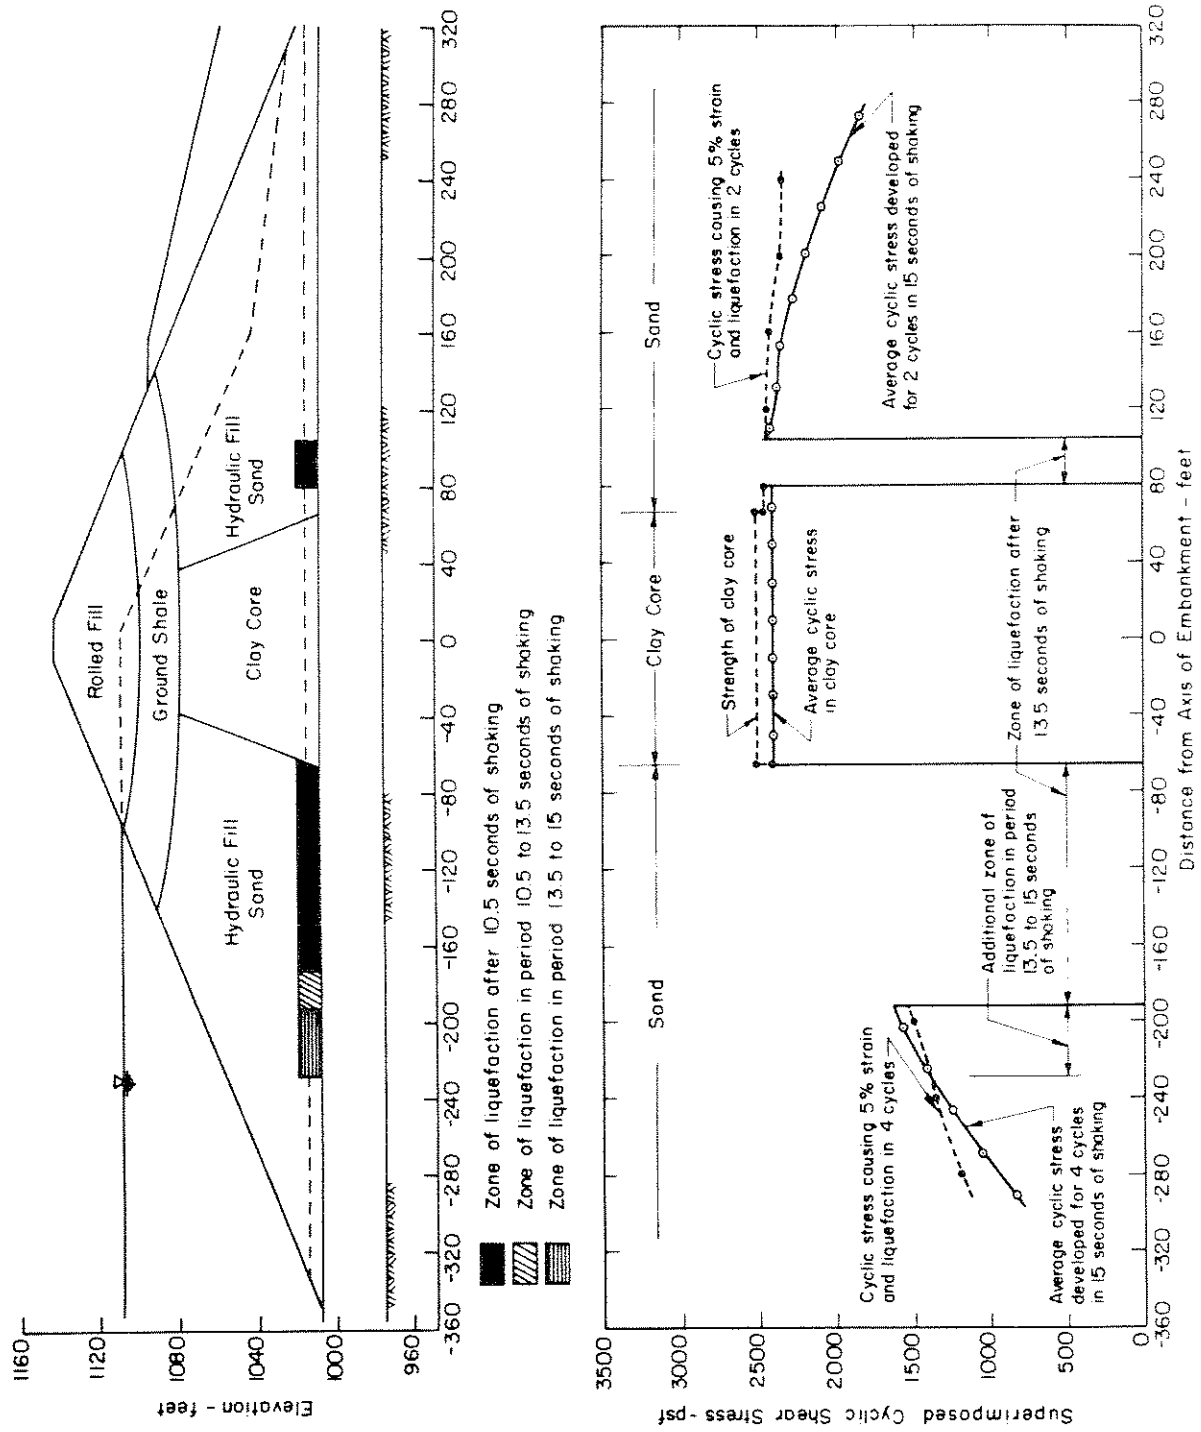
Fig. VIII-11 PROGRESSIVE LIQUEFACTION ANALYSIS ALONG BASE OF EMBANKMENT (E1.1014) AFTER 15 SECONDS OF SHAKING, USING BASE MOTIONS DETERMINED FROM SEISMOSCOPE RECORD - LOWER SAN FERNANDO DAM.

fill after 15 seconds of shaking was determined. The zones of liquefaction indicated by the analysis for the entire duration of motion are summarized in Fig. VIII-4. These zones are in reasonable agreement with the areas where liquefaction is indicated by the field observations and the reconstruction of the probable mechanism of sliding described in Part VI of this report.

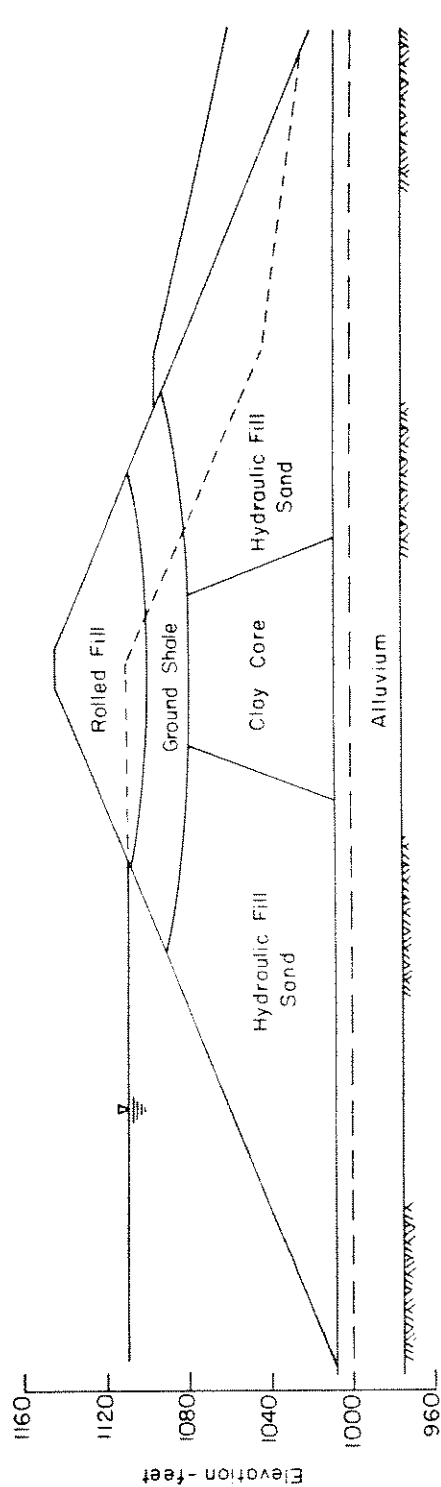
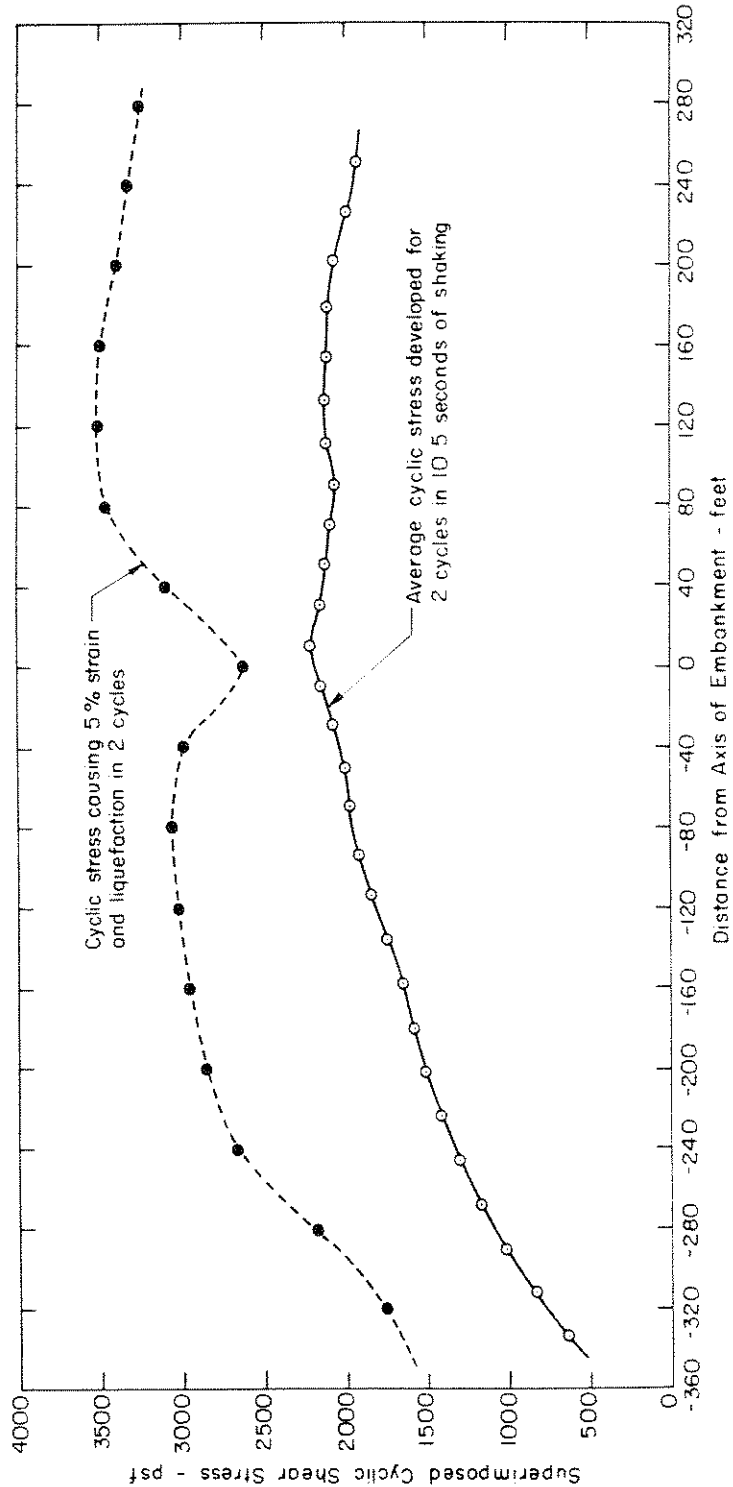
The evaluation of liquefaction and strain potential in the foundation layer at Elevation 1000 (which represents the average depth within the upper alluvium) is illustrated in Fig. VIII-12. The stresses induced by the earthquake during the first 10.5 seconds of shaking are shown in the lower part of the figure. These stresses are expressed as the equivalent average cyclic stress developed in 2 cycles. The stresses required to cause liquefaction and 5 percent strain in 2 cycles are also shown in the lower part of the figure. The latter stresses were obtained from data similar to that presented in Fig. V-39 and using the values of initial normal stress, σ'_o , and the ratio, τ_o/σ'_o , computed by the static finite element analyses. As can be noted, the stresses induced by the earthquake after 10.5 seconds of shaking in the upper alluvium are considerably lower than the stresses required to cause liquefaction. Similar studies for the full duration of the earthquake show that no liquefaction would develop in the alluvium

Fig. VIII-12 ANALYSIS OF STABILITY IN FOUNDATION SOIL (EI. 1000') AFTER 10.5 SECONDS OF SHAKING, USING BASE MOTIONS DETERMINED FROM SEISMOSCOPE RECORD LOWER SAN FERNANDO DAM

even after 15 seconds of shaking. The analysis would indicate therefore that there was ample margin of safety against development of liquefaction or 5 percent strain in the upper alluvium during the San Fernando earthquake. Since the lower alluvium is denser than the upper alluvium and has even higher cyclic strength characteristics, it would have an even higher margin of safety against deformation and failure during this earthquake.

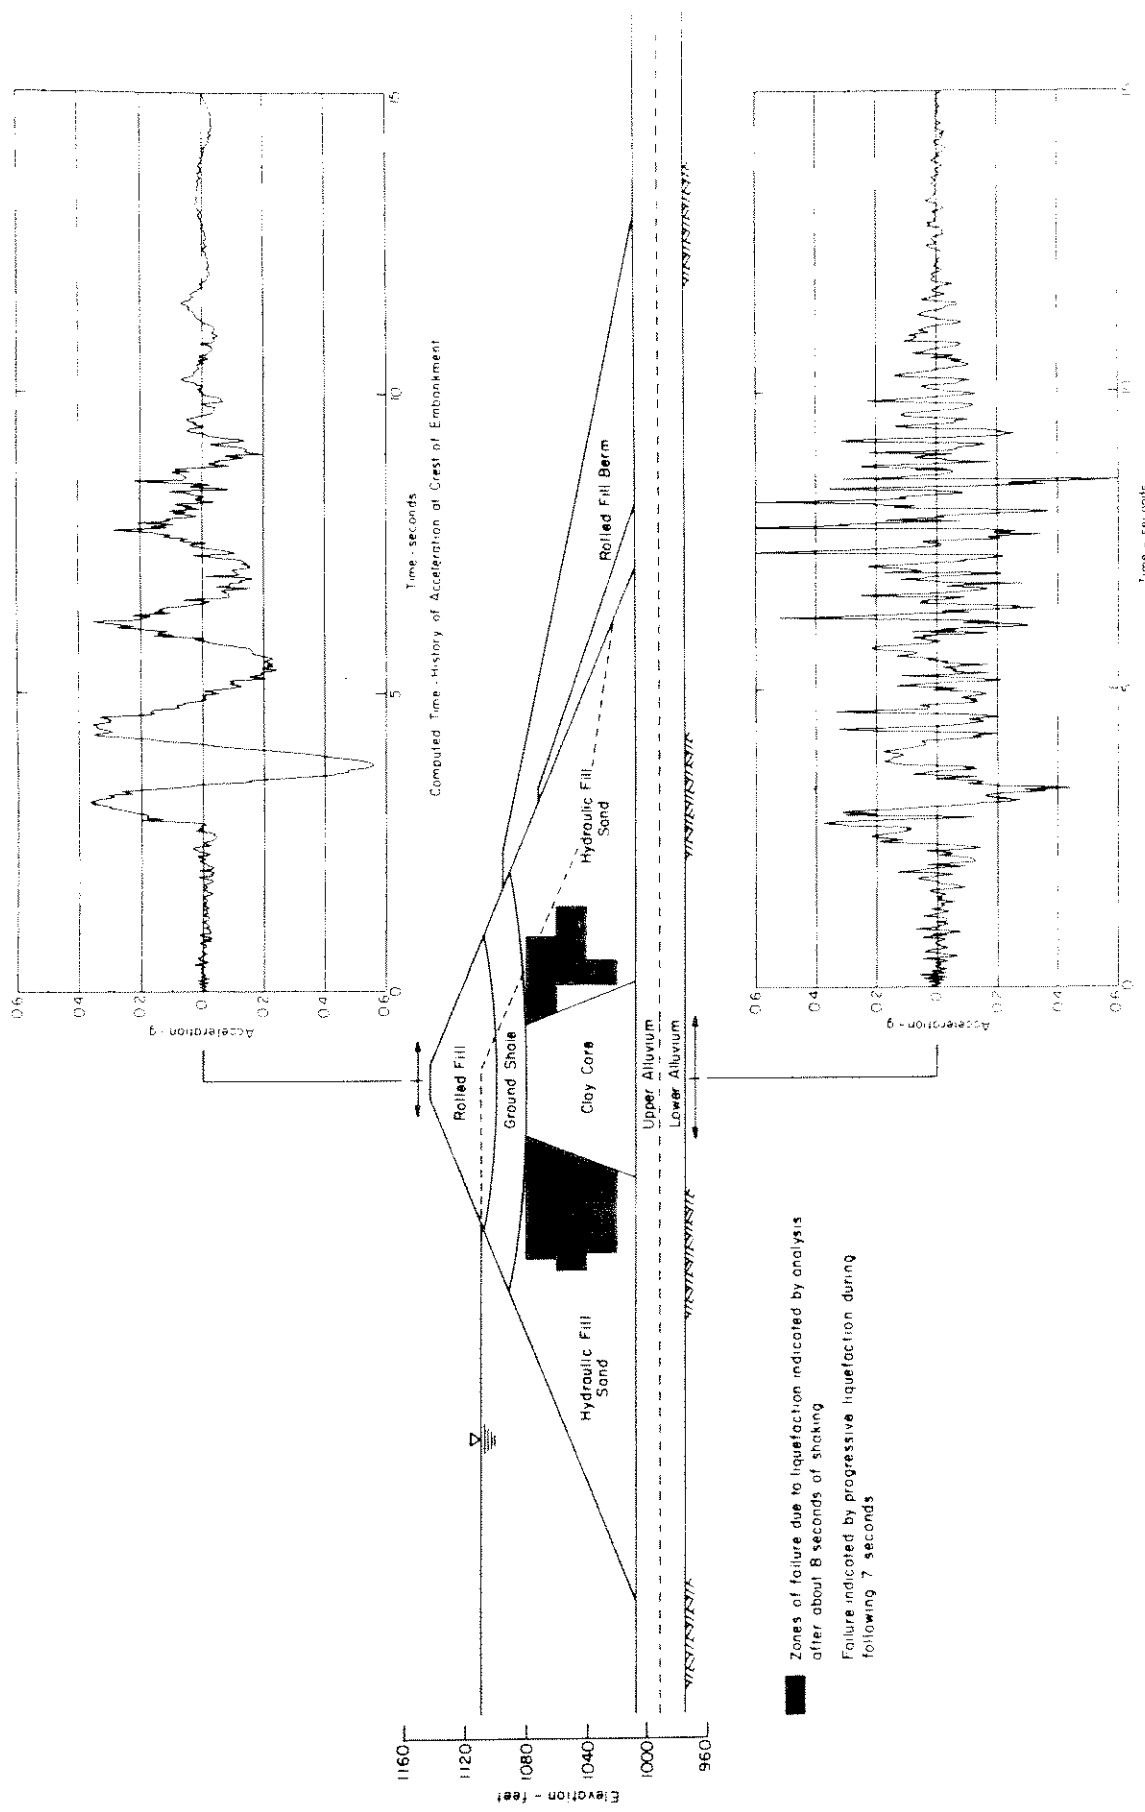
The same procedures as those outlined in the previous section were used to compute the response and to evaluate the stability of the dam during this applied base motion. The time history of the base motion and the computed time history of acceleration at the crest of the embankment are shown in Fig. VIII-13.

Fig. VIII-13 ANALYSIS OF RESPONSE OF LOWER DAM DURING SAN FERNANDO EARTHQUAKE TO BASE MOTIONS DETERMINED FROM MODIFIED PACOIMA RECORD.

strain along each plane provides the means for assessing the extent of liquefaction within each zone after 8 seconds of shaking. The extent of liquefaction for this duration of shaking is summarized in Fig. VIII-13.

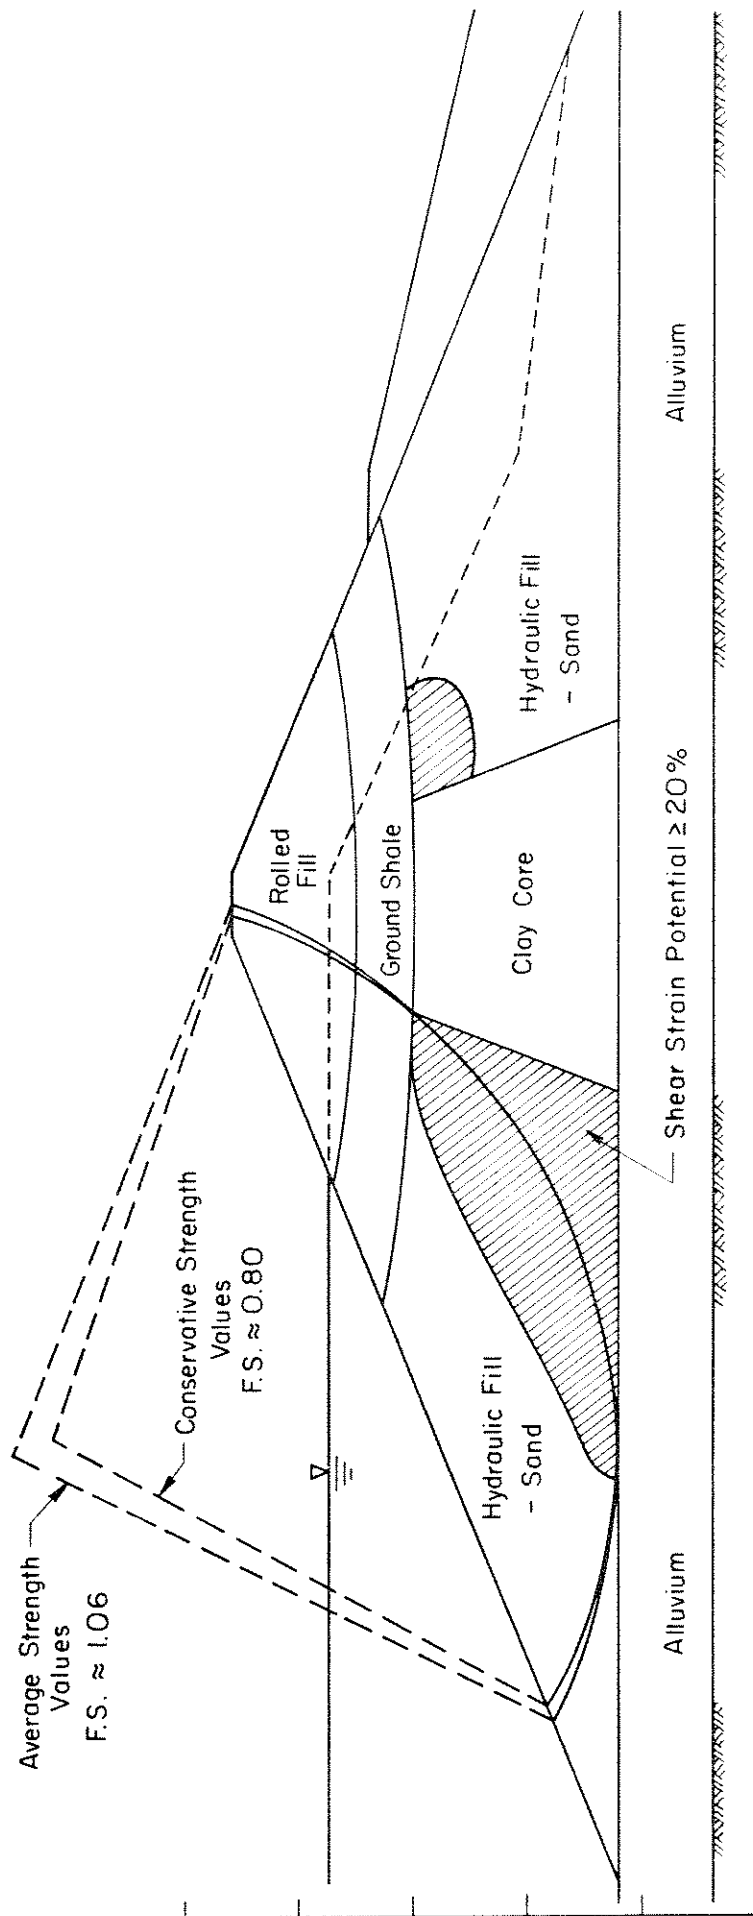
Fig. VIII - 21 ANALYSIS OF STABILITY OF LOWER SAN FERNANDO DAM AFTER DEVELOPMENT OF ZONE OF HIGH STRAIN POTENTIAL

liquefaction and the development of high pore water pressures during the earthquake), a stability analysis can be made to assess the stability of the slope against static failure, as shown in Fig. VIII-21. Using average consolidated-undrained strength parameters because of the sudden change in stress distribution (see Fig. V-38b), the computed factor of safety along the critical sliding surface shown in Fig. VIII-21 is about 1.06; using conservative values of strength parameters (Fig. V-38a), the computed factor of safety is about 0.8.

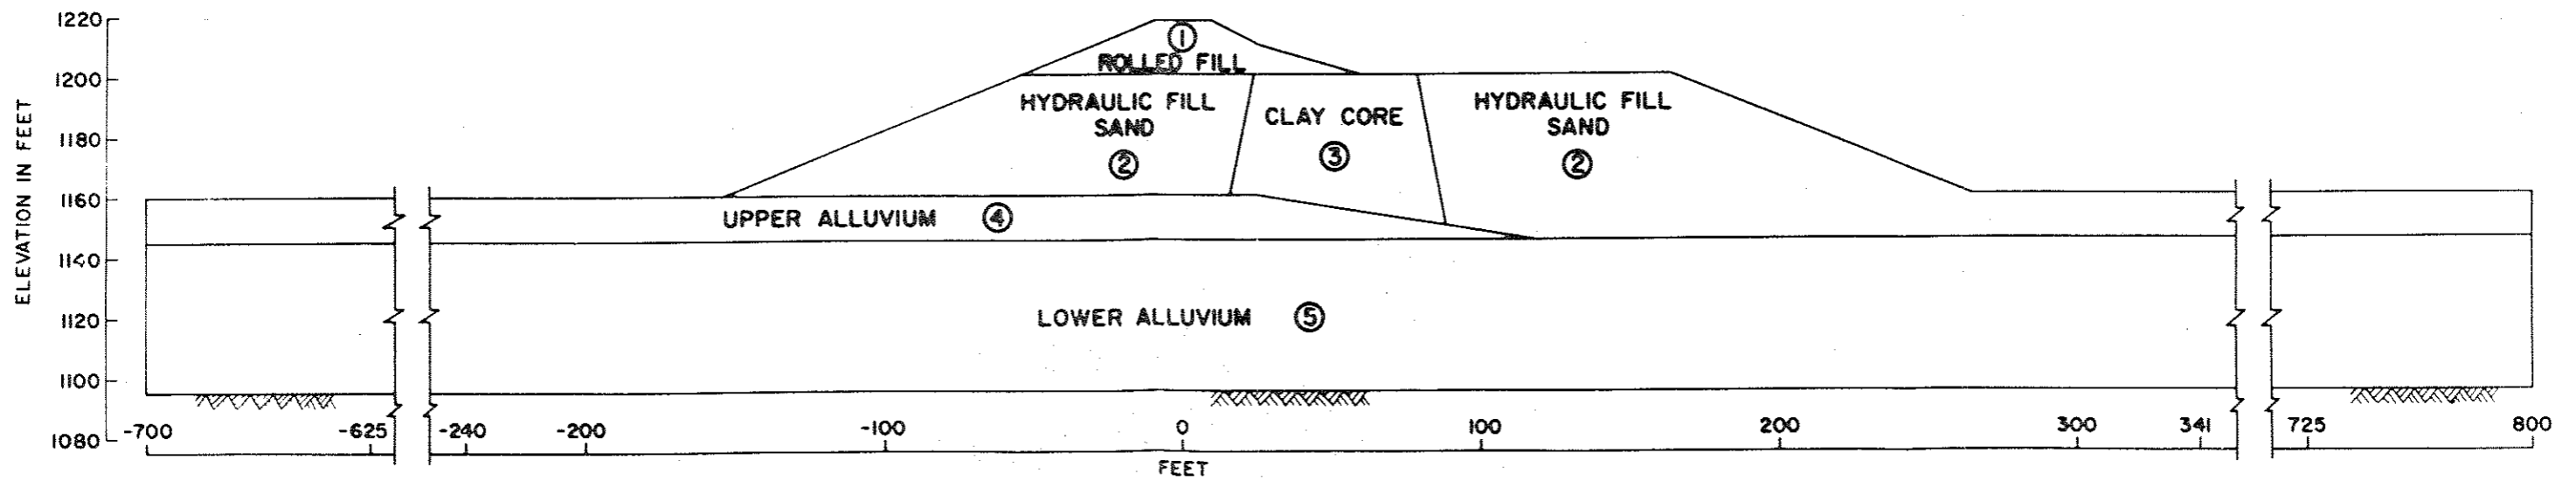
Fig. IX-1 CROSS-SECTION THROUGH UPPER SAN FERNANDO DAM USED FOR DYNAMIC ANALYSIS

The dam and underlying foundation were represented by the finite element mesh shown in the upper part of Fig. IX-1.

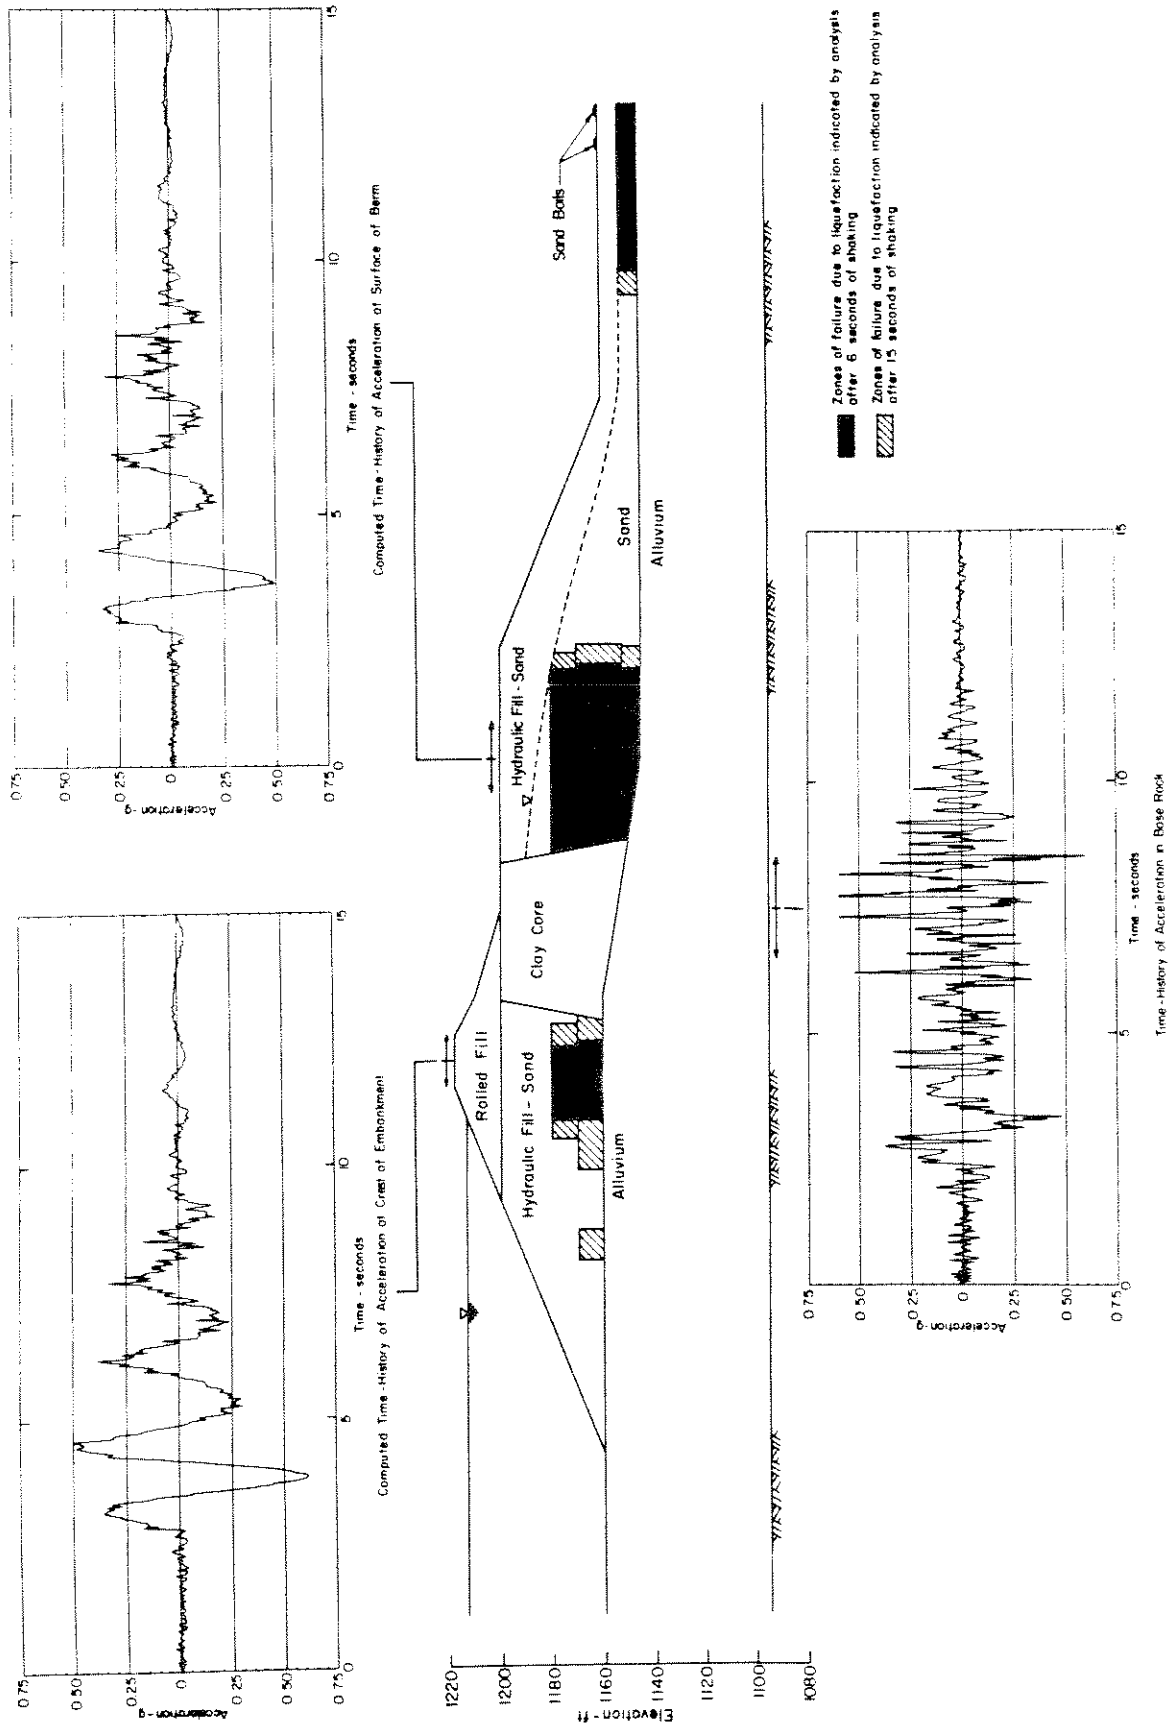
Fig. IX-2 ANALYSIS OF RESPONSE OF UPPER DAM DURING SAN FERNANDO EARTHQUAKE TO BASE MOTIONS DETERMINED FROM MODIFIED PACOIMA RECORD.

The response of the Upper Dam was then computed using the Modified Pacoima record as input base rock motion. The solution was repeated until strain-compatible modulus and damping values were obtained. Time histories of acceleration at every node and the shear stresses induced in each element during the earthquake were thus computed. The time history of accelerations at the crest and along the top of the berm, together with the time history of the input base rock motions, are shown in Figure IX-2. As can be noted, the computed maximum crest acceleration is approximately 0.6g and the acceleration along the berm is approximately 0.5g.

Similar plots, to that shown in the Lower part of Fig. IX-4, for the planes at Elevation 1156, 1165, 1175 and 1185 are presented in Figs. IX-5, IX-6, IX-7 and IX-8, respectively. Comparison of the values of developed stresses with the stresses required to cause liquefaction and 5 percent strain along each plane provides the means for assessing the extent of liquefaction and excessive strain within each zone after 6 sec. of shaking. The extent of liquefaction for this duration of shaking is summarized in Fig. IX-2.

The effects of additional shaking (i.e. from 6 to 15 sec.) were studied by continuing the analysis with greatly reduced moduli of deformation in the liquefied zones and comparing the equivalent stresses after 15 seconds of shaking with the available resistance of the soil. The increase in the extent of liquefaction as a result of this additional shaking is summarized in Fig. IX-2.

an extensive zone of liquefaction in the depth range from El. 1145 to El. 1152 beyond the downstream toe of the embankment as shown in Fig. IX-2. It may be noted that several sand boils were found in this area after the earthquake.

However it may be seen from Fig. IX-2, that most of the upstream shell of the embankment and a substantial part of the downstream shell do not liquefy or tend to develop excessive strains. It was presumably the continued mobilization of high resistance to deformation in these zones which prevented a catastrophic failure of the embankment during the earthquake.

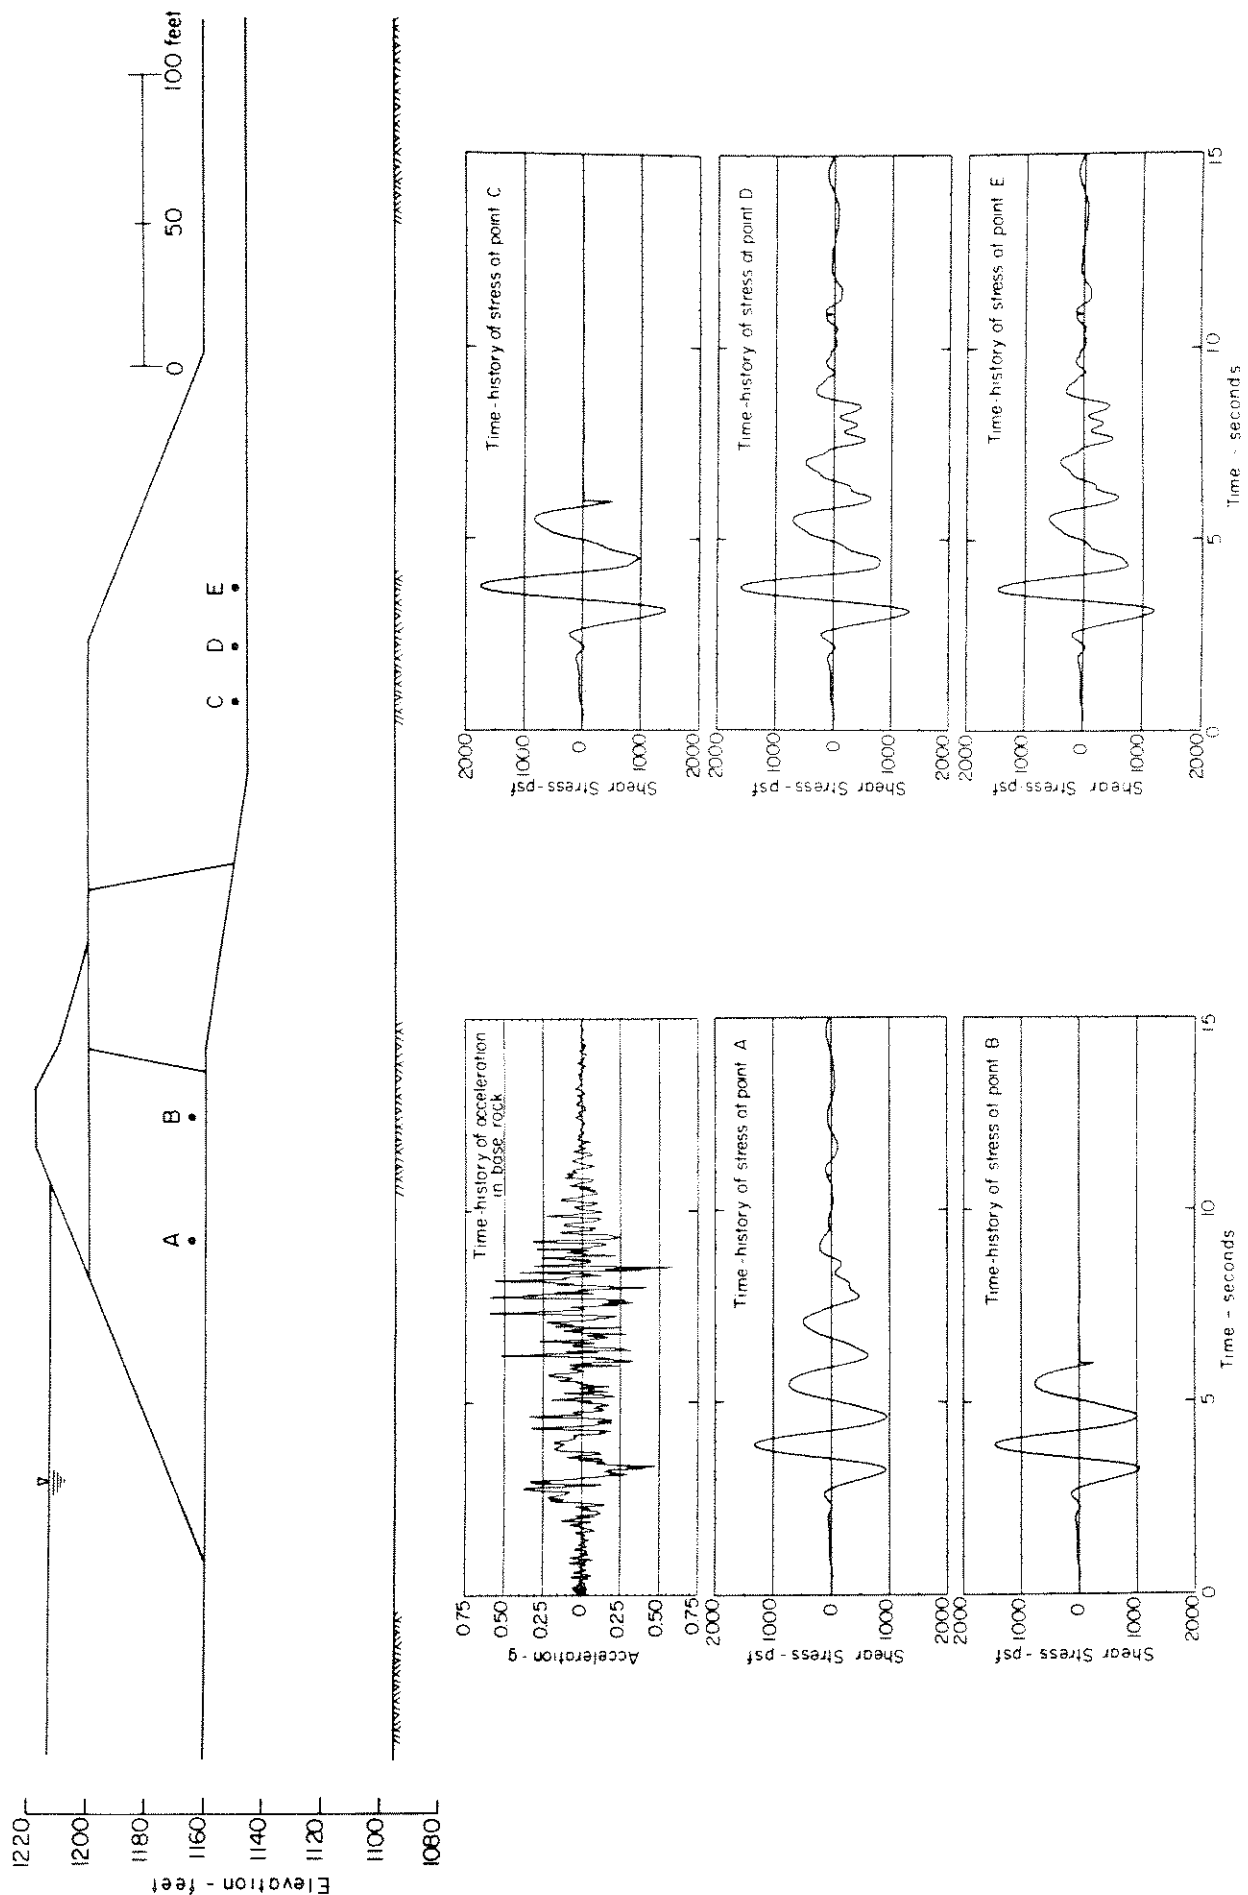
Fig. IX-3 PROGRESSIVE LIQUEFACTION ANALYSIS: TIME-HISTORIES OF SHEAR STRESSES DEVELOPED ALONG BASE OF EMBANKMENT - UPPER SAN FERNANDO DAM.

As in the case of the Lower Dam, the stability of the Upper Dam was evaluated taking into consideration the tendency for liquefaction in the hydraulic fill to develop progressively. The stability of the dam was therefore assessed in two steps; the behavior after 6 sec. of shaking was first evaluated and then the remainder of the motion (i.e. from 6 to 15 sec.) was applied. Typical time histories of stress at representative points in the embankment are shown in Fig. IX-3.
