REPORT NO.
EERC 73-2
June 1973

ANALYSIS OF THE SLIDES IN THE SAN FERNANDO DAMS DURING THE EARTHQUAKE OF FEB. 9, 1971

H. BOLTON SEED
K. L. LEE
I. M. IDRIS
F. MAKDISI

State of California Department of Water Resources
Los Angeles Department of Water and Power
National Science Foundation

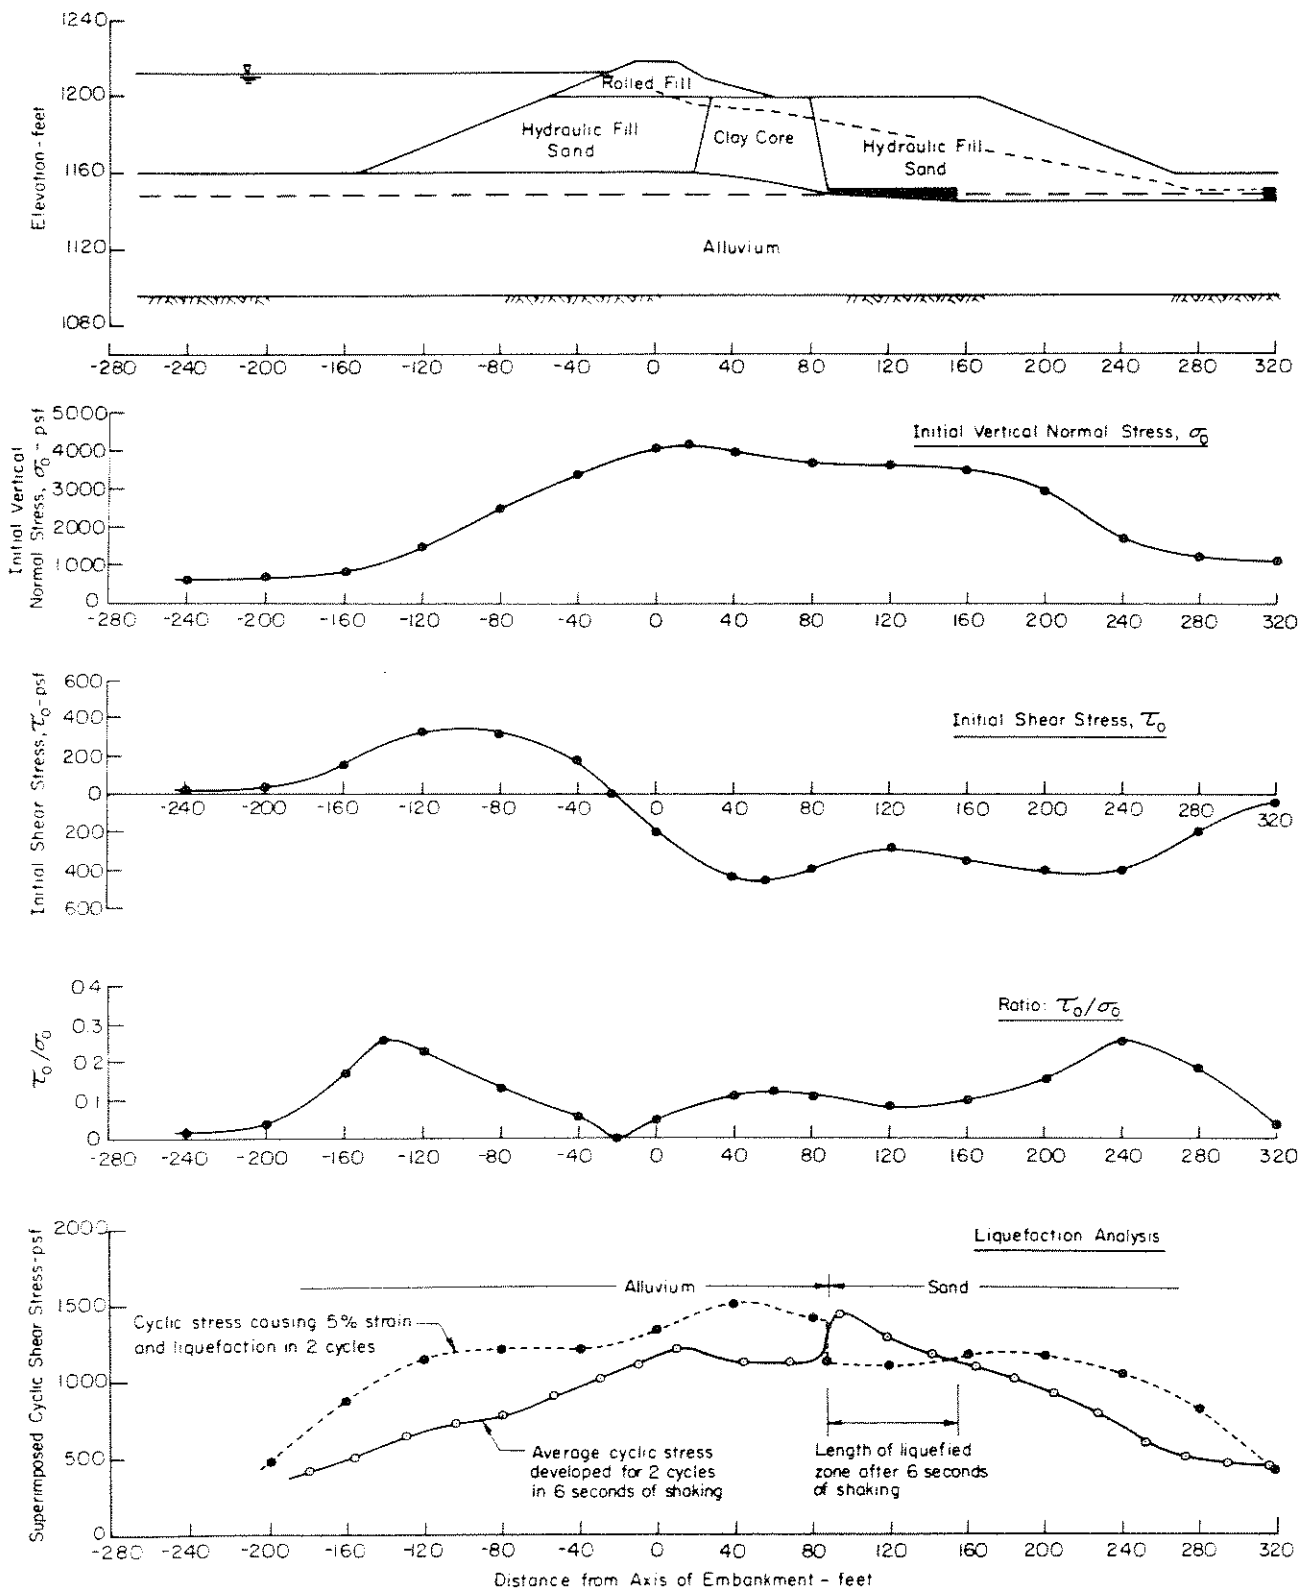
Fig. IX-4 ANALYSIS OF SOIL STABILITY ALONG PLANE AT ELEVATION 1148.5 FT. AFTER 6 SECONDS OF SHAKING, USING BASE MOTIONS DETERMINED FROM MODIFIED PACOIMA RECORD - UPPER SAN FERNANDO DAM.

The stresses developed at different points in the embankment and its foundation during the first 6 seconds of shaking were judged to correspond to 2 cycles of equivalent uniform stress. The equivalent uniform stresses developed for 2 cycles after 6 sec. of shaking along the base of the embankment are presented in Fig. IX-4. The stresses required to cause liquefaction in 2 cycles (as determined from the test data in Fig. IV-35 in conjunction with the values of initial normal stress, σ'_o , and the ratio, τ_o/σ'_o , shown in the upper part of Fig. IX-4) along the base of the embankment are also shown in Fig. IX-4. As can be noted, an extensive zone of liquefaction, accompanied by strains exceeding 5 percent, develops in the hydraulic fill downstream of the core. No liquefaction appears likely in the alluvium upstream of the core.

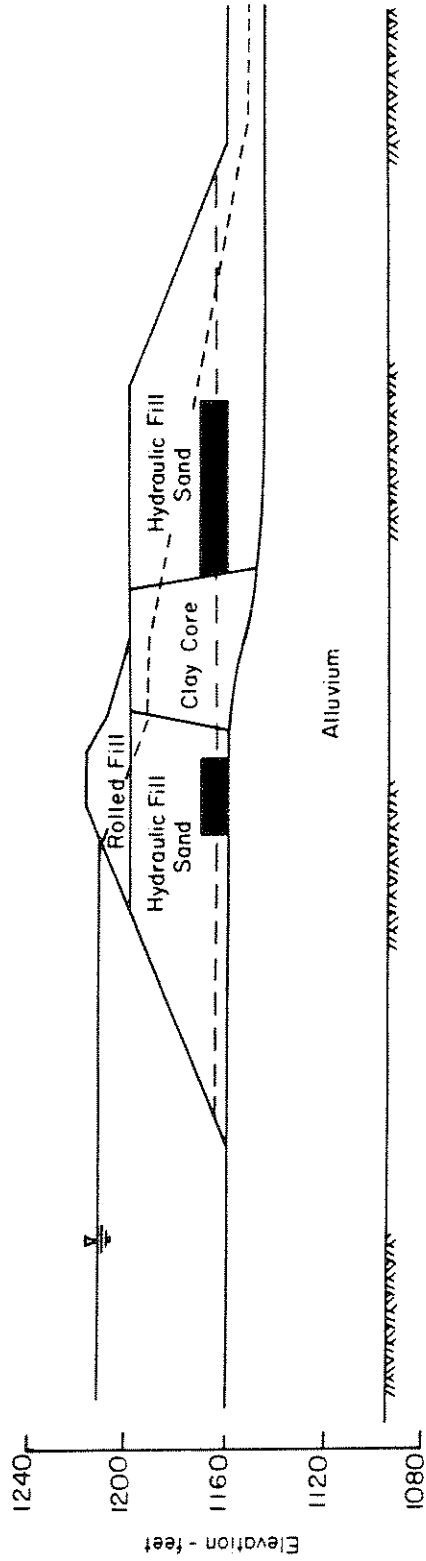
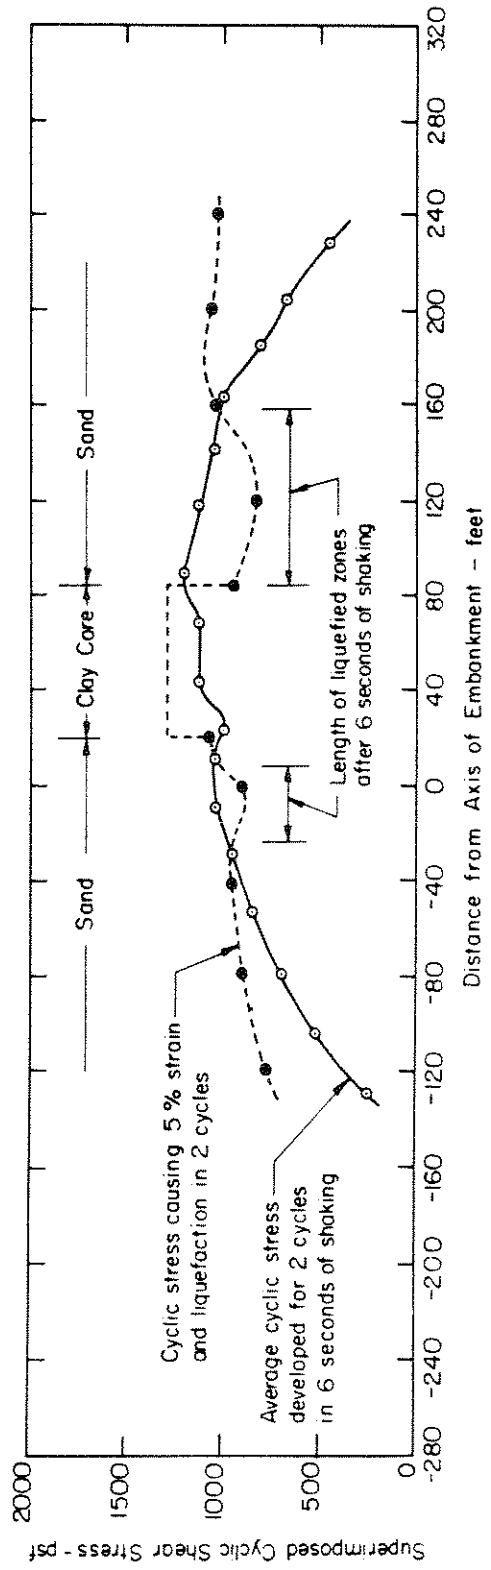
Fig. IX-6 ANALYSIS OF SOIL STABILITY ALONG PLANE AT ELEVATION 1165 FT. AFTER 6 SECONDS OF SHAKING, USING BASE MOTIONS DETERMINED FROM MODIFIED PAXOIMA RECORD - UPPER SAN FERNANDO DAM.

Zone of liquefaction after 6 seconds of shaking

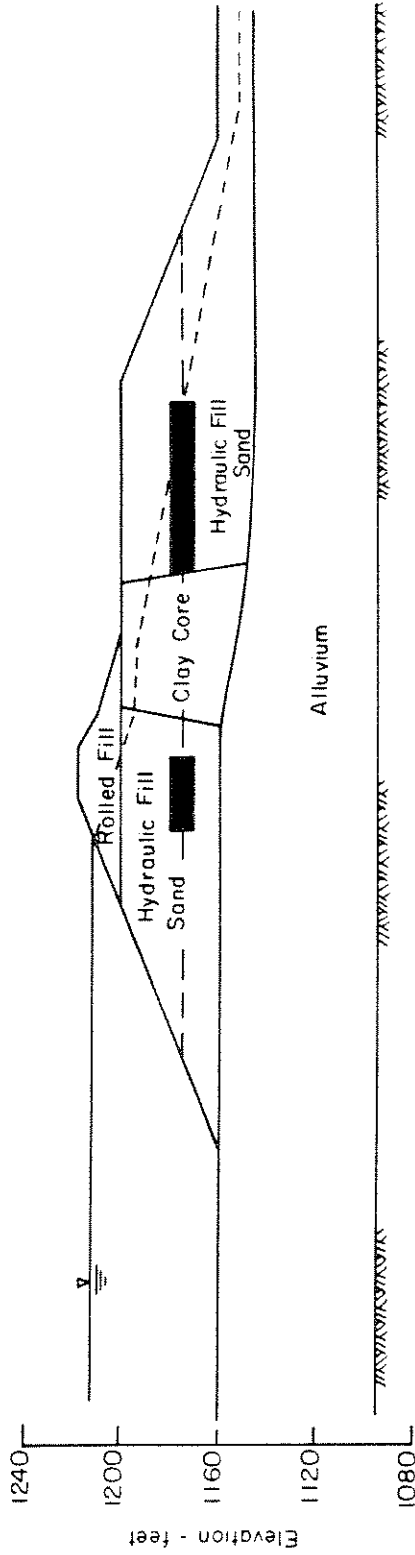
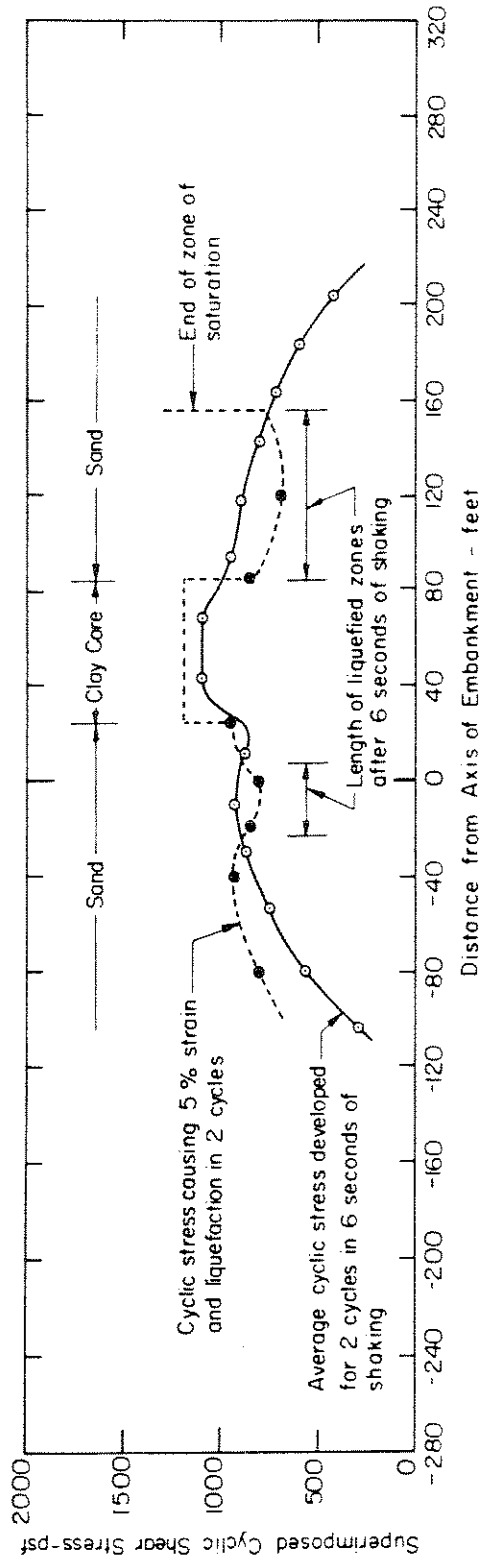
Fig. IX-7 ANALYSIS OF SOIL STABILITY ALONG PLANE AT ELEVATION 1175 FT. AFTER 6 SECONDS OF SHAKING, DUE TO BASE MOTIONS DETERMINED FROM MODIFIED PACOIMA RECORD - UPPER SAN FERNANDO DAM.

■ Zone of liquefaction after 6 seconds of shaking

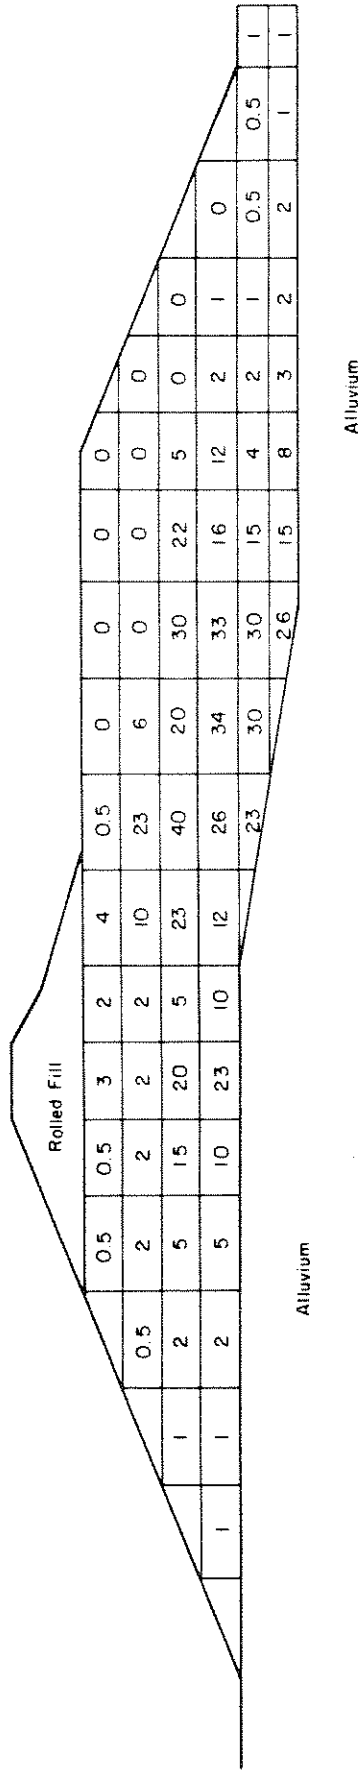
Fig. IX-9 STRAIN POTENTIAL IN HYDRAULIC FILL - UPPER SAN FERNANDO DAM.

A more quantitative evaluation of the behavior of the embankment during the earthquake can be obtained by using the cyclic shear stresses computed by the dynamic response analyses in conjunction with the cyclic load test data to determine the potential compressive strains of individual elements of the embankment, as described in the previous section. These strains are shown in Fig. IX-9. Contours of equal potential strain, based on these results are shown in Fig. IX-10. It may be seen that the

Figures indicate potential compressive strains of elements

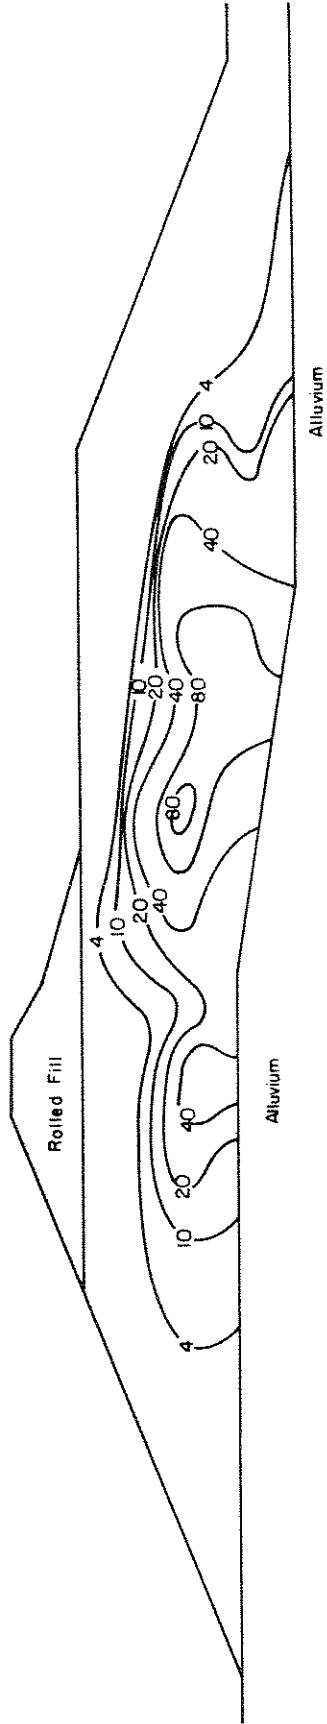
Fig. IX-10 CONTOURS OF SHEAR STRAIN POTENTIAL IN HYDRAULIC FILL
- UPPER SAN FERNANDO DAM.

zones in the embankment which tend to develop the largest strains are near the base and near the center of the embankment and below the crest of the dam. On the other hand the soil in the shells tends to develop relatively small potential strains ranging from 0 to 7 percent.

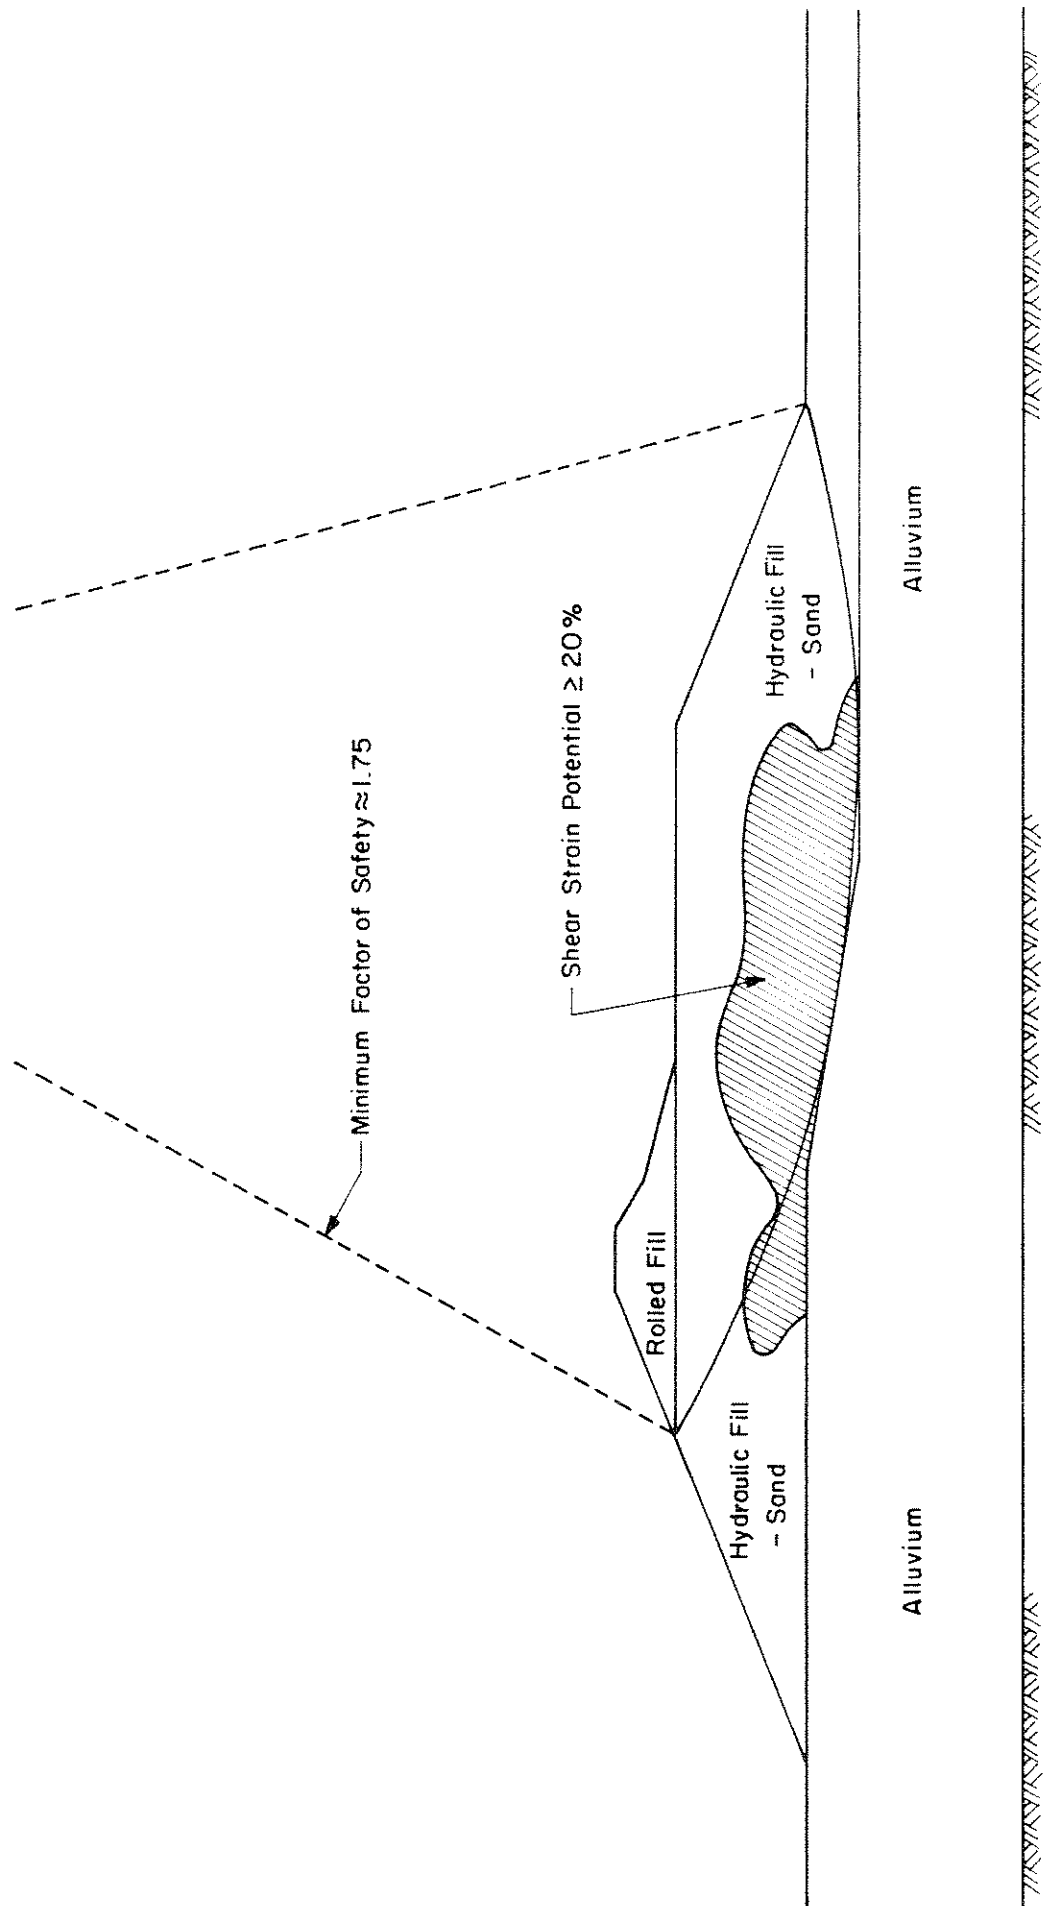
Fig. IX - II ANALYSIS OF STABILITY OF UPPER SAN FERNANDO DAM AFTER DEVELOPMENT OF ZONE OF HIGH STRAIN POTENTIAL

An assessment of the overall stability of the embankment, in spite of the development of zones of high strain potential, can be made by considering that the soil in zones where the shear strain potential exceeds, say, 20 percent or the compressive strain potential exceeds about 10 percent, would provide no effective resistance to slide movements in the embankment. These zones are shown in Fig. IX-11, together with the results of an analysis to determine the minimum factor of safety against sliding in the downstream direction. For the sudden change in stress conditions, consolidated-undrained strength parameters were used in the analyses and seismic forces were neglected. The computed minimum factor of safety was 1.75 indicating that the embankment would easily be able to withstand the small inertia forces developed in the later stages of the earthquake, together with the static stresses, without development of a residual downstream instability condition.

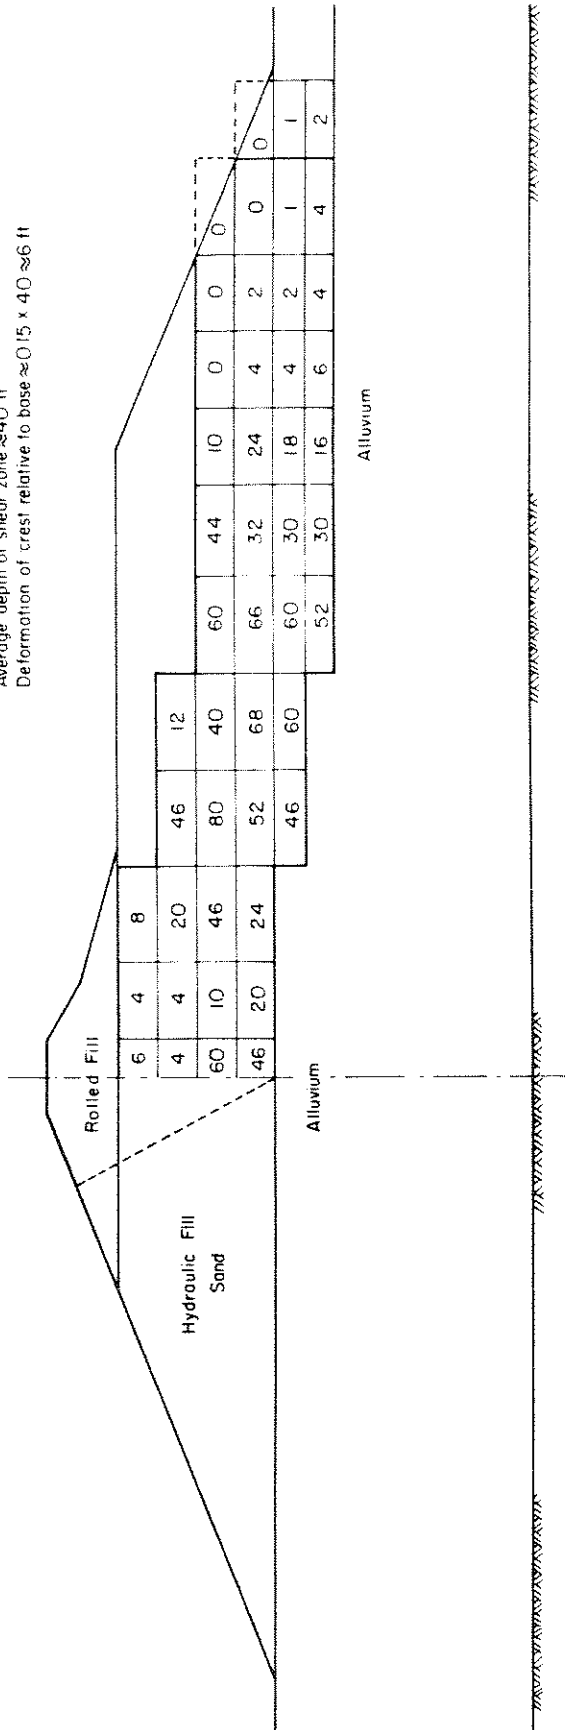
Fig. IX-12 SHEAR STRAIN POTENTIAL FOR INDIVIDUAL ELEMENTS OF EMBANKMENT
 - UPPER SAN FERNANDO DAM.

On the other hand, the magnitude of the strains developed in the embankment would be expected to lead to substantial residual deformations. Values of the shear strain potential for individual elements of the embankment, obtained by multiplying the compressive strains by 2, are shown in Fig. IX-12. Since the zones developing lower strains will tend to restrain the movement of zones of higher strain potential, again a first approximation to the overall horizontal movements of the embankment might be obtained from the overall average shear strain for elements located on the downstream side of the axis of the dam, as shown in Fig. IX-12.

Average shear strain for elements shown $\approx 23\%$
 Average depth of shear zone ≈ 38 ft
 Deformation of surface of embankment relative to alluvium $\approx 0.23 \times 38 \approx 8.7$ ft.
 Near crest: Average shear strain $\approx 15\%$
 Average depth of shear zone ≈ 40 ft
 Deformation of crest relative to base $\approx 0.15 \times 40 \approx 6$ ft

For the shear zone shown with a depth of about 38 ft, the average shear strain is about 22%. Thus the indicated relative movement of the surface of the embankment relative to the base is about 8.3 ft. A horizontal movement of this magnitude would be accompanied by sloughing of the triangular wedge of soil bounded by the dashed line in Fig. IX-12, producing slide scarps near the top of the upstream slope. In addition the movements near the base of the embankment would be relatively small.

It is interesting to note that the shear strains in the zone below the crest of the embankment are somewhat lower than those further downstream, indicating that the lateral movement of the crest would be somewhat less than that of the horizontal berm at El. 1200 approx. Such differential movements would be expected to lead to cracking near the downstream toe of the rolled fill, as was observed following the earthquake. Furthermore the average shear strain in the soil under the crest of the embankment is about 15 percent, indicating a crest displacement due to shear of about 6 ft, as shown in Fig. IX-12.

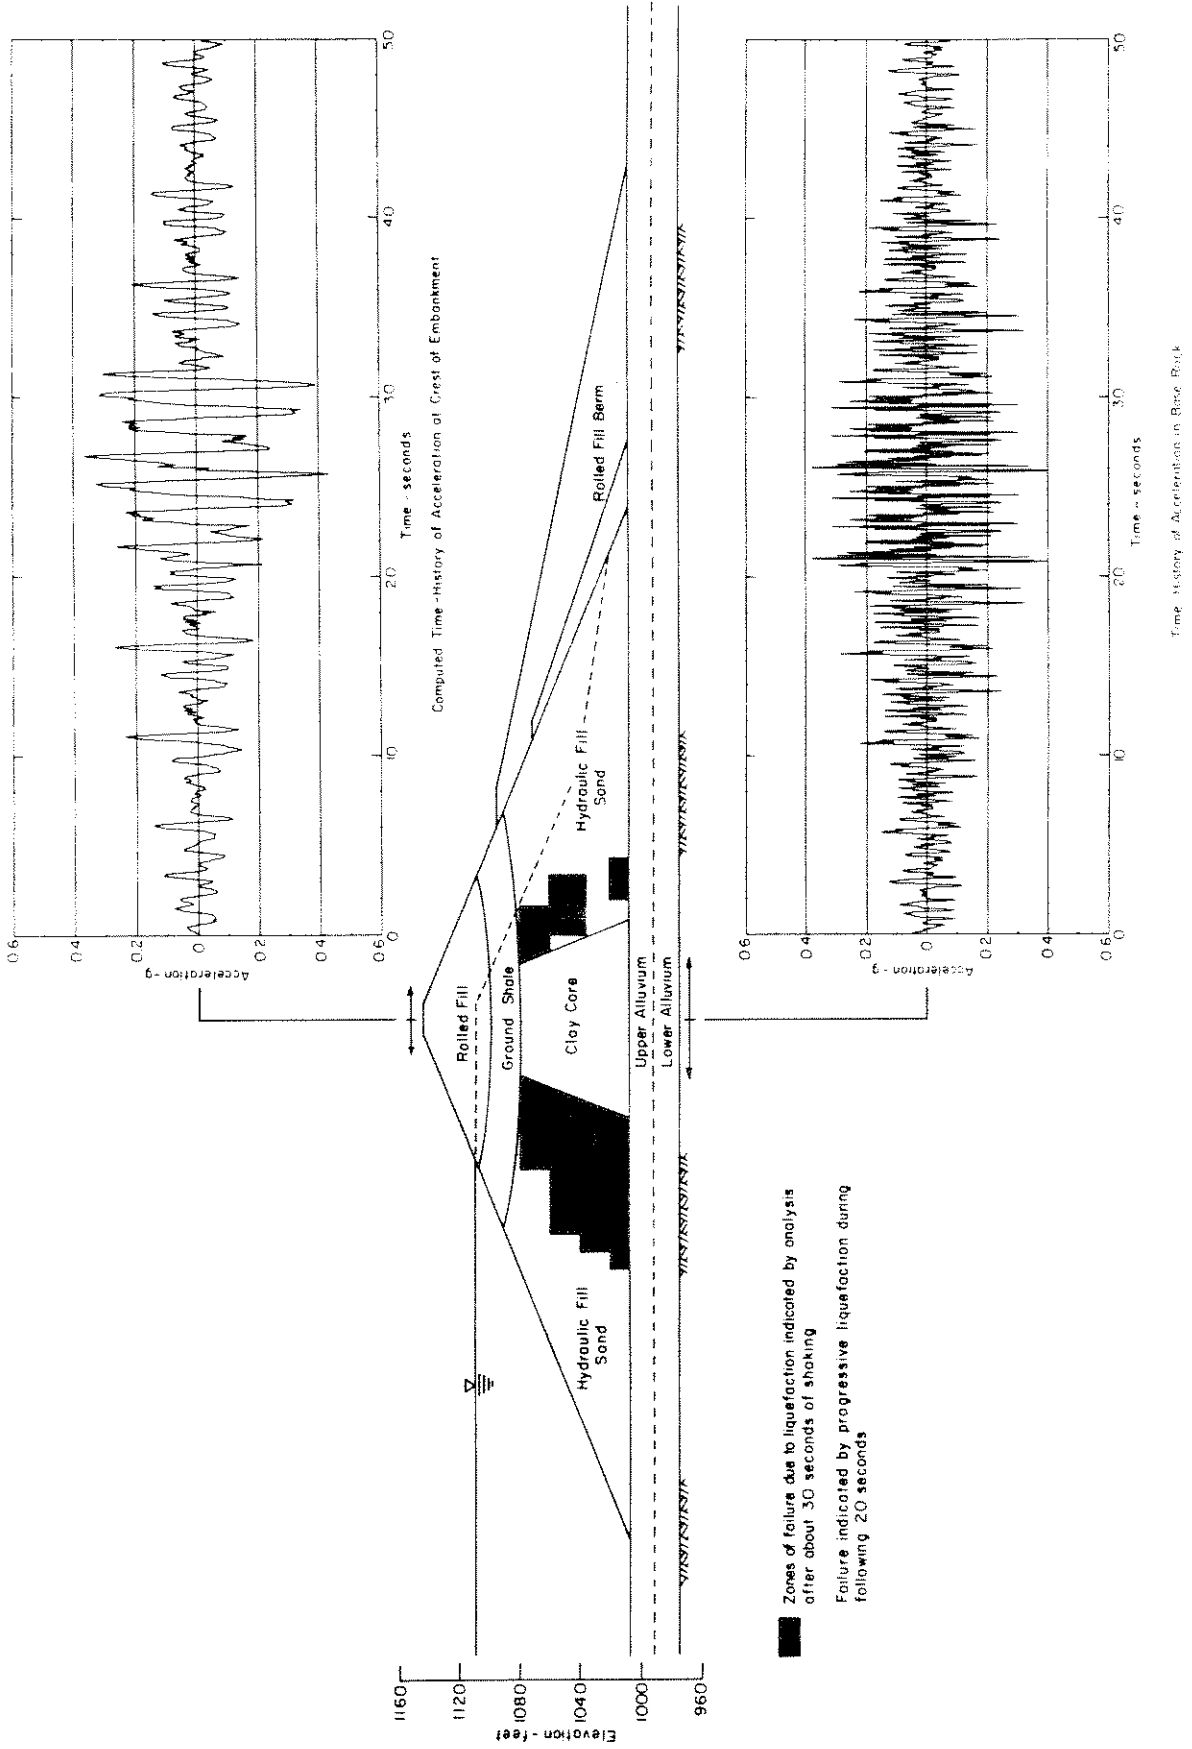
Fig. X-1 ANALYSIS OF RESPONSE OF LOWER DAM FOR MAGNITUDE 8 1/4 EARTHQUAKE ON SAN ANDREAS FAULT.

The results of the analysis of the stability of the Lower Dam for a magnitude 8-1/4 earthquake occurring on the San Andreas fault at a distance of 23 miles from the damsite are shown in Fig. X-1. The motions in the rock underlying the dam produced by such an earthquake were considered to have a maximum acceleration of about 0.4g and a time-history similar to that proposed by Seed and Idriss (1969) for such events. The time-history of rock motions at the base of the embankment is shown in Fig. X-1.

The computed accelerations at the crest of the dam are also shown in the figure together with the zones of soil in the hydraulic fill which the analysis indicates would have failed by liquefaction after about 30 seconds of ground shaking. It may be seen that the extent of the zones is comparable to that shown in Fig. VIII-4 to have developed after about 10.5 seconds of the San Fernando earthquake. However since the total duration of shaking from a magnitude 8-1/4 earthquake is likely to be about 60 to 70 seconds, it is clear that further liquefaction in such an earthquake would rapidly occur by progressive failure and in fact, the dam would almost certainly have failed more extensively in such an earthquake than it did in the San Fernando event.

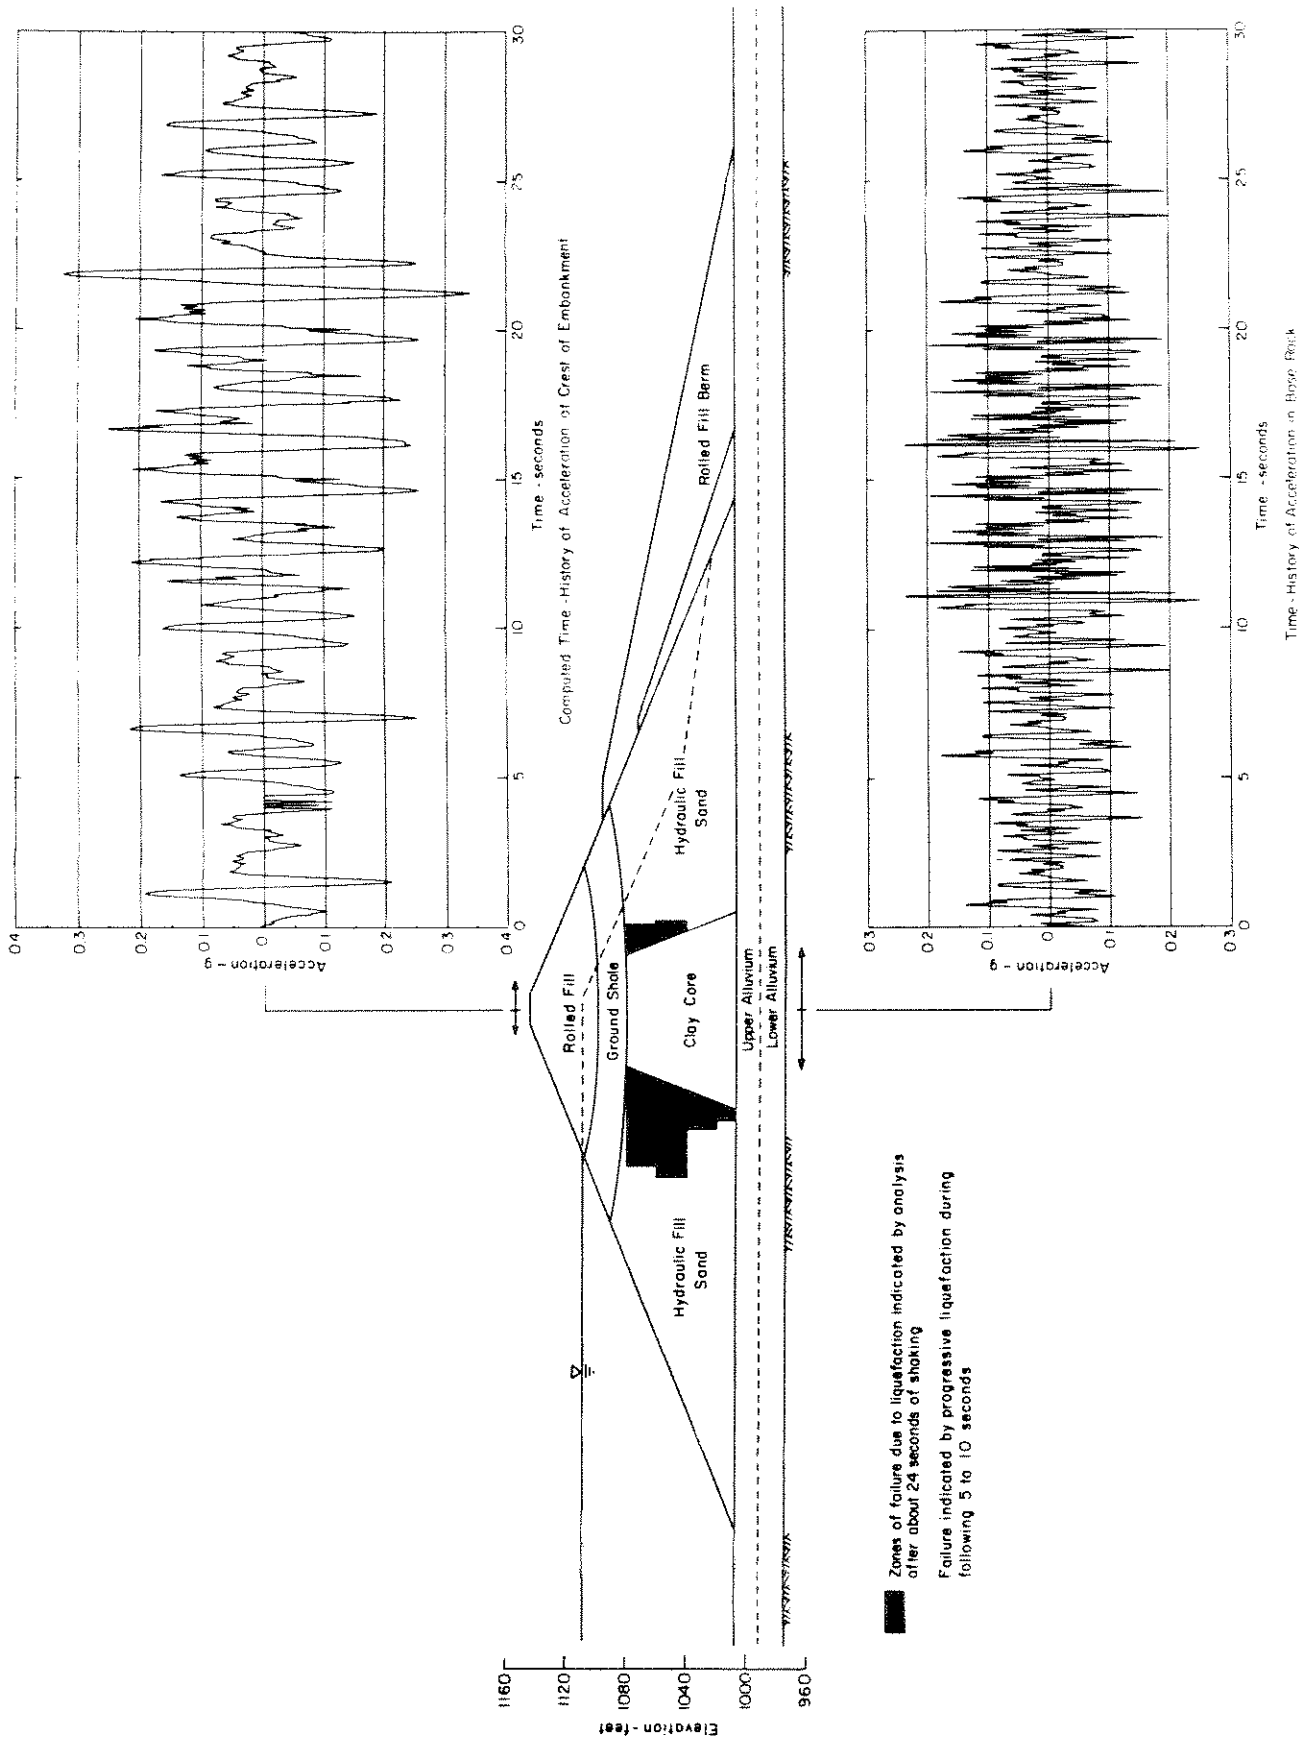
Fig. X-2 ANALYSIS OF RESPONSE OF LOWER DAM FOR MAGNITUDE 7 1/2 EARTHQUAKE ON SAN ANDREAS FAULT.

The results of an analysis of the stability of the Lower Dam for a magnitude 7-1/2 earthquake occurring on the San Andreas fault are shown in Fig. X-2. The motions in the rock underlying the dam produced by such

an earthquake were considered to be similar to those shown in Fig. X-1 but to have a maximum acceleration of 0.25g and a duration of strong shaking of about 35 to 40 seconds.

The computed accelerations at the crest of the dam for rock motions of this type are shown in Fig. X-2, together with the zones of failure in the hydraulic fill which the analysis indicates would have failed by liquefaction after about 24 seconds of ground shaking. While these zones are appreciably smaller in extent than those shown in Fig. X-1, they are never-the-less sufficiently comparable to those shown in Fig. VIII-4 to have developed after 10.5 seconds of shaking in the San Fernando earthquake that by analogy it seems highly probable that a similar slide in the upstream slope would occur by progressive failure in the subsequent 10 to 15 seconds of strong motion.

Thus an earthquake of magnitude 7-1/2 on the San Andreas fault might have been expected to cause sliding of a similar extent to that which occurred in 1971.

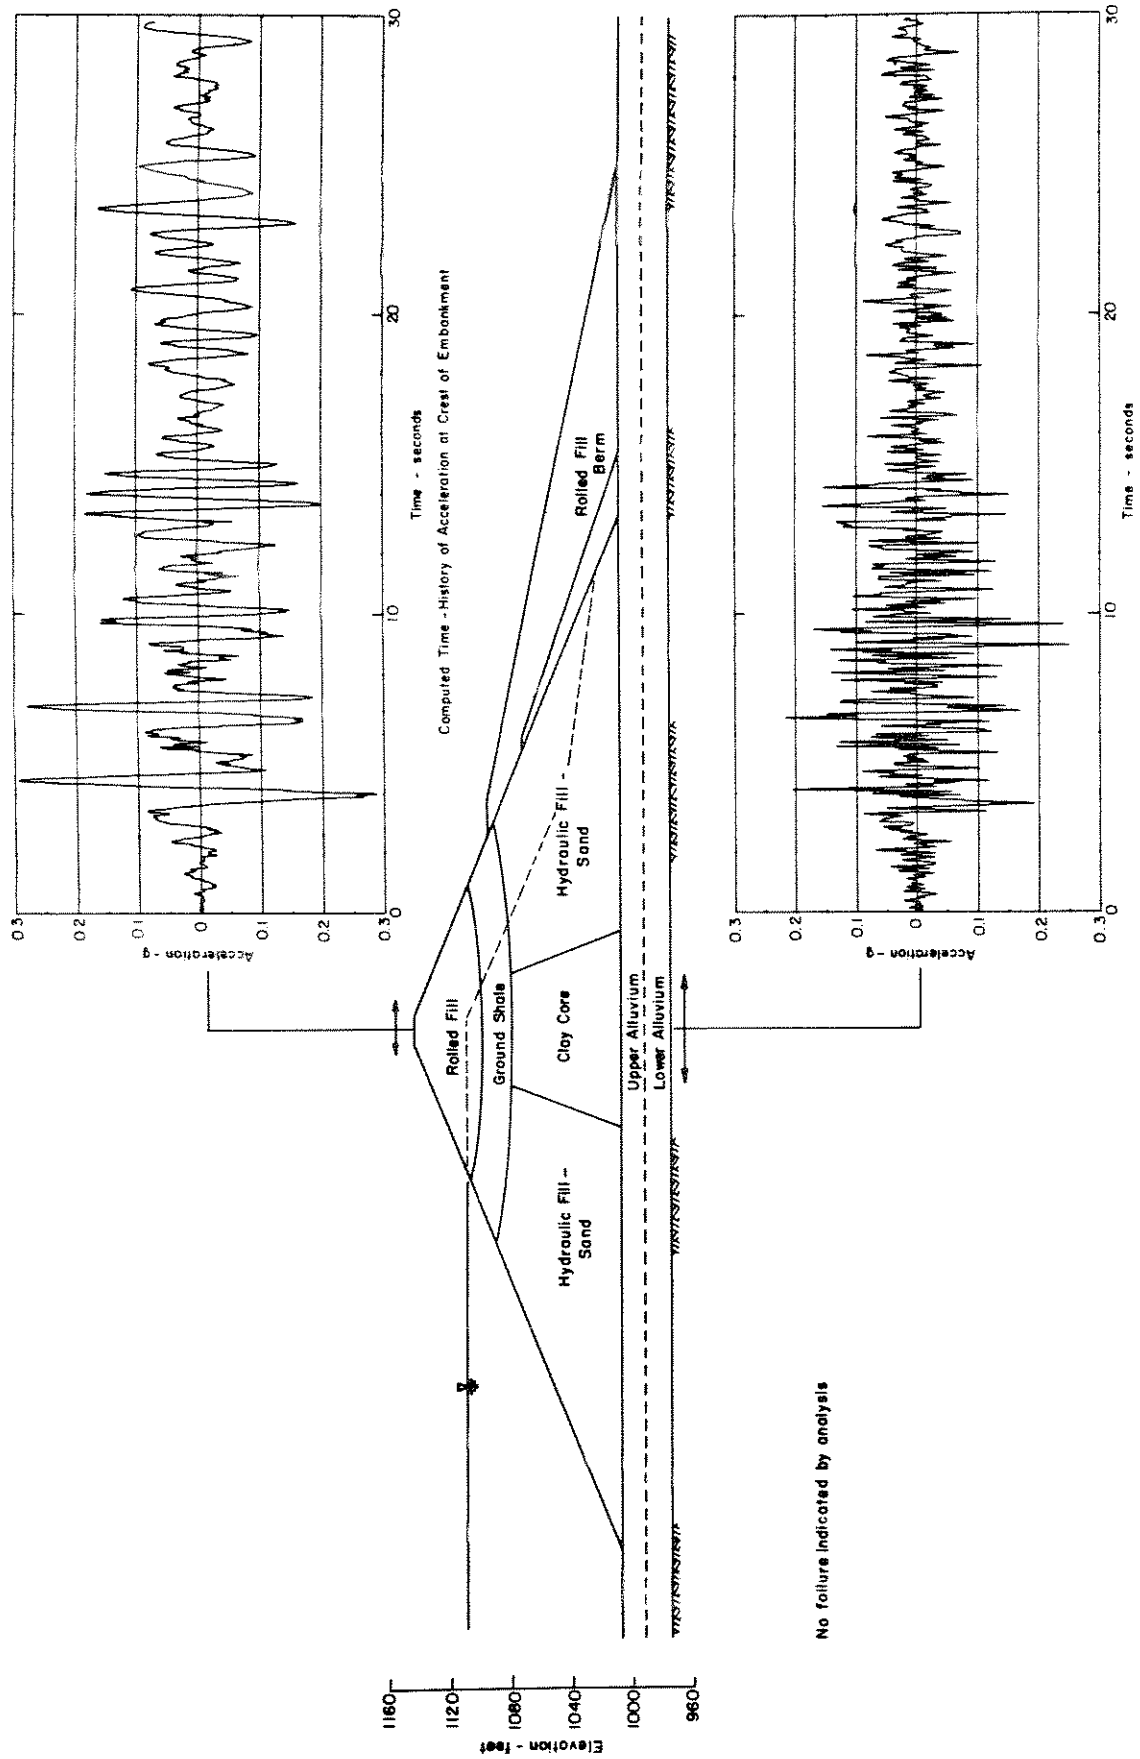
Fig. X-3 ANALYSIS OF RESPONSE OF LOWER DAM FOR MAGNITUDE 7 EARTHQUAKE ON SAN ANDREAS FAULT

The results of an analysis of the stability of the Lower Dam for a magnitude 7 earthquake occurring on the San Andreas fault are shown in Fig. X-3. The motions in the rock produced by such an earthquake were considered to have a maximum acceleration of about 0.2g, a duration of strong shaking of about 25 seconds and a time-history similar to that recorded at Taft in the Kern County earthquake of 1952. The resulting time history of such motions used in the analysis is shown in the lower part of Fig. X-3.

The computed accelerations at the crest of the dam are also shown in the figure but in this case, analysis of the stresses induced in the embankment did not indicate any zone where liquefaction would occur.

Accordingly it is concluded that the Lower Dam would have been able to withstand the shaking produced by such an earthquake without any significant detrimental effects.

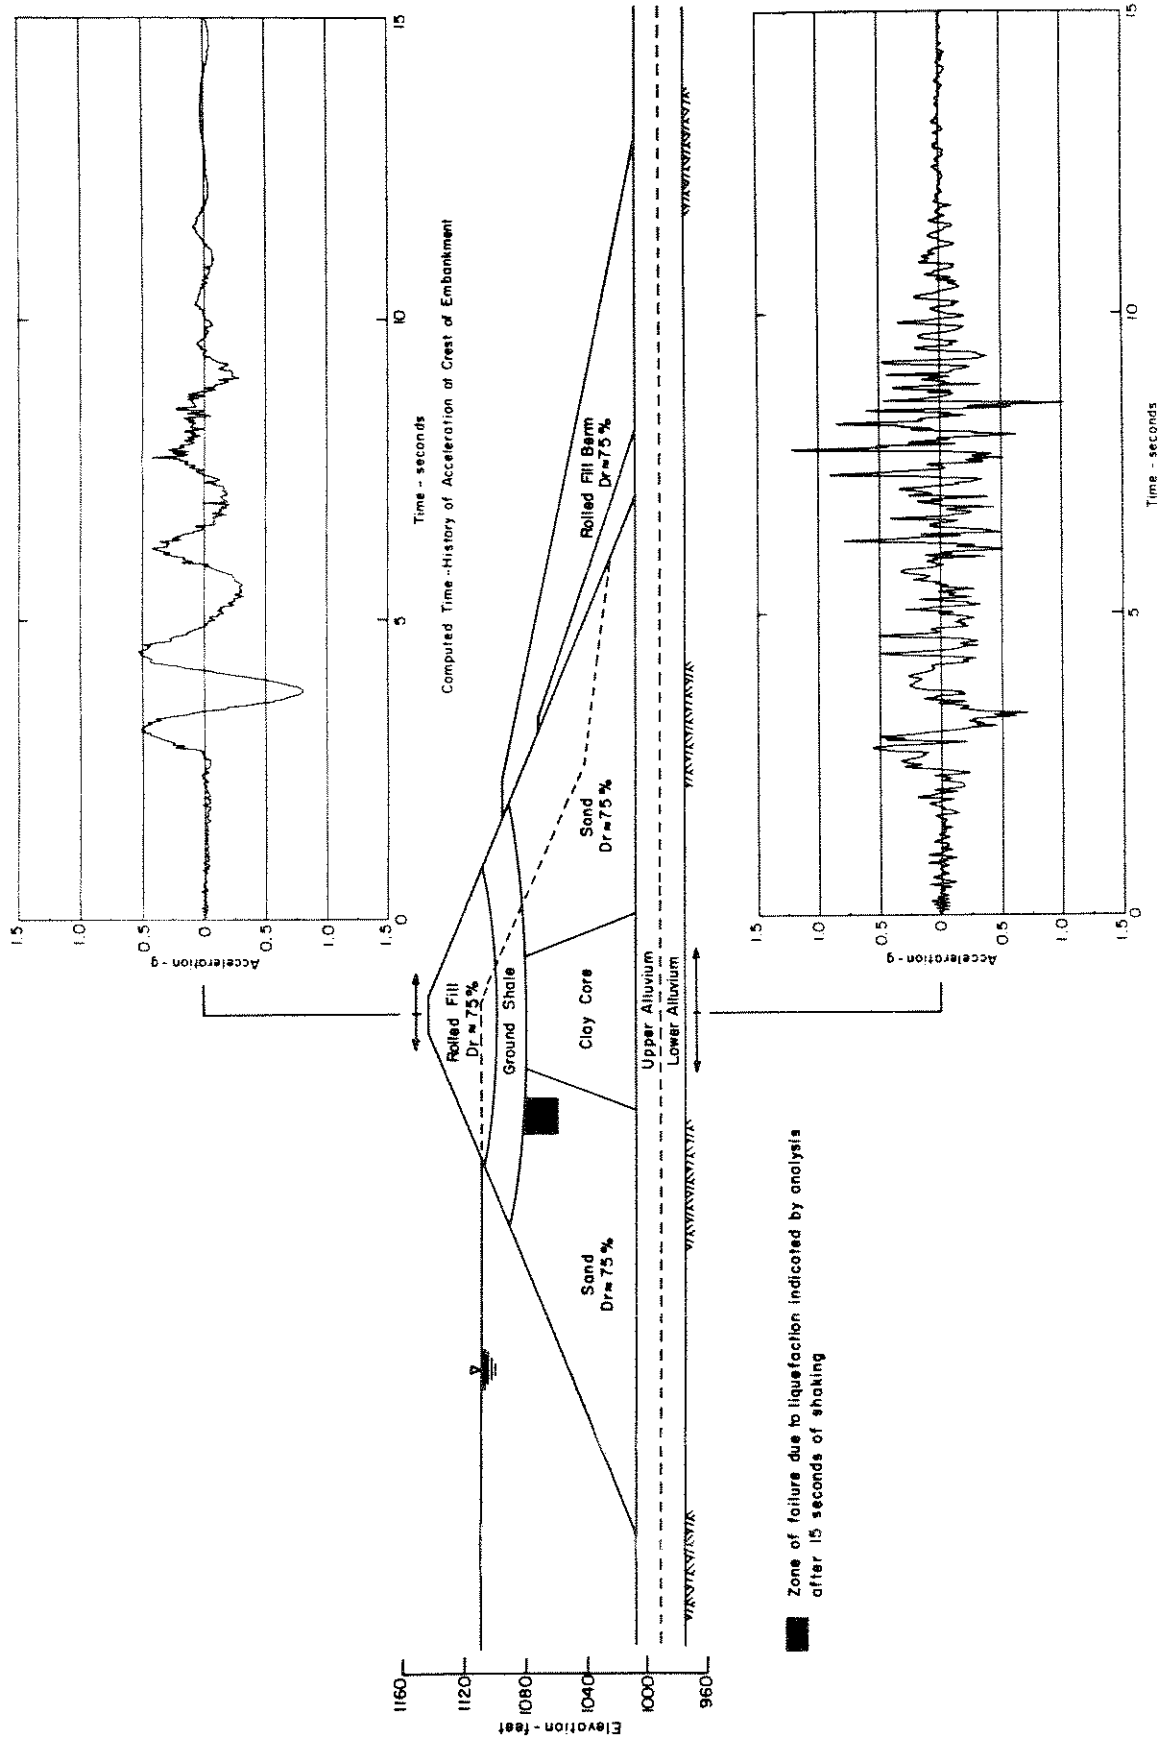
Fig. X-4 ANALYSIS OF RESPONSE OF DAM TO BASE MOTIONS DETERMINED FROM PACOIMA RECORD

With these assumptions an analysis of embankment stability was made as before. The time history of accelerations in the base rock is shown in the lower part of Fig. X-4, and the computed time history of accelerations at the crest of the embankment in the upper part of the figure. It may be seen that although the base motions have a maximum acceleration of 1.25g, the maximum crest acceleration is only about 0.8g and furthermore the maximum crest acceleration occurs well before the maximum base rock acceleration is reached. Thus in fact, the maximum response in the embankment is independent of the maximum acceleration pulse in the base motion.

Analyzing the failure potential of different elements in the embankment as described in Part VIII leads to the zones of failure after 15 seconds shown in Fig. X-4. The extent of those zones is insufficient to cause any significant degree of progressive failure of the embankment and thus it seems likely that an embankment constructed primarily of sandy material with a relative density of about 80 percent would be able to withstand safely the strongest earthquake motion recorded to date. However the Pacoima Dam record is not necessarily the most damaging motion which would affect a dam and further studies for other motions are required before general conclusions concerning embankment dam stability during earthquakes can be drawn.

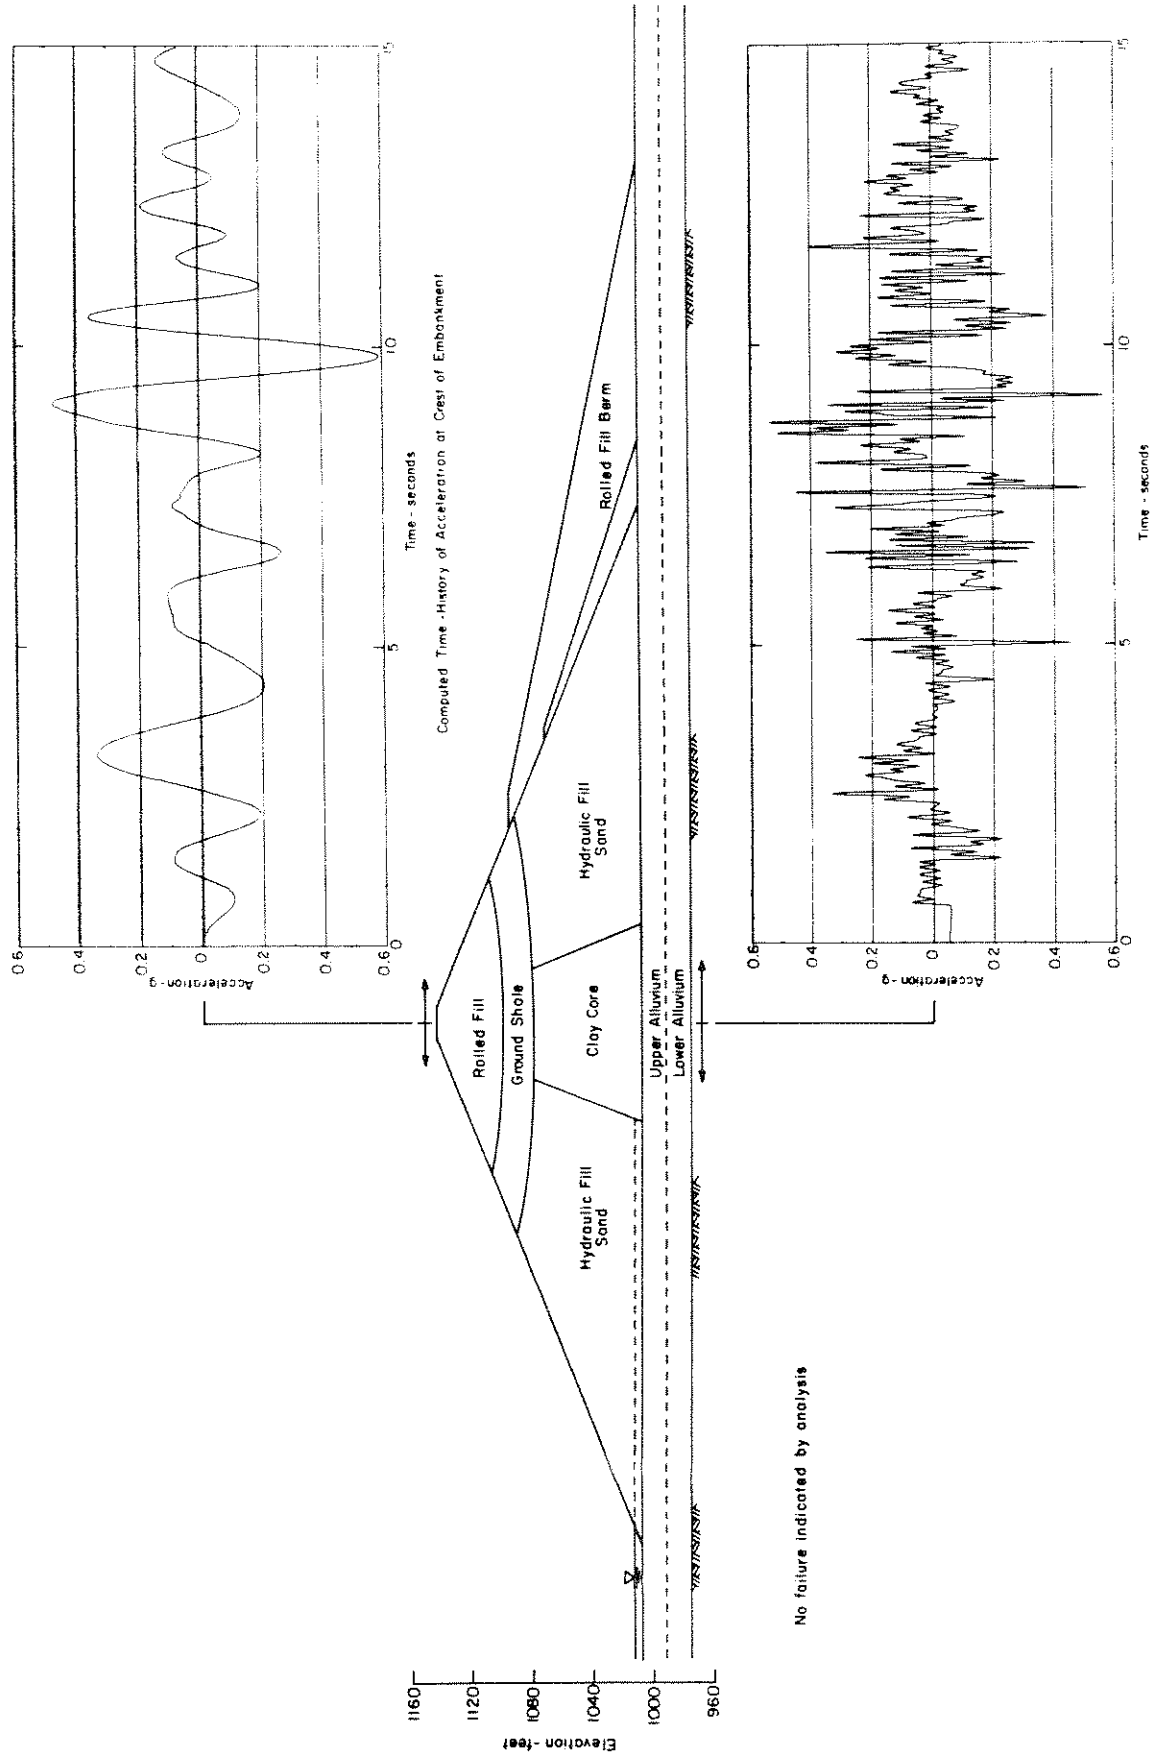
Fig. X1-1 ANALYSIS OF RESPONSE OF LOWER DAM WITH RESERVOIR ALMOST EMPTY TO BASE MOTIONS DETERMINED FROM SEISMOSCOPE RECORD.

The results of an analysis of embankment stability under these conditions, for the base rock motions represented by Scott's interpretation of the abutment seismoscope record are presented in Fig. XI-1. The maximum acceleration at the base of the embankment was about 0.6g and the computed maximum acceleration at the crest was about the same (see acceleration time histories in Fig. XI-1). However analysis of the stability of elements

within the embankment showed that none would reach a condition of 5 percent strain or liquefaction.

Thus the analysis indicates that the embankment would have been stable under these conditions, a conclusion confirmed to some extent by the performance of the Dry Canyon Dam in this earthquake. Dry Canyon Dam was located at about the same distance from the zone of energy release as the Lower San Fernando Dam. However it had no water in the reservoir and it suffered no significant damage, thereby demonstrating that hydraulic fills, per se, are not necessarily vulnerable to earthquake shaking; further it is the combination of the initial soil conditions, the pre-earthquake effective stress conditions and the dynamic stresses induced by the earthquake which determine the embankment stability. A significant change in any of these factors can materially affect the failure potential of an earth dam.
