REPORT NO.
EERC 73-2
June 1973

ANALYSIS OF THE SLIDES IN THE SAN FERNANDO DAMS DURING THE EARTHQUAKE OF FEB. 9, 1971

H. BOLTON SEED
K. L. LEE
I. M. IDRIS
F. MAKDISI

State of California Department of Water Resources
Los Angeles Department of Water and Power
National Science Foundation

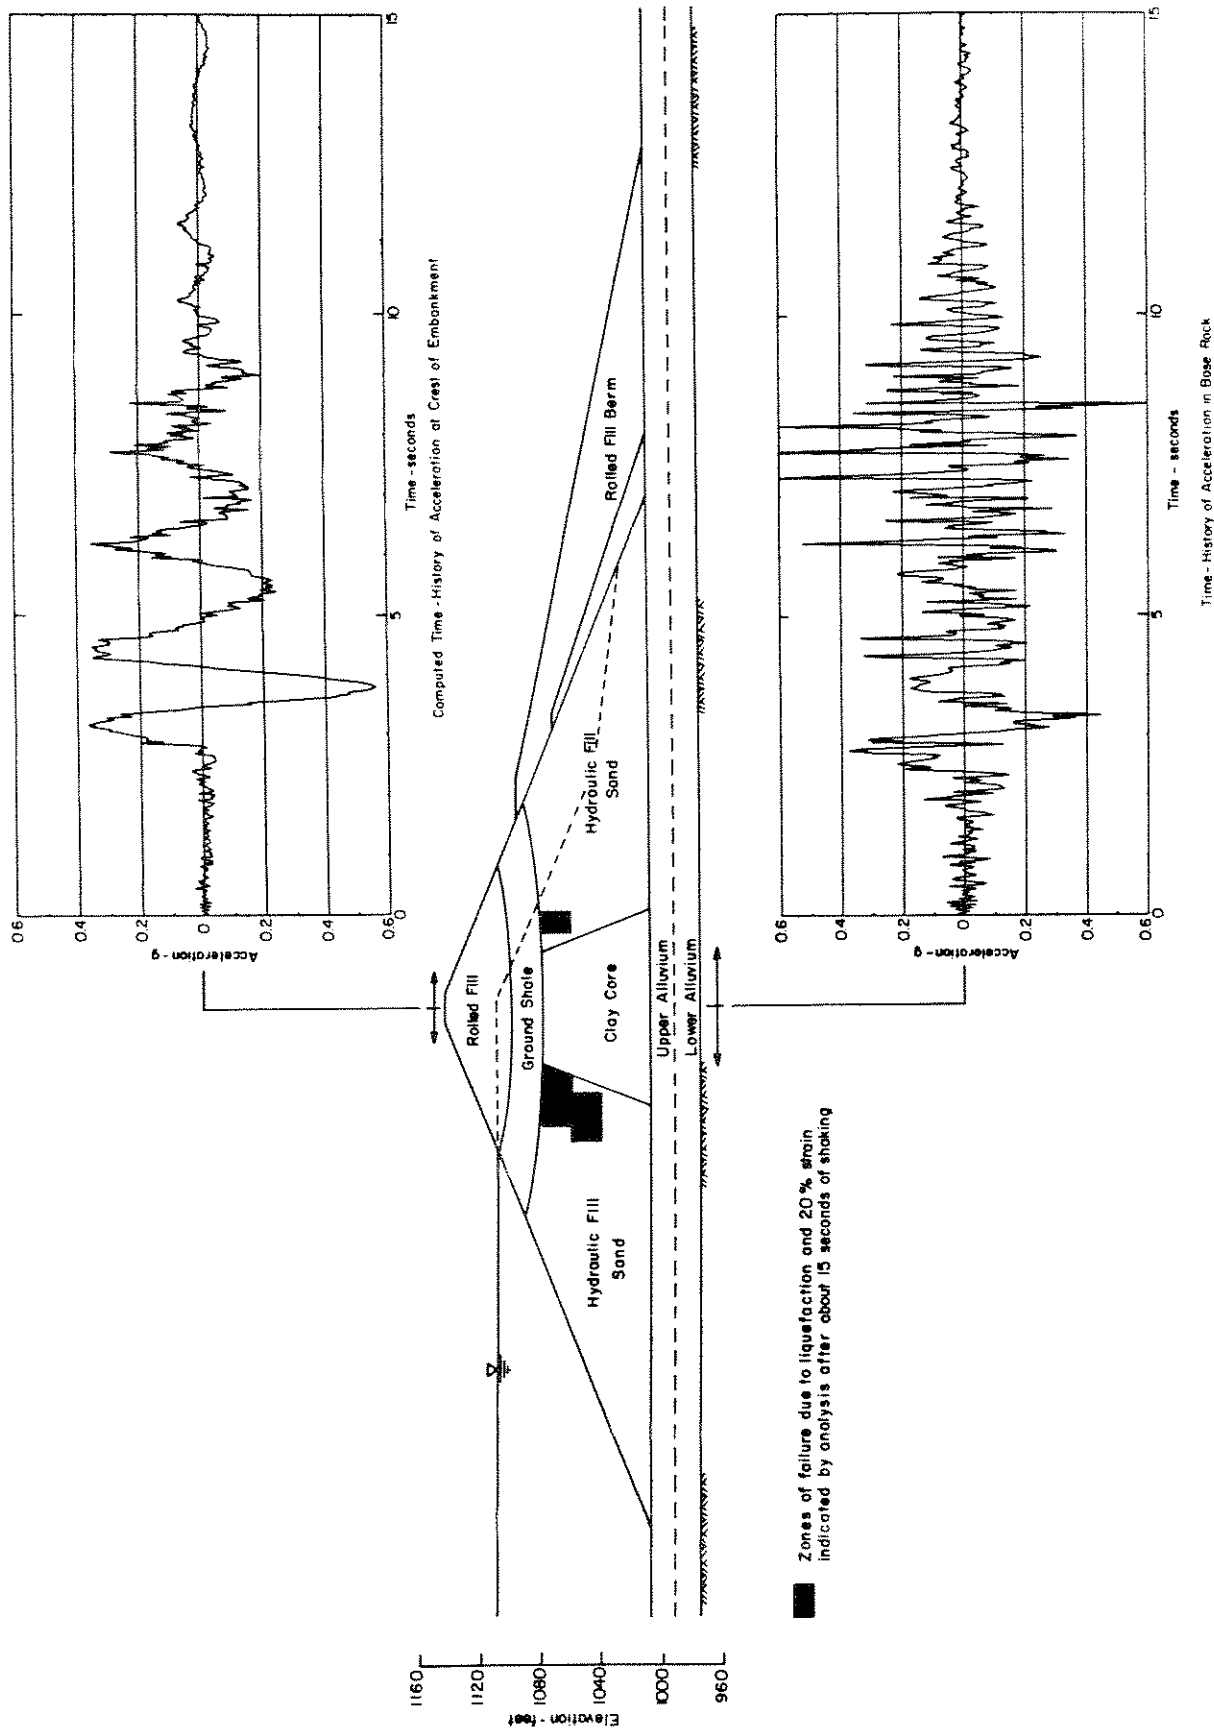
Fig. XI-2 ANALYSIS OF RESPONSE OF LOWER DAM DURING SAN FERNANDO EARTHQUAKE TO BASE MOTIONS DETERMINED FROM MODIFIED PACOIMA RECORD; FAILURE DEFINED BY LIQUEFACTION AND 20% STRAIN.

Accordingly a new analysis was made to compare the stresses induced in the embankment by the earthquake with those causing liquefaction and 20 percent strain determined in this way. The zones in which 20 percent strain would develop, as indicated by this analysis, are shown in Fig. XI-2. The limited extent of these zones might be considered indicative of adequate performance if the real behavior of the upstream slope had not been known.

Accordingly the use of higher strain criteria, without consideration of the possible effects of progressive failure, may lead to incorrect assessments of embankment performance under some conditions. In particular this study would seem to indicate the care required in interpreting the results of cyclic load tests for use in evaluations of embankment stability during earthquakes.
