Technical Evaluation of the Gold King Mine Incident

San Juan County, Colorado

U.S. Department of the Interior
Bureau of Reclamation
Technical Service Center
Denver, Colorado

October 2015

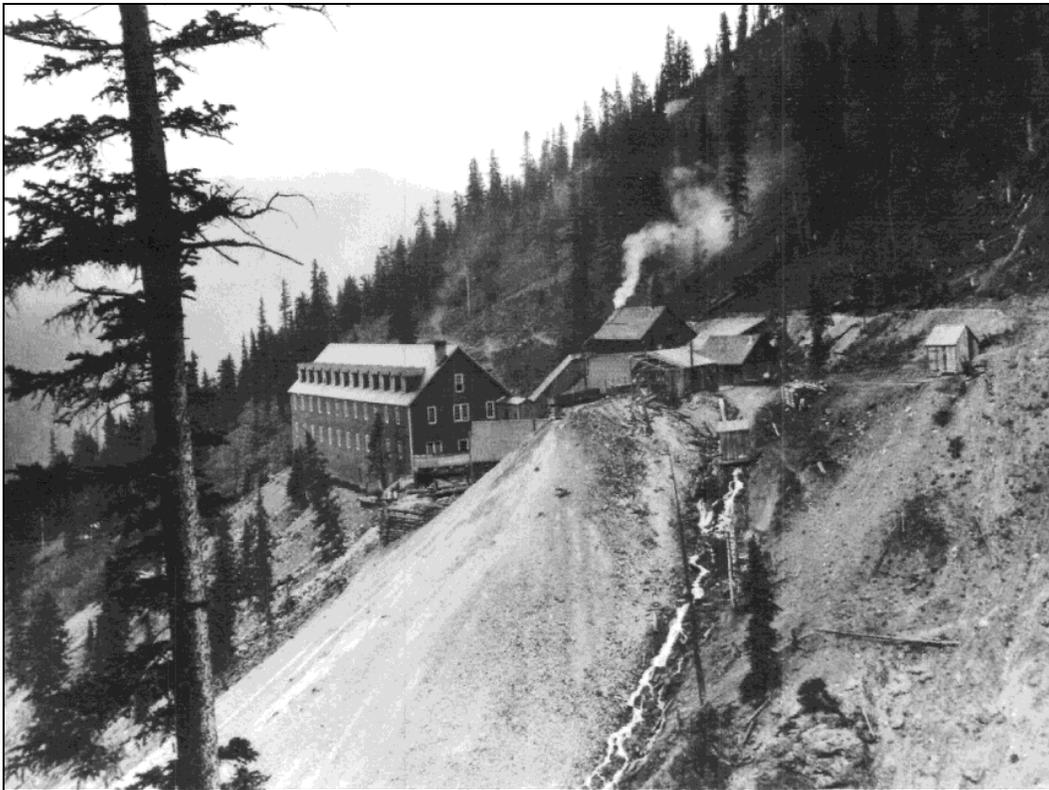
Figure 5.—Historical photograph of the Gold King Mine Level 7 taken prior to the mine closing in 1923. Note the drainage flow down the side of the waste-rock dump.

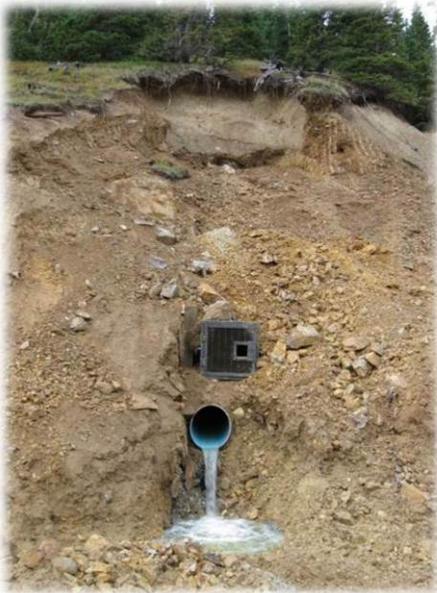
Gold King Level 7 Old Portal Closure

Both Level Seven portals were partially collapsed prior to backfilling in 2009. The Level Seven New Portal required additional fill to remove the unstable fifteen feet of continually collapsing timbered area that remained in front of the complete portal collapse from fifteen feet on. The Level Seven Old Portal also required additional closure in front of the complete portal collapse from thirty feet on. An observation pipe and drainage pipe were placed in the Level Seven Old Portal, but during filling around the pipes, the timbers in the portal collapsed and loose colluvial material completely covered the observation and drainage pipes. The drainage pipe continues to drain at roughly 200 gallons per minute, at the same flow rate as before the collapse. The observation pipe was meant to provide stable access to view the collapse at thirty feet, allowing the landowner and the DRMS to monitor this unstable draining adit, which is arguably one of the worst high quantity, poor water quality draining mines in the State of Colorado. Because of the collapse, DRMS decided to install a well point, driven into the collapse, through the drainage pipe, in an attempt to alleviate concerns about an unstable increase in mine pool head within the Gold King workings. The installed 6 inch perforated steel pipe penetrated approximately 12 feet of collapsed material thought to exist between the original collapse and the end of the drain pipe. The well point was unable to penetrate through any of the original existing collapse in the tunnel.

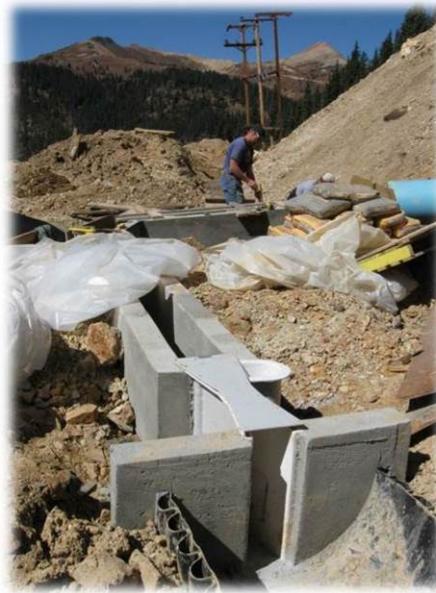
Gold King Level 7 Old Portal with 2" Parshall Flume Installed in Concrete Lined Ditch

A flume was installed at the Level Seven Old Portal as part of the bond revocation reclamation. The two inch Parshall Flume was installed in a concrete lined ditch immediately in front of the HDPE lined ditch. The flume will be used to monitor flow by the landowner and the Animas River Stakeholders Group (ARSG).

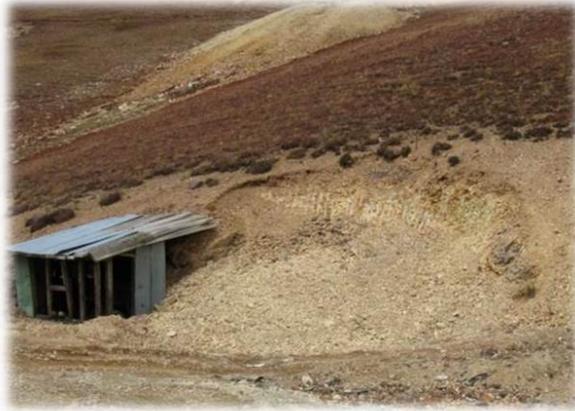
Number 1 Portal backfilled

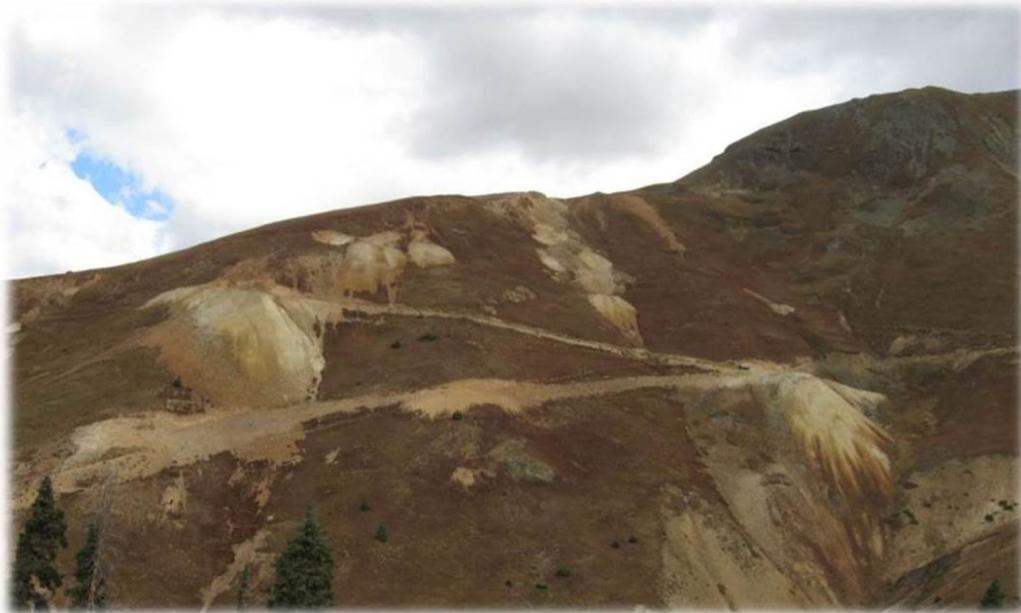
Sampson Portal, Drill Road, and Number 1 Portal as viewed from access road after reclamation. Drill Road has been re-contoured and revegetated in this photo.

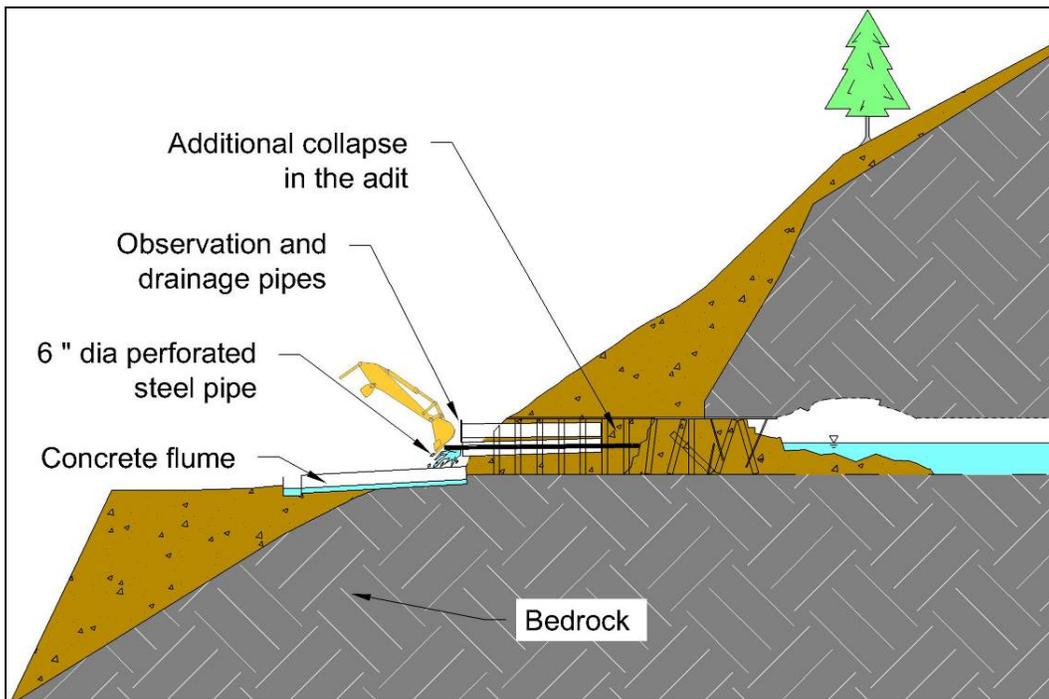
The DRMS stated in the project summary, “A future project at the site may attempt to cooperatively open the Level 7 Old Portal in an effort to alleviate the potential for an unstable increase in mine pool head within the Gold King workings.” Essentially, the closure did not provide adequate drainage and had the potential to blowout.

Figure 21.—Cross-section showing the installation of pipes by DRMS at the Gold King Mine Level 7 New Adit in 2009 (water level as assumed by DRMS) (not to scale).

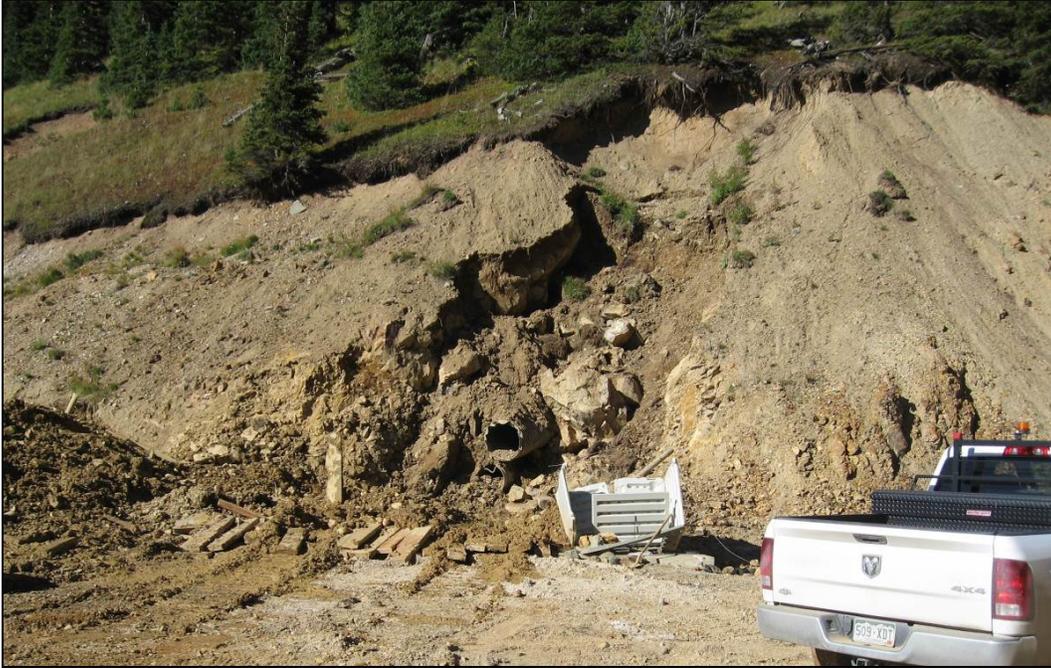
On September 11, 2014, excavations were performed to remove the metal grating and portions of the two pipes installed in 2009. As the excavation progressed down through the fill, seepage appeared (figures 25 through 27). The work stopped when EPA, DRMS, and others observed that in addition to the seepage from the base of the fill, additional seepage was now flowing from higher up on the face of the backfill. Because the excavation had a lip, the seepage ponded at a level equivalent in elevation to about 4 feet below the top of the adit. It was reportedly concluded by those onsite that there was 6 feet of water impounded in the mine (Way, 2014b). A small settling pond was installed at the base of the waste-rock dump to remove sediment from the mine water. The pond was not large enough to treat and settle what was believed to be 6 feet of impounded water. Therefore, the project was put on hold until the following year.

Figure 25.—Photograph showing excavation of the Gold King Mine New Adit portal on September 11, 2014. The metal grating and portions of the upper corrugated HDPE pipe and the lower solid-wall drain pipe have been removed (photograph from EPA project files).

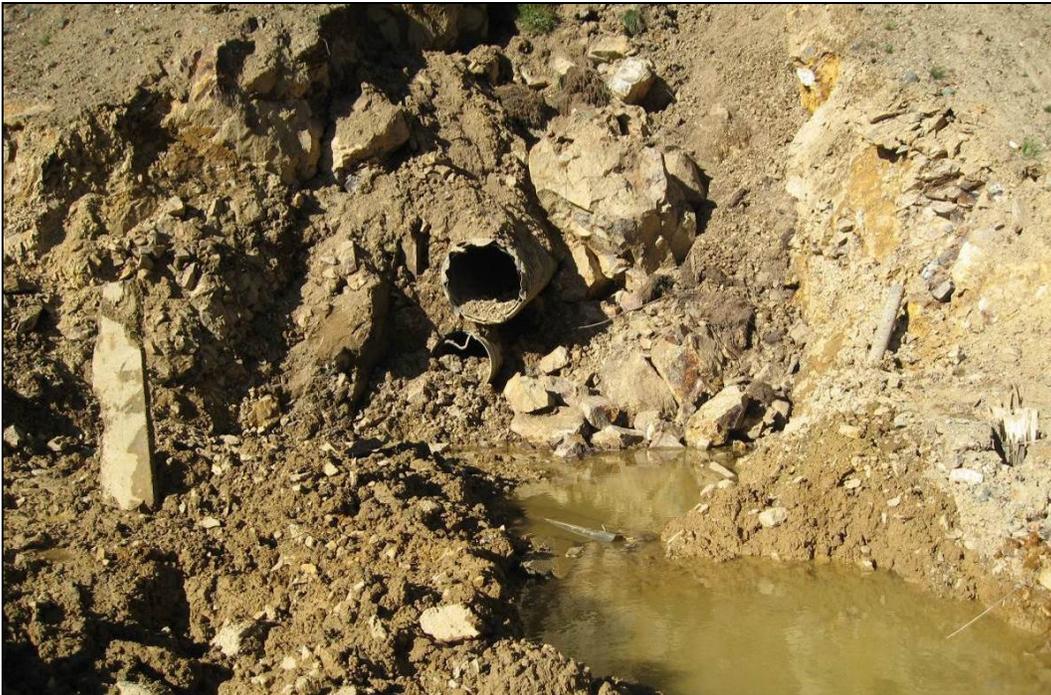
Figure 26.—Photograph showing the excavation of the Gold King Mine New Adit portal on September 11, 2014, taken shortly after the photograph in figure 23 (photograph from EPA project files).

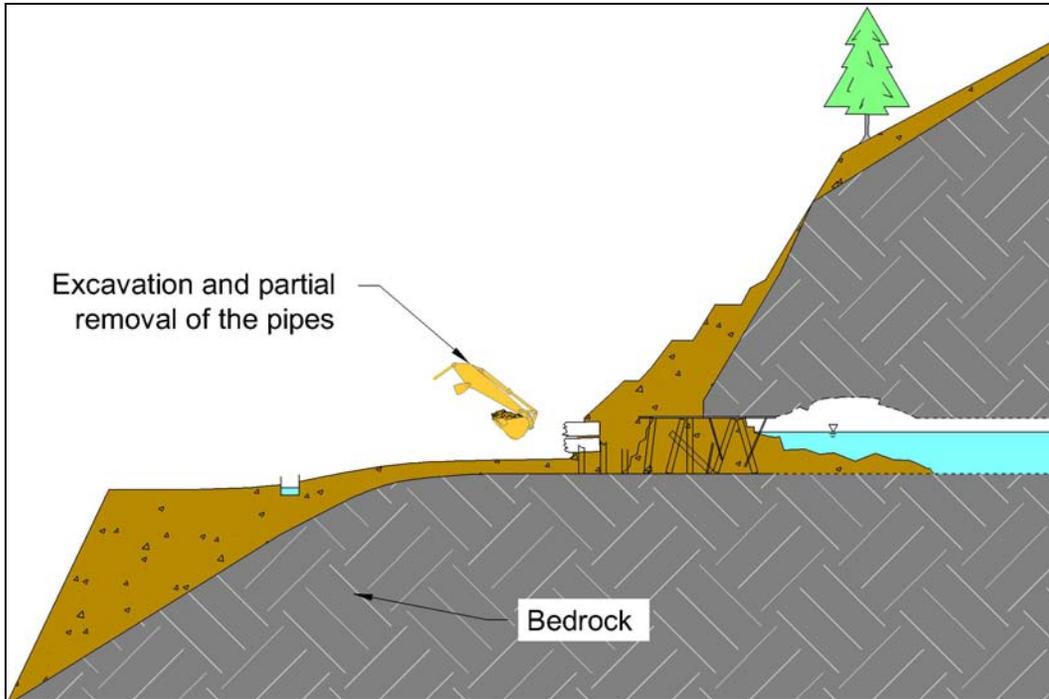
Figure 27.—Cross-section showing the condition of the Gold King Mine New Adit in 2014 (water level as assumed by EPA and DRMS) after the excavation shown in figure 23 was complete (not to scale).

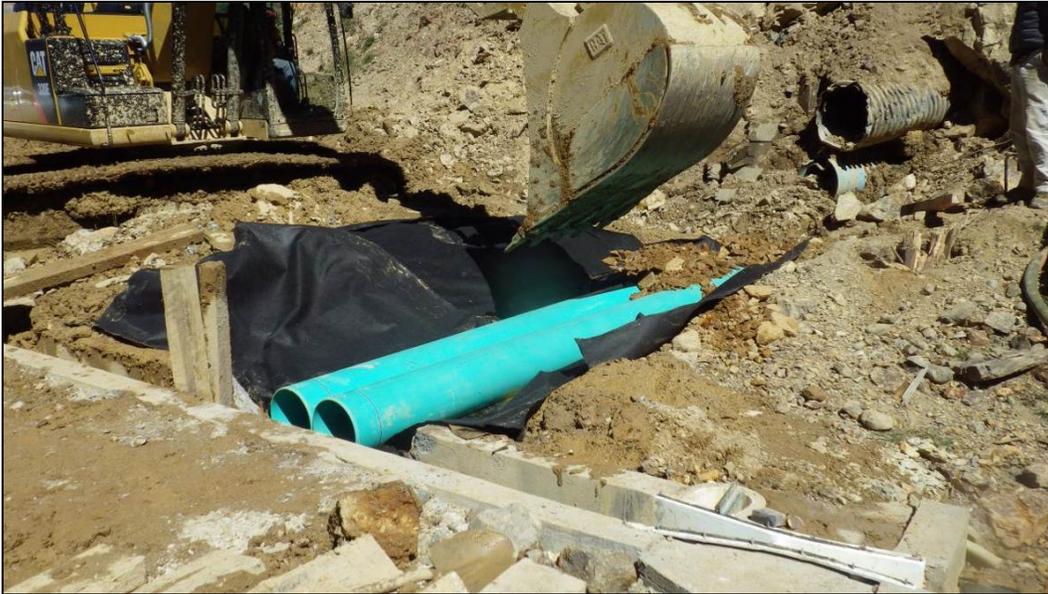
Because they had torn out most of the drain and observation pipes installed by DRMS in 2009, EPA decided to install two new drain pipes surrounded by gravel and a geotextile as a temporary measure. The new pipes were laid at a different angle than the 2009 installation. The side of the concrete trough had to be cut open to accommodate the new drain pipes (figure 28).

Figure 28.—Photograph taken on September 11, 2014, showing the installation of two new 2-foot-diameter drainage pipes. An entrance slot has been cut into the concrete trough for the pipes to discharge into (photograph from EPA project files).

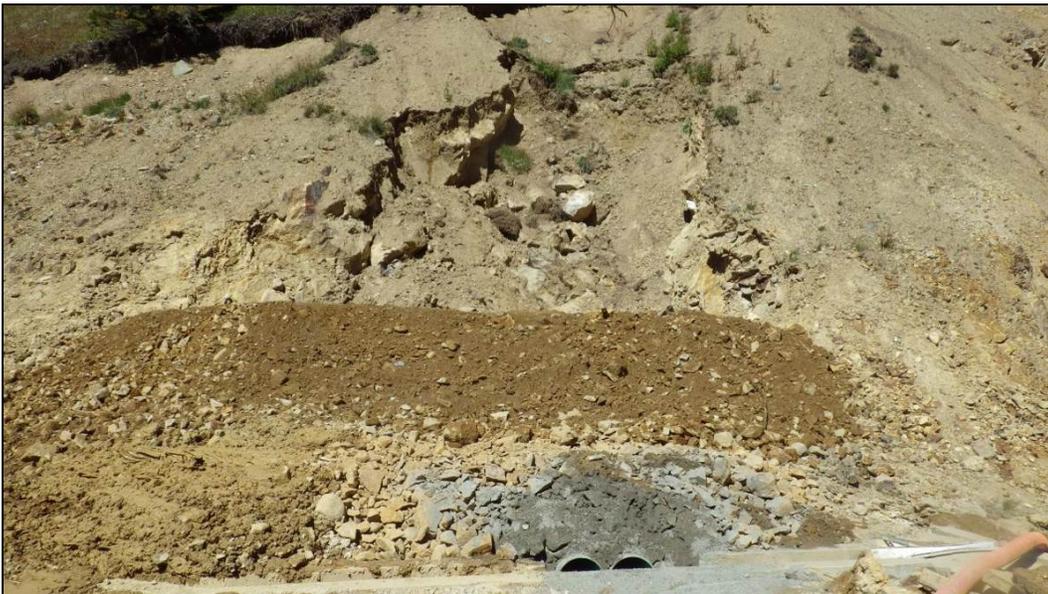
The pipes were covered with gravel. The geotextile was wrapped around the gravel to prevent infiltration of backfill to maintain a pervious zone around the pipes. The geotextile was then covered with backfill. In order to prevent erosion of the backfill soil into the concrete trough, a layer of fast setting concrete was placed over the backfill slope adjacent to the trough (figures 29 and 30).

Figure 29.—Gold King Mine Level 7 New Adit as it appeared on September 12, 2014, when EPA completed placing backfill over the two new drain pipes. Note that a steep slope was left in place in the mountainside above the drain pipe installation (photograph from EPA project files).

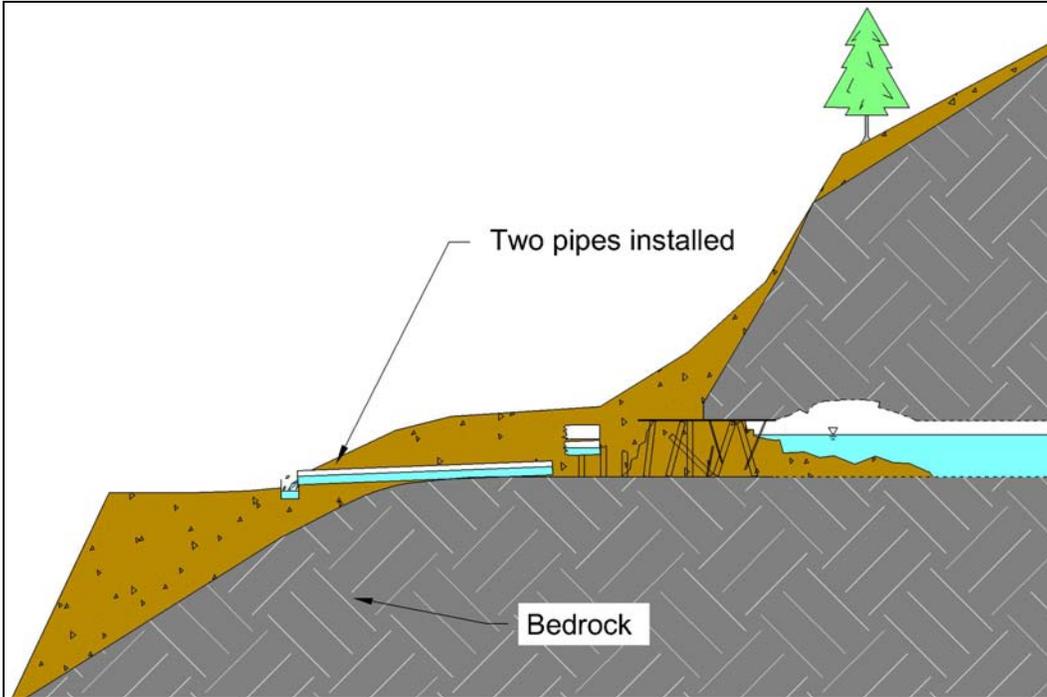
Figure 30.—Cross-section showing the condition of the Gold King Mine Level 7 New Adit in 2014 (water level as assumed by EPA and DRMS), after the installation of the two drain pipes and backfill cover (not to scale).

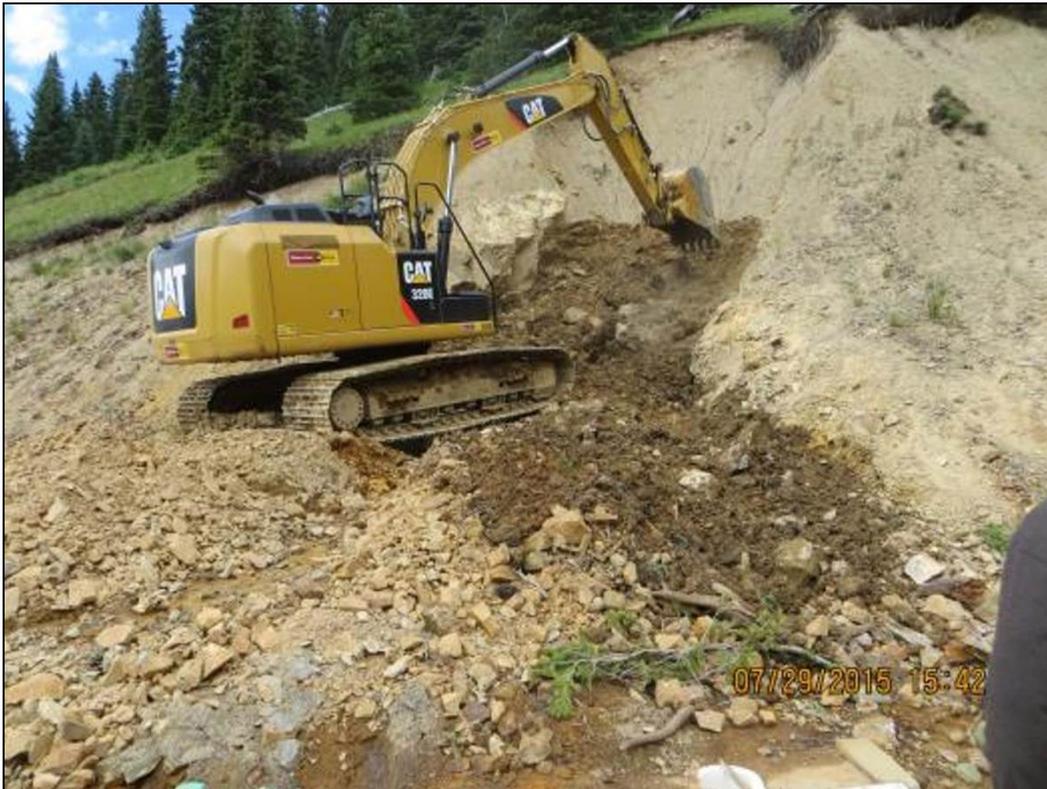
On July 29, 2015, some of the debris that had sluffed down over the winter was excavated from the portal area, and the ends of the pipes were exposed (figure 36). On July 31, 2015, work was begun putting together a manifold piping system that could be used to provide water filtration for the anticipated pump-down of the Gold King Mine.

Figure 36.—Photograph taken on July 29, 2015, showing initial excavation work at the Gold King Mine Level 7 New Adit that was performed to remove the additional accumulation of debris from the eroding slope above the adit (photograph from EPA project files).

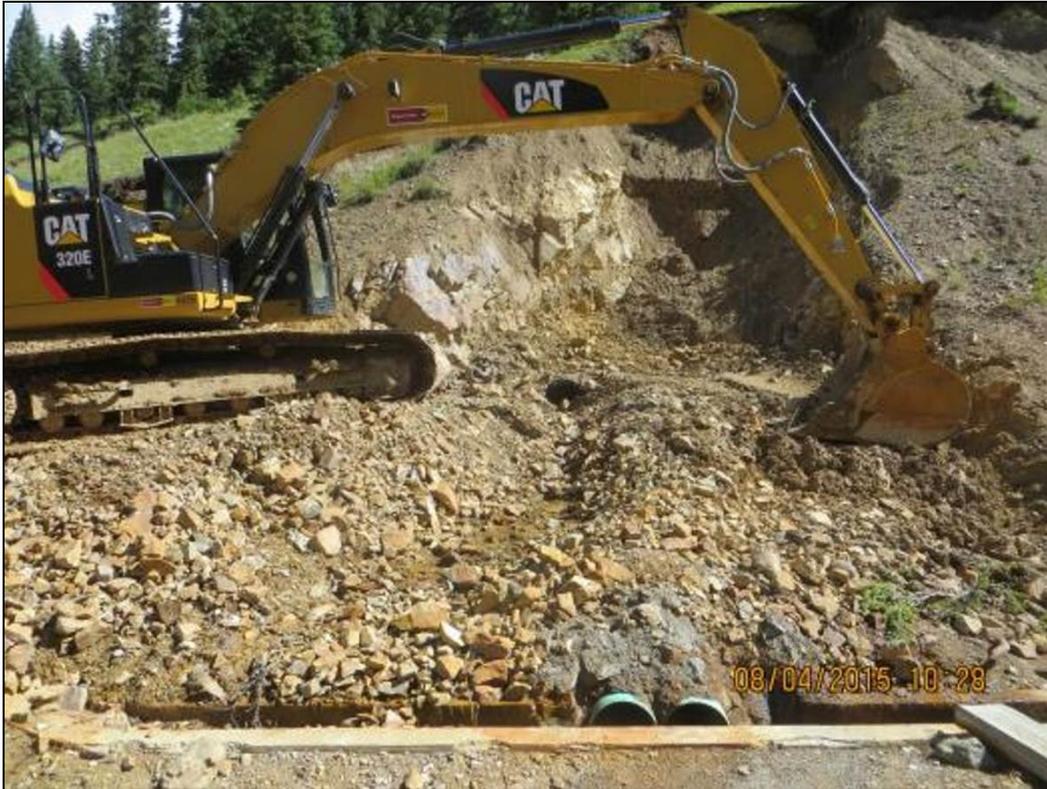
On August 4, 2015, a representative from DRMS was onsite and viewed conditions at the adit. EPA began excavation to examine conditions close to the mine opening similar to what had been done in 2014 (figure 37).

Figure 37.—Photograph showing additional excavation at the Gold King Mine Level 7 New Adit at 10:28 a.m. August 4, 2015 (photograph from EPA project files).

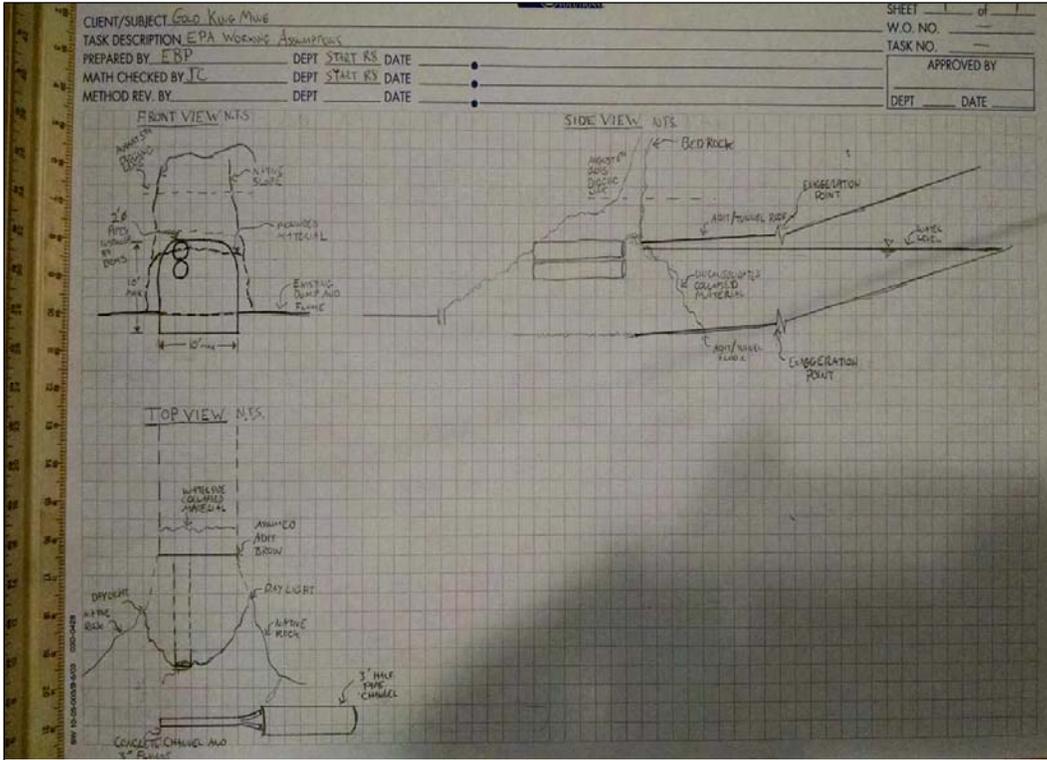
Figure 39 shows a sketch of the plan to open the Gold King Mine Level 7 New Adit portal. To provide a margin of safety, the plan assumes the water was more than 5 feet deep on the upstream side of the blockage, but still below the adit roof.

Figure 39.—Photograph showing the sketch used by EPA to illustrate the conditions at the Gold King Mine Level 7 New Adit portal (photograph from EPA project files).

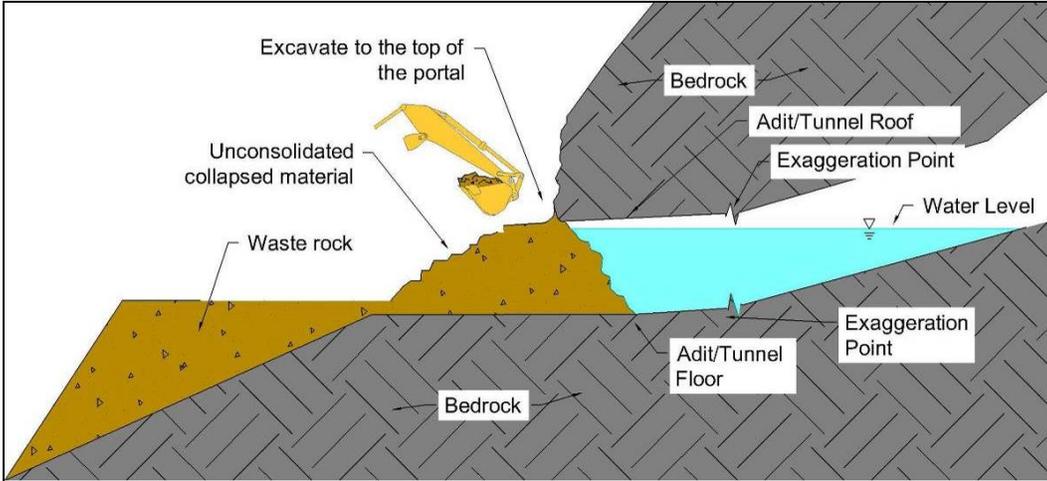
A key aspect of their plan was to only excavate fill lying above the assumed top of the water inside the adit. This method would leave in place the fill holding back the water (figure 41). The next step would push a steel pipe called a “stinger” through the top of the fill to gain access to the mine pool (figures 42 and 43).

Figure 41.—Cross-section illustration showing step 1, the initial excavation to remove the drain pipes and backfill and then carefully excavate the collapsed material to expose the bedrock in the slope above the adit (not to scale).

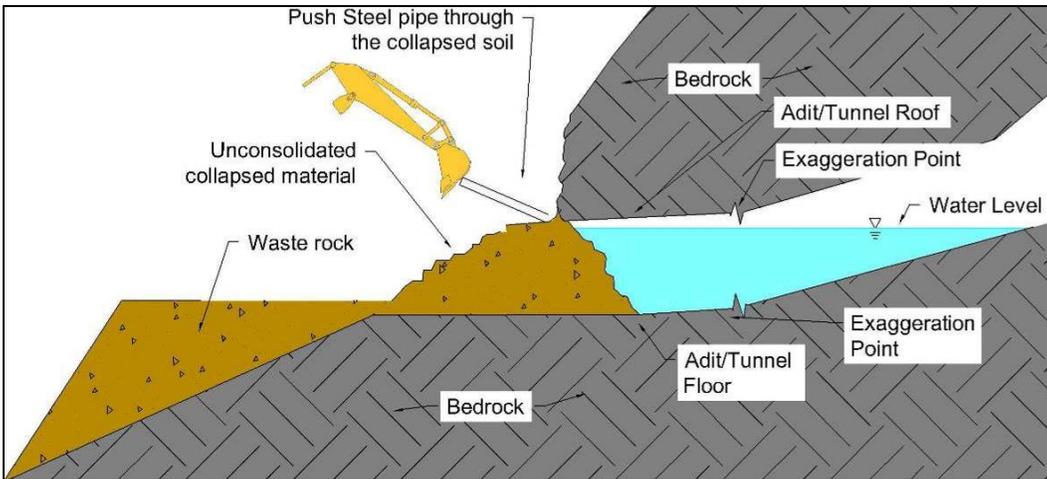
Figure 42.—Cross-section illustration showing step 2 of the plan (not to scale). With the bedrock above the crown of the adit exposed as a guide, a steel pipe called a “stinger” is positioned and pushed into the fill using the bucket of the hydraulic excavator.

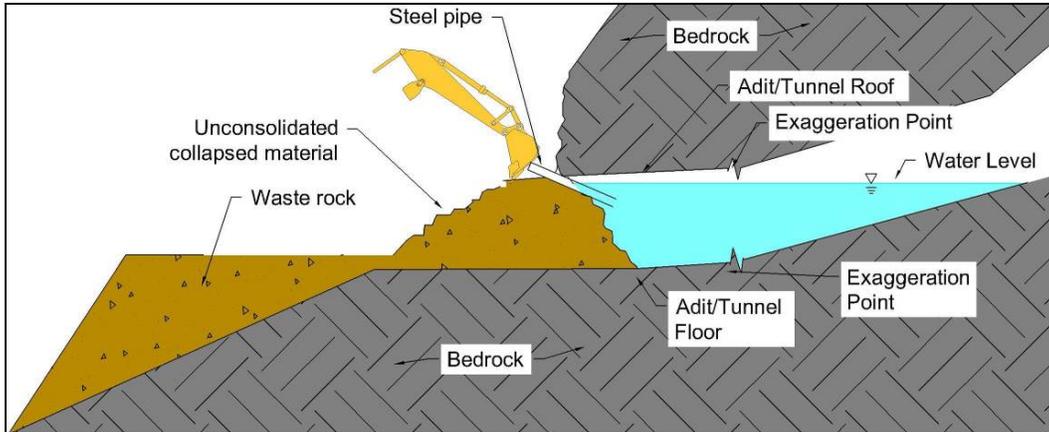
Figure 43.—Cross-section illustration showing step 3 of the plan (not to scale). With the steel pipe fully inserted, contact is made with the water impounded inside the mine.

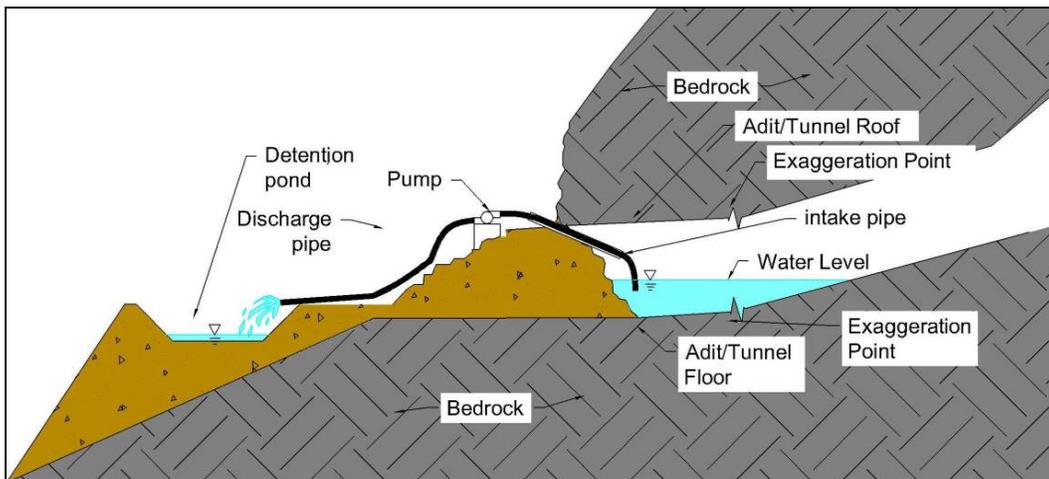
Figure 44.—Cross-section illustration showing step 4 of the plan (not to scale). An intake hose from a pump is inserted into the steel pipe. The pump discharge is taken to a small pond constructed on the waste rock dump. Water from the adit is pumped down. Not shown on this illustration is that the water in the small pond would be continuously removed by another pump and sent to treatment elsewhere on the site.

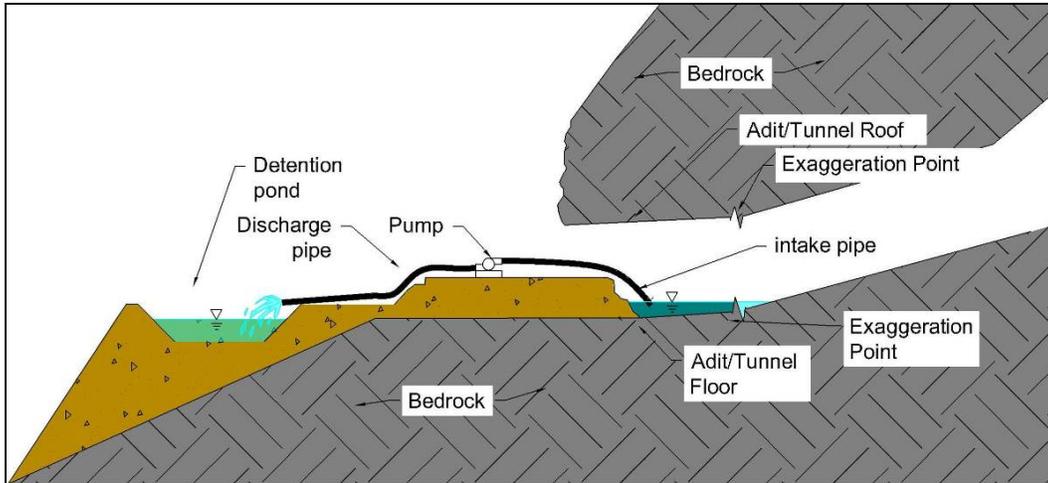
Figure 45.—Cross-section illustration showing step 5 of the plan (not to scale). As the water inside the mine is drawn down by pumping, additional fill from the blockage is excavated and the pump is repositioned to a lower level on the remaining fill. This step is repeated until all the impounded water and the remaining fill is removed; this will establish access to an open adit with the flow freely draining out.

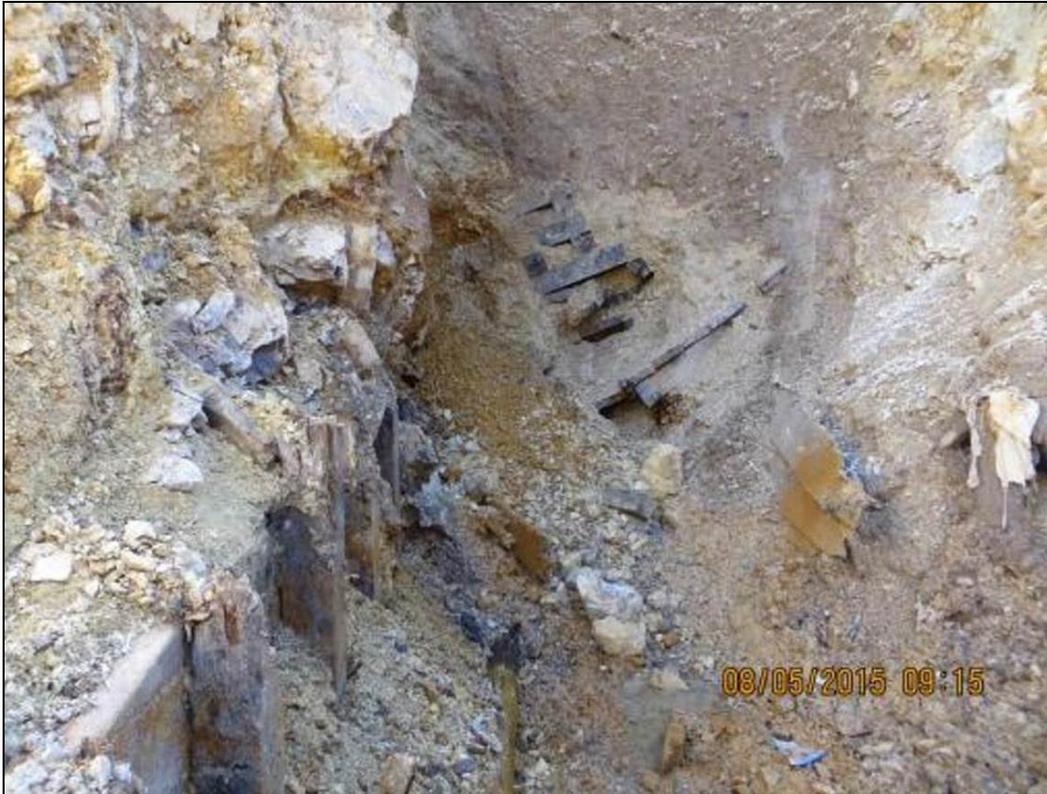
On the morning of August 5, 2015, a second DRMS abandoned mine specialist arrived at the site. The two DRMS specialists joined the EPA OSC to view conditions at the Gold King Mine Level 7 New Adit. The upper seepage appeared stable and was a few feet below the top of the timbers in the excavation as shown in figure 46. In a conversation with one of the DRMS specialists, it was stated that they believed the water inside the adit was below the crown (top) of the adit for the following reasons:

Figure 46.—Photograph taken at 9:15 a.m. August 5, 2015, showing the Gold King Mine Level 7 New Adit excavation uncovering mine timbers and lagging (photograph from EPA project files). Minor seepage is visible just to the left of the date stamp where a small puddle has formed. Note the soil in the upper end of the excavation above the timber lagging.

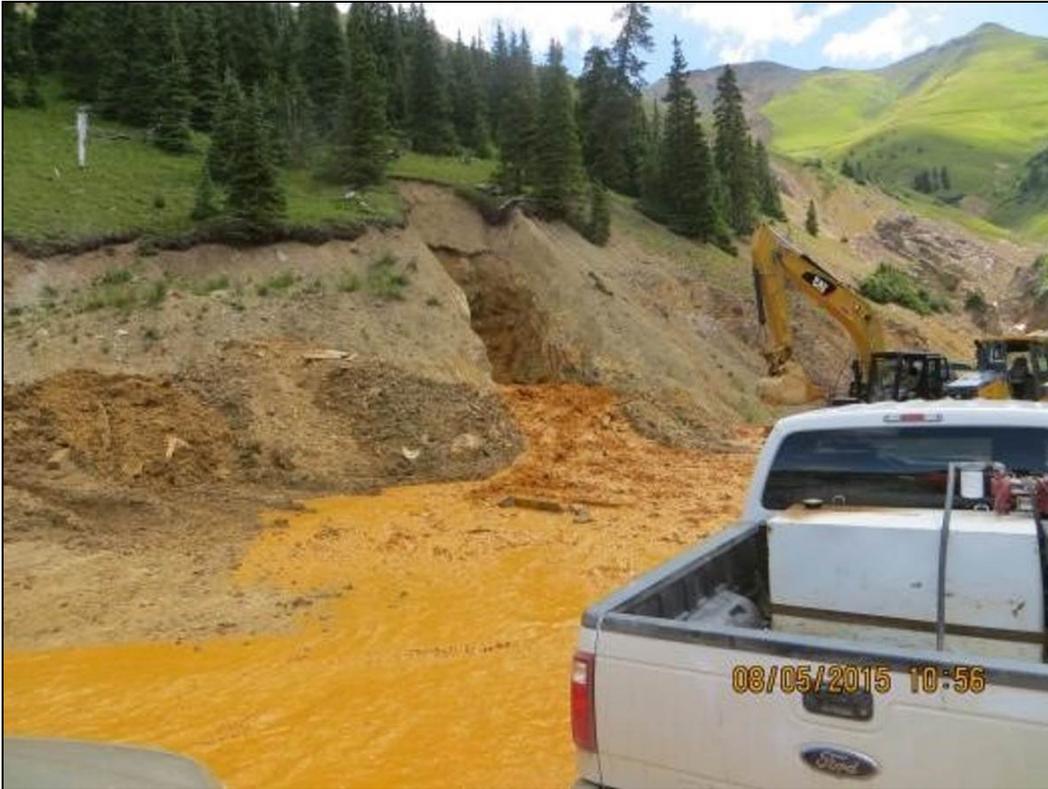
Figure 53.—Photograph showing the blowout at 10:56 a.m. on August 5, 2015 (photograph from EPA project files).

On August 5, 2015, the excavation by EPA shortened the seepage pathway through the soil. The spurt of water under pressure quickly changed in color, and the flow increased in volume. The pressurized flow had sufficient velocity to initiate internal erosion of the soil. The continued flow erosion rapidly enlarged the flow pathway resulting in the uncontrolled release of mine water. It is concluded that the failure mode was an excavation induced failure. The excavation shortened the seepage pathway through the soil initiating an internal erosion failure.

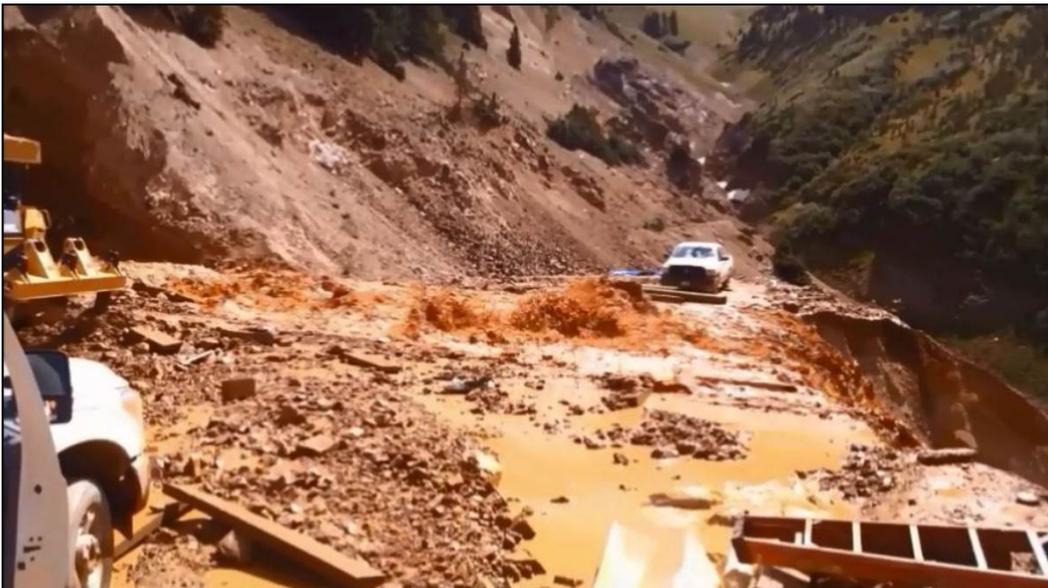
Figure 54.—Photograph showing the peak outflow from the blowout. The waste-rock dump is eroding on the right side of the photograph (still frame extracted from a video taken on August 5, 2015, at approximately 10:57 a.m.).

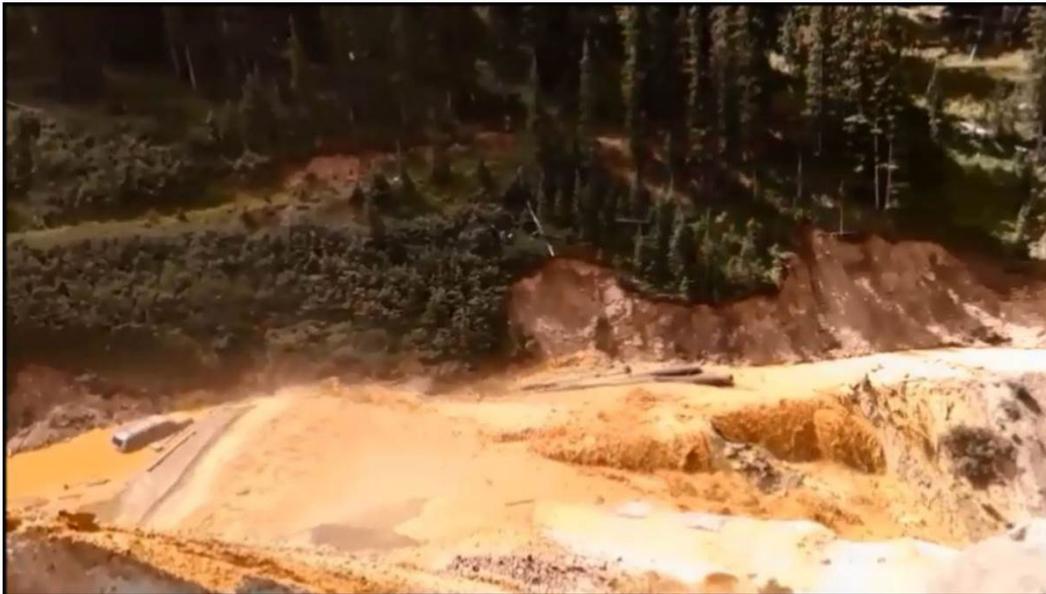
Figure 56.—Photograph showing at left, the inundation of a vehicle parked near the base of the waste-rock dump, and on the right water overwhelming the access road and cascading down into the North Fork of Cement Creek (still frame extracted from a video taken on August 5, 2015, at approximately 10:57 a.m.).

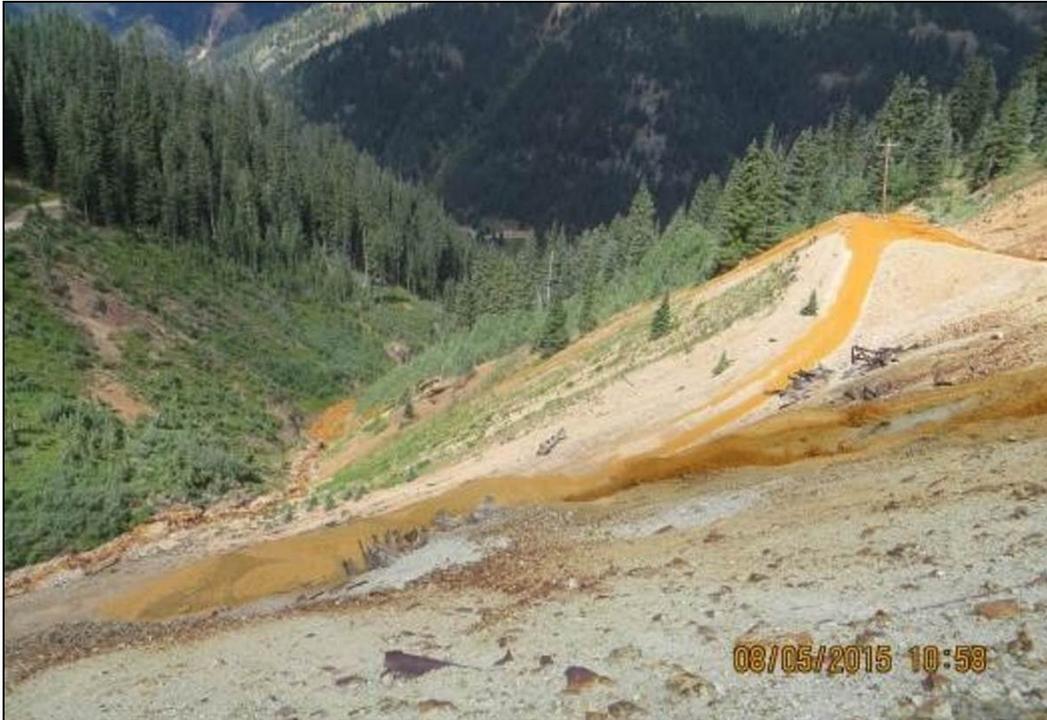
Figure 57.—Photograph showing a portion of the mine water flowing down the access road at 10:58 a.m. on August 5, 2015 (photograph from EPA project files).

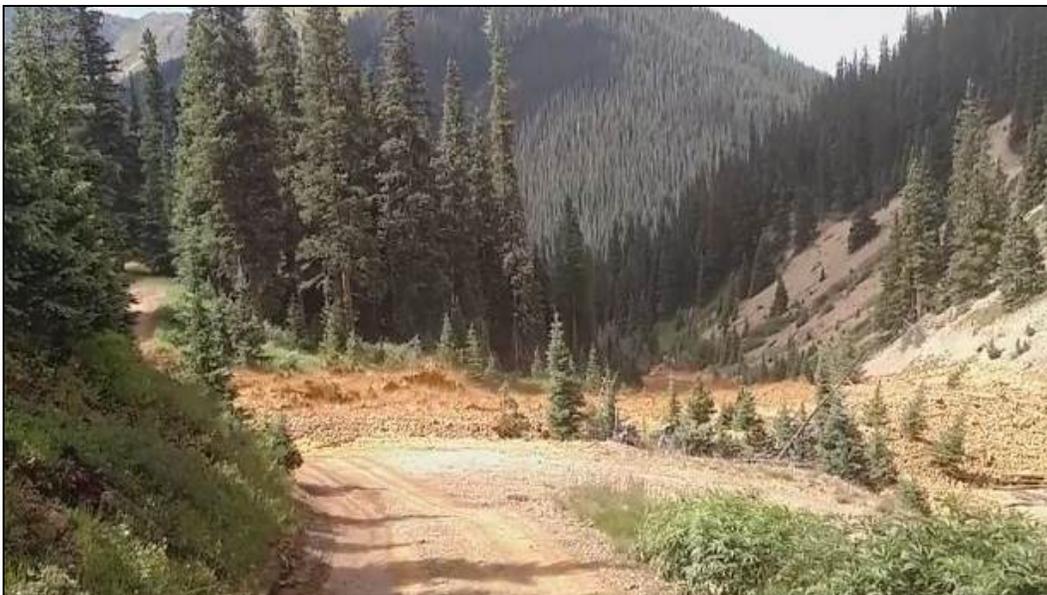
Figure 58.—Photograph looking south along the lower road and Cement Creek showing the blowout flow surging across the lower road and overwhelming Cement Creek (still frame extracted from a video taken on August 5, 2015, at approximately 11:00 a.m.).

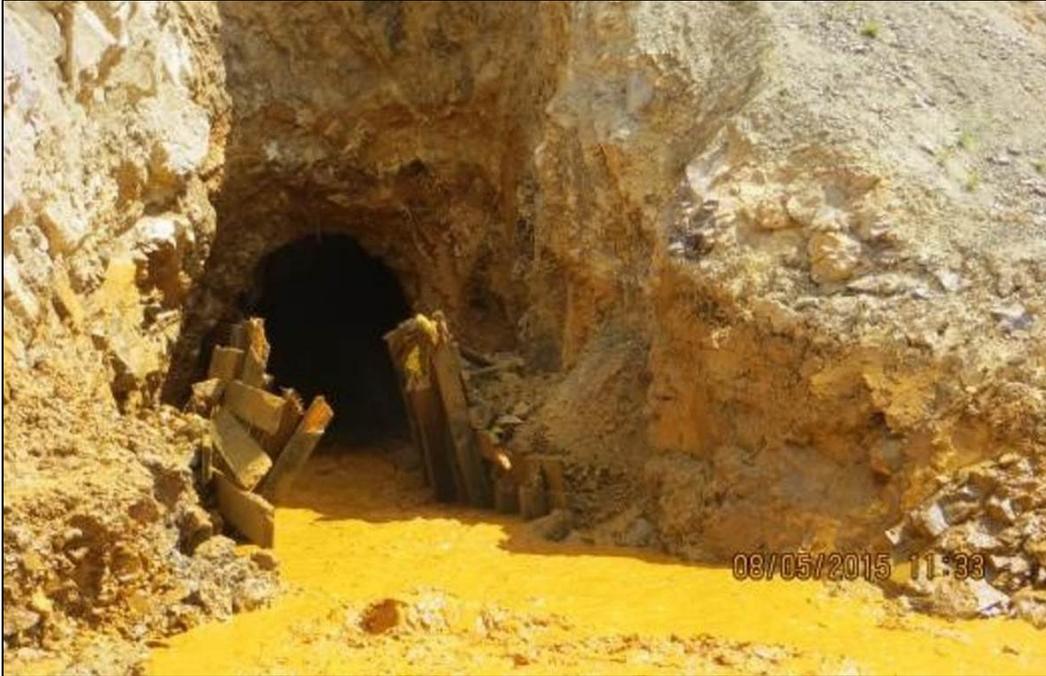
Figure 59.—Photograph showing the condition of the adit at 11:33 a.m., August 5, 2015; the peak flow of the uncontrolled release had passed and the flow rate was decreasing (photograph from EPA project files).

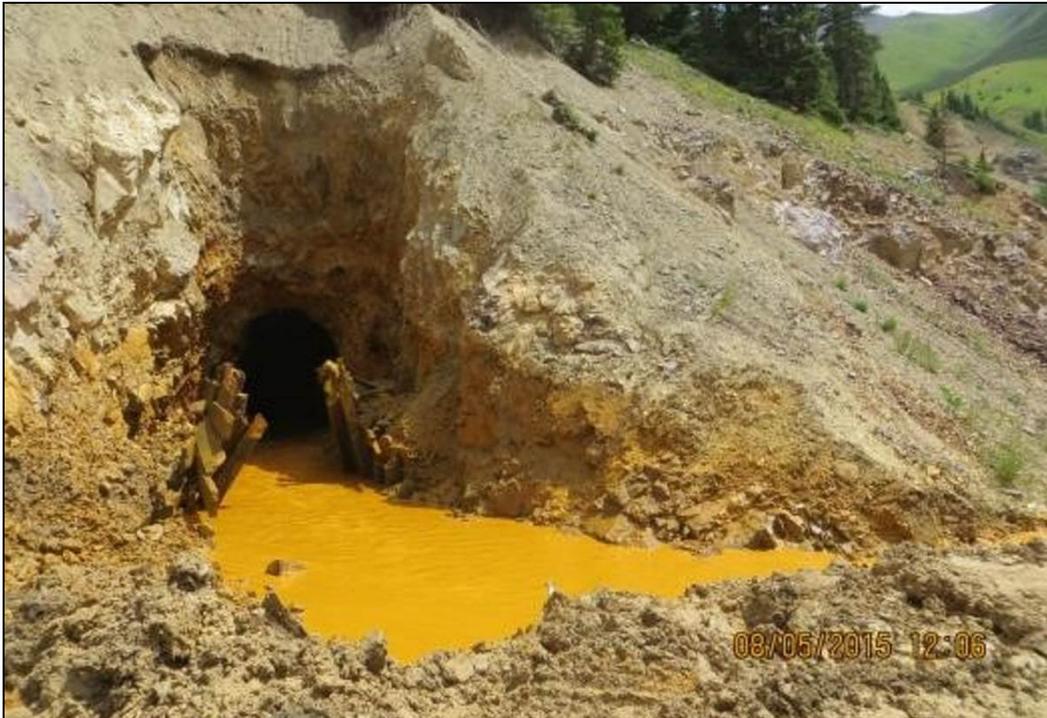
Figure 60.—Photograph showing that the flow had been routed back toward the half-round pipe by 12:06 p.m. on August 5, 2015 (photograph from EPA Project Files).

EPA called down for the roads to be blocked where the stream crosses them, which was promptly accomplished. They also had word passed on to people in Silverton. The details of the notifications made are not a subject of this report. At the site, the top of the waste-rock dump surface was repaired, and the flow was directed back into the remaining bit of the concrete trough and half-round pipe (figure 60). With this accomplished, all but one person left the site by walking down the mountain. One person stayed behind for a few hours to monitor the adit for additional outbursts.

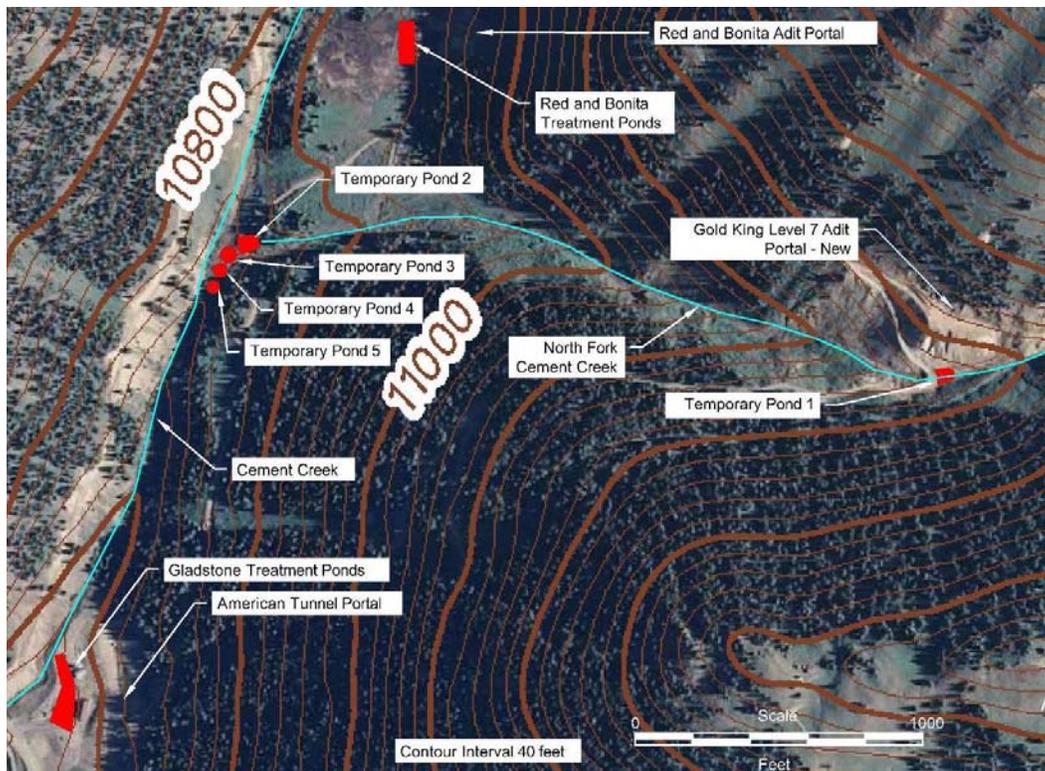
Figure 61.—Illustration showing the location of the temporary treatment ponds that were placed on the North Fork of Cement Creek after the incident.

After notifications were initiated, work began on road repair to reestablish access to the site. This work continued into mid-September. Most of the debris had been deposited in Cement Creek near the confluence with the North Fork of Cement Creek. The debris was removed. Temporary water treatment ponds were constructed on the North Fork using the debris (figure 61). The ponds were immediately put into operation.
