Technical Evaluation of the Gold King Mine Incident

San Juan County, Colorado

U.S. Department of the Interior
Bureau of Reclamation
Technical Service Center
Denver, Colorado

October 2015

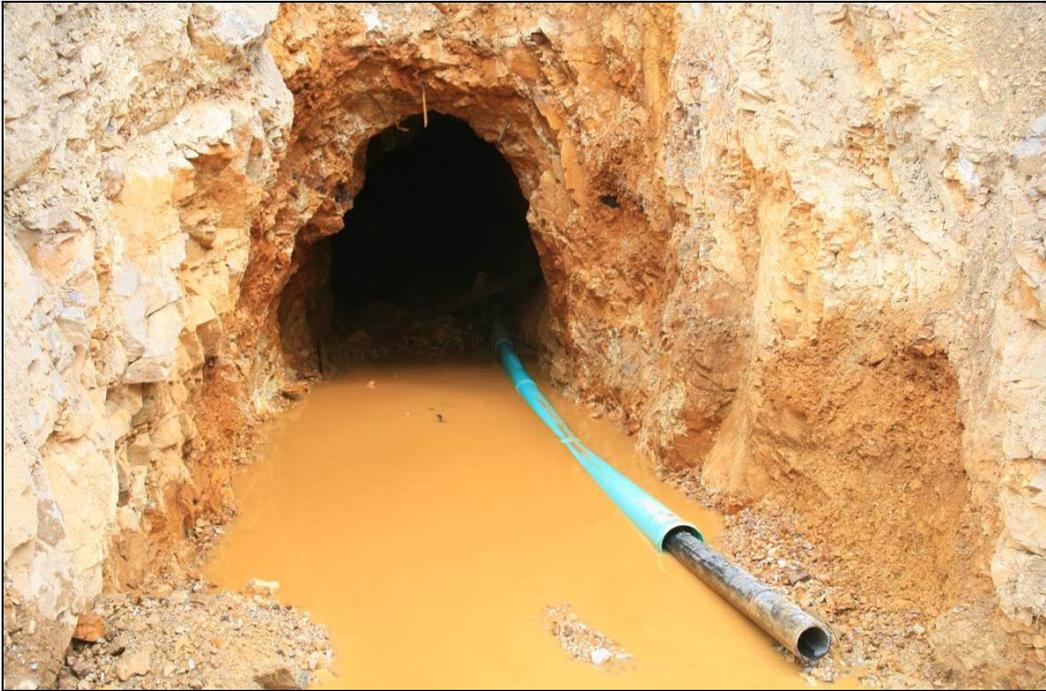
Figure 63.—Photograph showing the adit on August 16, 2015, with an 80-ft long (four 20-foot segments) turquoise-colored 24-inch outside-diameter drain pipe inserted into the adit opening. An 8-inch inside-diameter black HDPE pipe has been inserted into the 24-inch diameter pipe.

With the water treatment system in place, EPA initiated work to stabilize the mine opening. After removing the mine timbers (figure 62), a drain pipe was installed as far back as possible. This was a temporary measure to guard against the weak mine rock from caving in and blocking the drainage. Because a roof collapse would fall with great force, it could crush the 24-inch outside-diameter drain pipe, and so a stronger 8-inch inside-diameter thick-walled HDPE pipe was placed inside of it as shown in figure 63.

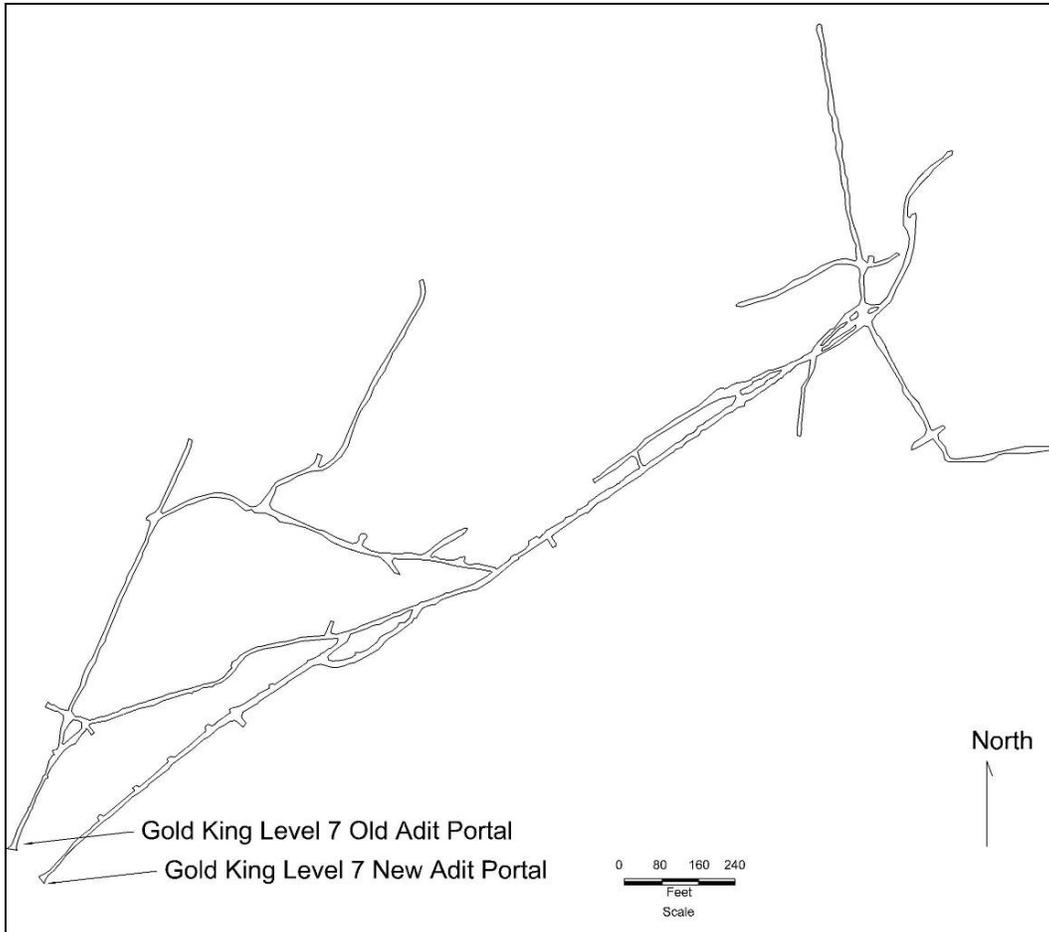
More importantly, because of the gently inclined slope of the new adit to provide drainage, even if the 3 million gallons did not completely fill Level 7 of the mine, it would have completely filled the mine portal area under pressure. The floor of the adit 1,000 feet back in the mine is 10 feet higher than it is at the mine entrance. Even if the water was only 1 foot deep there, the pressure against the portal blockage would have been equivalent to 11 feet of water. The Level 7 adit is estimated to be approximately 2,400 feet long, and therefore it can reasonably be assumed that the water pressure at the portal was significantly higher than that resulting from the water being simply full to the roof at the portal.

Figure 66.—Map showing the extent of the Gold King Mine Level 7 underground workings.

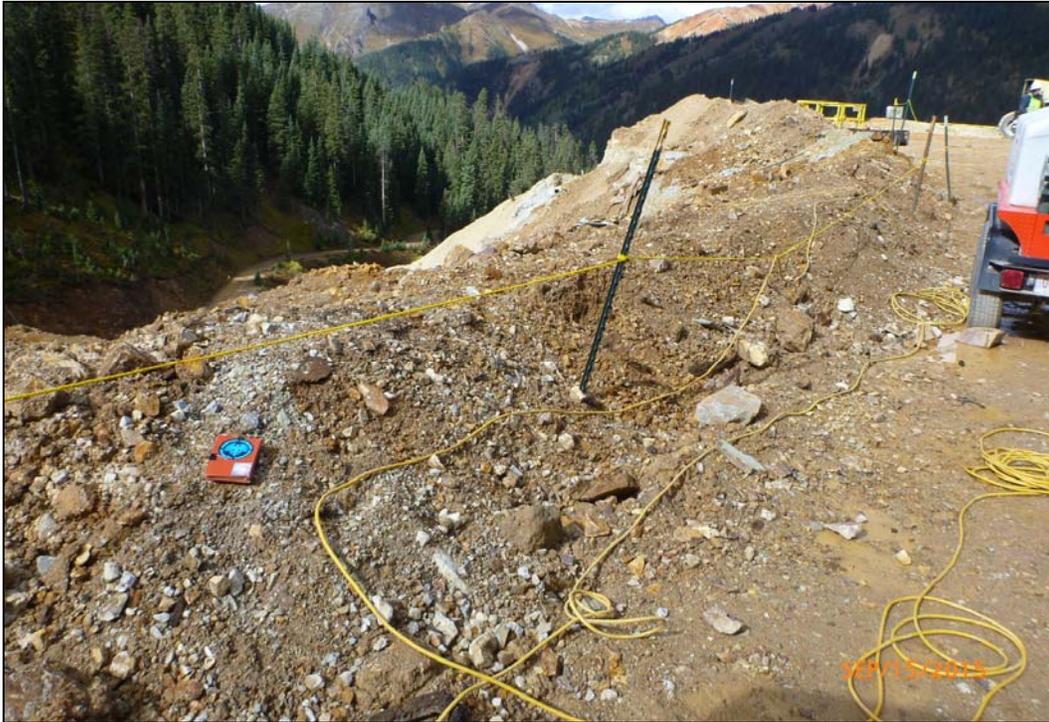
Two samples of the soil from the site were tested (appendix C). Both samples were classified as GC (clayey gravel with sand) with PI (plastic index) values of 13 and 14. Two samples of the clayey gravel were tested for permeability with results of 3.6×10^{-3} cm/s and 3.4×10^{-4} cm/s. This material is not free draining with respect to the observed seepage quantities

Figure C-1.—Photograph showing the safety berm made of soil that was excavated from in front of the Gold King Mine Level 7 New Adit portal. Sample No. 1 consisted of soil sampled from various locations along the safety berm.

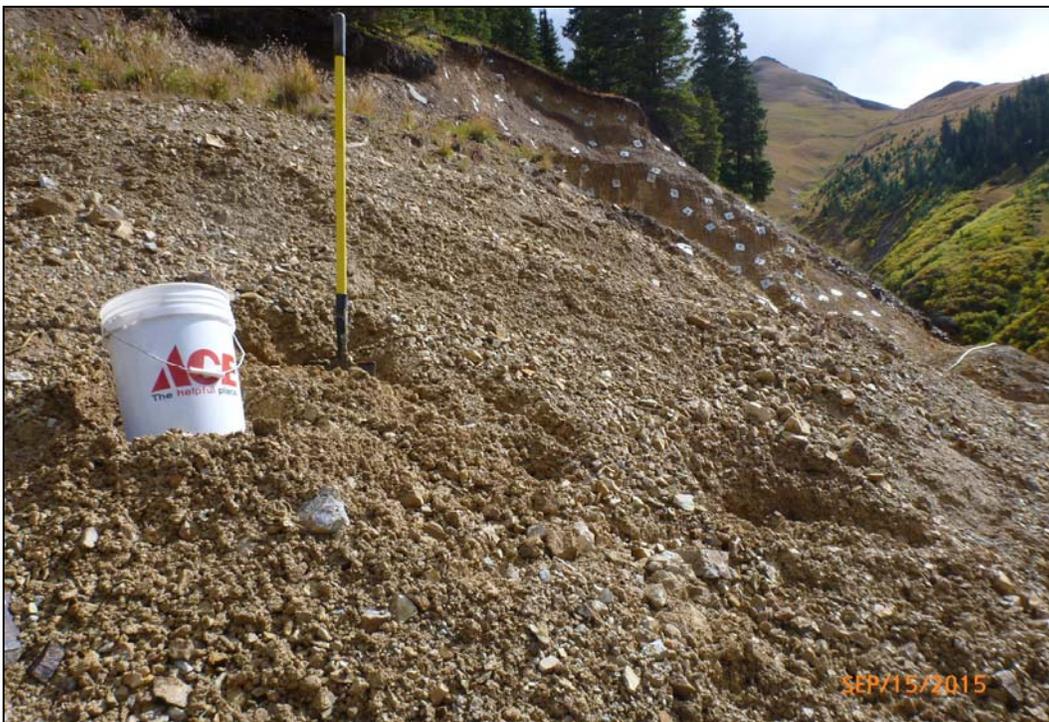
Figure C-2.—Photograph of stockpile where Sample No. 2 was collected. The rock anchors supporting the Gold King Mine Level 7 portal can be seen in the background.
