BUFFALO CREEK (W. VA.) DISASTER, 1972

PREPARED FOR THE
SUBCOMMITTEE ON LABOR
OF THE
COMMITTEE ON LABOR AND
PUBLIC WELFARE
UNITED STATES SENATE

Part I of II
**THE FAILURE OF REFUSE
DAMS ON MIDDLE FORK
Buffalo Creek**

**An Engineering Survey of
Representative Coal Mine Refuse Piles as
Related to the Buffalo Creek,
West Virginia, Disaster**

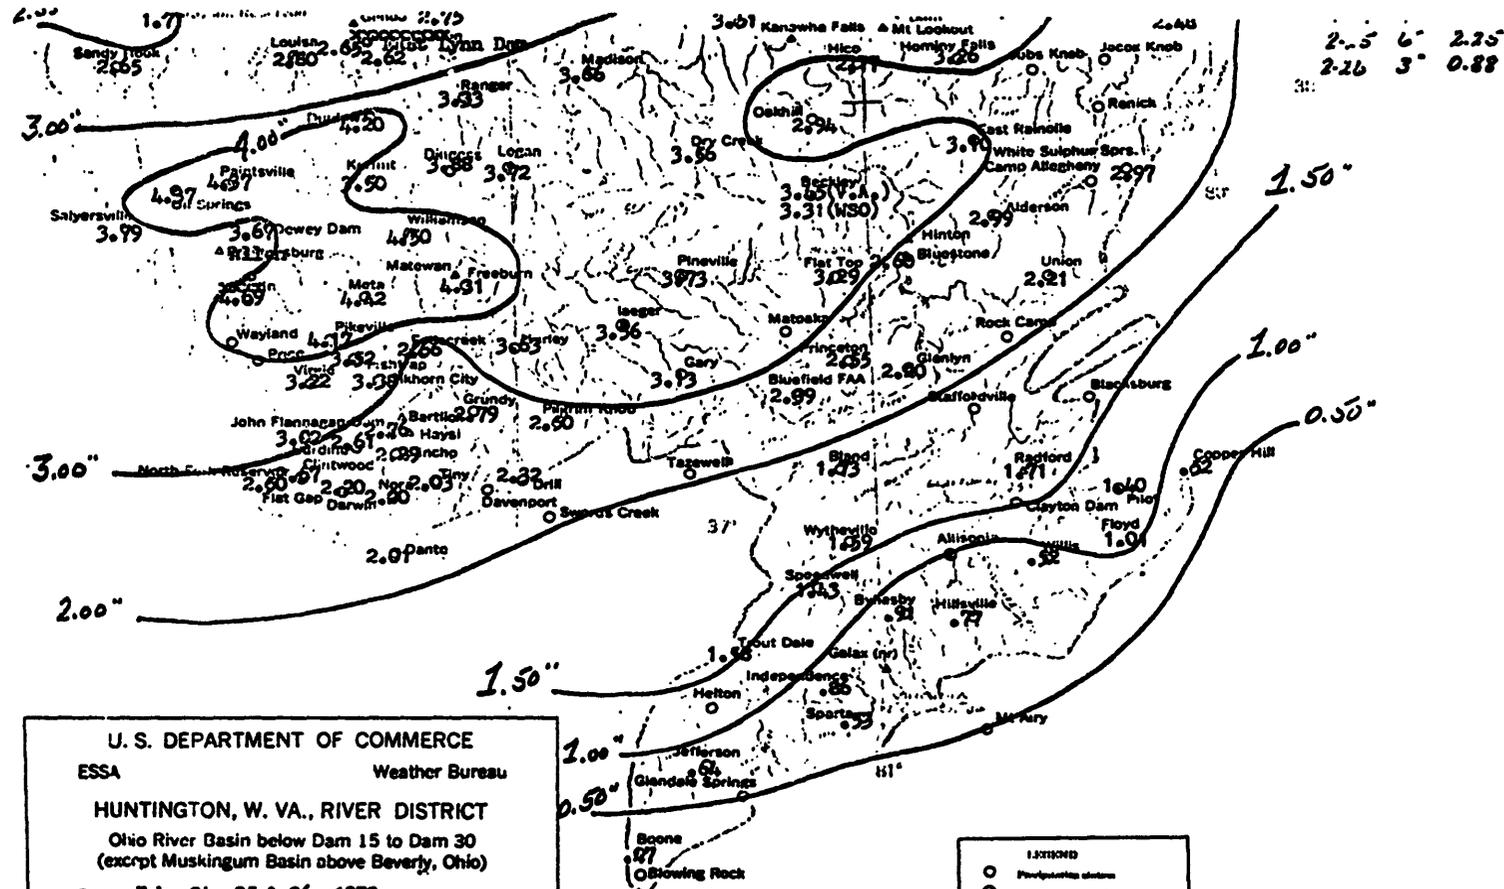
PLATE NO. 7

U. S. DEPARTMENT OF COMMERCE
 ESSA Weather Bureau
 HUNTINGTON, W. VA., RIVER DISTRICT
 Ohio River Basin below Dam 15 to Dam 30
 (except Muskingum Basin above Beverly, Ohio)
 Date Feb. 24, 25 & 26, 1972
 _____ PERIOD _____
 7: _____ hours, ending at 7 a.m. 26th
 _____ hours, ending at _____
 _____ hours, ending at _____
 MARCH 1970 RD 414

RAINFALL DATA

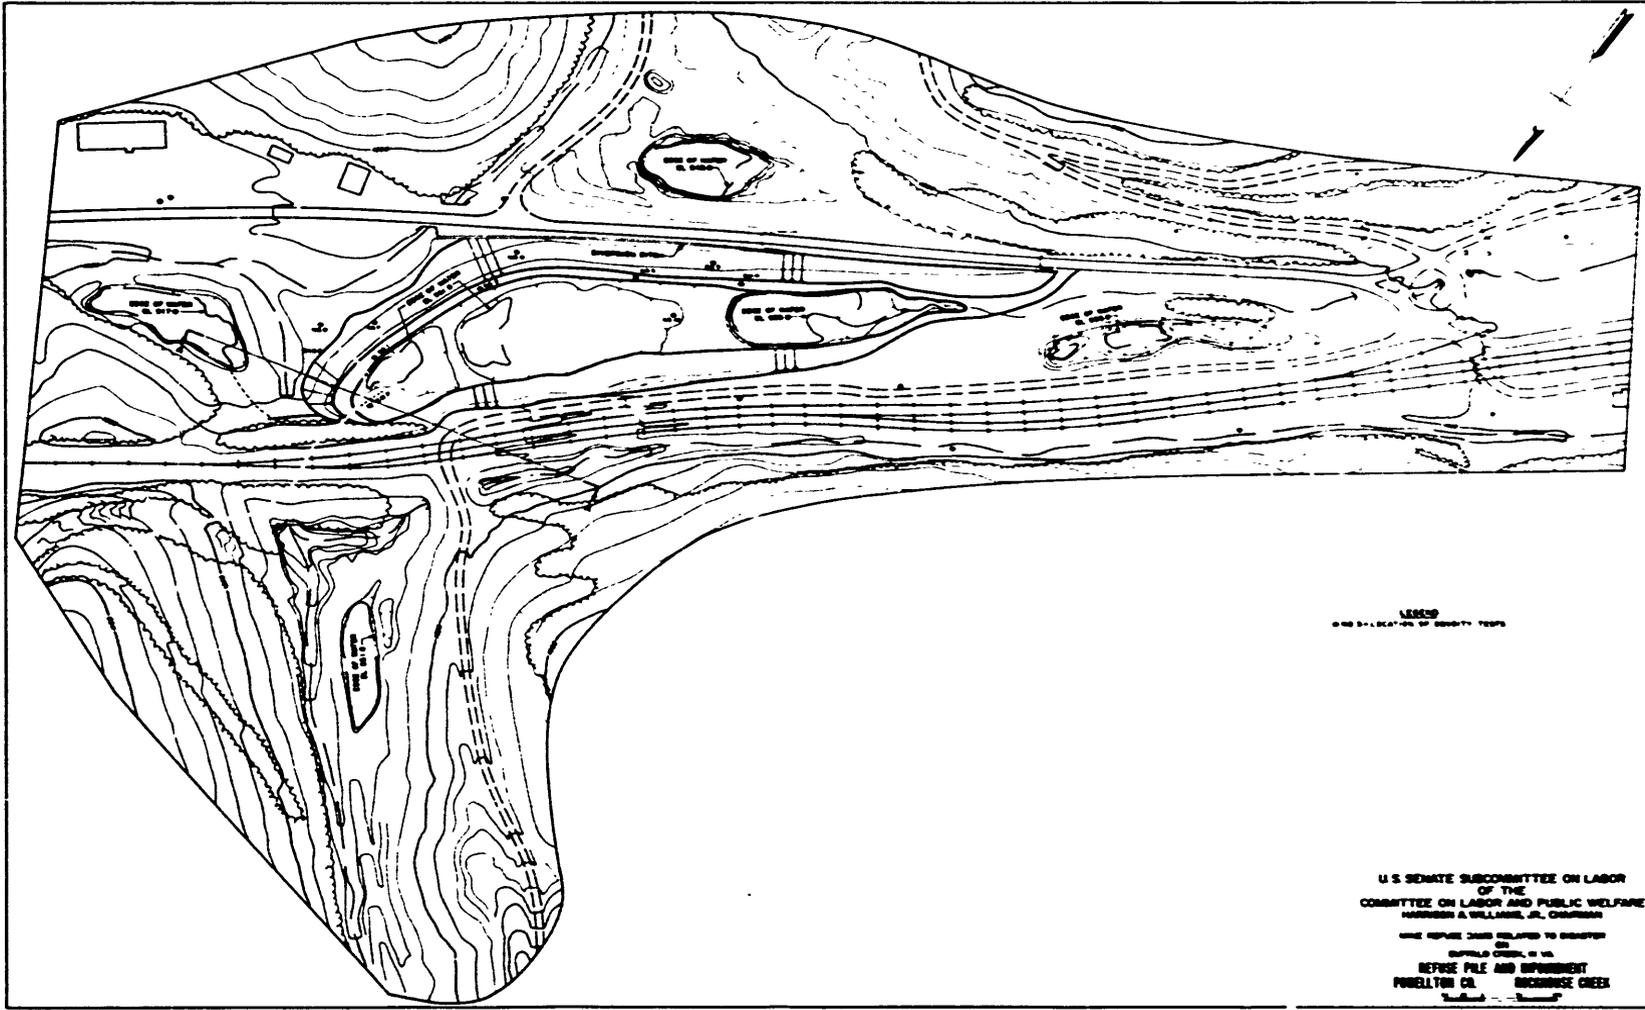
PLATE NO. 3

As elsewhere in this portion of West Virginia, this area is one of rugged terrain; the valleys rise with side walls as steep as 1 vertical to 1½ horizontal and the relief in the area is of the order of 1200 feet. The entire sludge impoundment area, however, is within the somewhat broader valley bottom of Rockhurst Creek. The gradient of the natural ground surface in the immediate vicinity of the impoundment is relatively gentle, being approximately 2-1/4%. (See Plates 2 and 3)

As is shown on Plates 2 and 3, on the northerly side of the impoundment is a railroad switching yard which serves the cleaning plant just upstream of the impoundment. On the southerly side immediately adjacent to the dam is a small diversion ditch and adjacent to that, a well traveled paved road leading upstream to the cleaning plant and mines and downstream, to Man.

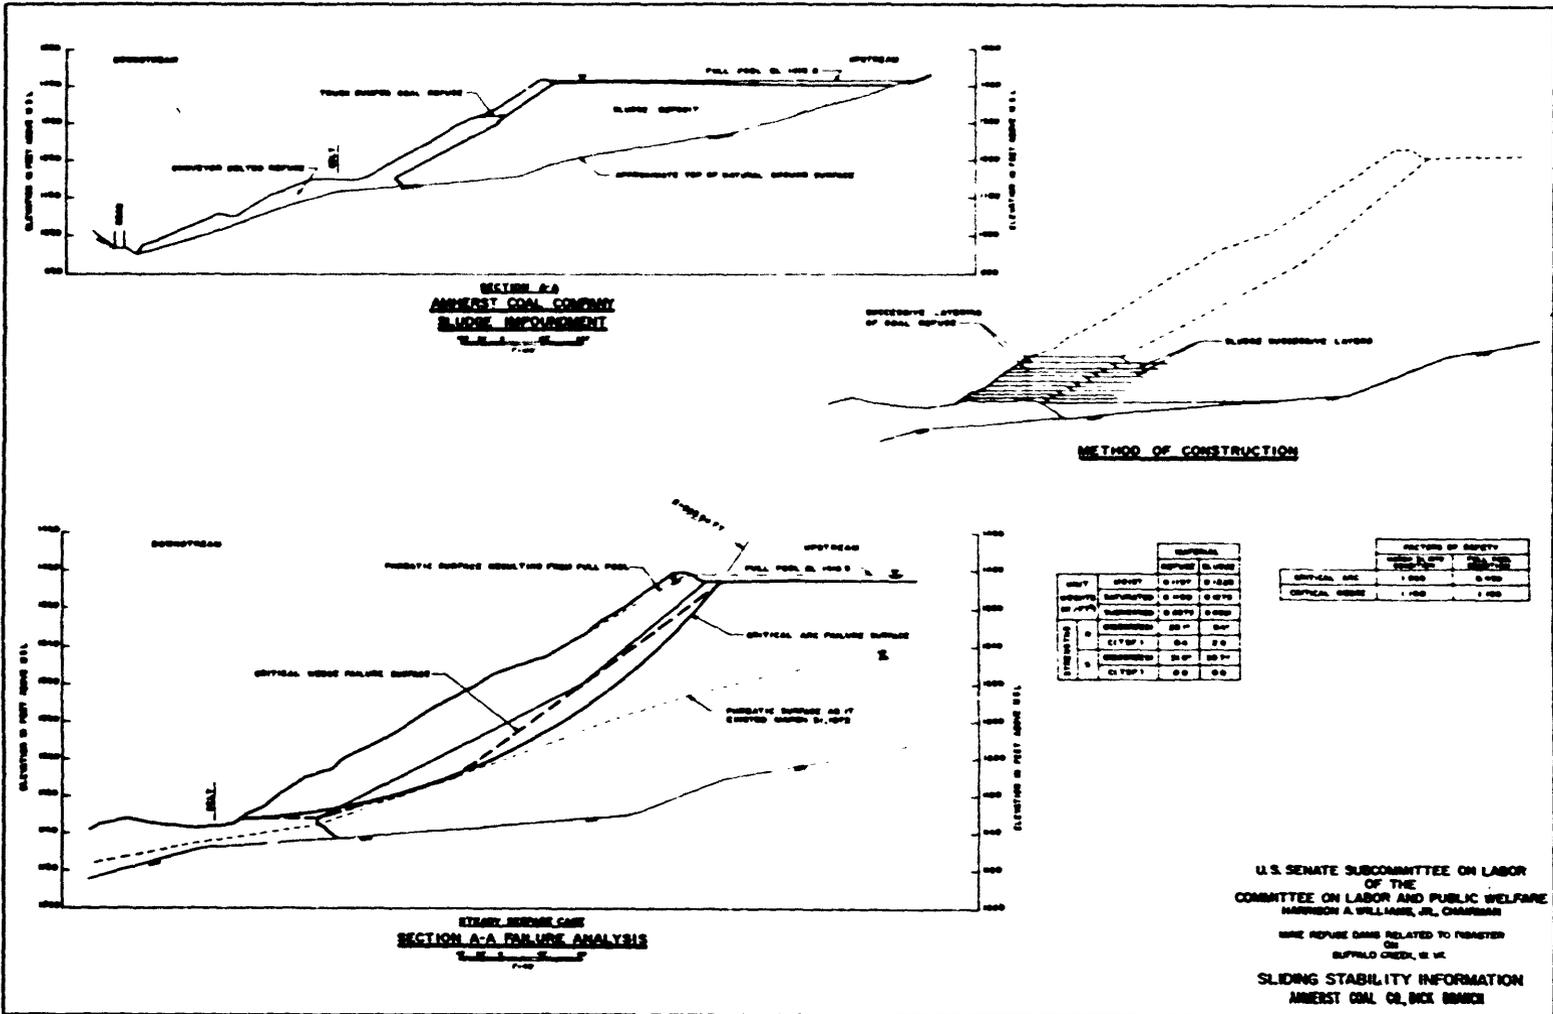
PLATE 13

U.S. SENATE SUBCOMMITTEE ON LABOR
OF THE
COMMITTEE ON LABOR AND PUBLIC WELFARE
HARRISON A. WILLIAMS, JR., Chairman
MINE REFUSE DAMS RELATED TO READER
ON
BUFFALO CREEK, N. Y.
SLIDING STABILITY INFORMATION
AMHERST COAL CO. DICK BRANCH

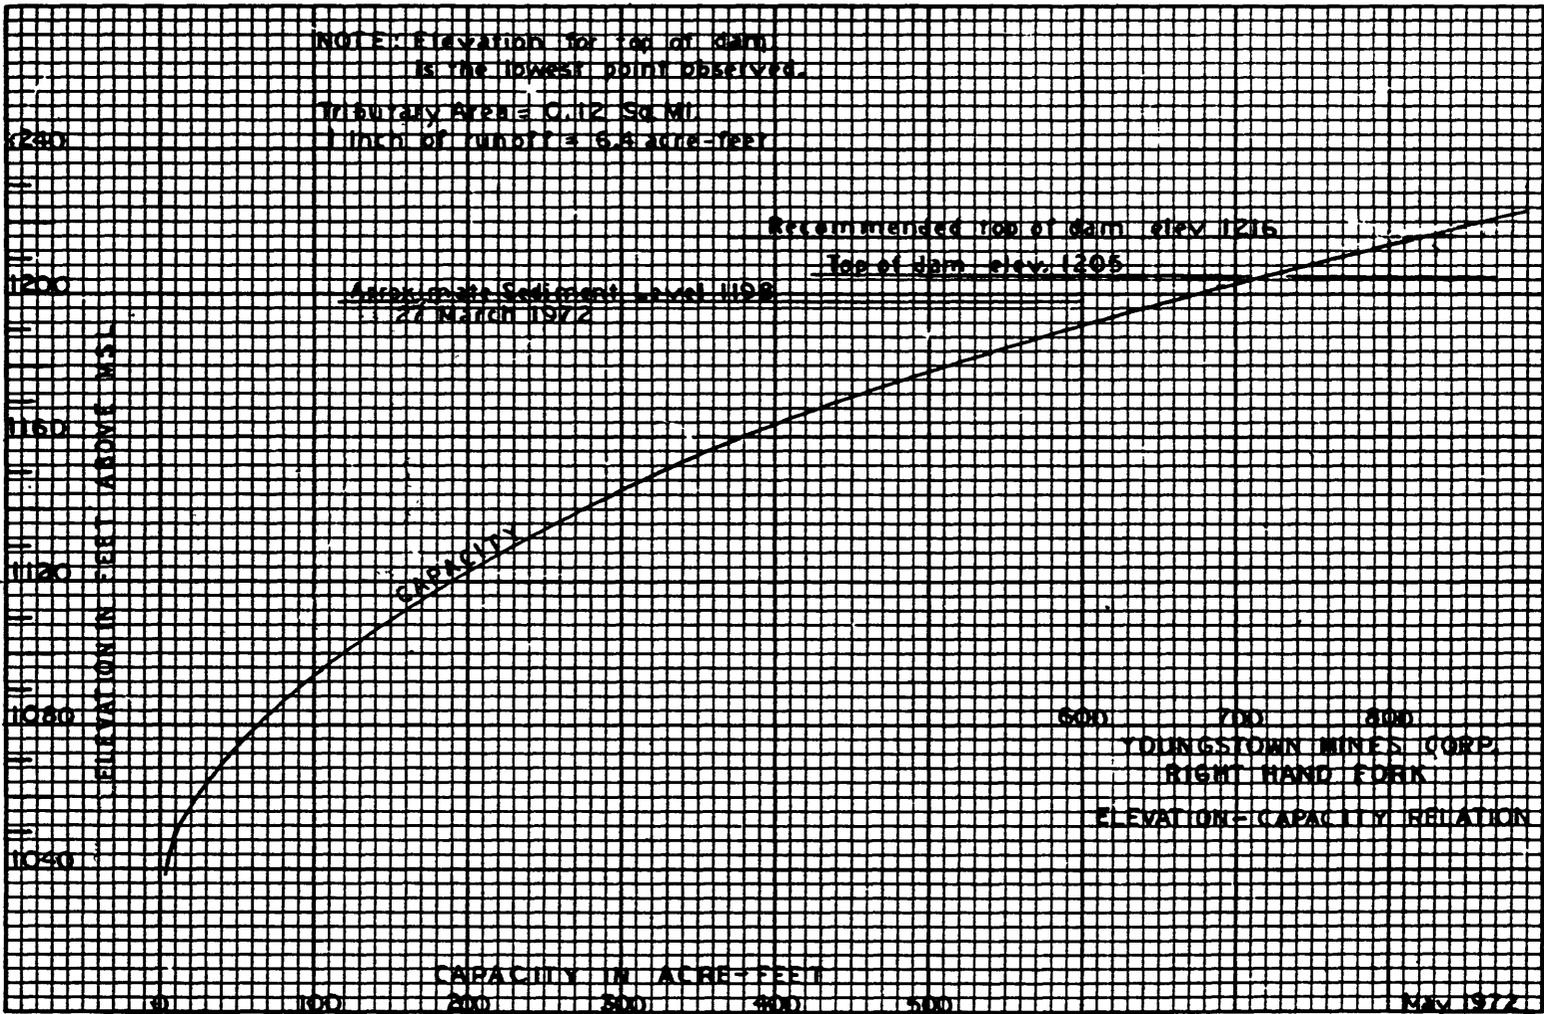
PLATE 19

Regardless of the upper seepage line shown on the steady seepage case, Plate 19, for a storm just sufficient to fill the pool (far less than design storm), the seepage would probably exit on the embankment slope. If this happened, serious erosion of the highly erodible embankment would occur, and a real possibility of piping and consequent failure of the dam result.
