# The 1977 Toccoa Flood, Report of Failure of Kelly Barnes Dam Flood and Findings

by Federal Investigative Board

December 21, 1977

## ABSTRACT

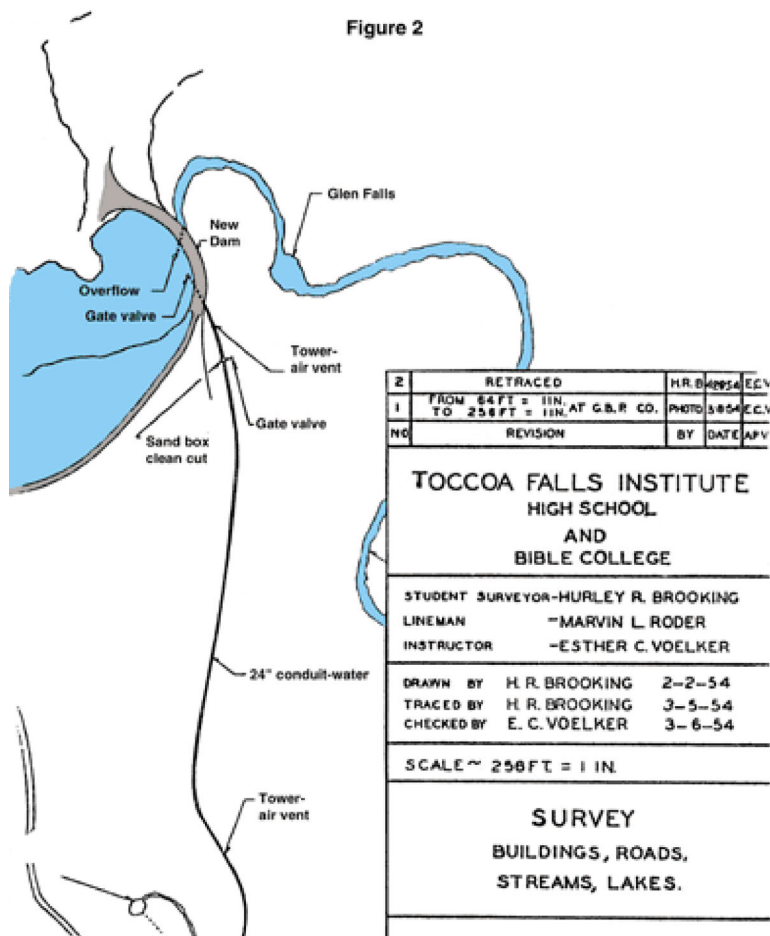
Figure 2

Some historical witnesses remember the penstock slide gate but do not recall the masonry structure. After the failure, this gate was retrieved from below the dam site and found to be closed. The conduits (glossary.html#conduit) for the spillway outlet and new penstock were both welded plate pipes approximately 30-inches in diameter. A historical witness stated that during placement of fill over the spillway conduit, the pipe began to cave in and had to be reinforced with metal struts. Descriptions of the earth fill (glossary.html#earthfilldam) construction and equipment are similar to the construction which occurred in the 1930's (Photo 2 (photos.html)). At this time or during previous construction, the old spiral riveted penstock pipe had been abandoned but not removed. Conflicting information suggests the possibility of a series of construction events during the 1940's. A 1954 Survey of Buildings, Roads, Streams, and Lakes of the Toccoa Falls Institute (Figure 2) locates the overflow pipe (low-level spillway), a 24-inch conduit (welded steel penstock), and the intake structures.

- i. Below the dam there exists remnants of two lines of pipe leading to the Toccoa Falls Power Plant. The older line is spiral riveted steel pipe such as exposed in the right embankment toe at the rubble area. The newer line is at a higher elevation and is welded steel pipe. This newer pipe aligns with the pipe excavated near the concrete sill upstream of the base line ([glossary.html#baseline](#)). The new line also exhibits an air vent tower and gate valve as shown in Figures 2 ([body2.html#fig2](#)) and 3 ([fig-3.gif](#)).
