Michigan Dam Incident Response Review

An Analysis of the 2020 Edenville and Sanford Dam
Failure Response

April 2022

FEMA

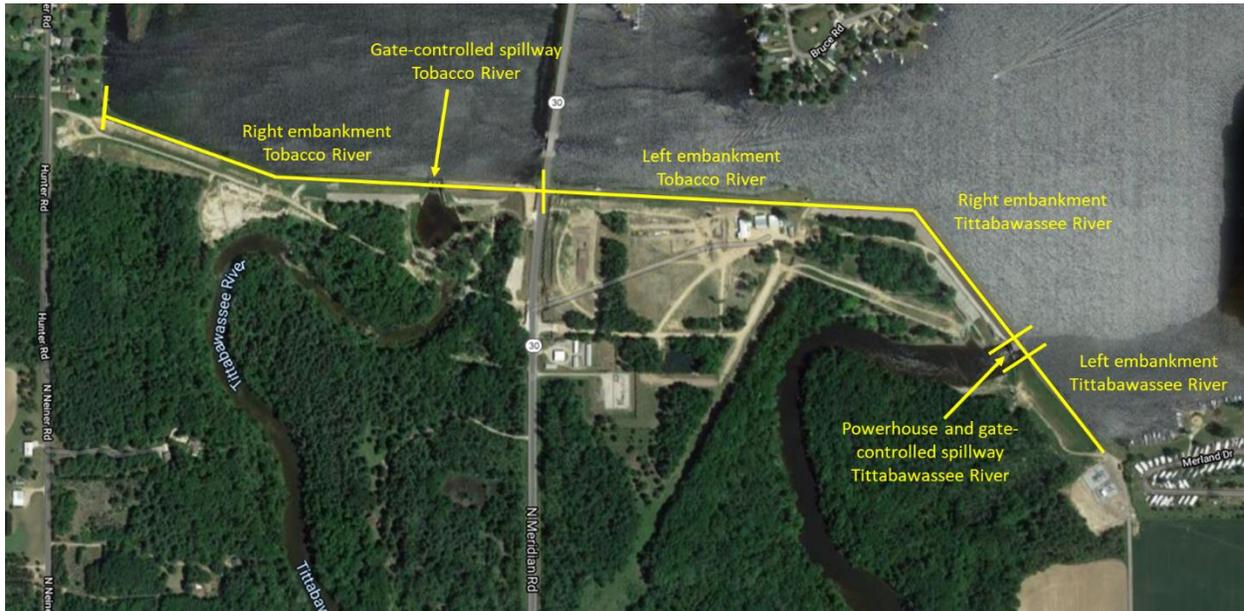
Figure 2: Main sections of Edenville Dam (left to right, looking downstream)

The Edenville and Sanford dams (figures 2 and 3, respectively) are both earthen embankment dams with concrete ogee spillways equipped with Tainter gates.¹ The Edenville Dam is located on the county border between Midland and Gladwin counties and was constructed in two sections: one embankment/gate-controlled spillway across the Tittabawassee River and another across the Tobacco River. The powerhouse is located on the Tittabawassee River side of the dam. Prior to failure, the Edenville Dam was 54 feet high and about 6,600 feet in length at its crest (TRC Engineers Michigan, Inc. 2020). Wixom Lake was approximately 2,300 acres (40,000 acre-feet) at

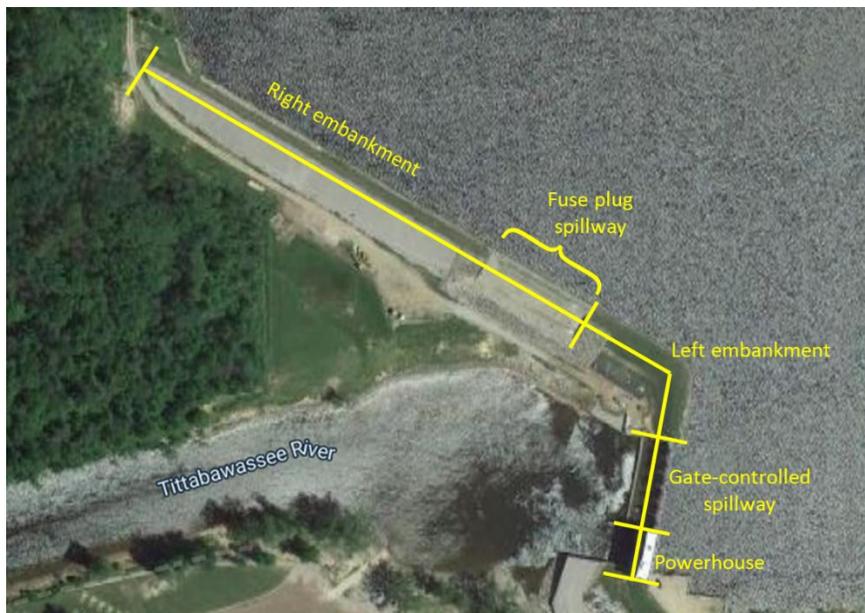
Figure 3: Main sections of Sanford Dam (left to right, looking downstream)

normal summer elevation. The Sanford Dam is located 10 miles south, downstream from Edenville on the Tittabawassee River. It consisted of four major components: the left embankment, powerhouse, gate-controlled spillway, and the right embankment with an additional fuse plug spillway. Prior to its failure, the Sanford Dam was 36 feet high and approximately 1,580 feet long (Spicer Group, Inc. 2019). At normal summer elevation, impounded water formed the approximately 1,500-acre (15,000 acre-feet) Sanford Lake.

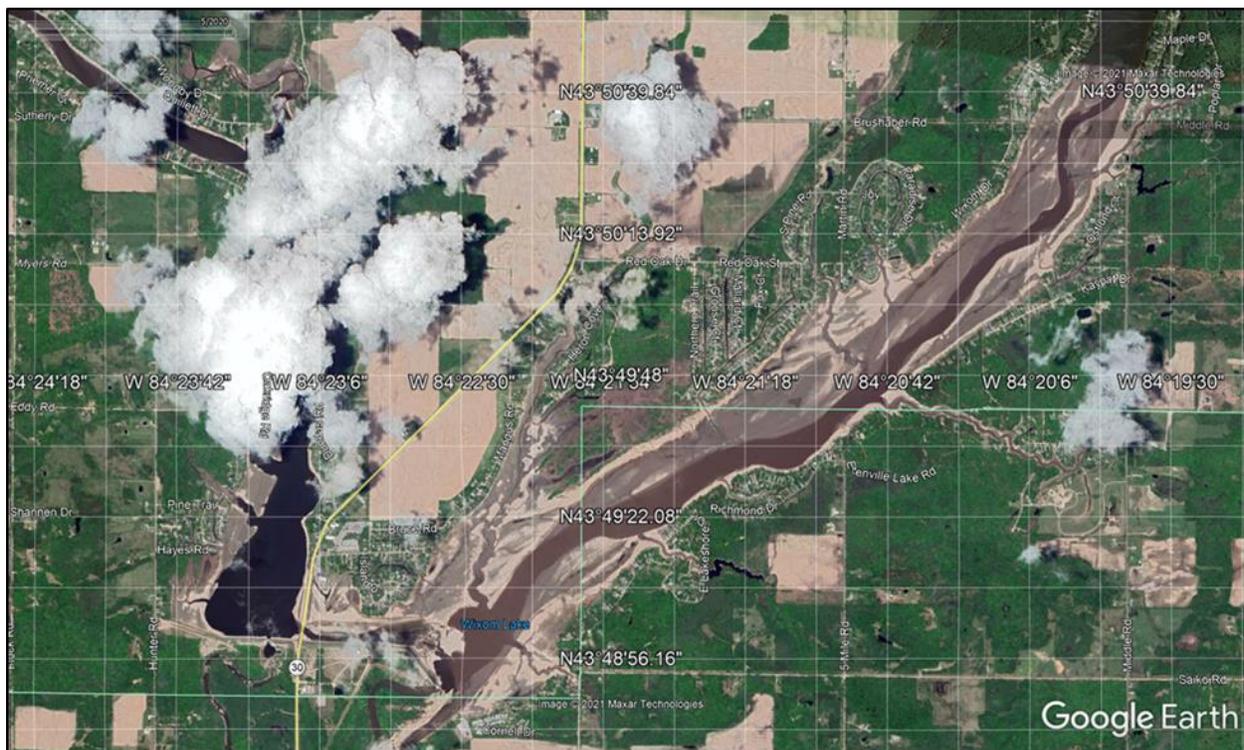
**Figure 17: Satellite imagery of Wixom Lake after floodwaters receded (May 25, 2020)
(Google Earth 2021)**

Following the May 2020 dam failure, water levels in Wixom Lake were significantly lower, as compared with normal conditions. The shoreline has been replaced with hundreds of feet of sediment and a drop-off where the water's edge had been located. Because of the breach location, the Tobacco River side of Wixom Lake was only partially emptied. On the Tittabawassee River side, the old riverbed under the emptied lake was clearly visible. Figure 17 shows satellite imagery of Wixom Lake on May 25, 2020, after floodwaters receded. Flow coming from the Tobacco River was being diverted to the Tittabawassee River, initially through the area where the M-30 bridge was washed out (see the Transportations Infrastructure and Access Issues section for more details on the M-30 bridge). The combined flows of the Tittabawassee and Tobacco rivers cut a new channel within the failed section of the Edenville Dam embankment.

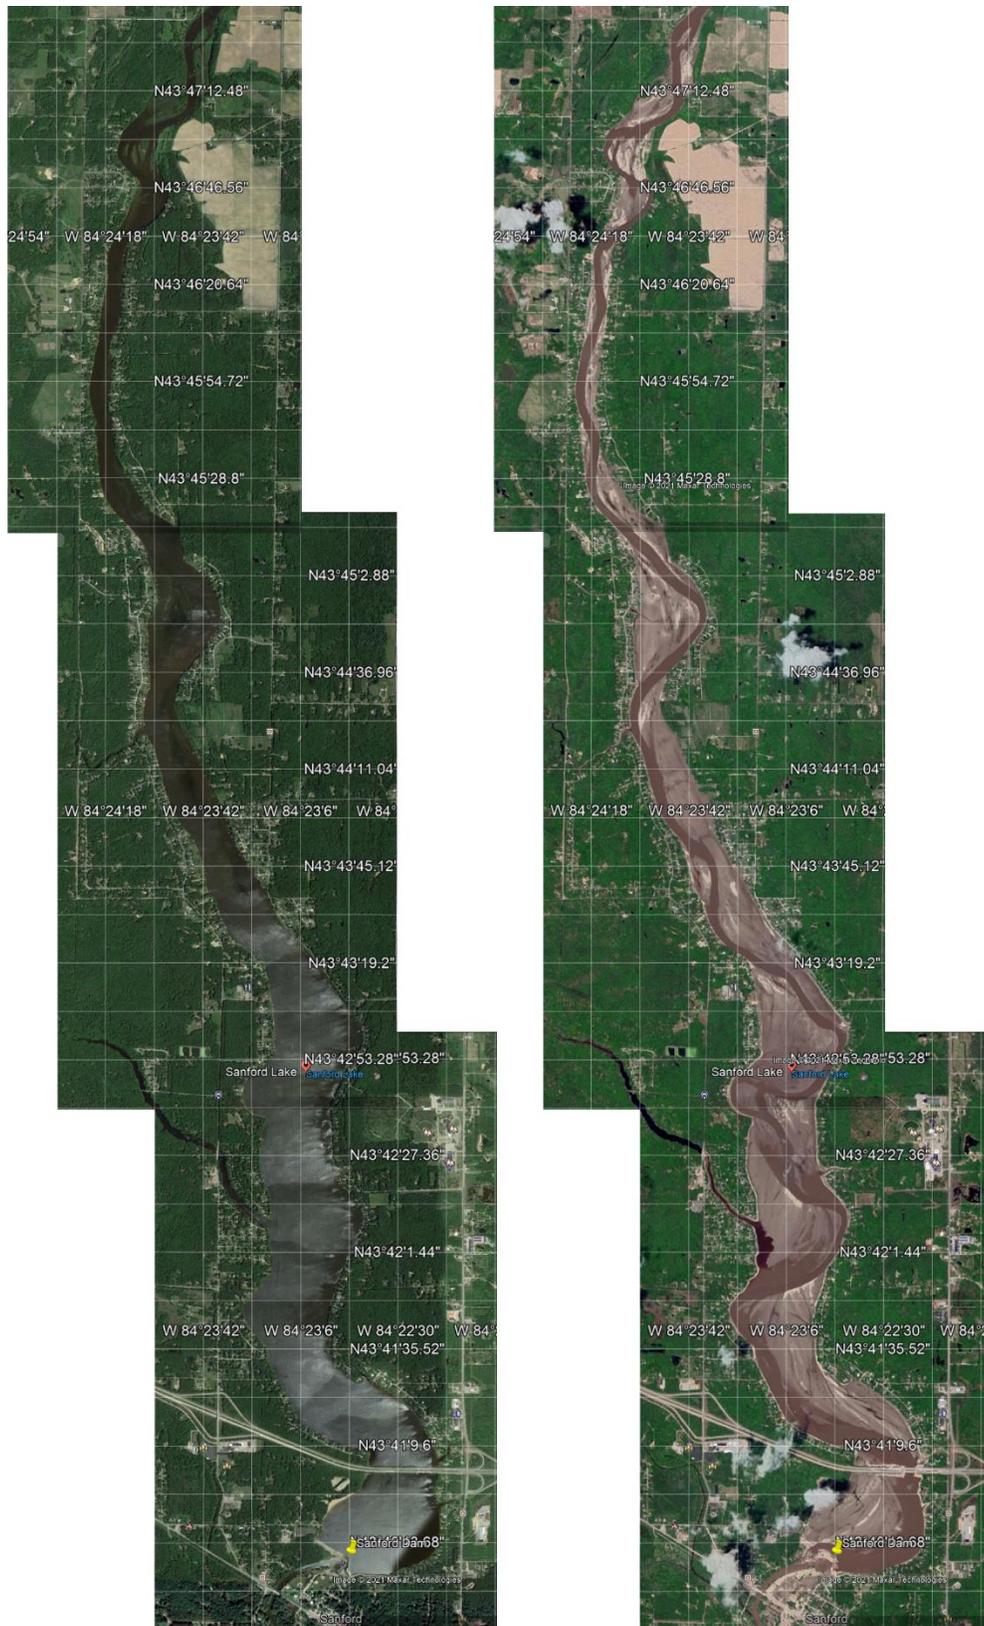
Similar to Wixom Lake, without the dam structures to impound the water, Sanford Lake has essentially drained, and the shoreline replaced with hundreds of feet of sediment. Figure 19 shows satellite imagery of Sanford Lake before (June 10, 2018) and after (May 25, 2020) the dam failures and the floodwaters receded. Down the entire length of the after image, the old, pre-dam riverbed is visibly evident.

Figure 19: Satellite imagery of Sanford Lake before and after the Edenville and Sanford dam failures (left, June 10, 2018, and right, May 25, 2020) (Google Earth 2021)

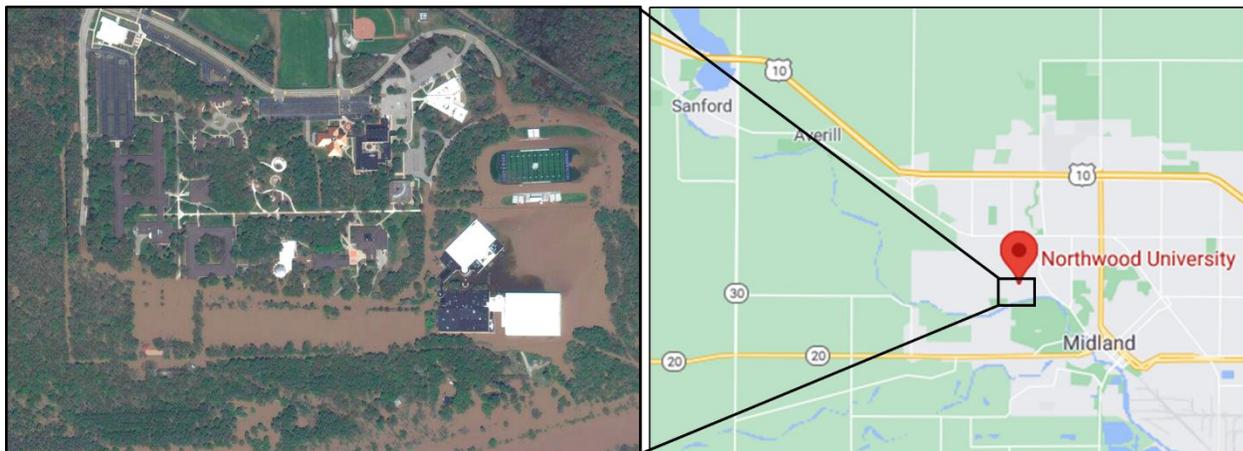
At Northwood University, a small private university in Midland along the Tittabawassee River, several buildings and most of the student athletic facilities (indoor and outdoor) were inundated by floodwaters ranging from six inches to eight feet deep (Kozlowski 2020, Petzold 2020). Figure 23 illustrates the location and extent of flooding at Northwood University. The entire AstroTurf surface of the football field, which appears to be untouched on higher ground (Figure 24), was actually floating on top of the floodwaters, nearly five feet above the ground (L. Thompson 2020). Initial damage estimates were around \$10 million, including \$4.2 million in damages to the athletic facilities (Petzold 2020).

Figure 23: Flooding at Northwood University in Midland, Michigan
(Maxar 2020, Google Maps 2021)

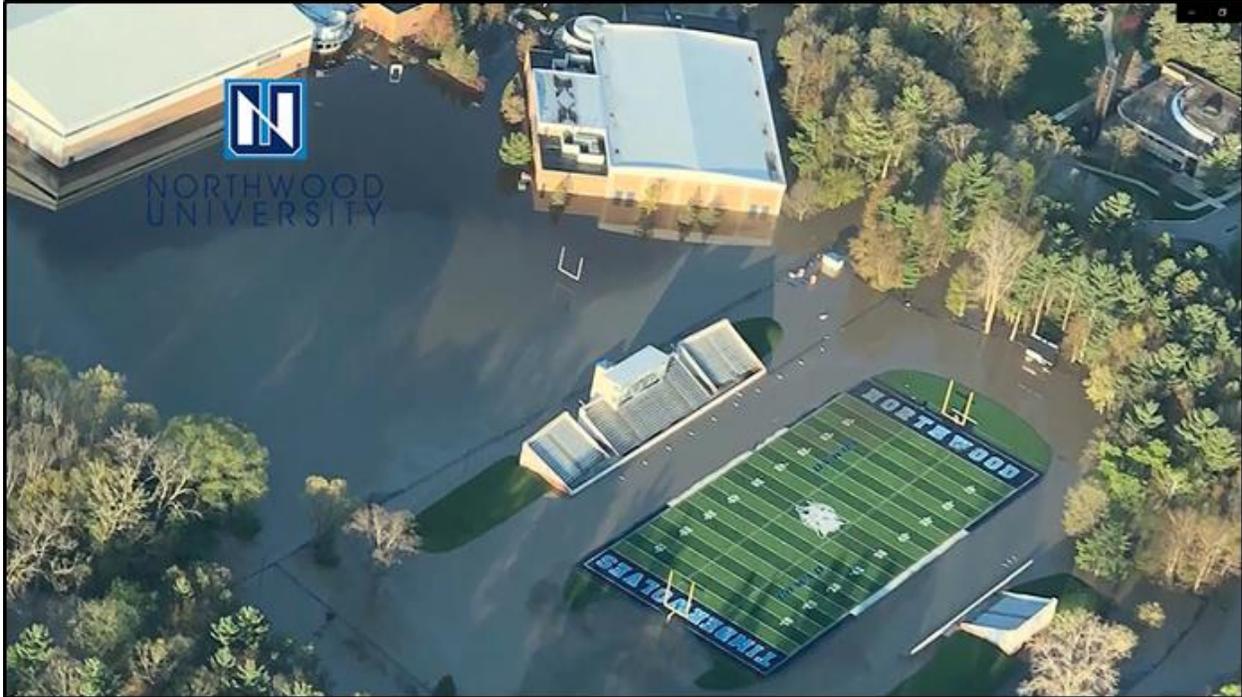
Figure 24: Student athletic facilities on Northwood University campus following May 2020 dam failure and flooding incidents (PBS 2020)

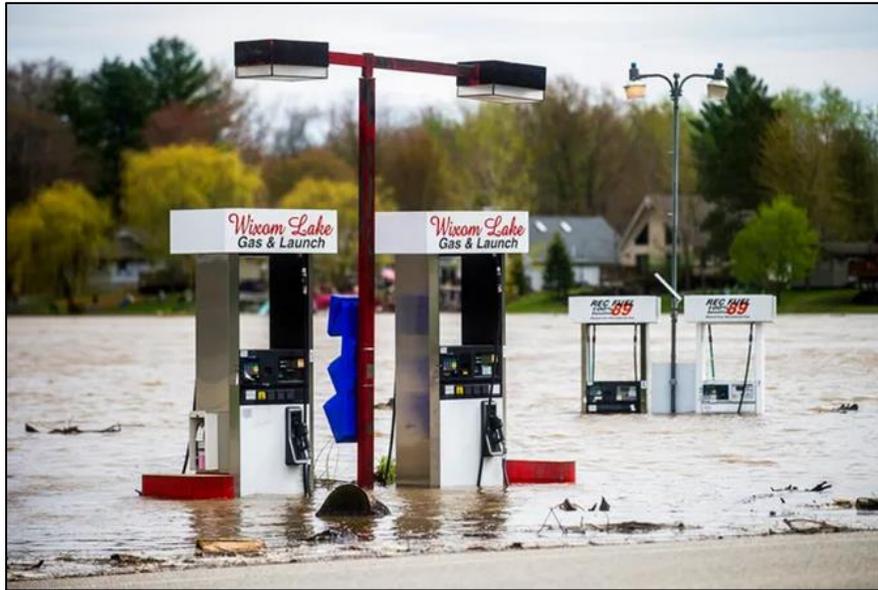
Figure 27: Flooded Wixom Lake Gas & Launch located along the west bank of the Tittabawassee River (Witsil 2020)

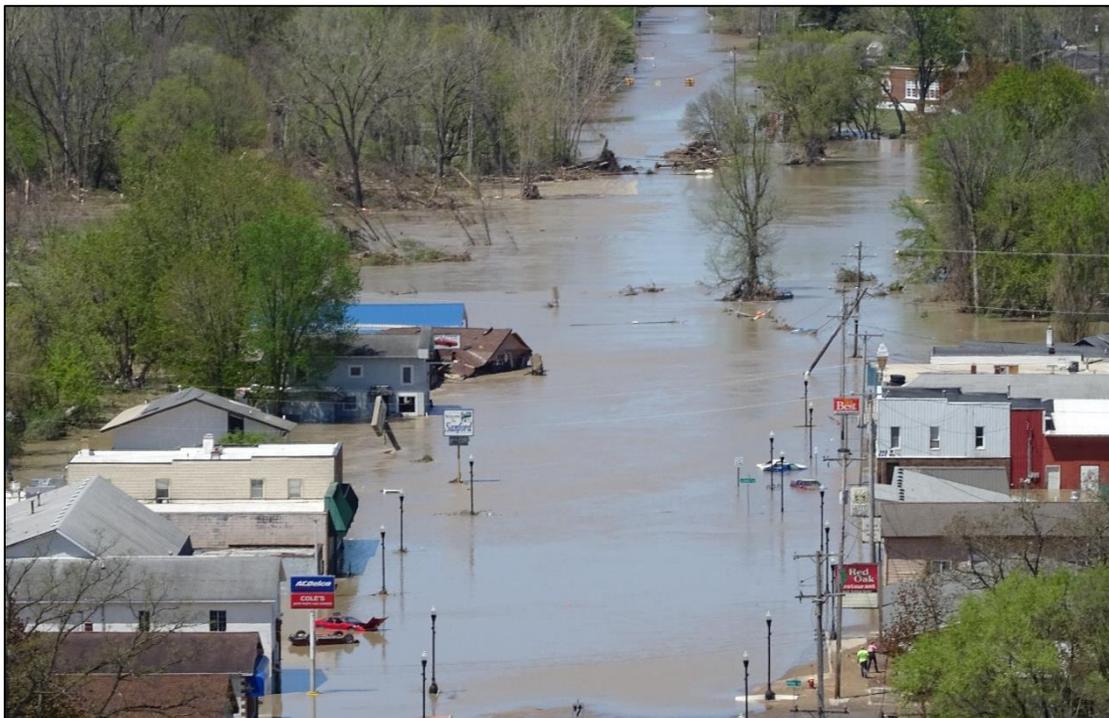
Downtown Sanford is located along the Tittabawassee River just south of the Sanford Dam. The small village, which spans only a few blocks, was completely submerged (Figure 28). The downtown

Figure 28: Downtown Sanford, just south of the Sanford Dam, after the dam failures (MSP 2022)

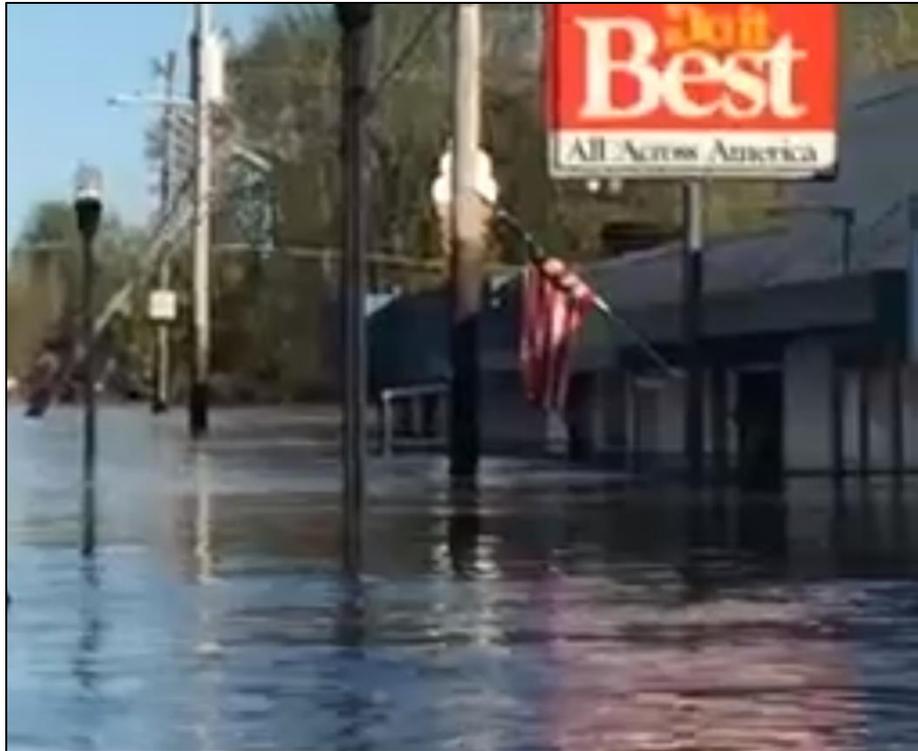
Figure 29: Hardware store in downtown Sanford (PBS 2020)

area included a hardware store (Figure 29), a grocery store, a bank, and a post office (**Error! Reference source not found.**), along with a couple of restaurants and a few other small businesses.

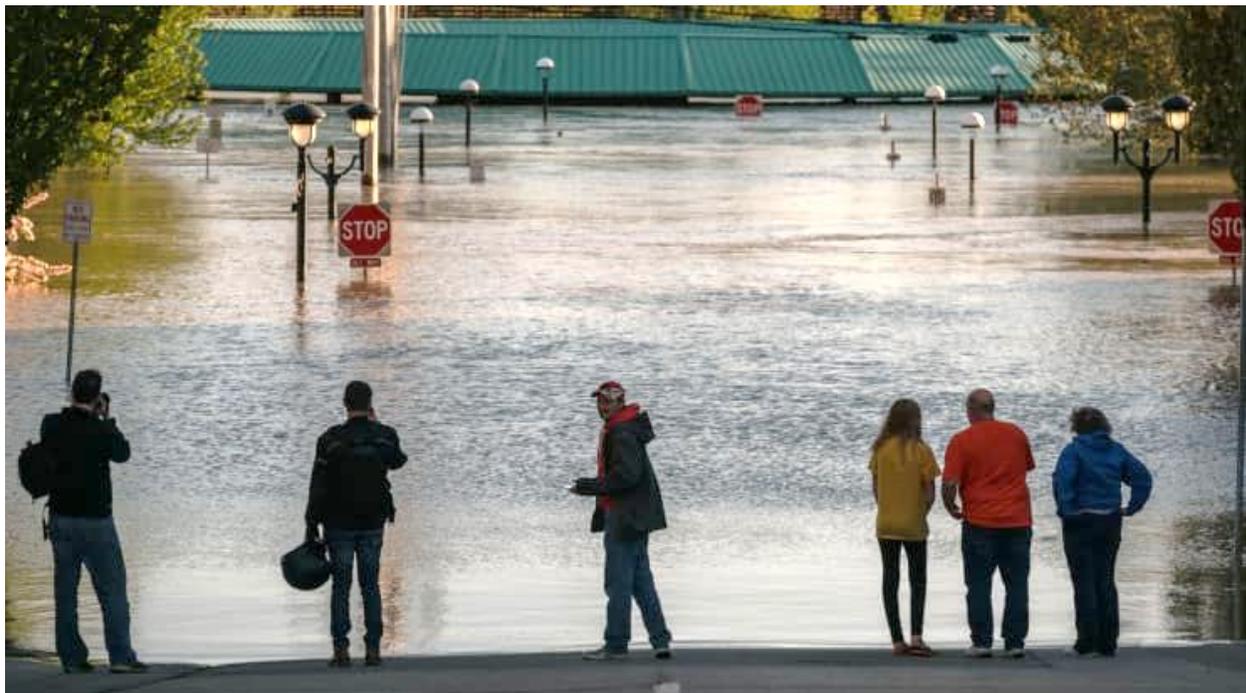
In the City of Midland, floodwaters affected numerous homes, stores, restaurants, churches, schools, government buildings, public parks, recreational facilities, historic landmarks, museums, and other businesses. Figure 31 offers a street-level view of the flood height at the circular pavilion of the Midland Area Farmers Market along the eastern bank of the Tittabawassee River. Figure 32 features before-and-after images of downtown Midland during the May 2020 dam failure and flooding incidents.

Figure 31: Midland Area Farmers Market circular pavilion following May 2020 dam failure and flooding incidents (Jeffery and Miller/Proctor 2020)

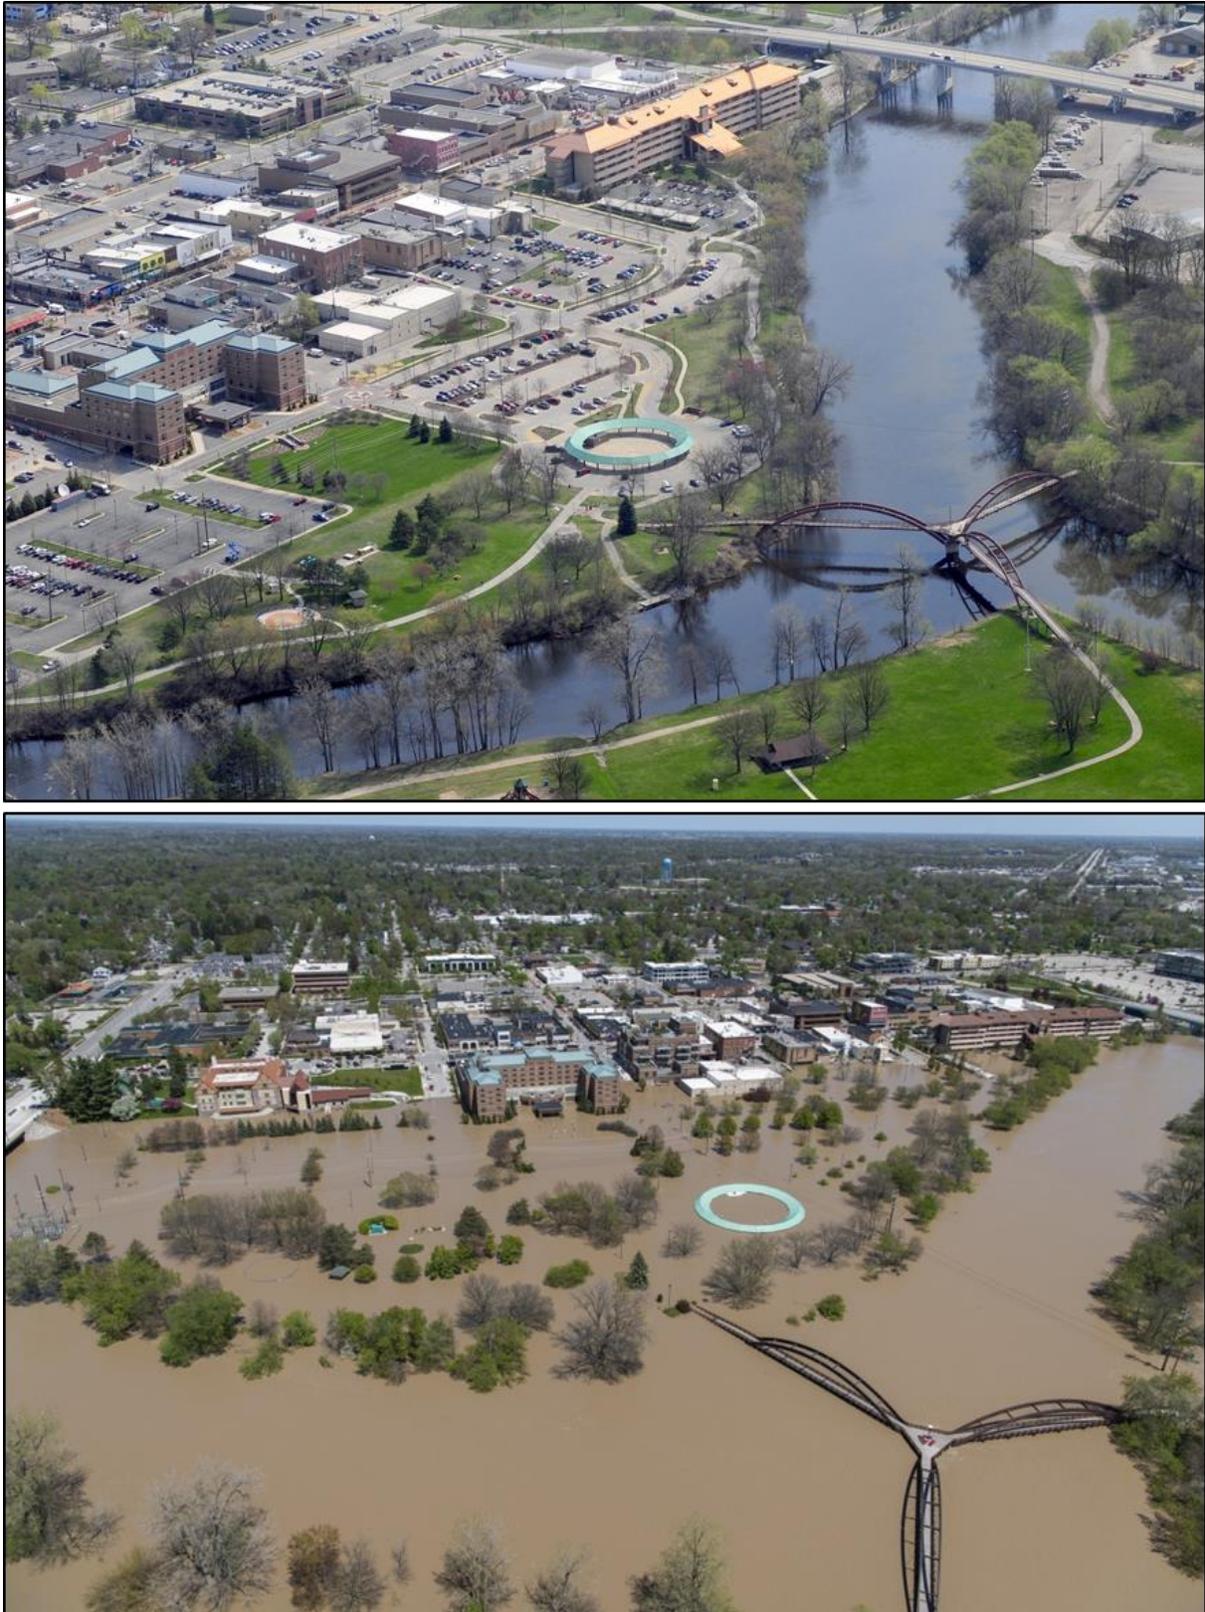
Figure 32: Downtown Midland before and after the dam failures (*top*, July 2012; *bottom*, May 2020)
(Campbell/Schrier 2012, S. Thompson 2020)

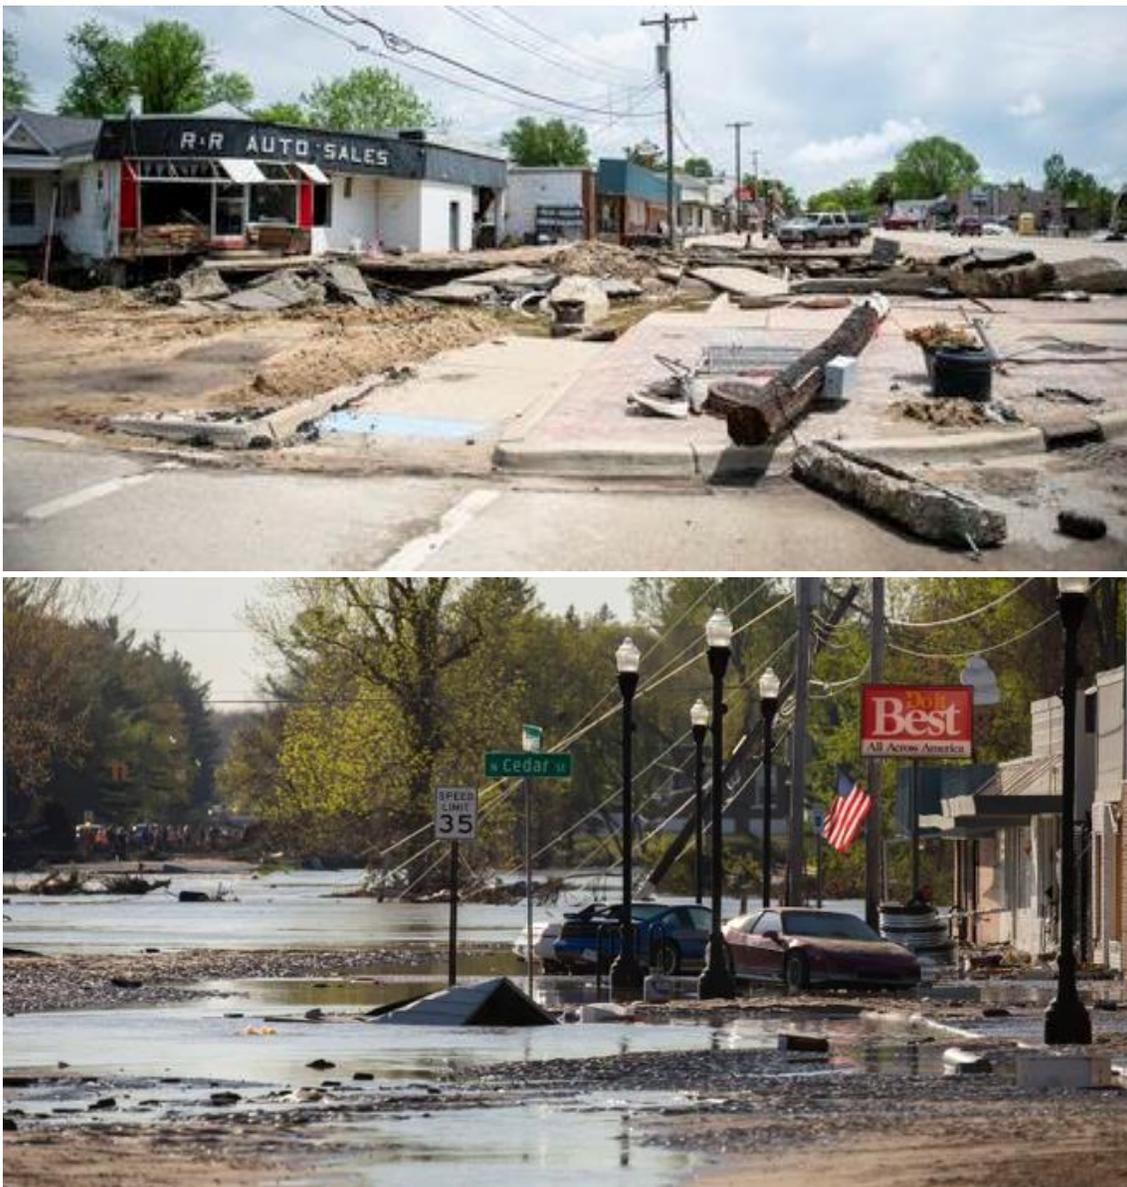
After the floodwaters receded, debris and destruction littered the streets and other inundated areas (Figure 33). Debris was left piled up behind remaining structures at the Sanford Dam (Figure 34), on bridges (Figure 35), and against bridge pilings (Figure 21, Box 2). Large additional waste and garbage (Figure 36) was generated by home and business owners doing cleanup and repair activities.

Figure 33: Debris and destruction littered the streets in downtown Sanford after floodwaters receded (Boomer 2020, Witsil 2020)

Extensive debris removal continued for months after the May 2020 incidents. Officials estimated that more than one million pounds of debris has been removed from Sanford (Kanerva 2020). In Midland, more than 110,000 cubic yards of debris was reportedly collected during their cleanup. This is triple the amount that ordinarily is sent to the landfill in a year (PBS 2020).

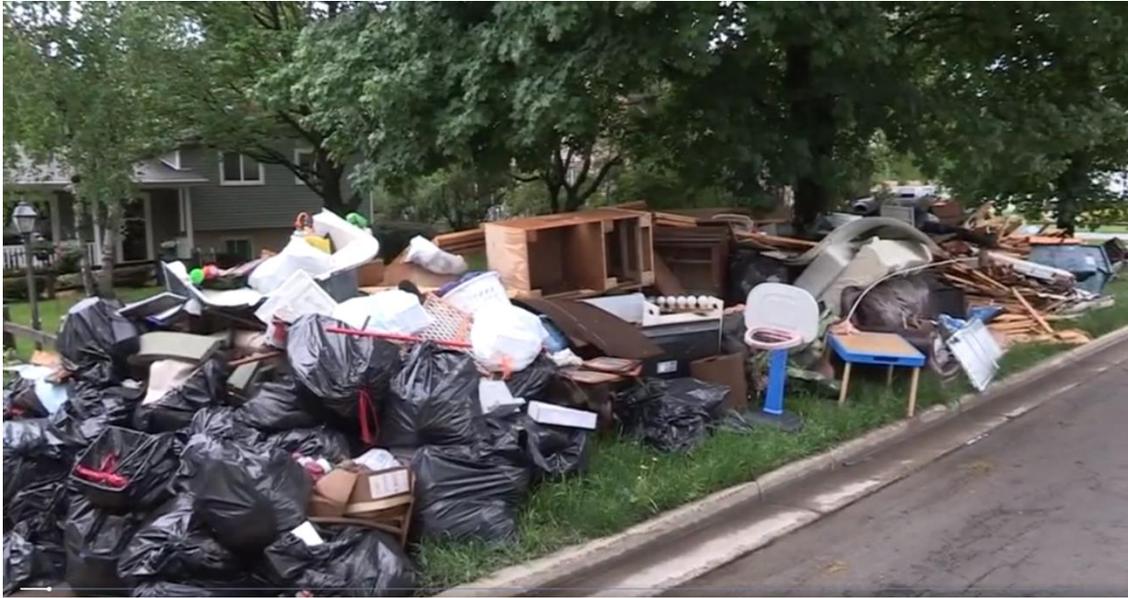
Figure 36: Large quantities of waste and garbage generated by home and business owners from cleanup and repairs activities (PBS 2020)

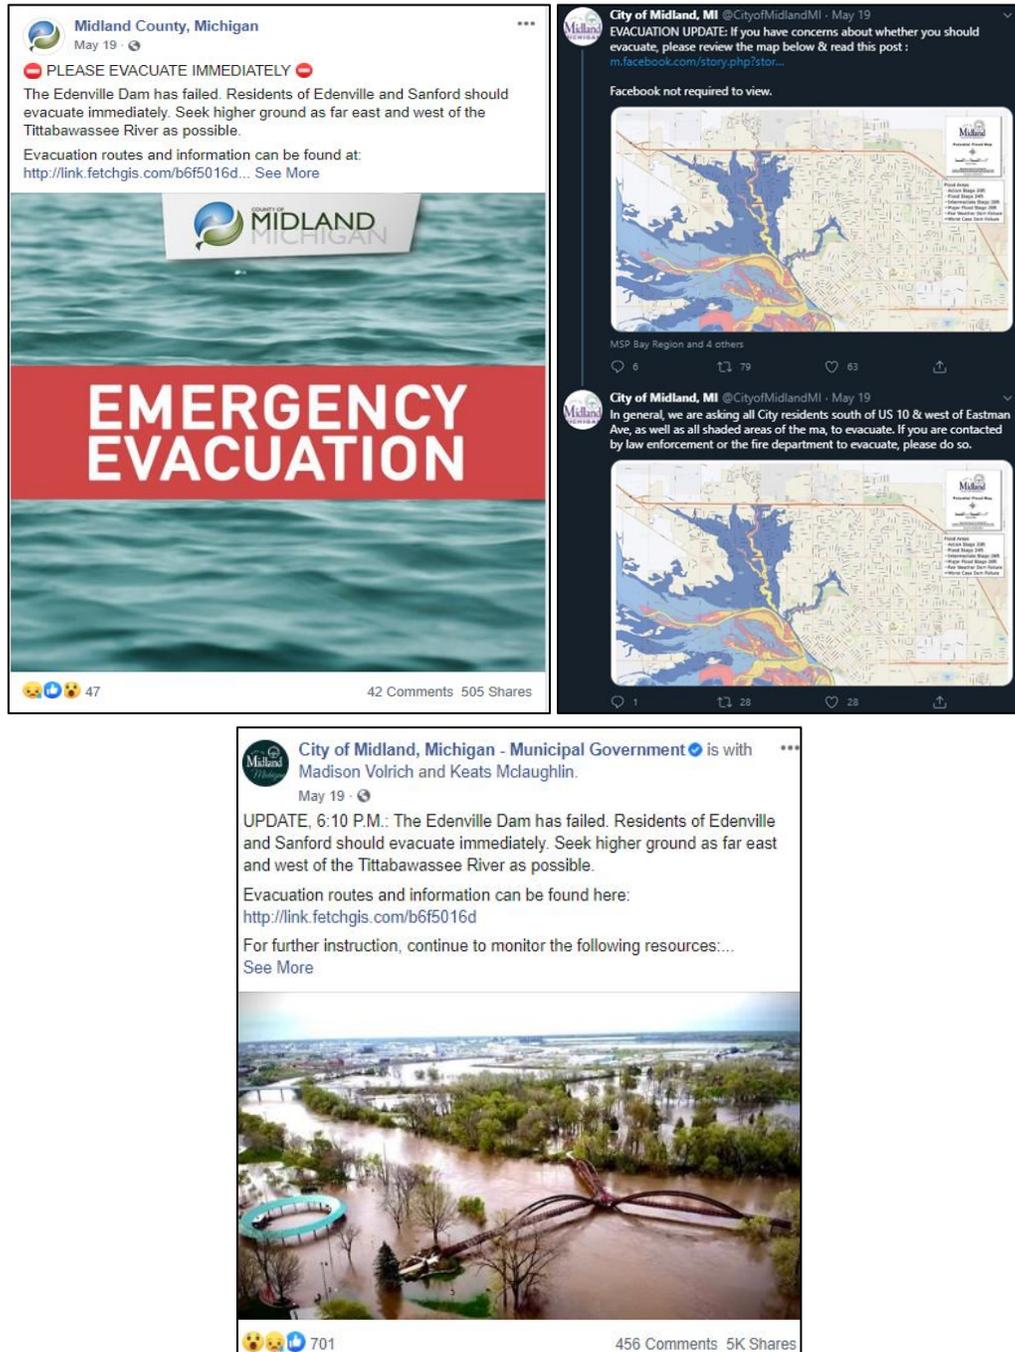
Figure 38: Alerts and messages included clear and appropriate visuals (City of Midland 2020a,b, Midland County 2020b)

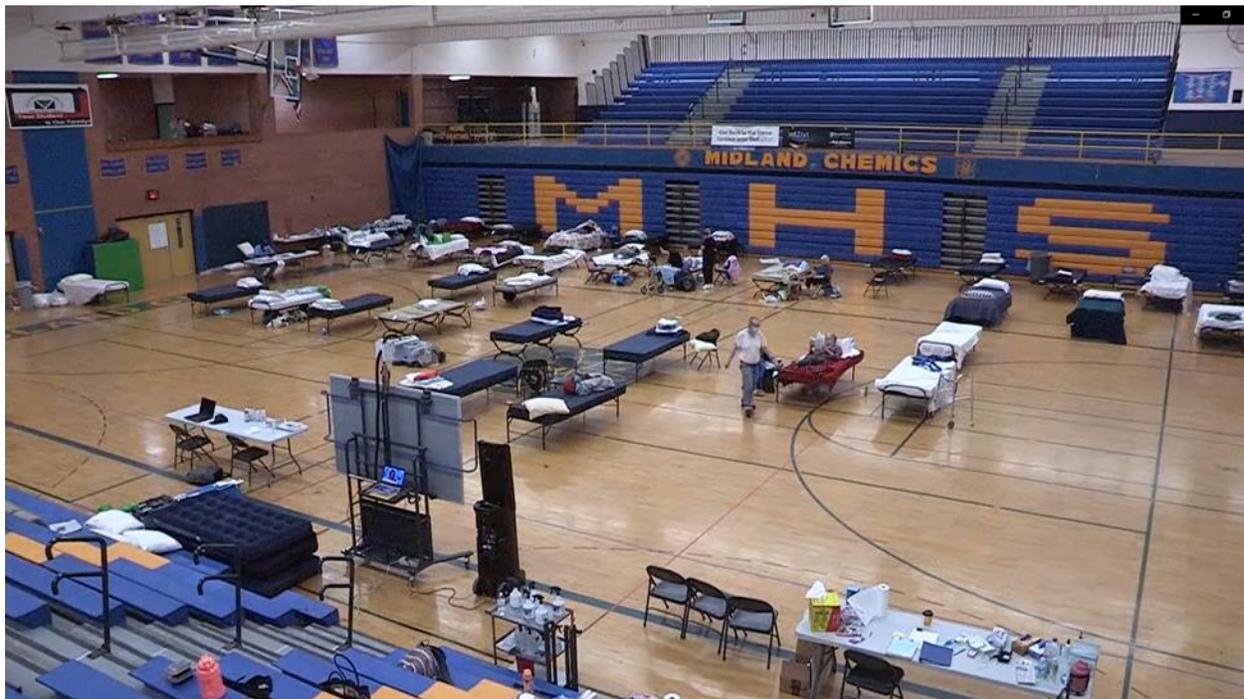
Figure 39: Emergency congregated shelter setup in the Midland High School gymnasium (PBS 2020)
