CAUSE AND CONSEQUENCE OF THE FUJINUMA DAM FAILURE FROM THE 2011 TOHOKU EARTHQUAKE

Paul Risher, PE
Senior Water Resources Engineer

September 13, 2021 • ASDSO Dam Safety National Conference

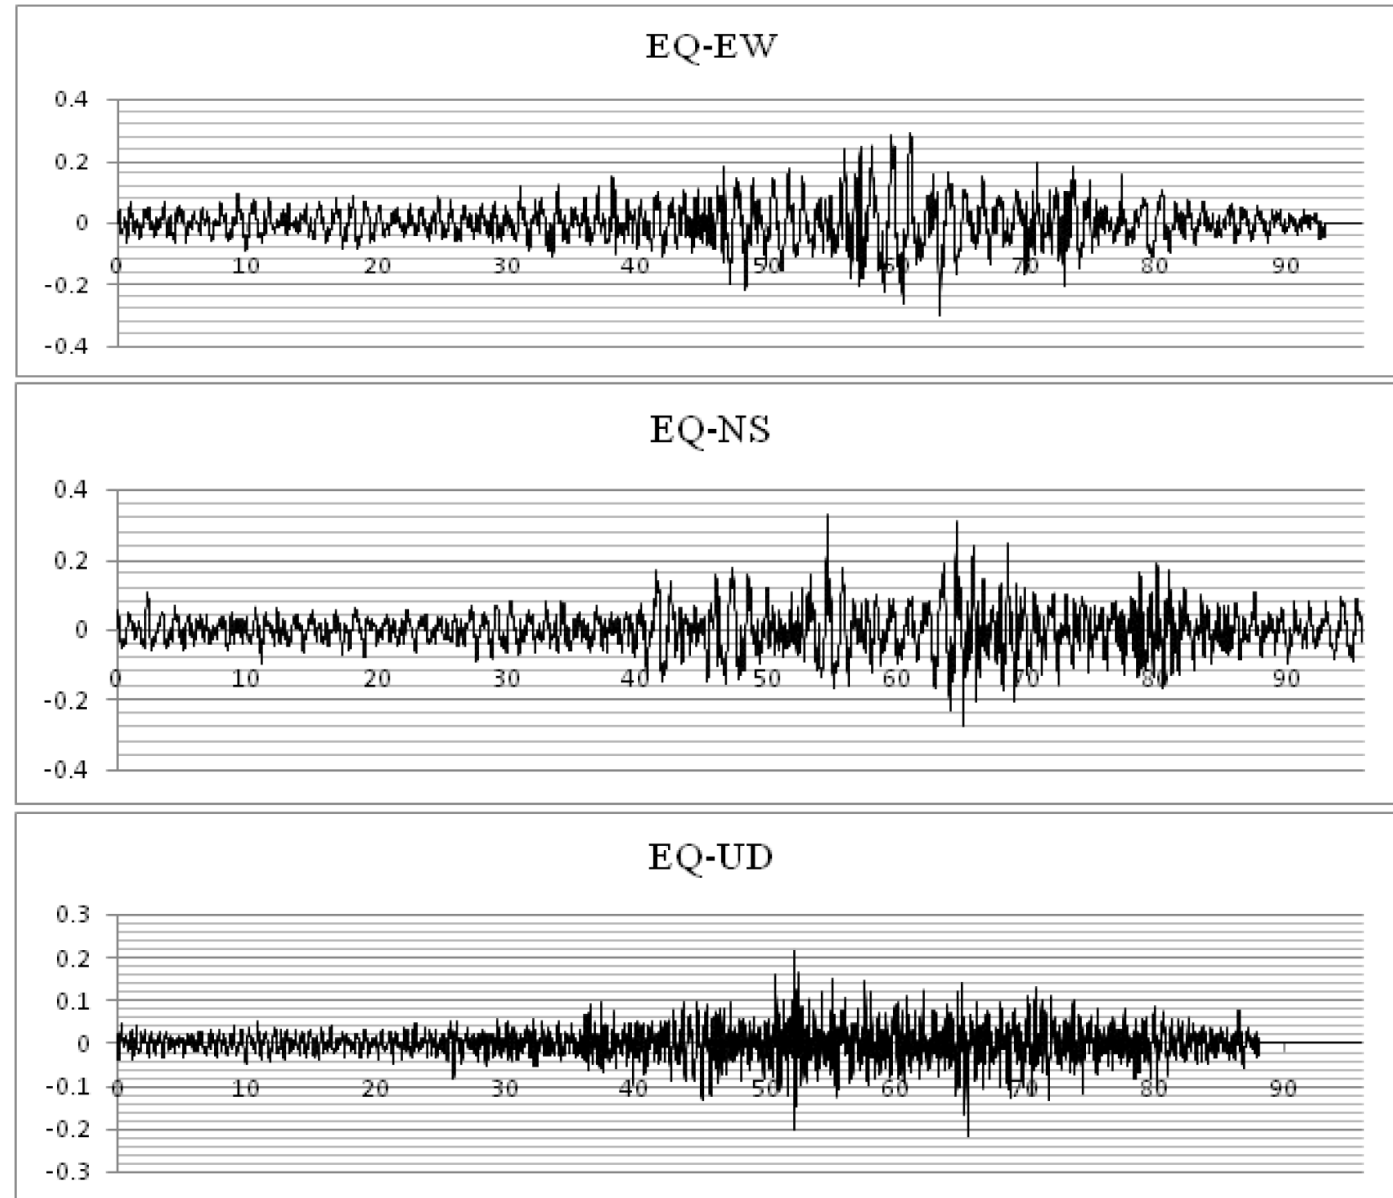
- Seismograph 2.8 Km away
- Max 0.315g
- Shaking lasted up to 300 sec.

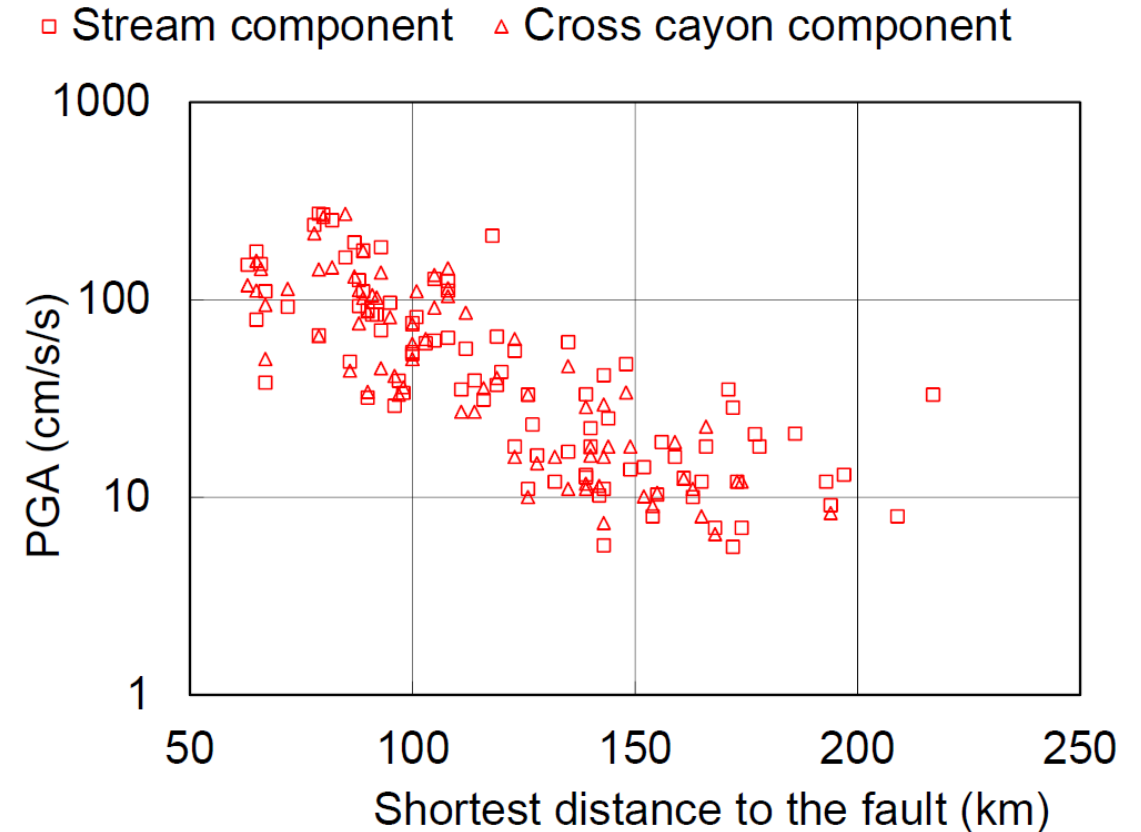
PGA at dam foundations (Horizontal)

- 750 of 3730 agricultural dams were damaged in Fukushima, 1 failure
- Only 2nd known type of seismic induced dam failure in Japan (1st since 1854)
- Others have failed by seepage through large cracks (hours to days later)
- Embankment dams had the worst damage
 - Some bad longitudinal cracking
- Some concrete dams also damaged

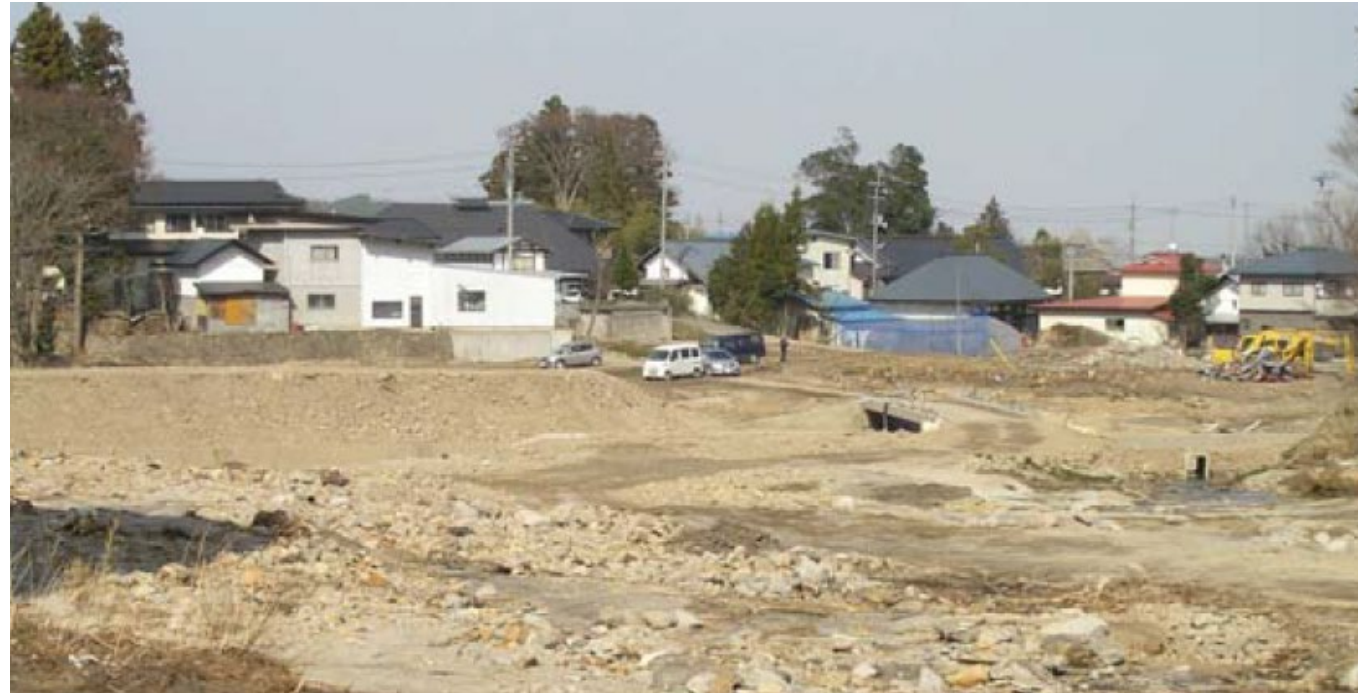
Dam Failure Consequences

- 19 homes destroyed
 - 32 homes flooded inside
 - 30 with flooding below the first floor
 - Other buildings damaged
-
- 3.78 people / HH in 2010 (census)
 - PAR = ~306
-
- 8 flood fatalities (2.6% of PAR)
 - 4 others from the earthquake
