The Meadow Pond Dam Dam Tragedy

Human and Physical Failures

ABSTRACT

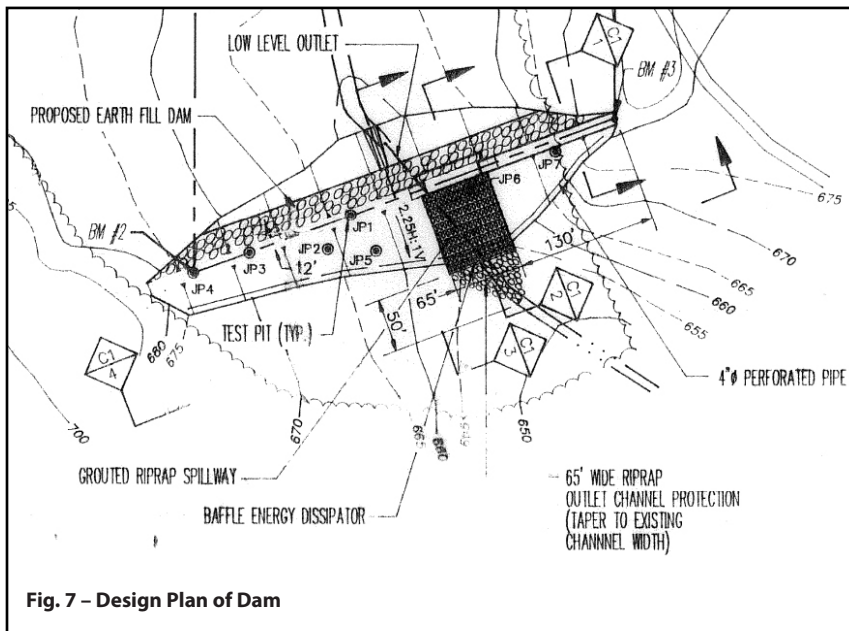
Fig. 7 - Design Plan of Dam

a gravel blanket protected the upper 10 ft of the upstream slope. Figures 7, 8, and 9 show the design plan, elevation, and section at the spillway (note: Figs. 7-11 are excerpts taken from the original design drawings).

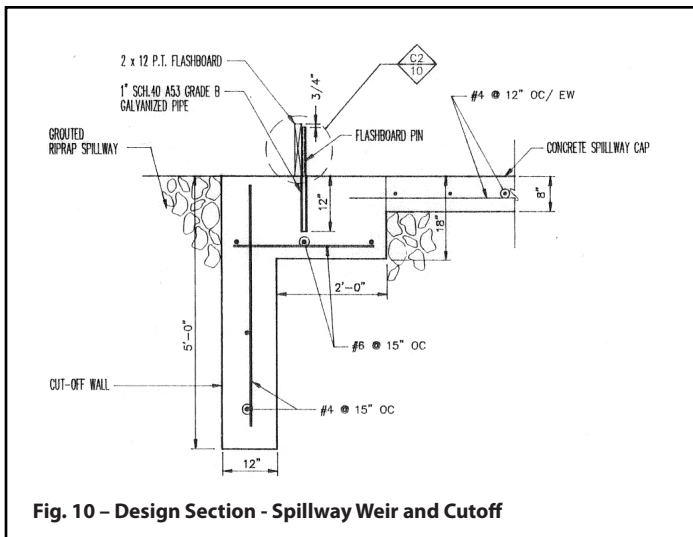
Fig. 10 – Design Section - Spillway Weir and Cutoff

- A 3-ft-wide weir/stop log section on the upstream edge of the crest, set at the same elevation as the 8-inch slab and tied to the 8-inch slab with reinforcing (Fig. 10). The upstream 1-ft-wide section of the weir was designed as a seepage cutoff extending to a depth of 5 ft, while the downstream 2-ft-wide section of the weir was to have a depth of 18 inches. 11.25-inch-high flashboards topped the weir and were supported by galvanized pipes set in the weir. With the stoplogs, the dam had a freeboard of 2 ft.

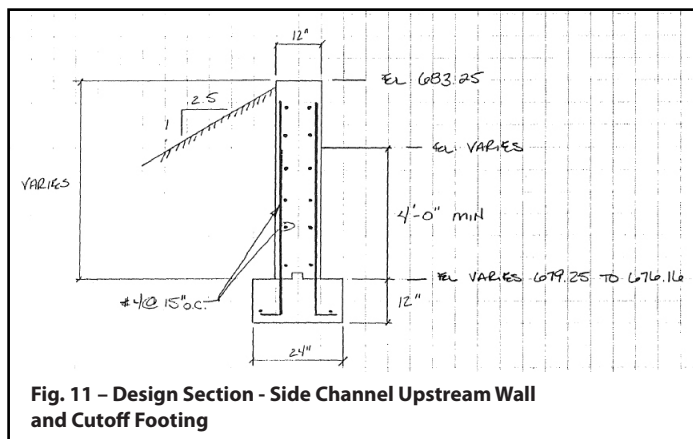
Fig. 11 – Design Section - Side Channel Upstream Wall and Cutoff Footing

- 5H:1V channel side slopes across the crest, also covered by an 8-inch-thick reinforced concrete slab.
- A variable height reinforced concrete wall on the upstream side of the side slopes with a design crest set at the same elevation as the embankment (Fig. 11). This side slope wall was designed with a 5-ft-deep reinforced concrete strip footing, which was to act as a seepage cutoff. Both the wall and the cutoff footing were to extend 27 ft from the level part of the spillway, 12 ft laterally beyond the top of the side channel slopes, on either side.
