WALTER BOULDIN DAM FAILURE  
AND RECONSTRUCTION

SEPTEMBER 1978

FEDERAL ENERGY REGULATORY COMMISSION  
OFFICE OF ELECTRIC POWER REGULATION  
WASHINGTON, D.C. 20426

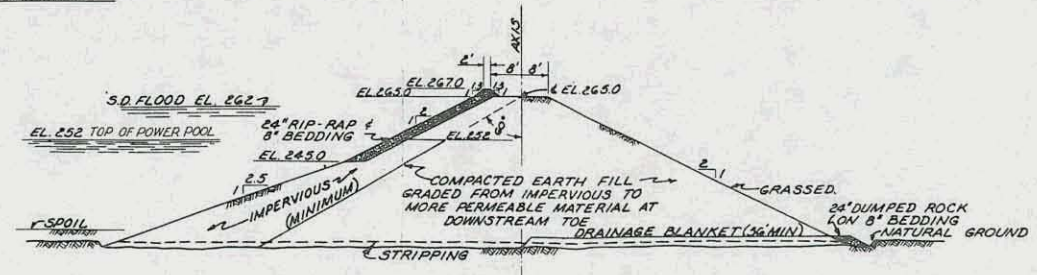
TYPICAL SECTION THRU DIKE  
SCALE: 1" = 20'

Except where the embankment joined the concrete structure, fairly moderate slopes were used. A typical section of the earth dike is included on Plate 3. The

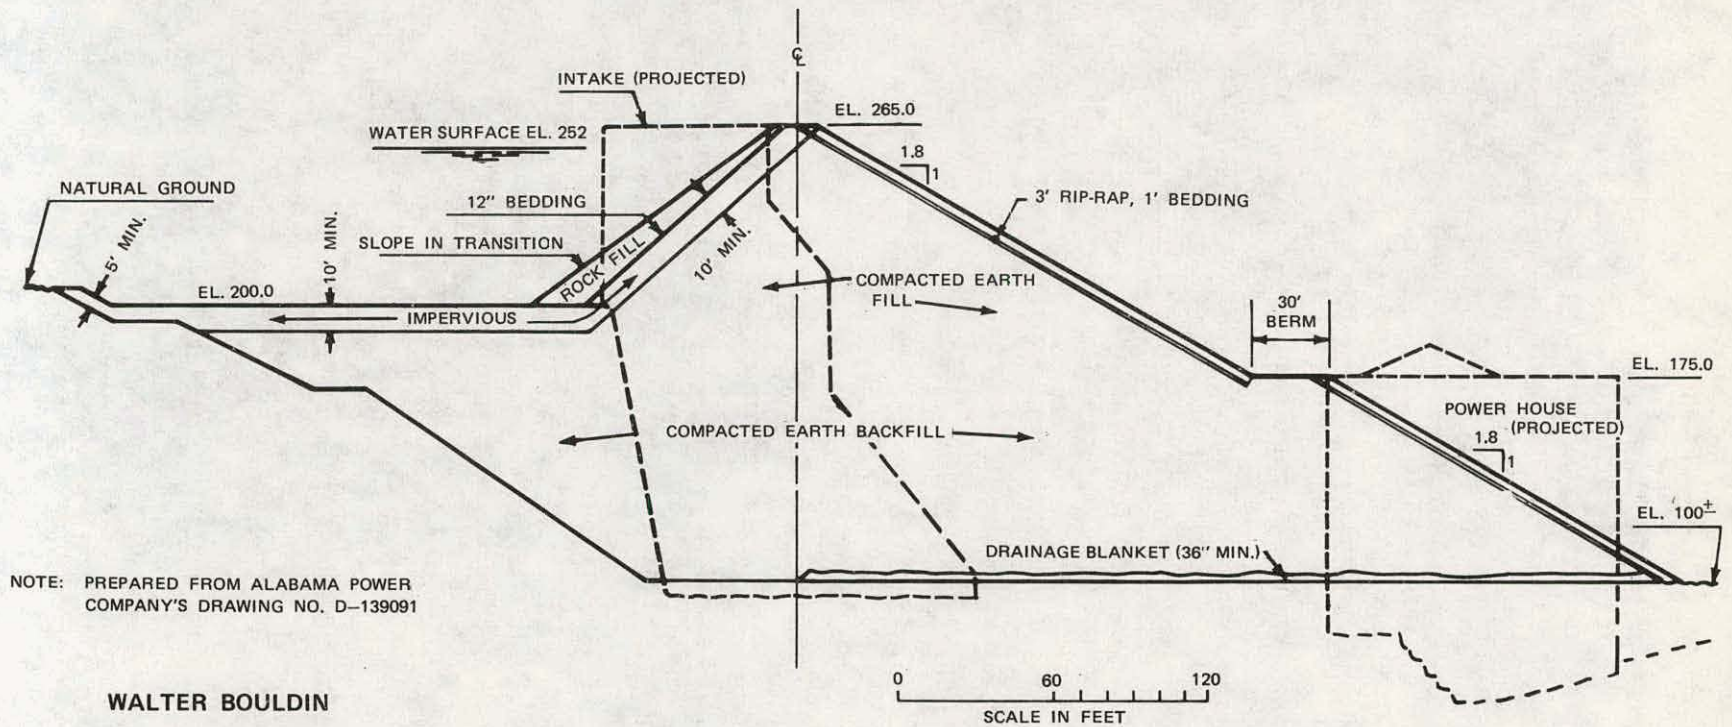
WALTER BOULDIN DAM  
FAILURE AREA

1-02 Failure of Earth Embankment. The Bouldin Dam earth embankment was breached at approximately 1:30 a.m. on February 10, 1975. The breach occurred adjacent to the intake on the east side. Plate 5 shows the location of the failure area with respect to project features. Before- and after-photographs of the failure area are shown on Plates 6 and 7. The breach in the earth embankment extended about 300 feet eastward of the east face of the intake structure. Erosion at the breach extended vertically downward to remove a significant volume of the foundation and the backfill at the east end of the concrete structure. A portion of the scoured area was backfilled with granular material, apparently from the action of gradually decreasing water velocities following the breach. Subsequent investigations indicated that the scour exceeded the depth of the original excavation for the construction. The maximum depth of scour was 165 feet below the top of the earth embankment and occurred near the east edge of the powerhouse. A cross section of the designed embankment section at the location of the breach east of the intake is shown on Plate 8.

Erosion to a depth of 50 feet below the original reservoir bottom continued along the upstream toe of the dike both east and west of the concrete structure. The semicircular trash rack structure, enclosing the entrance of the intake, was demolished and deposited in the foundation and tailrace area. The upstream slopes of both the east and west dikes were undercut extensively, creating numerous slides. Two of the more conspicuous failure zones included: (1) a 500-foot section of the east dike beyond the 300-foot breach which had its upper portion removed to about station 54 and (2) a drawdown slide, a secondary failure over 500 feet long, which occurred at the upstream slope of the west embankment near the location of the microwave tower.
