## Risk Analysis Perspectives on the Camará Dam Failure

Cassandra Wagner, P.G., Engineering Geologist, Bureau of Reclamation, Technical Service Center  
Dom Galic, P.E., Geotechnical Engineer, Bureau of Reclamation, Technical Service Center

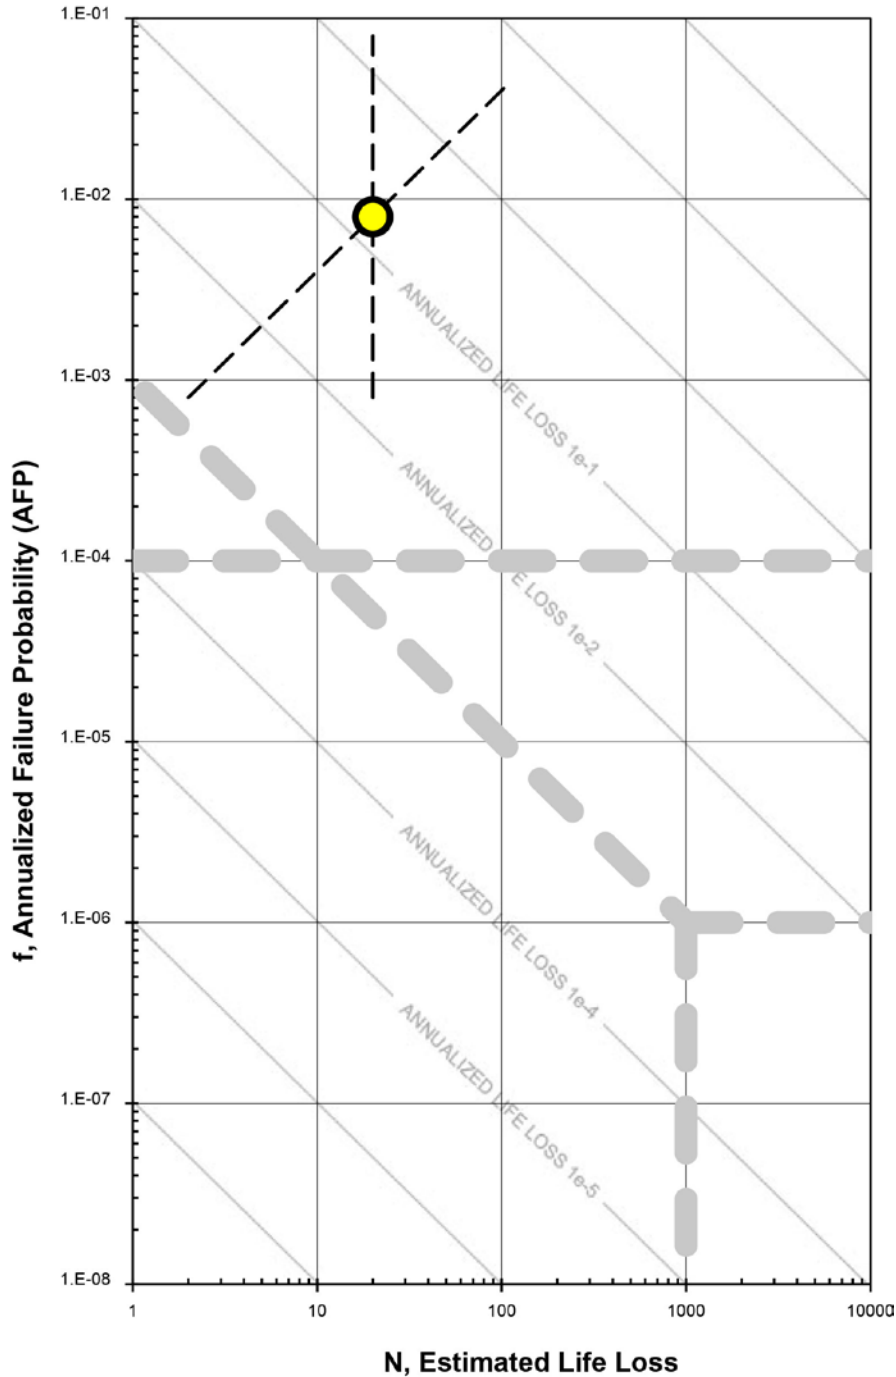
The fN chart risk portrayal corresponding to the failure probability and life loss estimates developed by the hypothetical risk team is shown in Figure 4. The total risk marker, which is associated directly with the uplift PFM (since no other PFMs are considered for this exercise), plots approximately two orders of magnitude above both the AFP and Annualized Life Loss guidelines. While an estimated AFP on the order of 1E-2 would in itself be a cause for concern (since the average dam failure probability *before* the passage of dam safety legislation in the 1970s was only about 1E-4 [12]), the risk estimates would not be used as the sole basis for any recommended actions. Instead, a case for action would have been built by bringing in additional arguments, such as:

Figure 4. Hypothetical risk portrayal circa February 2004. Yellow marker shows the total risk for the dam (with respect to the PFM evaluated). The size of the uncertainty cross hairs would be based on the results of a Monte Carlo simulation of the output AFP and Annualized Life Loss distributions.

In taking action to reduce the risk of failure, the logical first step would have been to lower the reservoir and keep it as low as possible. Other interim actions, such as 24-hour monitoring, would also have been considered, and conversations with emergency response staff would likely have been initiated. Once the situation at the dam had been stabilized (to the extent that this was possible under the projected inflows), long-term risk reduction measures would have been evaluated, and a permanent modification designed. Some of the modification alternatives that would potentially have been considered are discussed below.
