Best Practices in Dam and Levee Safety Risk Analysis

Part H – Other Risks

Chapter H-2 Landslides

June 2017

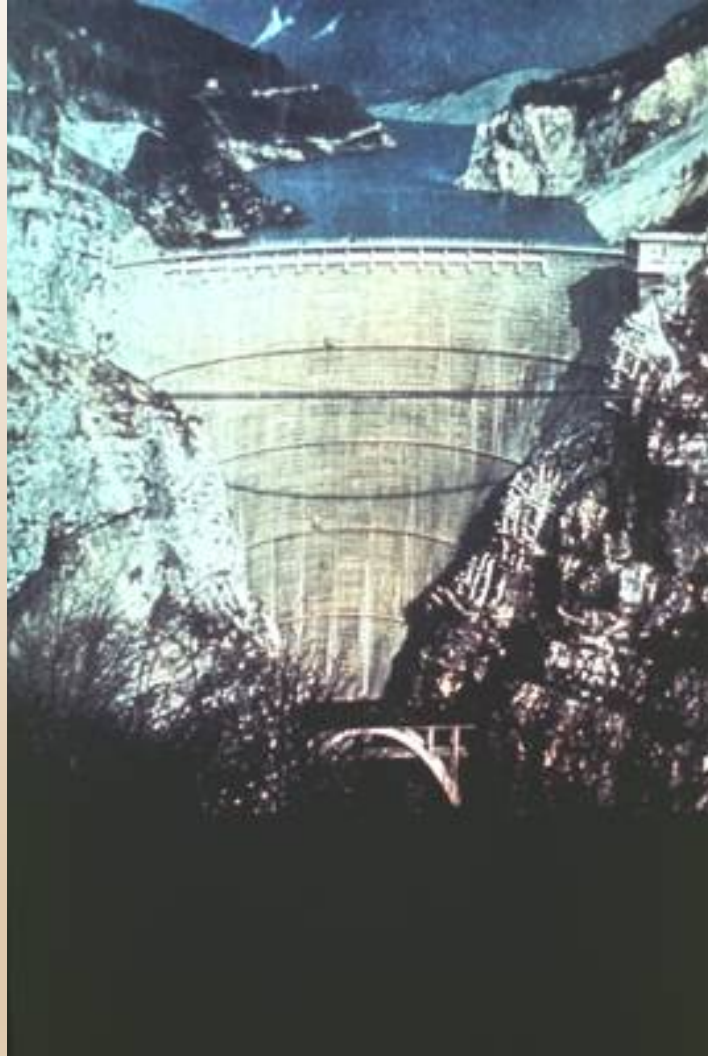
Vaiont Dam, Italy

- 870' high arch dam on Vaiont River near Longarone, Italy
- Completed in 1960
- The foundation and reservoir slopes composed of bedded limestone
- Left bank slide mass from post-glacial period

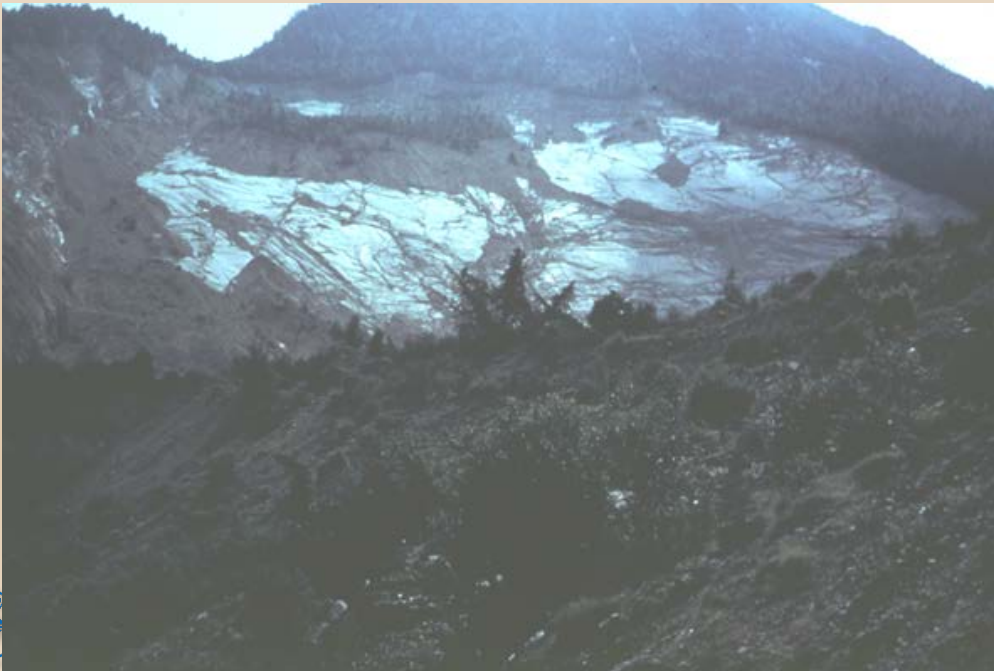
Vaiont Dam (Overtopping Wave)

- A part of the mountain side slid into the reservoir on Oct. 9, 1963
- Filled the entire reservoir for a mile upstream of the dam creating huge wave
- Sliding occurred on clay-filled bedding planes with $\phi = 10$ to 12° with dip of $35^\circ \pm$ to 0°
- Approx. 250 million yd^3

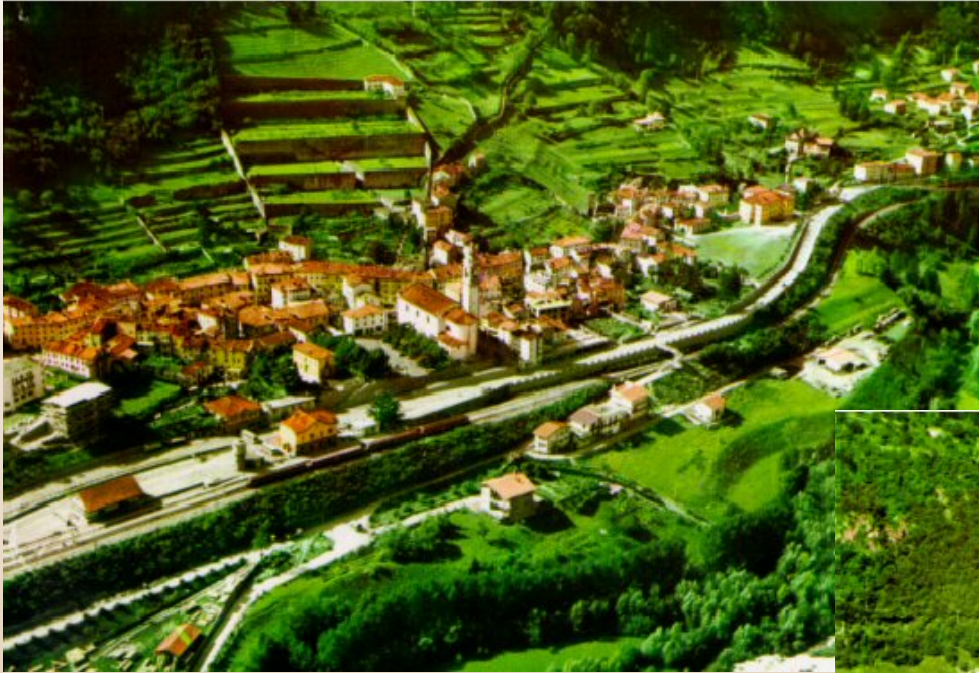
Slide sent wall of water
330' high over the top of
the dam downstream
(dam survived)

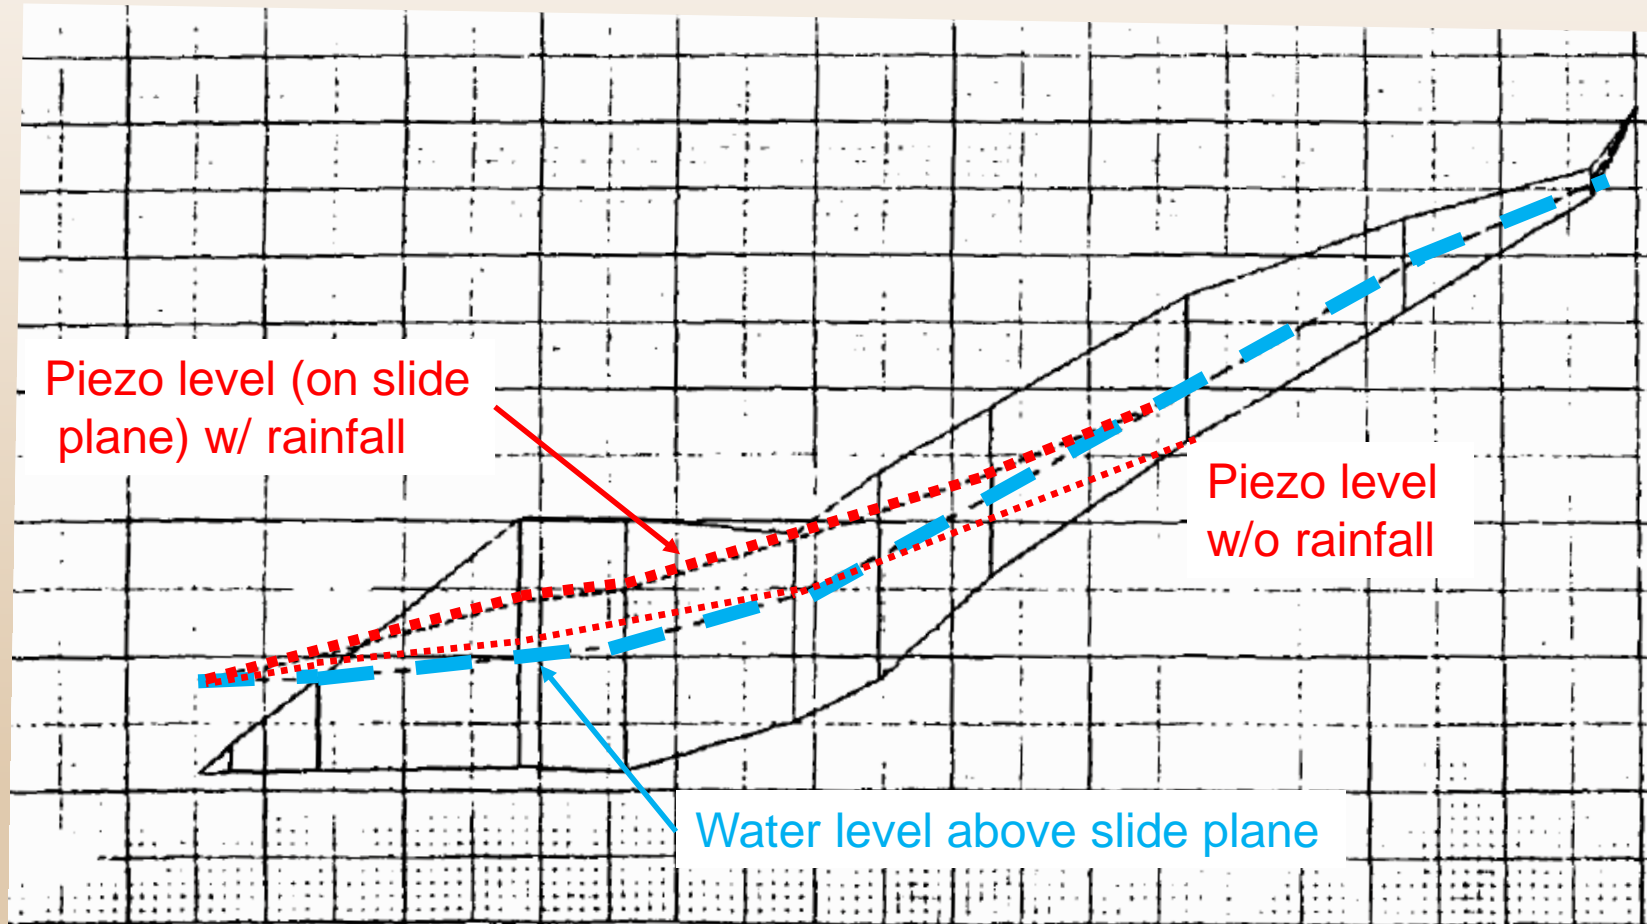
Vaiont Dam 3-D

Res (m)	Rain	F.S.
710	High	1.00
710	Low	1.10
650	High	1.08
650	Low	1.18
None	High	1.12
None	Low	1.21

Vaiont Slide - Semenza Section 2, 710 m reservoir, October 1963, with rainfall

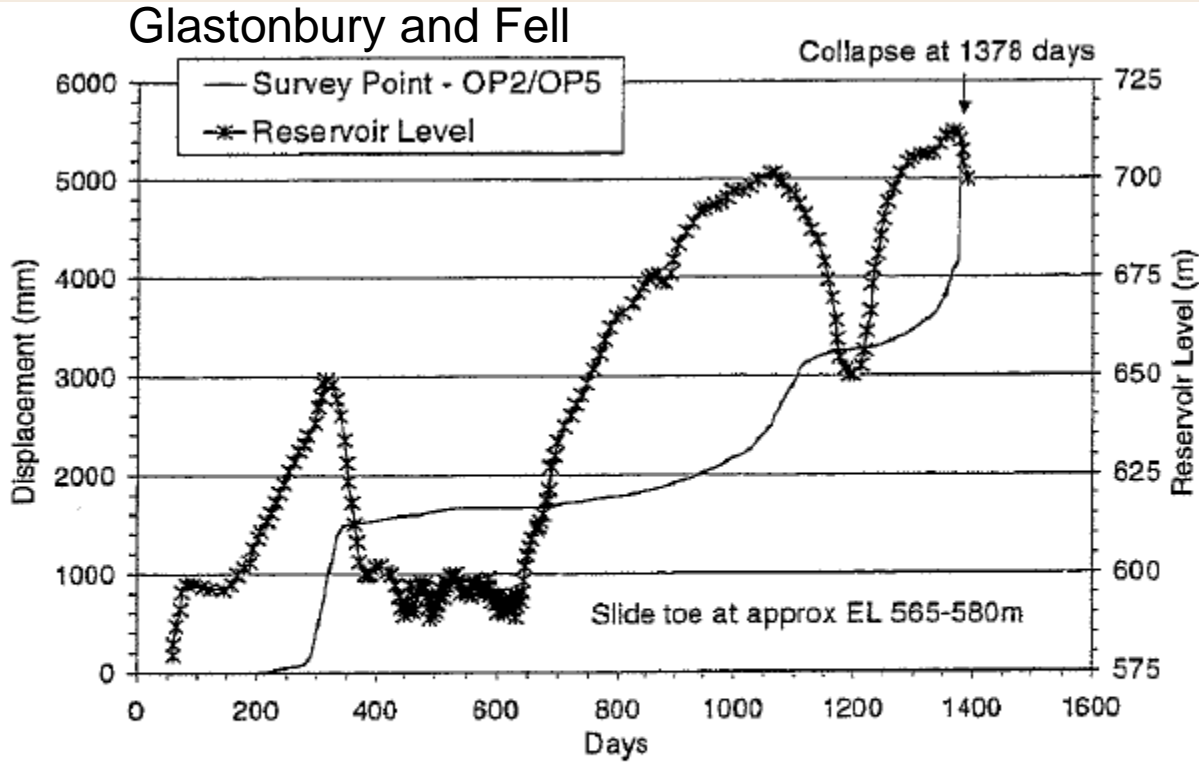
Displacement and Reservoir Level vs Time

Figure Q : Displacement-time data for Vaiont showing relationship with reservoir level (Data modified from Hendron and Patton, 1985).

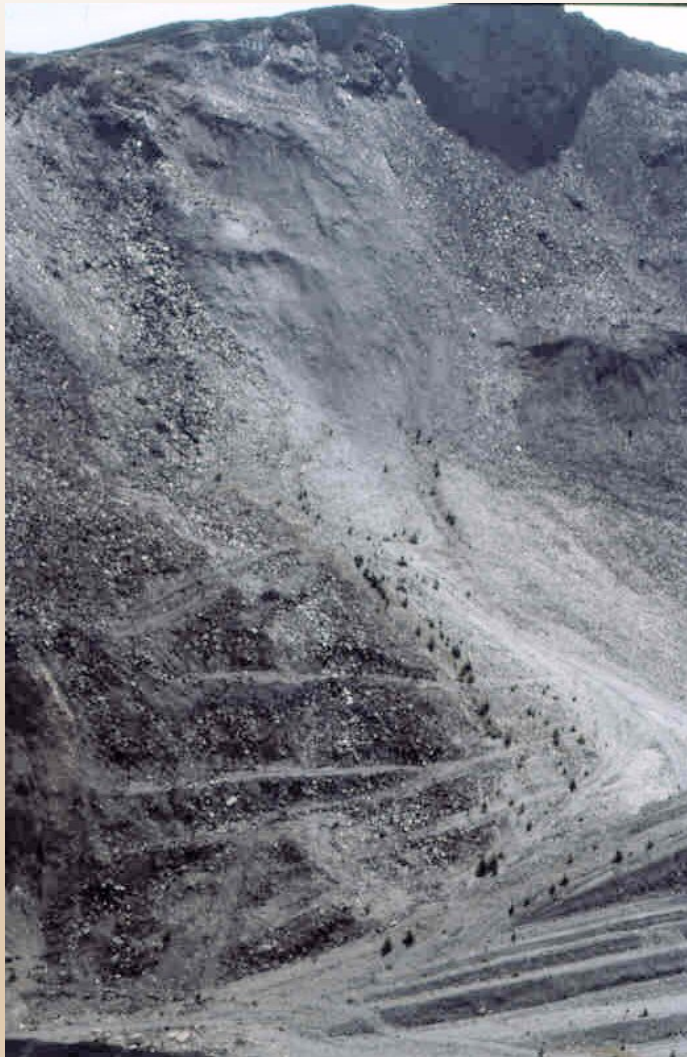
Quake Lake Landslide

- Triggered by August 17, 1959 Hebgen Lake E.Q.
- M7.5-7.8 in SW part of Yellowstone Park
- 43,000,000 c.y. slid across canyon and up opposite side nearly 400'
- 27 fatalities in campground on opposite side of river

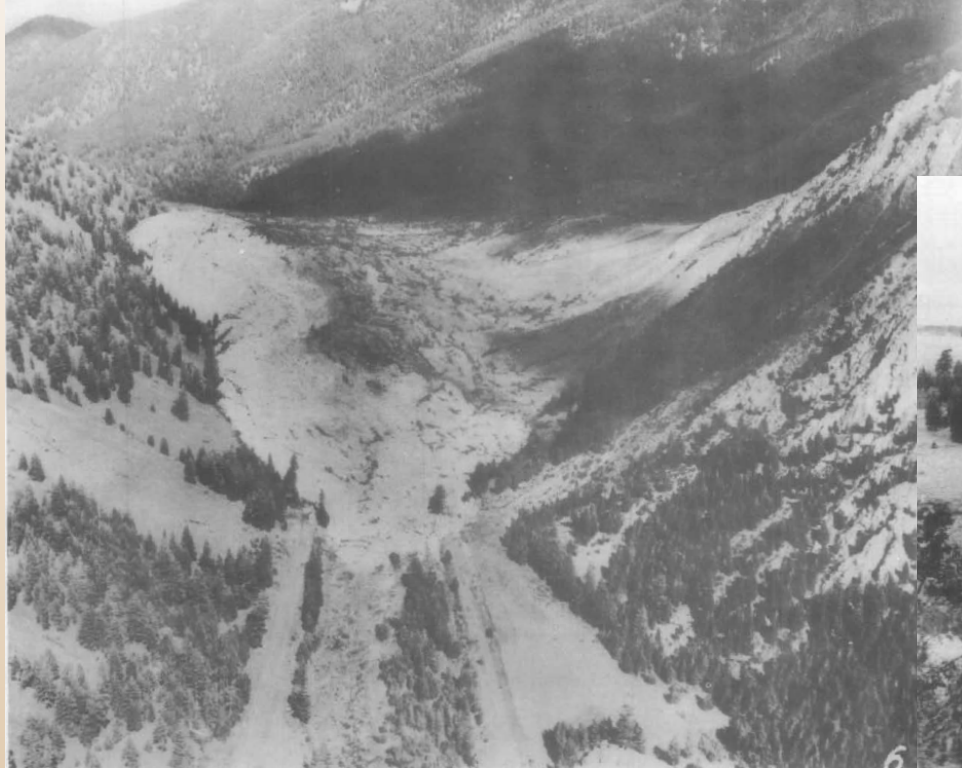
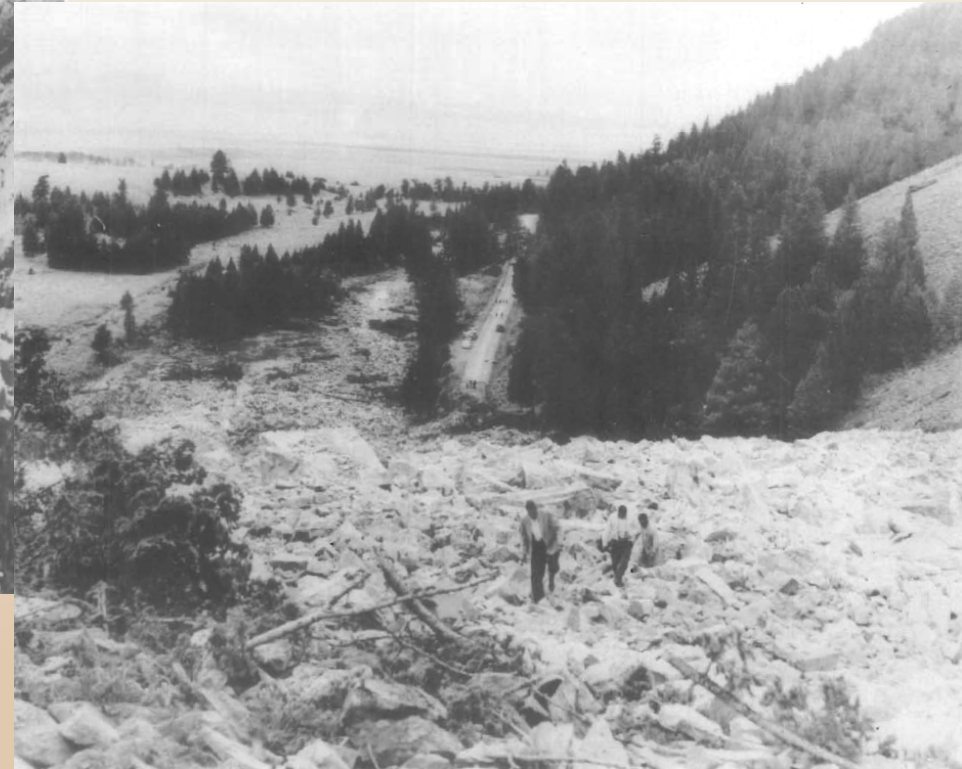
Slide Mass Immediately Afterward

- Landslide debris dam 4,000' long and 200' high across Madison River d/s Hebgen Dam formed "Quake Lake" - leakage to ~ 200 cfs
- Hebgen Lake nearly full at the time and dam was damaged by earthquake (inspection desirable)
- Volume in Hebgen Lake nearly 4 times that which could be accommodated in Quake Lake
- In time allowed, spillway notch 250' wide cut through slide with capacity of 10,000 cfs
- Simultaneous armoring with 2-3' rock
