# Hidden Dangers and Public Safety at Low-head Dams

BRUCE A. TSCHANTZ, PE

KENNETH R. WRIGHT, PE

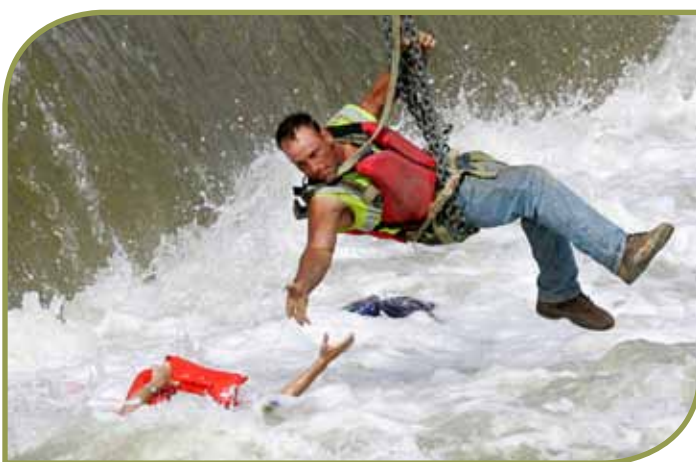
**Figure 1. Photo by Mary Chind, Copyright 2009, The Des Moines Register and Tribune Company. Reprinted with permission.**

Figure 1 shows a dramatic June 30, 2009 rescue below a low-head dam on the Des Moines River, Des Moines, Iowa, where drownings have occurred.

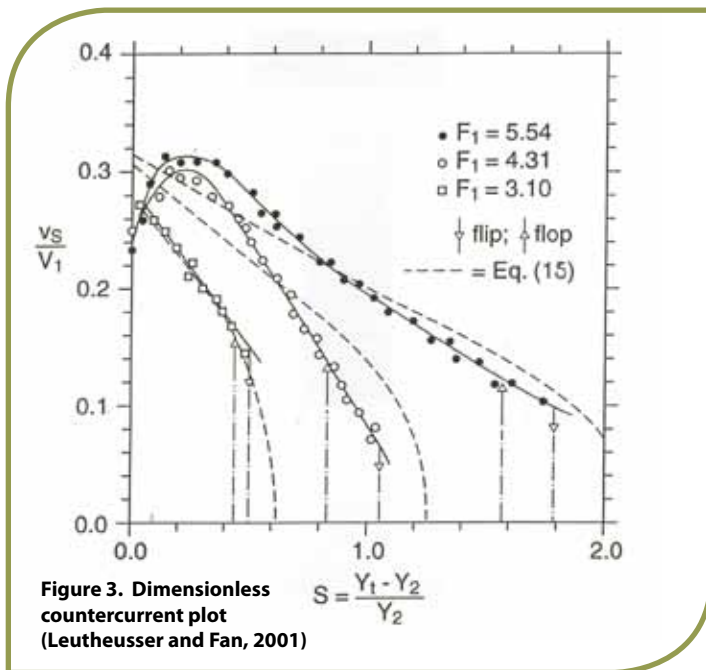
**Figure 3. Dimensionless countercurrent plot (Leutheusser and Fan, 2001)**

Leutheusser and Fan presented a dimensionless chart (Figure 3) for estimating the reversed surface velocity ( $V_s$ ) as a function of its ratio to the supercritical inflow velocity,  $V_s/V_1$ , and a submergence factor  $S = (Y_T - Y_2)/Y_2$ , as defined by Roa and Rajaratnam (1963). Figure 3 shows that during each test, surface countercurrents ( $V_s$ ) exist for a range of  $S$  from zero to a value where a rising tailwater and increasing  $S$  reach a critical point where the nappe flips ( $\nabla$ ) to the free surface, the jump is drowned out, and the vortex vanishes simultaneously. At this point, a dangerous countercurrent surface velocity ceases to exist. On the other hand, a decreasing tailwater depth and lower  $S$  force the nappe to flop back ( $\Delta$ ), to begin to cause dangerous countercurrent conditions. In other words, a dangerous condition will always exist for  $S$ -values less than the flop ( $\Delta$ ) points for any Froude Number. The small range of  $S$  between flip and flop is explained in terms of incomplete ventilation of the nappe when the tailwater decreases. Important conclusions and findings from this work and other studies are as follows:

- In Figure 3, starting at about  $V_s/V_1 = 0.25$  where  $S = 0$ , the test curves of different incoming Froude Numbers ( $F_1$ ) peak at about  $V_s/V_1 = 1/3$  at  $S \approx 0.25$  to  $0.30$  and then drop gradually with increasing tailwater and  $S$  to their respective flip and flop points, which occur when the average tailwater depth ( $Y_T$ ) to upstream depth ( $H_0$ ) becomes approximately  $1/1.15$  or 87 percent.

For this example, the subcritical depth after the jump is  $Y_2 = 3.13$  ft. Note that the higher tailwater depth of 4.1 ft will thus force the jump upstream against the weir and cause it to be mildly submerged (Case C). The submergence ratio  $S = (4.1 - 3.13)/3.13 = 0.3$  can be seen in Figure 3 to cause a maximum countercurrent velocity  $V_s/V_1$  ratio equal to about 0.31 for  $F_1 = 4.75$ . Thus maximum surface velocity toward the dam is  $V_s = V_1 [V_s/V_1] = 19.1(0.31) = 5.92$  ft/sec, or almost 6 ft/sec\*.

\*If the tailwater for this flow had risen to approximately 87 percent of the headwater depth  $H_0 = 8$  feet, or about 7 feet,  $S$  would increase to a critical “flip” point (approximately 1.2 in Figure 3) where the jump would be completely drowned out and would no longer produce dangerous countercurrents, as represented in Case D of Figure 2. It can also be demonstrated for this example that tailwater depths within the range,  $3.3 < Y_T < 4.7$ , would produce reversed current velocities in excess of 5 ft/sec.

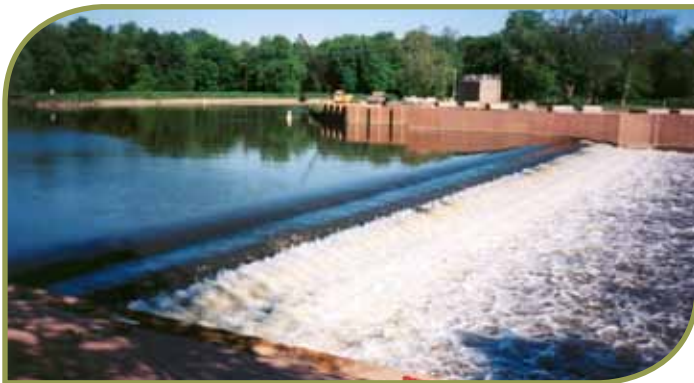
**Figure 7. Island Farm Weir stepped spillway modification.**

The Island Farm Weir was modified in 1998 after four drownings and three near-drownings in only three years following its construction. The successful retrofit consisted of providing a series of steps on the downstream face (Figure 7) to dissipate energy and to eliminate the opportunity for a submerged jump and reverse roller to form below the dam structure.

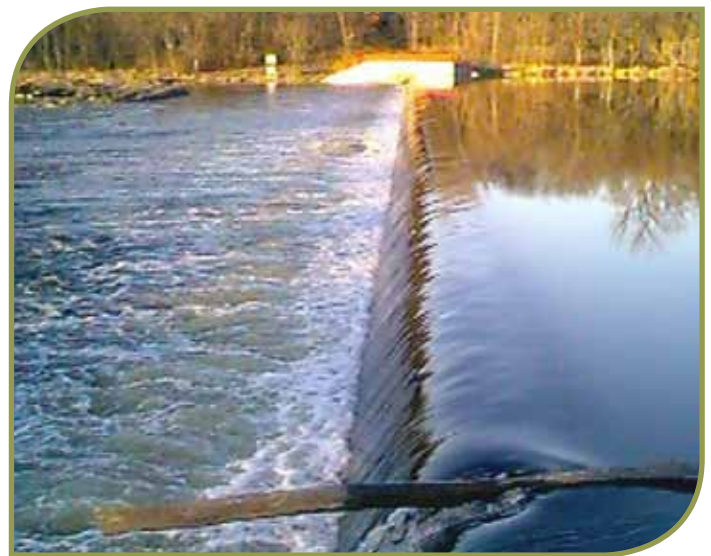
**Figure 8. Yorkville Dam on the Fox River.**

While accidents and drownings at low-head dams are reported regularly in the local and national media, little statistical data is available to assess the full national extent of the problem. Minnesota's Boat and Water Safety Section of the Department of Natural Resources reports 52 deaths and 50 injured or rescued people at low-head dams in that state between 1974 and 2002 (Minn., 2003). In Illinois, the Fox River has a notoriously dangerous segment of 15 dams in the 115-mile reach, just west of Chicago, between Wisconsin and its mouth at the Illinois River. At the 7-foot high Yorkville Dam (Figure 8), at least 12 people are reported to have drowned since it
