## **A HEIGHTENED FOCUS ON PUBLIC SAFETY AT DAMS DOES NOT HAPPEN BY ACCIDENT**

Located near Leesburg, Virginia in the heart of one of the fastest growing and most affluent areas in the United States, Goose Creek Dam and Beaverdam Creek Dam are important sources for water supply. In the past decade, these dams and their reservoirs have become destinations for public interaction and recreation. Because of increased development and public awareness and usage of these facilities, Loudoun Water decided develop a public safety plan for their dams. These public safety efforts were amplified by strategic partnerships with the county government and regional park authority, both of which own and operate park properties adjacent to the reservoirs. Public engagement and acceptance was enormously successful. The United States Society on Dams (USSD) recognized these efforts by selecting Loudoun Water as the recipient of the *2016 Award for Recognition of Public Safety Around Dams*.

The focus of this paper is to present: (1) the process that was used to develop and document a public safety plan; (2) the specific actions implemented by Loudoun Water to protect the public; (3) the methods used to

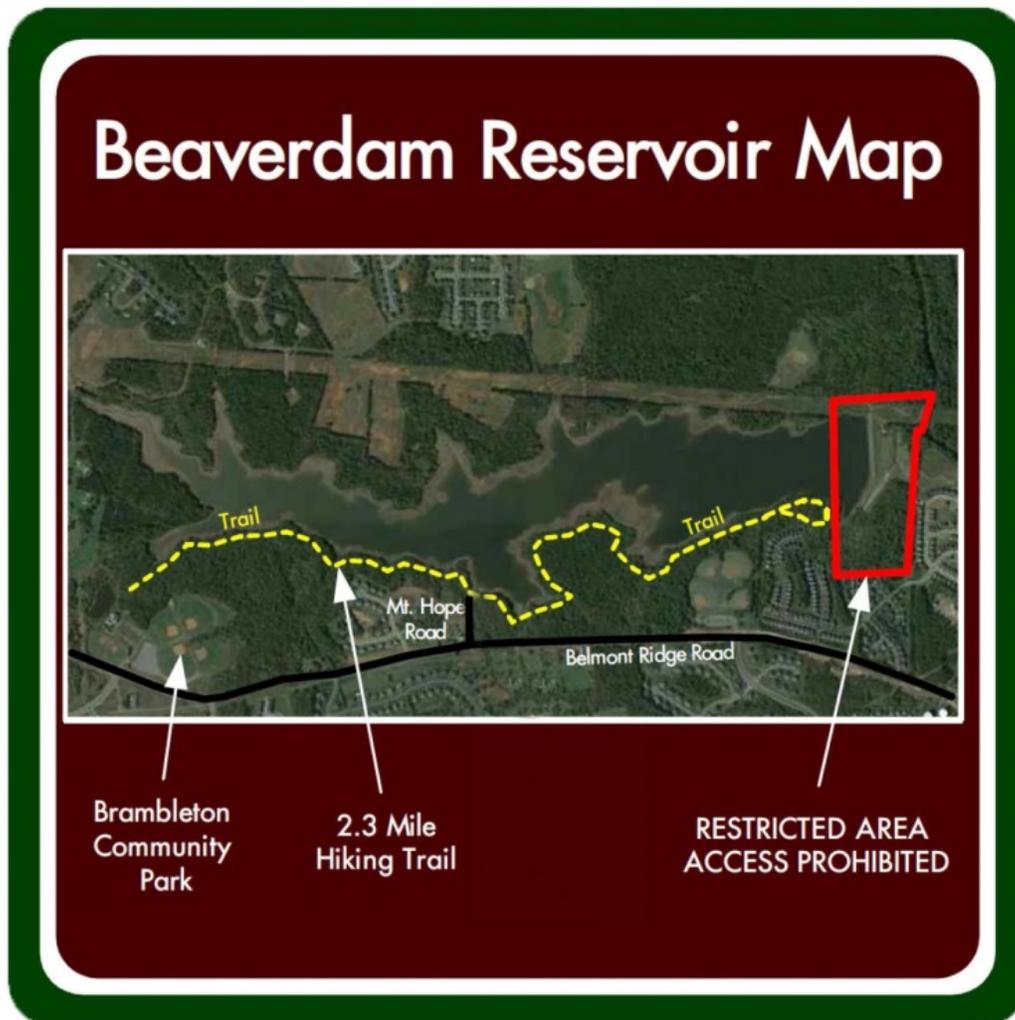
Figure 3: Exclusion Zone / Restricted Area at Beaverdam Creek Dam

- Established restricted areas and exclusion zones in the vicinity of dams and spillways. The exclusion zone at Beaverdam Creek Dam was developed to protect the public from potentially unsafe conditions that can be present during pumped refill or reservoir release operations. The exclusion zones at Goose Creek Dam were developed to alert and warn boaters on the river upstream and downstream of the dam about potentially dangerous conditions that exist in the vicinity of the dam, which mainly relate to the drop over the spillway and the hydraulic roller at the toe of the spillway.

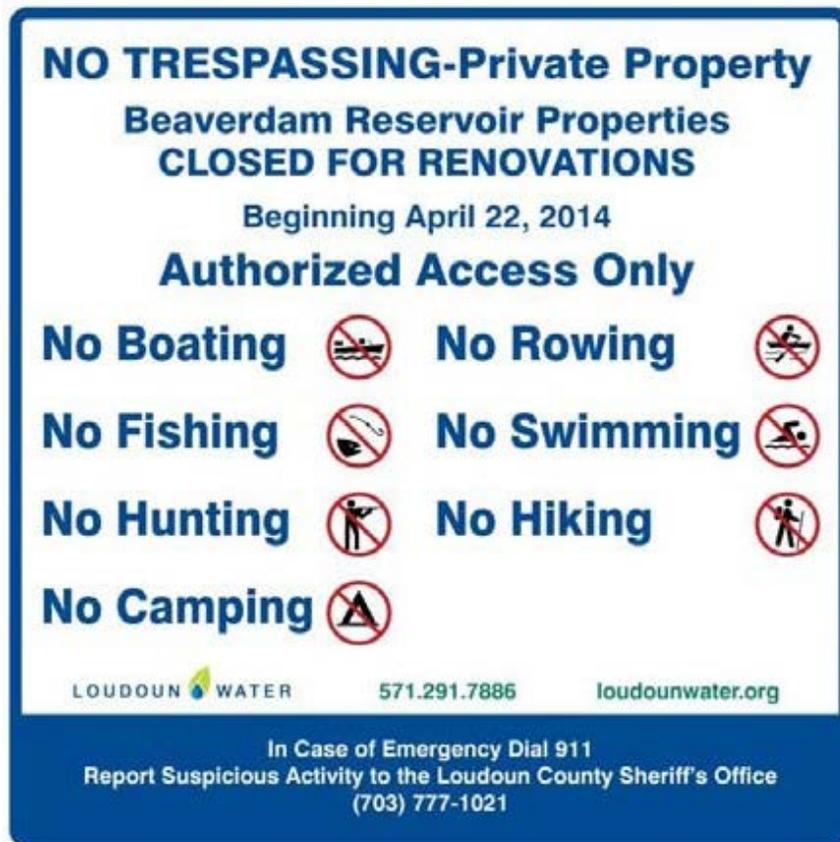
**Figure 4: Warning Sign**

- Installed warning signs consistent with the Public Safety Plan recommendations. The general public is not always aware of the potential dangers that may be present around dams. Boaters upstream of Goose Creek Dam may not be aware of the presence of the dam and could potentially be carried over the ogee weir of the concrete gravity dam. Signs such as the one shown below were placed in the vicinity of the dams to alert the general public of the dangers associated with the facility.

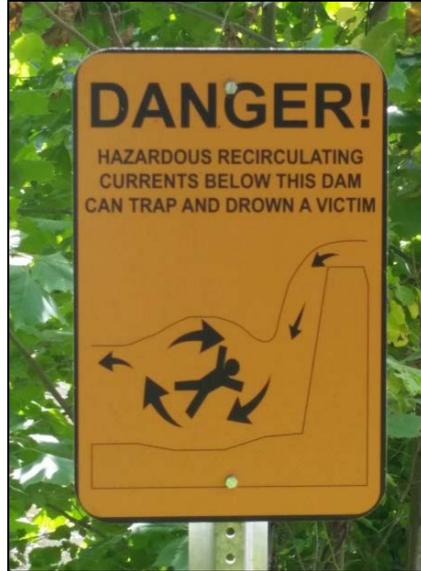
**Figure 5: Warning Sign Installed at Goose Creek Dam**

During certain flow conditions, dangerous hydraulic conditions can develop at the toe of a run-of-the-river concrete gravity dam. Persons swimming, wading, canoeing, or boating at the toe of the dam can become trapped in the hydraulic roller. Loudoun Water installed warning signs in the area downstream of Goose Creek Dam to alert the public of the dangers associated with the recirculating currents present at the downstream side of the dam.

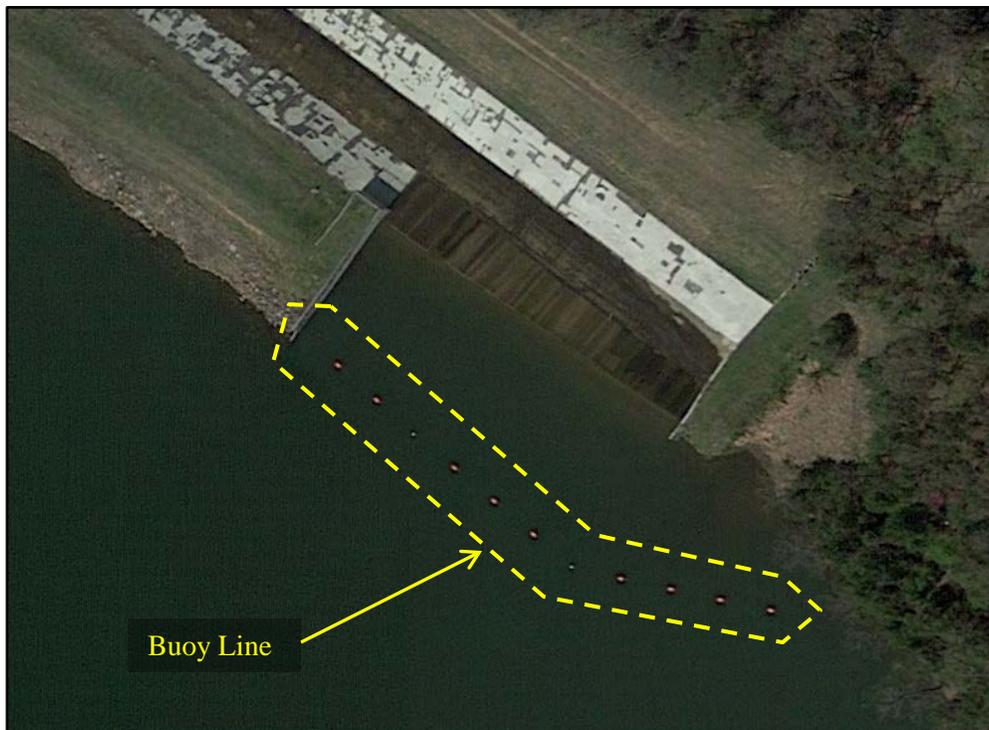
**Figure 6: Buoy Line at Beaverdam Creek Dam**

- Installed warning buoys and a buoy line in the spillway approach channel at Beaverdam Creek Dam to alert boaters on the reservoir of the presence of the spillway and to create an exclusion zone upstream of the spillway. Dam warning buoys are also positioned on Goose Creek upstream and downstream of Goose Creek Dam.

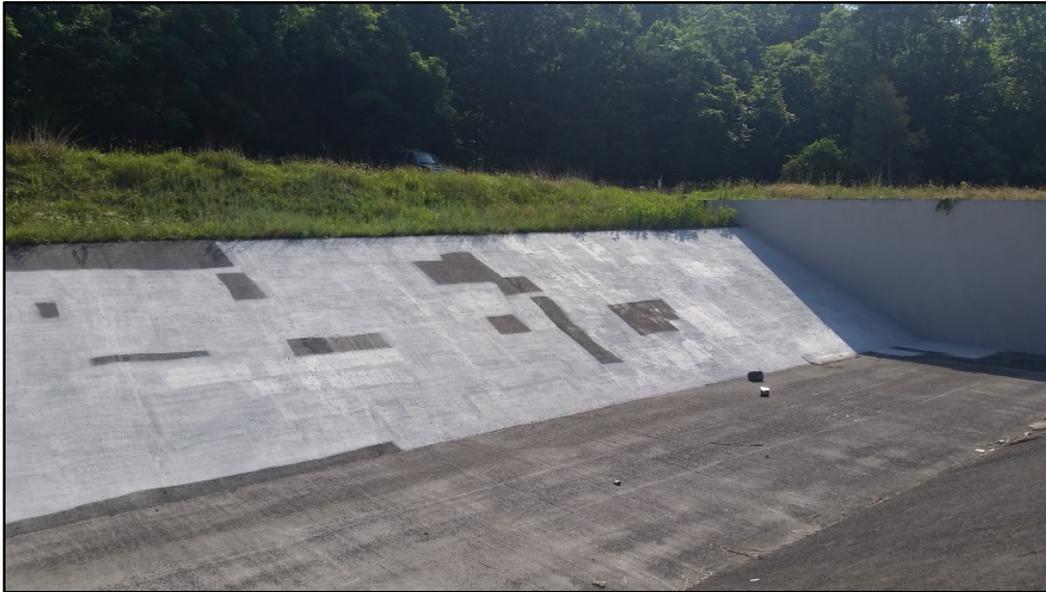
**Figure 9: Graffiti Removal at Beaverdam Creek Dam Spillway**

- Removed graffiti by painting the spillway walls at Beaverdam Creek Dam to discourage loitering and new graffiti.

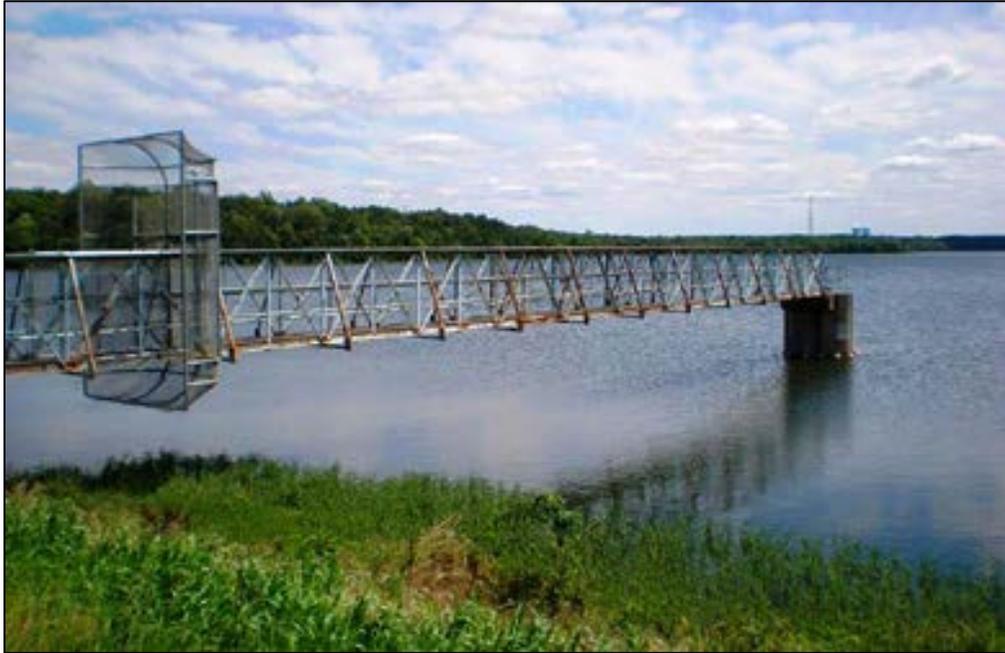
**Figure 11: Existing Access Bridge and Security Gate at Beaverdam Creek Dam to be Removed**

- Removal of an existing access bridge that extends from the dam embankment to the control tower. This is in response to the public using the bridge as a platform for diving into the reservoir, which is extremely unsafe. Attempts were made by the previous owner of the reservoir to install a security gate to prevent trespassers from

accessing the bridge; however, the trespassers where able to bypass the security gate. Based on continued issues with trespassers, Loudoun Water decided the best alternative would be to remove the access bridge.

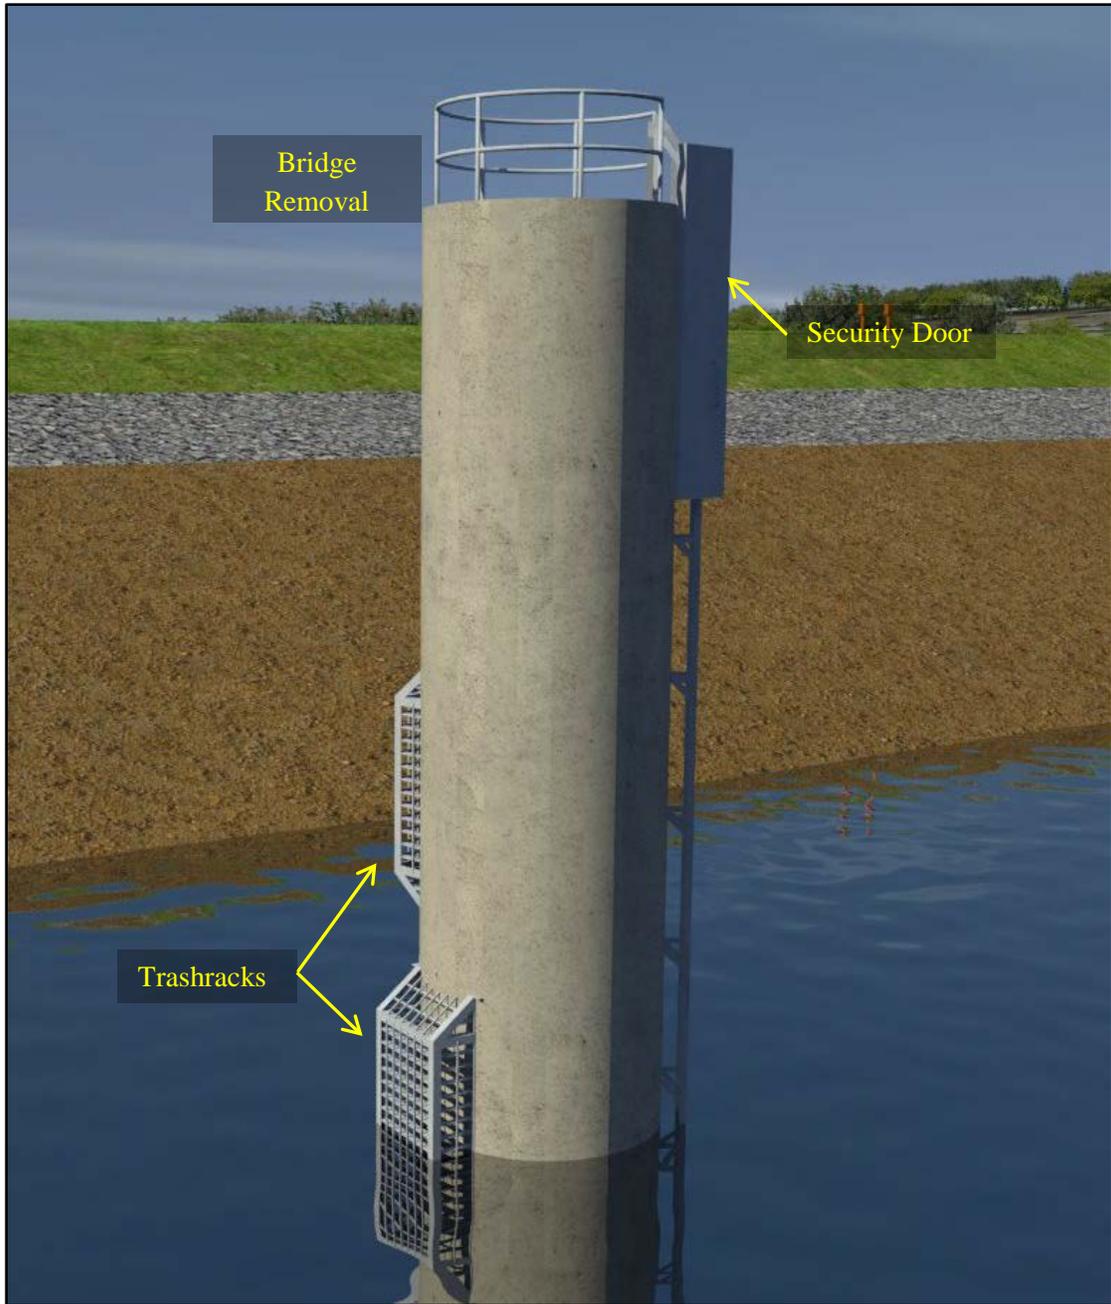
**Figure 13: Rendering of Control Tower Modifications at Beaverdam Creek Dam**

- Adding a ladder to the exterior of the control tower to allow access to the tower via boat and over a range of reservoir levels. Access to the top of the tower will be restricted to Loudoun Water personnel with the addition of lockable security covers installed at the upper portion of the ladder.

- Trashracks will be added on the exterior of the control tower at two of the gated inlets. The trashracks are sized and designed to maintain safe entrance velocities during reservoir releases.

*Note: Reservoir level shown below normal pool for visualization purposes.*

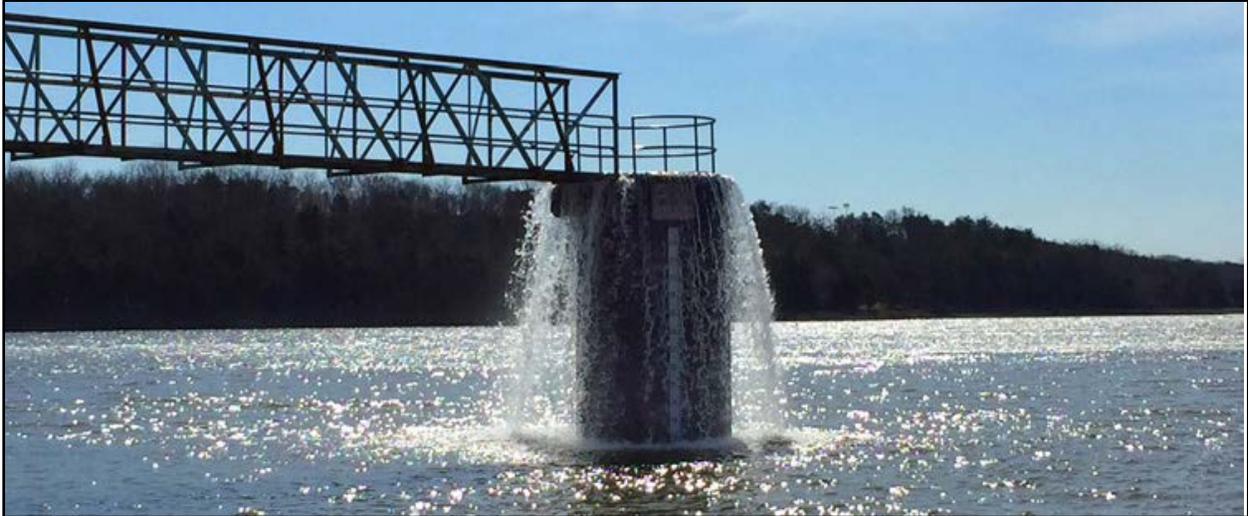
**Figure 14: Existing Reservoir Refill Pumping Operations through Inlet Control Tower at Beaverdam Creek Dam**

- The discharge location of pumped refilling operations is being changed to minimize the attraction to the public. The pumping operations currently discharge in a “geyser-like” fashion into the atmosphere from the top of the inlet control tower. The new pumped discharge location will be from the end of a new, submerged 30-inch diameter refill/release pipeline into the new spillway approach channel. A grate will be installed on the end of the reservoir release segment of the pipeline to restrict public access at the location where the pipeline discharges into the new spillway chute.

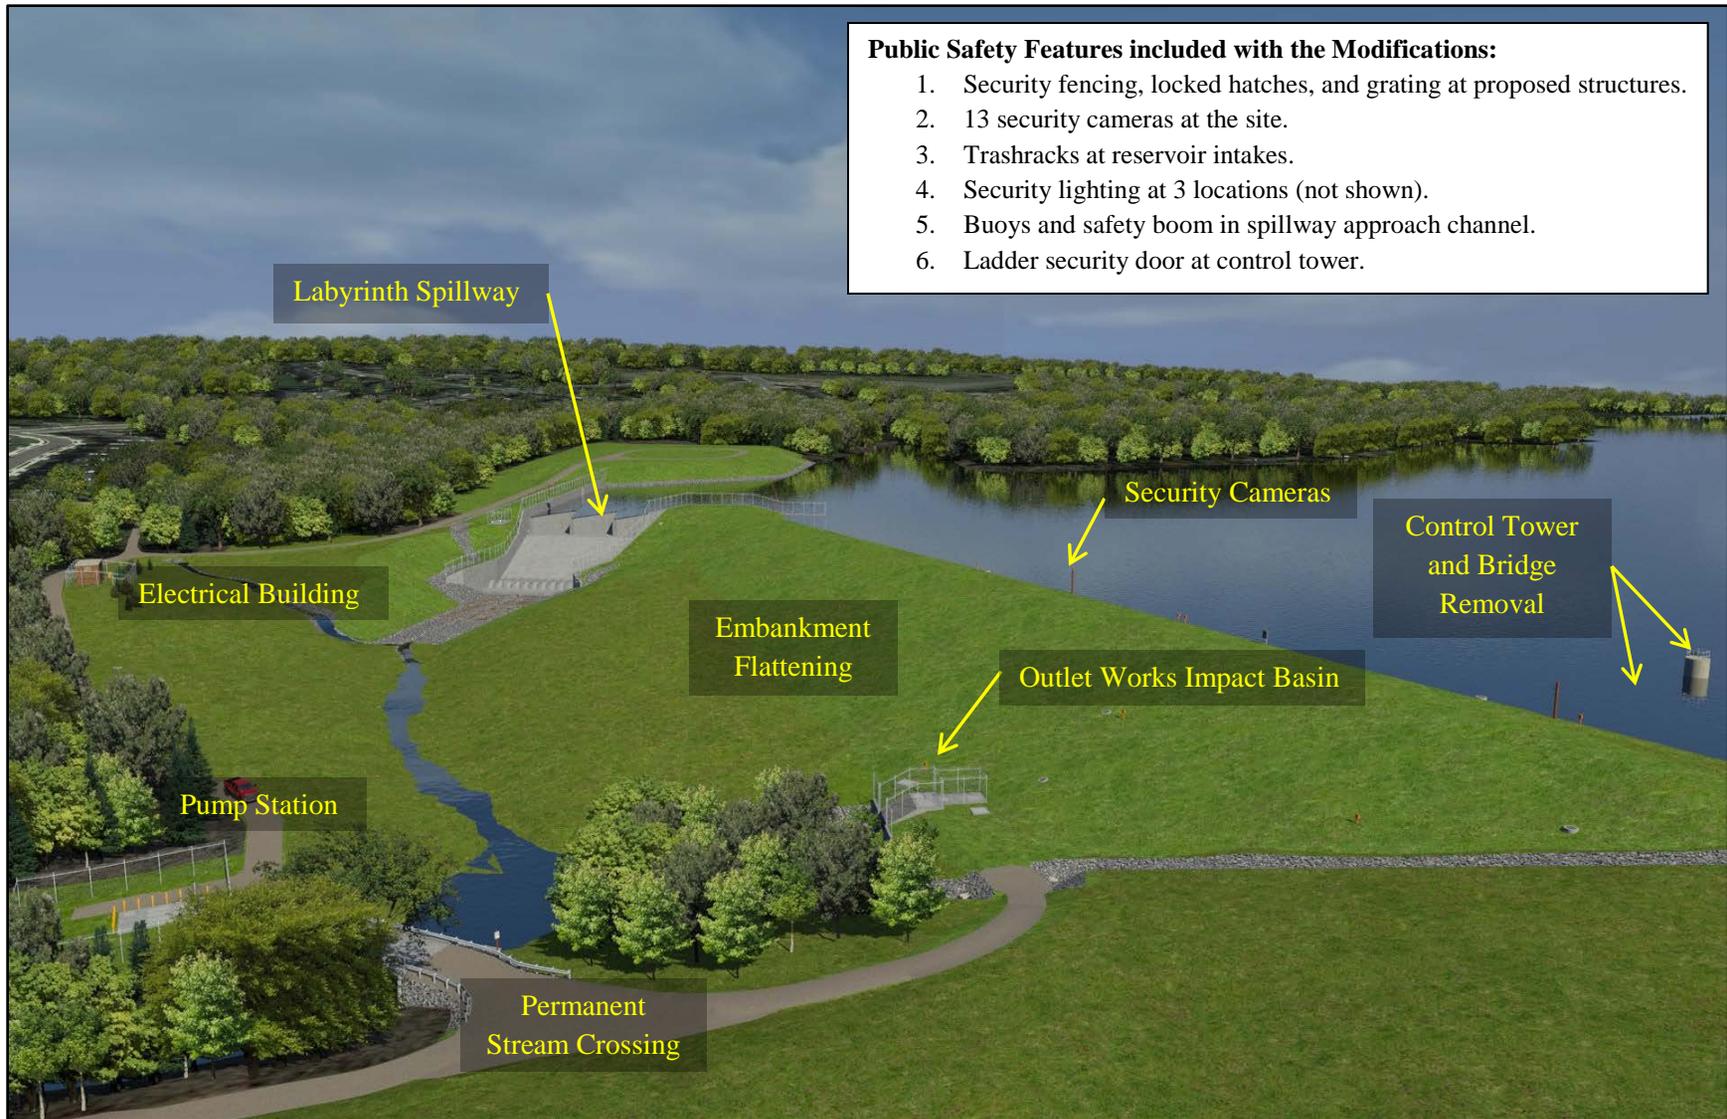
**Figure 15: Rendering of Modifications at Beaverdam Creek Dam.**

- 13 new security cameras (bullet type and pan tilt zoom type) will be added at the dam site, with remote control and monitoring capability.
- Security lighting will be installed at the dam crest, new labyrinth spillway, and new electrical building.
- Security fencing will be installed around the perimeter of the new labyrinth spillway structure, outlet works impact basin, and spillway valve chamber and pump station facilities to discourage access. Within the fenced areas, secure grating and hatches will be installed to minimize the potential for falling into openings.

Construction for the rehabilitation of Beaverdam Creek Dam began in November 2016. The project consists of replacing the existing spillway, flattening the embankment and adding an internal drainage system, construction a new transfer pump station, construction of an electrical building, and construction of a permanent stream crossing. The primary objectives of the project were to bring the dam up to current dam engineering standards as required by the Virginia Department of Conservation and Recreation Dam Safety Program for high hazard dams and to improve reservoir release and pumped refill operations. The project also involves the implementation of numerous new public safety improvements, which include the following:

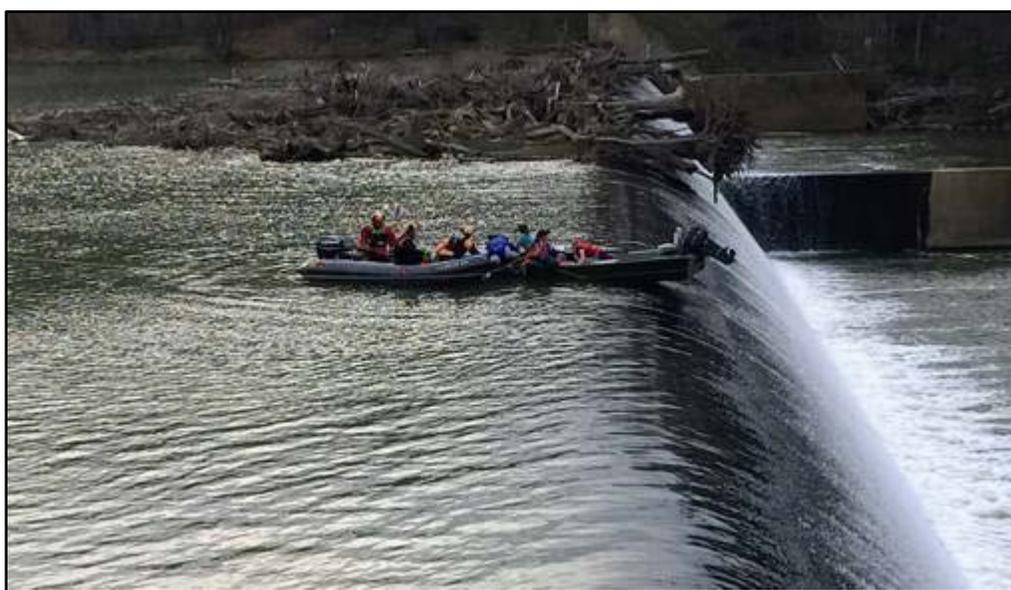
**Figure 16: 2017 Incident at Goose Creek Dam**

Loudoun Water installed appropriate signage and buoys to create exclusion zones upstream and downstream of Goose Creek Dam. The signage and buoys allowed boaters to identify the dam and the restricted areas upstream and downstream of the dam. However, in April 2017, a family boating on Goose Creek upstream of the dam experienced engine problems with their small boat, which left the boat disabled and unable to steer clear the dam. Emergency responders were alerted and were able to rescue the boaters before the boat passed over the dam.
