# **Don't Go With the Flow!**

## **Identifying and Mitigating Hydraulic Hazards at Dams**

*Paul Schweiger, P.E., Gannett Fleming, Inc.*  
*Steven Barfuss, P.E., Utah State University*  
*William Foos, CPP, PSP, Gannett Fleming, Inc.*  
*Greg Richards, P.E., Gannett Fleming, Inc.*

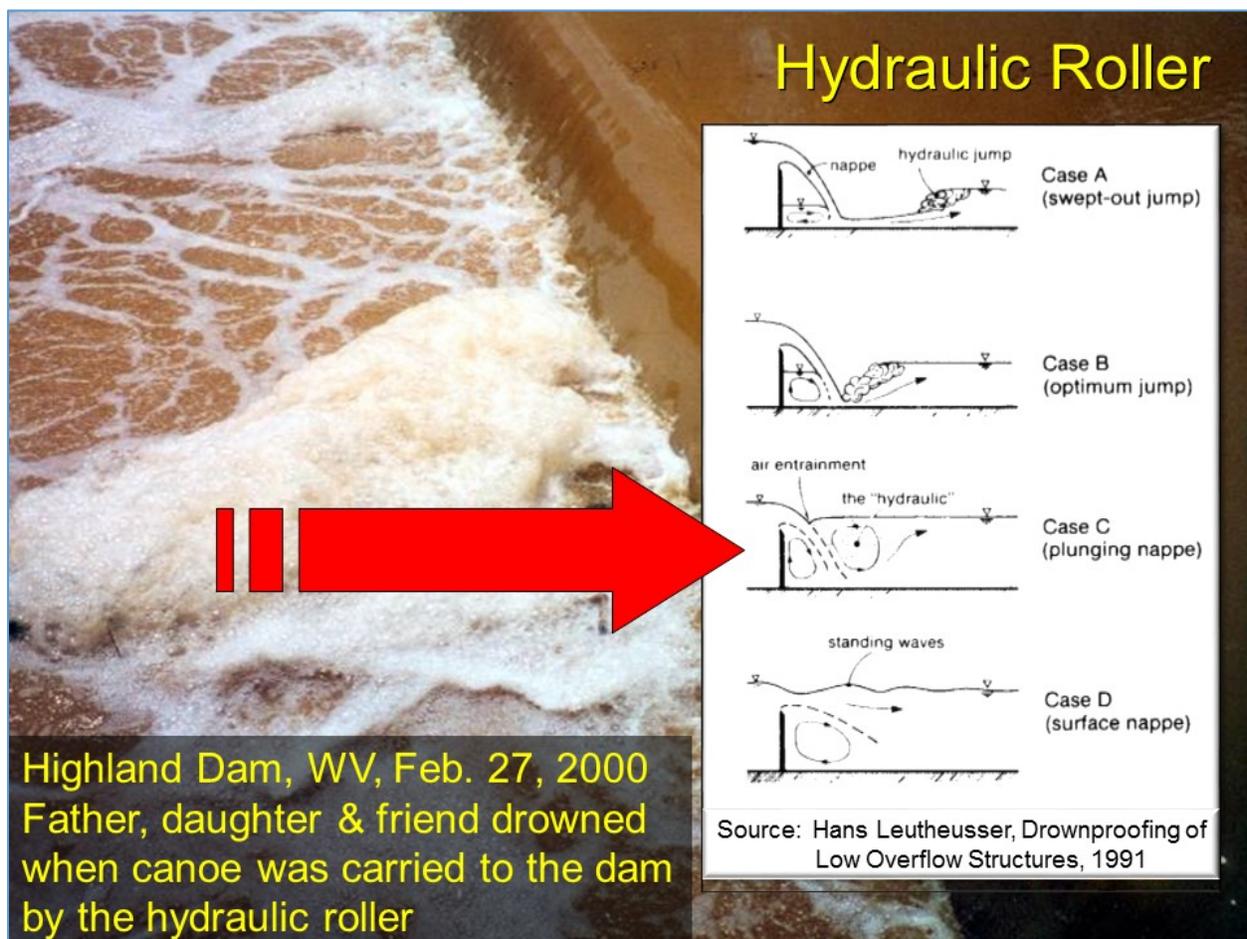
**Figure 1. Illustration showing hazardous transient flow condition commonly found at low-head dams referred to as a “submerged hydraulic roller” (Case C) that can trap and drown victims.**

The roller from a submerged hydraulic jump can feature an upstream directed surface velocity that is strong enough to trap debris or people near the face of the dam for prolonged periods of time. The length of the standing vortex or “hydraulic roller” can be about three to four dam heights in length and have an upstream surface velocity comparable in magnitude to the maximum human swimming velocity of about seven feet per second [Leutheusser, 1991]. The rolling water takes any object, including a person, to the bottom of the stream, releases it to the surface, draws it back to the face of the dam, and then pushes it back to the bottom. This cycle is a function of streamflow and can continue for an extended period of time. Air bubbles mixing in the water can decrease buoyancy by as much as one third [Wright et. al., 2003]. The victim may therefore have a difficult time staying afloat, even with a life jacket. These factors combined with the recirculating current create a nearly inescapable drowning machine.

In most cases the hydraulic drop over the structure may only be a few feet with a smooth streamline over the crest and relatively placid appearing water below the structure, except for bubbles rising to the surface. When the conditions appear tranquil, they can be most dangerous [Wright et. al., 1995]. A reverse flow velocity in this scenario may be so modest as to go unnoticed by recreational boaters, fisherman, or swimmers. Under these conditions, one might see tree limbs or other floating debris bobbing at the base of the dam. The upstream velocity from the boil area to the face of the dam, even if only a few feet per second, can create a trap that is often fatal to even the strongest swimmers.

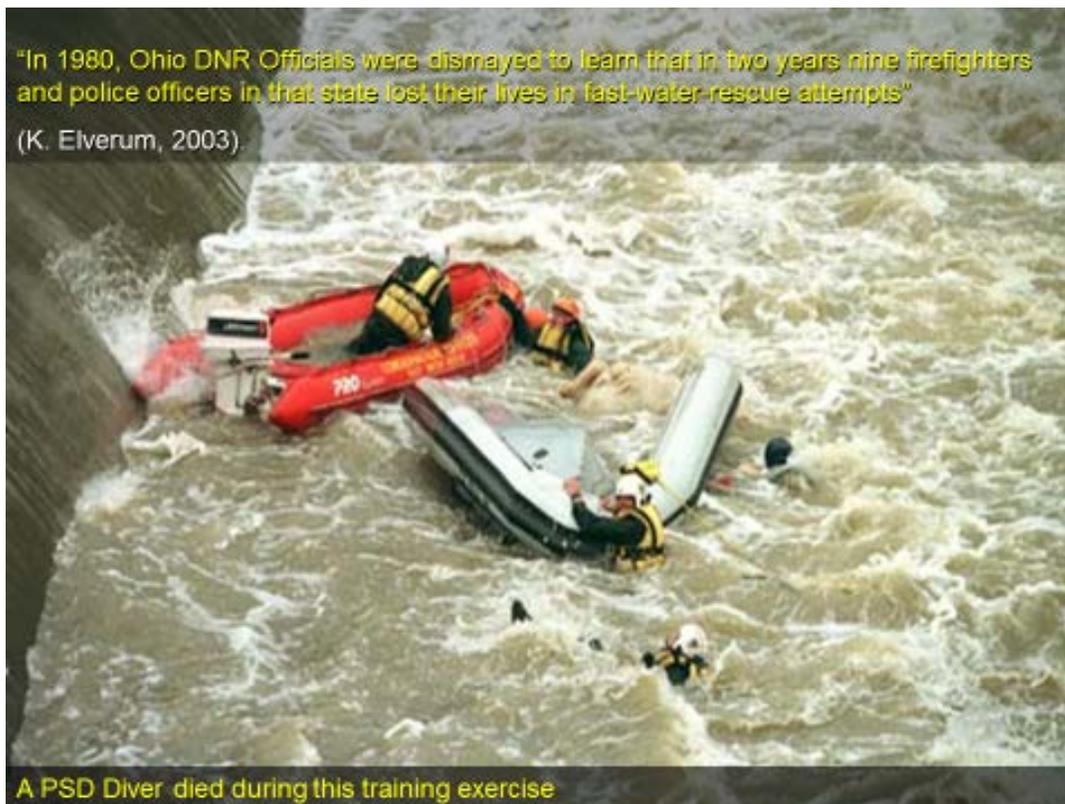
**Figure 2. Photo taken during training exercise for fast water rescue responders at a low-head dam in Illinois. A PSD diver died during the exercise. Source: “Over, Under, Gone” video.**

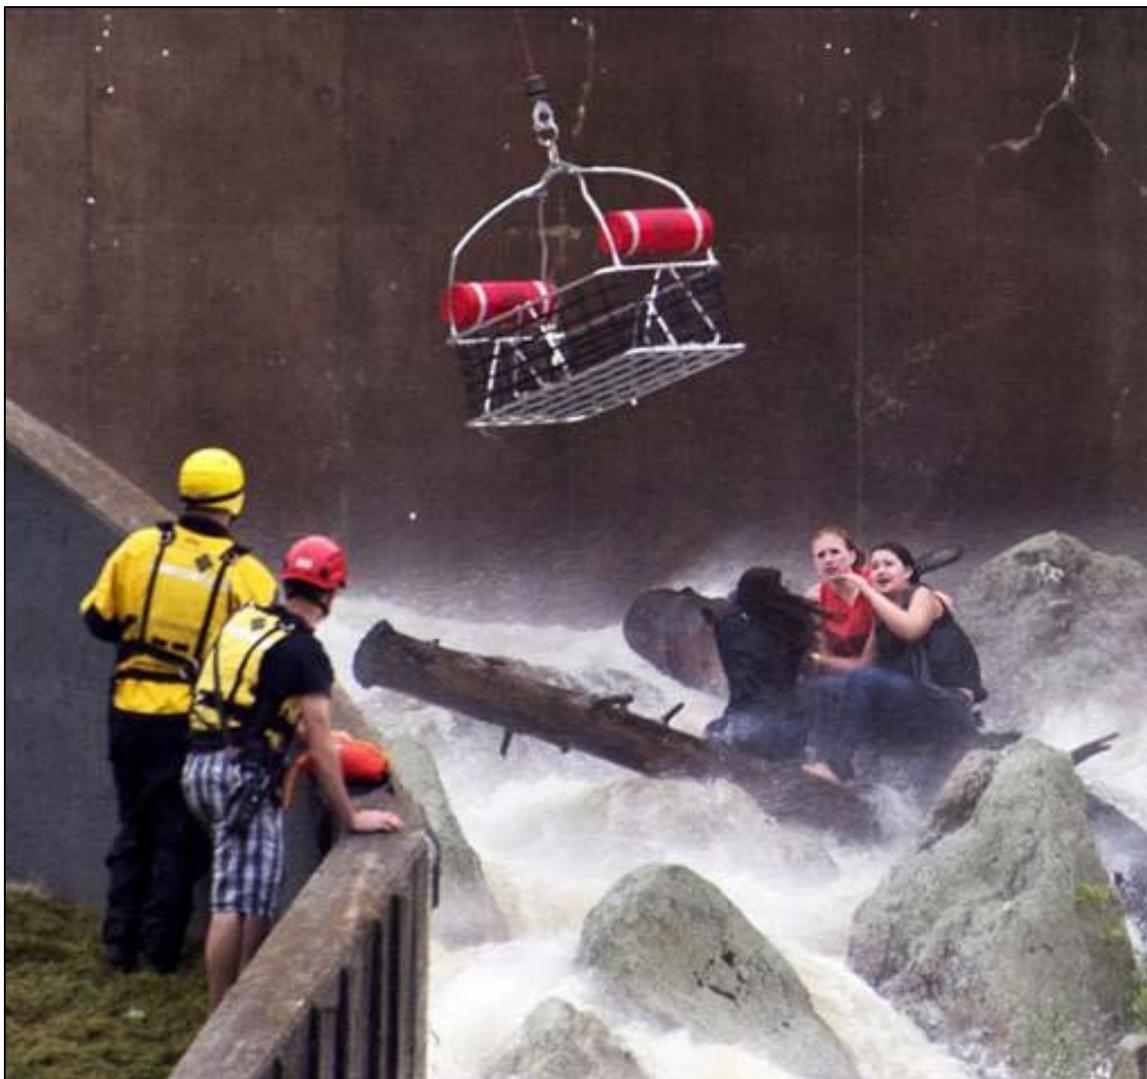
**Figure 4. Photograph showing rescue of three teenagers swept over the spillway at Lake Linganore.**

**Incident 3: Lake Linganore Dam, New Market, Maryland, (June 29, 2015).** Nine people were on board a pontoon boat when the vessel went over the spillway of Lake Linganore Dam. The crew included a grandfather (age 62) with his 16-year old granddaughter and her friends

who were all under 18 years of age. Numerous emergency medical crews, fire personnel and deputies responded to the scene which was in a remote area that included much foliage and hilly terrain. Three of the eight rescued were stranded in the spillway, clinging to rocks as a Maryland State Police helicopter hoisted them up to the aircraft one by one. Others were pulled out of the water by first responders and neighbors. The grandfather was first seen alive wedged between two large rocks about 100 yards downstream of the spillway. Though he survived the fall over the spillway, the rapidly-rising and turbulent waters likely caused his death before he could be rescued.

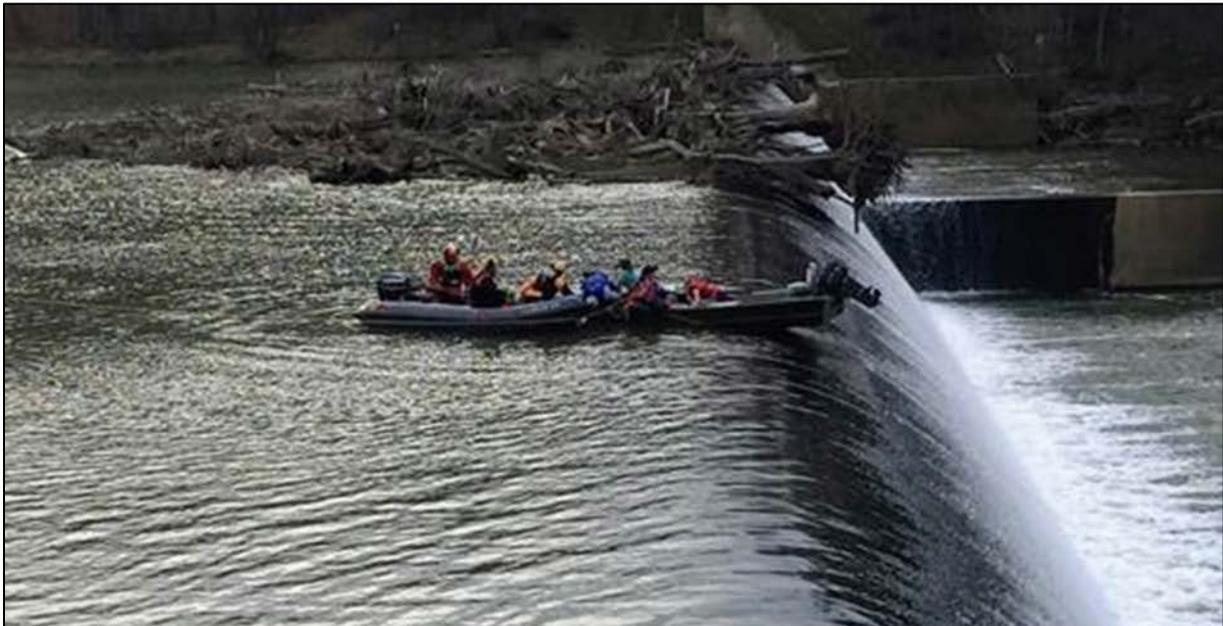
**Figure 5. Photograph showing family of five being rescued from spillway crest of Goose Creek Dam. Photo courtesy of Loudoun County Fire and Rescue.**

**Incident 4: Goose Creek Dam, Loudoun County, Virginia (April 11, 2017).** A family of five was rescued from their boat teetering on the crest of the spillway of Goose Creek Reservoir Dam. According to reports, the Loudoun County Emergency Communications Center received a call at approximately 5:30 p.m. from an individual stating he and his family were stranded in a boat on top of the Goose Creek Reservoir Spillway. The man said the motor on the small fishing boat had failed leaving them to drift and ultimately stop atop of the 20-foot high concrete ogee spillway. A portion of the boat was hanging over the edge of the dam. Fire and Rescue units were dispatched with rescue boats. When the first unit arrived they found a small boat teetering precariously on the edge of the dam. The boat was occupied with two adults and three small children.

The swift moving current made the boat unstable, and all the occupants were seated in the bow of the boat to keep it from falling over the dam. With the exception of one adult, all were wearing life vests. Initial attempts to reach them using an aerial ladder were unsuccessful because the stranded boat was too far from shore. First responders were eventually able to successfully deploy an additional lifejacket to the stranded vessel using a throw rope from the end of the aerial device. Crews were also deployed downstream with rescue equipment in the event that the vessel fell over the dam. Upon arrival of the water rescue team, a boat and crew quickly launched and made their way out to the stranded family. Rescuers connected a tow rope to the fishing boat and pulled the family safely to shore.

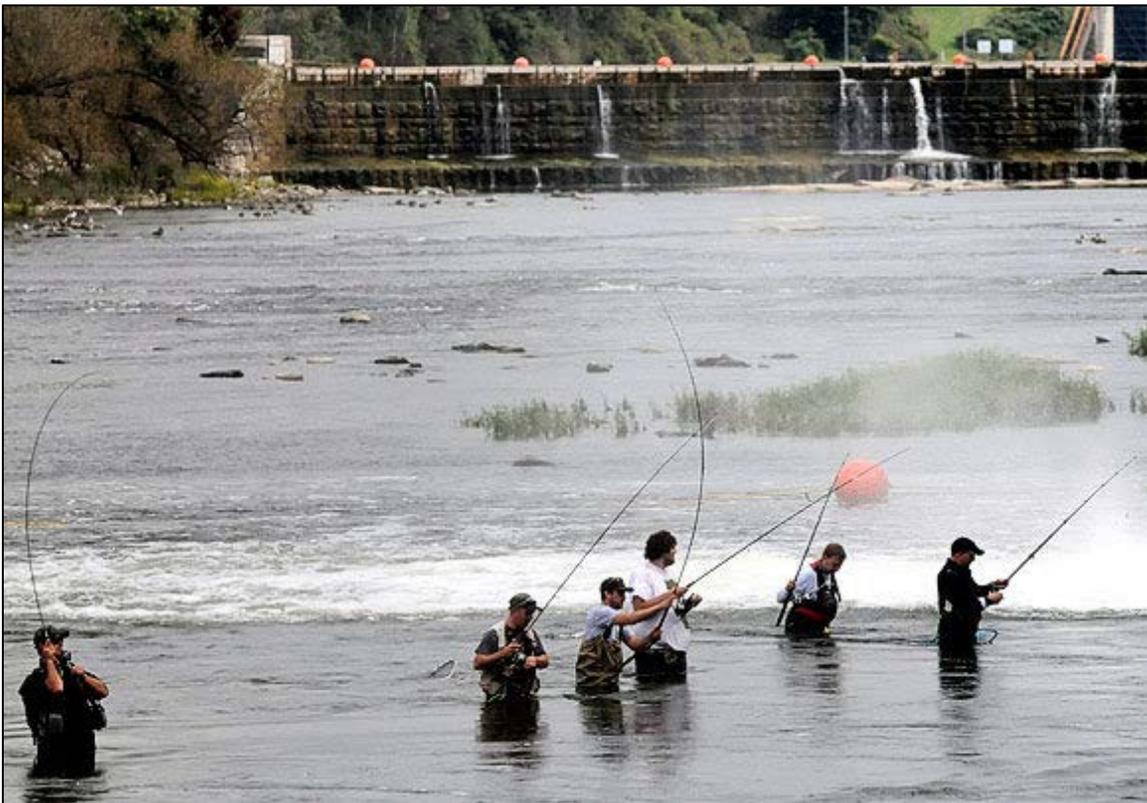
**Figure 6. Photograph showing fishermen downstream of hydropower dam on the Oswego River near Oswego, New York.**

**Incident 7: Brookfield Power Hydroelectric Dam on the Oswego River, Oswego, New York (September 28, 2010).** Two men were fishing in the river downstream of the hydropower dam on the Oswego River when rapidly rising water carried them away. One of the men died that day in Oswego Hospital. The other died a week later. A lawsuit, filed in federal court in the Northern District of New York against Brookfield Renewable Energy, was settled for \$1.8 million. The lawsuit stated that the men died as “a result of drowning after a massive quantity of water was negligently, carelessly and/or intentionally released, without proper advance warning, into the Oswego River by the owners and/or operators of the power plant facility.”

Witnesses said that warning sirens went off too early, then did not sound at all when the water rose later that day, sweeping the two men away. Brookfield Renewable Energy subsequently installed warning lights, new 911 and rescue stations, and ladders near the hydroelectric plant to improve safety as a result of the deaths and the lawsuit, according to news reports.

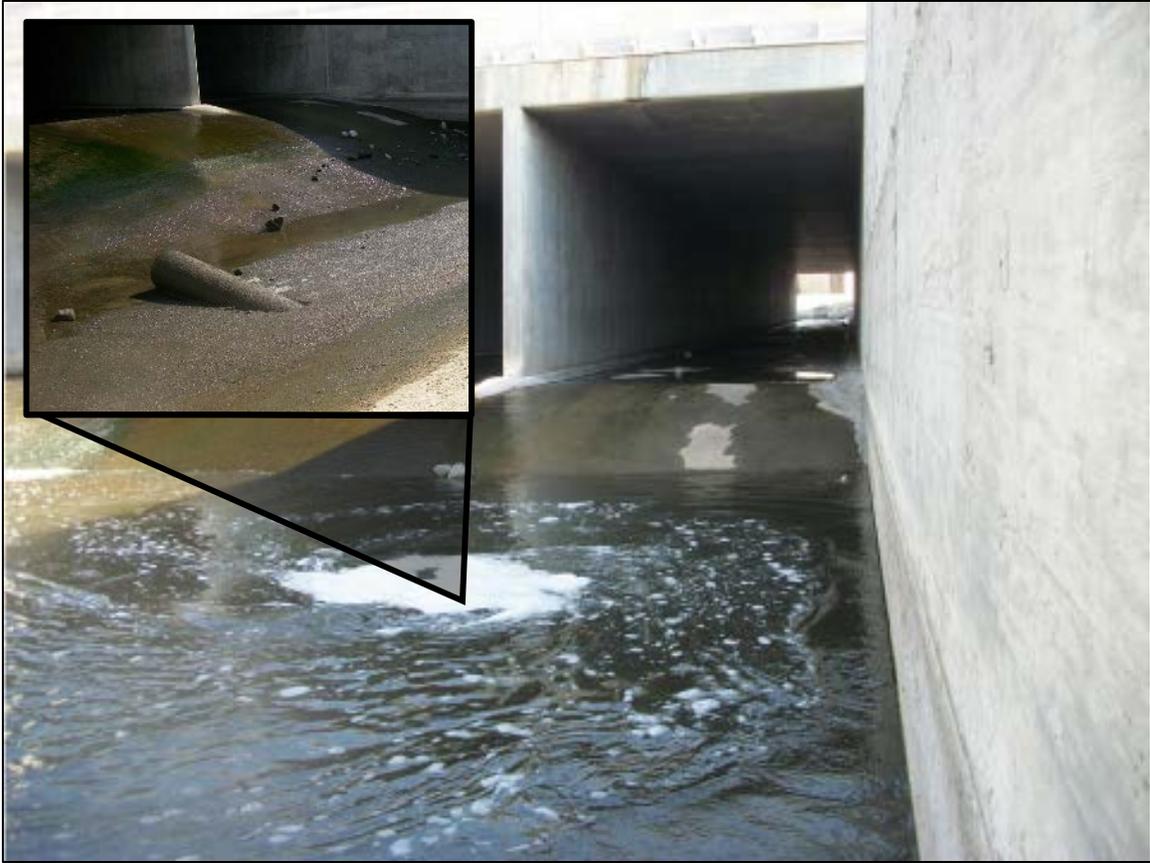
**Figure 7. Photograph showing inlet pipe at Lake Wanahoo Dam where boy became trapped and drowned. Photographs courtesy of Tim Gokie.**

**Incident 11: Lake Wanahoo Dam, Lincoln, Nebraska (June 12, 2012).** An 11-year-old boy pestered his mother about going to his favorite spot, just south of the Lake Wanahoo Dam spillway on Sand Creek, to go fishing. His mother had other plans for Bayden and his siblings. He became upset and decided to go anyway by himself. Bayden's body was recovered in the spillway of the dam. One of the boy's legs apparently got caught in a 12-inch concrete drain pipe. He was pulled down into the water and drowned. An employee of the Nebraska Game and Parks Commission spotted the body, and the spillway was shut down to retrieve him. It appeared that the boy climbed up into the outlet works, a place that is normally not accessible. The lawsuit involving the drowning of the 11-year-old boy was settled for \$300,000.

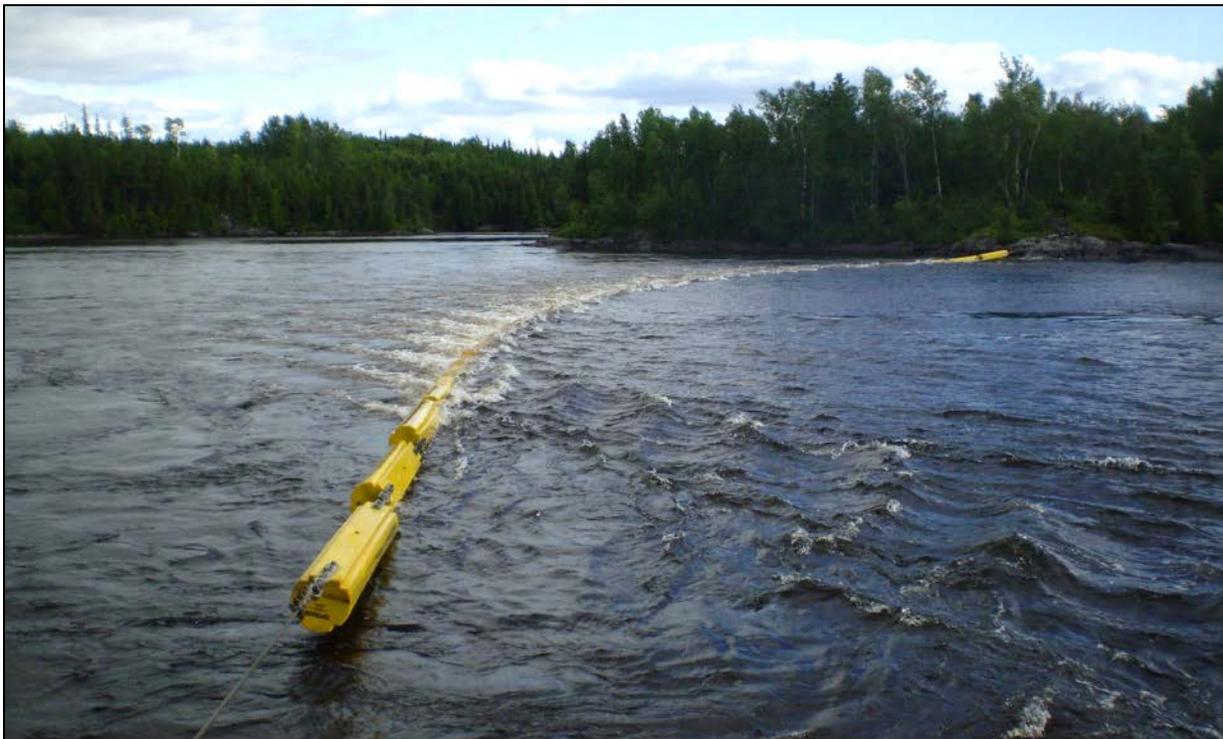
**Figure 8. Photograph showing buoy line upstream of dam on Lac St. Jean, Quebec, where a canoeist became capsized and subsequently drowned.**

**Incident 12: Lac St. Jean Dam No. 7, Quebec, Canada (2008).** Lac St. Jean is a large reservoir approximately 15 miles wide and 31 miles long. The reservoir and its environs are used by the public for recreational activities including camping, fishing, kayaking, canoeing, hiking, and cycling. A safety boom or buoy line was installed approximately 500 feet upstream of Lac St. Jean's Dam No. 7 to discourage public access and protect boaters from being swept through the spillway gates. Under certain flow conditions at the dam, the buoy line was subject to swift currents and became completely submerged. In 2008, a 16-year-old girl in a canoe capsized against the submerged boom line as a result of this condition. The girl was subsequently swept through the spillway gates and drowned.
