CHAPTER D-3 FLOOD OVERTOPPING FAILURE OF DAMS AND LEVEES

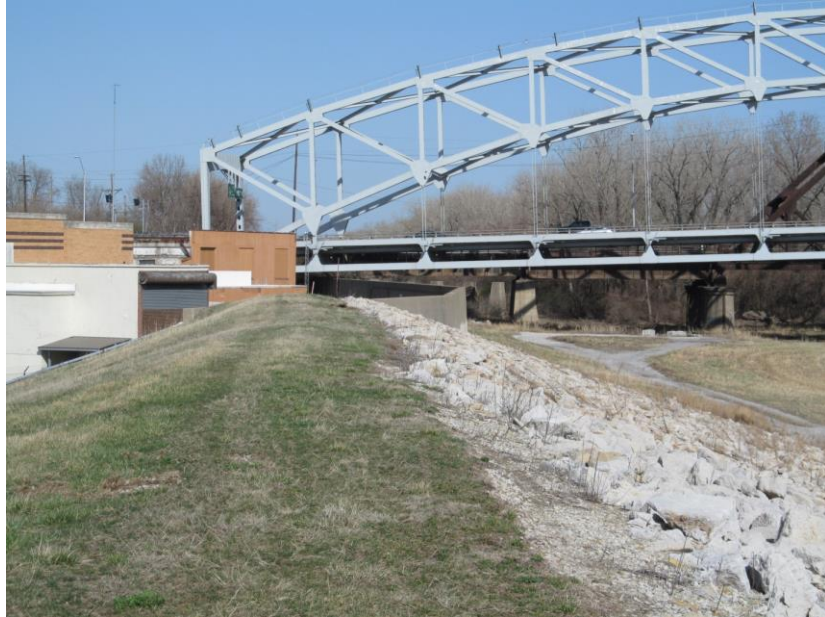
Riverine levee crest near transition to floodwall , which is visible below bridge. The river under normal flow conditions is located about 300 feet to the right of the embankment.

List factors that affect the overtopping erosion for a riverine levee, a hurricane (coastal) levee, a water conservation area levee (Florida):

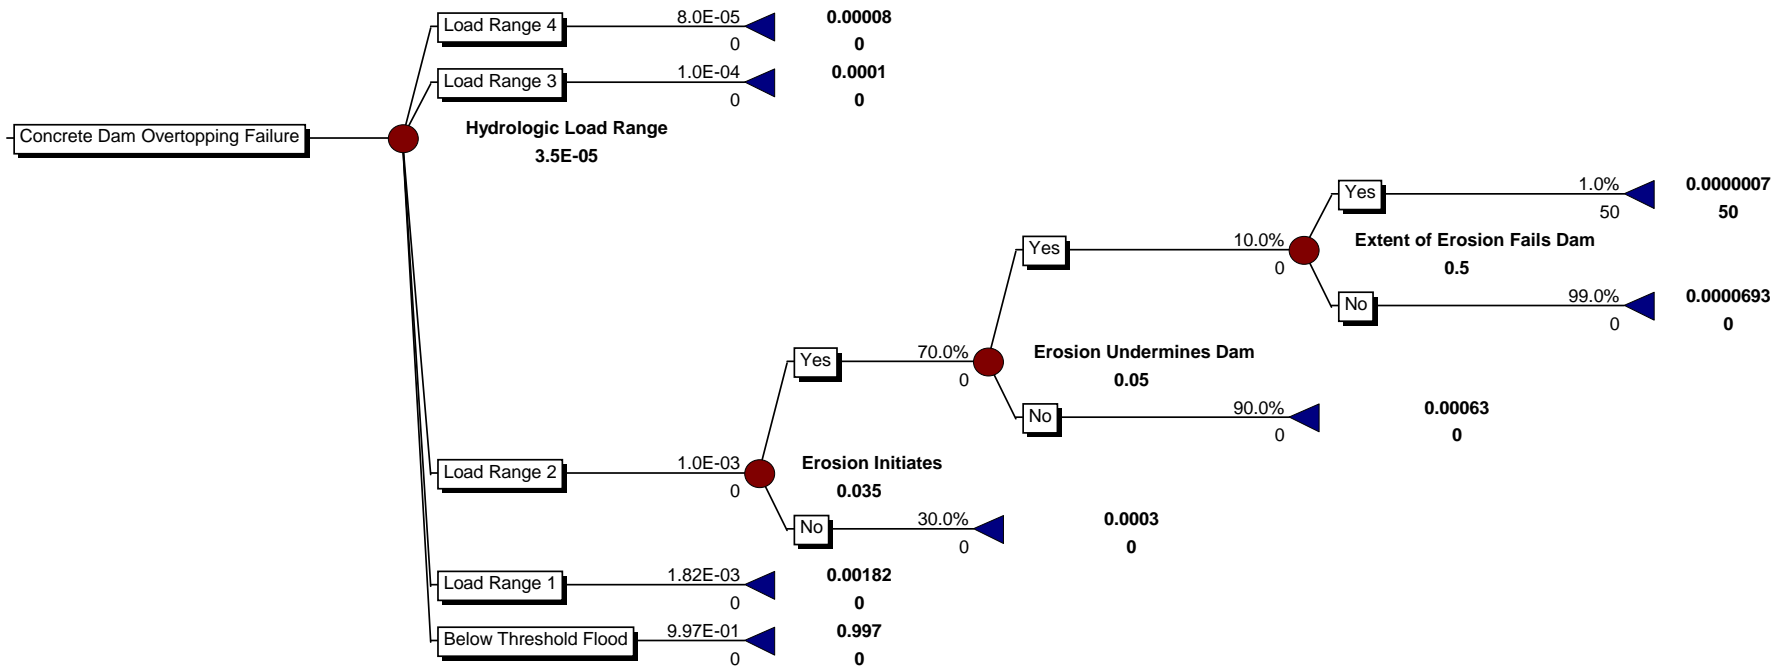
Figure D-3-3 Example Event Tree for Flood Overtopping Failure of a Concrete Dam
