CHAPTER F-1 HYDRAULIC FAILURE OF SPILLWAY CHUTES

F-1.2 Description of Potential Failure Mode

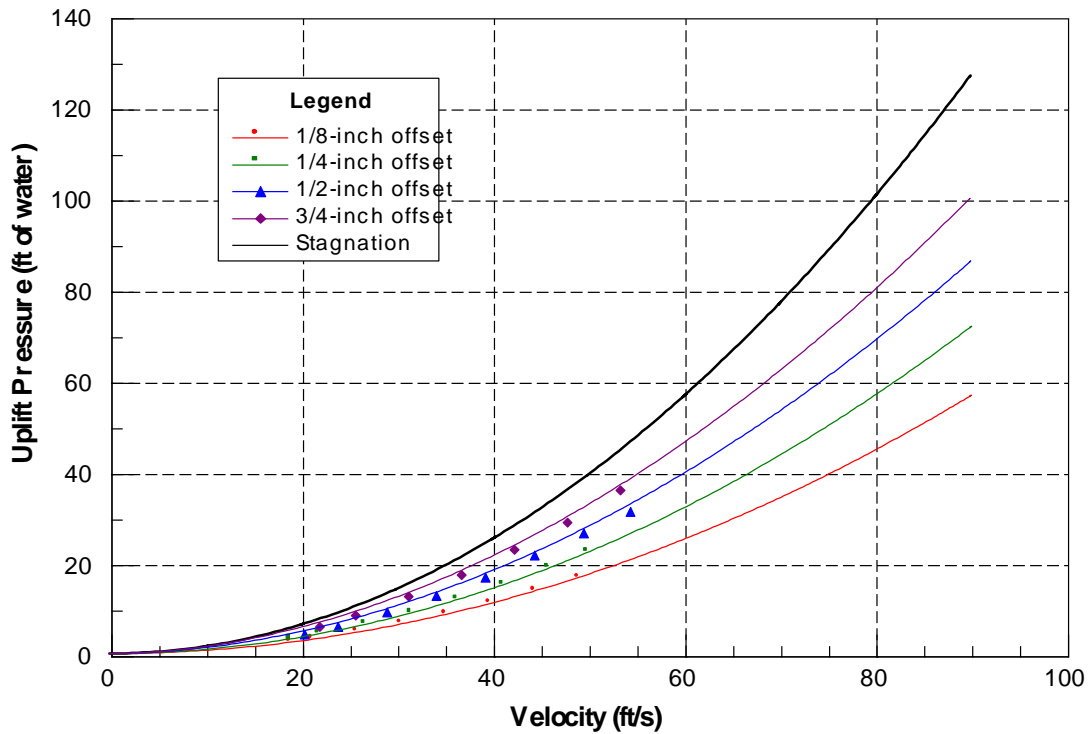
Figure F-1-4 - Mean uplift pressure, sharp-edged geometry, sealed cavity, 1/8-inch gap.

Having established that there are, or may be unfavorable conditions at joints or cracks, the likelihood of flows that can initiate potential failure can be estimated. Model tests for offsets into the flow as small as 1/8-inch, with gaps as small as 1/8-inch indicate that significant pressures and or flow can develop (Figures F-1 4, F-1 5, F-1 6, F-1 7 and F-1 8, Reclamation, 2007). It should be noted that some of these tests were conducted with a sealed water vessel beneath the “slab”, where all hydrodynamic pressures were transmitted to this system (see Figure F-1 4). Head loss that would occur as the water traveled through cracks, foundation materials, or drains was not modeled or captured. These results are, therefore, quite conservative and should be used with caution. A second set of tests were conducted, in which the water vessel beneath the “slab” was opened or “vented” by allowing drainage out of the cavity (see Figures F-1 5 and F-1 6). These tests allowed flow through the system, and uplift pressures on the “slab” were measured as well as flow through the joint. Venting of the cavity produced a reduction in uplift pressure for all test configurations. However, it should be noted that the drainage flow rates were a function of the losses within the test system. These include the crack entrance losses and losses within the piping and valve that allowed water to flow out of the area beneath the “slab.” Therefore, if enough drainage was provided to accommodate all flow that tended to enter the crack, the uplift pressures could be even lower.
