Ohio Department of Natural Resources

Division of Water Resources

DAM SAFETY FACT SHEETS

Information for Dam Owners

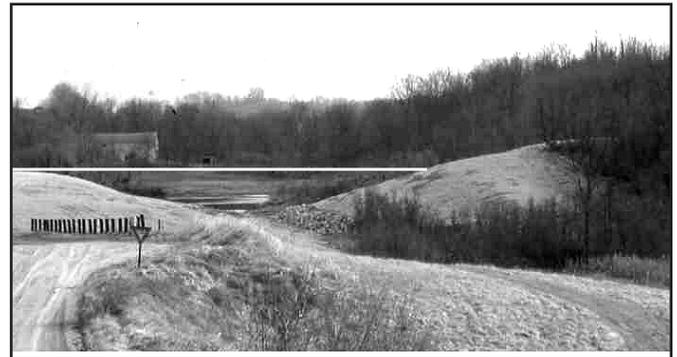
Photograph of dam breach from downstream. White line shows former dam crest.

Description: A breach is defined as an opening in a dam that prevents the dam from impounding a significant amount of water (see photograph). A breach extends from the upstream side of the embankment to the downstream side and typically has mild side slopes. A dam breach could be considered partial removal of a dam. Breaching the dam alleviates the need to obtain a construction permit or to address the required remedial measures listed in the inspection report.
