**Burned Area Emergency Response (BAER) Report
Carlton Complex Fire (State and Private Team)
September 14, 2014**

Introduction

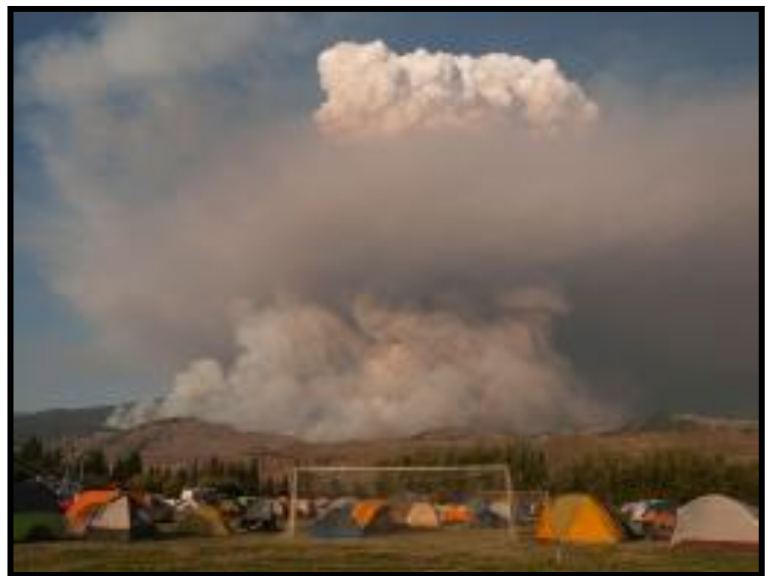
The Carlton Complex started on July 14th from four lightning caused fires (Stokes, Gold Hikes, French Creek and Cougar Flat) burning over 250,000 acres, consisting of National Forest System lands on the Okanogan-Wenatchee National Forest, Bureau of Land Management lands, Washington State and private lands. Hot weather and windy conditions pushed the fire over the ridge tops and into the town of Pateros resulting in a large number of evacuations. The fire made significant runs towards the cities of Brewster and Pateros between July 17th and 18th, consuming approximately 300 homes in its path and destroying critical infrastructure. These fires grew into one larger fire on July 20th. Great Basin Incident Management Team 1 assumed command of the Carlton Complex, along with the Little Bridge Creek Fire and the Upper Falls Fire on August 11th.
