THE FORMATION AND FAILURE OF NATURAL DAMS

By John E. Costa and Robert L. Schuster

US GEOLOGICAL SURVEY
Open-File Report 87-392

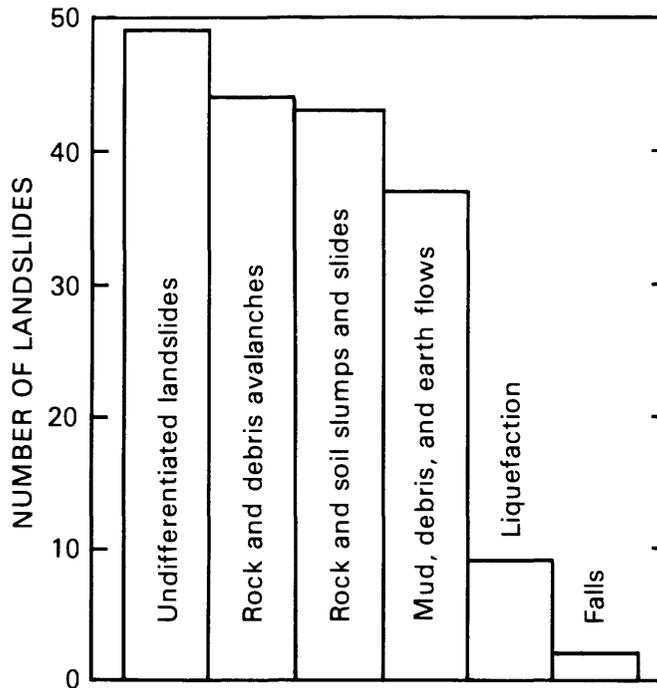
Figure 1.--Graph showing distribution of landslide dams by type of landslide, based on 183 cases from the literature and the authors' experience. Classification based on Varnes (1978)

Study of 184 cases of landslide dams from the literature and the authors' experience has shown that a broad range of mass-movement types can cause landslide dams (fig. 1; table 2). However, most landslide dams are caused by avalanches, slumps and slides, and flows. Relatively few dams have been caused by slope failure in sensitive clays or rock and soil falls. The number of dams resulting from failure of sensitive clays is small because of their limited extent and common occurrence in areas of low relief. The number of dams resulting from falls is small because the volumes of material constituting failures of this type are small.

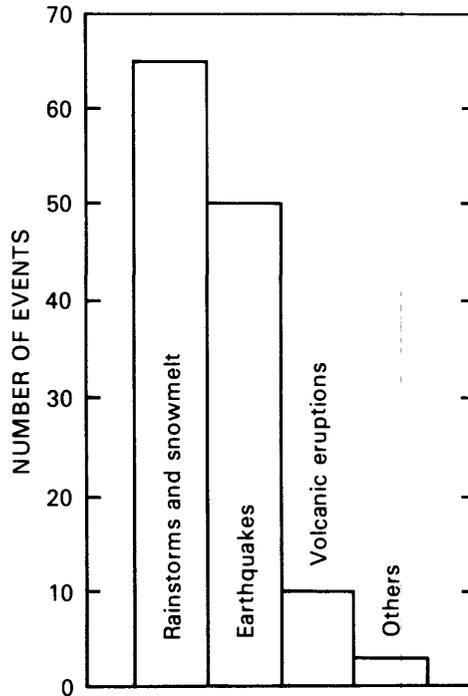
Figure 2.--Graph showing causes of landslides that have formed dams, based on 128 cases from the literature and the authors' experience.

The two most important processes in initiating dam-forming landslides are excessive precipitation (rainfall and snowmelt) and earthquakes (fig. 2). These account for 90 percent of the landslide dams investigated. Volcanic eruptions constitute the third most significant dam-forming process (about 8 percent). Other mechanisms, such as devegetation and stream undercutting and entrenchment, account for the remaining 2 percent.

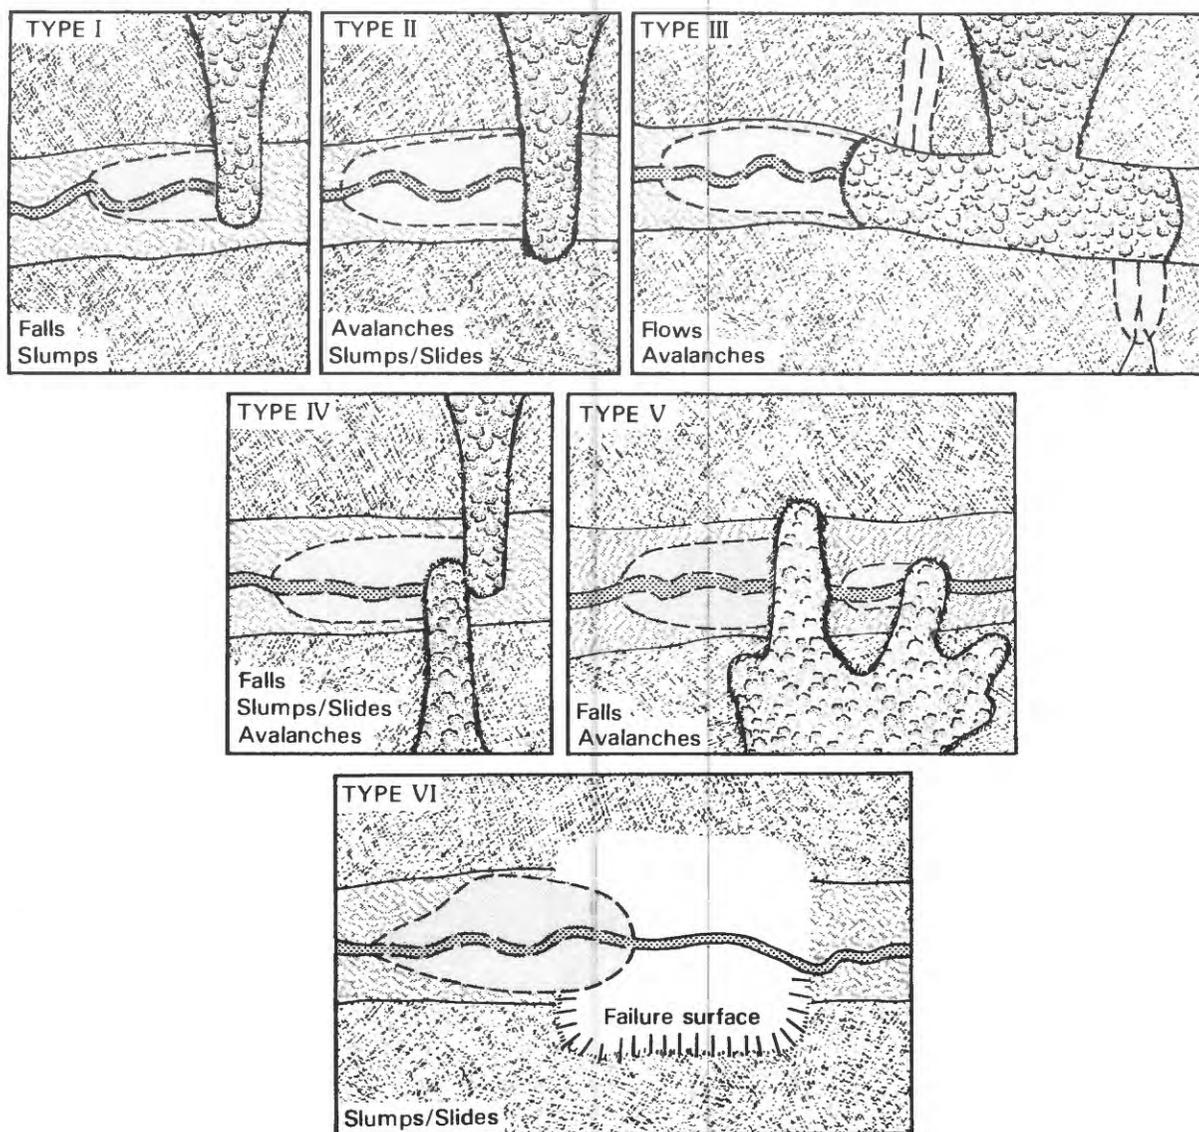
Figure 3.--Diagrams showing classification of landslide dams. Mass-movement processes most likely to form particular landslide dams are listed in lower left corner of each category. (Modified from Swanson and others, 1986)

Landslide dams can be classified geomorphically with respect to their relations with the valley floor (Swanson and others, 1986; fig. 3). Type I dams are small with respect to the width of the valley floor and do not reach from one valley side to the other. Type II dams are larger and span the entire valley floor, occasionally depositing material high up on opposite valley sides. Type III dams fill the valley from side to side and move considerable distances upvalley and downvalley from the failure. These dams typically involve the largest volume of landslide material. Type IV landslide dams form by the contemporaneous failure of material from both sides of a valley. The landslides can adjoin head-to-head in the middle of the valley, or they can juxtapose one another. Type V landslide dams form when the same landslide has multiple lobes of debris that extend across a valley floor and form two or more landslide dams in the same reach of river. Type VI landslide dams involve one or more failure surfaces that extend under the stream or river valley and emerge on the opposite valley side from the landslide. These dams typically involve slow basal sliding and slumping and form lakes by raising the elevation of the streambed, changing the local gradient of the stream.

Of the 184 landslide dams classified from around the world, the most common are Types II (44 percent) and III (41 percent). The other types are much more infrequent (Type I = 11 percent; Type IV = 1 percent; and Type VI = 3 percent). Type I landslide-dam lakes commonly are small, low, and usually not hazardous. Type II landslide-dam lakes are larger and much more dangerous. Type III dams not only can form large hazardous lakes behind the obstruction, but also can block tributaries to the main valley, creating additional potentially dangerous lakes. This is the case at Mount St. Helens, Washington, as a result of the 1980 debris avalanche that dammed tributaries to the North Fork Toutle River. Type IV and V landslide-dam lakes can be hazardous if the valleys are narrow and the volumes of landslide materials are large enough to form high dams. Only one example of a type IV landslide dam is known, the Yinping landslide blockage of the Min River, Sichuan Province, China, which forms Da Lake (Li and others, 1986; fig. 4). Only one example of a Type V landslide dam is known, the Slide Lake rockfall-avalanche in Glacier National Park, Montana (Butler and others, 1986). Only a few examples of Type VI are known, from Japan (Swanson and others, 1986) and one from Colorado (Muddy Creek landslide). This type of landslide dam typically poses less threat of downstream flooding than the other types because there may never be a complete blockage. The stream may continue to flow over the dam debris, so that the likelihood of abrupt overtopping and rapid incision of the dam is unlikely. Water storage usually is small and the stream gradient not relatively steep.

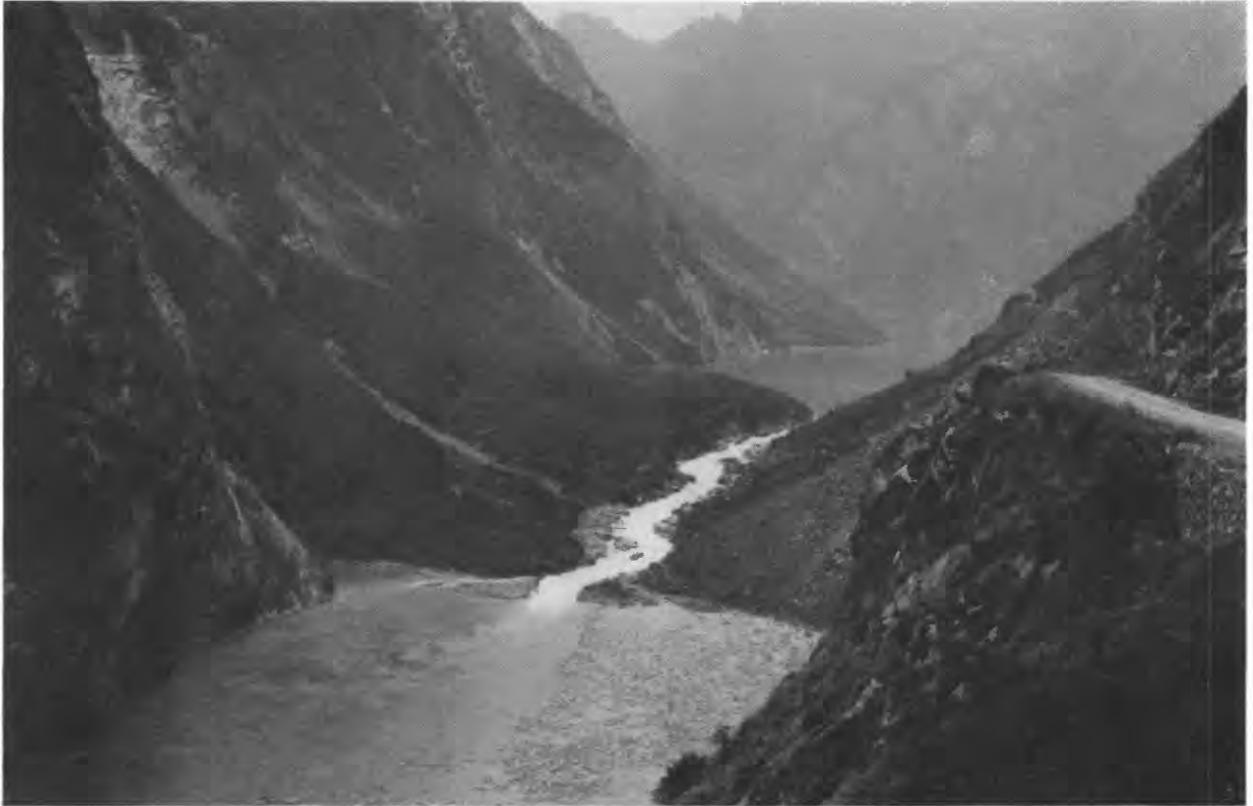
Figure 4.--Photograph view upstream along the Min River, Sichuan Province, Peoples Republic of China, showing remains of the 1933 earthquake-induced Yinping landslide dam. Xico Lake (foreground) was impounded by another landslide dam caused by the same earthquake.

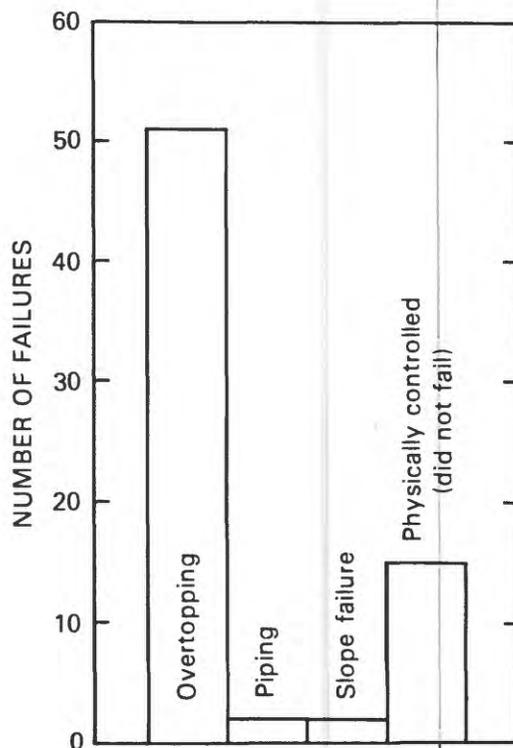
Figure 5.--Graph showing modes of failure of landslide dams, based on 55 failures from the literature and the authors' experience.

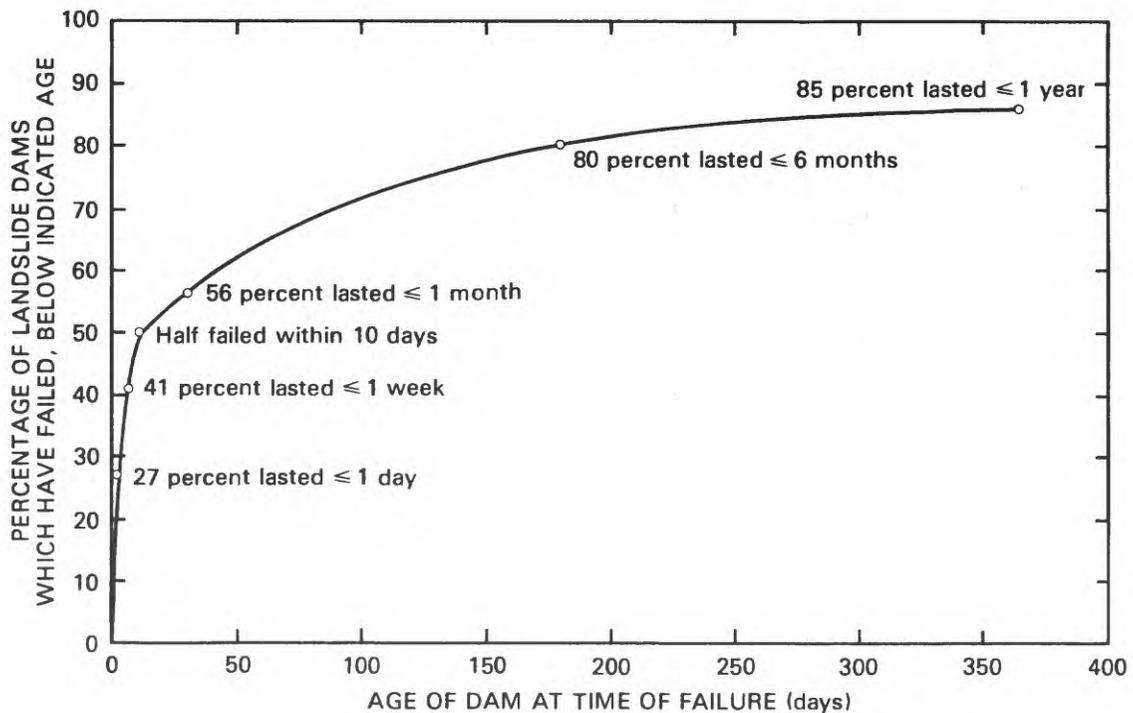
Figure 6.--Graph showing length of time before failure of landslide dams, based on 73 cases from the literature and the authors' experience.

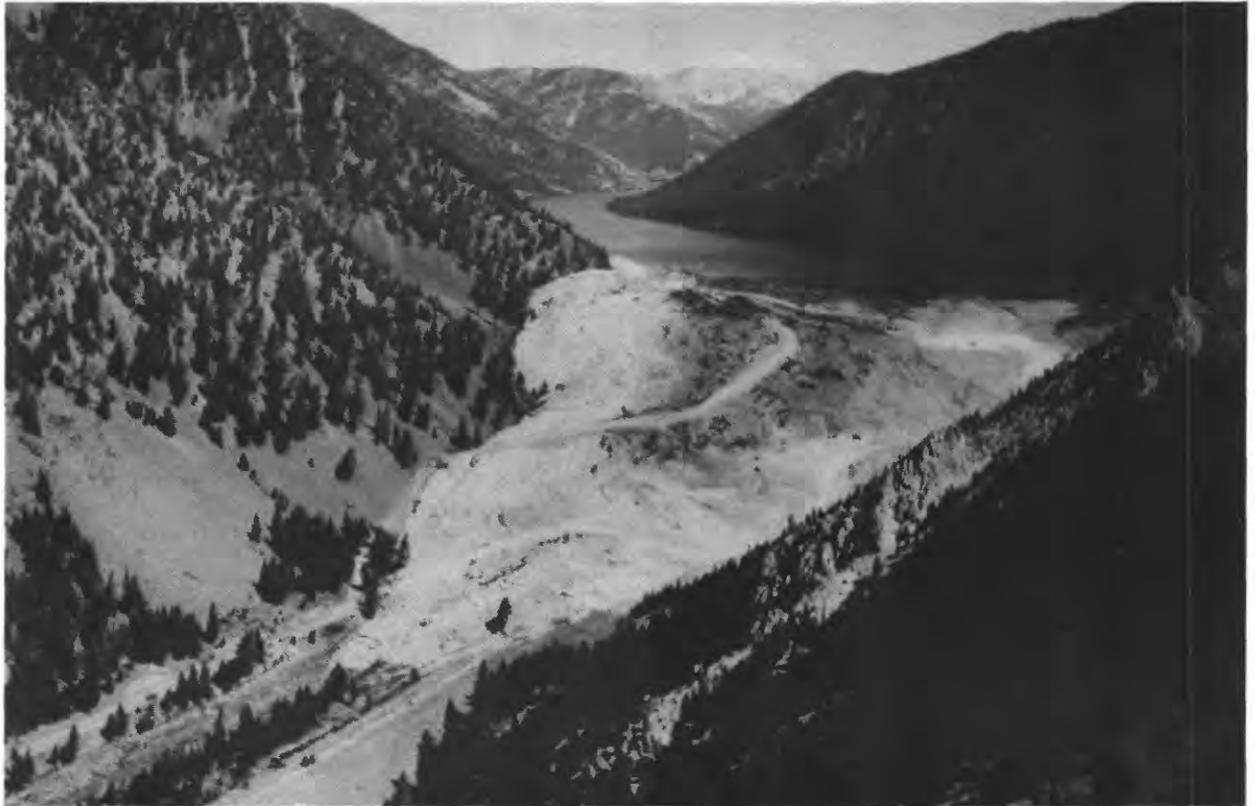
Figure 7.--Photograph of the landslide dam formed by the 1959 Madison Canyon landslide, Montana, and Earthquake Lake, which it impounds. (Photograph by J. R. Stacy, U.S. Geological Survey)

The most simple and most common method for stabilizing landslide dams has been construction of channelized spillways, either across adjacent bedrock abutments or directly over the landslide dams. A well-known example of a successful spillway across a landslide dam is the spillway constructed in 1959 by the U.S. Army Corps of Engineers on the Madison Canyon landslide, Montana (Harrison, 1974; fig. 7).

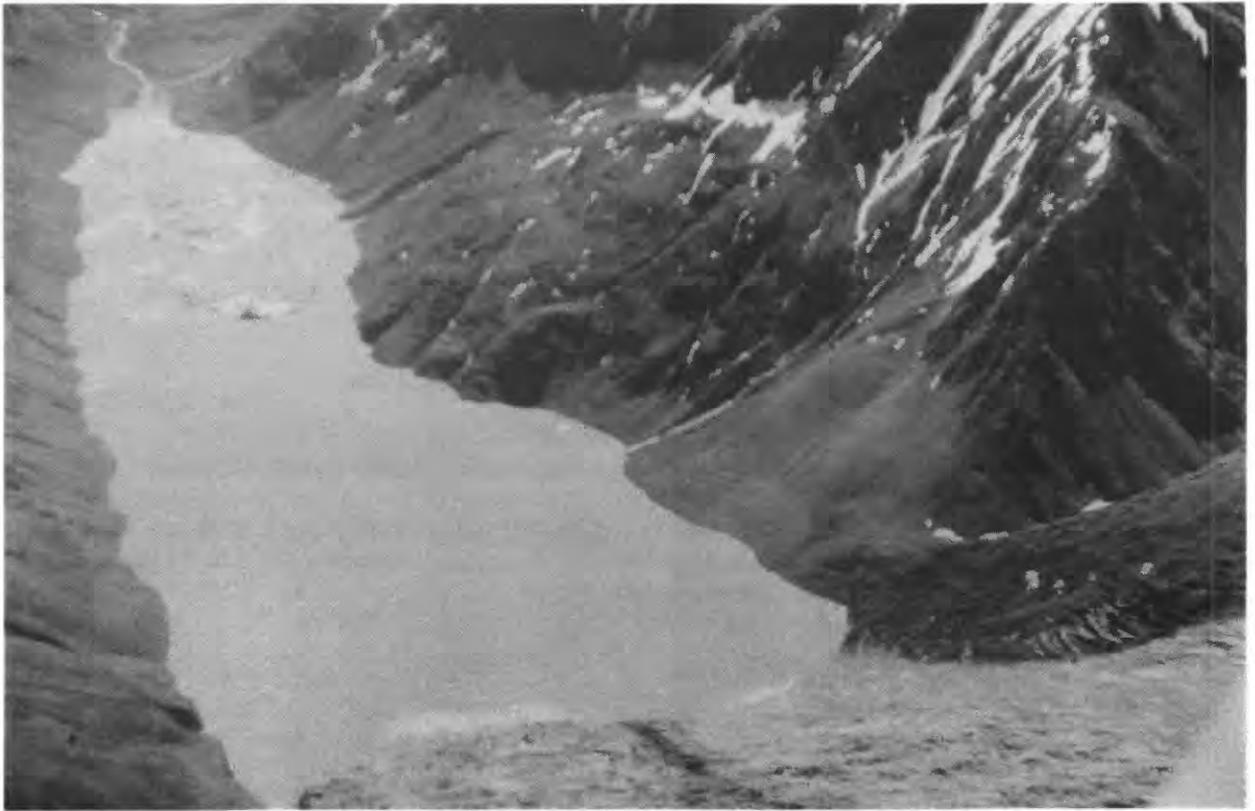
Figure 8.--Photograph of a glacier-dammed lake in a tributary valley (type D, table 4), Coast Mountains, Alaska. Note the strand lines indicating previously higher lake levels. (Photograph by W. C. Bradley, University of Colorado)

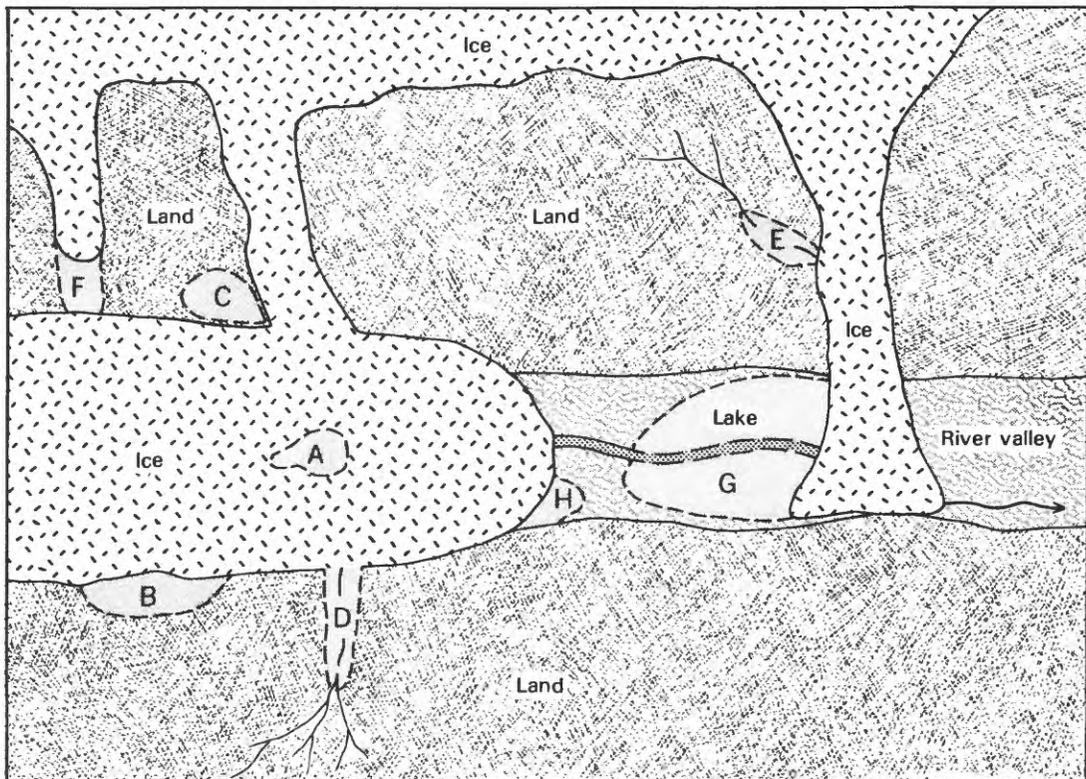
Figure 9.--Diagram showing classification of glacial-ice dams, keyed to table 4. (Modified from Maag, 1969; and Blackut and Ballantyne, 1976)

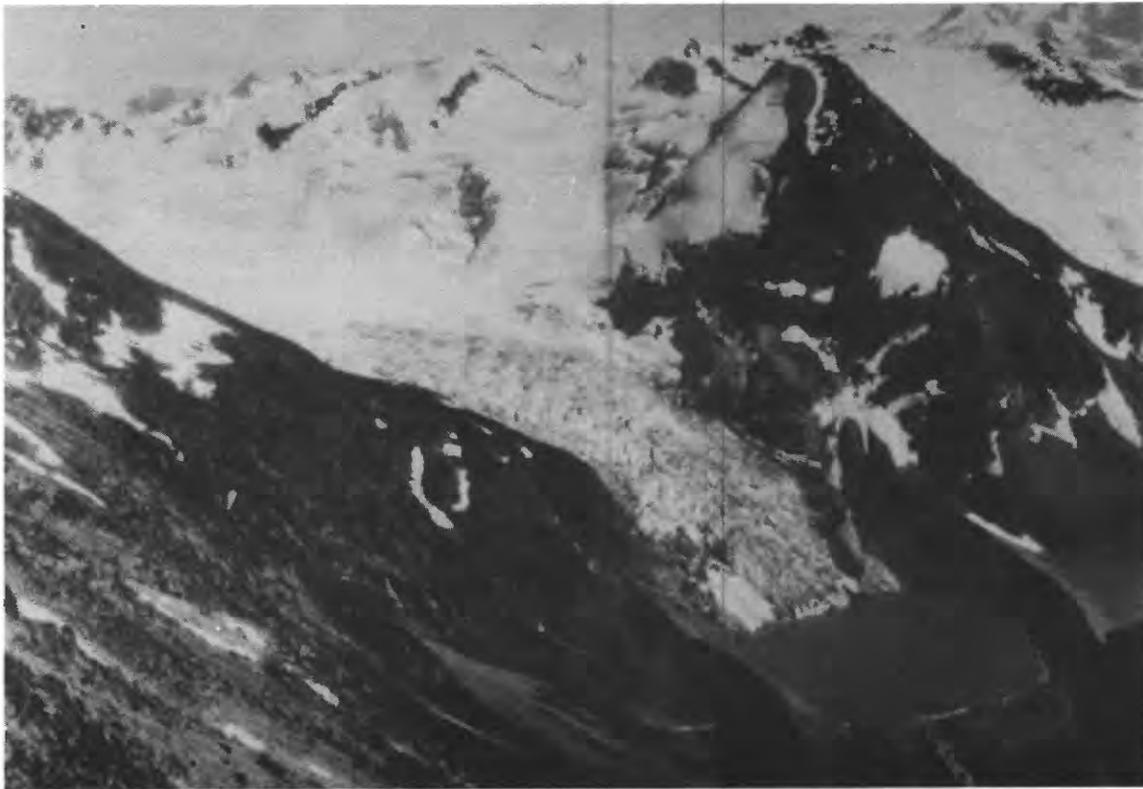
Figure 10-A.--Photograph of Nostetuko Lake, a neoglacial moraine-dammed lake, and Cumberland Glacier, British Columbia, Canada, in July 1977. (Photograph by J. M. Ryder, courtesy of Michael Church, University of British Columbia)

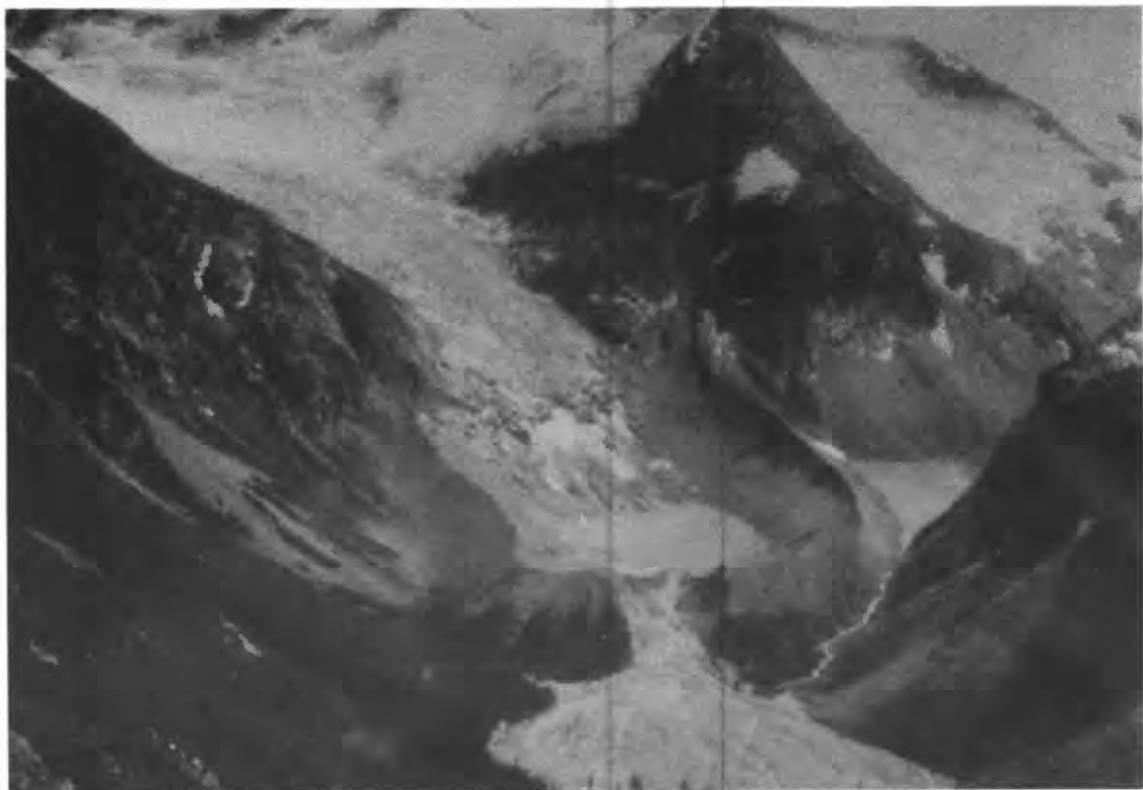
Figure 10-B.--Photograph of Nostetuko Lake and Cumberland Glacier, British Columbia, Canada, in August 1983, after failure of the moraine dam. (Photographs by Michael Church, University of British Columbia)

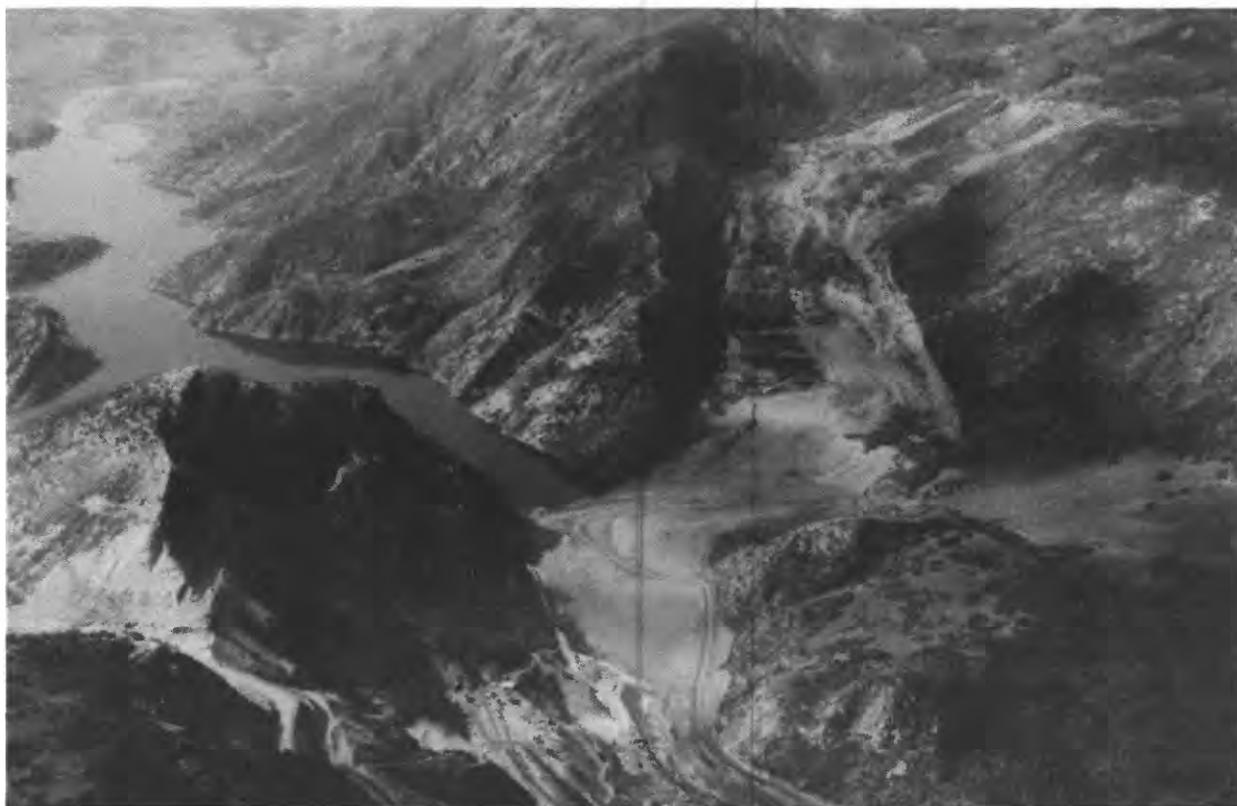
Figure 11.--Photograph of the 1983 landslide at Thistle, Utah, and its temporary impoundment, Thistle Lake, in September 1983. The lake inundated the town of Thistle and was drained late in 1983 by a bedrock tunnel constructed through the mountain at lower left.

Because landslide dams tend to occur in mountainous areas, certain types of structures, such as hydroelectric plants, may be rendered inoperable because of inundation of intakes, flumes, generators, and transportation and transmission facilities (Schuster and Costa, 1986b). A recent example of the consequences of upstream flooding from a landslide dam occurred in April 1983, when a 22-million cubic meter landslide in central Utah dammed the Spanish Fork River and flooded the town of Thistle, Utah (Kaliser and Fleming, 1986; fig. 11).

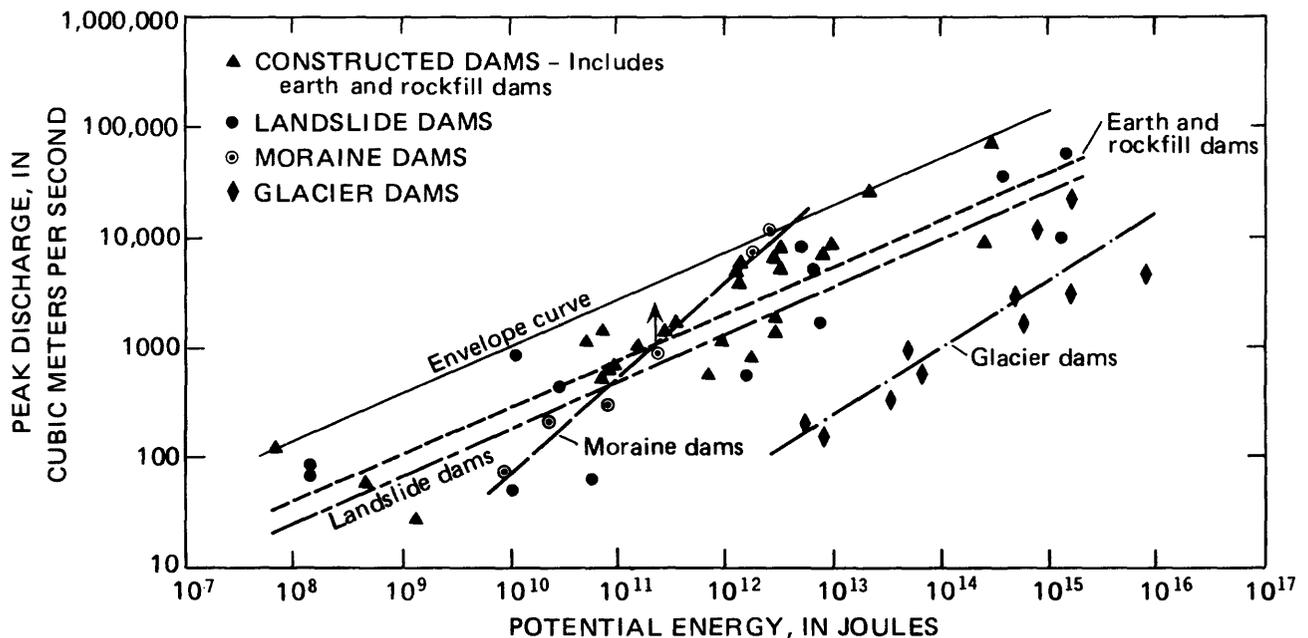
Figure 12.--Graph showing potential energy versus peak discharge for various types of dam failures. Dashed lines are least-squares regression lines for earth- and rock-fill, moraine glacial ice, and landslide dams. Solid line is the envelope curve for all dam-failure data. Data from Costa (1985) and Table 5.

A dam failure is a complex hydrologic, hydraulic, and geologic phenomenon, controlled primarily by the failure mechanism and characteristics and properties of the dam. One way to compare different kinds of dam failures is to investigate the relationship between the specific energy of the lakewater behind the dam prior to failure and the flood-peak discharge from the failure of the dam (fig. 12). Potential energy of a lake behind a dam can be computed as the product of dam height (meters), volume (cubic meters), and specific weight of water (9,800 newtons/cubic meter). Dam-failure flood peak discharges used in figure 12 come from tables 3 and 5 and from Costa (1985).

Glacier-dam failures commonly involve the enlargement of subglacial or englacial tunnels during failure. This enlargement requires time and produces relatively small peak discharges compared with other kinds of natural and constructed dams with the same potential energy. Landslide dams are typically much wider than constructed earth- and rock-fill dams and involve much larger volumes of material. The Madison Canyon landslide that dammed the Madison River in 1959, forming Earthquake Lake, had a base width five to eight times as great as would have been used in building a rock-fill dam of the same height (Knight and Bennett, 1960). In figure 13, transverse sections of the Mayunmarca landslide dam in Peru and the Nostetuko moraine dam in British Columbia are compared to the Oroville Dam, a large earth-fill dam in California. The landslide dam in Peru is higher at the abutments and almost as high as the constructed dam in the center, but is over three times as wide. When a landslide dam is overtopped, much more earth material commonly is present for water to erode before a full breach is developed than is the case for constructed embankment dams. This is indicated by the parallel but displaced positions of landslide and earth- and rock-fill dam regression lines shown in figure 12.

Moraine dams are relatively high and narrow compared to many landslide dams and have much steeper slopes. The predominate failure mechanism for moraine dams (wave overtopping) leads to rapid erosion of cohesionless sandy and gravelly till comprising many moraine dams. The rapid breach development in moraine-dam failures, compared to other kinds of dams, is primarily responsible for the location of the regression line in figure 12.

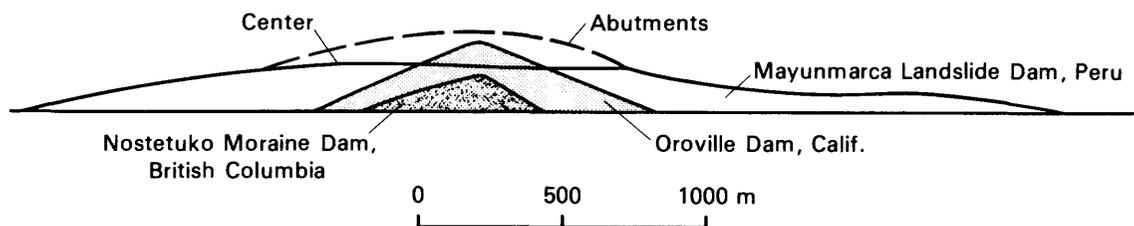
Figure 13.--Diagram showing cross section of Mayunmarca landslide dam, Peru, and Nostetuko moraine dam, British Columbia, compared to the maximum cross section of a large earth-fill dam at Oroville, California. (Modified from Lee and Duncan, 1975)
