**Observed Performance of
Dams During Earthquakes**

Volume III

February 2014

Prepared by the USSD Committee on Earthquakes

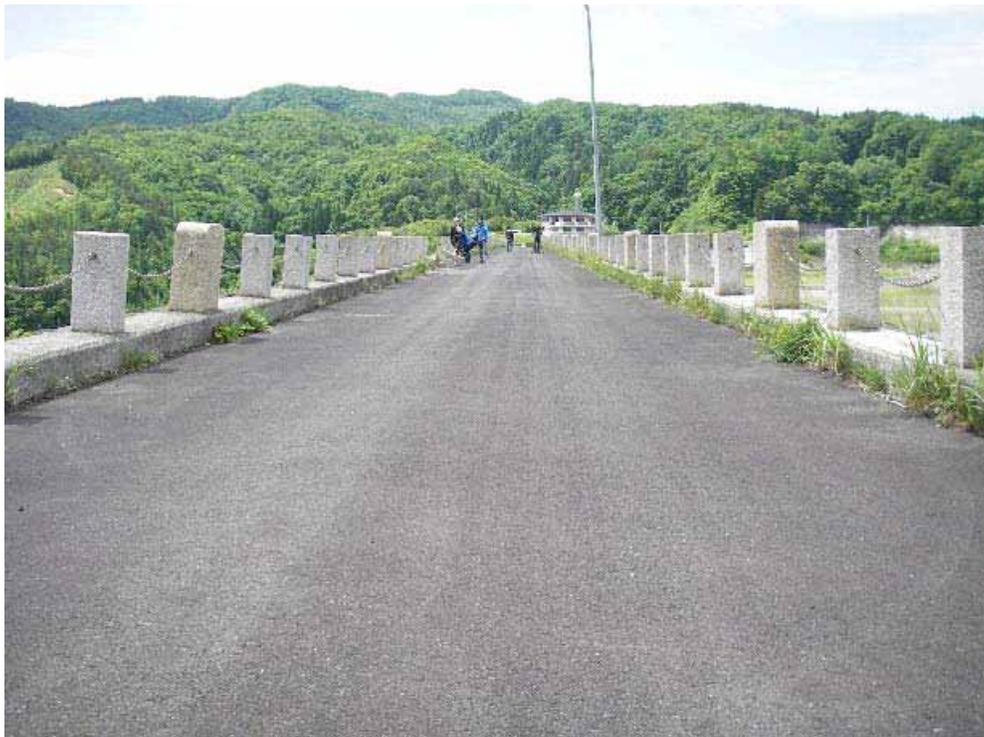
Figure 4. Dam crest showing tilting and fallen monuments (from Yamaguchi et al., 2008).

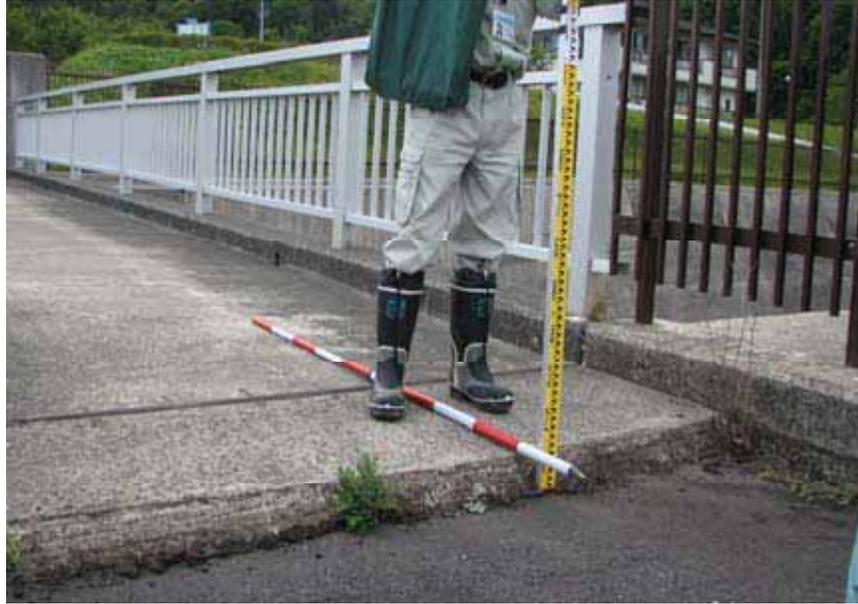
Figure 5. 10 cm of embankment settlement at the spillway (from Tani, et al., 2008).

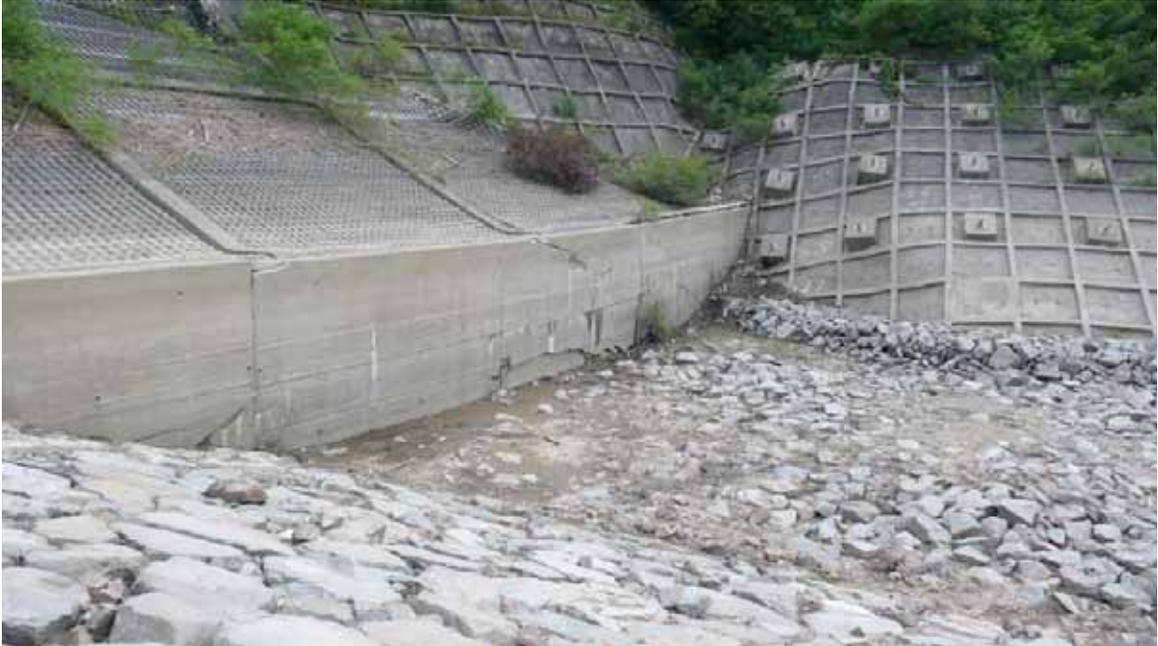
The minor cracking of a retaining wall that is part of the spillway structure shown in Figure 7 may be due to offset on a short fault that moved as a result of the earthquake

shaking. Figure 8 identifies locations of road damage that is in line with the cracking. This cracking is the only reported damage to appurtenant structures. (Kayen et al., 2008)

Figure 7. Cracking of spillway retaining wall structure (from Kayen et al., 2008).

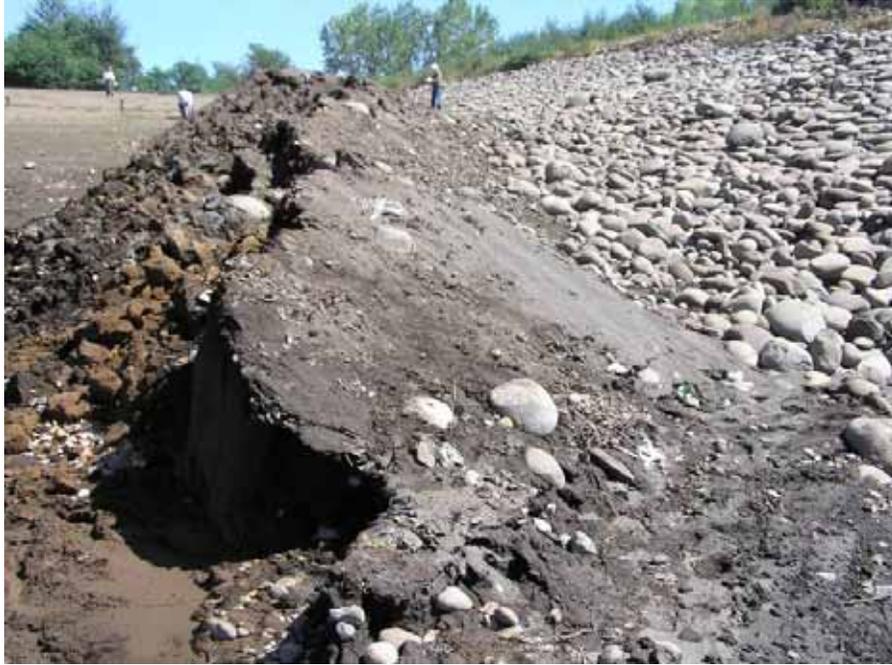
Figure 7. Slough A — side view of bulge (from Bray et al., 2010).

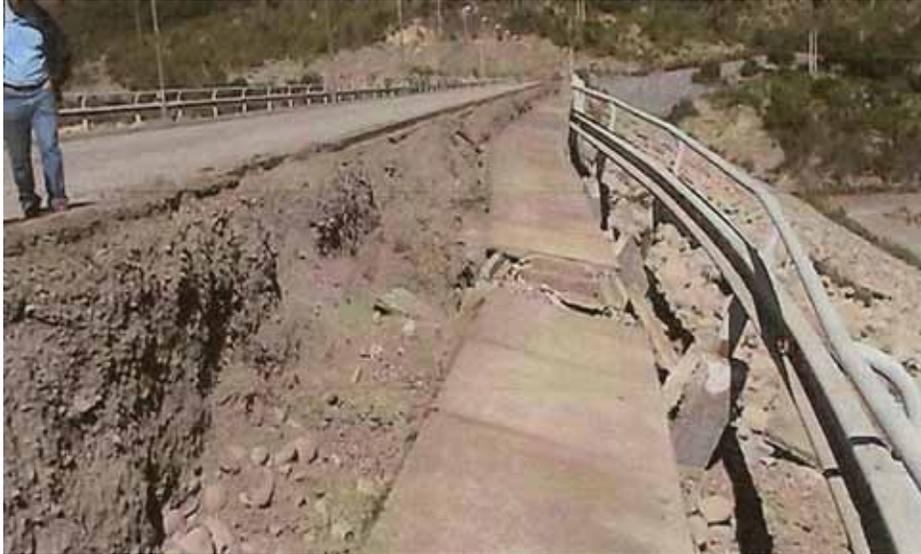
Figure 3. Displaced electrical conduit on downstream edge of crest (from Noguera 2010).

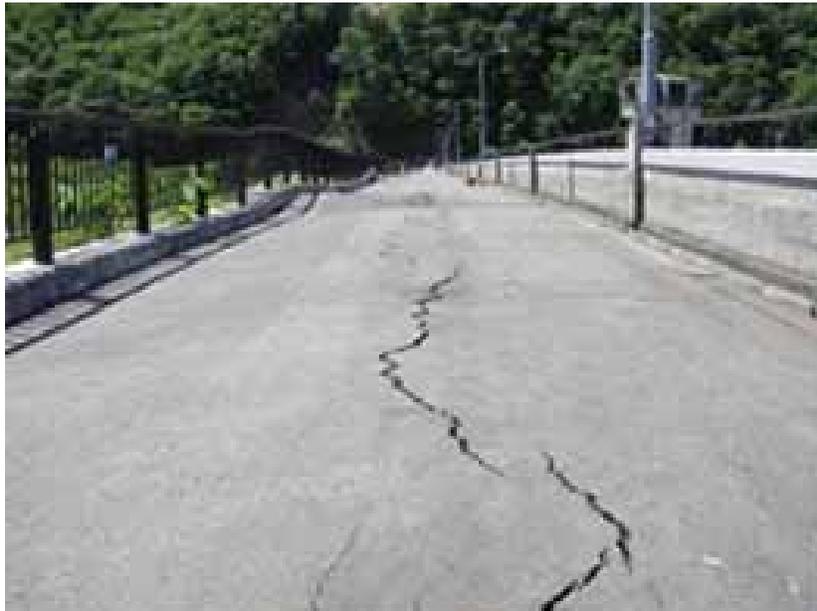
As shown in Figure 5, the earthquake motions formed 50 cm high waves in the dam crest pavement (Yamaguchi and Iwashita 2008). The phenomenon was caused by the embankment settling and the concrete piers from the construction trestle not yielding. Figures 6 and 7 show damage caused by movement of some large rocks in the upper part of the downstream face, as would be expected from the high accelerations. The maximum earthquake caused crest settlement was about 55 cm. The embankment had settled a maximum of about 43 cm by 2007. Figure 8 shows the seismically induced movements at five sections along the dam.

Figure 5. Dam crest – note waves in pavement (from Yamaguchi 2010).

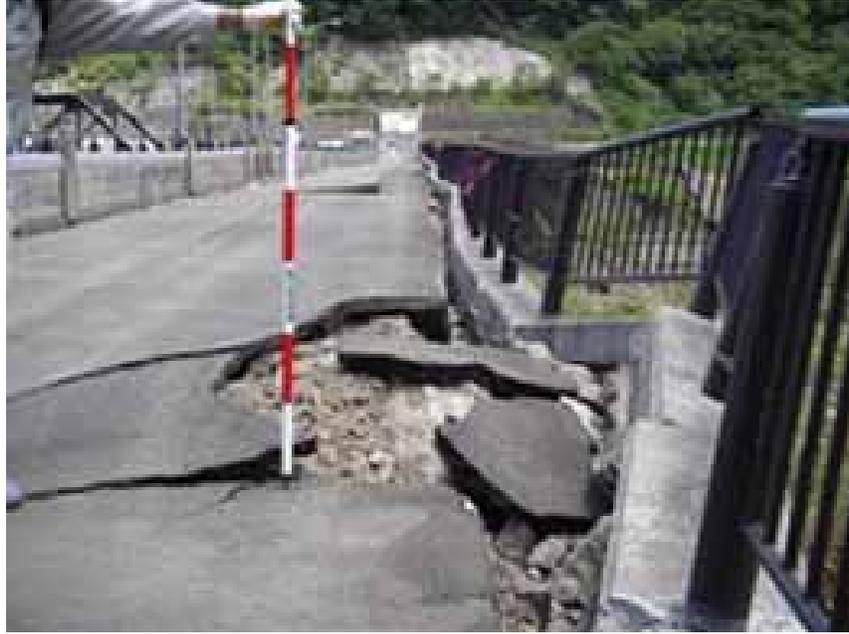
Figure 6. Deformation at downstream edge of crest. (from Yamaguchi, 2010).

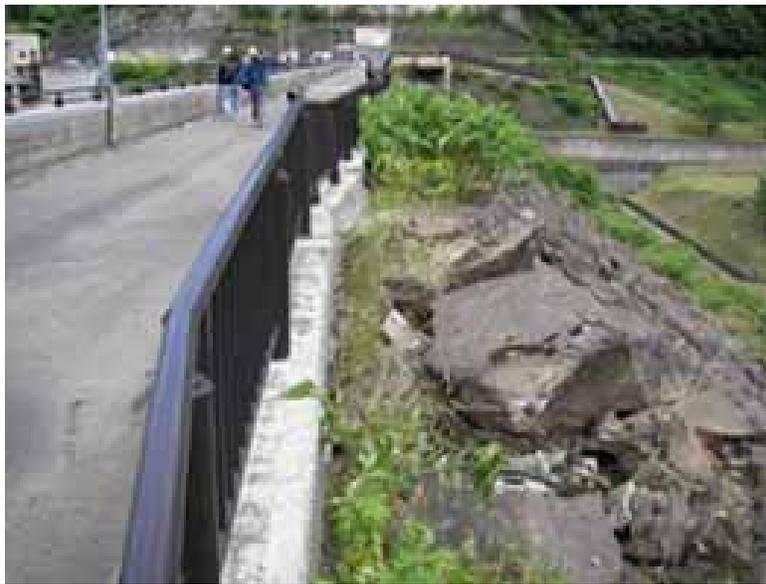
Figure 7. Displaced rock on downstream slope (from Yamaguchi, 2010).

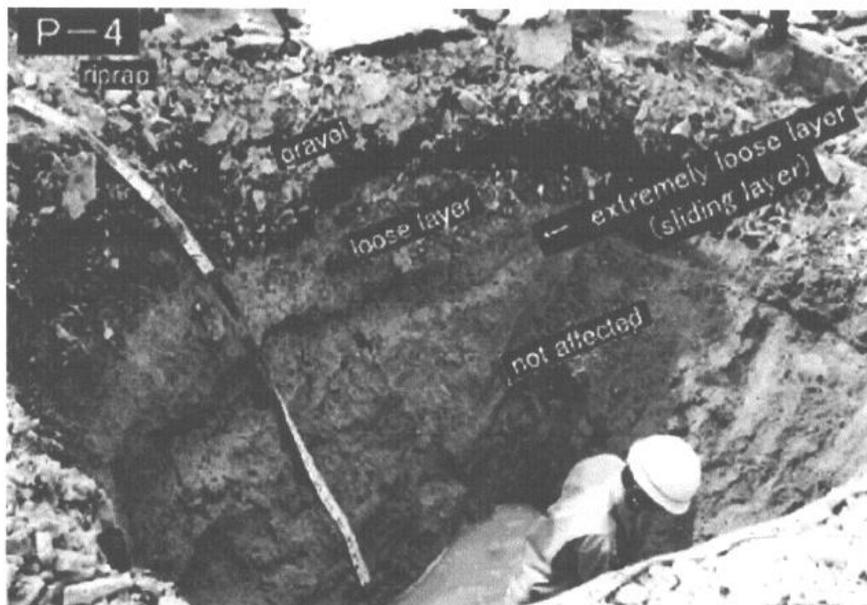
Fig.3 View of pit (P-4) excavated at the failure zone of the dam

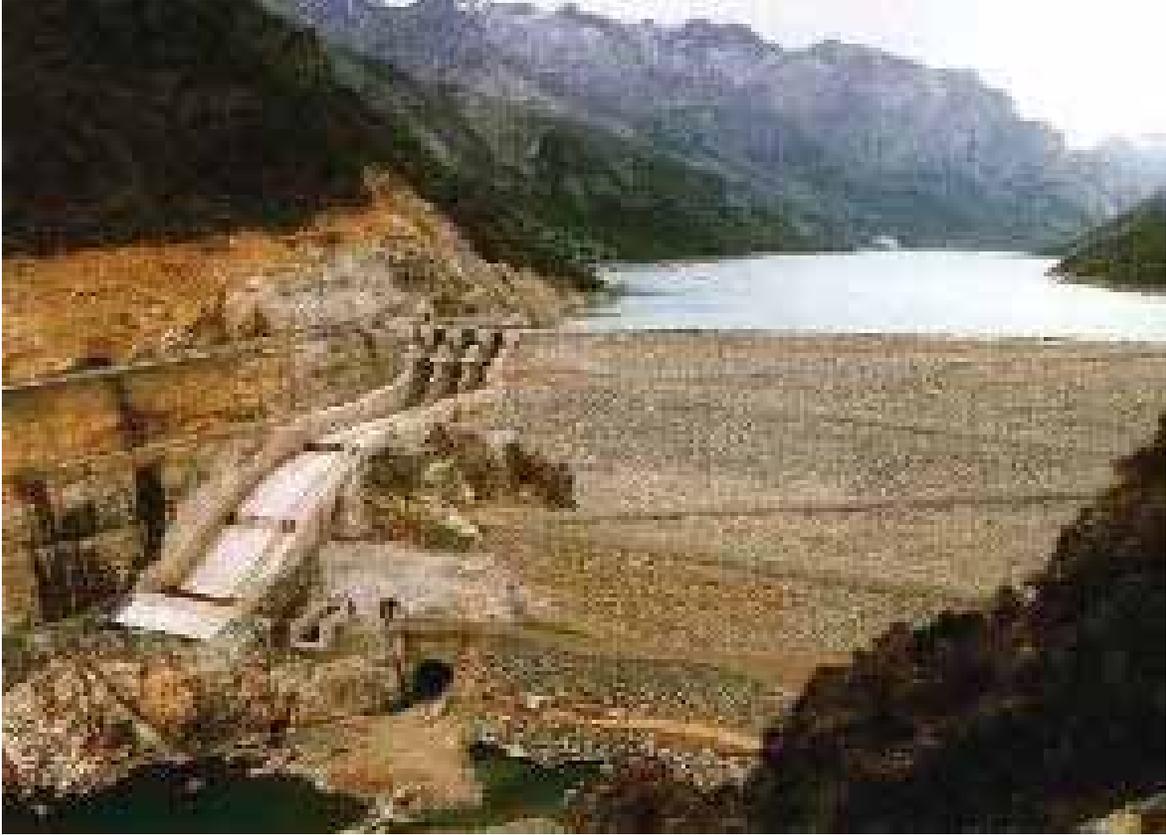
Transverse cracks “4 to 5 cm thick” were reported on the crest at the abutments. Transverse cracking in asphalt pavement at abutments is common in embankment dams with steep abutments (Figure 2) and a small crest length to dam height ratio, 3.4:1.

Figure 2. Photograph from downstream (from Vicini).

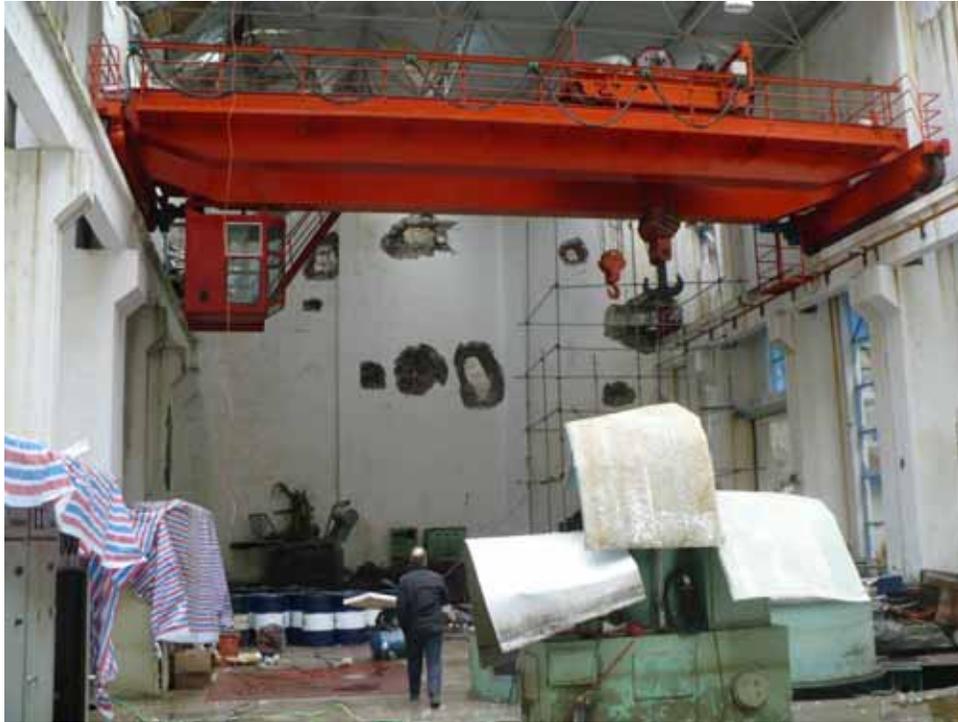
The power house, control center buildings and operators homes were bombarded by rockfalls. The plant roof and walls were damaged and the plant filled with rocks, damaging the equipment (Figures 6 and 7). A rockfall ruptured a penstock coupling. The resulting spray was 80 meters high and caused more rocks to fall. The powerhouse was flooded. Falling rock heavily damage a tailrace flume. Little repair had been completed on these remote facilities when the photographs were taken 10 months after the earthquake.

Figure 6. Inside Shapai Powerhouse (Babbitt).

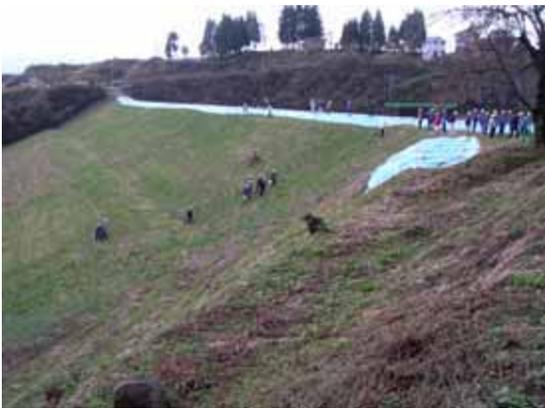
The seismic damage to the Asagawara Dam included the formation of cracks at the dam crest and stepped settlement on the upstream slope. Along the crest, several cracks ran transverse to the dam axis and settled stepwise with a maximum difference at the centerline of 1.7 feet. The settlement of the dam body at maximum was 2.5 feet. No seismic deformation was observed on either the upstream or downstream slopes of the dam.

Based on the post earthquake investigation, the cracks and steps along the dam crest extended deeper in the upstream direction and were found to be no deeper than 10.8 feet. The crest deformation has been attributed to the insufficient compaction of the upper 3 meters of the dam body.

Downstream view
(from Omachi)

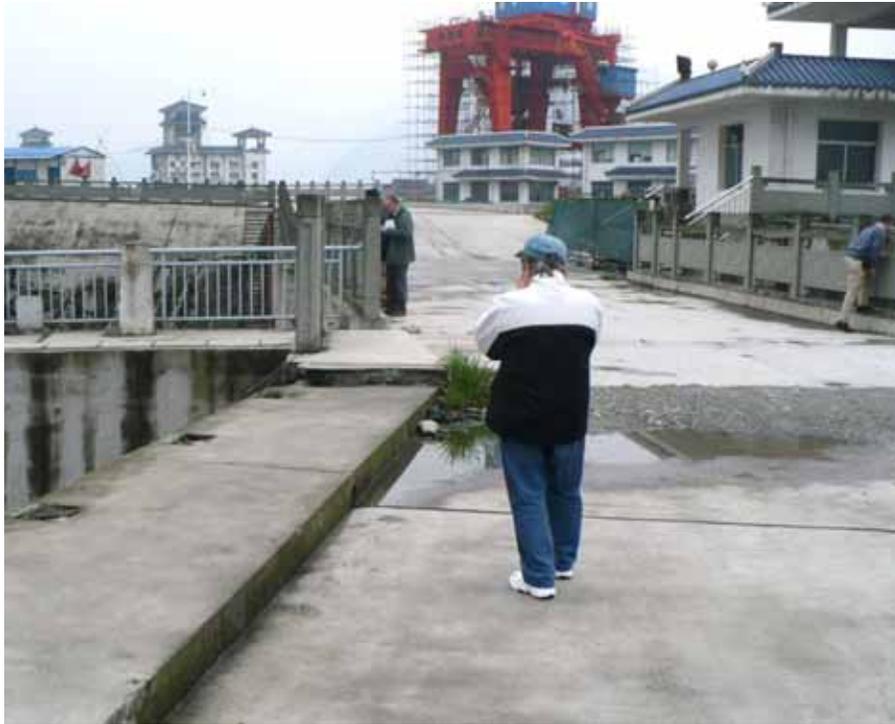
Figure 7. Embankment settlement at spillway wall (Babbitt).

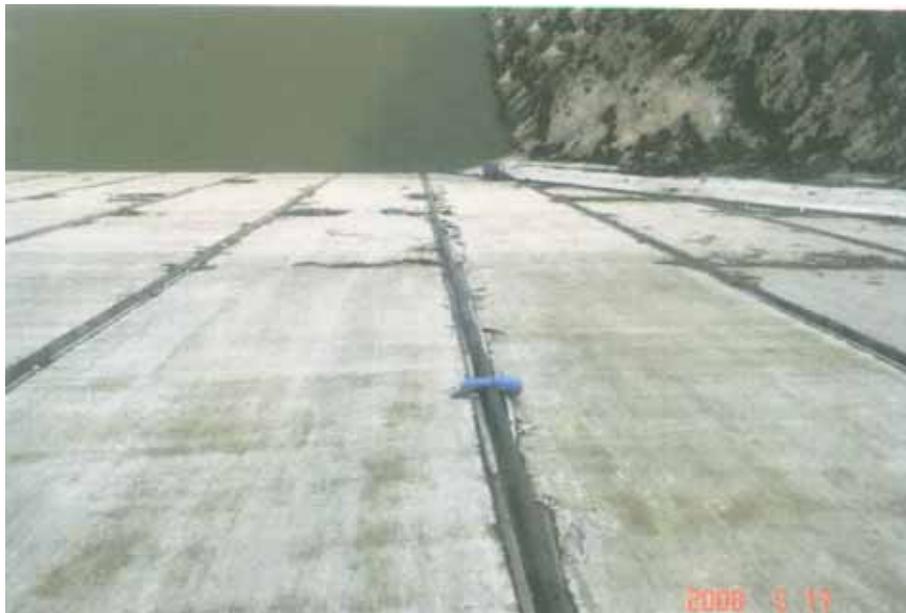
Overall, the face slab and water stops performed as designed. The damage was mainly above the reservoir water level. A vertical contraction joint near the maximum section and another one near the base of the steep left abutment (Figures 8 and 9), the highest horizontal construction joint (Figures 10 and 11), and the slab-parapet/retaining wall joint near the left abutment suffered enough compression damage that they were rebuilt. The parapet/retaining wall suffered compression damage near the maximum section and extension damage near the abutments, requiring repair. Campos Novos, Barra Grande and Mohale Dams, high CFRD dams with steep abutments, have suffered similar slab and wall damage due to post construction settlement from embankment volume loss, with no earthquake shaking.

Figure 8. Face slab joint 5/6 near left abutment (from Wen).

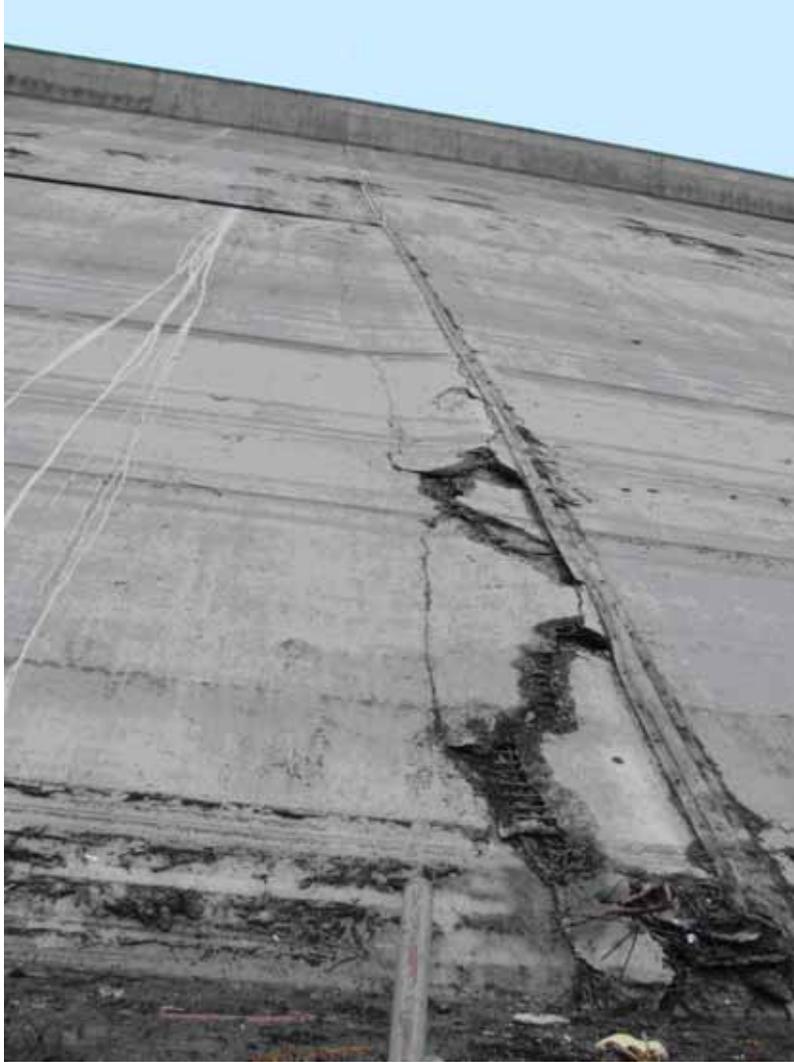
Figure 9. Face slab joint 23/24 near maximum section (from Chen).

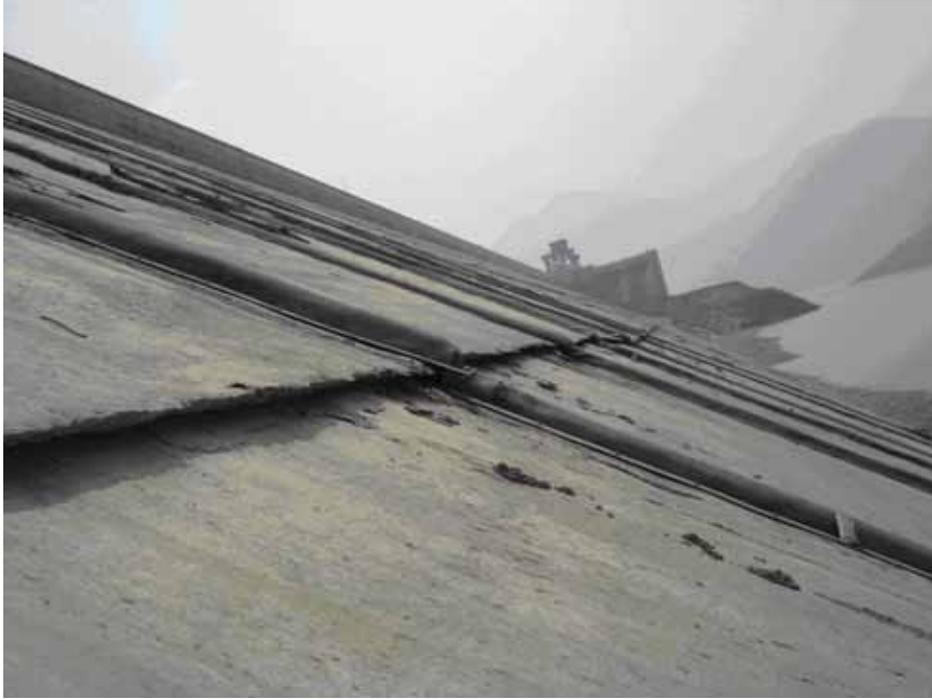
Figure 10. Highest horizontal construction joint (from Chen).

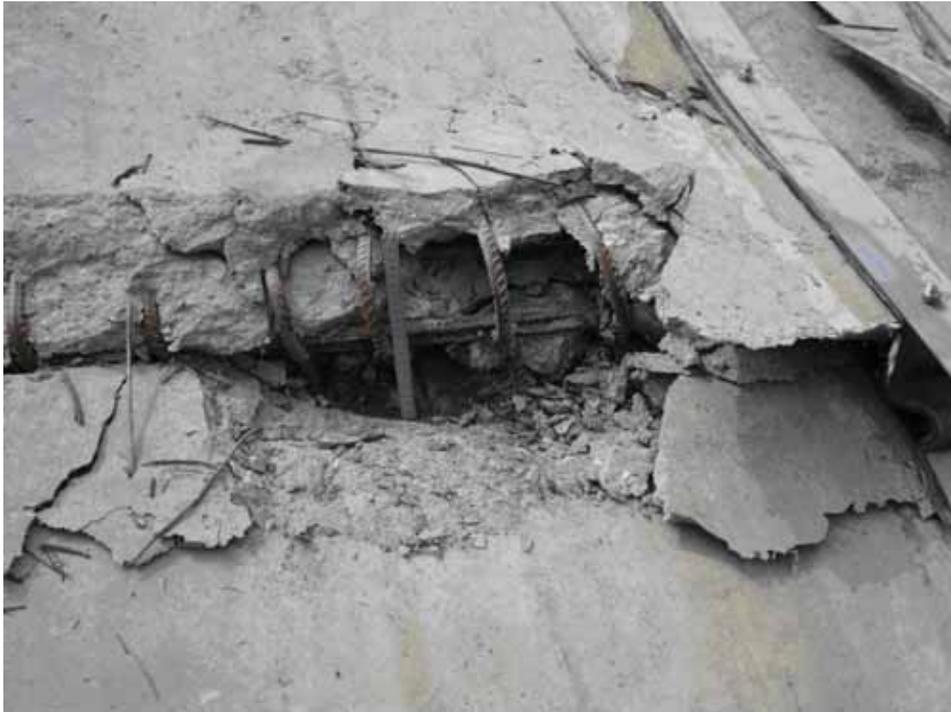
Figure 11. Highest horizontal construction joint detail (from Chen).
